**HAVERFORDWEST THE CRYPT,
PEMBROKESHIRE
(SM 95226 15560)
ARCHAEOLOGICAL WATCHING BRIEF**

December 2009

RHIF YR ADRODDIAD / REPORT NO. 2010/5
RHIF Y PROSIECT / PROJECT RECORD NO. PRN 98681

HAVERFORDWEST, THE CRYPT ARCHAEOLOGICAL WATCHING BRIEF

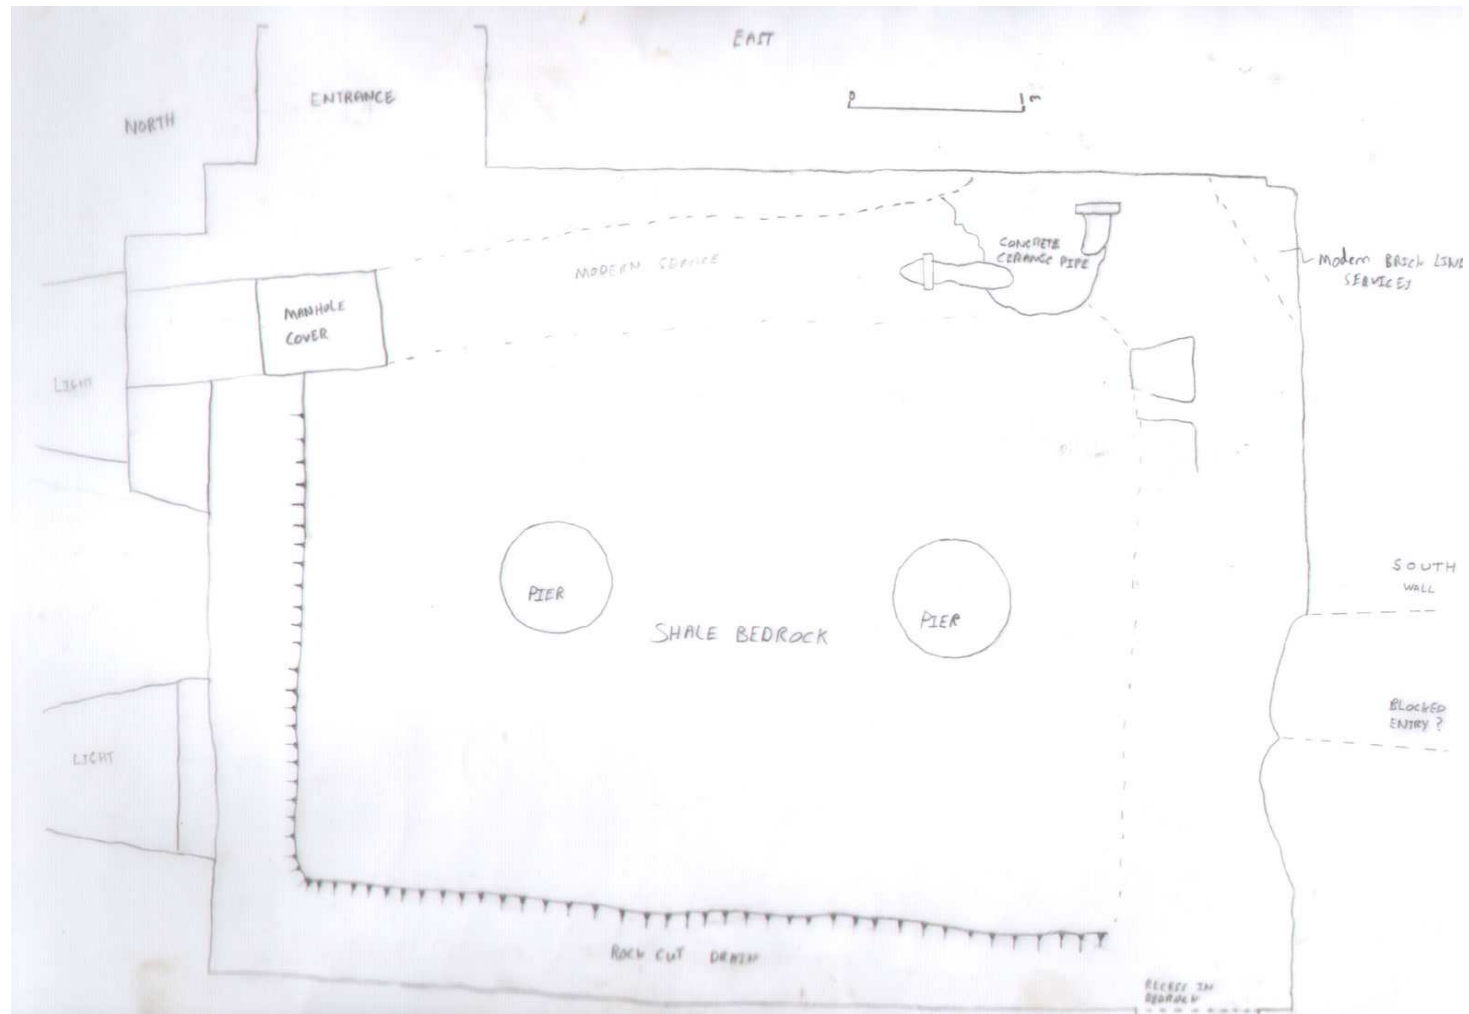
Figure 3: Plan showing drain on west and north side of undercroft after excavation.

Following the removal of the existing gravel surface (0.04m thick), a number of large flagstones were revealed around the edges of the room. These were at first thought to be the remains of a floor surface. Closer examination, however, demonstrated that the stones were capping for a drain running along the base of all four internal walls of the undercroft. The drain consists of a rock cut channel measuring 0.20m in deep and 0.43m wide in the southwest corner and 0.23m deep and 0.54m wide in the northwest corner.

The drain cut was lined with mortared vertical stone slab sides, and was capped with stone slabs and occasionally roofing slates.

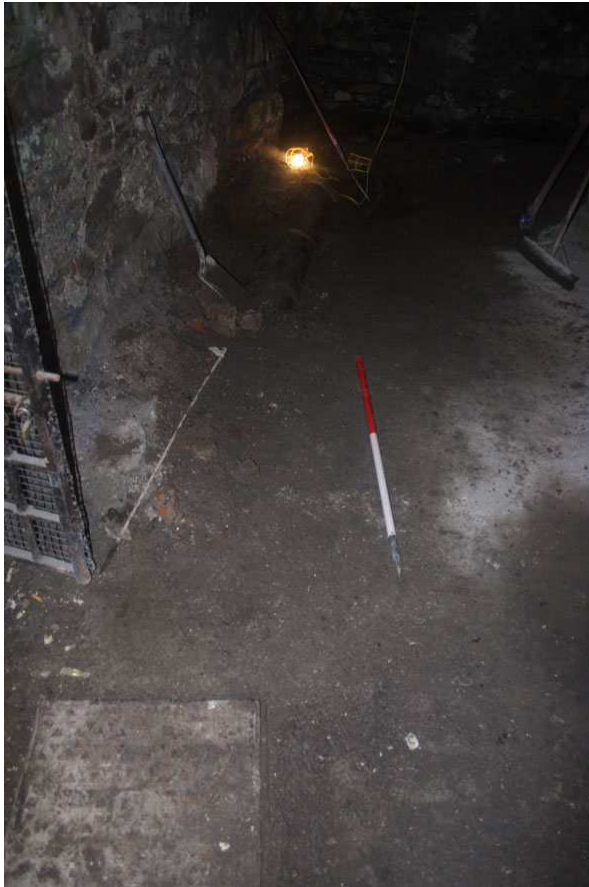
Photo. 3: Looking along eastern wall of undercroft showing modern services.

On the eastern wall and part of the southern wall the drain was cut by modern services. The modern services may have destroyed evidence for the drain exiting through the north wall to link with a drain elsewhere.

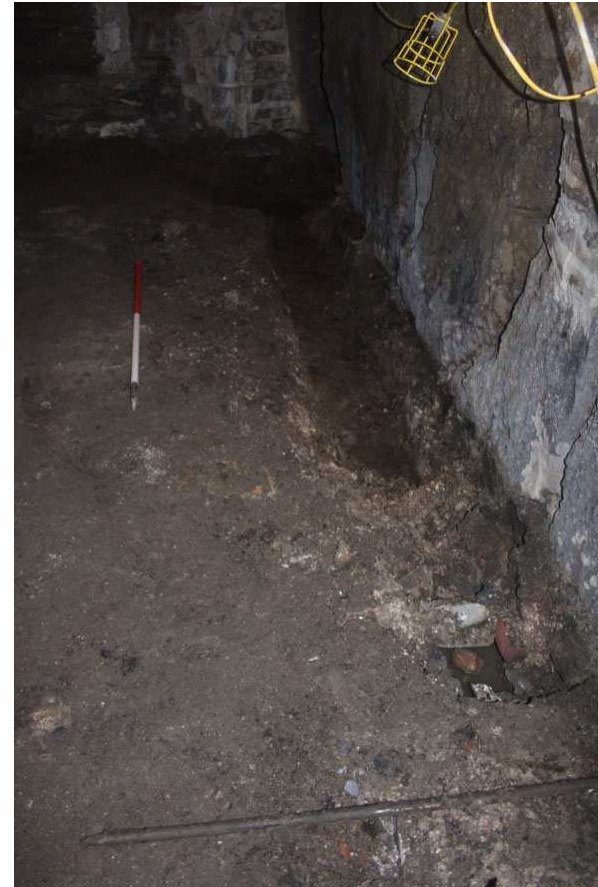
Photo. 4: Looking south along western wall of undercroft showing partly excavated drainage channel.

The drain contained a dark brown silty clay with occasional animal bone and fragments of post medieval glass and ceramics. Modern food wrappers were also noted, but these may have been introduced to the drain by rodent activity.

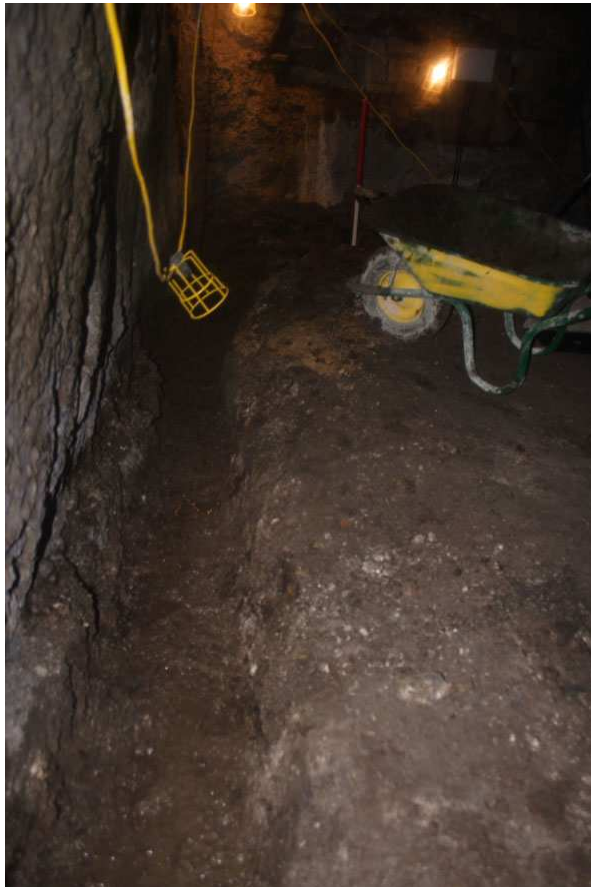
Photo. 5: Looking north along western wall of undercroft showing rock cut drainage channel.

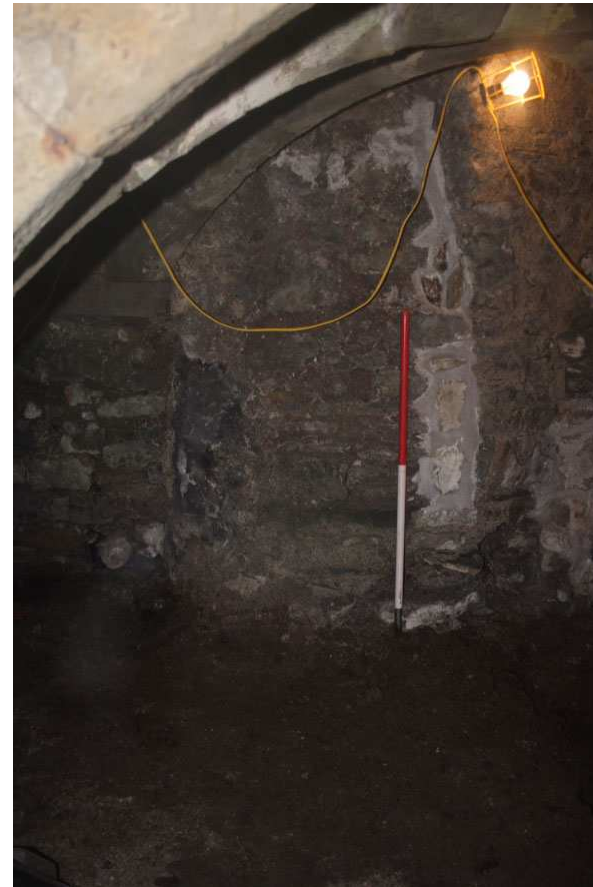
Photo. 6: Looking south at possible medieval doorway.

Although impossible to date with certainty, the drain running along the base of the undercroft walls appears to be a post medieval modification, presumably intended to dry out the cellar. Ludlow (2005) mentions that there is a possible door situated in the south west corner of the undercroft which may have been the original entrance to the undercroft. The blocking up of this entrance, and other changes around the undercroft may have caused drainage problems, which the drain was intended to alleviate.

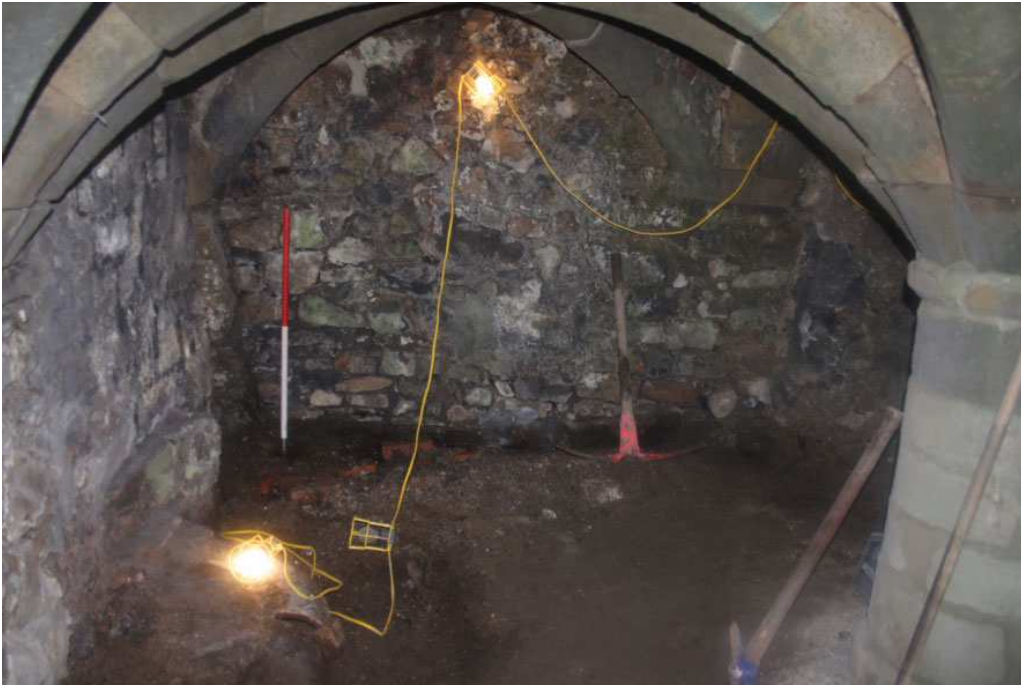
Photo. 7: Photo looking towards southern wall of undercroft
