EXPLORATION TYWI!

WERN FAWR, LLANDEILO

ARCHAEOLOGICAL EVALUATION 2009

2010/06
98682

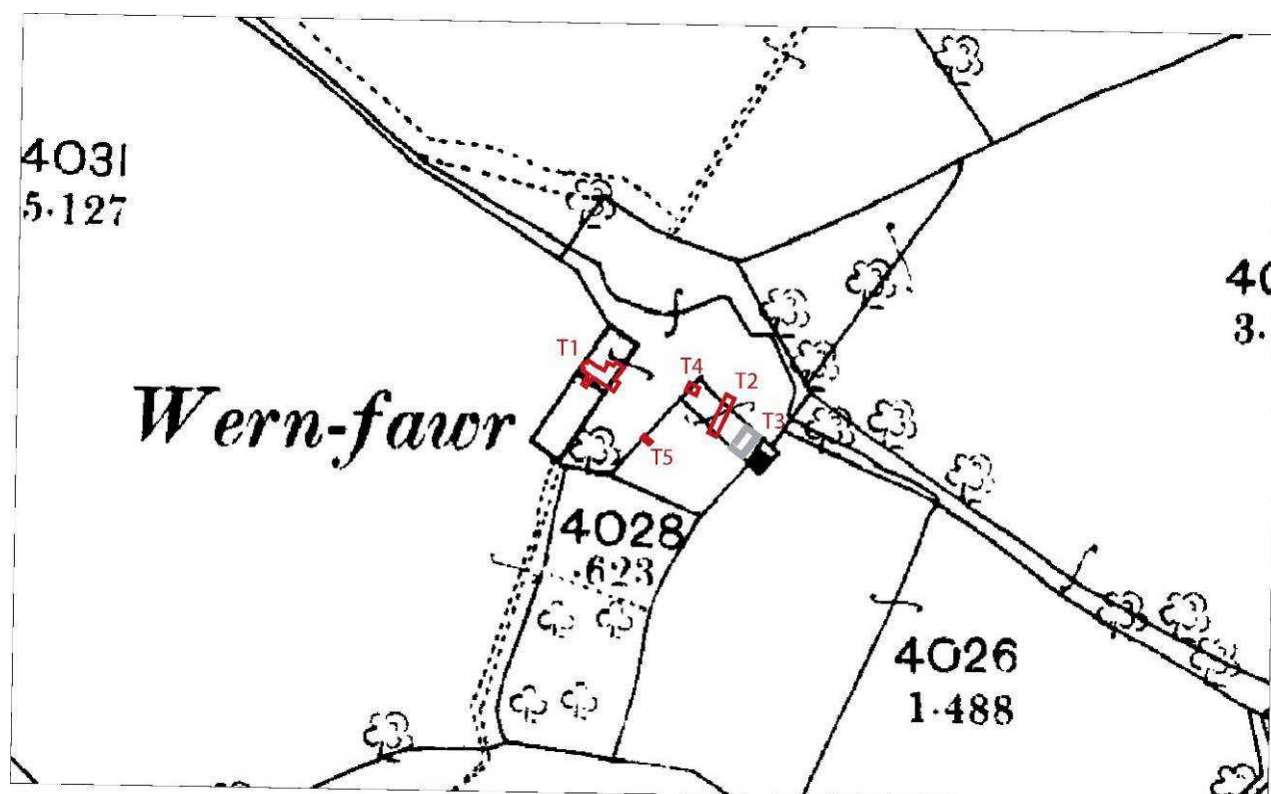
Fig 3: Trench locations overlaid on an extract from the 1;2500 1st edition Ordnance Survey map of 1886.

Trench 2 was positioned primarily to locate and investigate the easternmost farm building as depicted on the 1st Edition Ordnance Survey map of 1886 (fig 3). This farm building also appears on the tithe map of 1841. A consistent topsoil (201) of mid grey-brown silty-clay was encountered throughout the trench, which contained numerous small fragments of assorted porcelain and various glazed gravel-tempered wares, along with small fragments of ceramic drying tiles, glass, a clay pipe stem, a small brass handle and a fragment of burnt bone. A thin deposit of similar soil (202) was spread across the northern part of the trench for c.2m, underlying the topsoil. This deposit contained a similar range of finds.

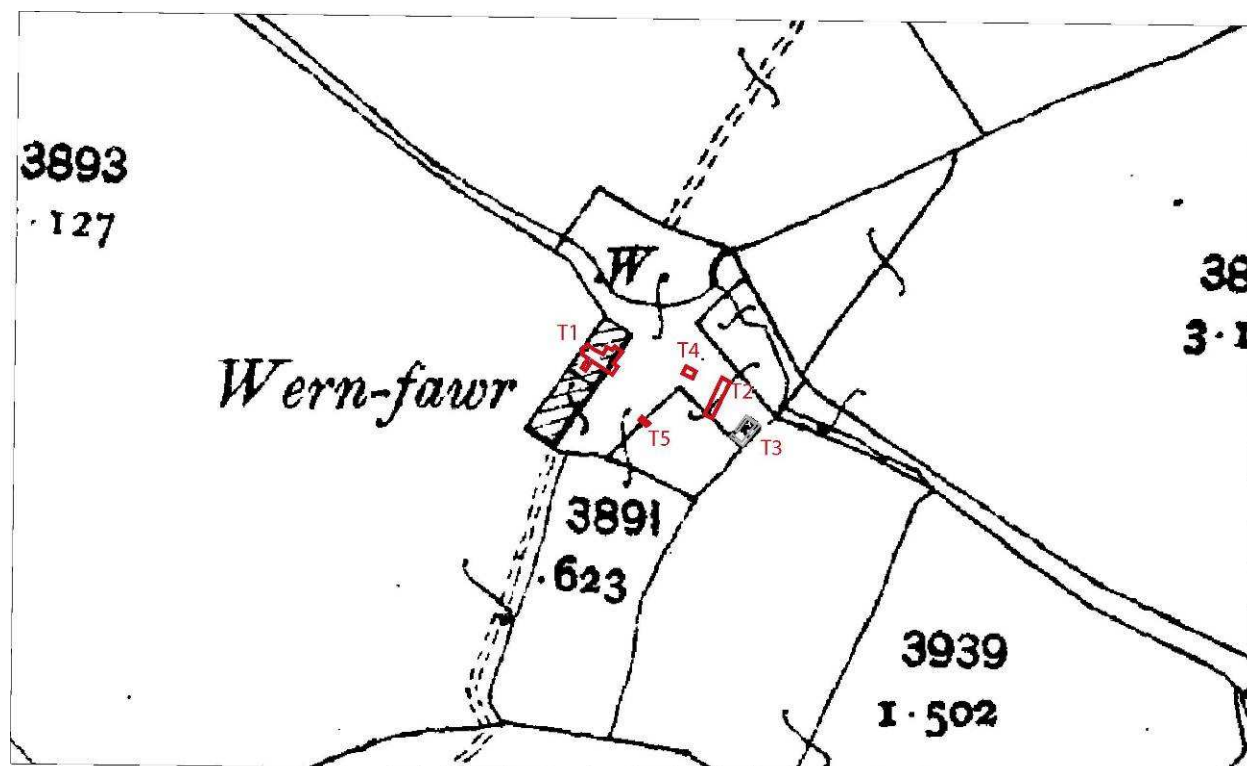
Fig 4: Trench locations overlaid on an extract from the 1;2500 2nd edition Ordnance Survey map of 1906.

By the time of the 2nd Edition Ordnance Survey map of 1907 (fig 4) the easternmost building has gone, leaving the westernmost subdivided building and a small possible pigsty to the east. The 1911 census records John Thomas and his wife living there along with a groom and a young woman engaged in dairy work. Given that only a single building is still standing, it would appear to be divided between the main domestic farmhouse, along with an attached dairy. This farm building was destroyed by fire in the same year, presumably John Thomas and his wife were living there at the time. A photograph reportedly taken shortly after the fire shows substantial destruction to the site (photo 1), the roof has gone and the interior of the domestic section (the northern end) gutted, with what appears to be almost total destruction of the adjoining dairy.

This trench was sited to investigate visible wall remains amongst a clump of trees in the southeast corner of the farmstead site and as such involved mainly the clearance and recording of the visible walling with little excavation (photos 15 – 17). These walls appeared to be on the line of the easternmost farm building but also in the area of a small building marked on the 1906 Ordnance Survey map, assumed to be pigsty (fig 4).

The former southern boundary to the farmstead is now visible as a low bank lying just to the north of the current fenceline. The central boundary bank extended northwards from this bank for c.14.7m before coming to an abrupt end. A continuation of this bank is no longer visible above ground, but this would appear to correspond to the length of the bank as depicted on the 1906 Ordnance Survey map (fig 4).

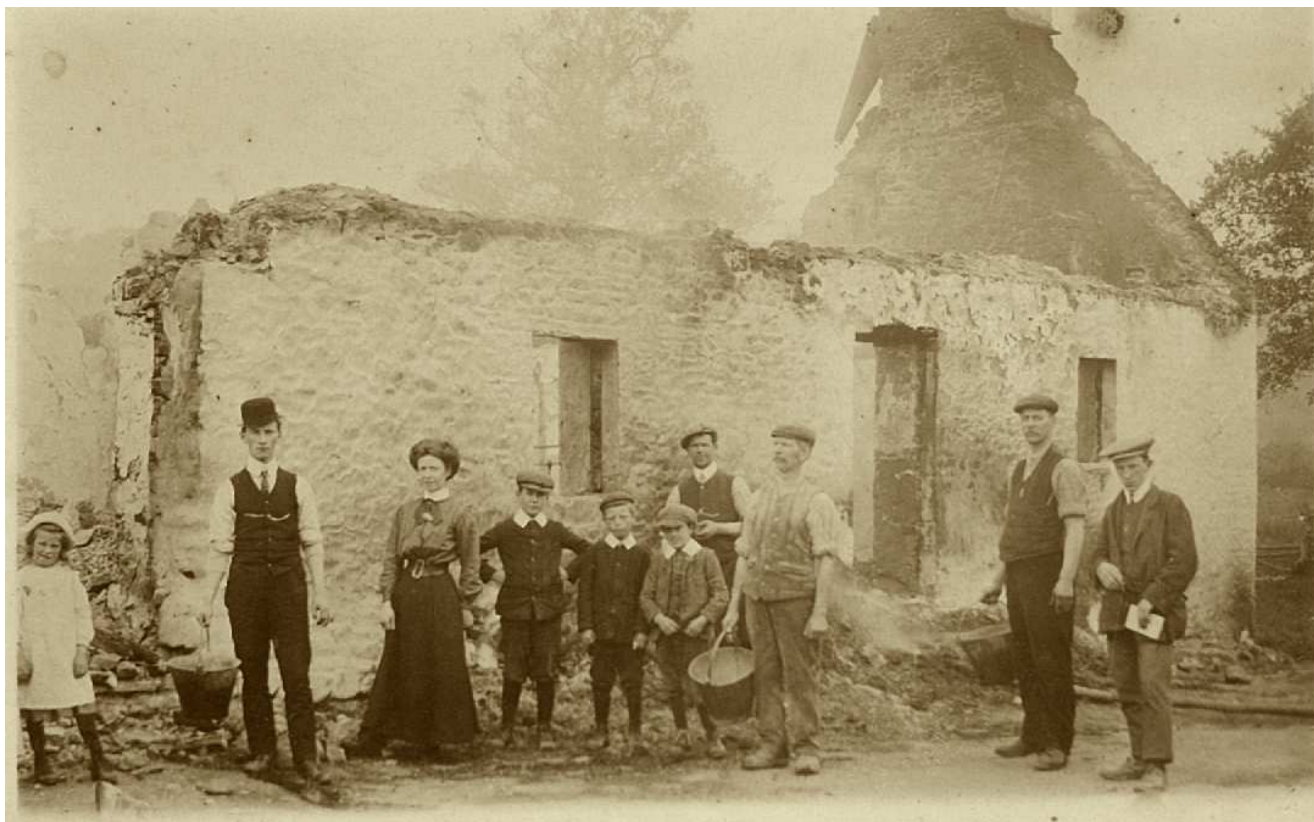
Photo 1: Photo of Wern Fawr farmhouse taken shortly after its destruction by fire in 1911. Believed to be showing the eastern wall, with the northern gable wall and chimney behind.

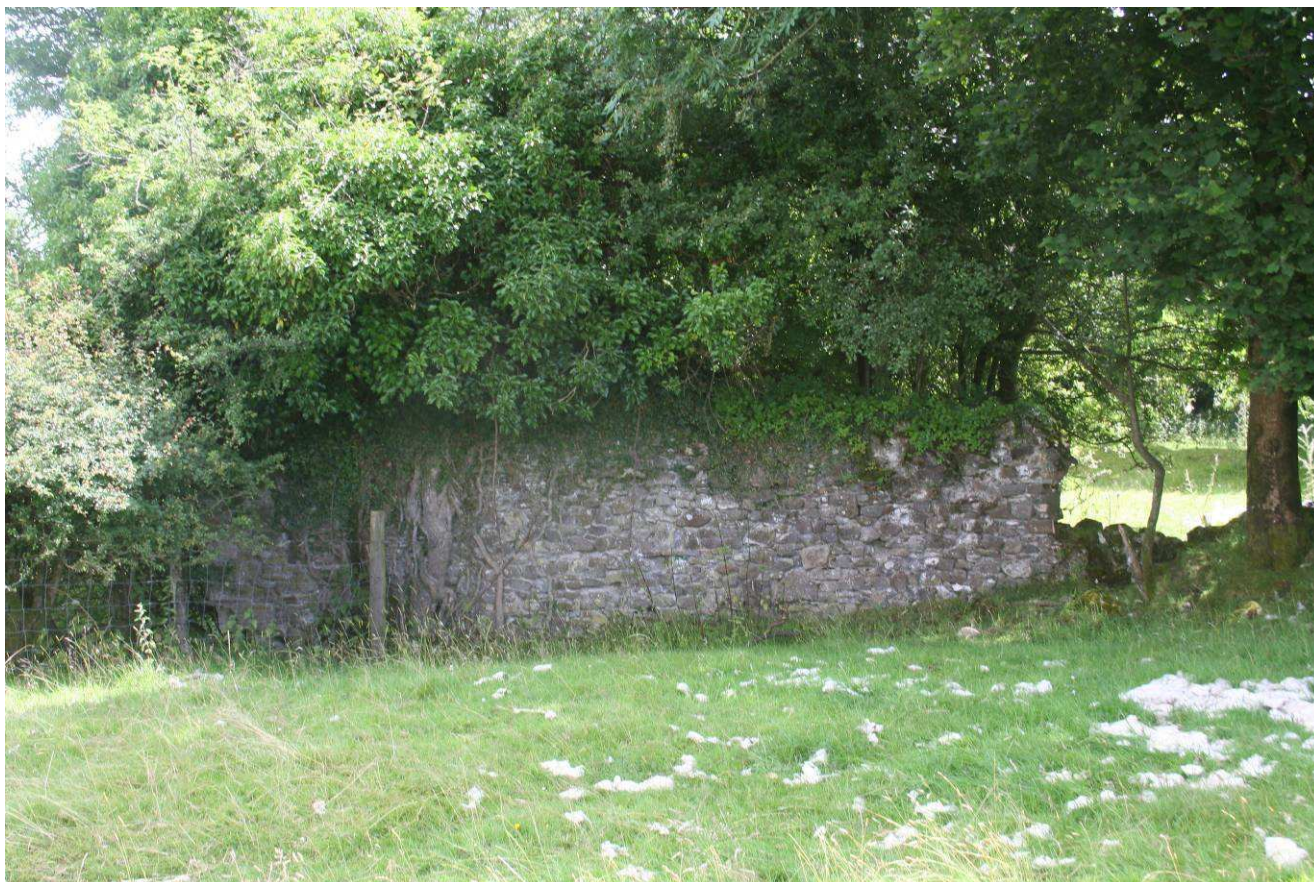
Photo 2: Current upstanding remains of the northern gable wall, taken looking south.

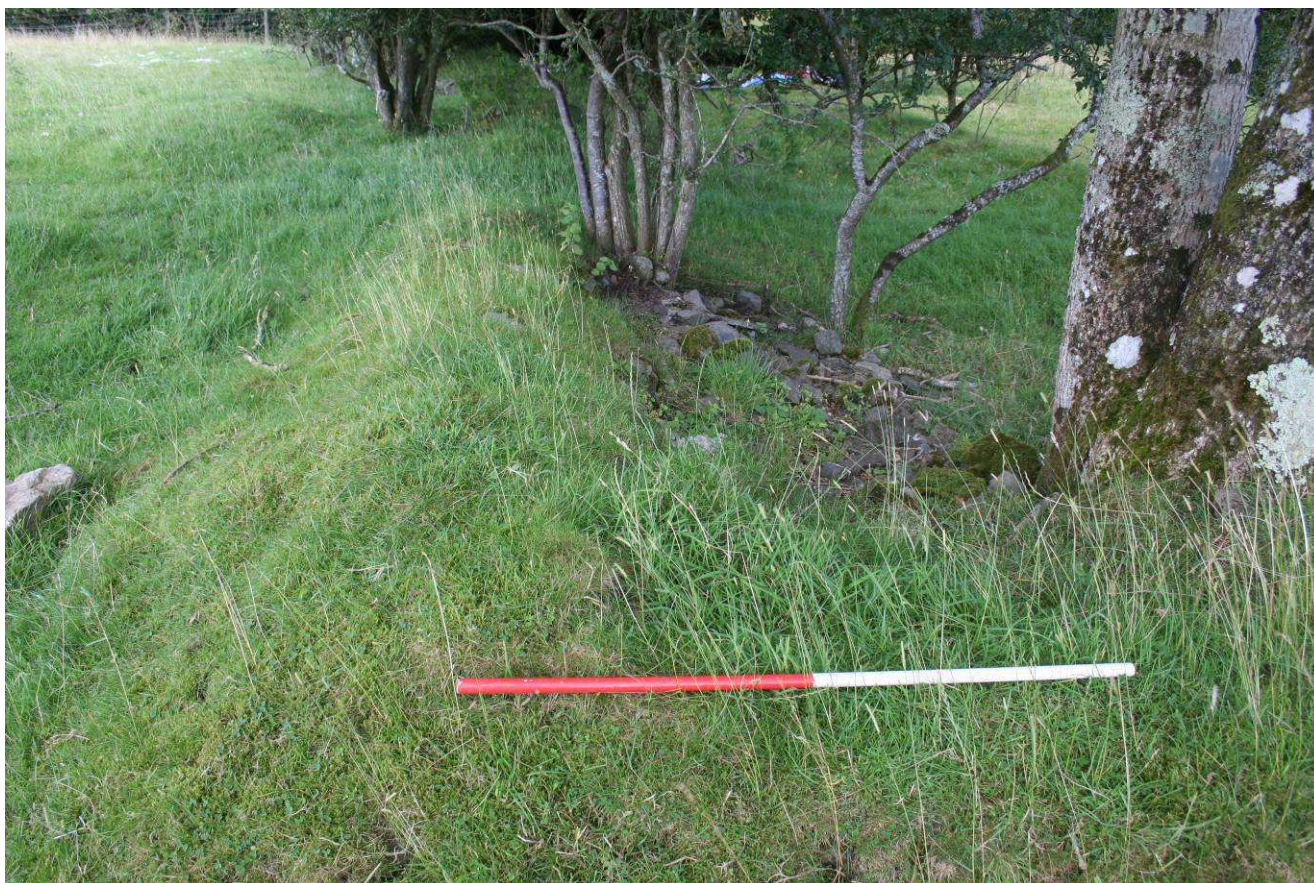
Photo 3: Grass-covered banks representing the remains of the southern part of the main farmhouse building. 1x1m scale.

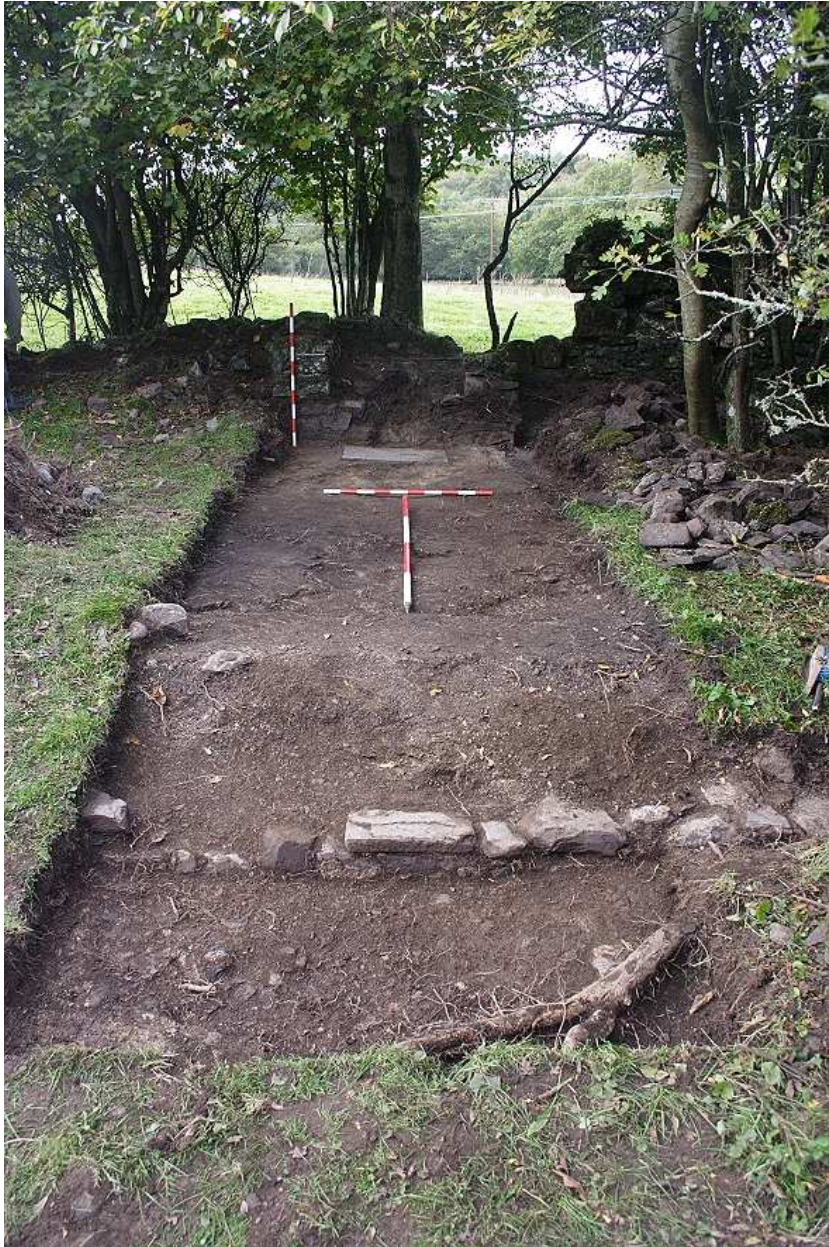
The floor (105) in front of the hearth (103) consisted of compacted and levelled light yellowy-grey sandy mortar surface 0.08m thick, with the occasional stone and charcoal inclusion (photos 4 & 5). The surface, which had been broken up in places, extended for 4.4m seemingly across the full width of the building, although the eastern edge had been disturbed by wall robbing. The surface was bounded by a wooden beam slot (116) to the north, but an extension to Trench 1 showed the surface to continue uninterrupted for 3.7m to the south. The surface was overlain by the hearthstone (106) and its associated mortar (114) against the hearth (103), but elsewhere there was no evidence of any surface either set into or overlying 105. The surface was also laid directly onto the natural shale bedrock.

Photo 4: NW facing shot of Trench 1. 2x1m & 1x2m scale.

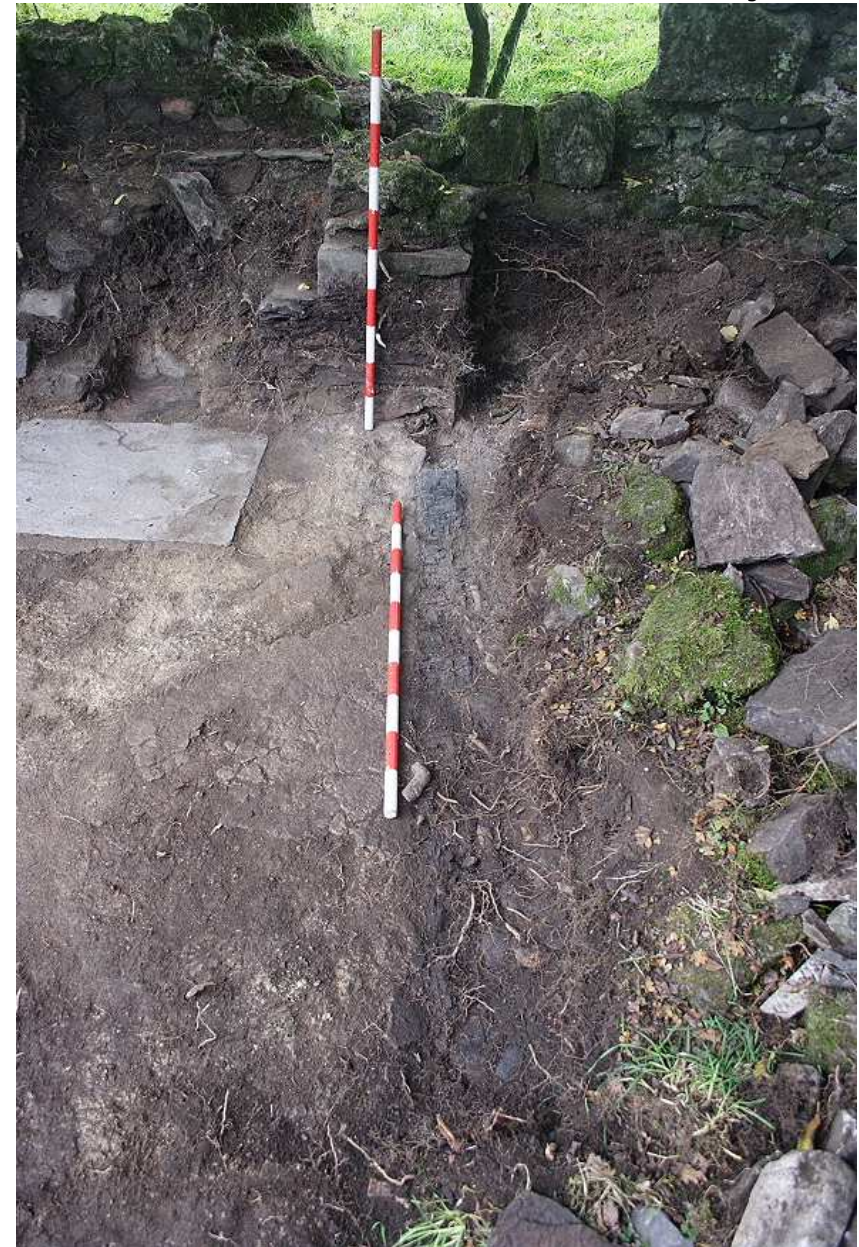
Photo 5: NW facing shot of burnt partition timber 107.

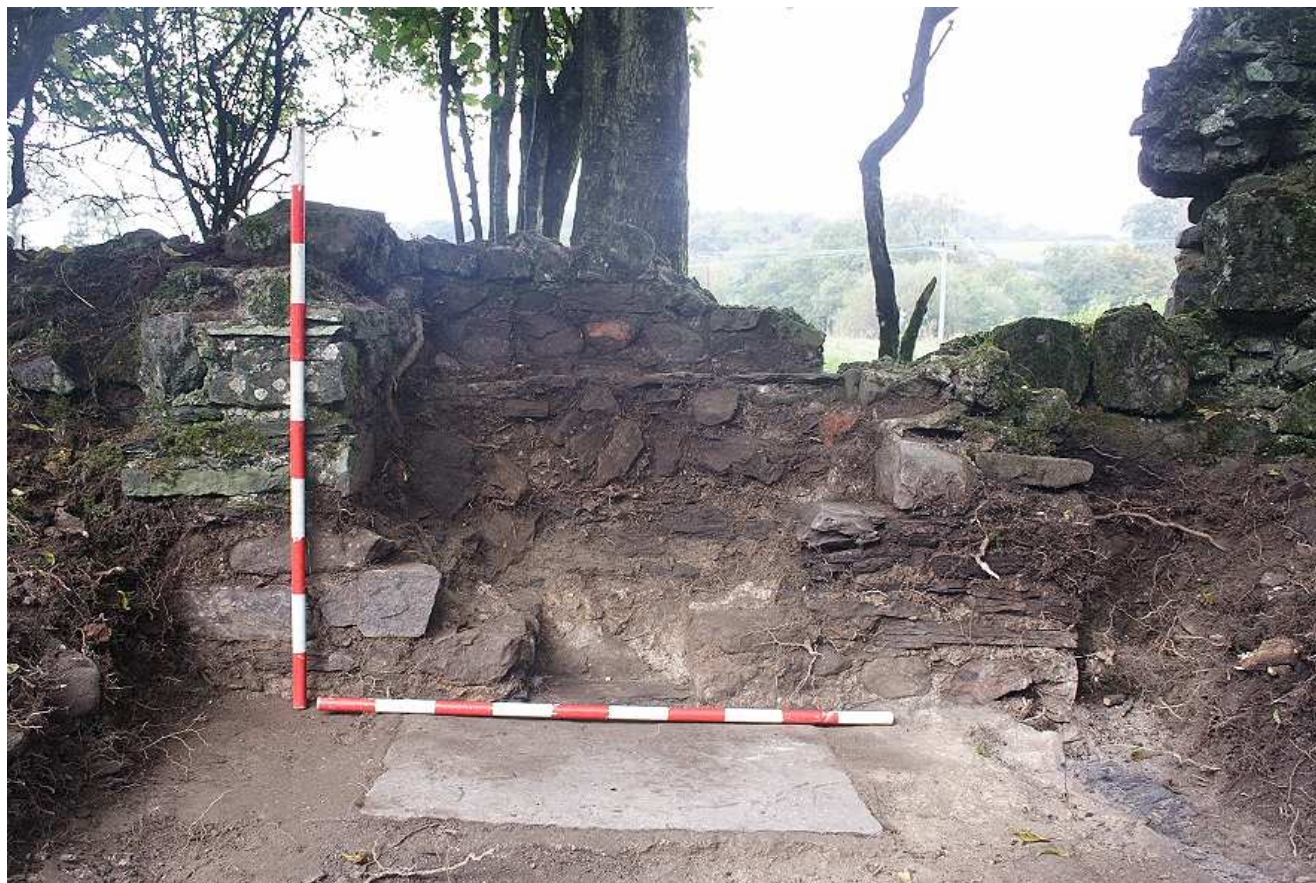
Photo 6: NW facing shot of hearth 103. 2x1m scale.

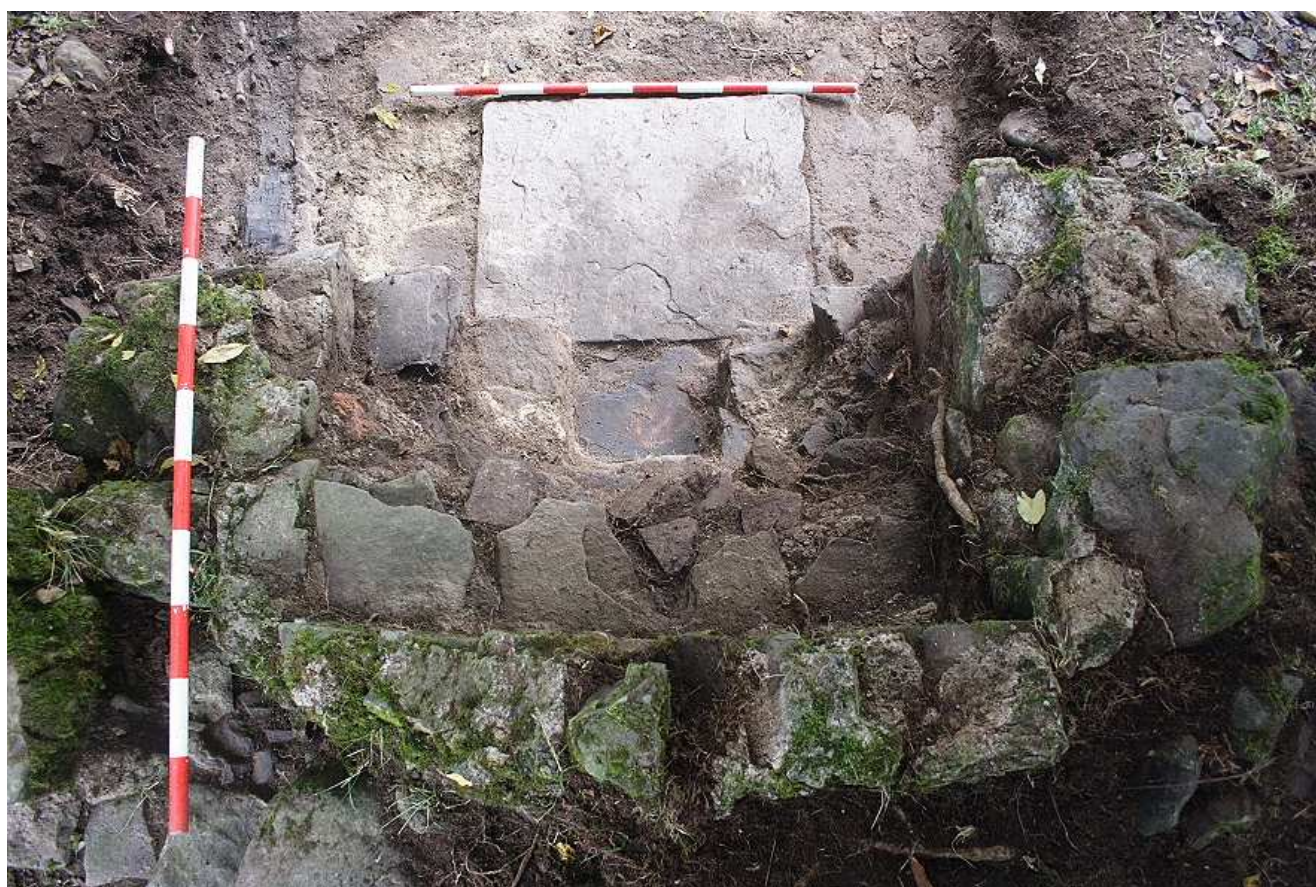
Photo 7: Shot of hearth 103 in plan. 2x1m scale.

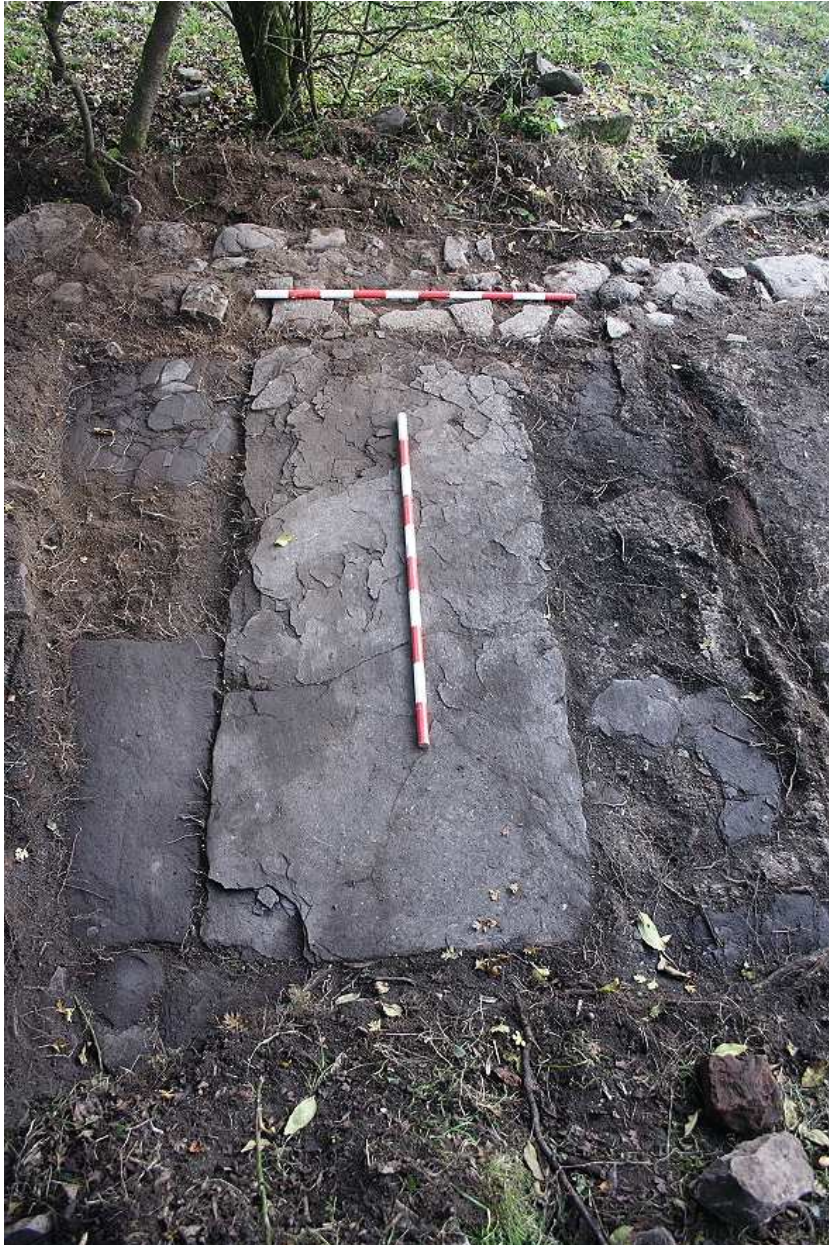
A 2.5m section of Trench 1 was extended for 3m to the northeast of this beam slot as it appeared the slot may mark a room division (photo 8). Northeast of the beam was a surface of large flat slate slabs (108) set in a mortar bed (117). These slabs measured up to 1.7m by 0.45m and extended beyond the area revealed, butting against the outer wall (120) to the southeast. The slabs were carefully laid except for a slot 0.4m wide against the beam slot (116) where smaller slabs were roughly laid with large gaps between, presumably an area that was not normally visible, hidden under a wall plate or similar. A charcoal spread (113) also overlay the slate surface on the northern side of the beam slot (116). The topsoil overlying this charcoal spread was indistinguishable from topsoil south

Photo 8: SE facing shot of slate flooring 108. 2x1m scale.

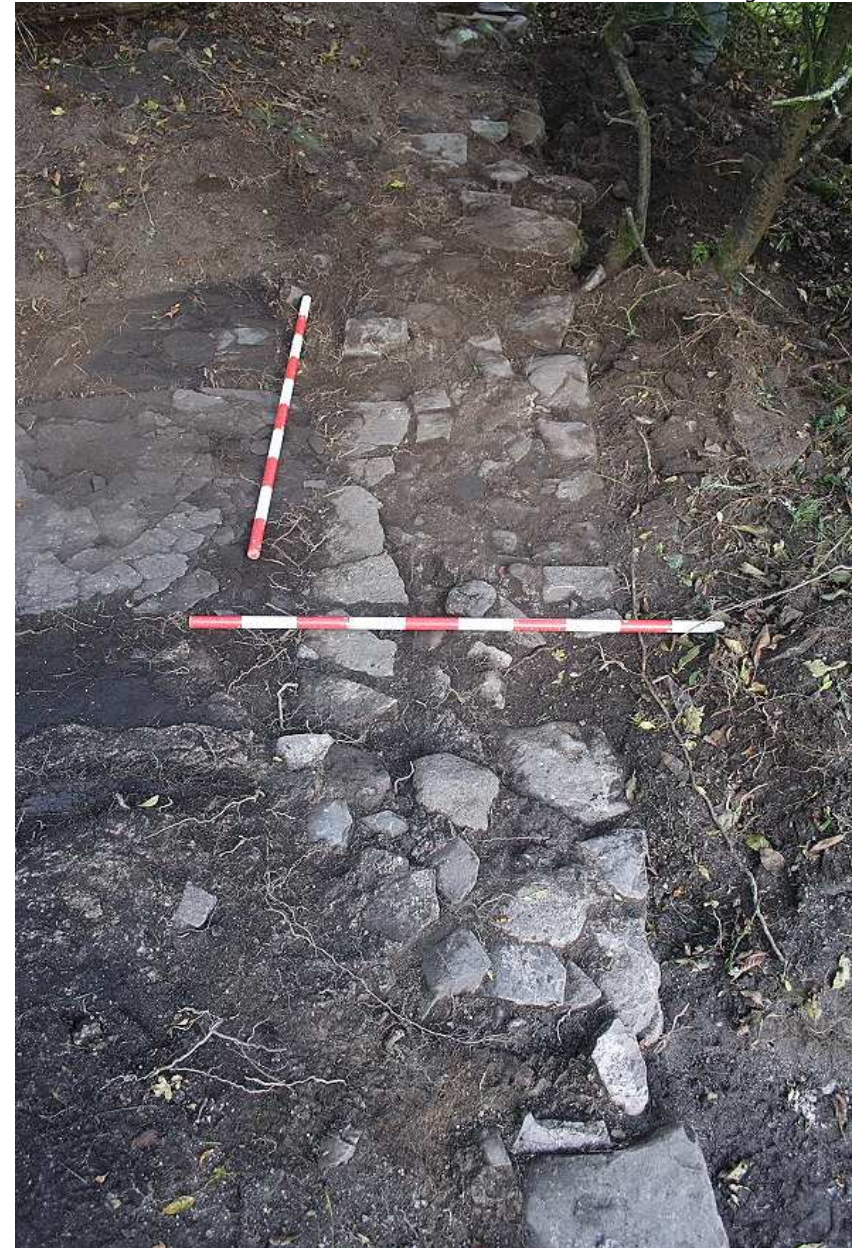
The remains of the front wall of the building were seemingly robbed out to the lower foundation courses (photos 9 & 10). This wall consisted of two abutting walls (110 & 120) although it is was not possible to determine which was the earlier wall. The northernmost wall (120) was 0.6m wide, built of roughly coursed sub-rounded stone rubble, externally faced. The stones were bonded by a light whitish-grey mortar and appeared to be a continuation of the upstanding remains of walling that could be seen further to the north. This section of wall was aligned set 38° to the northeast and appeared to have been robbed out below the level where a doorway and any other opening would be visible.

Photo 9: NE facing shot of eastern wall to the main farmhouse building.

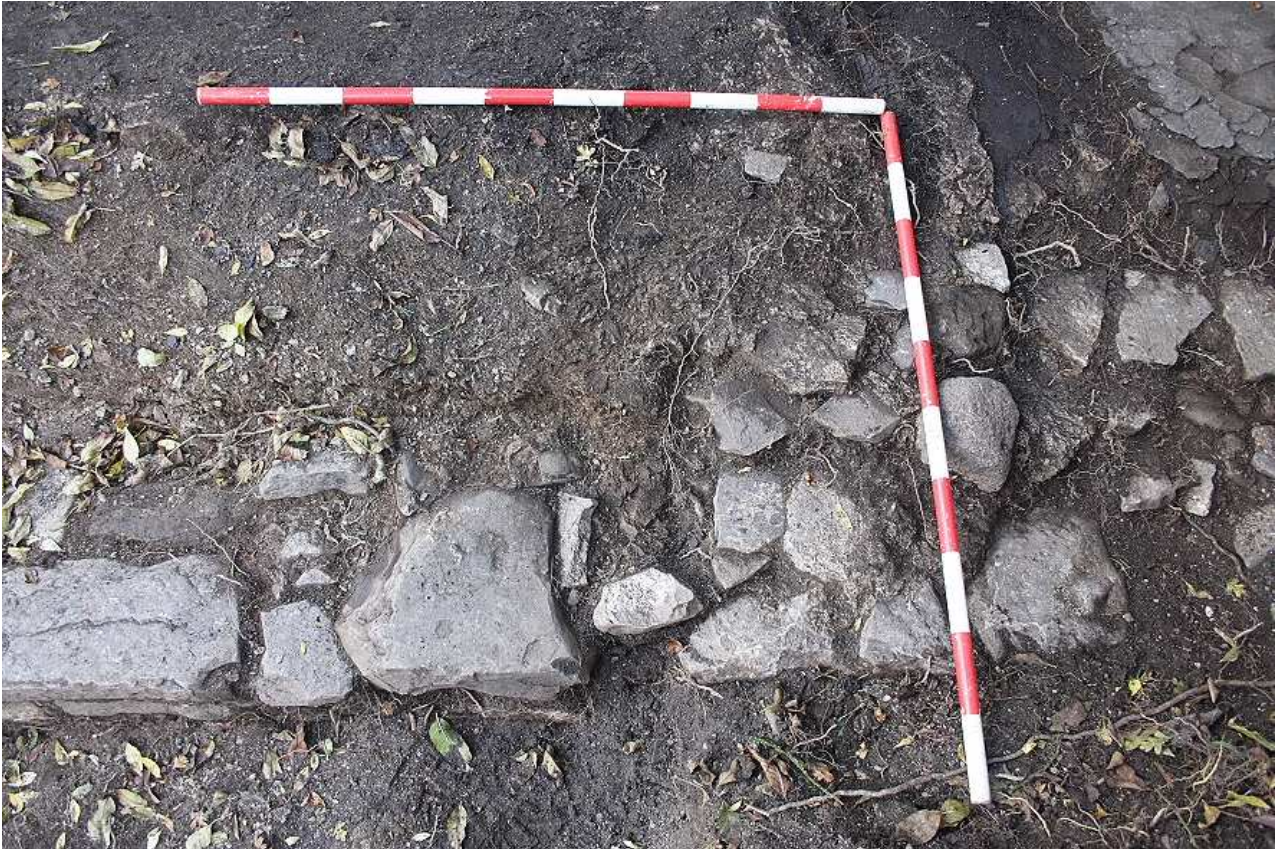
Wall (110) was a slightly different alignment (set 35° from NE), measured only 0.38m wide and was bonded by a light yellowish-grey mortar. The wall was set tightly into its bedrock-cut foundation trench. These walls indicated a total interior width to the main farm building of 4.9m.

Photo 10: NW facing shot of the join between wall 110 on the left and wall 120 on the right.

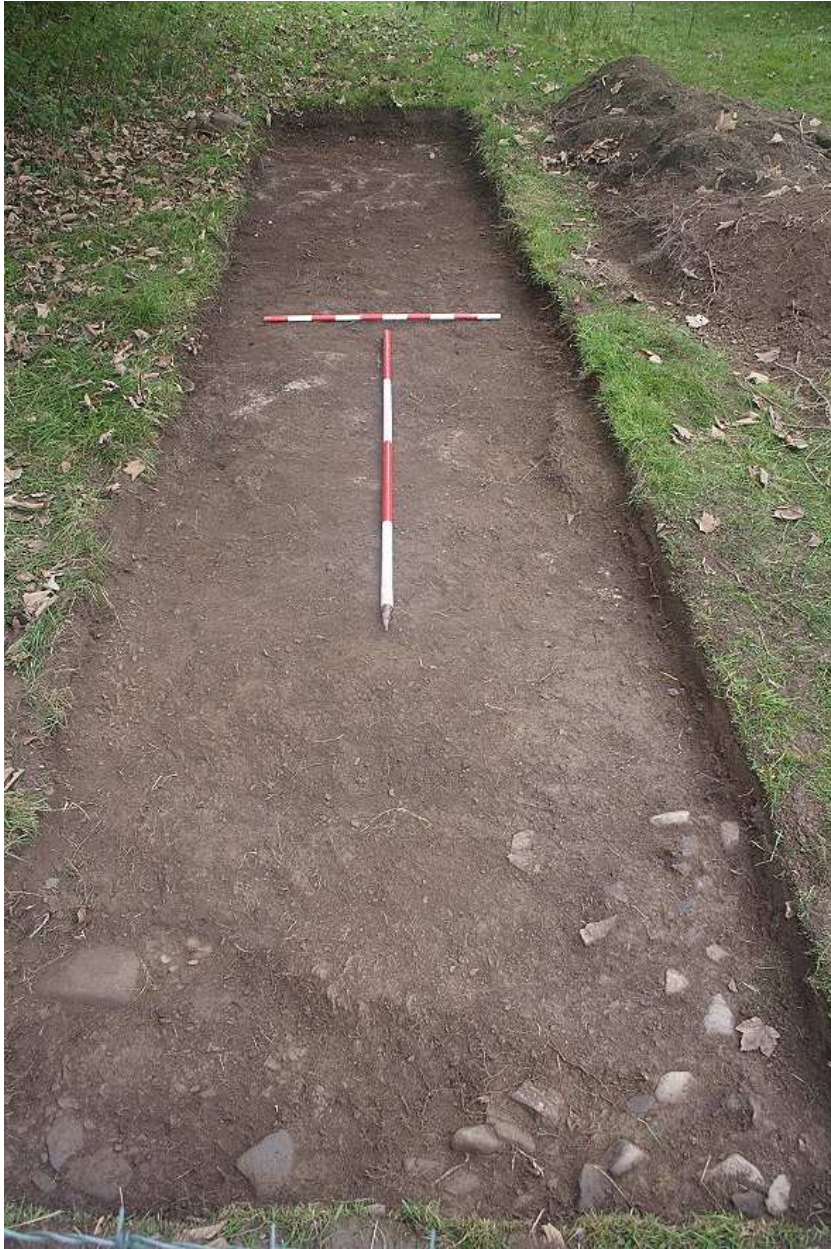
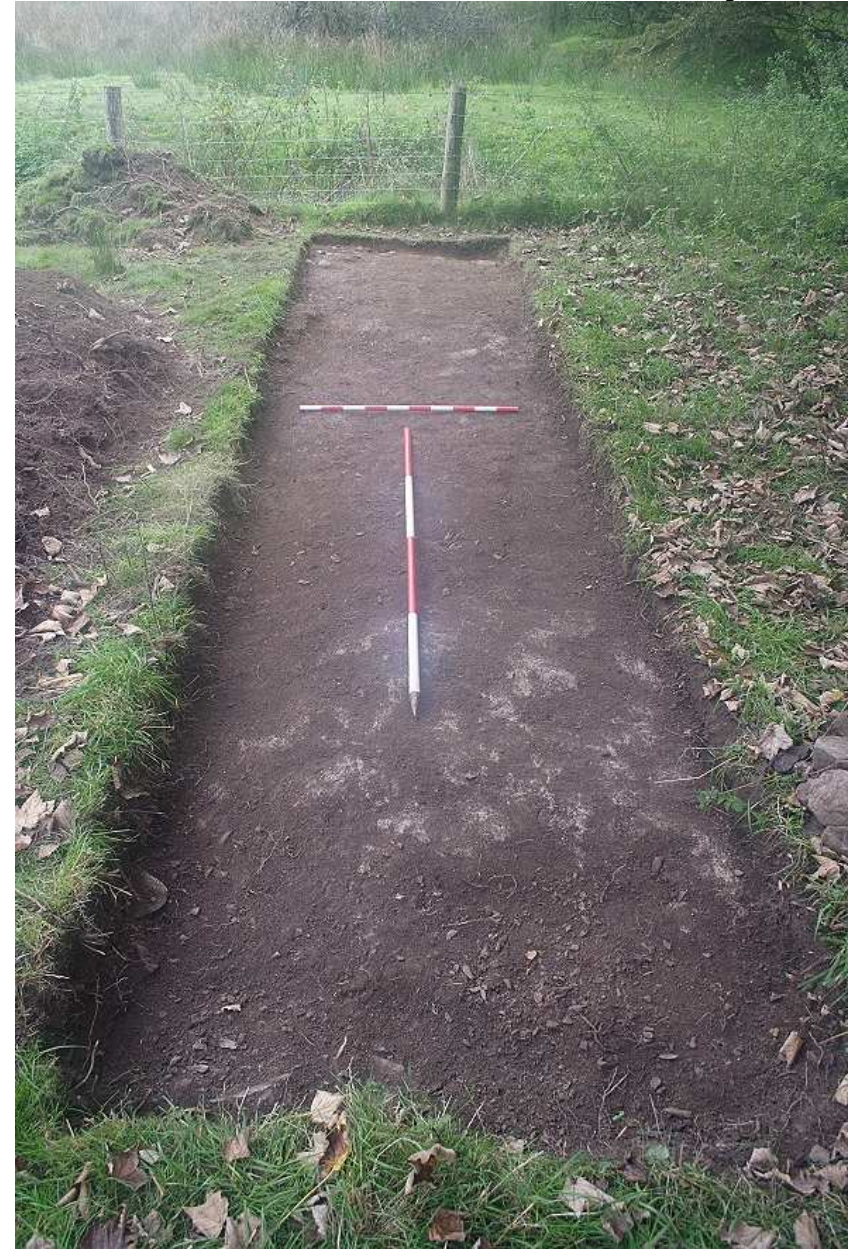
Underlying the topsoil and spread throughout most the trench, was a deposit of hard, light whitish-grey mortar 0.04m thick (204), with the occasional charcoal inclusion (photos 11 –14). Where surviving, this lay bonded to a lower layer of stonier yellow-grey mortar 0.03m thick (205), making a total deposit 0.07m thick. This mortar deposit occurred as a roughly level deposit, but uneven in plan spread mainly towards the northern end of the trench, and again towards the southern end of the trench. Remnants of mortar occurred between these two concentrations suggesting they come from the same partially truncated deposit. A sondage through the southernmost mortar spread revealed it lay directly on the underlying bedrock.

Photo 11: SSW facing shot of Trench 2. 1x2m & 1x1m scale.

Photo 12: NNE facing shot of Trench 2. 1x2m & 1x1m scale.

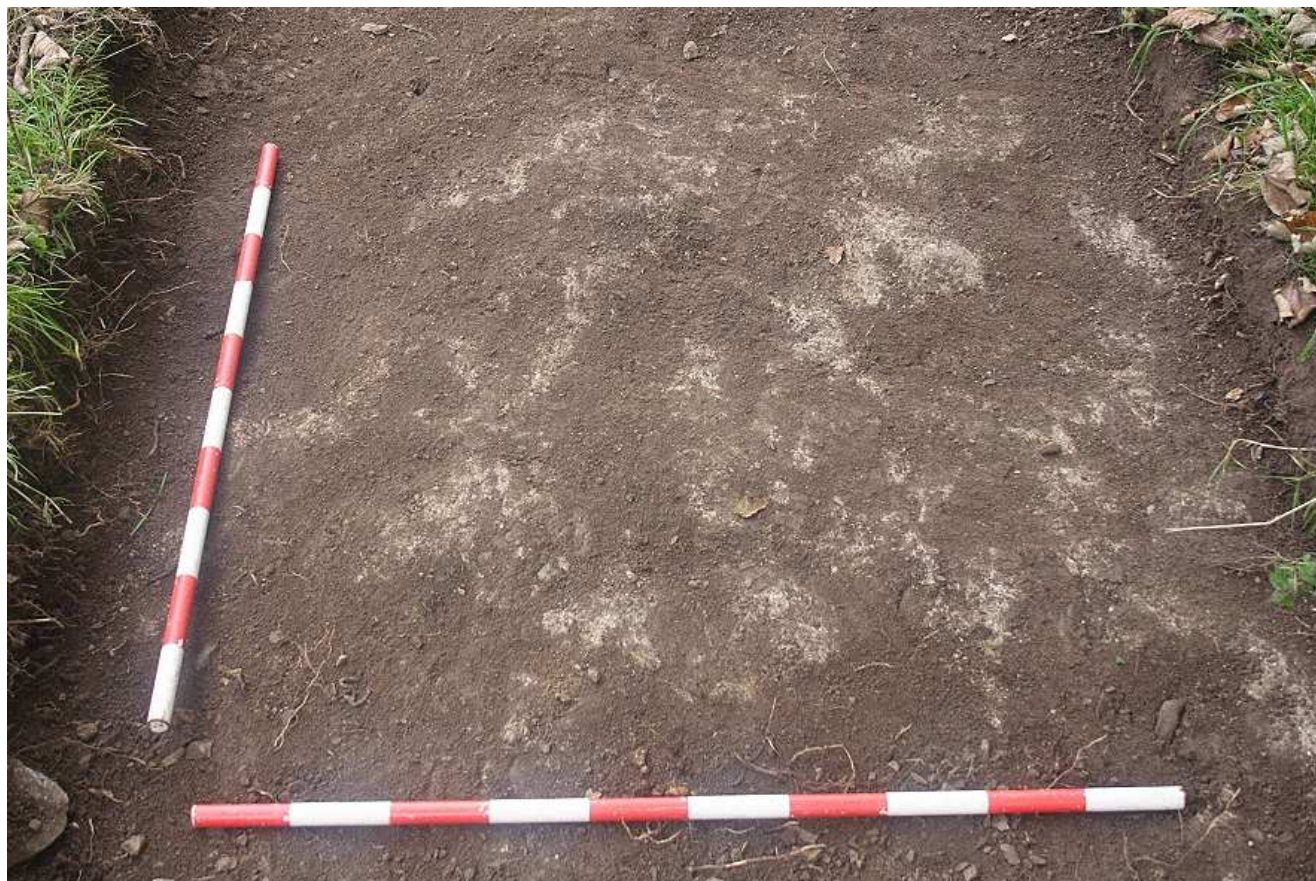
Photo 13: NNE facing shot of the remains of a mortared floor surface in Trench 2. 1x1m scale.

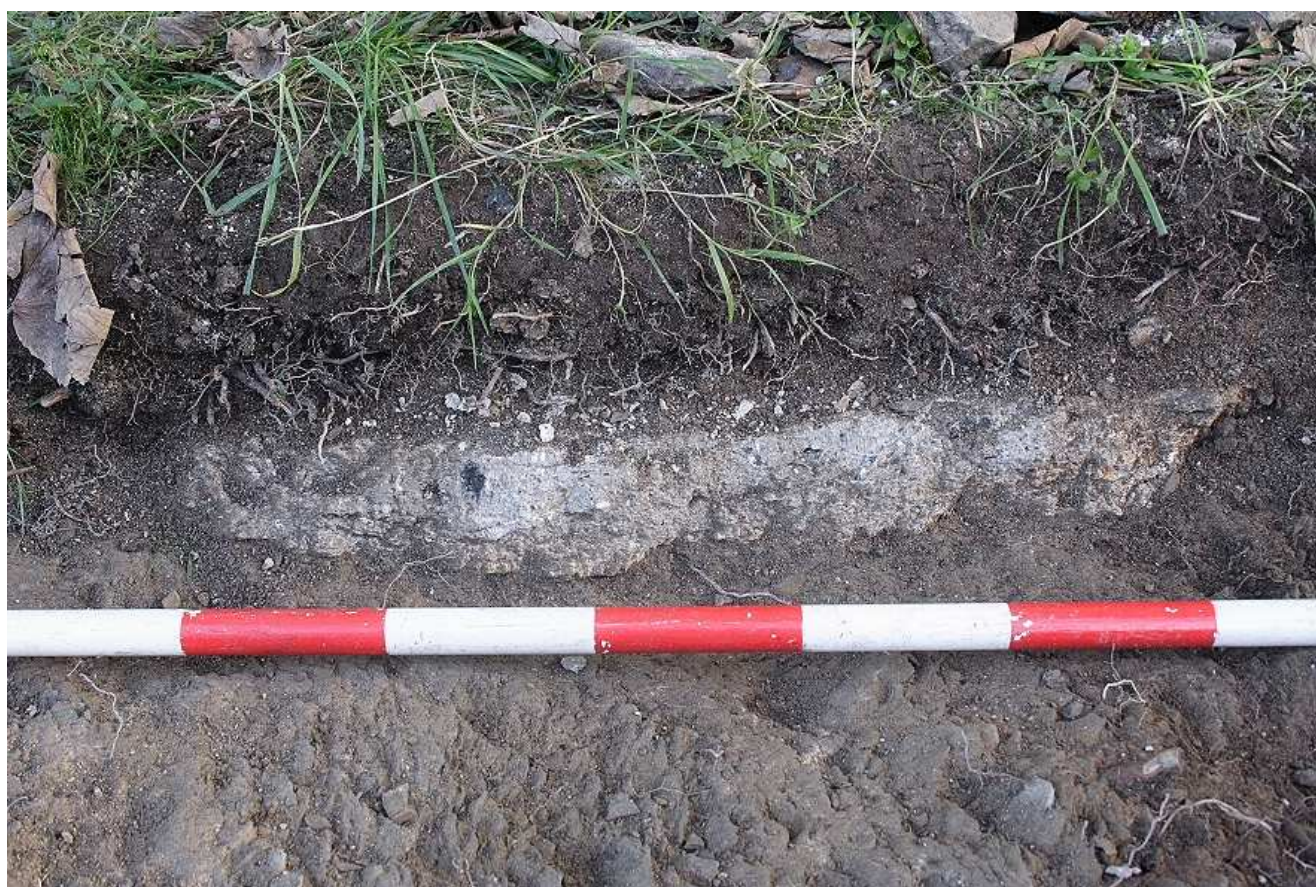
Photo 14: A section through the mortared floor surface in Trench 2. Scale in 0.1m segments.

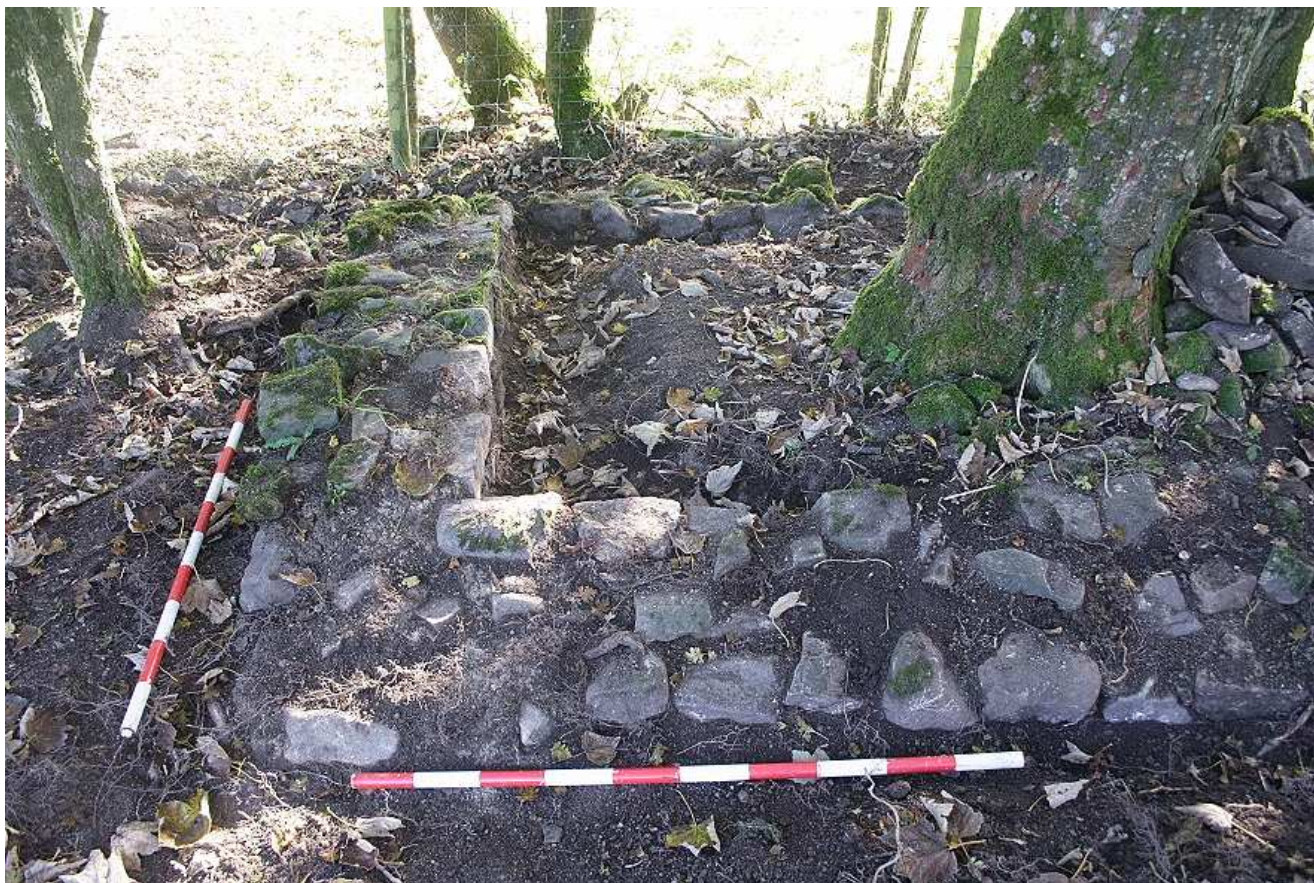
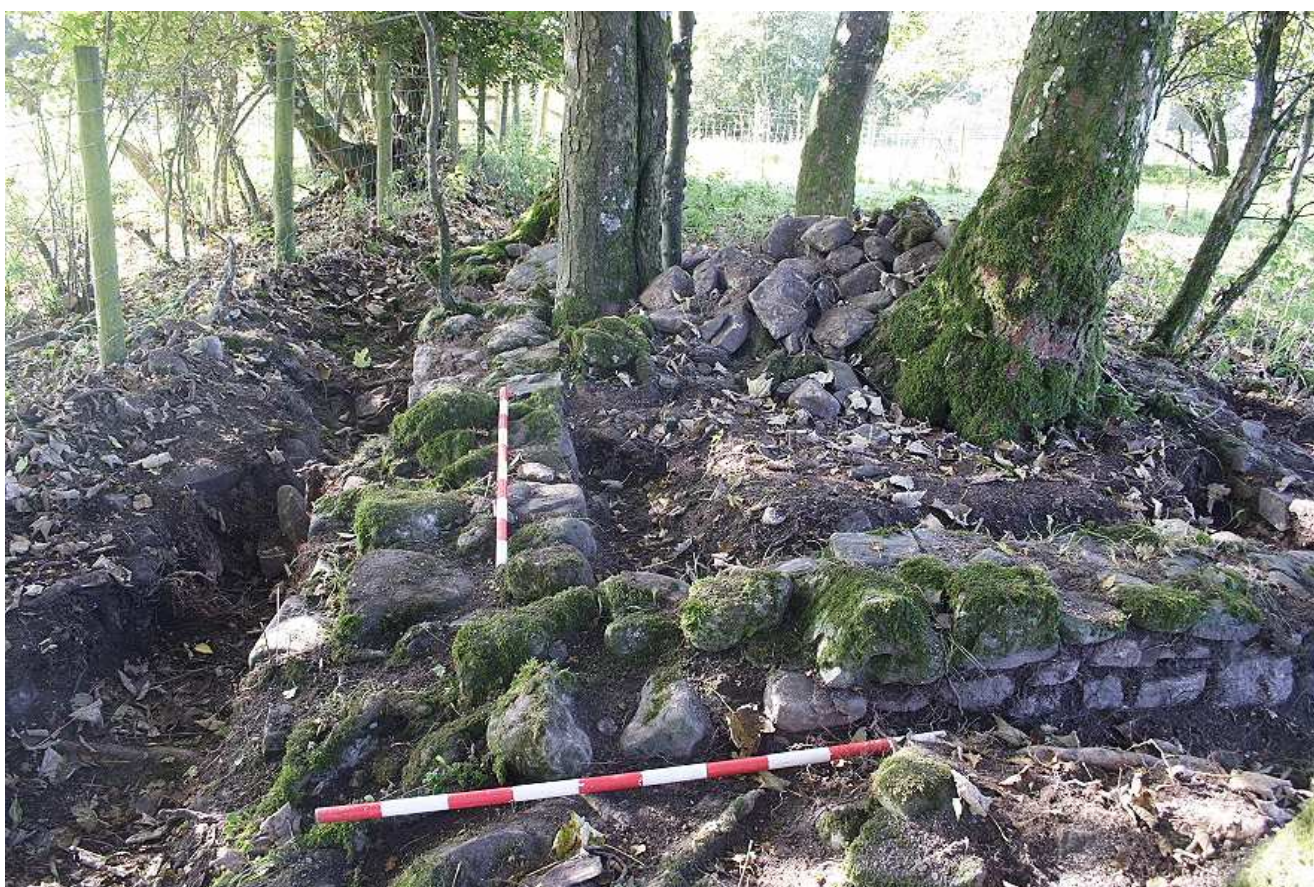
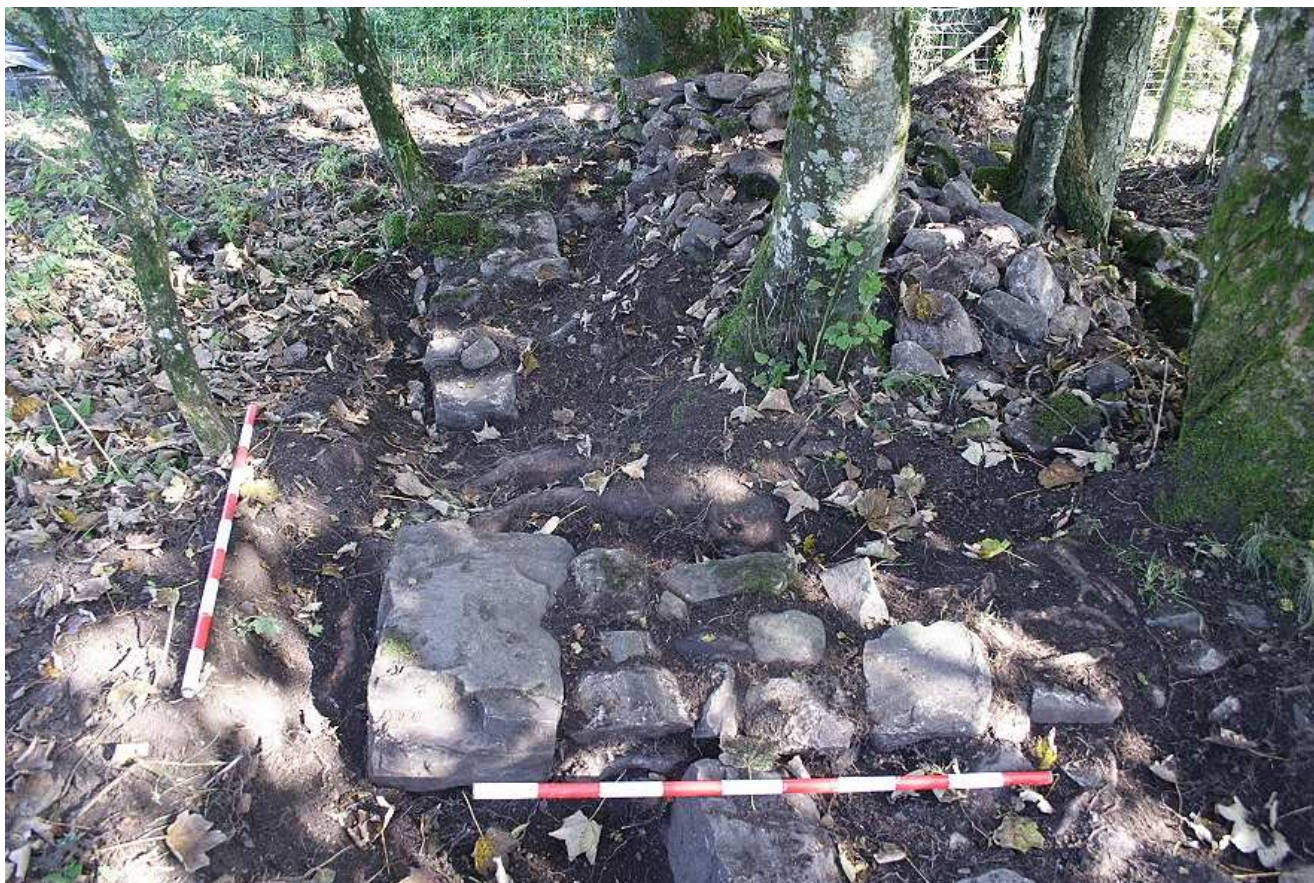
mortar. The walls ran in a continuous line, and appeared to be of one build, enclosing an internal rectangular area measuring 3.8m NE-SW by 1.8m. A 0.85m wide gap at the southern end of the western wall represented the only visible entrance to the building. There was no evidence of a continuation of any of the walls beyond what was recorded, suggesting the visible walling relates to the structure depicted on the 1906 Ordnance Survey map.

Photo 15: SE facing shot of the cleared wall remains (Trench 3). 2x1m scale.

Photo 16: SW facing shot of the cleared wall remains (Trench 3). 2x1m scale.

Photo 17: NE facing shot of the cleared wall remains (Trench 3). The entrance to the building can be seen above the large stone forming the corner. 2x1m scale.
