EXPLORATION TYWI!

WERN FAWR, LLANDEILO

ARCHAEOLOGICAL EVALUATION 2009

2010/06
98682

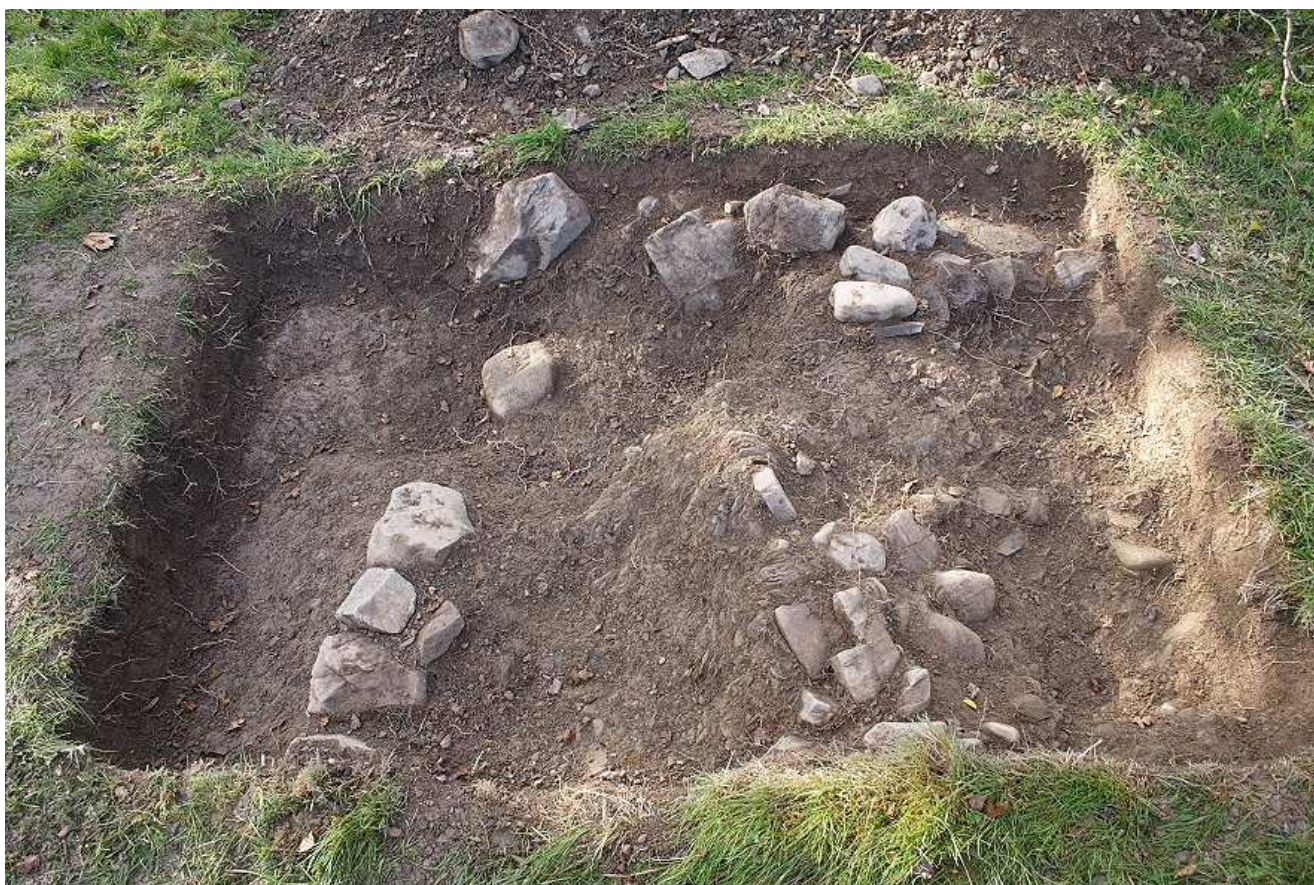
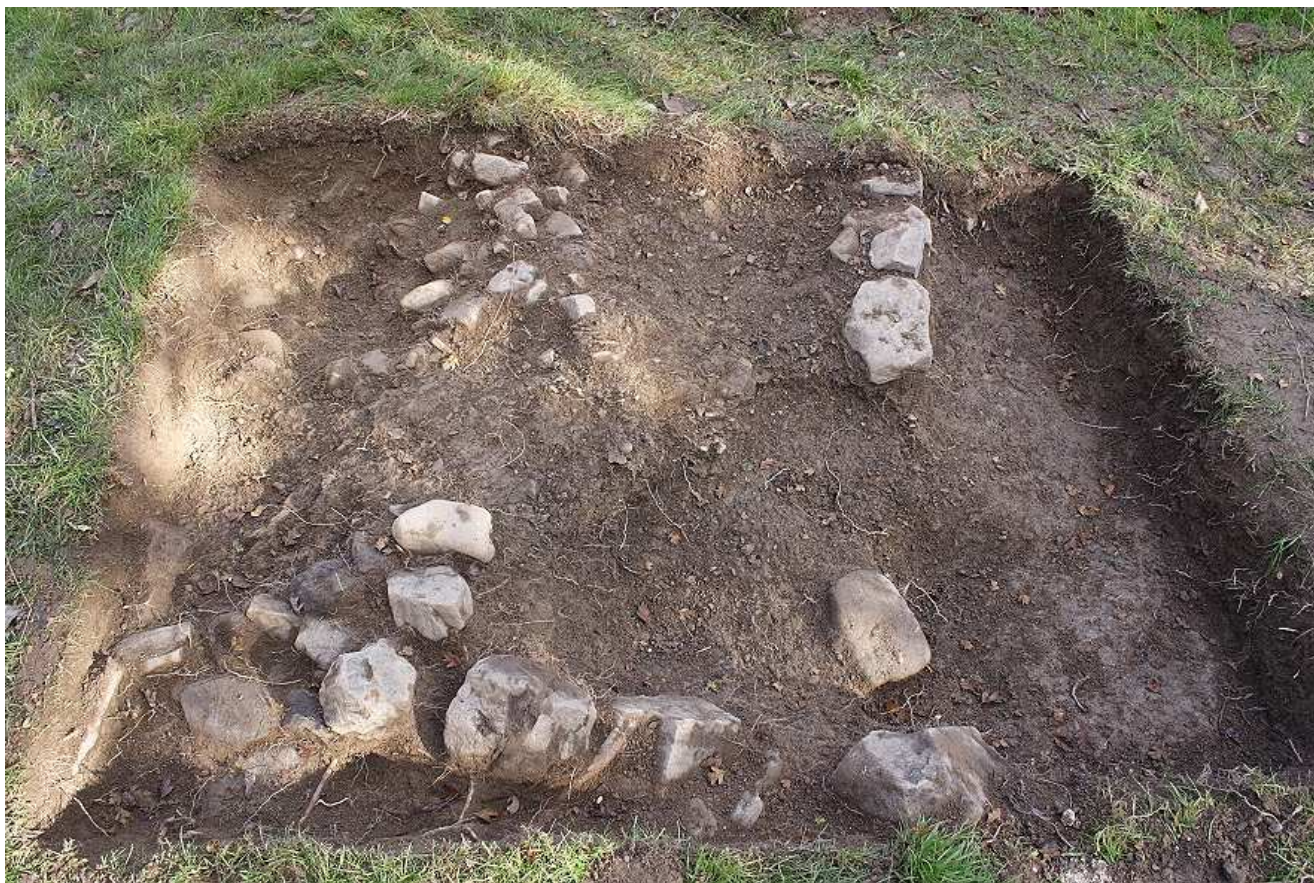
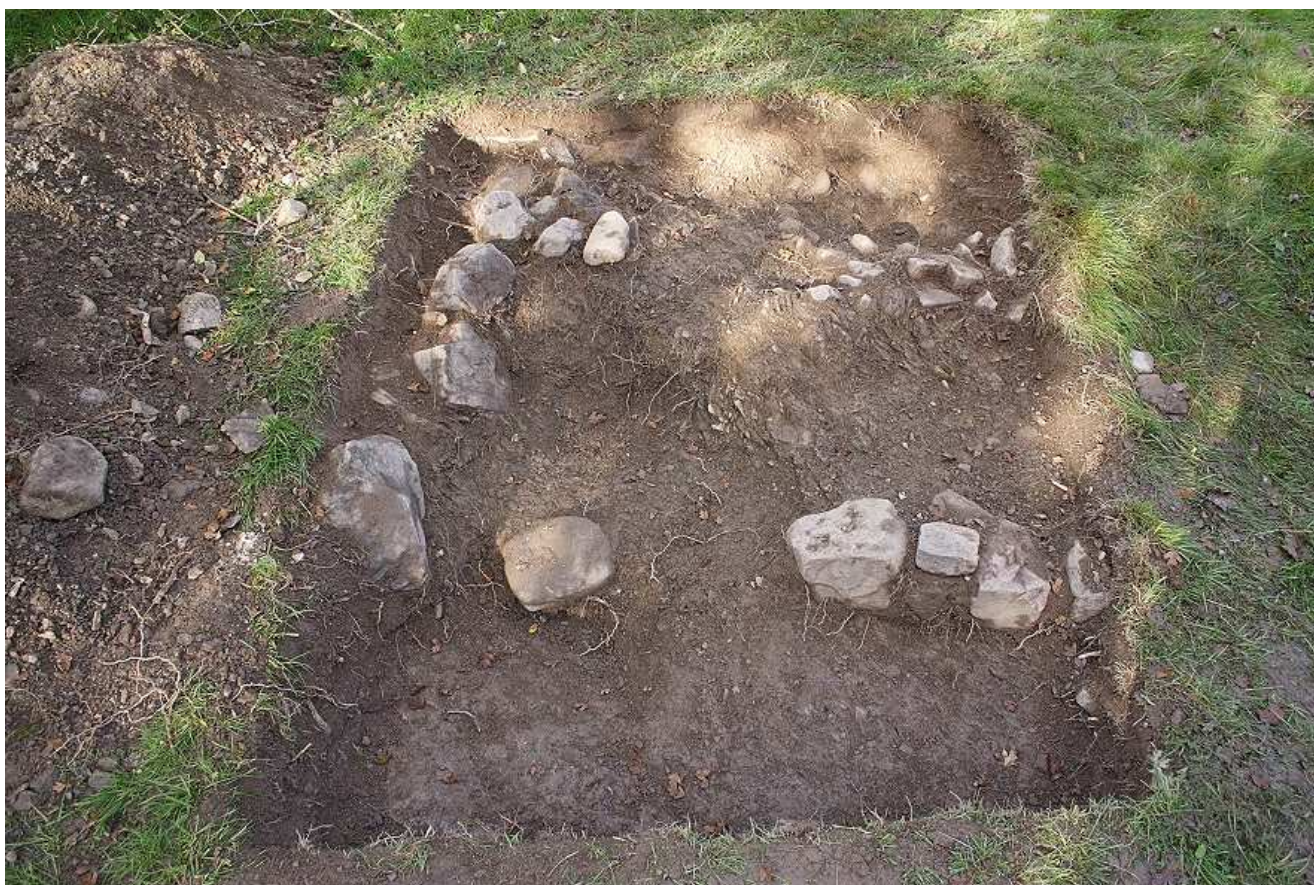
As with the other trenches a typical topsoil (401) of mid grey-brown silty-clay was revealed, although the underlying archaeology proved harder to identify (photos 18 – 20). This topsoil contained a spread of small assorted porcelain fragments, various glazed wares, some broken ceramics including small fragments of ceramic drying tiles, an assorted collection of glass including some melted glass, one fragment of plaster and several iron nails. Initially it appeared the topsoil overlay the natural broken shale bedrock, although several large sub-angular stones appeared to be interspersed amongst the broken shale bedrock. On further excavation the occurrence of pottery fragments within the broken shale revealed this to be uneven bank of redeposited natural (402). The stones were revealed in three rough linear arrangements. These linears were unbonded but were very roughly coursed, one course wide and appeared to represent near vertical stone revetment at most 0.25m high, around an internal bank of redeposited broken shale. The broken shale had collapsed beyond the line of the stones making the original dimensions of the revetted bank difficult to establish, but the stone does indicate an east, west and southern face, suggesting the southern terminus of the bank within Trench 4. Such a boundary corresponds closely to that reported in the previous pipeline evaluation work (Nacap Land & Marine forthcoming).

Photo 18: SW facing shot of the stone-revetted bank remains in Trench 4.

Photo 19: NE facing shot of the stone-revetted bank remains in Trench 4.

Photo 20: NW facing shot of the stone-revetted bank remains in Trench 4.

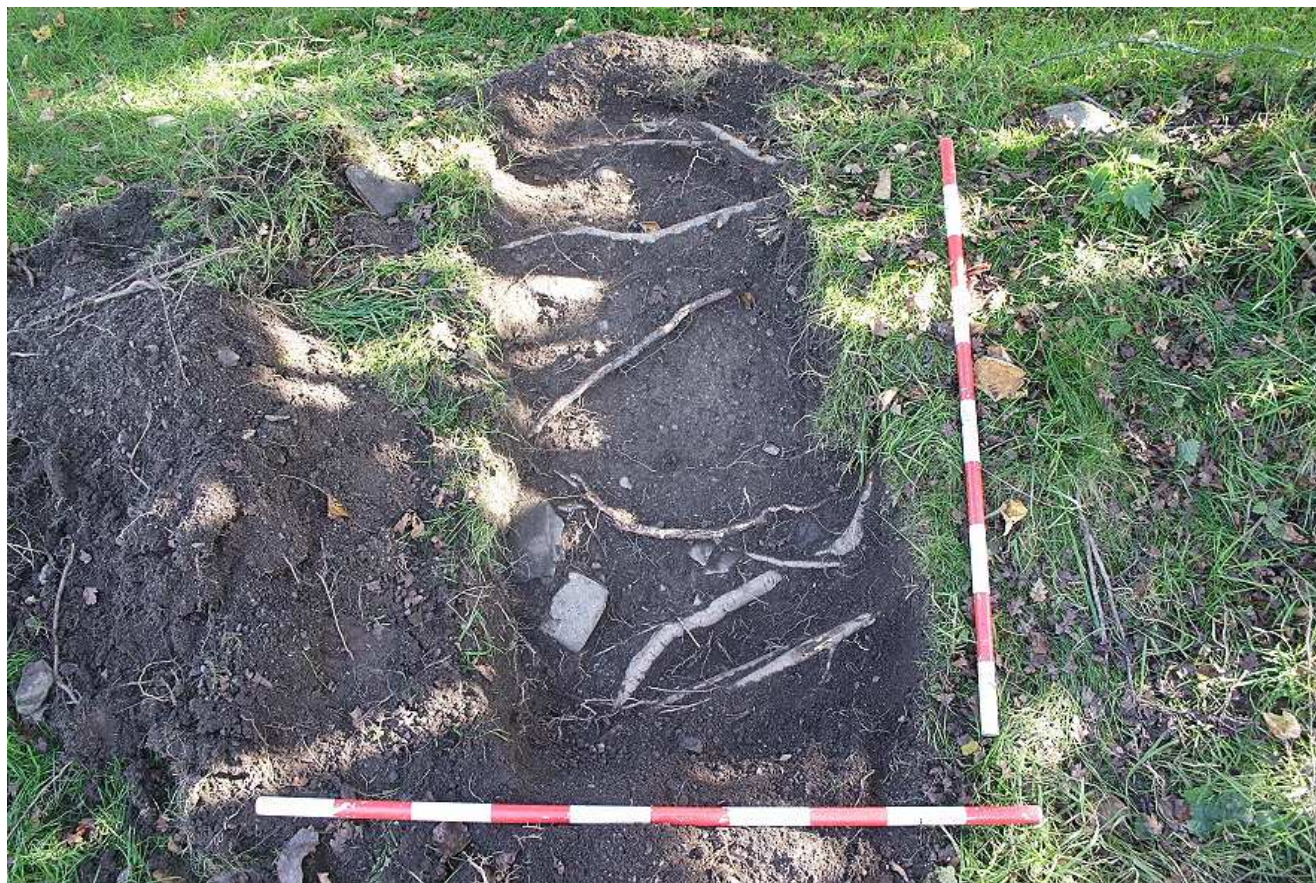
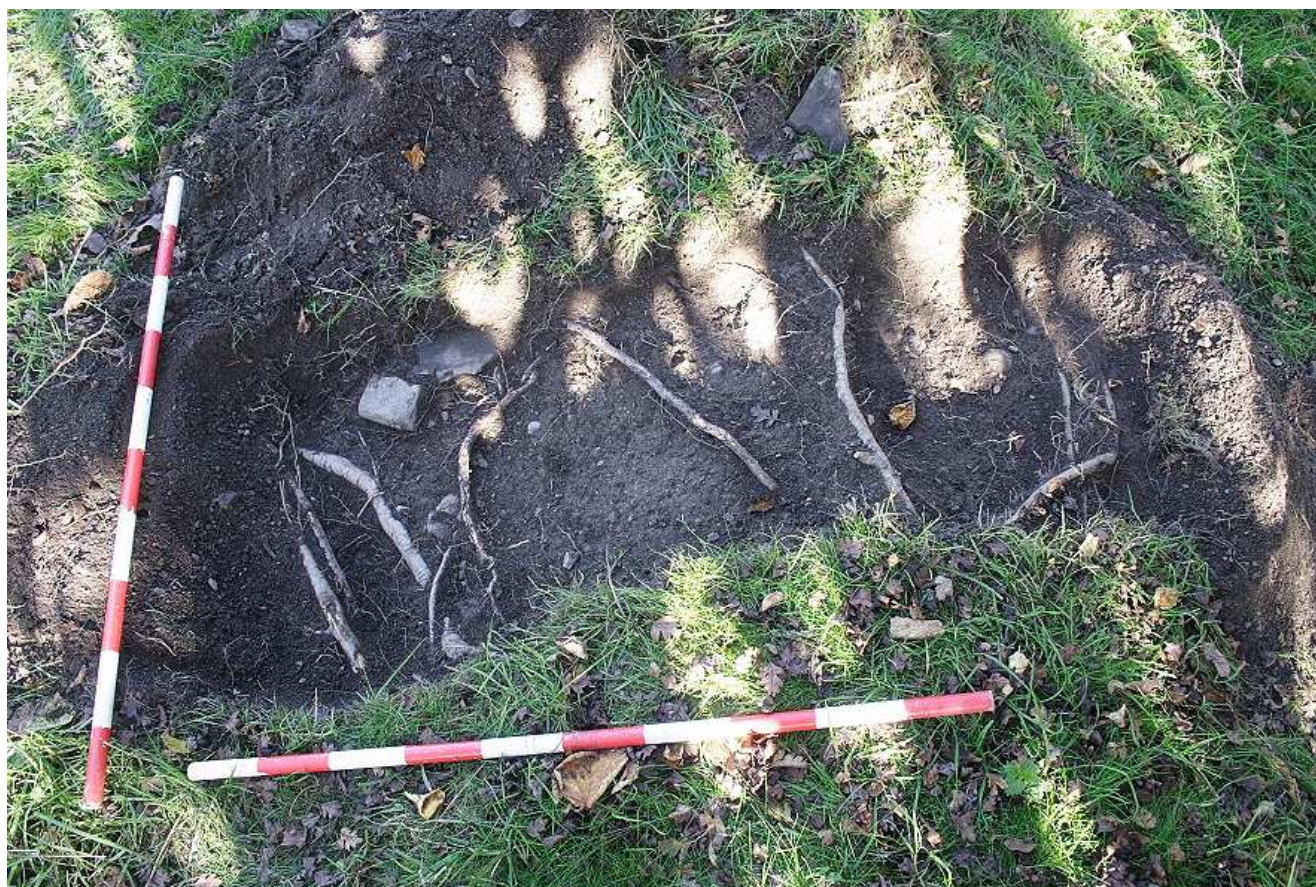
This trench was located on the visible remains of the central farmstead boundary bank to investigate its makeup and confirm the findings reported in the previous evaluations as part of the pipeline work (photos 21 – 22).

This revealed a thin deposit of topsoil (501) overlying a wide low bank of redeposited broken shale (502). The topsoil contained a large quantity of very small porcelain fragments along with some glazed ware, glass, a small iron buckle and a small spread of animal bone. The natural appearance of the broken shale helped to interpret the findings from Trench 4 and corresponded closely to the description from the previous evaluation (Nacap Land & Marine forthcoming). However no evidence of revetting was revealed within this trench although the height of the bank and the very gradual nature of its sides suggested the bank may have slumped beyond the limits of its revetment. Due to time constraints the bank was not excavated further.

Photo 21: SE facing shot of Trench 5.

Photo 22: NE facing shot of Trench 5.
