A WATCHING BRIEF AT NORTH BEACH ABERAERON CEREDIGION

February to April 2009

Prepared by Dyfed Archaeological Trust
For: Ceredigion County Council

RHIF YR ADRODDIAD / REPORT NO. 2010/14
RHIF Y PROSIECT / PROJECT RECORD NO. 98689

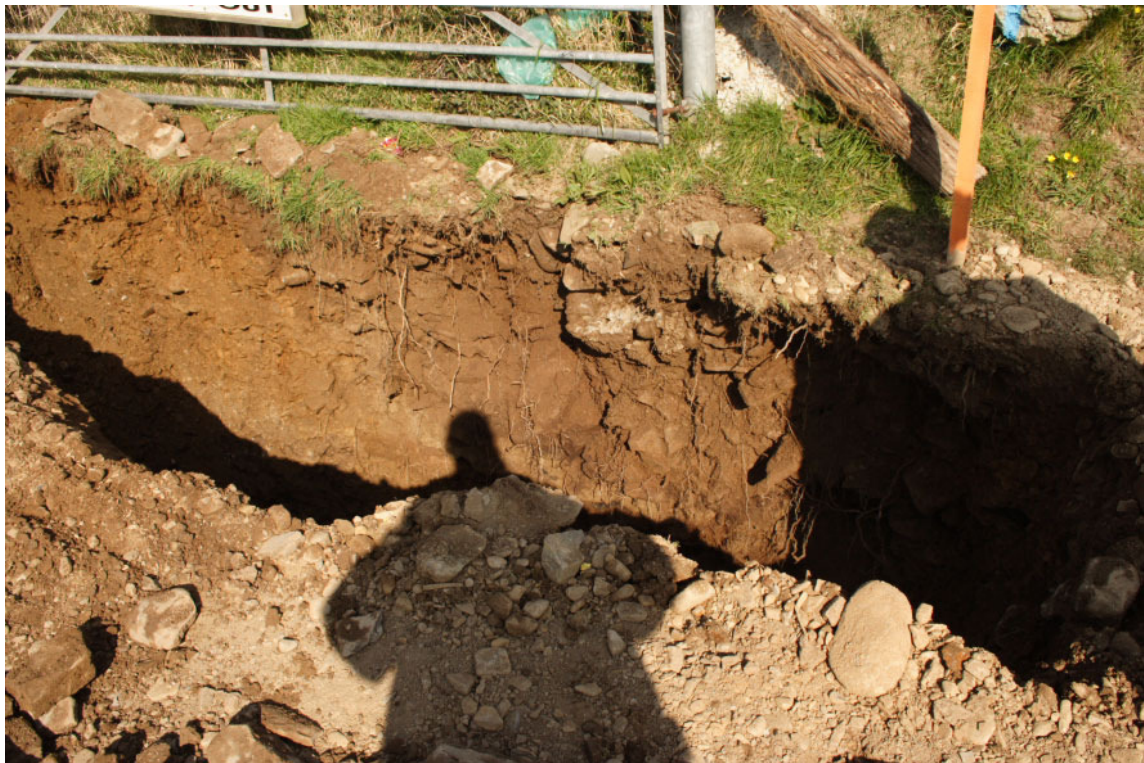
A possible cut was noticed in the side of the trench along the trackway (photo 1) in one area adjacent to the sea front and in close proximity to Castell Cadwgan. While this could have been part of an outer defensive ditch associated with the castle site, this possibility cannot be confirmed. No finds or other characteristics could be discerned to add more credence to this theory, and it is perhaps more likely to be a later feature.

Photo 1: Excavation along edge of trackway showing possible ditch (indicated by change in soil colour)

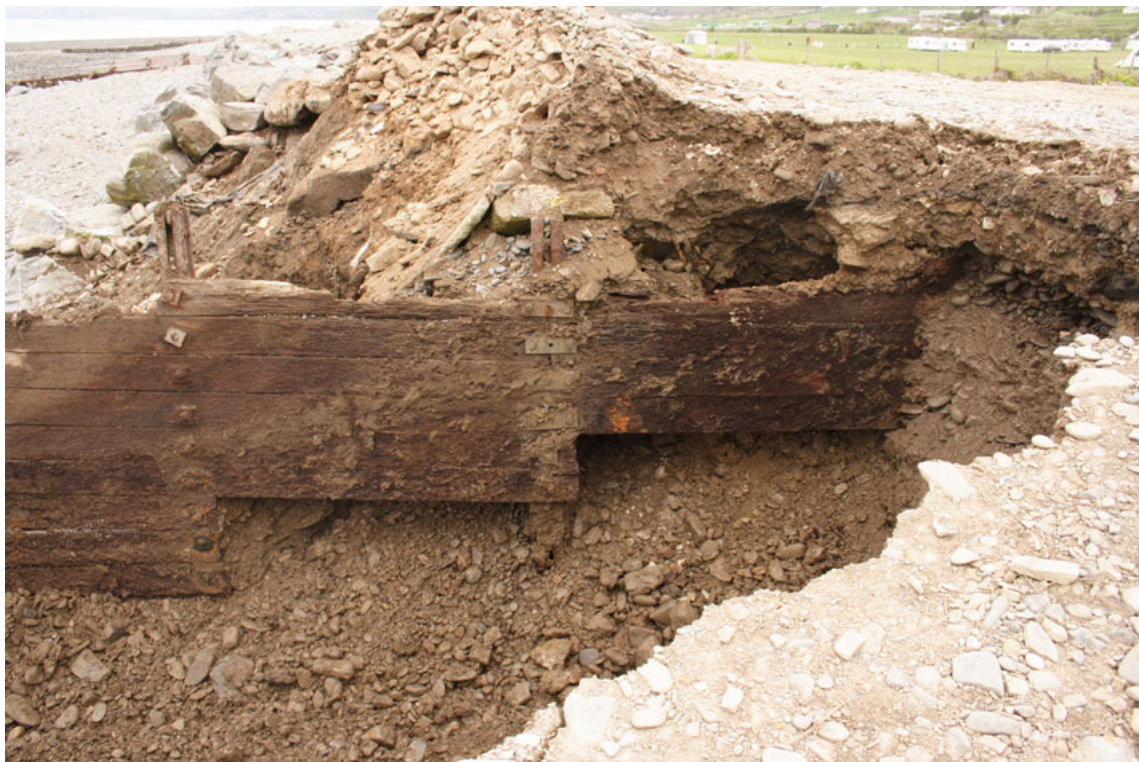
A visit was also undertaken during the removal of an existing groyne (photo 2), close to the castle.

Photo 2: Exposure of existing groyne prior to removal

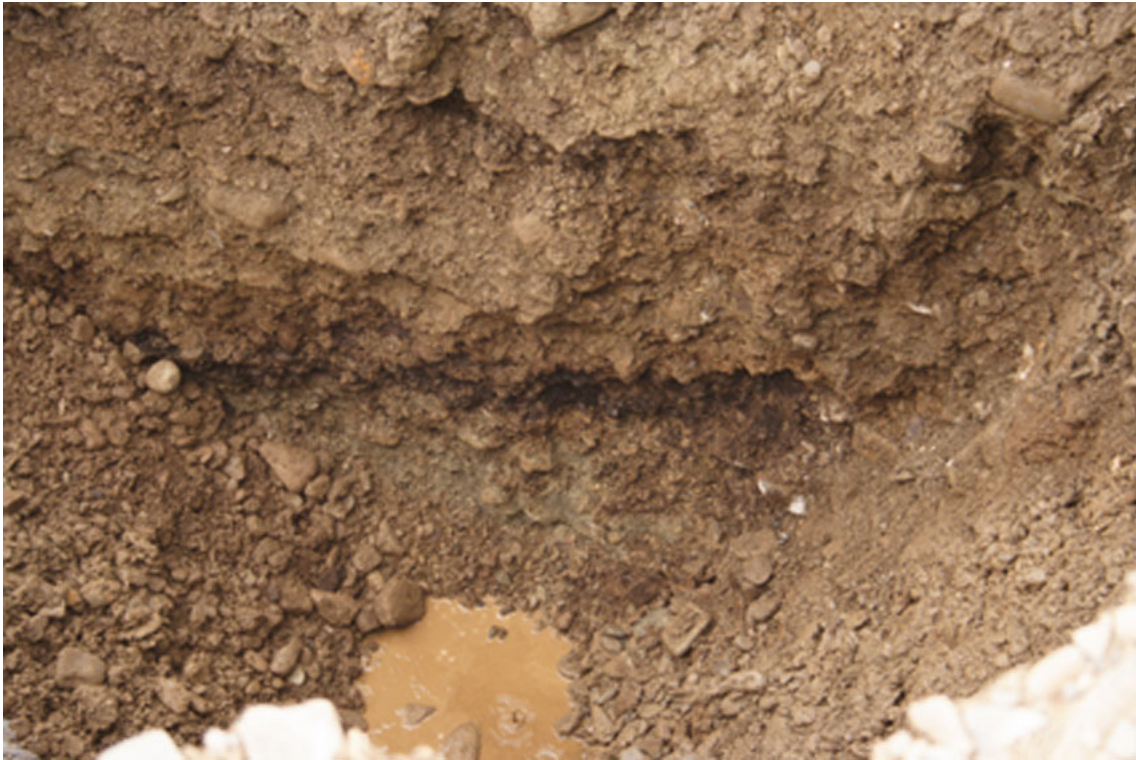
A possible buried ground surface was exposed at the base of the excavation to remove the existing groyne (photo 3). No evidence of this deposit was apparent further inland, but the relative levels are not known. The depth of the deposit (at least 2.5m below the current height of the coast path), may suggest it pre-dates the construction of Castell Cadwgan. No artefacts were recovered and no environmental samples were taken during the removal of the groyne.

Photo 3: Possible paleo-soil exposed during removal of groyne posts

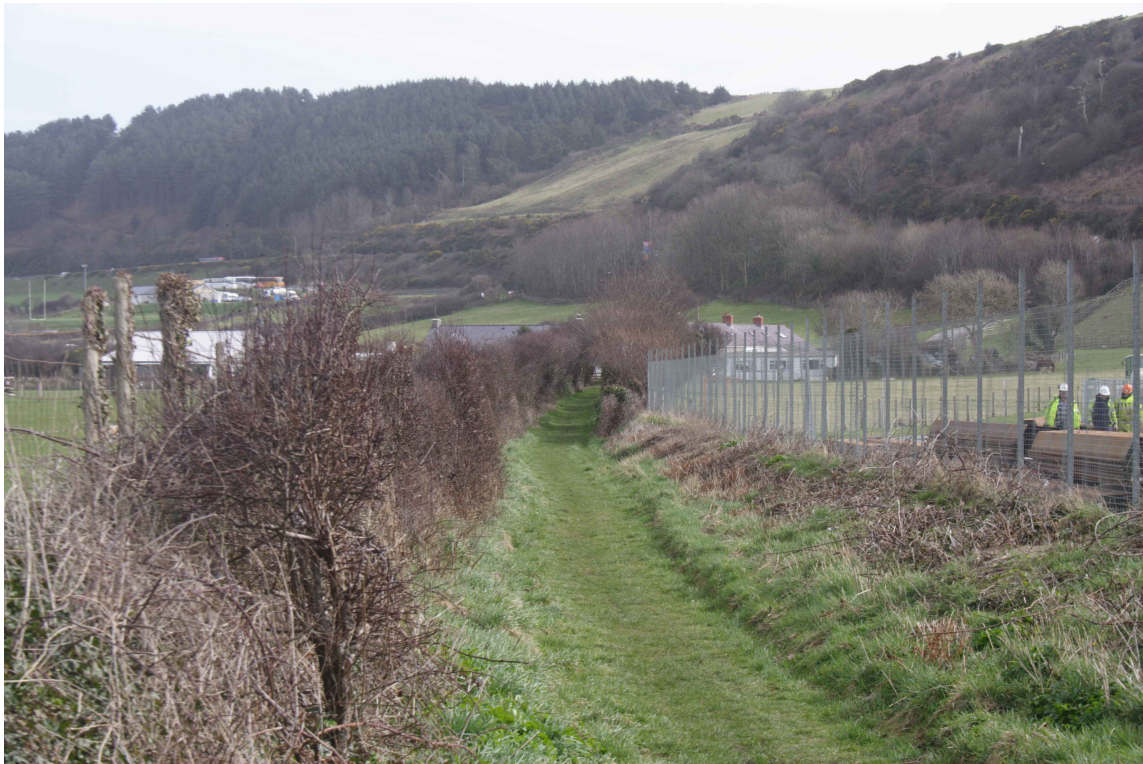
The trackway leading from the beach and the former area of Castell Cadwgan is partially sunken, suggesting a Holloway (track worn deep through the passage of people over many years) and may indicate the location of an earlier trackway leading to the castle.

Photo 4: Possible holloway leading from former site of Castell Cadwgan

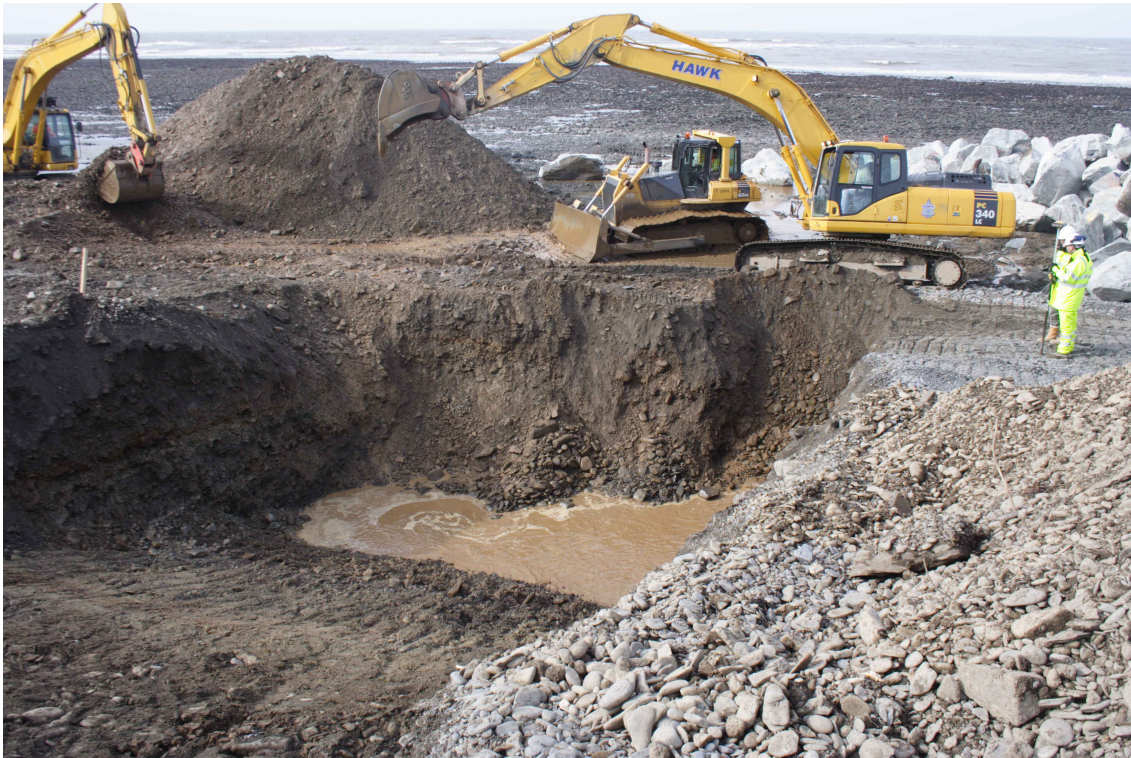
The excavation of the trenches for the flood defences involved a significant depth of material being removed from the beach by large tracked excavators with toothed buckets. This material comprised beach pebbles and very coarse sand layers (photo 7), although no detailed record of the deposits was possible, due to the depth of the trench and instability of the trench edges. The depth of the deposits would suggest that the majority would pre-date the construction of Castell Cadwgan.

Photo 5: Excavation of trench close to Castell Cadwgan to lay new sea defences

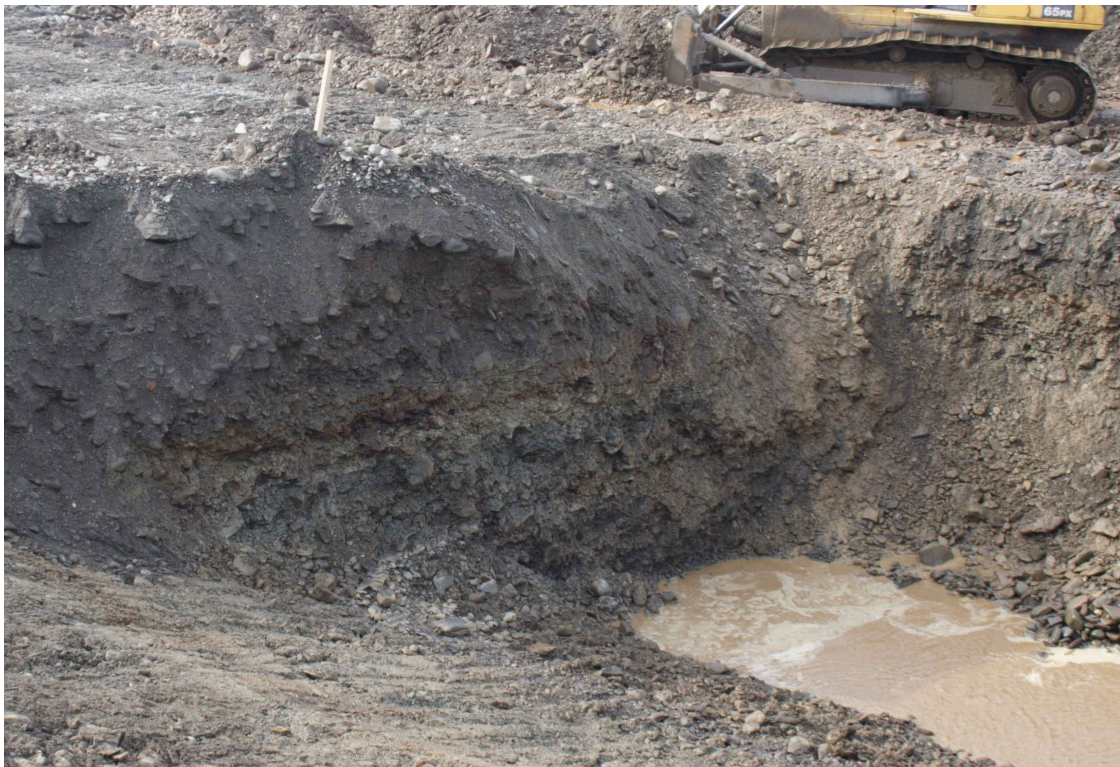
Photo 6: Strata of beach deposits in southern side of excavated trench

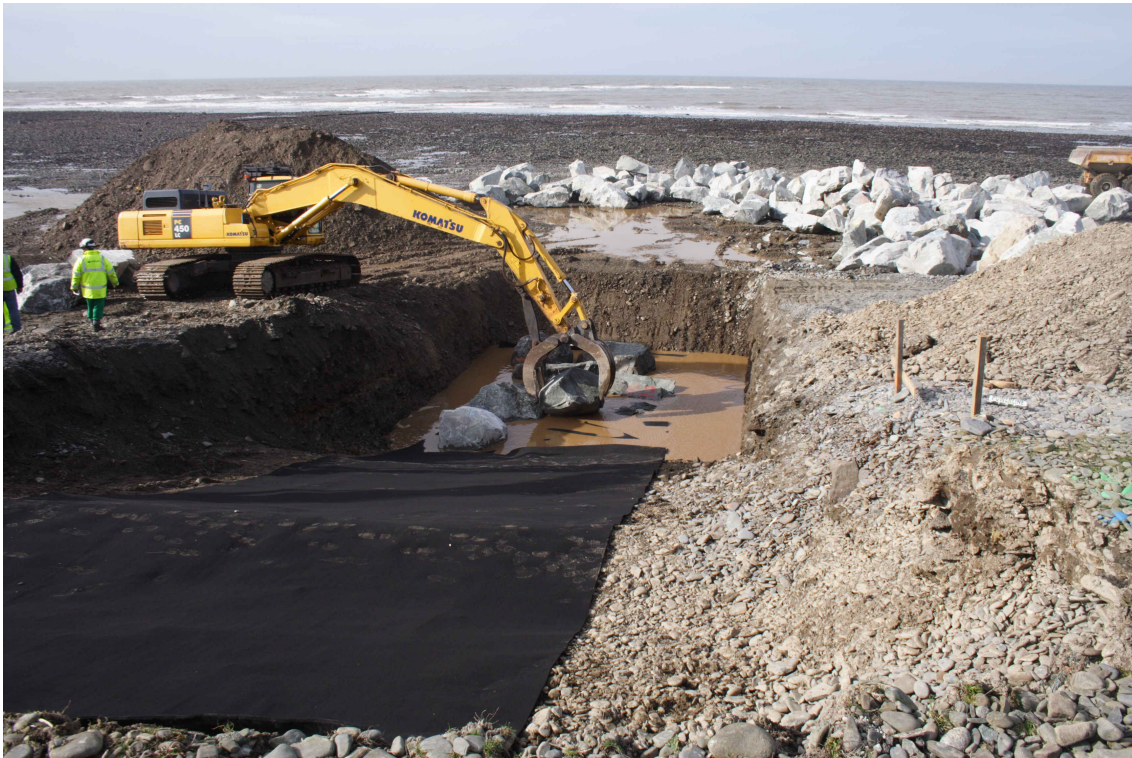
The trench bases were covered with a geo-textile membrane and then large boulders were placed upon this, banked up towards the end of the beach to create the sea defence. No archaeologically significant deposits could be identified within these excavations.

Photo 7: Laying boulders to form sea defences within trench

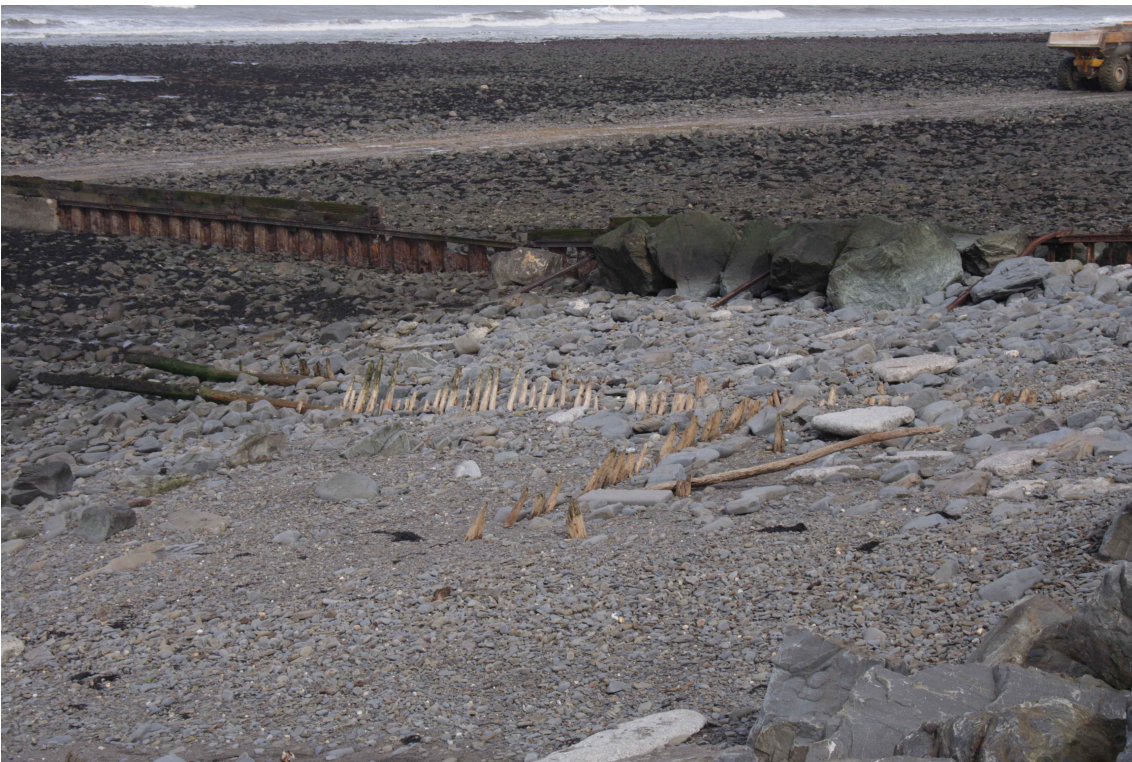
Photo 8: Remains of timber groynes shown on the 1905 Ordnance Survey map located to the north-east of the former site of Castell Cadwgan
