**MEADOW VIEW, LLANGOEDMOR,  
CEREDIGION  
(SN 2011 4580)  
ARCHAEOLOGICAL WATCHING BRIEF**

RHIF YR ADRODDIAD / REPORT NO. 2010/15  
RHIF Y PROSIECT / PROJECT RECORD NO. 98690

## MEADOW VIEW, LLANGOEDMOR, CERDIGION, ARCHAEOLOGICAL WATCHING BRIEF

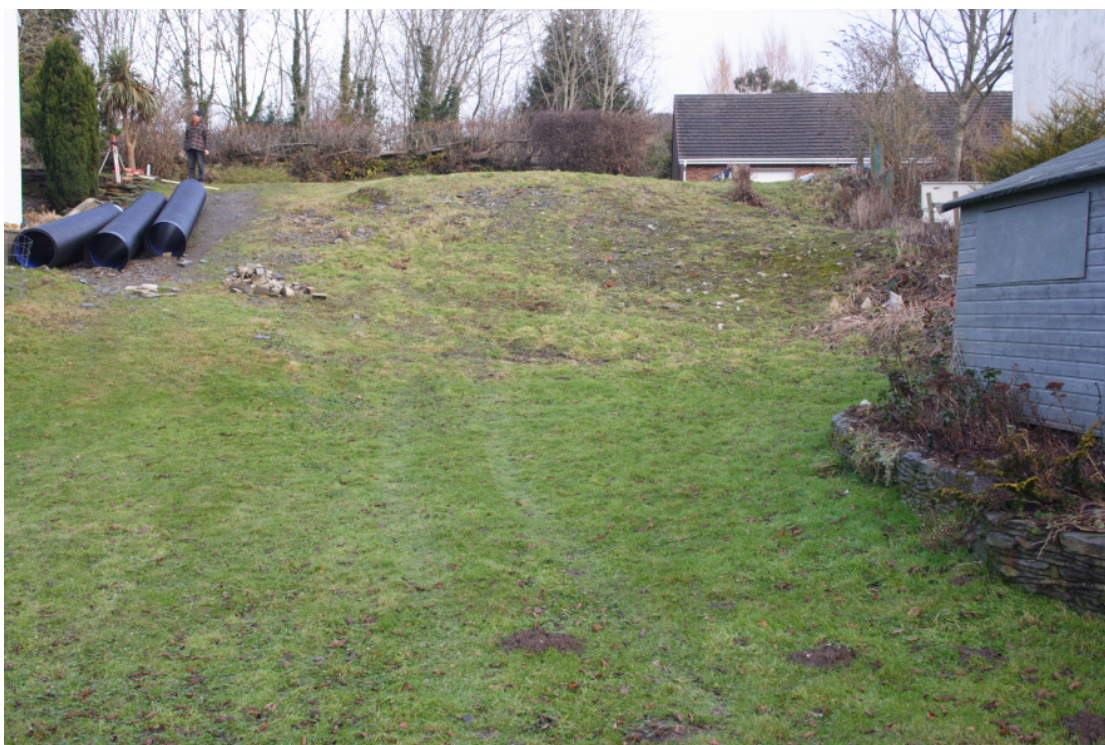
**Photo 1:** Pre-ex photo showing development site.

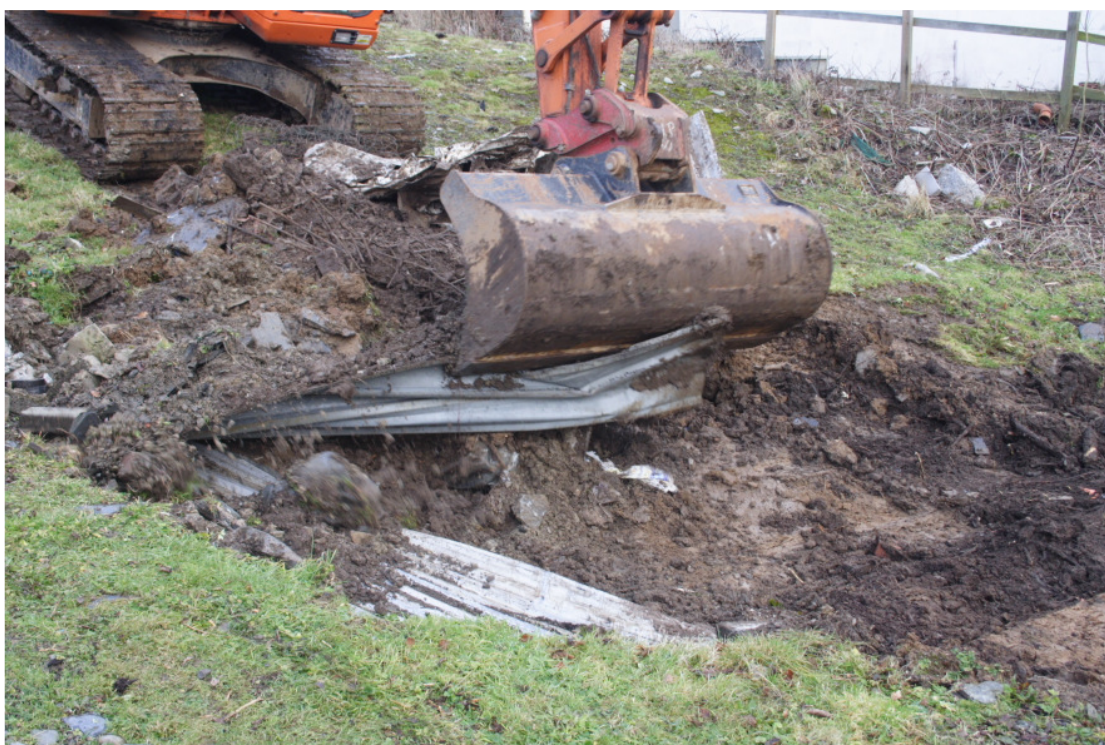
3.2.1 The building plot was located on a south-facing slope, which had been used to dispose of modern building debris, presumably originating from development of the adjacent buildings. This building debris layer proved to be up to 1 metre deep in places and covered the natural topography of the land.

**Photo 2:** Photo showing removal of modern debris.

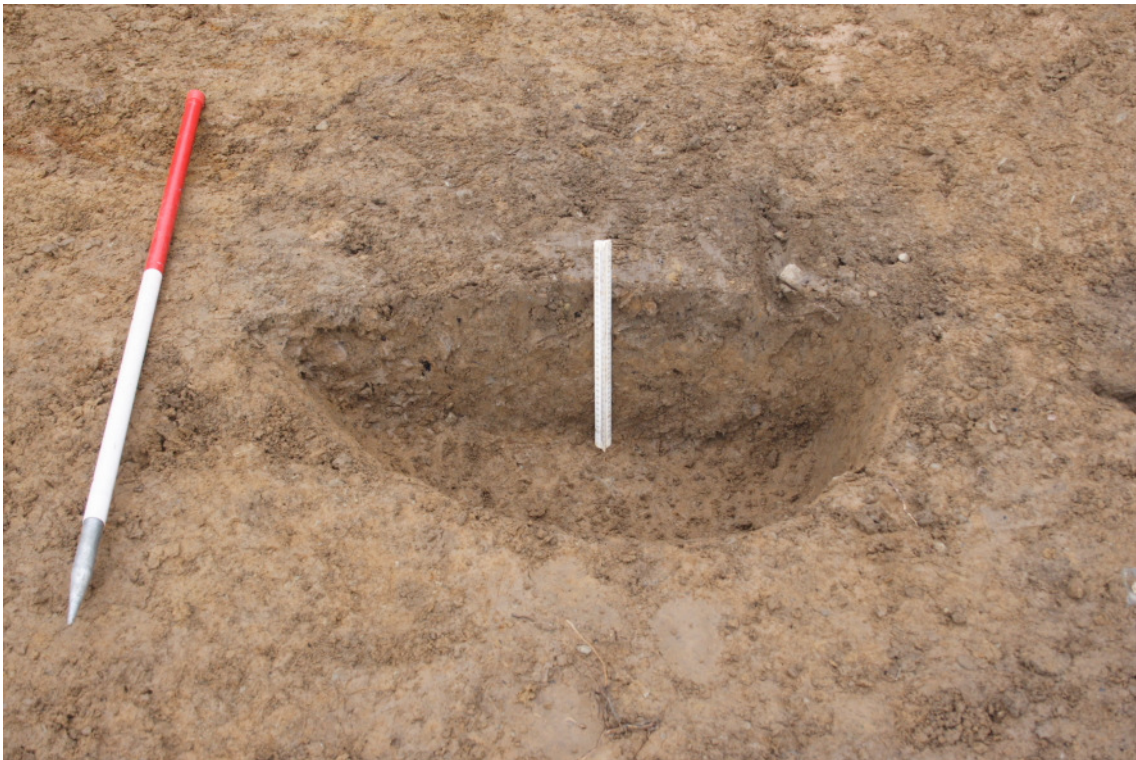
3.2.5 Three archaeologically significant features were revealed within the building plot, lying beneath the subsoil and cutting through the natural substrata. A circular pit [104], measuring c.1.20m in diameter and c.0.27m in depth. The pit contained a light yellowish brown, silty clay with occasional small pieces of charcoal, quartz and burnt fragments of bone. The bone showed signs of being heated under high temperatures. An animal tooth was recovered from the fill which suggests that the pit had most likely been backfilled with debris from a fire or a hearth, as opposed to being a pit associated with a cremation burial. The pit fill contained no dateable artefacts and it is considered that it pre dates the post medieval period.

**Photo 3:** Photo looking north at half sectioned pit [104].

4.3 Pit [104] contained bone that had been burnt at a high temperature, which could indicate a cremation, although as an animal tooth was also found in the pit, this is considered unlikely. It is probable that the bone originated from within a domestic hearth or fire, and the pit filled with the resulting debris when cleaned out. The edges of the pit showed no signs of heat and it was therefore most likely a pit dug out to dispose of rubbish. The fill of the pit also shows signs that it was backfilled in one episode, again pointing to it being a rubbish pit. It is unknown if all of the features are roughly contemporary, although it is considered quite likely.

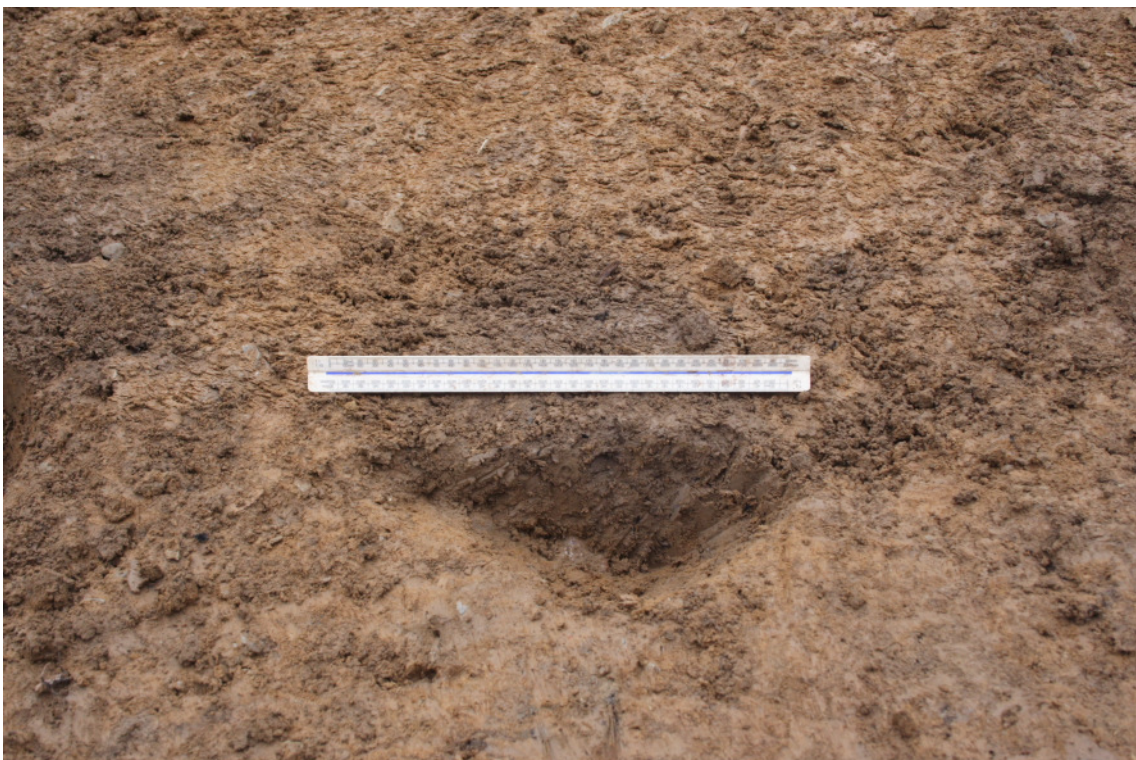
3.2.6 A stake hole [106] was recorded 0.18m to the south east of pit [104]. The feature was very shallow, filled with a mid greyish brown soil with charcoal. The feature measured 0.30 metres in diameter and 0.09 metres in depth.

**Photo 4:** Photo looking northwest showing stake hole [106].

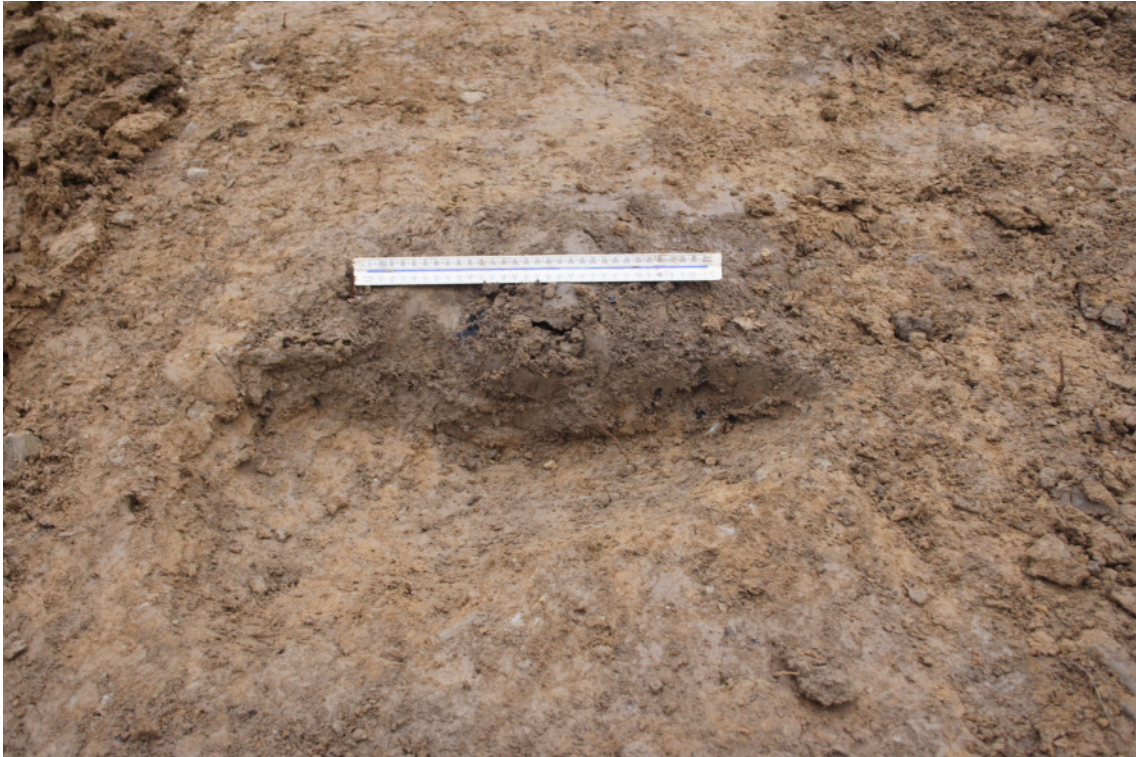
3.2.7 Situated 1.8m to the west of pit [104], another smaller pit was present. This pit had an almost identical fill to the stake hole [106] and could be considered contemporary.

**Photo 5:** Photo looking north showing shallow pit [108].
