# MYDDFAI, CARMARTHENSHIRE, DWR CYMRU ARCHAEOLOGICAL WATCHING BRIEF

February 2010

Prepared by Dyfed Archaeological Trust For: Black and Veatch Ltd

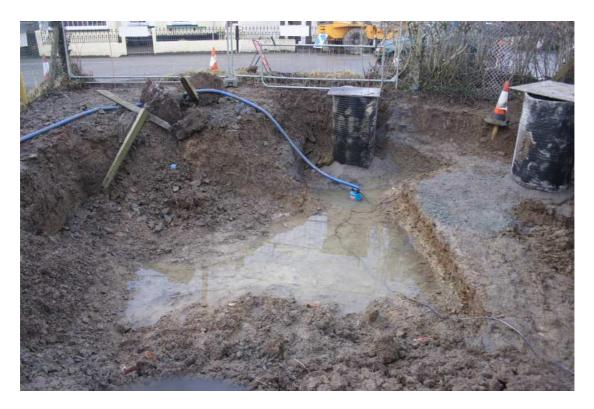
**Photo 1:** Photo south west showing excavated footprint for sewage pumping station.

The buildings foundation footprint measured 4 metres by 4 metres and was excavated using a toothless bucket to a depth where the natural subsoil horizon was visible. Through viewing the natural subsoil it was apparent that there were no archaeological features visible. The western side of the buildings footprint, however, did require the removal of part of the north south linear field boundary, which continued parel along the western side of the buildings footprint. By removing part of the eastern side of the field boundary a perfect section was gained to view the field boundaries make up. A single piece of blue and white china was visible at the bottom of the field boundaries make up situated just above the natural subsoil, which would suggest that the field boundary was constructed no earlier than the post medieval period.

The general area in which the buildings footprint was situated did show signs of disturbance mainly centred on the footprints eastern side and middle part. Large amounts of brick and post medieval pot fragments were found here suggesting that his part of the site was largely composed of made up ground. The western part of the development area appeared to be virgin ground and not have any modern disturbance or archaeological features except for the field boundary running north south.

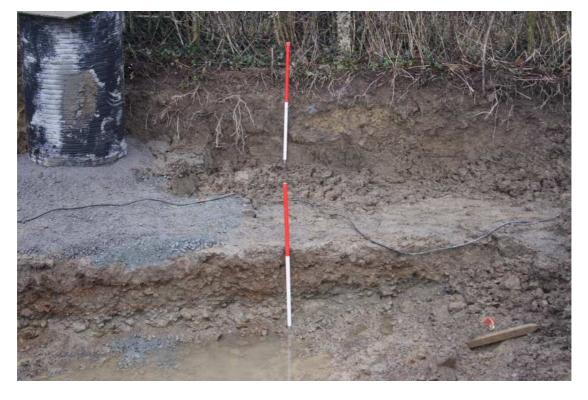
**Photo 2:** Photo looking west showing section of bank and below excavated natural.

The topsoil within the development area was a mid brown silty clay with inclusions of small sub angular stones and was a maximum depth of 0.18 metre. Underlying this mid brown topsoil was a light brown silty clay subsoil. The natural layer proved to be a mid greyish brown silty clay with inclusions of frequent small sub angular stones. This layer had a firm compaction.

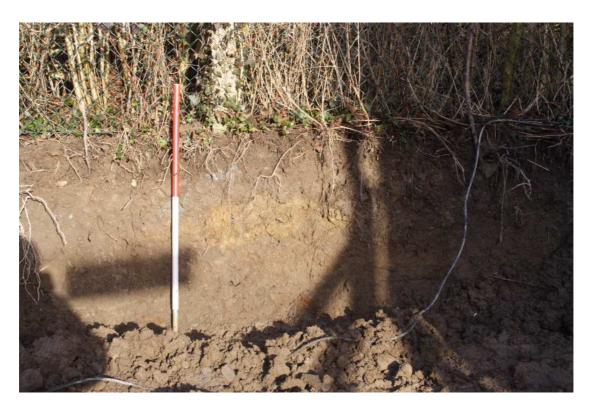
**Photo 3:** Close up photo showing earth bank section.

An area measuring 9 metres square was stripped to the natural subsoil to form a footprint for the building and for the archaeologist onsite to be able to view the ground and decide whether there were any archaeologigical features present. The footprint for the building when excavated proved to have largely contained made up ground, except for the west part of the footprint which had a hedge boundary running north south along the footprints edge which had part of its eastern side removed to provide a clear view of its makeup. The date of the hedge bank appeared to be post Medieval as a piece blue and white china was visible at the bottom of the banks makeup.
