# MRS JOHNES' FLOWER GARDEN, HAFOD

RHIF YR ADRODDIAD / REPORT NO. 2010/29  
Project No 99577

**Mrs Johnes' Flower Garden, Hafod**

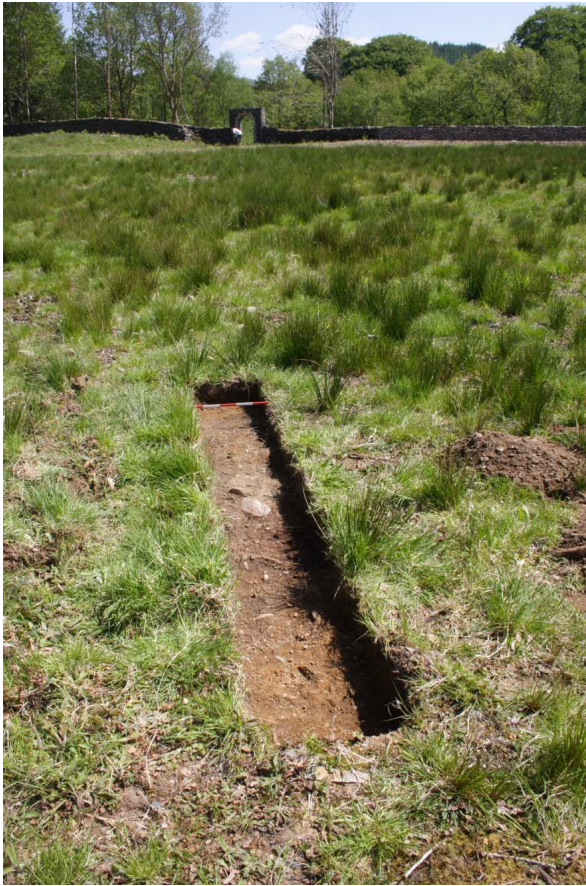
Photograph 1. Trench 1 looking east.  
Scale 0.5m. The path is visible as a slightly darker band running across the trench.

Trench 1 was located over the circuit path on the west side of the garden. The path was found to coincide with the position of the one shown on the 1<sup>st</sup> Edition OS 1:2500, though narrower.

Topsoil: c. 180mm thick, but less, c. 120mm thick over the path. Loose mid/dark brown, loose silty-loam with occasional small/medium-sized rounded stones. High organic content and many roots. A sherd of a red pottery flower pot was found in the topsoil.

Path: A slightly raised band of loose stones and gravel, c. 1.5m wide. It was very poorly defined, with the stones spread over the neighbouring subsoil. Occasional river cobbles (200mm x 100mm x 50mm) were present, but most of this layer was made up of rounded stones c. 50mm x 20mm x 20mm and gravel. The gravel was patchy, but where present formed a coherent surface. The path had been laid in a shallow, linear hollow (c. 100mm deep maximum) scraped out of the subsoil. At its thickest, this layer of stones and gravel making up the path was c. 150mm thick. It is likely that most material for this path was obtained from the river gravels of the Ystwyth 100m to the south.

Subsoil: Silty-loam, mottled in colour ranging from orange-brown to pale grey, with occasional cobbles.

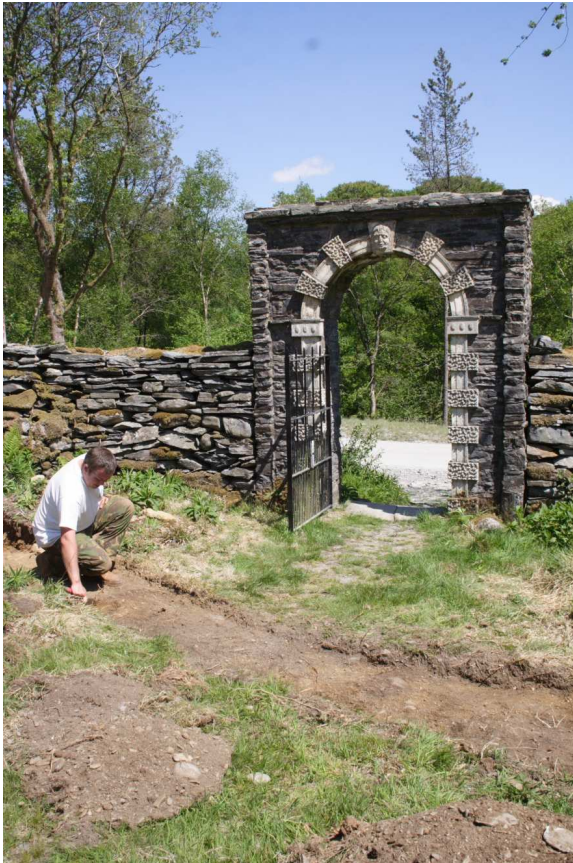
Photograph 2. Trench 2 looking  
east towards the east gate.

This trench was located just within the east gate to the garden. The 1<sup>st</sup> Edition OS 1:2500 map seems to show the gate in a slightly different position to its present location. It has been suggested that it was relocated during restoration in the 1980s. The trench was located to ascertain whether the gate had been moved.

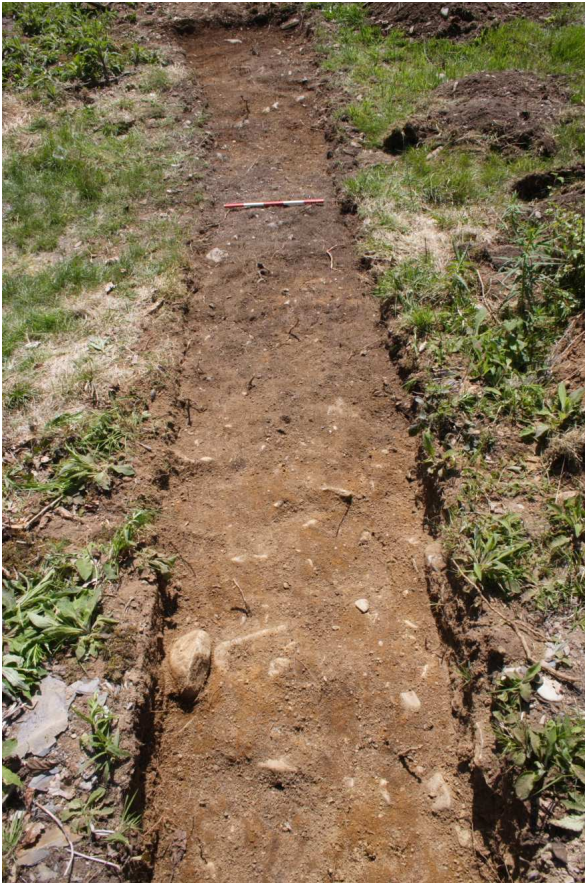
Left. Photograph 3. Trench 2 looking south. Scale 0.5m. The scale rests on the path running across the trench.

Below. Photograph 4. Trench 2. The path partly excavated showing the hollow in which the path make-up sits. Scale 0.5m.

Topsoil: Almost non-existent. At its maximum 100mm of silty-loam, but generally just a skim of turf, roots and other organic matter.

Path: This was difficult to identify as it had been spread over the surface of the subsoil. It consisted of a c. 1m wide band of loose stones and soil – the stones comprising c. 70% of the total. Gravel was the main component of the stones, but with occasional cobbles and smaller rounded stones. The stony/soily layer making up the path was set in a shallow linear hollow up to c. 100mm deep. The path was aligned on the present gate, indicating the gate is still in its original location, and that the locational discrepancy between the 1<sup>st</sup> Edition OS 1:2500 map and the modern survey is due to differences in surveying and is not actual. It is likely that most material for this path was obtained from the river gravels of the Ystwyth 100m to the south.

Subsoil: Orange-brown silty-loam with occasional cobbles.

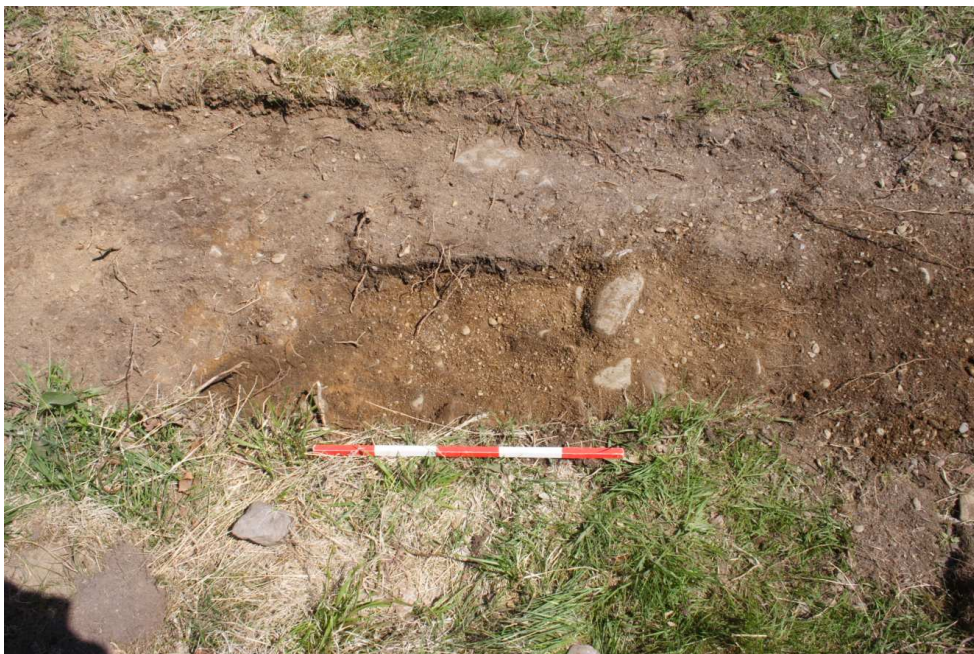
Trench in garden across the line of an historic walk

Topsoil: thin, c 10cm thick, dark brown silty-clay loam with gravel and stones

Walk: c 0.7m wide band/ridge of angular pieces of blue-grey shales. Pieces c 10cm x 5cm x 10cm down to 20cm x 10cm x 5cm. Occasional rounded pieces present. The stones are very loosely laid and rest directly onto subsoil. The band/ridge is c 50-70cm thick. The colour of the stones contrasts sharply with the subsoil.

Subsoil/gravel geology: yellowish/oranger brown gravel/cobbles in a silty matrix.
