**GELLI AUR, GLANRHYD,  
PEMBROKESHIRE  
(SN 1496 4248)  
ARCHAEOLOGICAL WATCHING BRIEF**

**June 2010**

RHIF YR ADRODDIAD / REPORT NO. 2010/38  
RHIF Y PROSIECT / PROJECT RECORD NO. 99809

## GELLI AUR, GLANRHYD, PEMBROKESHIRE, ARCHAEOLOGICAL WATCHING BRIEF

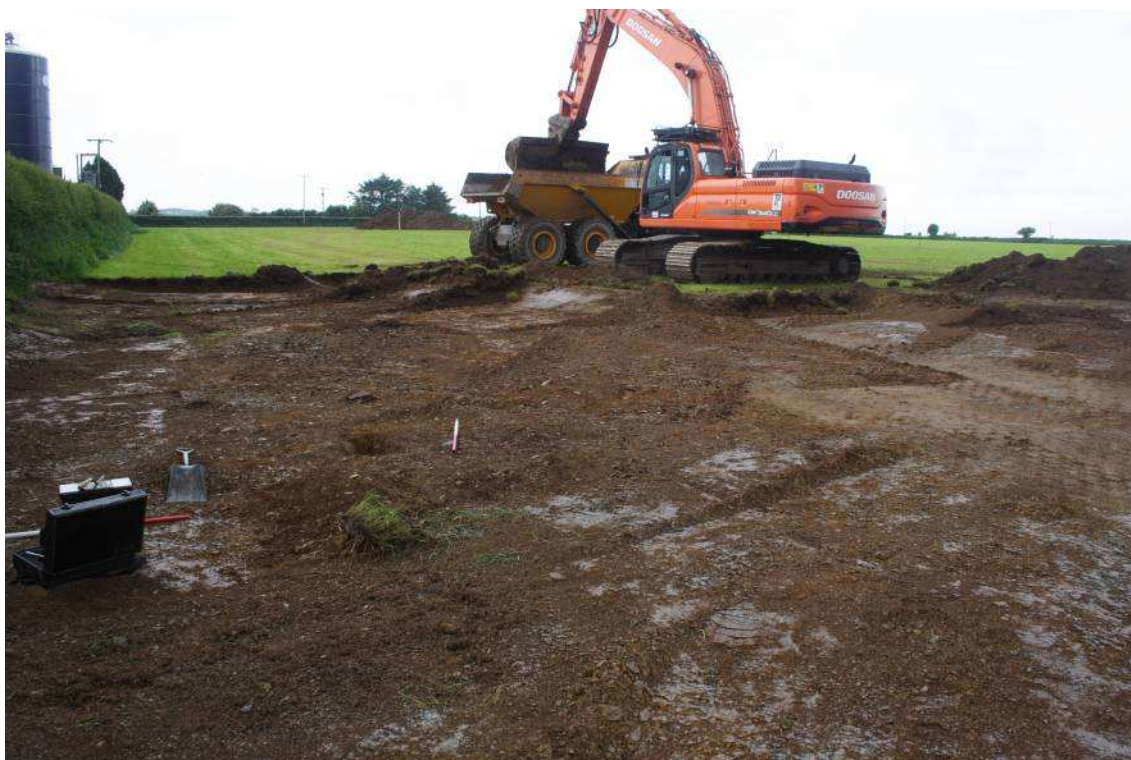
4.1.1 The topsoil [100] was a dark brown silty clay, which contained small sub-angular stones and measured an average of 0.25m in depth.

4.1.2 The underlying natural subsoil (101) comprised a light-yellowish brown silty clay, and was observed at an average depth of 0.25m below ground level. Discrete patches of degrading shale bedrock were exposed below 101.

**Photo 1:** Pre-excavation view showing the development site during initial topsoil removal.

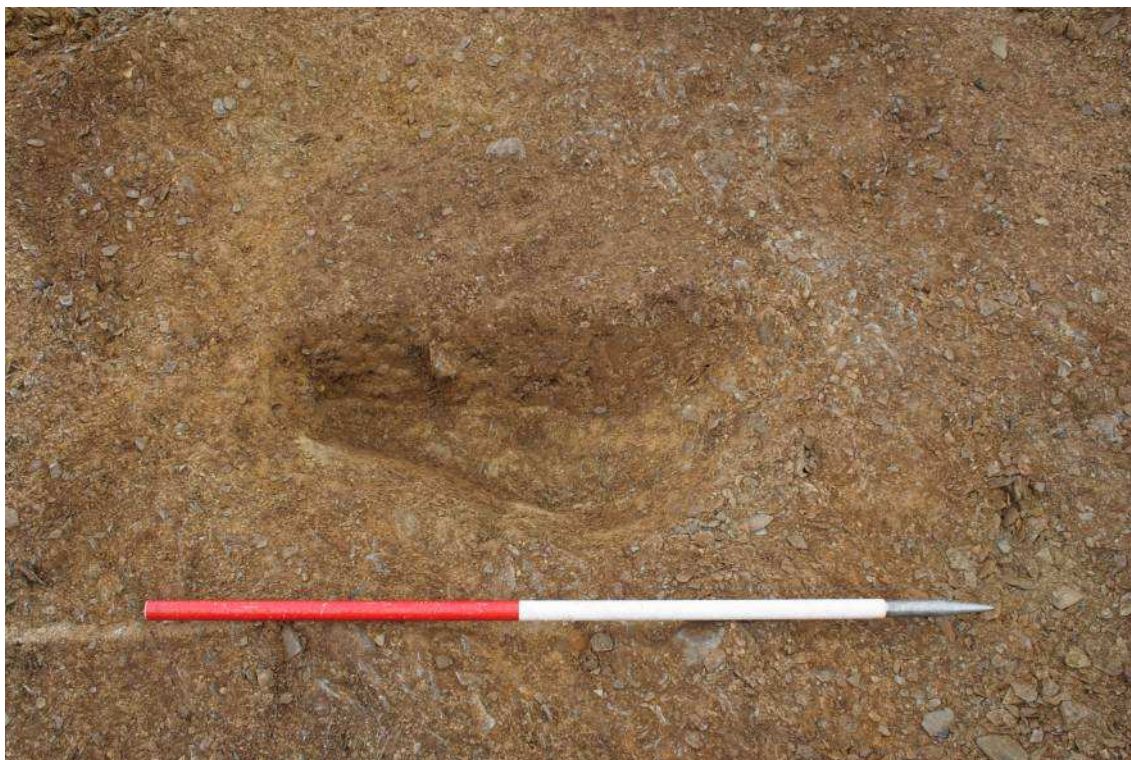
4.2.1 A sub-rectangular pit [112] was revealed at the southern end of the yard extension (see figure 4); this feature measured 0.77m wide by 0.89m in length and was a maximum depth of 0.25m (photos 2 and 3).

4.2.2 The fill (113) of pit 112 was a light orange brown silty clay with inclusions of small sub-angular stones. No finds or dating evidence was recovered from the fill.

**Photo 2:** View of pit [112] after half-sectioning. 1m scale.

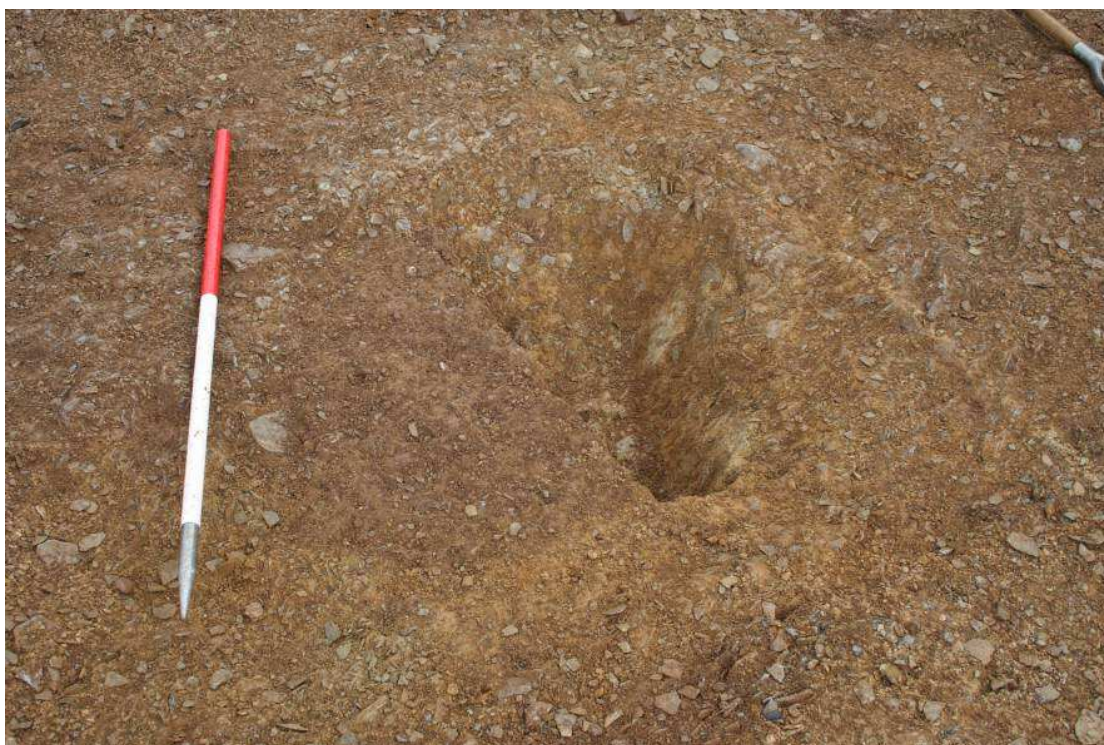
**Photo 3:** View south of half-sectioned pit [112].1m scale.

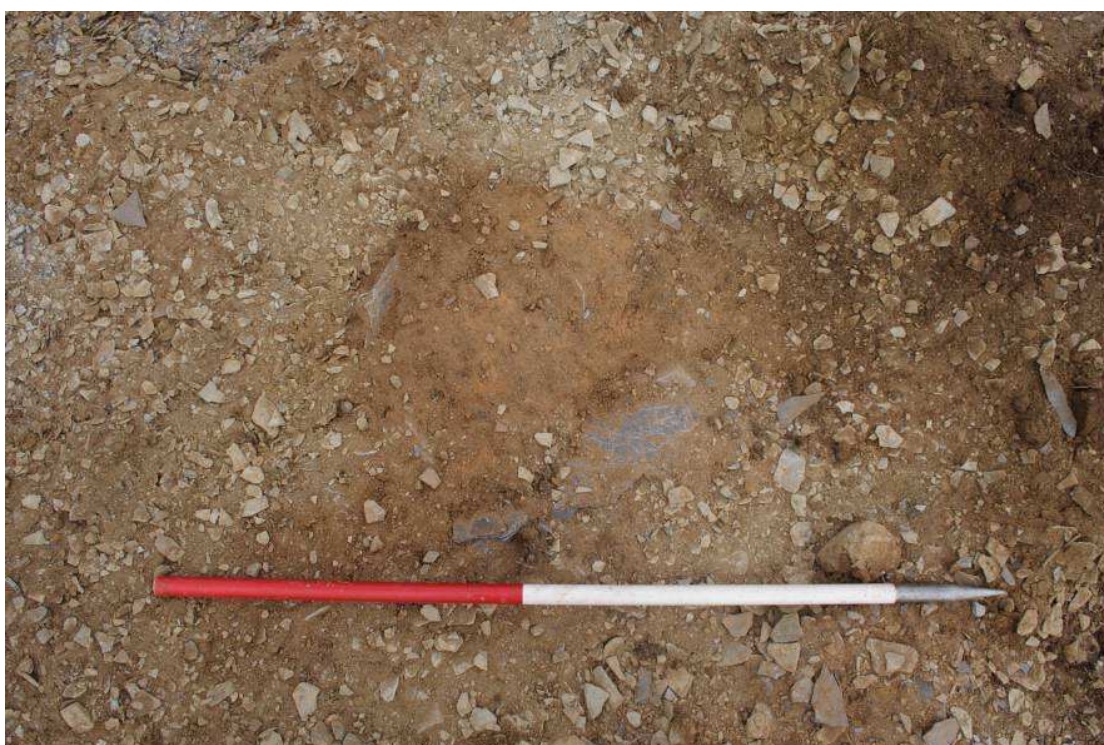
4.3.3 The south-eastern posthole [102] measured 0.32m in diameter and was 0.07m deep. The bottom of the posthole was lined with slates suggesting the possible presence of a post pad. The fill (106) was a light reddish brown silty clay soil containing occasional small pieces of burnt daub, small sub-angular stones and frequent flecks of charcoal (photos 4,5 and 6).

**Photo 4:** View of unexcavated posthole [102]. 1m scale.

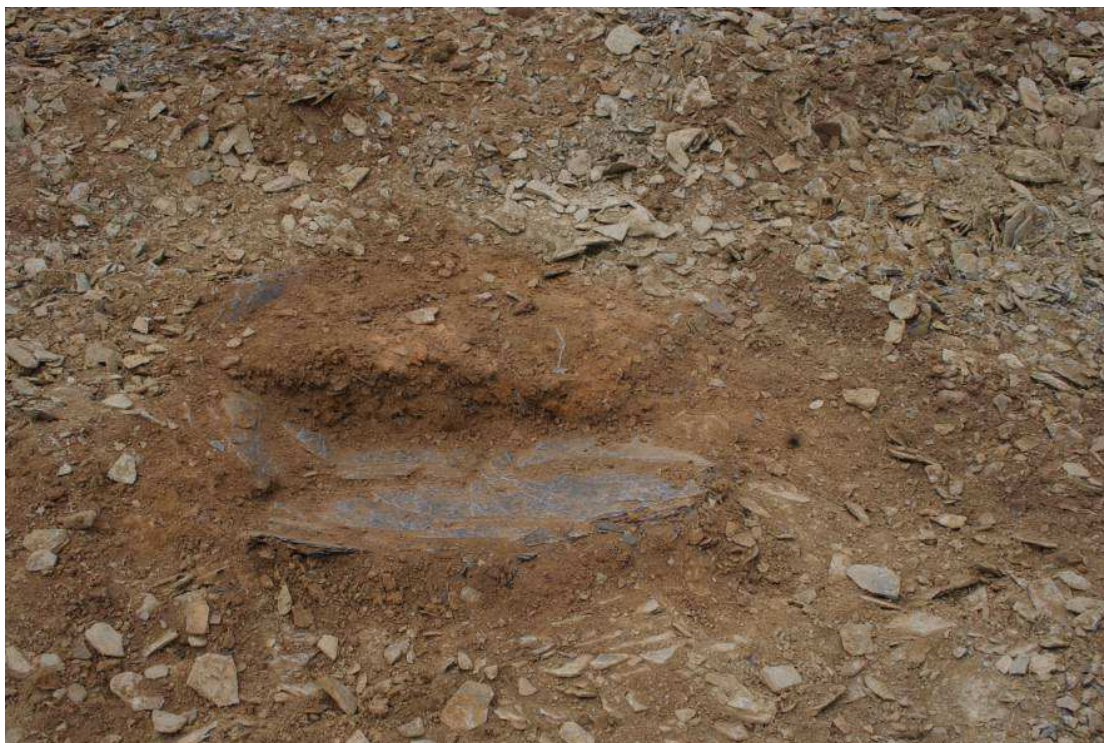
**Photo.5:** View north of half-sectioned posthole [102].

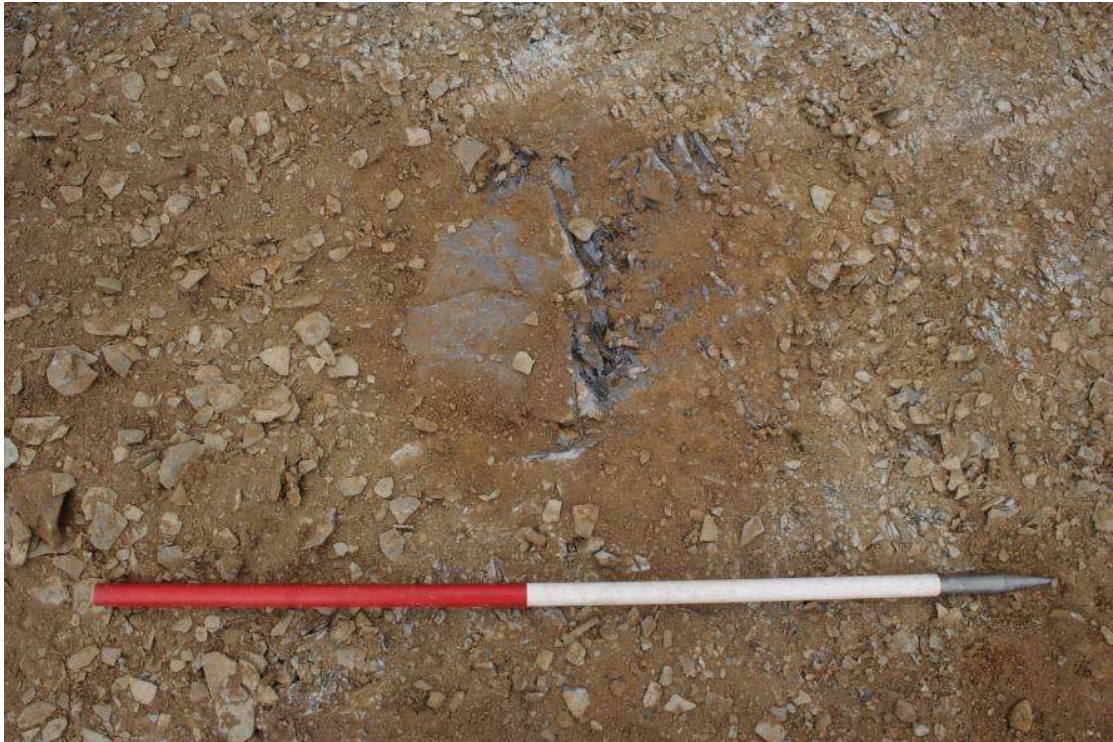
4.3.4 This posthole [103] was 0.64m in diameter. Two large slates appeared to have been placed in the bottom of the cut, which may have formed a post pad. Very little of the fill (116) remained as the posthole had suffered greatly from plough erosion which had probably truncated the majority of the feature. The slight remains of 116 was a light reddish brown silty clay similar to the fills of the other features in this group (photo 7).

**Photo.7:** View of posthole [103]. 1m scale.

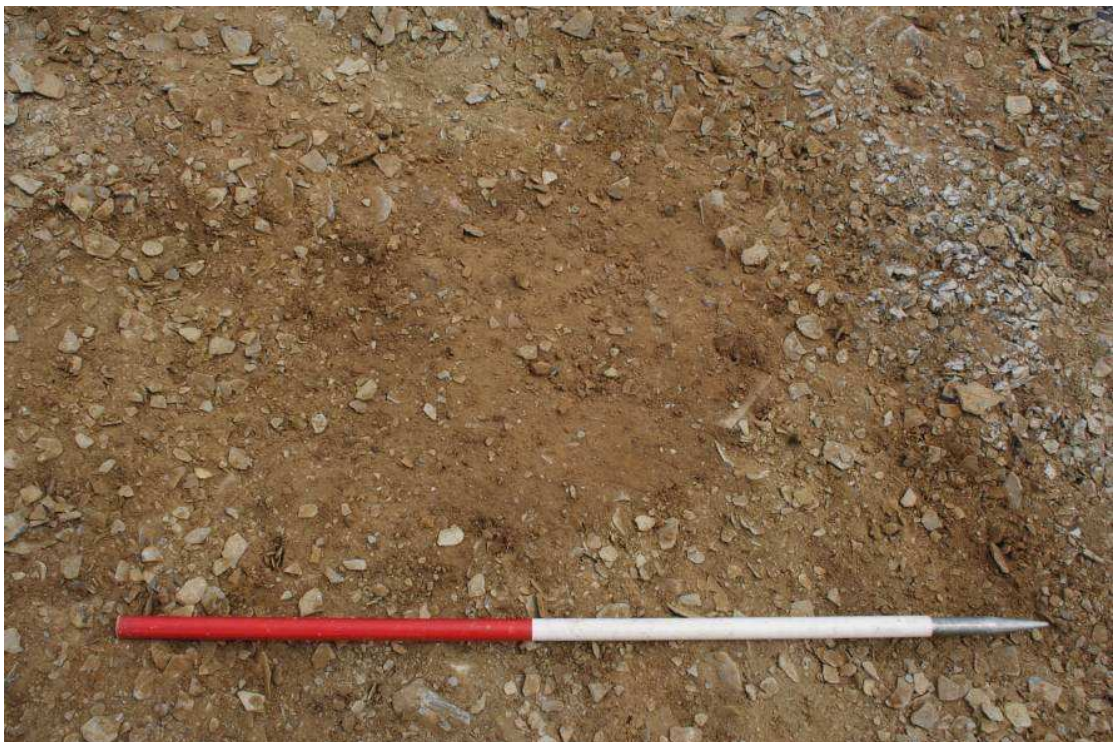
4.3.5 The north western posthole [105] measured 0.38m in diameter. The fill (107) was a light reddish brown silty clay soil and was very similar to (106) (see photo 8). Slate fragments were noted within the fill, although the feature was left unexcavated.

**Photo.8:** view of posthole [105]. 1m scale.

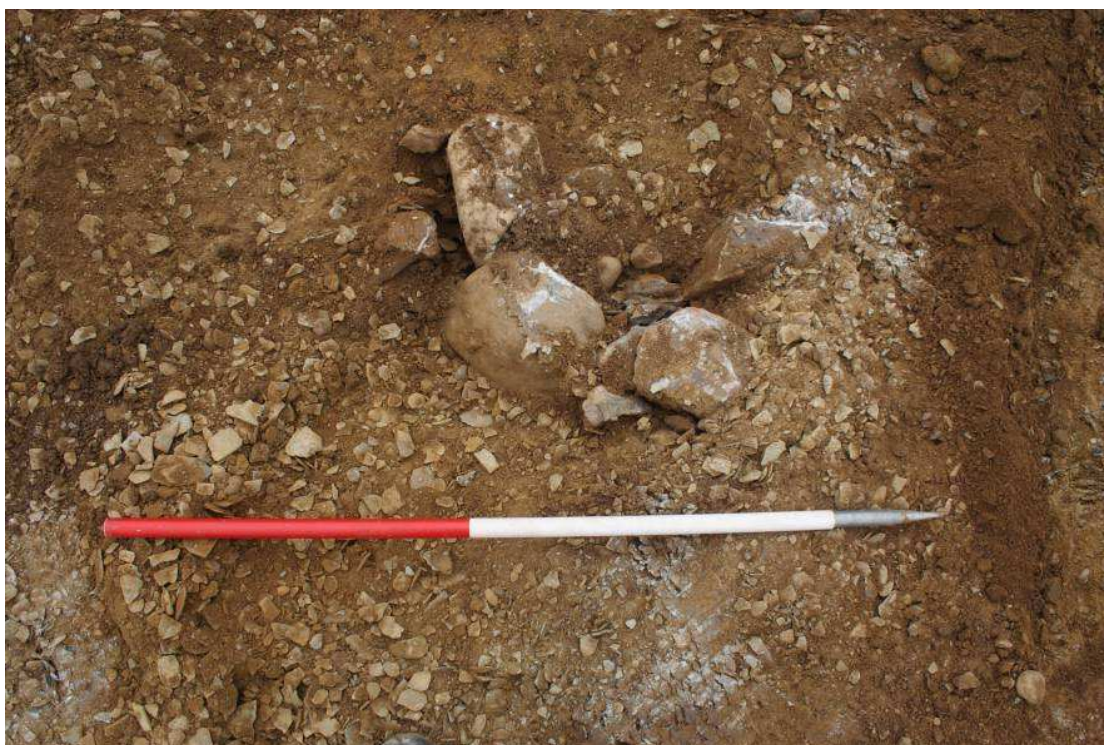
4.4.1 Posthole [108] measured 0.52m in diameter and had a maximum depth of 0.28m. The fill (109) contained a mid brown silty clay soil containing rare flecks of charcoal. Several small to medium sized stones were present in the fill which may have been representative of post packing material.

**Photo 11:** Pre-excavation view of posthole [108]. 1m scale.

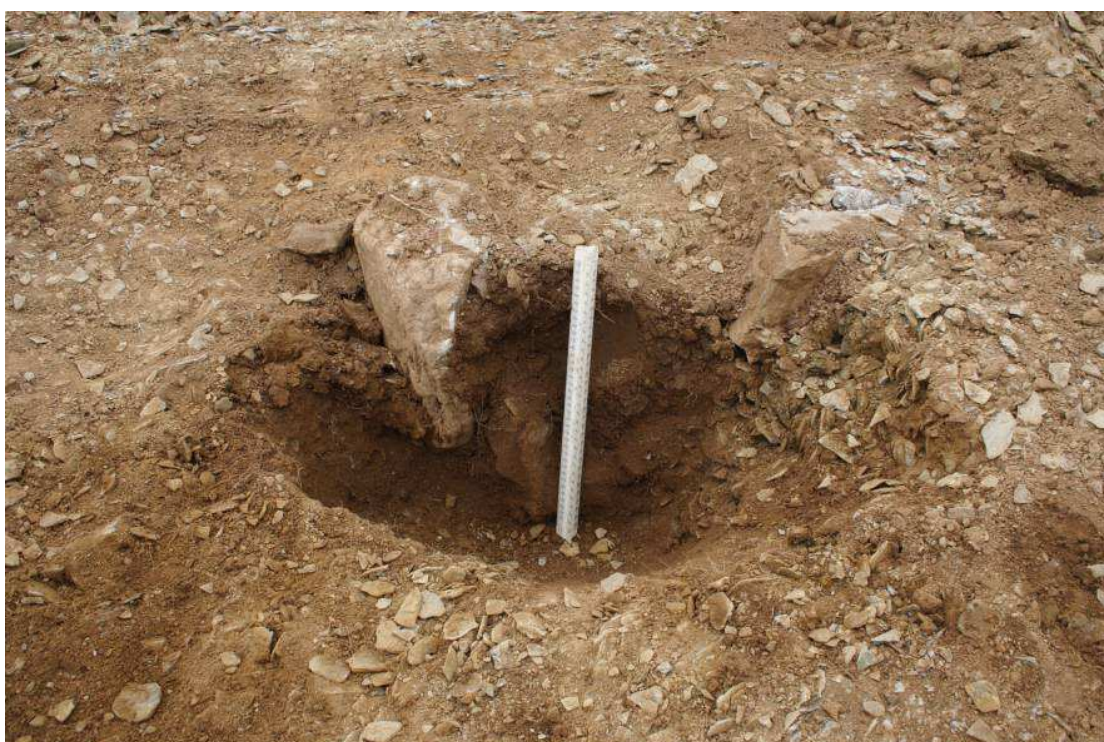
**Photo 12:** View of half-sectioned posthole [108].

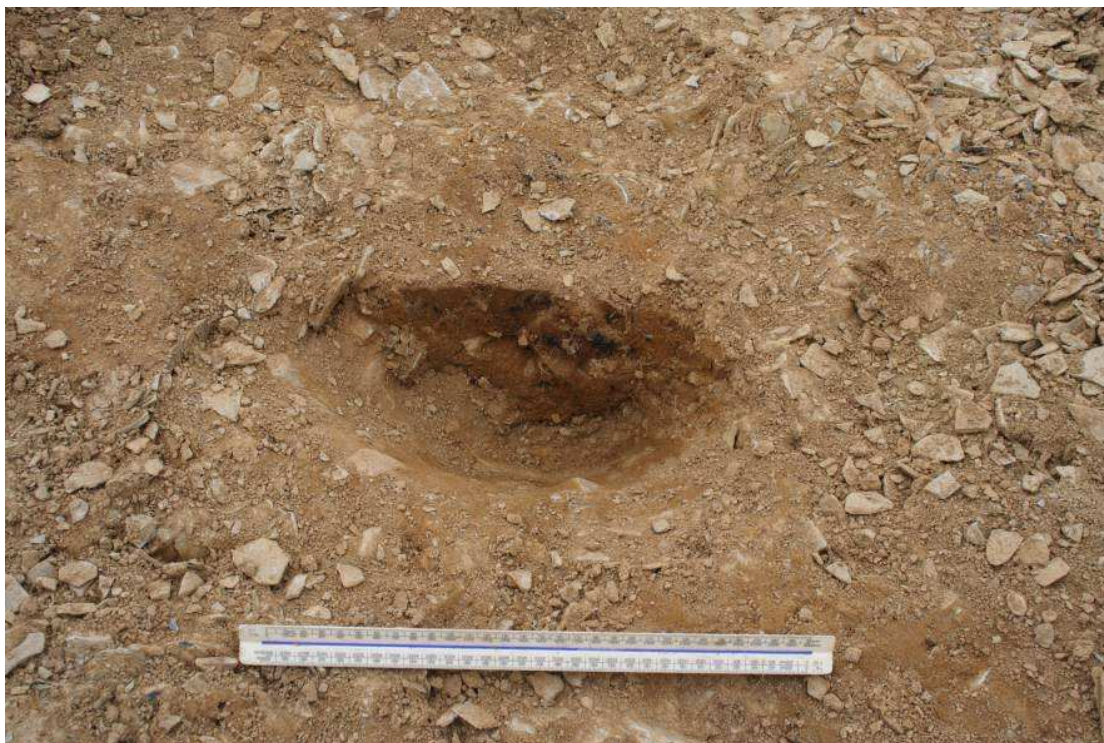
4.4.2 Situated 0.82m to the east of posthole [108] a smaller posthole [110] was recorded. This feature measured 0.28m in diameter and had a maximum depth of 0.14m. The fill (111) comprised a mid brown silty clay soil containing rare flecks of charcoal.

**Photo.13:** View of posthole [110].

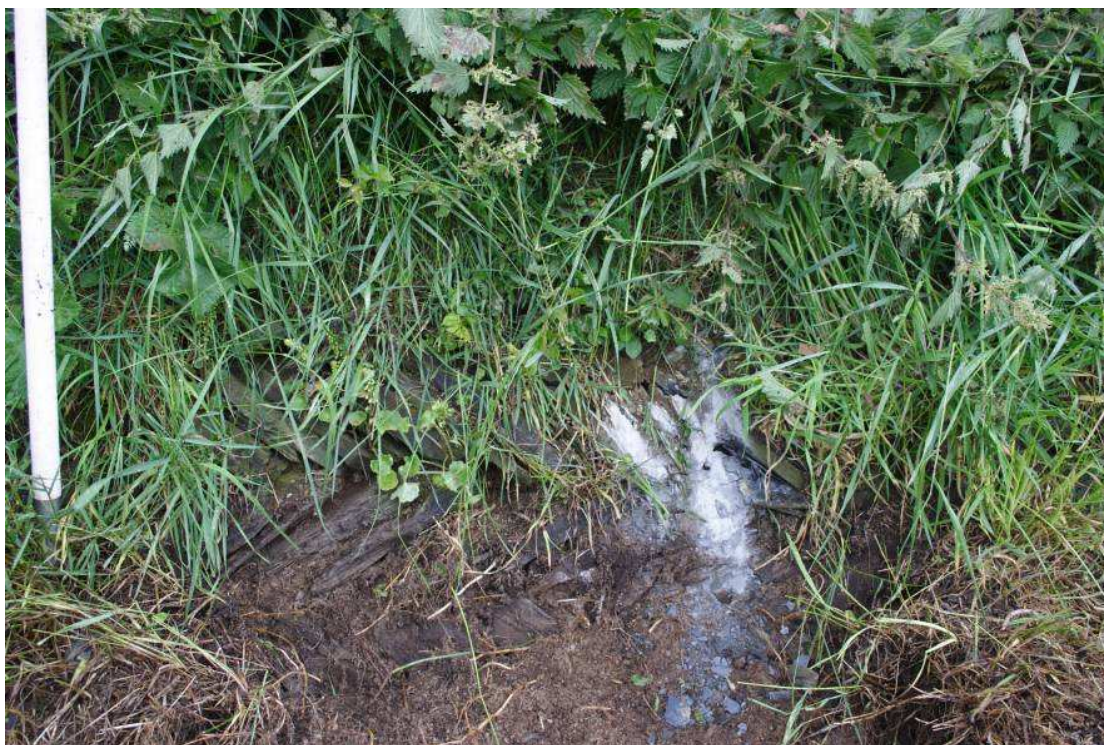
4.5.1 An entrance for access to the development area was constructed through the western field boundary beyond which the yard extension was situated. The field boundary appeared to be constructed of an earth internal core and faced, externally, with slates in a herring bone pattern. The hedge bank measured 2.80m in width along its base and tapered up to a maximum of 1m in height.

**Photo.14:** View of western field boundary's herring bone patterning on its eastern exterior.
