TALBENNY HALL FARM, LITTLE HAVEN, PEMBROKESHIRE: ARCHAEOLOGICAL WATCHING BRIEF

RHIF YR ADRODDIAD / REPORT NO. 2010/39
RHIF Y PROSIECT / PROJECT RECORD NO. 99810

**TALBENNY HALL FARM, LITTLE HAVEN,
PEMBROKESHIRE:
ARCHAEOLOGICAL WATCHING BRIEF**

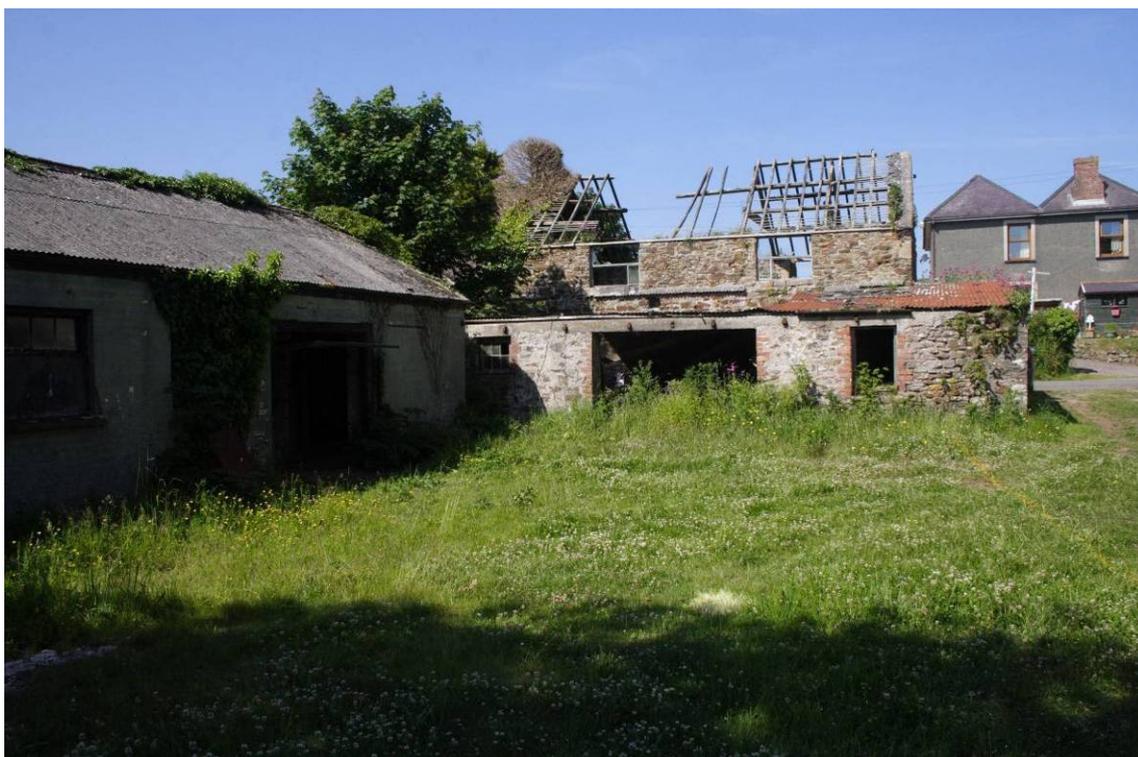
The site comprises an overgrown yard area, between a former cart shed to the west on the road frontage, and a second more modern building along its eastern edge (Photo 1). A property boundary defines the northern edge with a gated field boundary to the west.

Photo 1: View west across site area before excavation of drainage trenches, showing the eastern brick built extension of the cart shed

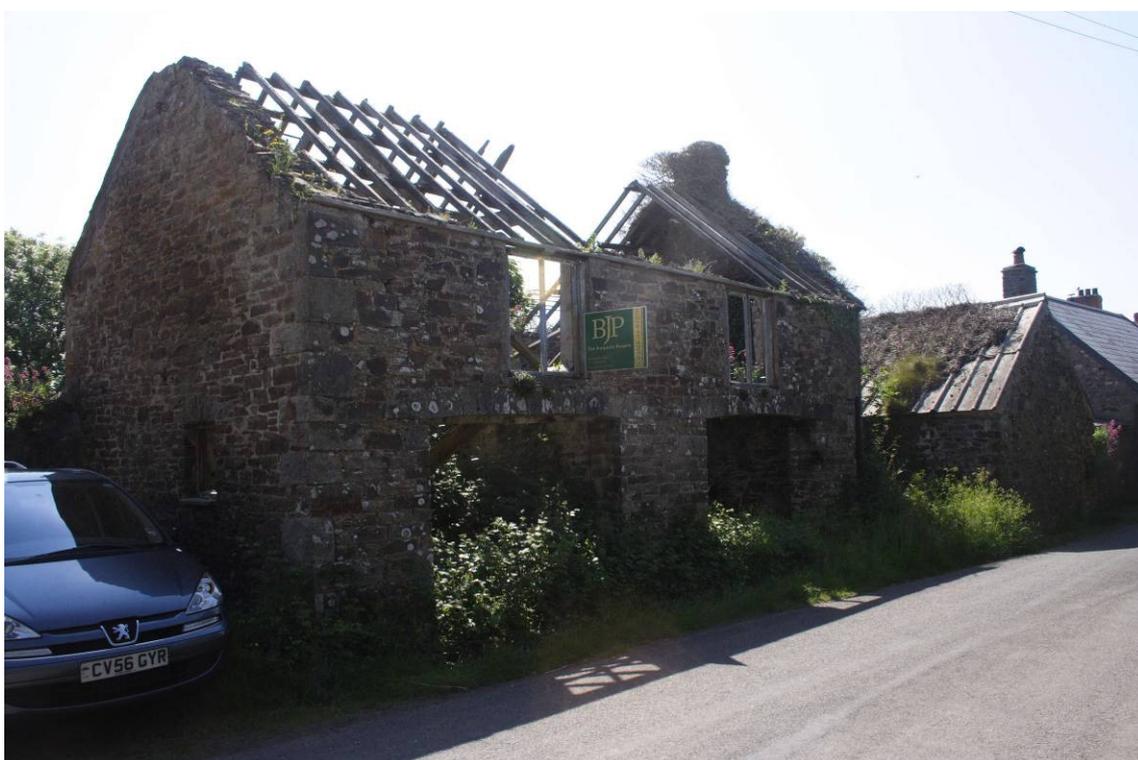
The cart shed is constructed of stone with brick detailing and a brick built extension on its eastern side (Photos 1 - 5). The stone built part of the structure is of two storeys, with two cart entrances on the road frontage (Photos 2, 4 & 5). A fireplace is located at the southern gable end of the building, with an opening at ground floor level (Photo 3). The building is in a poor state of repair, with the floor and roof timbers partially collapsed (Photo 3). The inside of the building was not entered.

Photo 2: The western façade of the cart shed

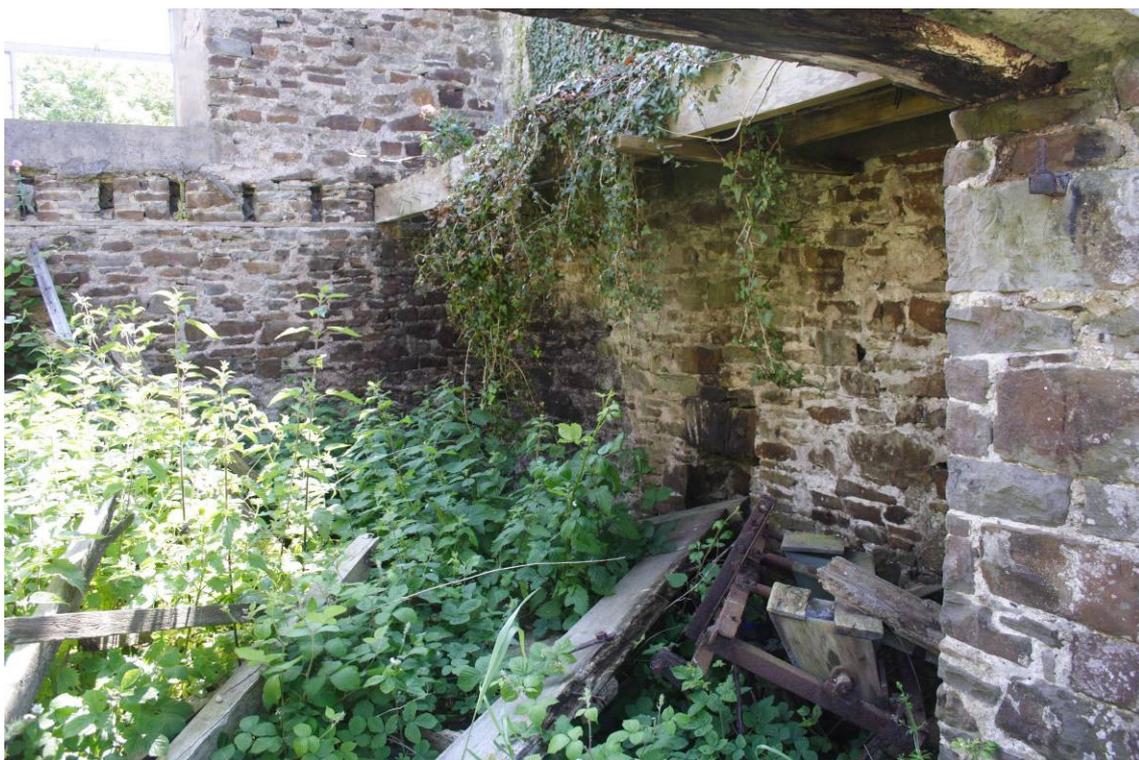
Photo 3: Fireplace on southern gable end of building at ground floor level, showing collapsed roof and floor joists within cart shed

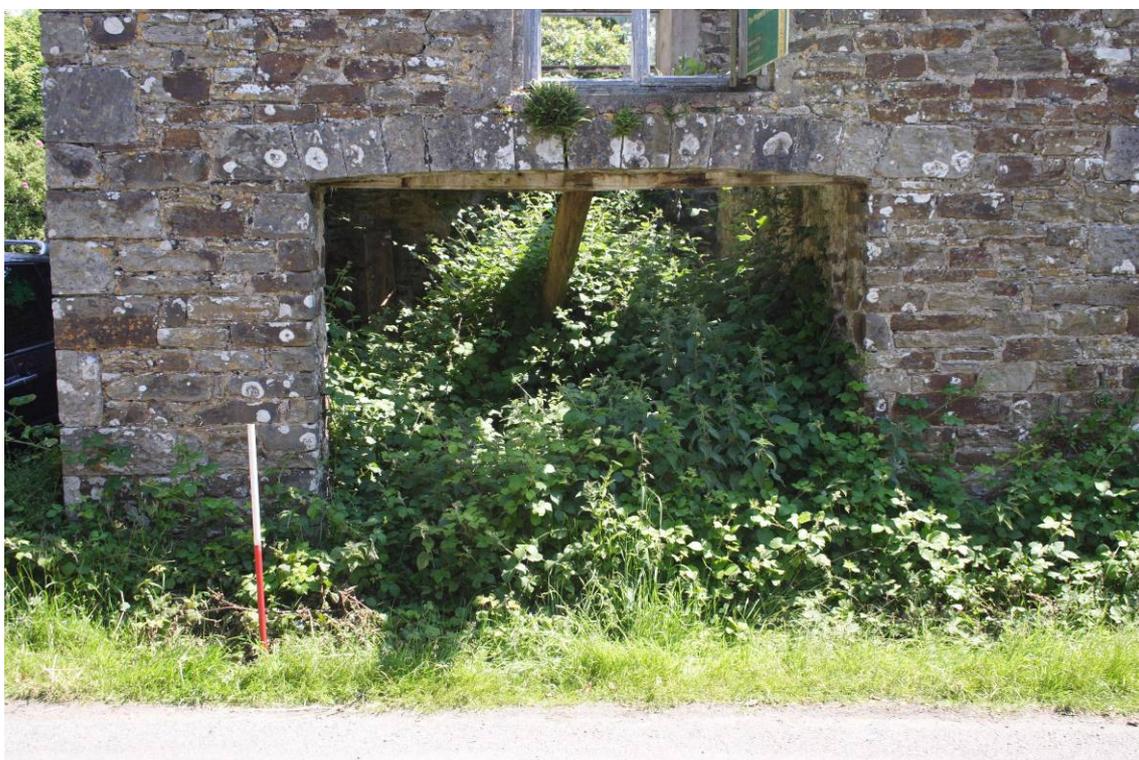
Photo 4: Northern cart entrance (2.6m wide and 2.18m in height)

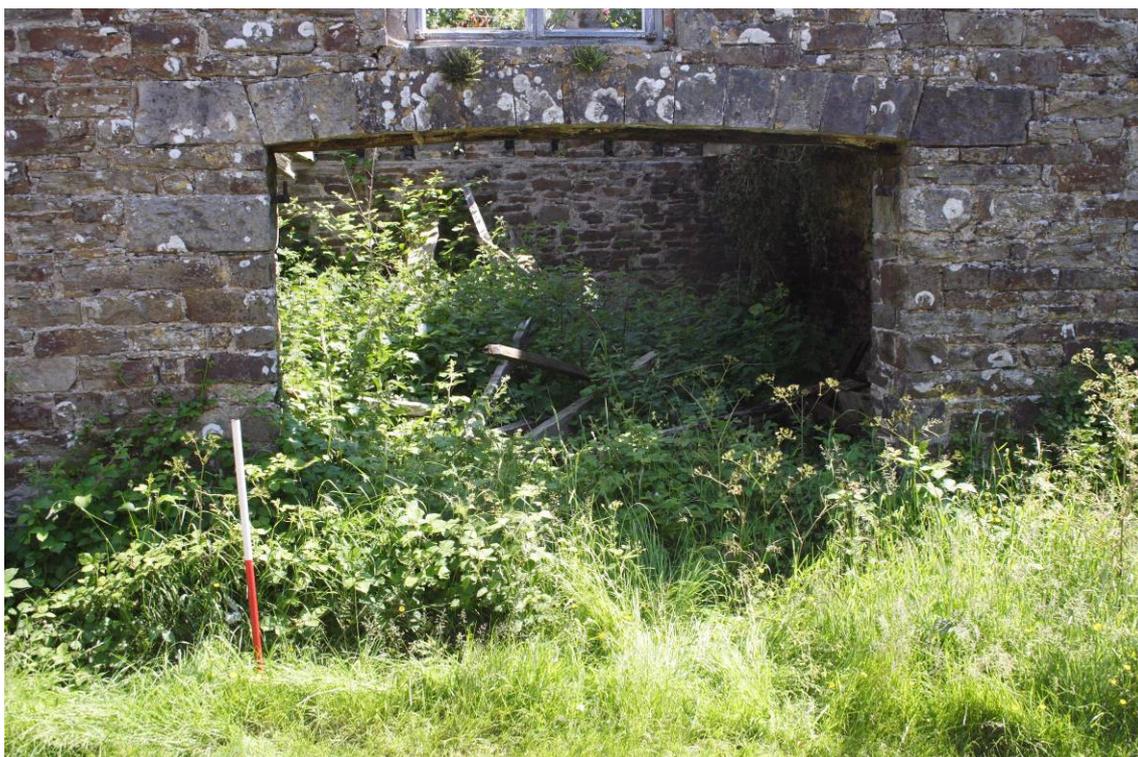
Photo 5: Southern cart entrance (2.8m in width and 2.14m in height)

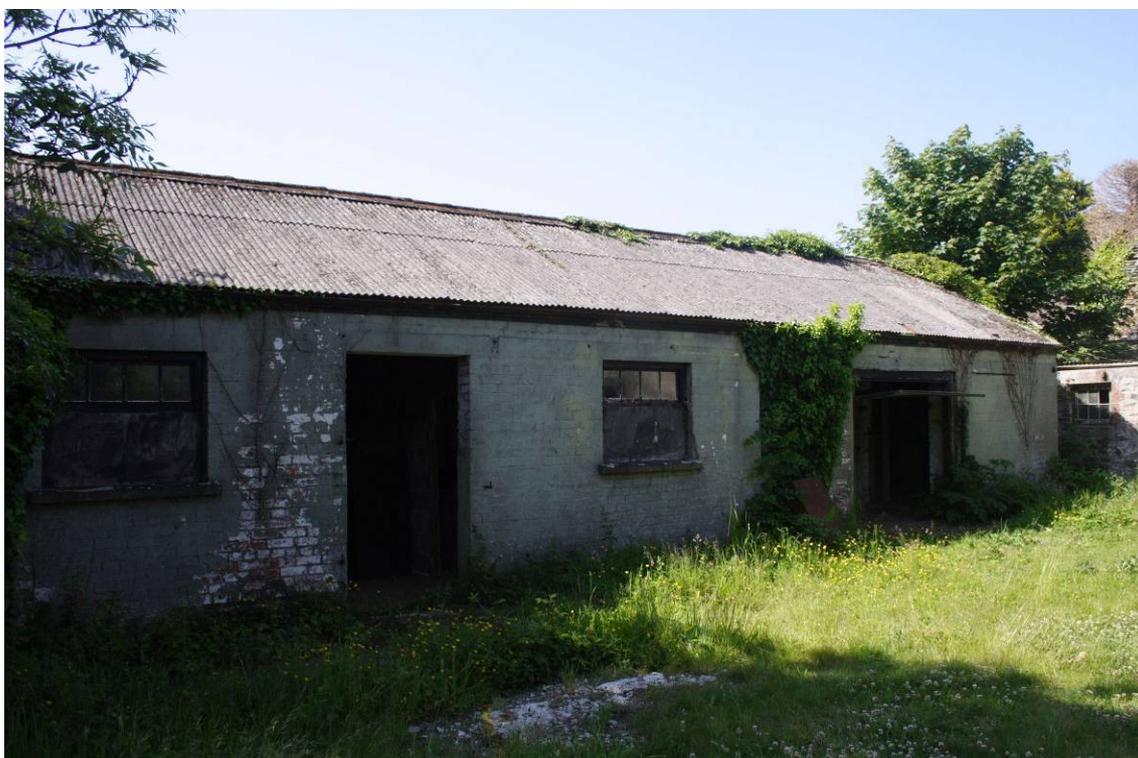
The modern building on the southern side of the area was a single storey brick-built structure with corrugated asbestos cement gabled roof (Photo 6). The structure appears to be of 1940s date, and of military style, presumably associated with the adjacent airfield of RAF Talbenny. The building has two doorways on its northern façade, with a number of windows. The southern façade has no openings. A small extension is located at the eastern end of the building which blocked a doorway and one former window opening. It is not known what the original use of the building was, although local opinion suggests it was a small barracks. Since the military function of the building has ceased, it has been converted to agricultural use. A modern breeze block partition wall has been constructed within the building (Photo 7). The windows in the building are wooden framed, and appear to be original, although it was more common for metal framed windows to be used in buildings at this time due to the shortage of timber (Photo 8). An area of concrete slabs is present to the west of this building.

Photo 6: 1940s building along southern edge of site

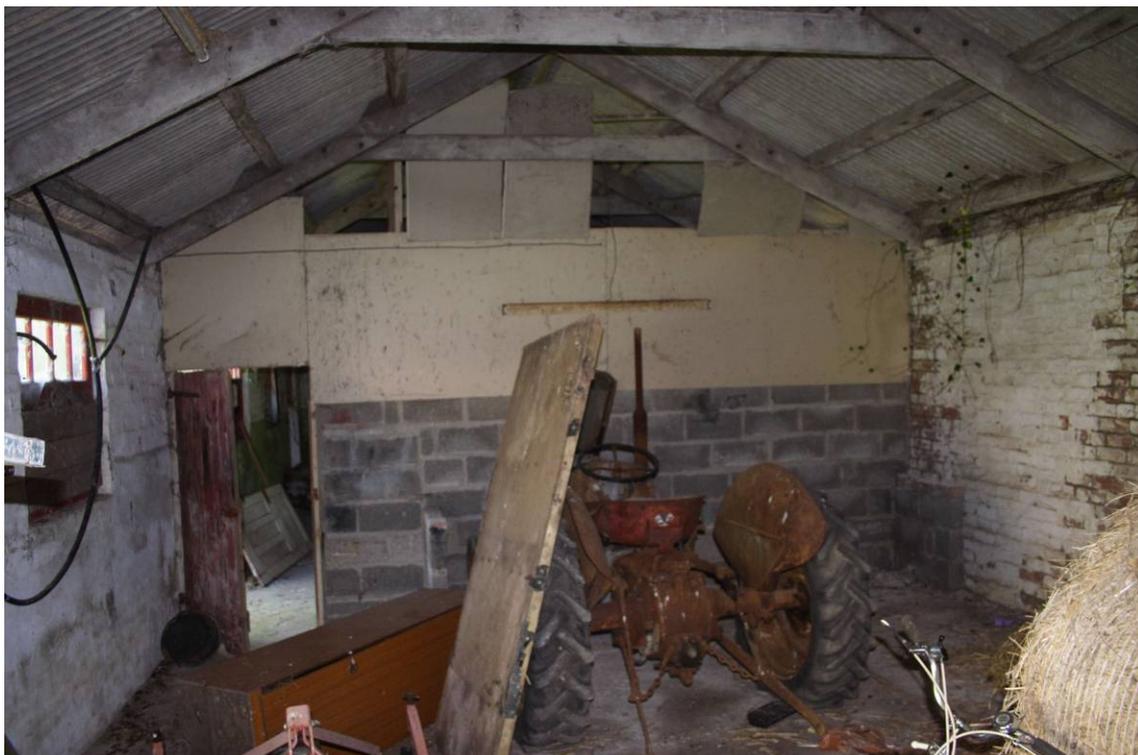
Photo 7: Internal view of 1940s building showing recent breeze block partition

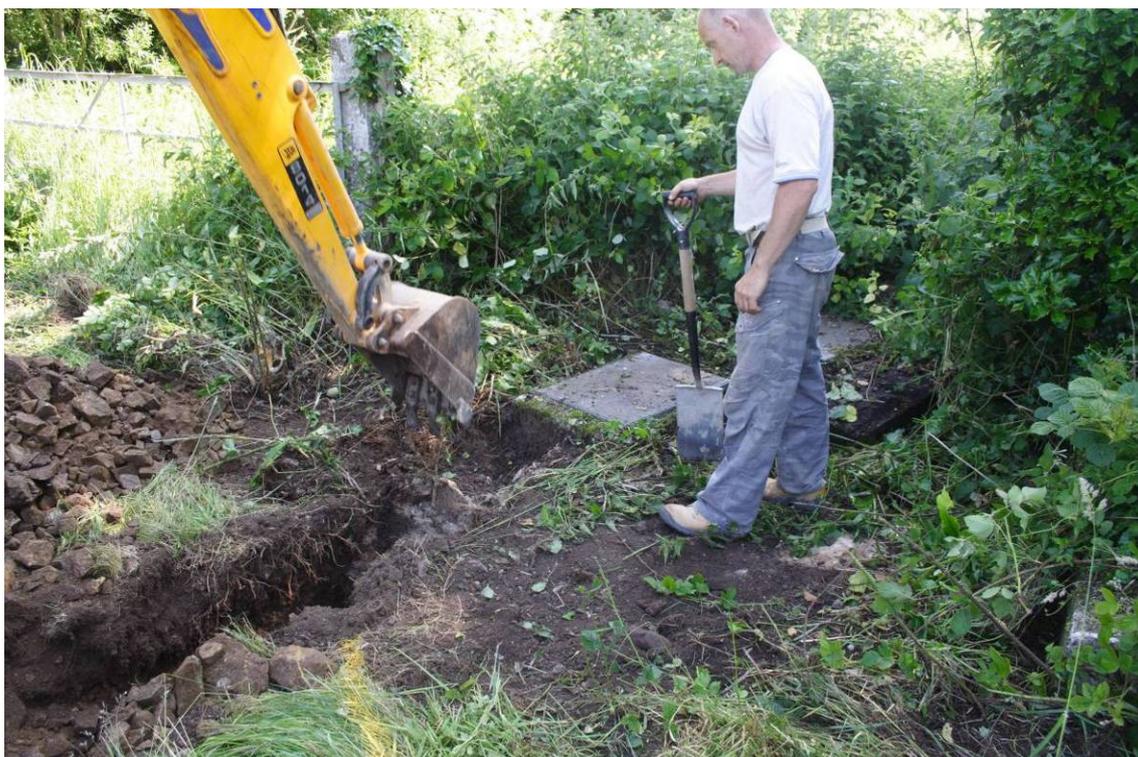
The excavations began at the site of the septic tank, with a short east-west stretch of trench being excavated from the concrete edge of the tank to the junction of the drainage trenches some 1.5m to the west (Photo 9). The soil removed from the trench was very mixed in this area, presumably the result of backfill from the original excavation to accommodate the septic tank. A number of modern artefacts were noted within the fill (glazed pottery, glass and iron) but these were not retained. The trench fill comprised large quantities of stone, from small to large blocks, with very little soil content. The stone appeared to be natural bedrock that had been disturbed during the installation of the septic tank. The trench was excavated to a depth of 0.8m maximum from ground level.

Photo 9: View north-west showing start of drainage trenches at the location of the existing septic tank

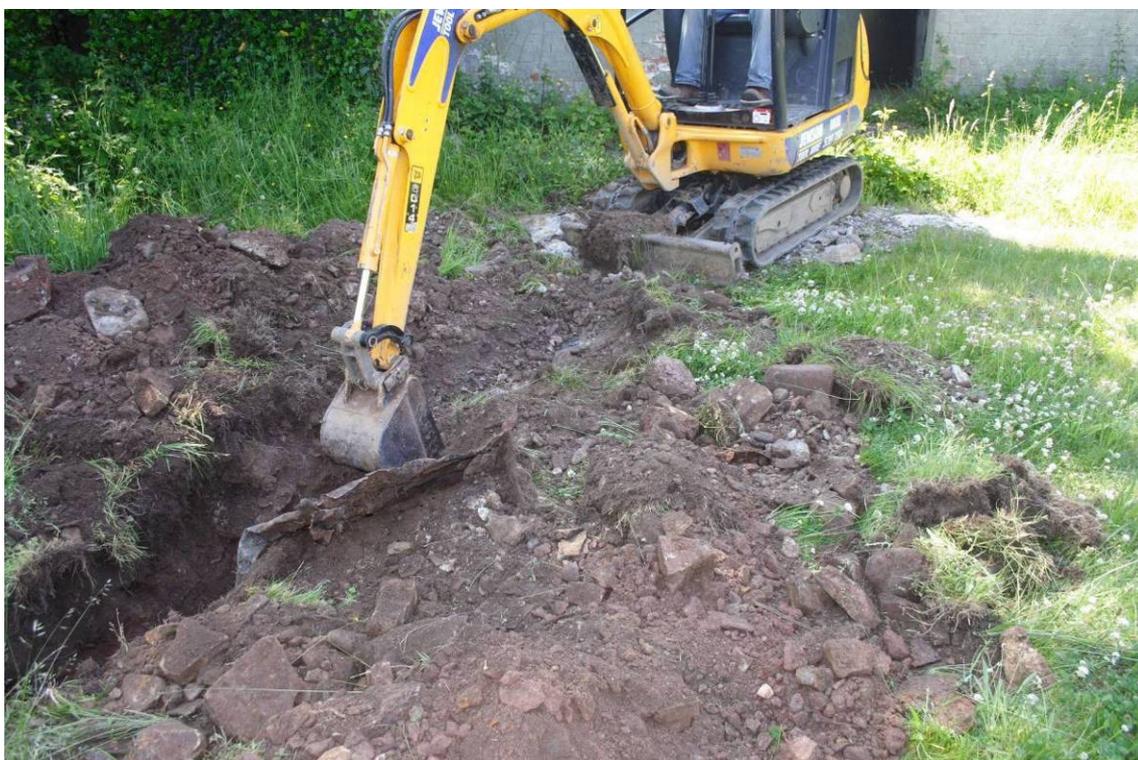
The drainage run towards the 1940s building was excavated through similar material at its northern end, but the excavated material got steadily more mixed towards the south-west (Photo 10). The soils contained considerable quantities of modern debris, including metal objects, corrugated iron and large concrete blocks. It is assumed that much of this material was deposited during construction of the building, perhaps as levelling material, or had been laid down later, perhaps during demolition of other 1940s structures that may have been present within this area. The trench was excavated to a maximum of 0.6m in depth.

Photo 10: Excavation of south-west aligned drainage trench showing mixed nature of soils containing fragments of stone, metal and other detritus

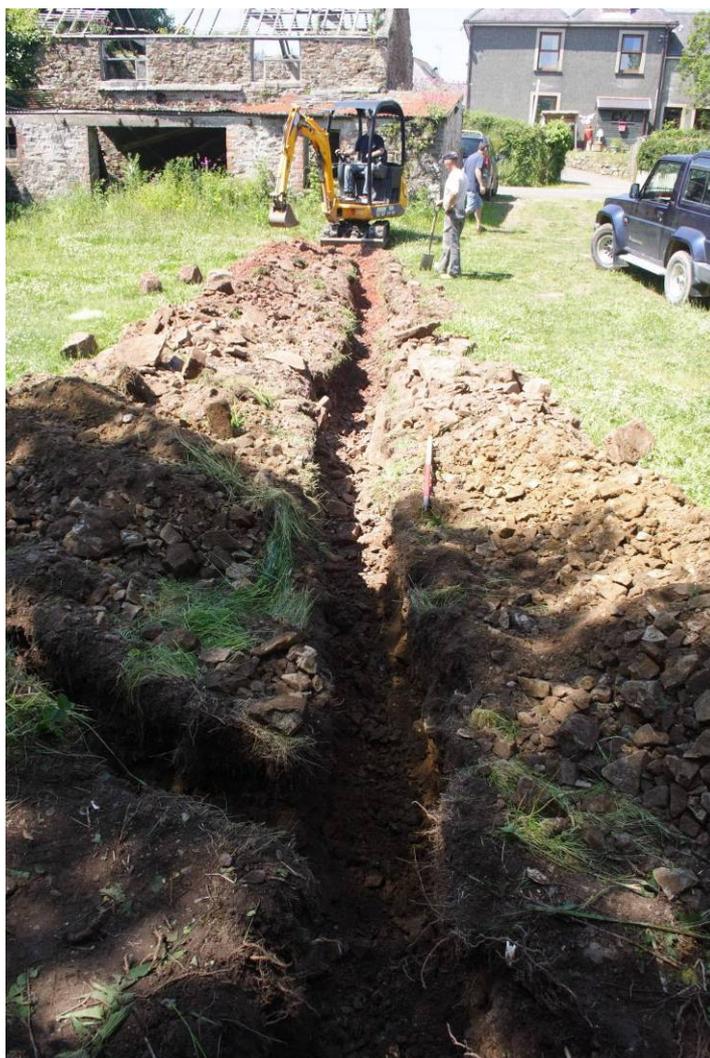
Photo 11: View west along drainage trench towards former cart shed

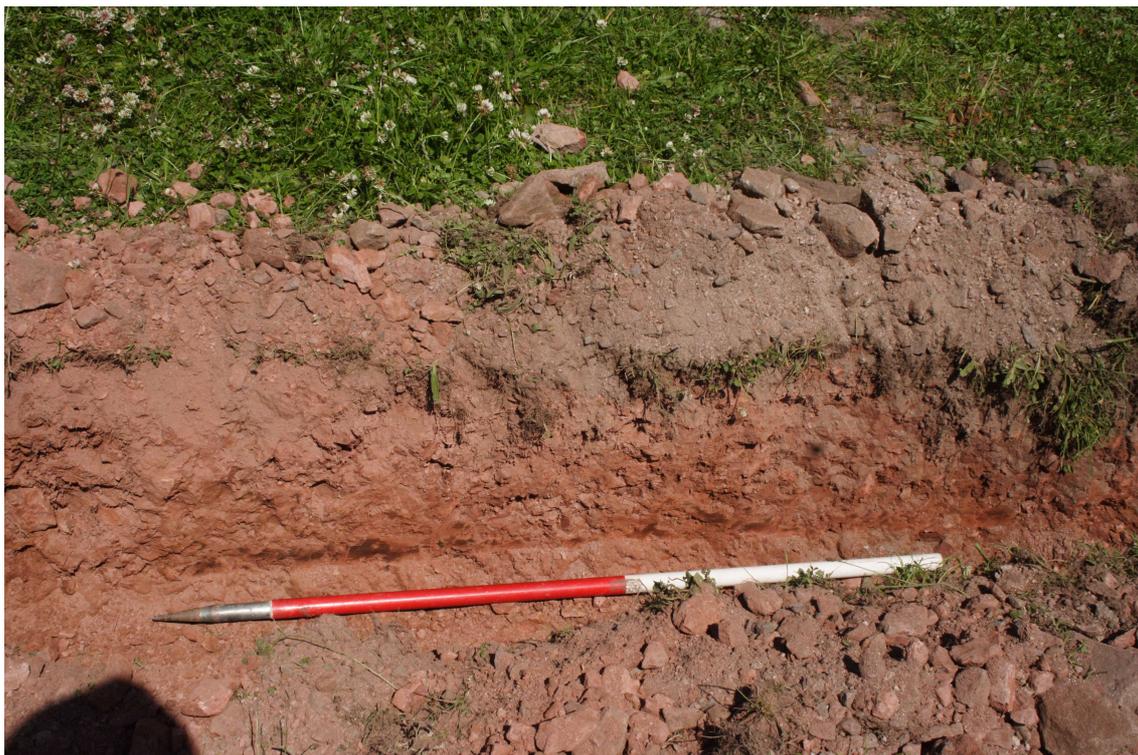
The east to west drainage trench exposed natural bedrock underlying a very thin reddish brown topsoil, demonstrating that this area had been far less disturbed. The natural bedrock comprised areas of undisturbed rdb (Photo 12) as well as more compact stone in blocks. Some metalwork was noted within the topsoil, including old hooks and racks, but they were considered to be modern and were not retained. The topsoil contained a few redeposited large stone blocks, which may have come from a former structure in the vicinity (Photo 13). The trench was excavated to a maximum of 0.6m in depth.

Photo 12: Section through east-west drainage trench showing thin depth of topsoil and undisturbed rab beneath

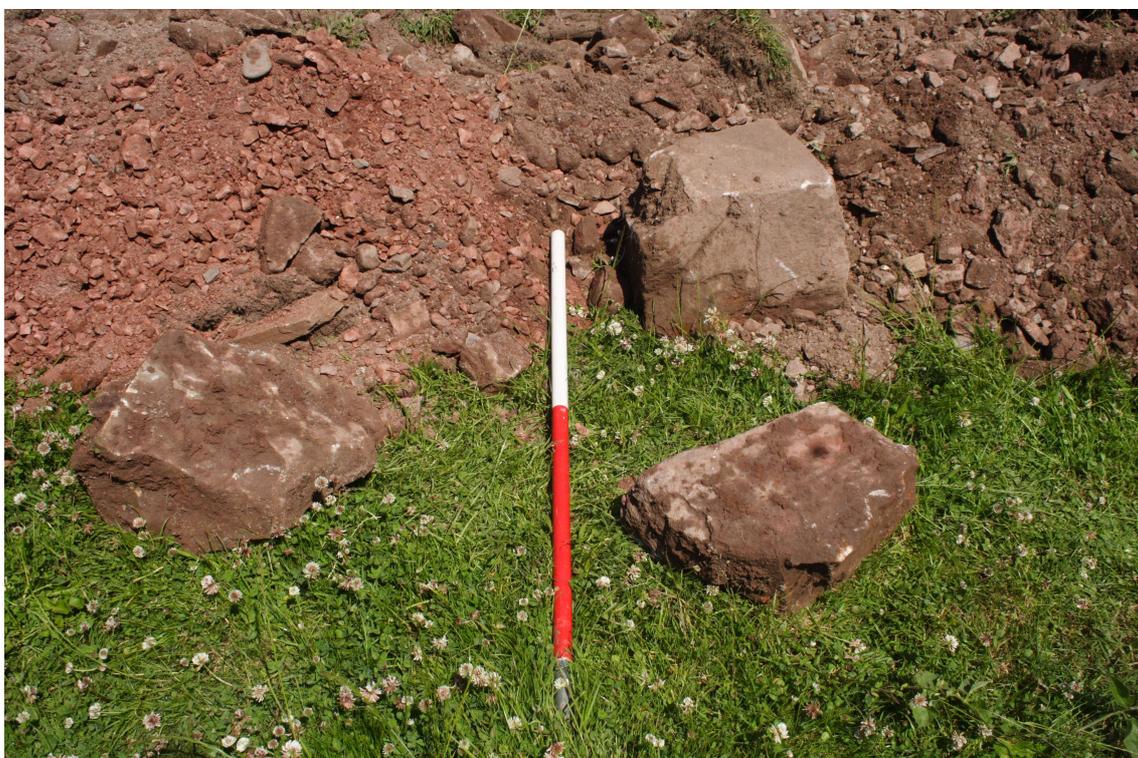
Photo 13: Large stone blocks recovered from topsoil of east to west drainage trench
