**INNER COURTYARD, NEWTON HOUSE,
LLANDEILO, CARMARTHENSHIRE
(SN 61418 22474)**

ARCHAEOLOGICAL WATCHING BRIEF

RHIF YR ADRODDIAD / REPORT NO. 2010/40
RHIF Y PROSIECT / PROJECT RECORD NO. 99811

INNER COURTYARD, NEWTON HOUSE, LLANDEILO, CARMARTHENSHIRE, ARCHAEOLOGICAL WATCHING BRIEF

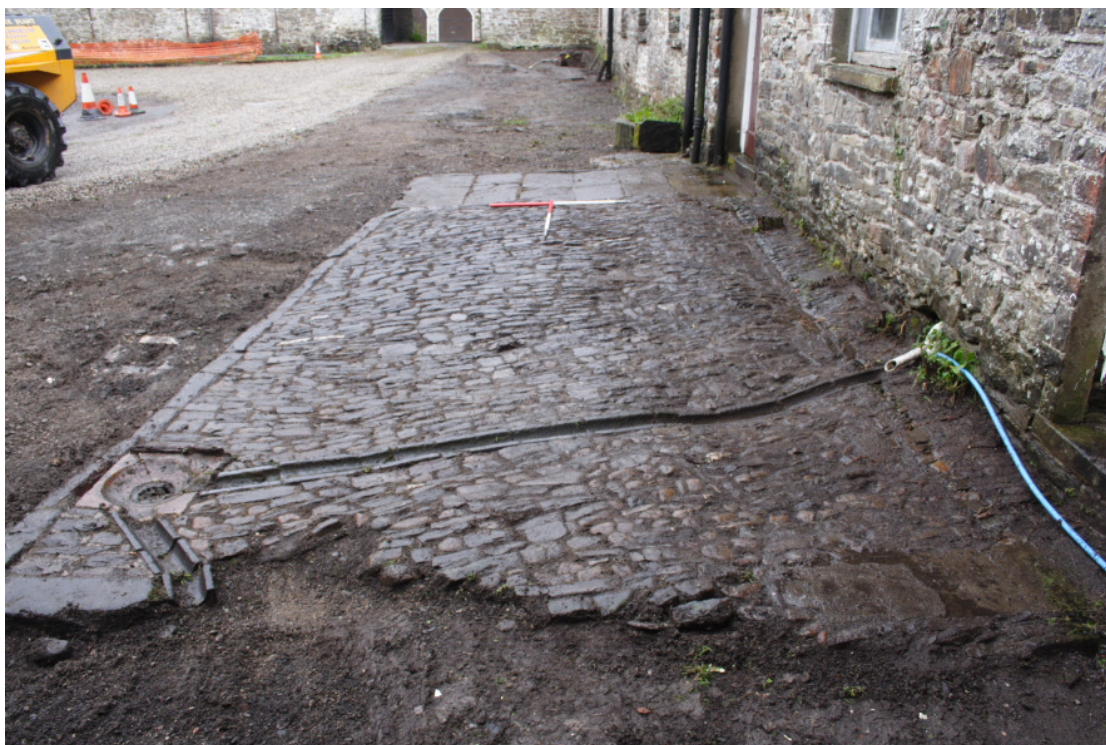
3.2.1 A pitched cobble surface and a path of flagstones were observed and recorded situated in the north-western corner of the Inner Courtyard (photos 1 – 6). The path consisted of flagstones laid two abreast, and continued in an east-west alignment leading to the doorway entering the western wing of the courtyard. The pathway measured 3.10m long by 1.60m wide and the each flagstone measured 0.40m x 0.40m square. The pathway abutted the pitched cobble surface along its northern edge.

3.2.2 The pitched cobble surface was constructed of small rectangular blocks of local stone (photos 1 – 4). The average size of each stone was 0.15m long by 0.06m wide in plan and many were well worn in places. The sets were roughly hewn and some variation in size and colour was apparent across the surface. The stones were linearly set with a slight curve in the layout towards the west. A drain had been laid through the surface, continuing diagonally across the cobbles, commencing at the base of the wall of the western courtyard wing and leading northeast towards a drain abutting the eastern kerbing of the floor surface (photo 1). It is possible that this drain is a later addition to the pitched cobble surface. The surviving area of the cobbled surface measured 5.6m in length and protruded 3.10 in width from the wall of the west wing of the Inner Courtyard.

Photo 1: View south of cobbles situated at north-western corner of courtyard with drain visible

4.6 Through viewing the 1912 drainage map of the inner courtyard of Newton House (Figure 4), it appears that the drain located at the north western side of the courtyard set within the cobbled area (see picture 1 & 2) is probably associated with the former Brew House and is likely to represent an outflow for waste produce. Two other drainage gullies are also depicted on the 1912 map, the first is located at the northern end of the courtyard outside the scullery, the second is situated on the western side of the courtyard outside the still room. Both would have been for waste water. Depicted in the centre of the yard is a soft water tank which has a pipe connected leading to the still room and is probably associated with the production process involved in distillation.

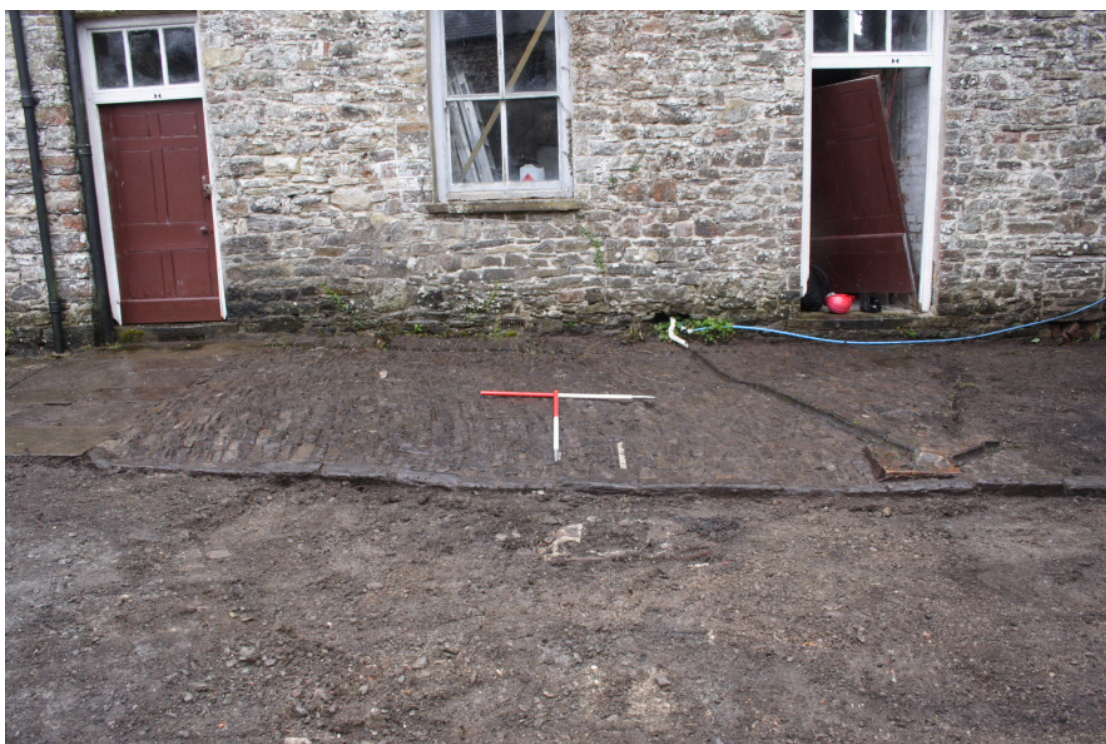
Photo 2: View west of cobbles situated at north-western corner of courtyard

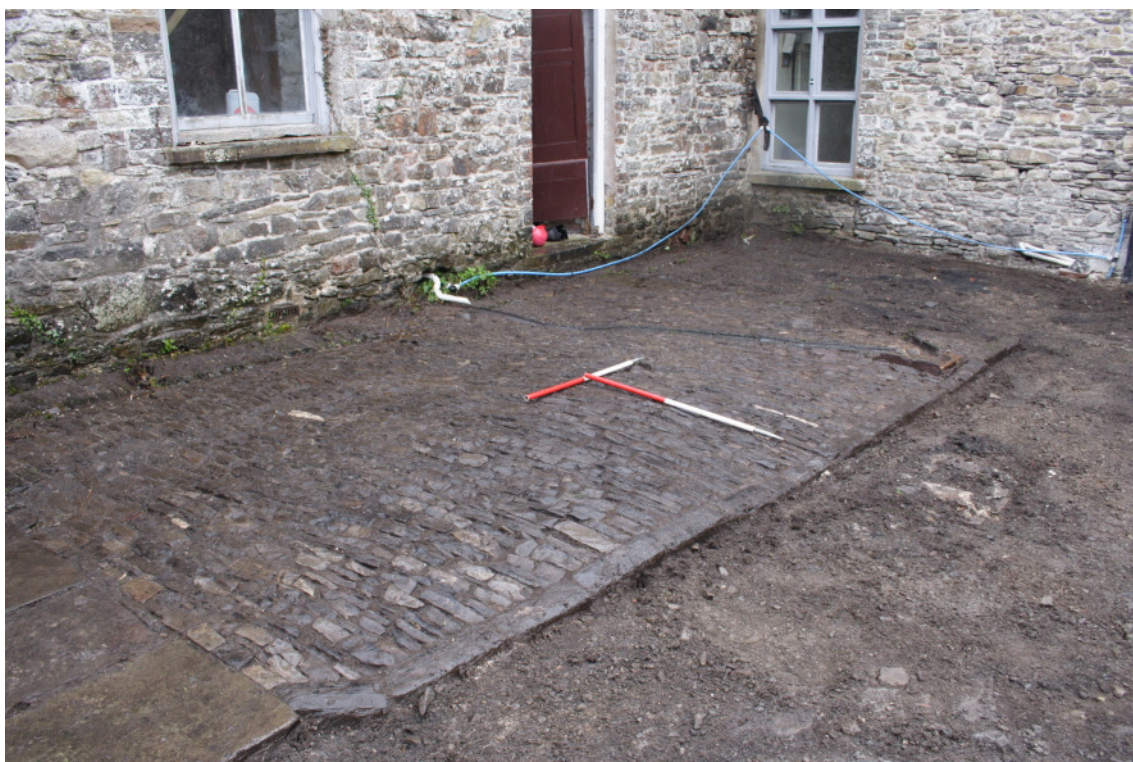
Photo 3: View north-west of cobbles situated at north-western corner of courtyard

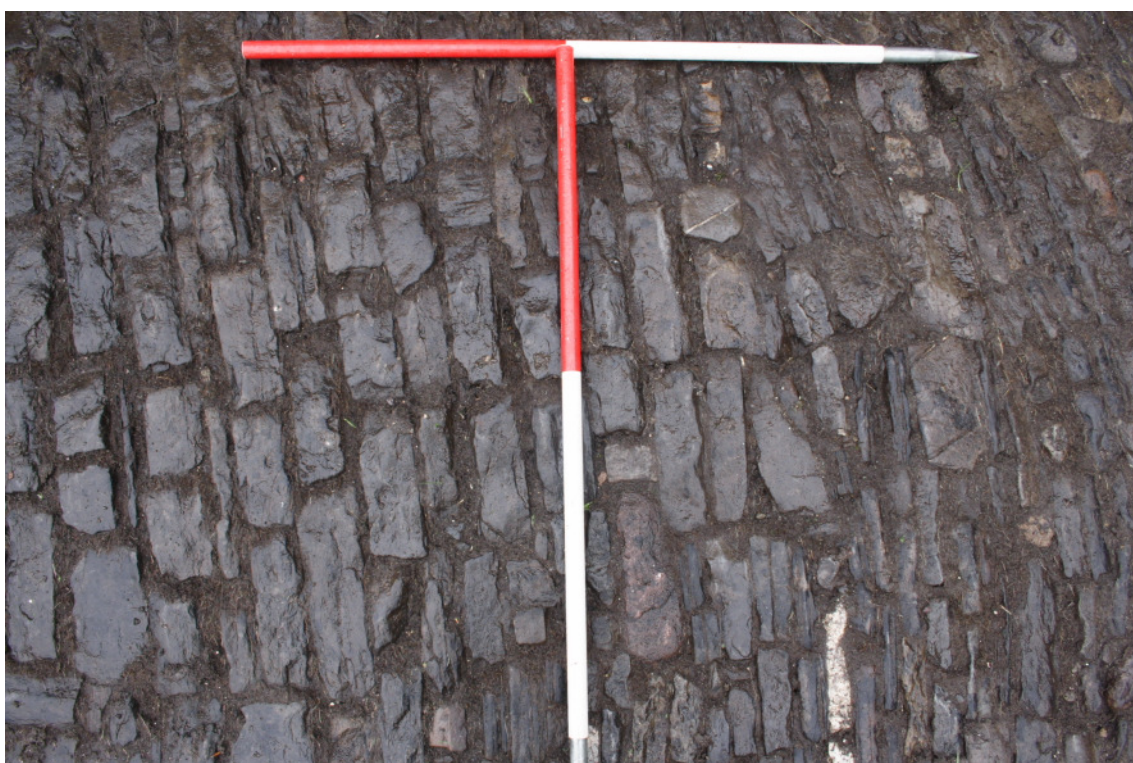
Photo 4: Vertical view of pitched cobble surface situated at north-western corner of courtyard

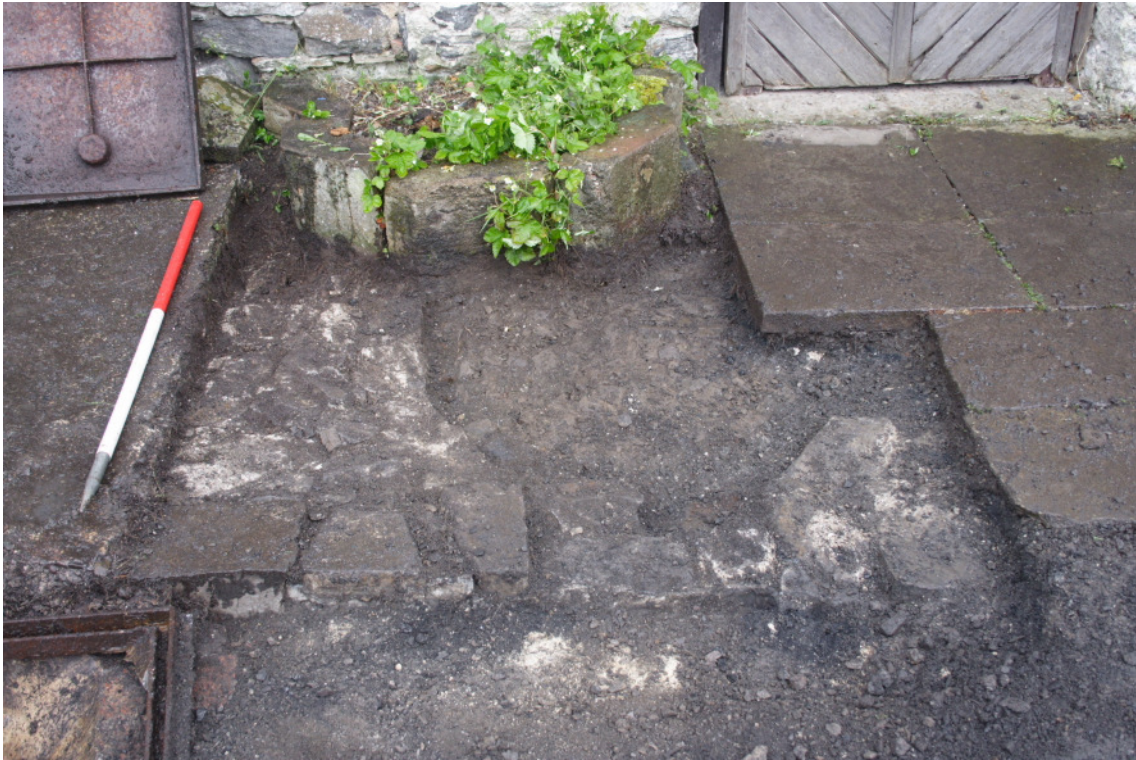
3.2.3 A possible flagstone path foundation was discovered protruding 1.36m from the edge of the doorway of the northern wing headed in a east\west alignment for 1.60m. The limestone blocks were bedded onto bedrock. The bonding material appears to be made up of a lime mortar mixture. The remains of a glass bottle was found within the flagstone pavement foundation which appears to date to the late 18th century through to the early 19th century.

Photo 5: View north of flagstone foundation

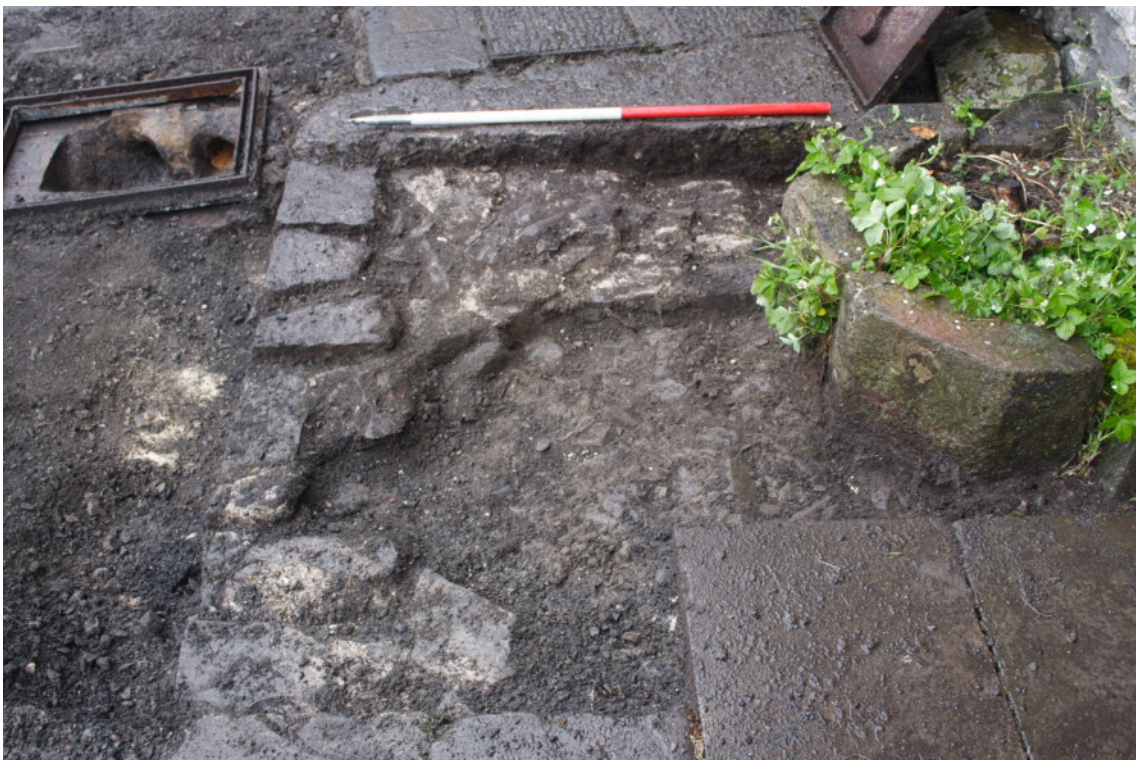
Photo 6: View west of flagstone path foundation

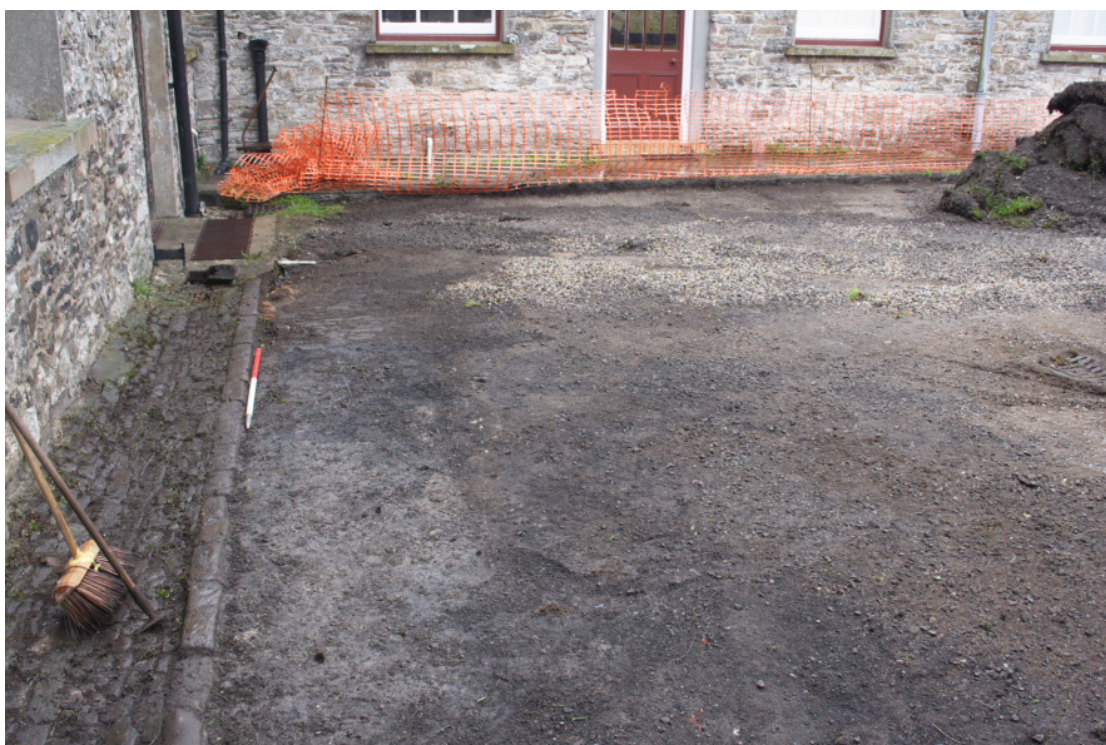
3.2.2 In the north-eastern corner of the courtyard a similar cobbled surface was revealed (photo 7 & 8). The cobbles were of similar size as the cobbles found in the first cobbled surface, although the second surface has not been laid in a linear pattern as the first was and are more irregularly placed. A modern brick lined service cuts part of the northern extremity of the cobbled surface. The material used in the construction of this surface consisted of roughly sub rounded and sub linear stones.

Photo 7: View east of second pitched cobble surface

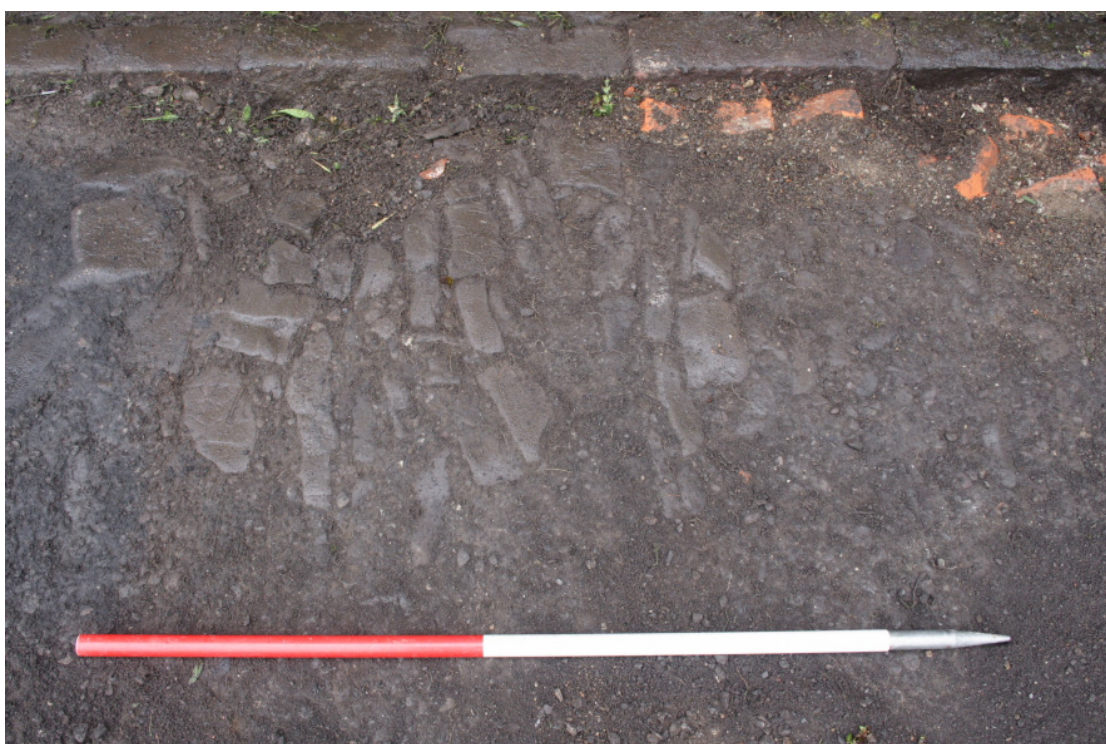
4.5 Numerous modern services were also revealed during ground clearance in the courtyard, one of which had truncated the patch of cobbles situated in the north eastern corner of the courtyard.

Photo 8: View north of second pitched cobble surface, with bricks in backfilled service trench showing in top right hand corner of picture

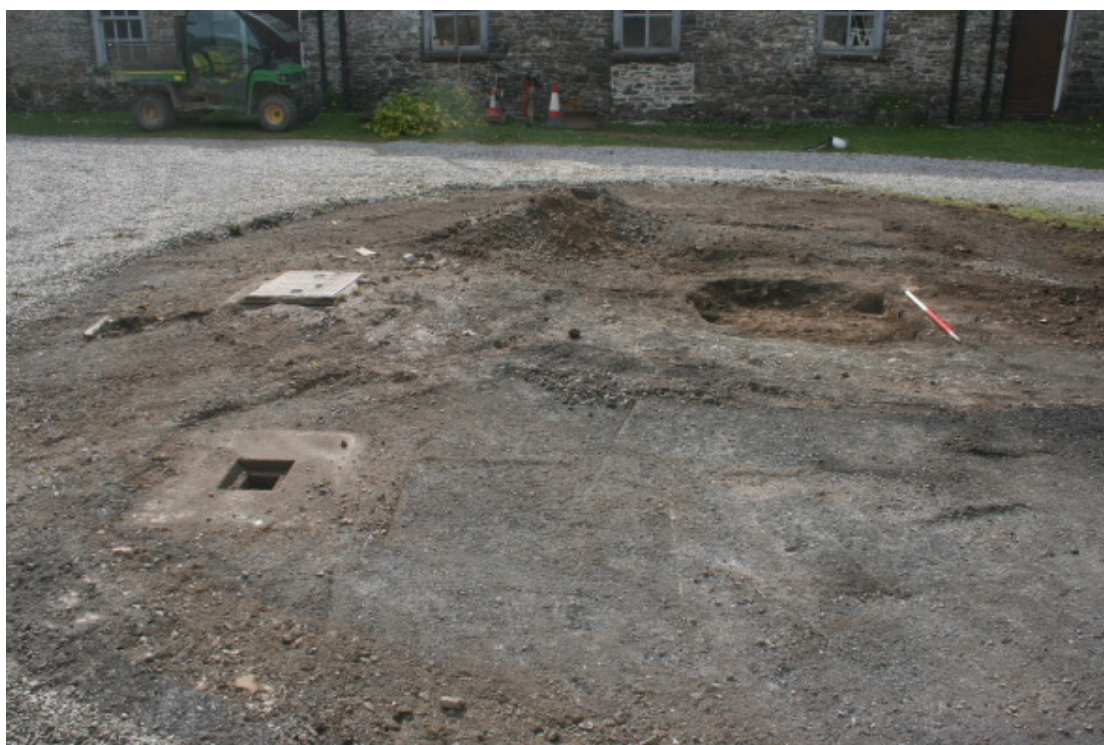
3.2.4 The foundation for a game larder was found within the centre of the courtyard. The foundation consisted of a square cut into the natural geology which measured 1.5 metres square (Photo 9 & 10). The game larder can be seen in a photograph taken in the mid-seventies, prior to its demolition (Photo 12). The game larder can also be seen depicted on the 1912 drainage map of the inner courtyard, please see (Figure 4).

4.2 A foundation cut for a game larder was found within the centre of the courtyard. The foundation was of a minimal size, representing the base of the stone plinth on top of which was set the timber larder.

Photo 9: View west of excavated game larder

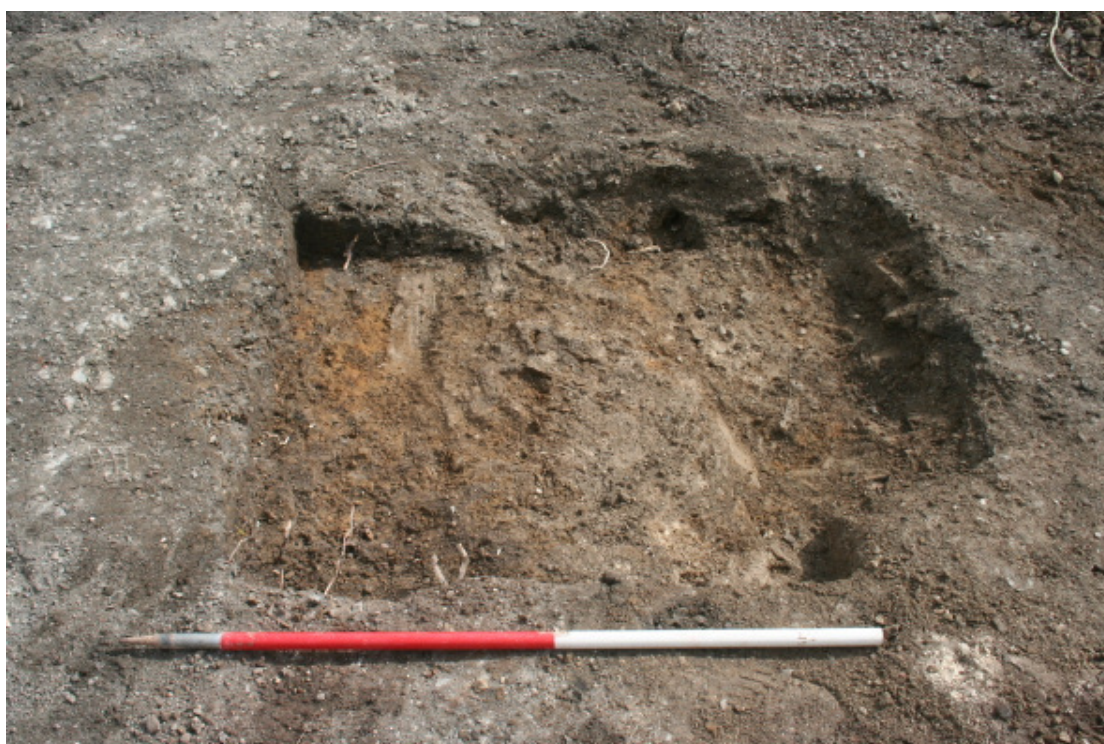
Photo 10: Close up view of excavated game larder.

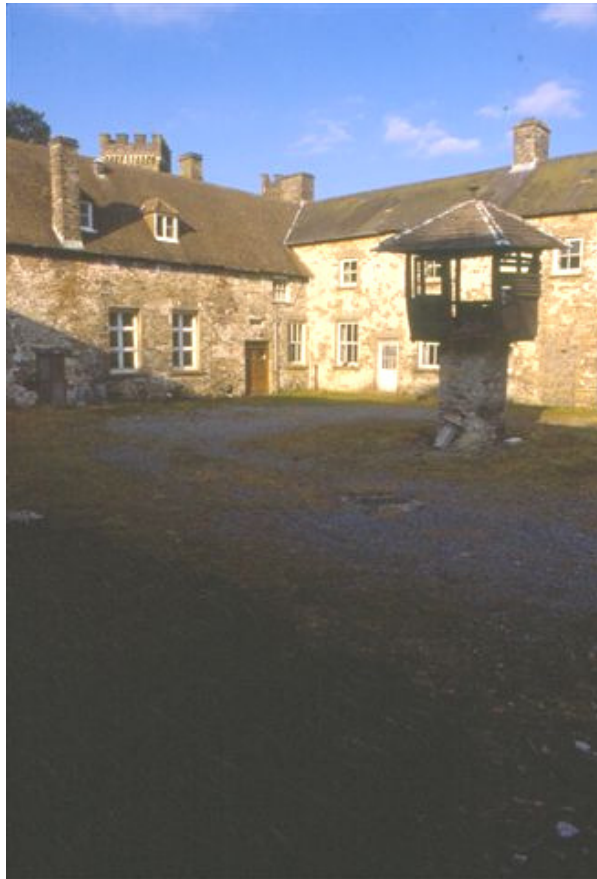
Photo 11: View of the game larder in the mid 1970s

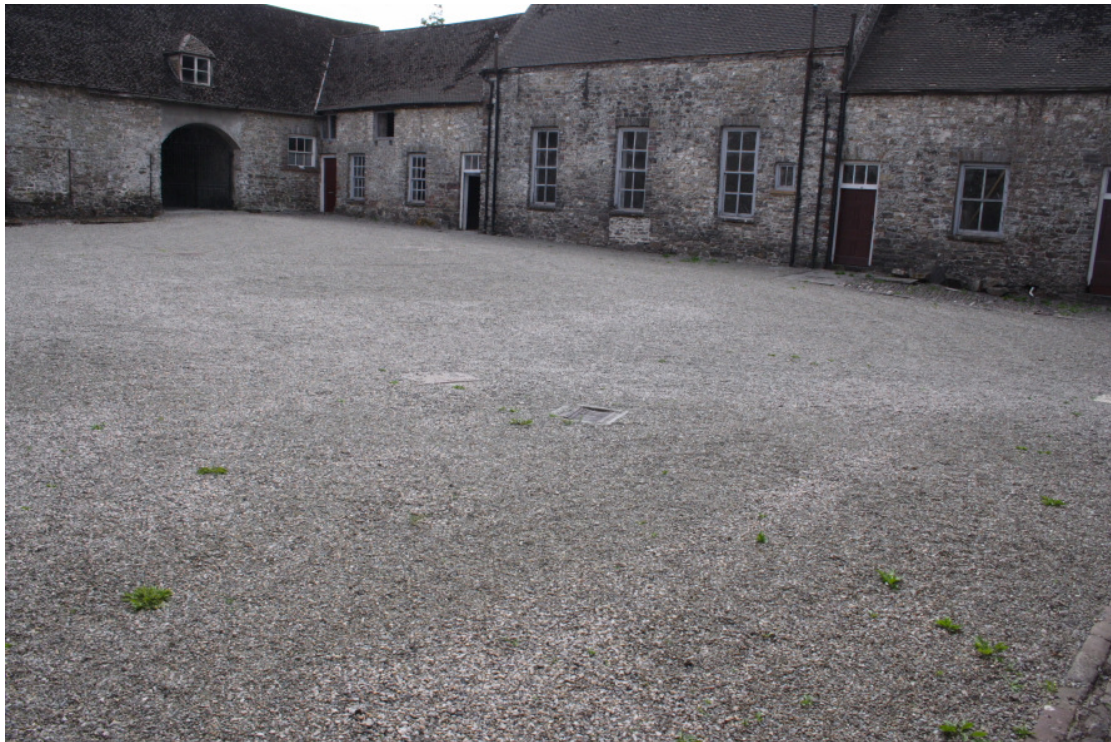
4.8 The groundworks caused minimal below ground disturbance, removing only thin layers of gravel and turfs from the courtyard. All exposed features and former surfaces (including the two areas of cobbles) were preserved beneath the new laid gravel surface (Photo 12).

Photo 12: View south-west of finished gravel surface.
