CARNAWLLON FAWR, PONTNENRI, CARMARTHENSHIRE: ARCHAEOLOGICAL EVALUATION

RHIF YR ADRODDIAD / REPORT NO. 2010/42
RHIF Y PROSIECT / PROJECT RECORD NO. 99813

**CARNAWLLON FAWR, PONTNENRI,
CARMARTHENSHIRE:
ARCHAEOLOGICAL EVALUATION**

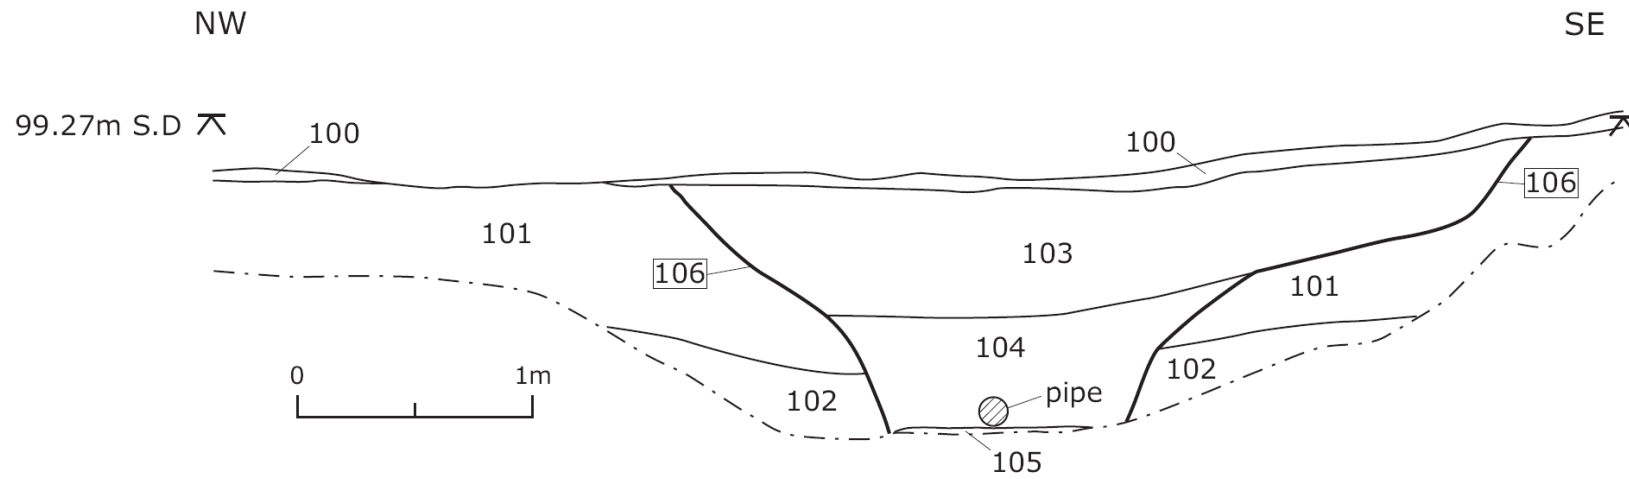
Figure 5: Section through feature [106] showing feature and natural deposits (101) and (102)

Towards the south-eastern end of the trench a feature [106] was revealed (Photos 2 & 5; Figure 5). The feature measured c.3.60m in width and had a maximum depth of 1.12m. The feature crossed the trench in a roughly east-north-east to west-south-west alignment, and a depression could be seen within the adjacent land following this alignment, indicating its continuation on either side of the trench. The line of the ditch is indicated by the former field boundary on Figure 4.

The upper fill (103) of feature [106] was a mix of the topsoil (100) and the underlying clay (101), giving an overall dark appearance with yellowish brown clay patches. A lower fill (104) was a friable, greyish brown silty clay with occasional stones. Within (104) a plastic pipe was revealed (Photo 6), which sat upon a sub-base of angular stones (105), which were not fully excavated so as not to undermine the drainage pipe. The fills (103) and (104) had the appearance of being redeposited backfill of whatever material had been removed from the area when the drainage pipe trench 106 was excavated.

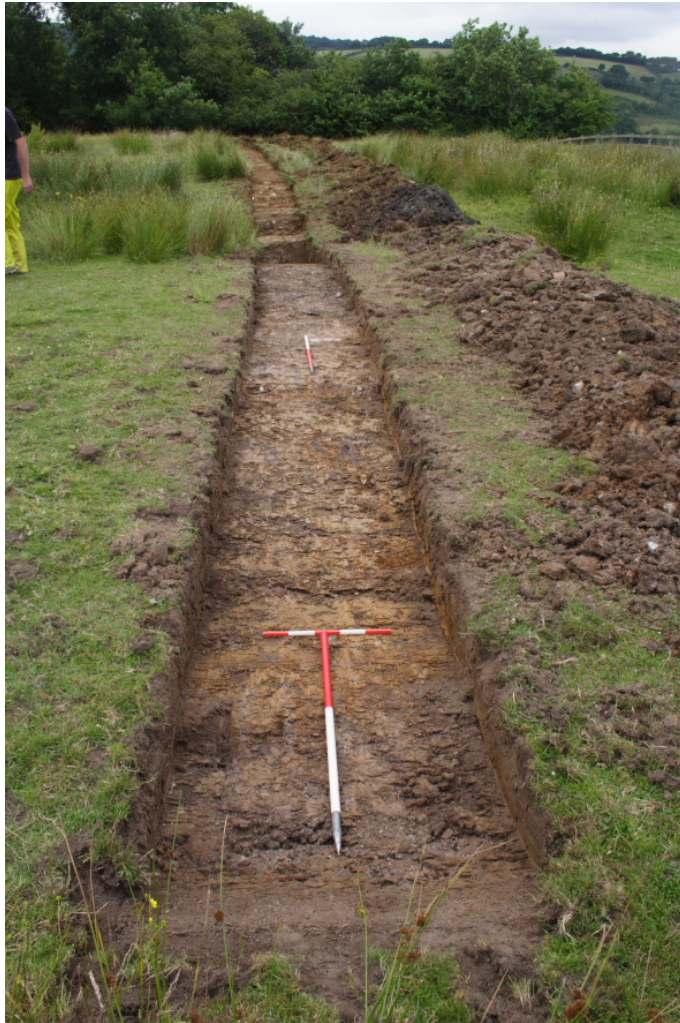
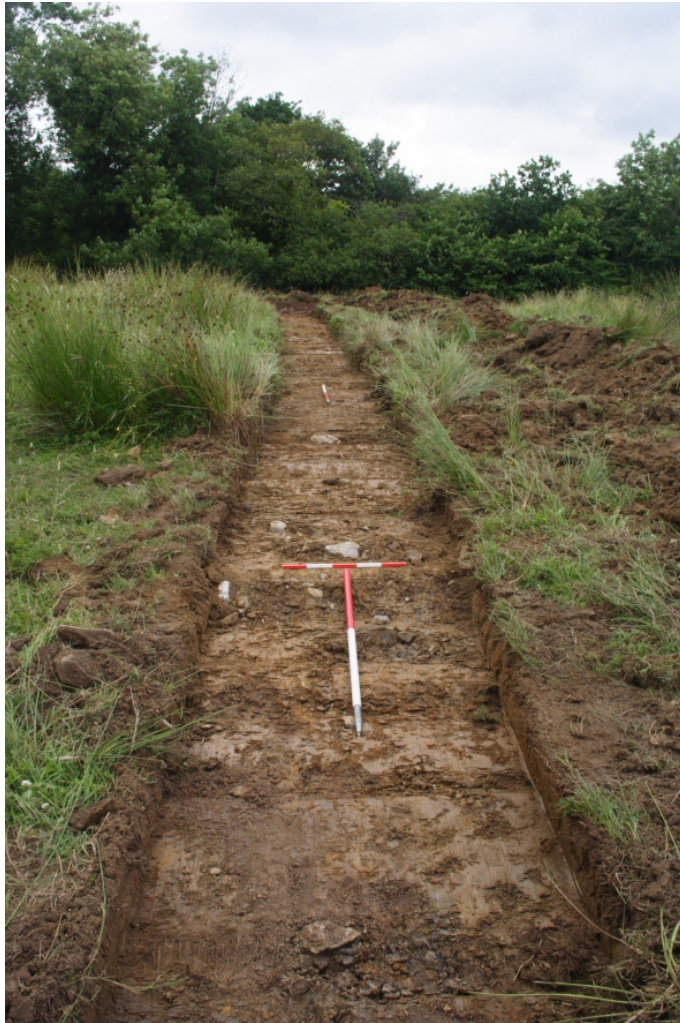
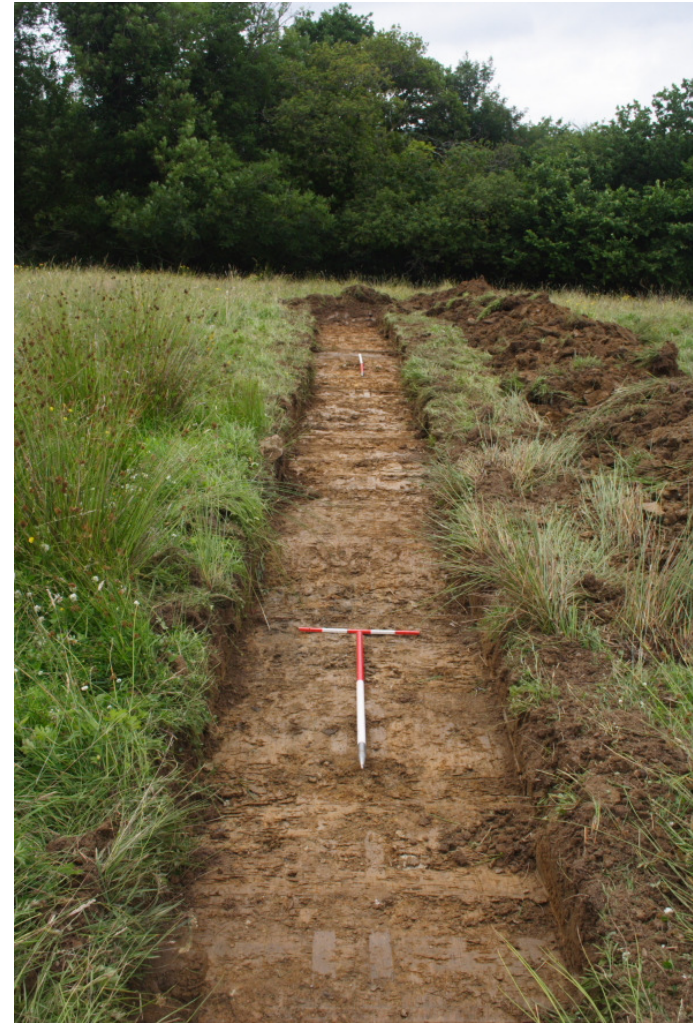
The trench (Photos 1 – 4) was aligned roughly north-west to south-east, parallel with the LNG boundary. The trench projected into the possible central, interior, area of the fort and crossed its southern boundary.

The topsoil (100) across the trench measured between 0.15m and 0.20m in depth. It comprised a dark reddish brown sandy silt clay with occasional small to medium angular stones.

The topsoil lay directly upon an undisturbed natural orange clay (101) exposed to a maximum depth of 0.75m in one area. Beneath the orange clays, in the one area exposed, was a further layer of greyish brown gleyed clays with discrete areas of orange ferric staining (102). The full depth of these greyer clays was not exposed.

Photo 1: South-eastern end of Trench

Photo 3: North central part of trench

Photo 4: North-western end of trench

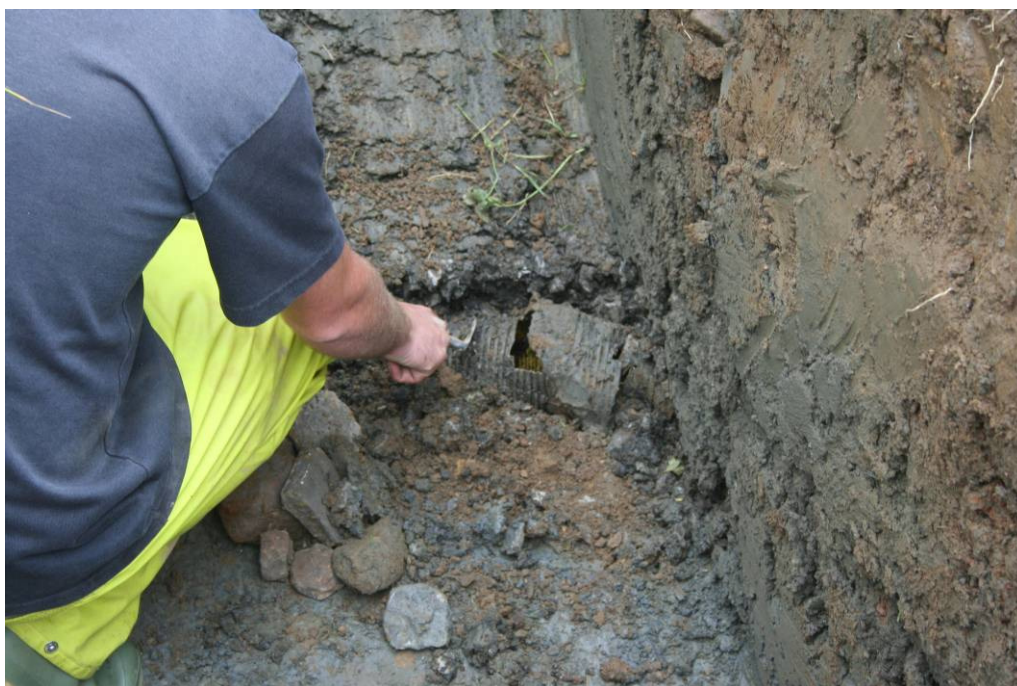
Photo 6: Excavation of ditch [106] showing plastic pipe in base

The archaeological evaluation undertaken at the site of Carnawllon Fawr defended enclosure has demonstrated the presence of a large ditch along the line of the southern side of the projected defences. The ditch also aligns with a post-medieval field boundary indicated on earlier Ordnance Survey maps and depicted as still being in place as late as 1968. The area of the excavated ditch exposed within the evaluation trench was entirely of modern date as evidenced by the section excavated through the feature which could be seen to have an upper and lower fill, with a modern plastic pipe placed in the base which was laid upon a deeper cut containing a sub-base of angular stones.

Although the ditch exposed within the trench was a modern drainage ditch, it does follow the line of the earlier field boundary shown on Ordnance Survey maps. We know that this field boundary (or at least a ditch) was still present up until at least 1968, but once it was no longer needed the ditch was entirely cleared out by machine and a modern drainage pipe laid at the base. The ditch was then backfilled. The act of clearing the field ditch may have in effect re-cut and removed all evidence for the earlier ditch.

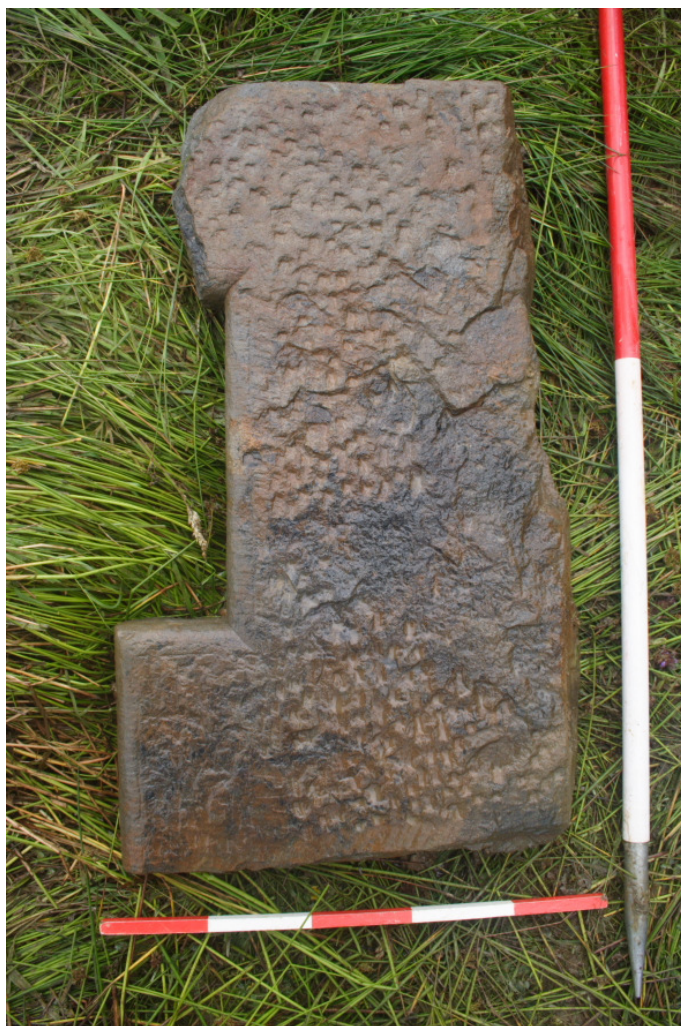
Photo 7: Worked stone recovered from upper fill of [106], with cut-out to left of photo

In the upper fill of the ditch (103) a large worked stone fragment was recovered (Photo 7). The stone was roughly rectangular measuring 0.75m x 0.42m and with a thickness of c.0.10m. A rectangular cut-out was present on one long edge (left hand side of Photo 7). One flat face of the stone had been chisel cut, with numerous chisel marks showing (presumably left in partially as decoration). The cut-out had been neatly made with clear right angled cuts. The edges had been very neatly chamfered. The stone had been broken above the cut-out on one side, although the inner corner was still visible. Chisel marks were also present on the thin edge of the stone (Photo 8).

The worked stone block found within the ditch [106] has evidently been made with some skill and care. The right angles and chamfering are very neat, and the chisel marks on the main flat surface are almost decorative. The skills used would indicate a medieval or post-medieval date for it. It has evidently been backfilled within the modern drainage ditch, but no other sign of such masonry was found either within the evaluation trench or on the surface in the vicinity of proposed open-cast site. The stone may have originated from a nearby church or other important building, but there is no clue as to its origin or as to why it ended up in this location. It is very unlikely to indicate the presence of a high status medieval stone building within the Carnawllon Fawr enclosure. Alternatively the stone may be associated with an industrial building or other structure. The break on one of its edges may have occurred during its working which rendered the stone useless, and it was therefore either discarded or used by a local farmer for another purpose, eventually being thrown away into the ditch.
