# **Twentieth Century Military Sites: Second World War and later Camps and Ranges in South Pembrokeshire**

## **Interim Report 2017-18: Desk-Based Assessment**

## **Second World War and later Camps and Ranges; South Pembrokeshire**

### **Desk-Based Assessment**

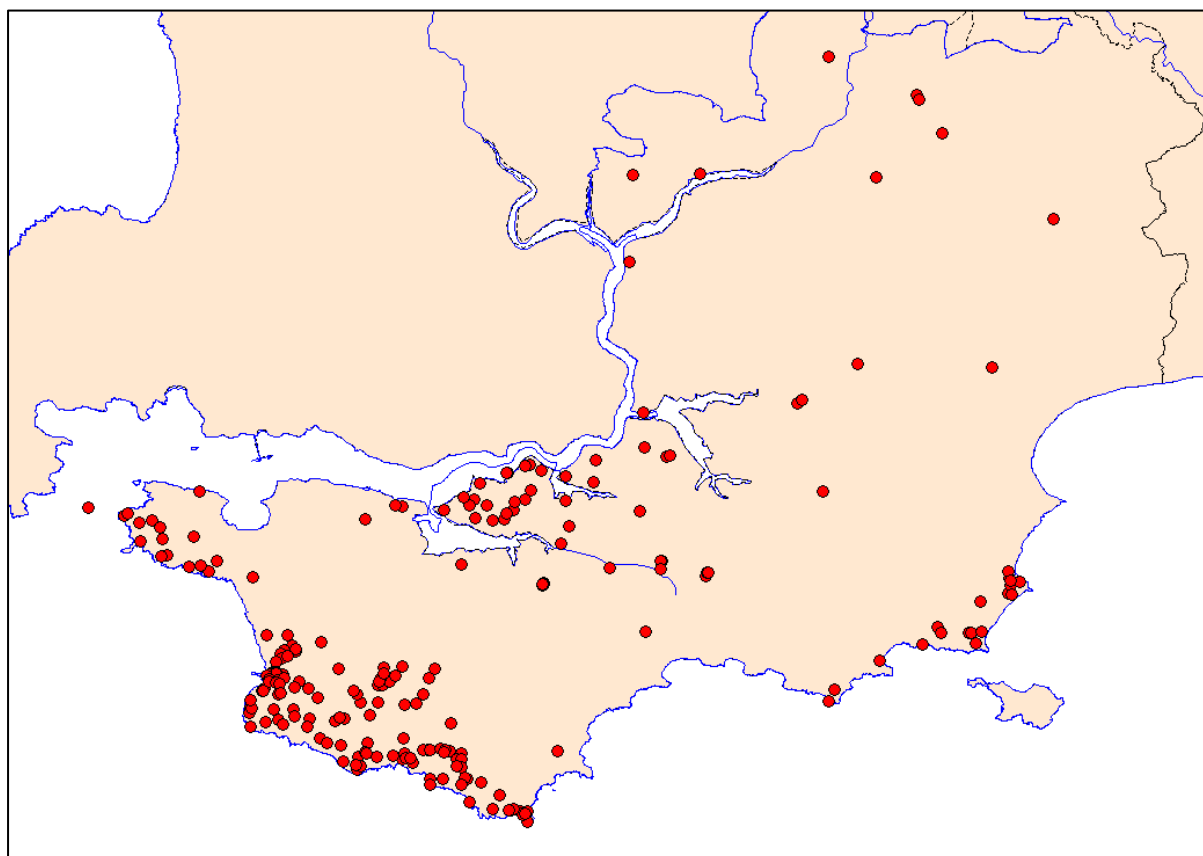
Figure 1: Distribution of sites across South Pembrokeshire

Following the assessment a further new 88 sites have been added to the HER and the existing sites updated and enhanced, see Figure 1 and the following table:

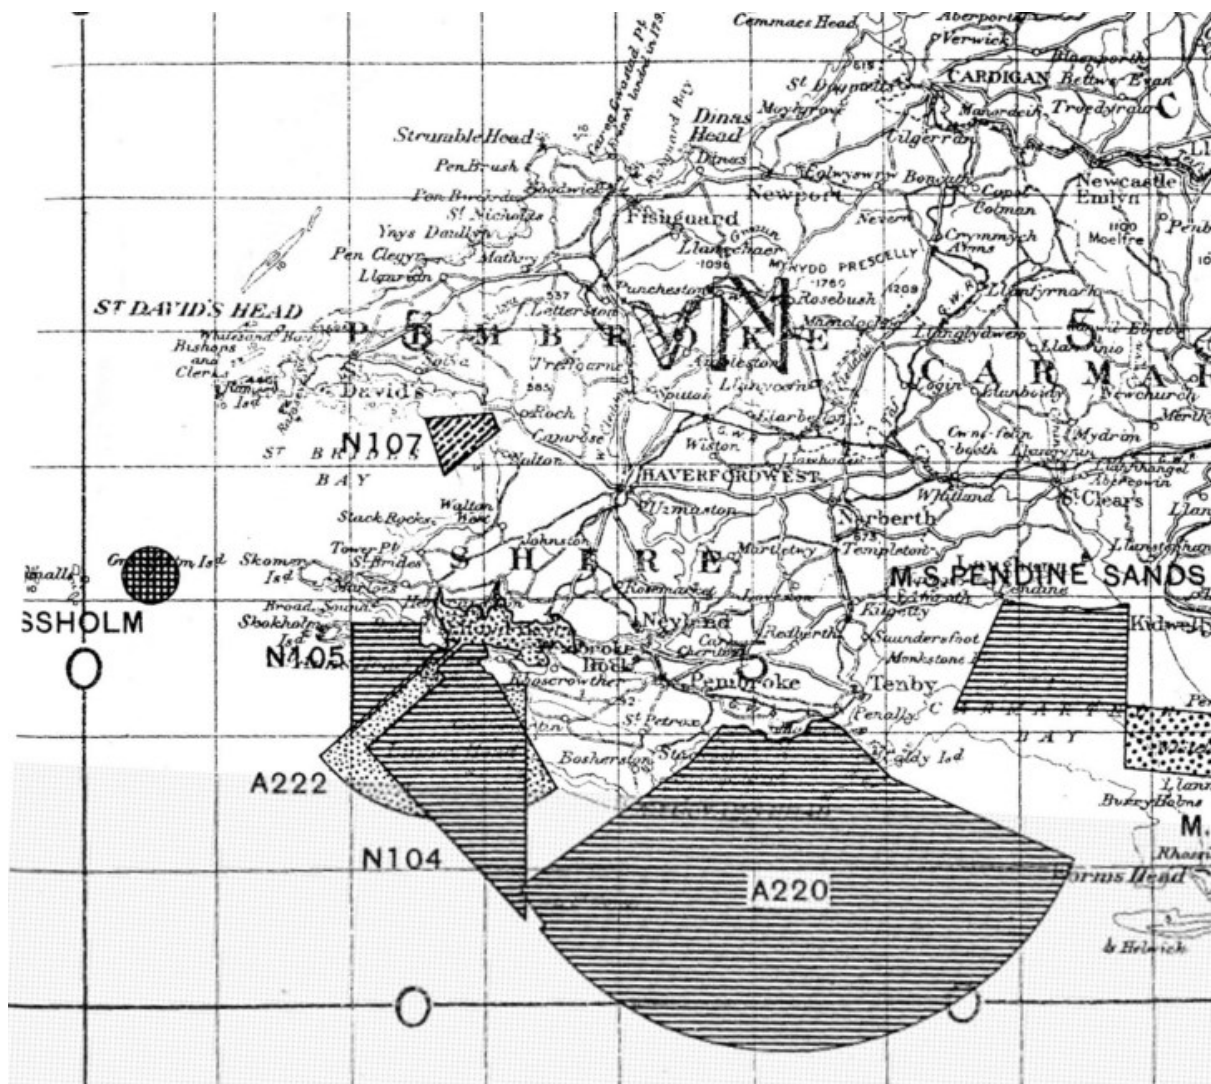
Figure 2: SD 559 ranges map (1945), West and South Wales

The Map and List appended to the List of Firing Ranges in 1945 (Figure 2) identified the Milford Approach Naval Ranges (PRN 111336) in addition it also demonstrates the extent of the ranges of Castlemartin, and Manorbier and Penally.

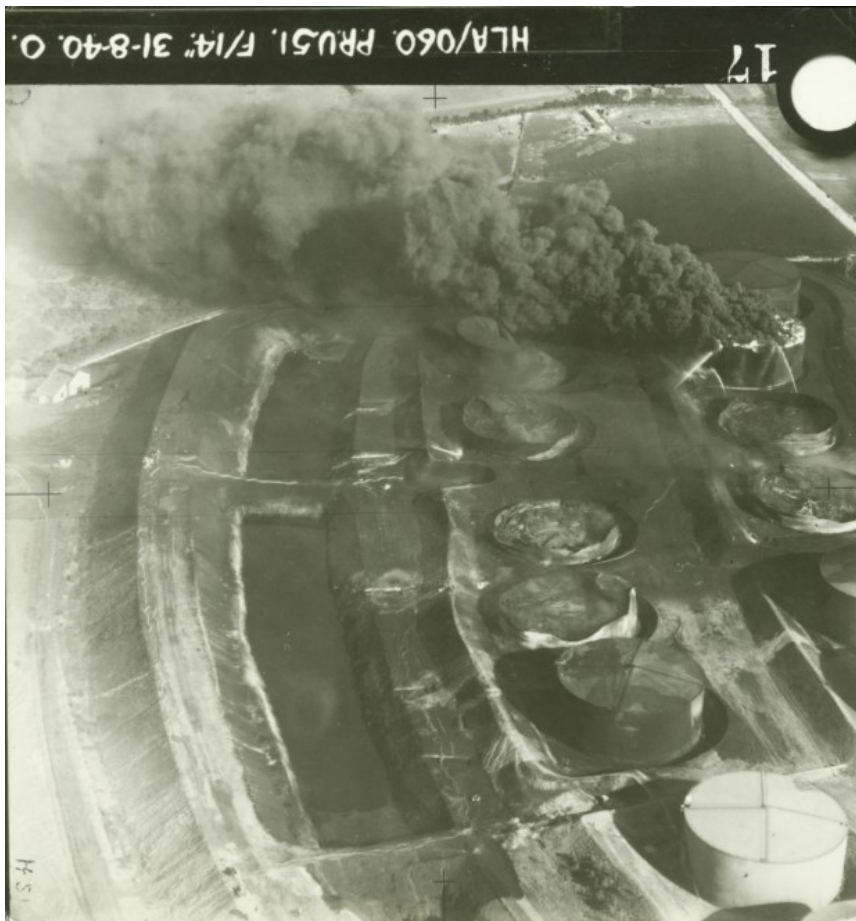
The oil tanks of Llanreath ablaze some 12 days after being bombed, photograph taken 31<sup>st</sup> August 1940 Medmenham collection M2177\_17

1928-78 Admiralty Oil Depot now derelict. 16 oil storage tanks four deep rock-cut moats pumphouse and buildings linked to Royal Dockyard by a tunnel. All oil tanks have been demolished nine due to wartime damage. Site in use as a golf course in the early part of the 21st century. RJC Thomas 24-01-93

On August 19th 1940 a lone German bomber struck one of the seventeen tanks and started a fire which was to burn for three weeks. The fire was fought by 650 men from 22 fire brigades from as far as Birmingham and Cardiff. Five firemen lost their lives in the blaze. Thirteen George Medals were awarded to the firefighters. (A Pyper based on Besley 2004)

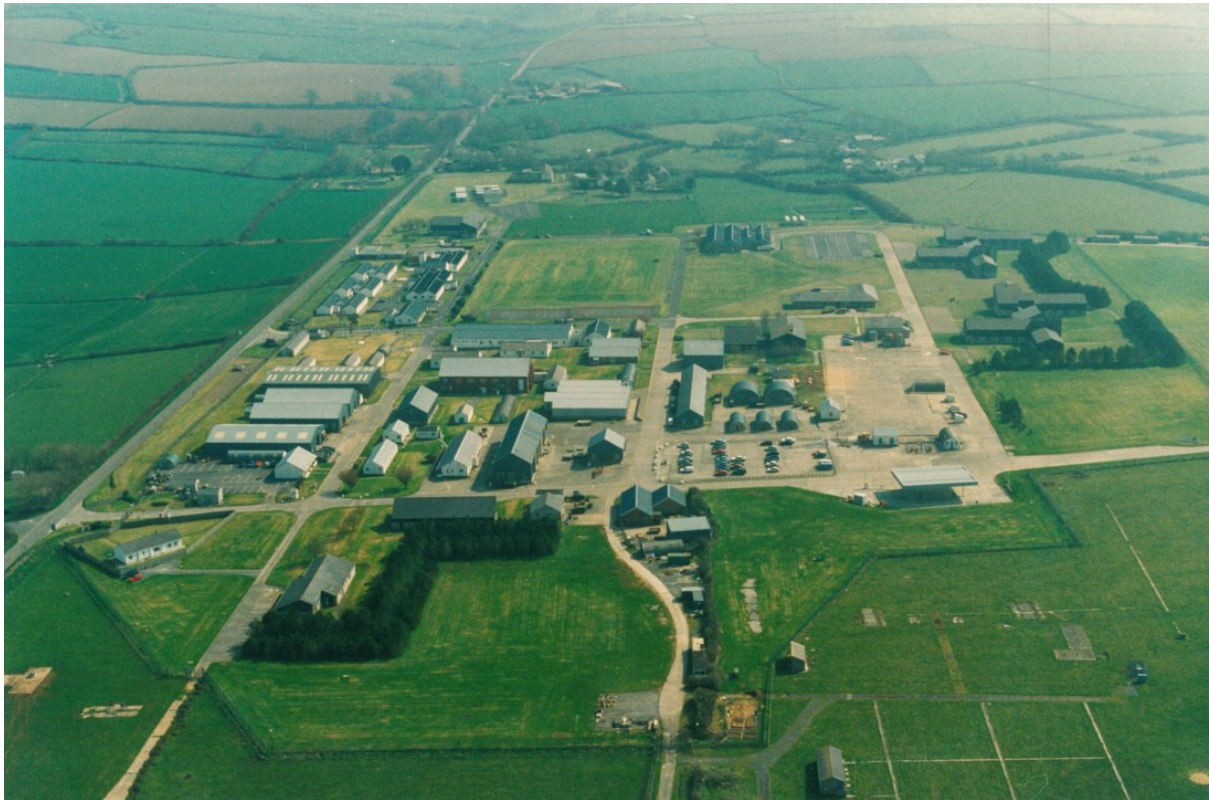
Merrion Camp looking east. No date. (Castlemartin Range Office)

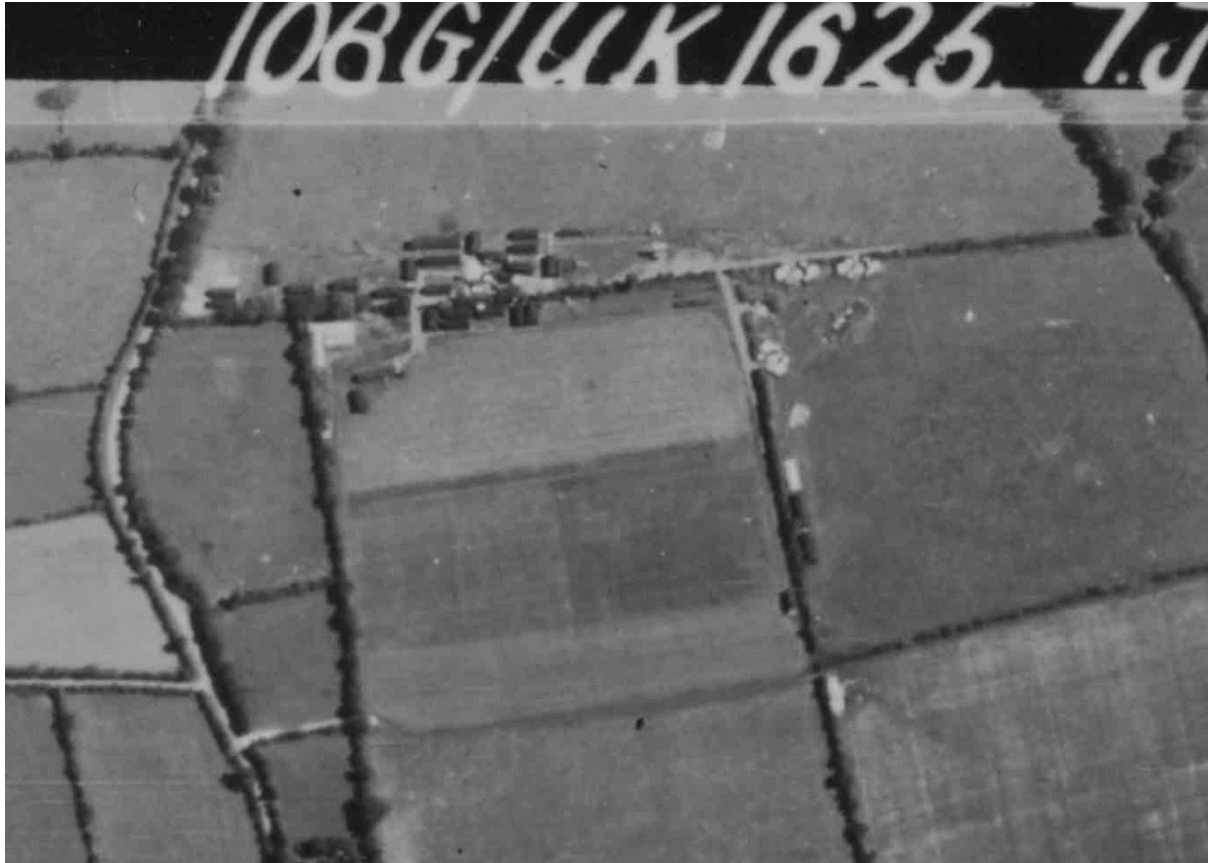
Anti-aircraft battery and associated hutted accommodation RAF 106G UK 1625/6342

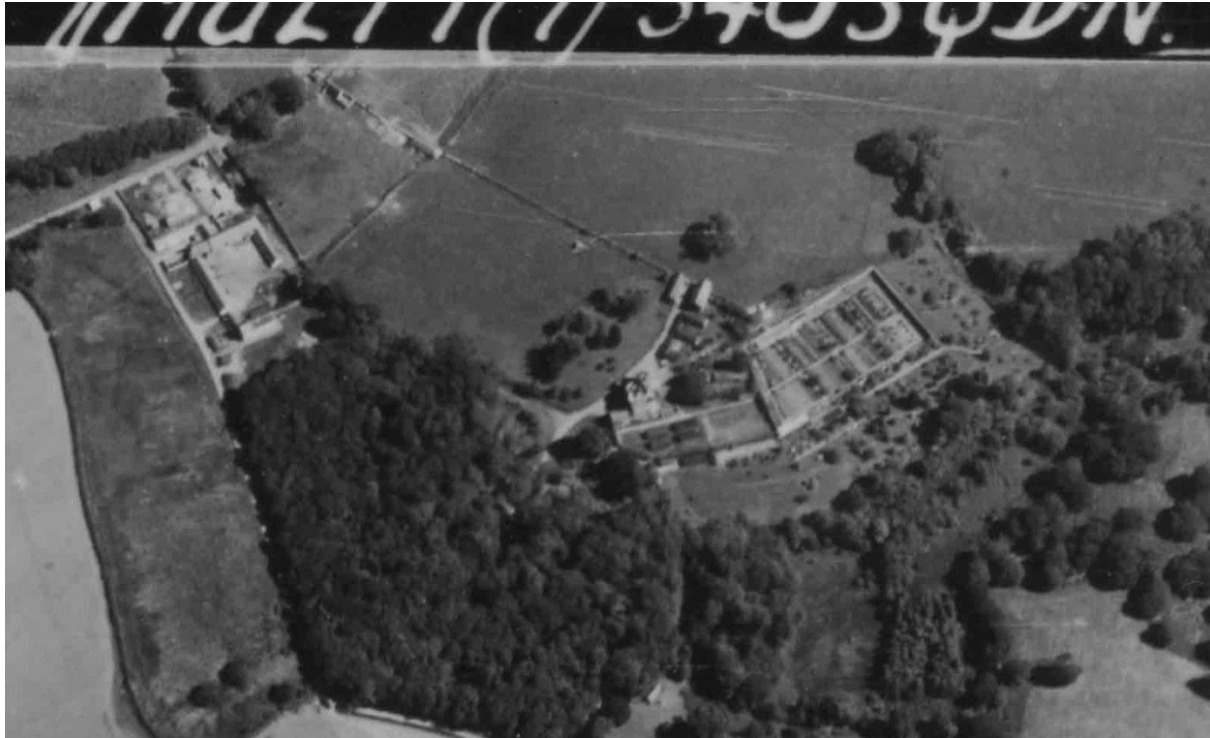
RAF 106G/UK1625/6342 7<sup>th</sup> July 1946

A number of hutted buildings are visible within the grounds of the castle

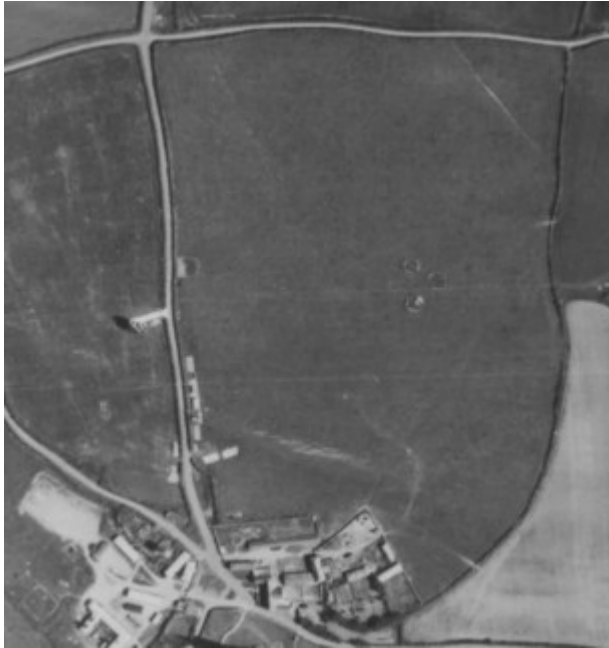
A searchlight emplacement and associated huts. RAF 106G/UK 1625/5395

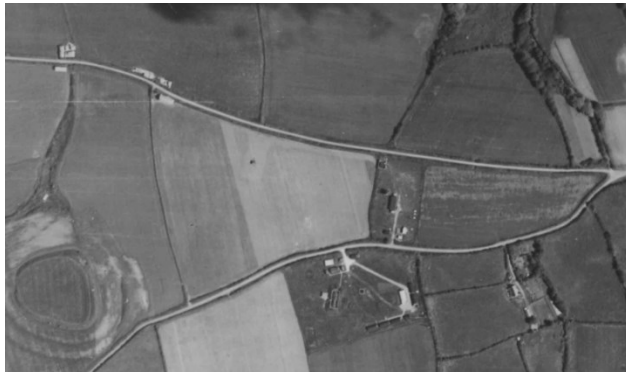
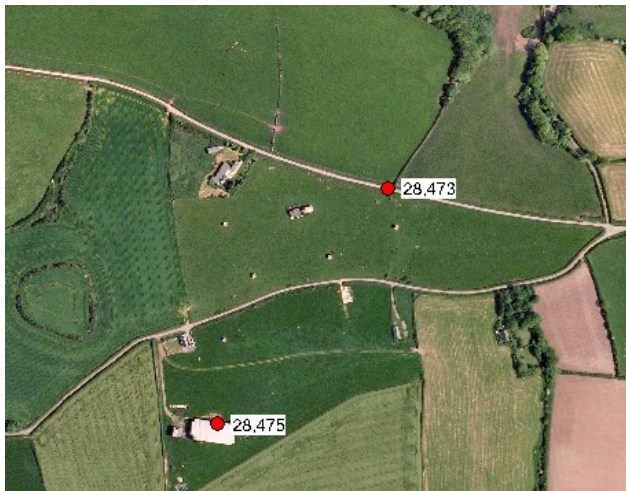
A complex of structures and buildings shown on the RAF 106G/UK 1625 5393, 7<sup>th</sup> July 1946, above and Next Perspectives 2009 aerial mapping below.
