5 MAENOR HELYG, PEMBREY, CARMARTHENSHIRE ARCHAEOLOGICAL WATCHING BRIEF

RHIF YR ADRODDIAD / REPORT NO. 2017/49 RHIF Y DIGWYLLIAD / EVENT RECORD NO. 110737

> Awst 2017 August 2017

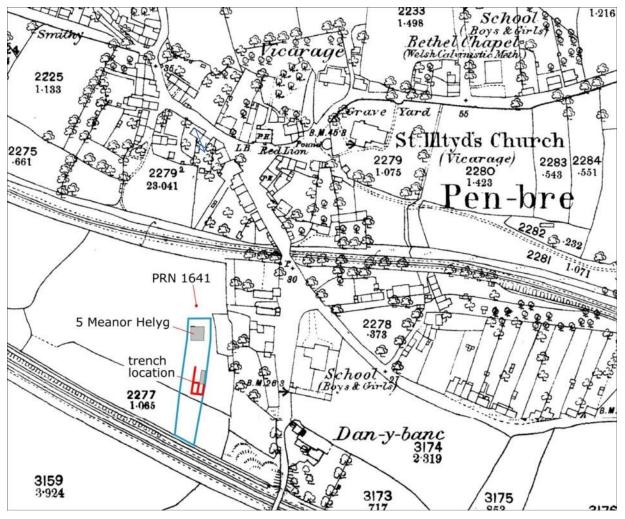
Figure 2: Extract from the OS 1st edition showing location of multiple burials (PRN 1641), property boundary (blue) and trench locations (red).

- 2.2.2 Historic maps shed no light on why burials are at this location. Prior to the construction of houses in the second half of the 20th century, the parish tithe and later maps (Figure 2) show the area as one of agricultural fields. Neither are there any records within the Historic Environment Record in the vicinity of the burials or the surrounding area that help our understanding of the reasons why this cemetery exists and what period it might originate from.

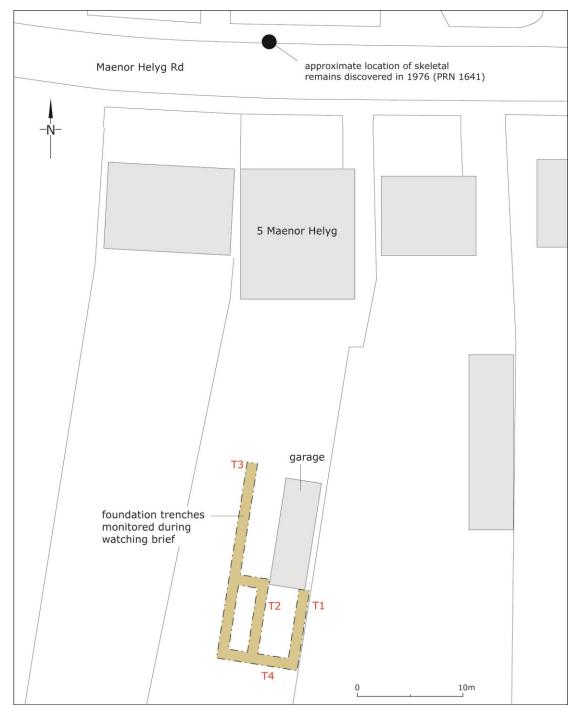
Figure 4: Location of foundation trenches within property and in relation to multiple burials (PRN 1641).

- 4.1 The four foundation trenches excavated during the watching brief are labelled T1, T2, T3 and T4 (see Figure 4).
- 4.2 The north end of T1 butted up against a garage wall and ran southwards alongside a breeze block, boundary wall for 7.6m. It was approximately 1m wide. Its base cut through the natural windblown sand for its entire length (Figure 4, Photo 1).The trench was stepped once achieving a maximum depth of 1.05m; a typical profile can be seen in Photo 2, consisting of 0.45m of topsoil and dark garden soil, beneath which stood approximately 0.6m of sand. No cuts or deposits of archaeological or historical significance were observed within the trench.

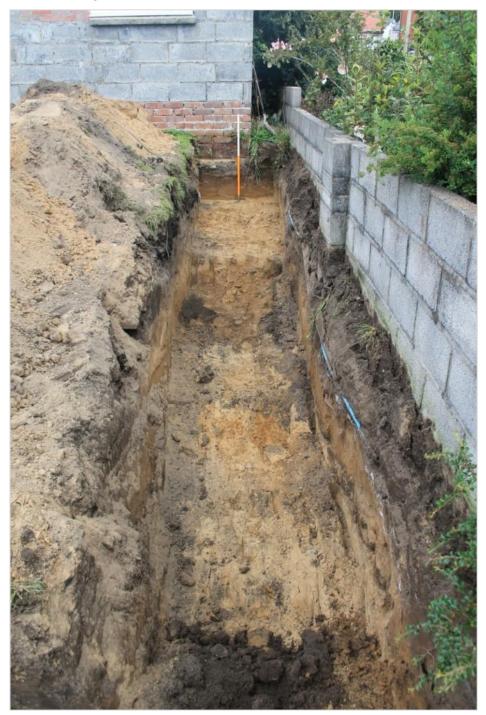
Photo 1: View north along T1. 1m scale.

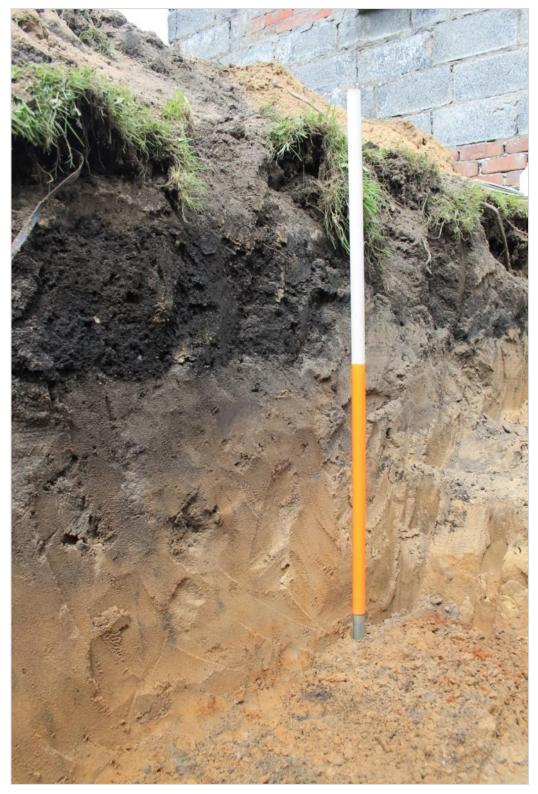
Photo 2: East facing section in T1 showing extent of windblown sand. 1m scale

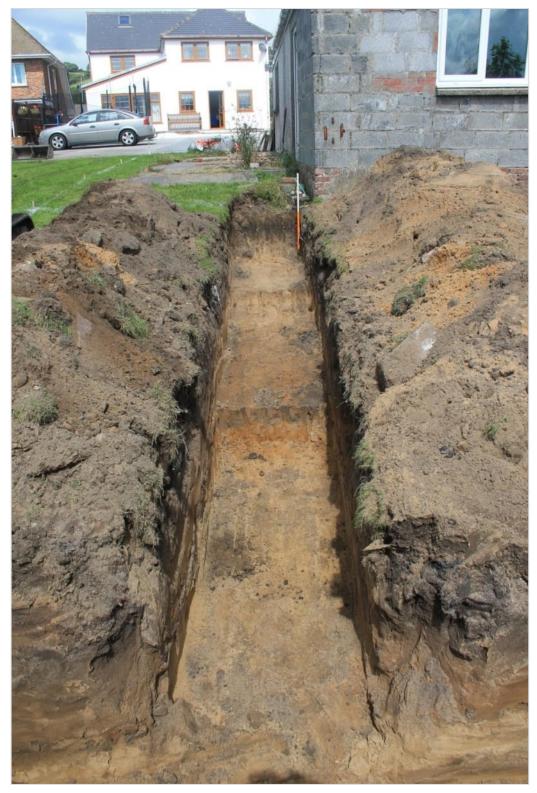
Photo 3: Looking north along T2. 1m scale

- 4.3 The north end of T2 was situated beside the SW corner of a garage. It ran for 7.6m and was stepped twice, reaching a depth of 1.05m at its southern end. Its base cut through natural windblown sand for its entire length. A small patch of clay was seen at the bottom of the trench towards the south end. No cuts or deposits of archaeological or historical significance were observed within this trench (Figure 4, Photo3).

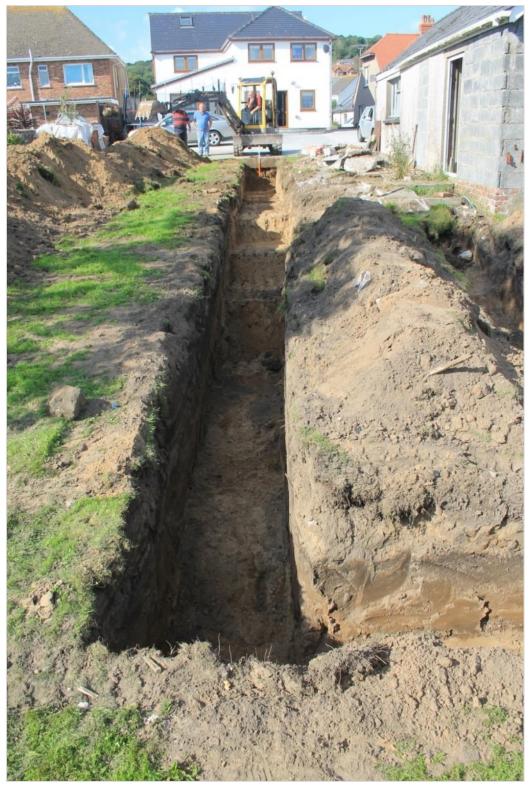
- 4.4 T3 was aligned in north-south and was 18.6m long by 1m wide. It was stepped three times and its base cut through natural windblown sand for its entire length, achieving a maximum depth of 1.3m (Figure 4, Photo 4). A lens of clay was observed approximately 1.5m long and 0.15m thick near the base at the southern end. It is probably associated with the patch of clay seen at the bottom of T2 (Photo 5). The sand deposits in the northern half of the trench were within 0.2m of the garden surface (Photo 6). The section in T3 clearly showed the sand gently sloping down to the south. No cuts or deposits of archaeological significance were observed within this trench.

Photo 4: Looking north along T3. 1m scale

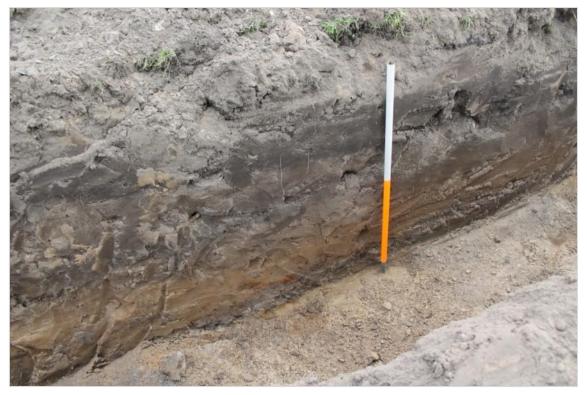
Photo 5: West facing section along southern half of T3 showing clay lens within sand. 1m scale

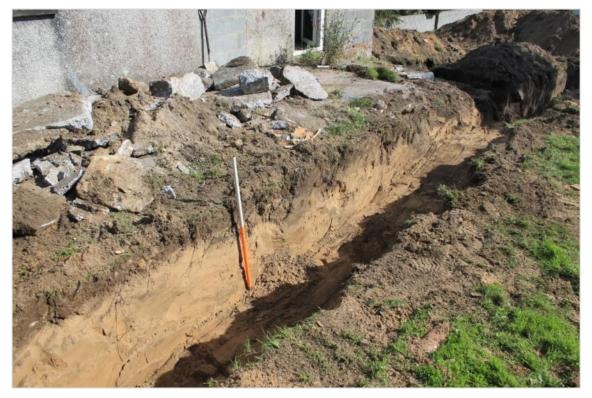
Photo 6: West facing section in northern half of T3 showing windblown sand very close to the surface of the garden. 1m scale

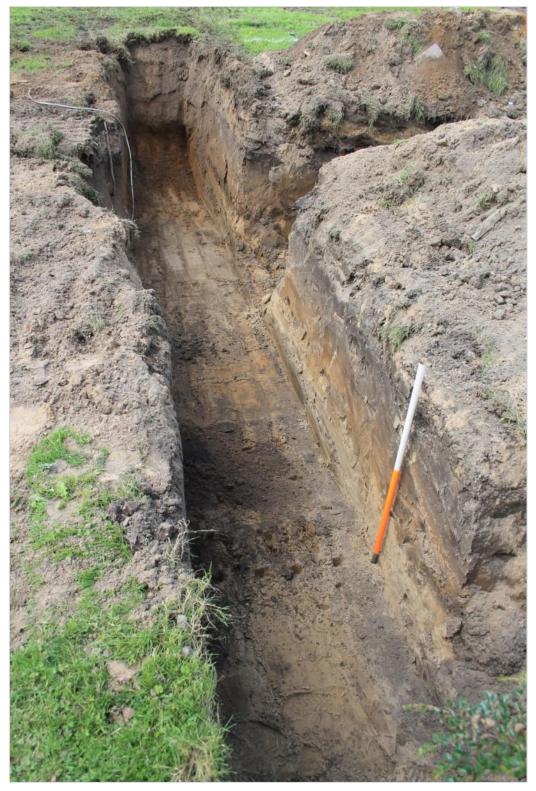
- 4.5 T4 was aligned east-west and was 7.7m long and 1m wide. Its section was approximately 1.05m deep comprising 0.45m of topsoil and garden soil with 0.6m of windblown sand beneath. No cuts or deposits of archaeological interest were observed within this trench (Figure 4, Photo 7)

Photo 7: View west along T4. 1m scale
