**ROCHE COURT, BROADWAY,
LAUGHARNE CARMARTHENSHIRE:
ARCHAEOLOGICAL
WATCHING BRIEF
(SN 29470 10212)**

RHIF YR ADRODDIAD / REPORT NO. 2012/11
RHIF Y DIGWYDDIAD/ EVENT RECORD NO. 102739

ROCHE COURT, BROADWAY, LAUGHARNE, CARMARTHENSHIRE: ARCHAEOLOGICAL WATCHING BRIEF

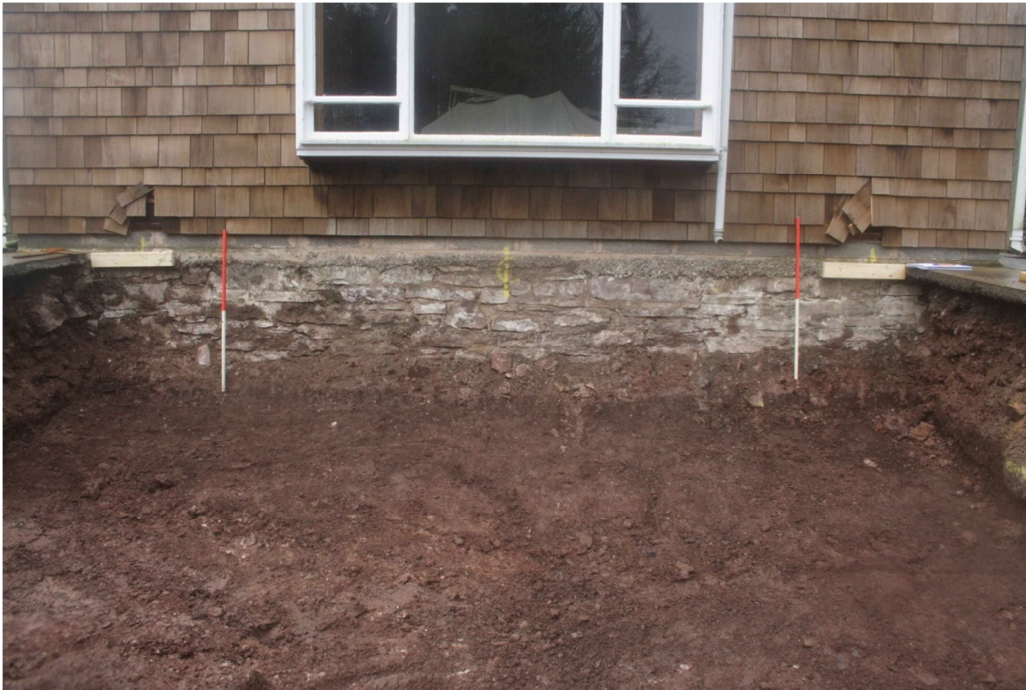
4.3 The footing of the existing bungalow was revealed on the western side of the excavated area. This was constructed of coursed stone with concrete capping. The bonding material was modern cement (Photo 1).

Photo 1: Eastern extension area following machining.
Note the stone wall used as footing for bungalow.

6.2 The wall footing exposed on the eastern gable end of the existing bungalow of Roche Court was seen to be constructed of random coursed stone. The footings could relate to the reuse of an earlier stone wall, but this is very unlikely as the wall alignments are different to anything known about the alignment of the castle and later cottage on the site. The increased depth of the footings on this side of the building compared to that to the north was quite substantial, but presumably relates to the reduction in ground level to the east. The wall footings to the north were also of stone and cement, but in this area they were much shallower and sat directly upon bedrock. It is very likely that wall footings were contemporary with the 1960s bungalow, but were made using stone taken from the castle.

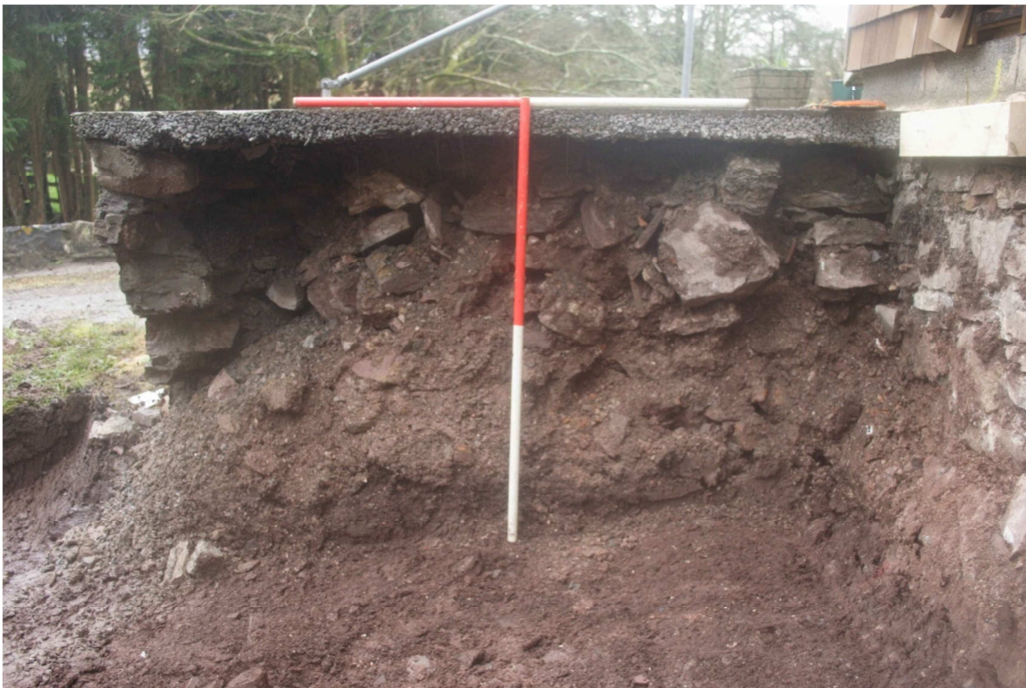
4.4 Also on the western side of the excavated area was a modern raised tarmac pathway that crossed in front of the bungalow gable end. This path had been set on rubble infill (Photo 2). The ground level around this end of the bungalow was significantly lower than the tarmac path, and a steep drop in the ground level was visible (Photo 2).

Photo 2: Rubble infill beneath path on southern side of eastern extension area.
Note the sharp change in ground level to east.

6.3 The eastern extension was located in an area where the ground level had already been significantly altered. The ground naturally drops to the west and to compensate for this drop, the ground level had been previously raised using rubble. A tarmac path had then been constructed on top of this raised ground adjacent to the bungalow. The ground level may also have been previously reduced when the bungalow was built.

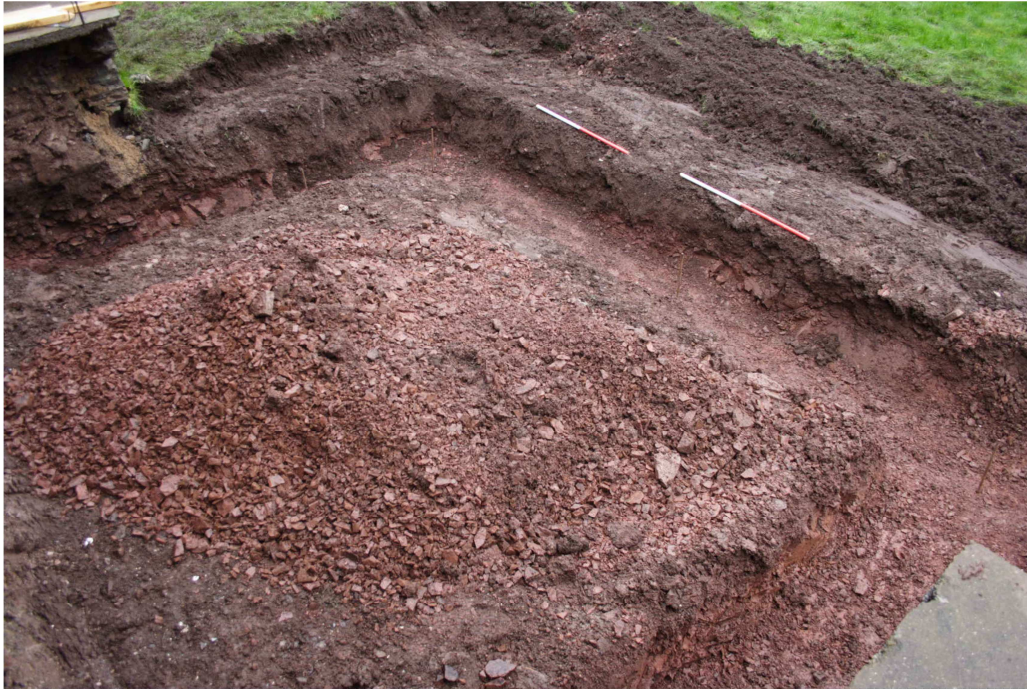
4.6 The footing trenches were excavated a further 0.45m in depth from the formation level into the bedrock (Photo 3).

Photo 3: Eastern extension area following excavation of footings

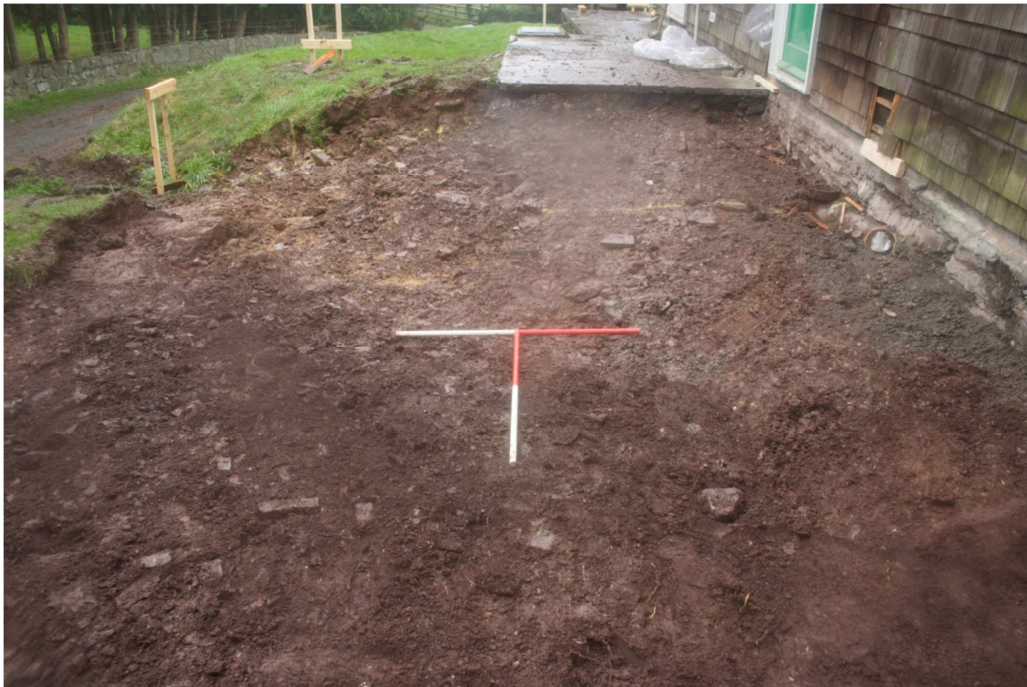
4.7 The footprint of the extension on the northern side of the bungalow measured 7m x 4m. Initial stripping to formation level was quite shallow and revealed a spread of rubble containing 19th and 20th century ceramic material (Photo 4). It was determined that the ground surface comprised areas of both exposed natural bedrock and areas of stone rubble.

Photo 4: Northern area of extension after initial machining to formation level.
Note the rubble spread and stone footings for bungalow to the south.

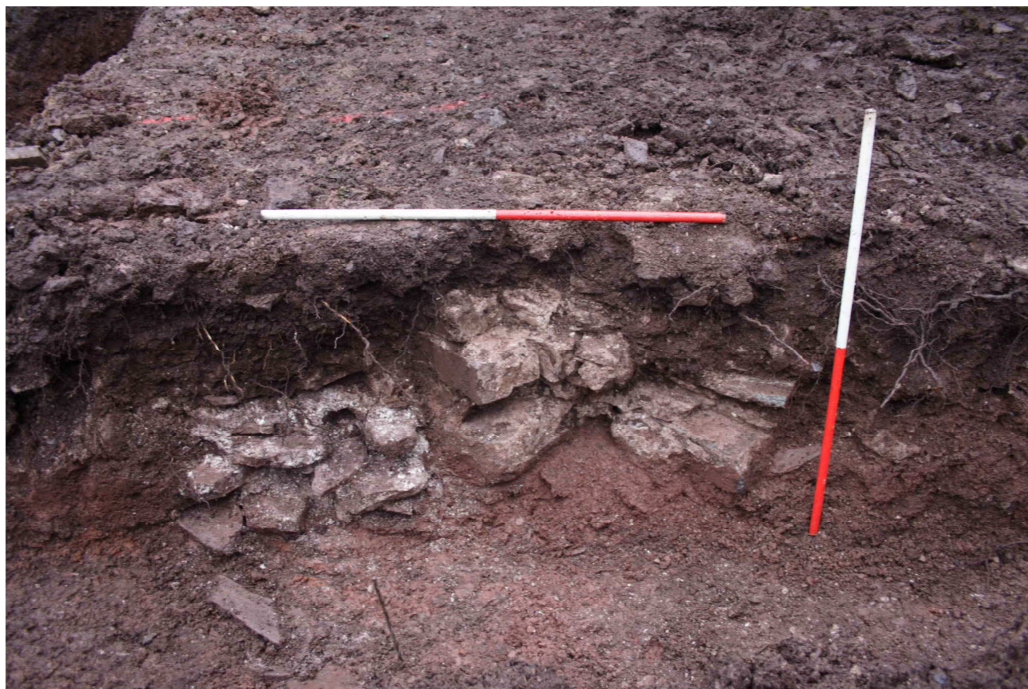
4.9 As excavations progressed the truncated ends of stone walls were revealed on the inside of the foundation trench. The walls were only visible in the southern section of the foundation trench and all appeared to continue under the footprint of the proposed extension and the bungalow. Archaeological excavations undertaken in the 1960s on the site indicate that a northwest – southeast aligned wall footing was identified in a very similar location (Figure 4), but the interpretation and date of the wall was unclear. Further hand cleaning of the wall demonstrated it was formed by two abutting walls identifiable through differences in the mortar and stone (Walls 100 and 101; Photo 5).

4.10 Wall (100) measured 0.33m in height with a width of 0.5m and was constructed of non-faced rubble, bonded with a very white lime mortar suggesting a high lime content. The wall did not look very substantial.

4.11 Wall (101) survived to a height of 0.63m with a visible width of 0.6m. This wall appeared to be of a much more substantial nature than (100) and was

faced with roughly dressed stone, bonded with a darker mortar with much lower lime content than (100). It is possible that wall (101) represents a corner of a wall, turning from a northwest – southeast alignment to a northeast – southwest alignment. This was implied by possible facing stones seen on the western wide of the wall.

4.12 Both walls lie outside the former cottage site, but it is possible that wall (100) may represent a boundary associated with the cottage.

4.13 Wall (101) is considered to pre-date wall (100). It could potentially be the remnants of an original castle wall, and possibly the saem asthat seen in the 1960s excavations. Due to the limitations of the excavation area, it was not possible to confirm this. No medieval finds were recovered from the area.

Photo 5: Walls (100) and (101).

6.4 The two abutting walls revealed within the footings excavations undertaken on the north side of Roch Court are of earlier date. Wall (100) may relate to a former boundary associated with the 19th century cottage, but it has not been possible to substantiate this. The wall was roughly coursed and used a very lime rich mortar. The wall appeared to be aligned northwest to southeast, but was not visible in the northern face of the foundation trench.

6.5 Wall (101) appears to predate (100) and retains some of its dressed facing stones. It was also aligned northwest to southeast as far as could be ascertained. The wall was only seen in the north facing side of the foundation trench. It is possible that the wall formed a corner turning 90 degrees to a northeast to southwest alignment. Possible facing stones on this perpendicular stretch of wall may just have been visible in the section. If the wall did turn here, it would explain its absence in the opposing section of the trench. The wall may potentially relate to the castle, but given the limited nature of the excavations it was not possible to confirm this. It is possible that the northwest to southeast part of this wall aligns with the wall footing identified during excavations undertaken ahead of the construction of Roch Court in the 1960s.

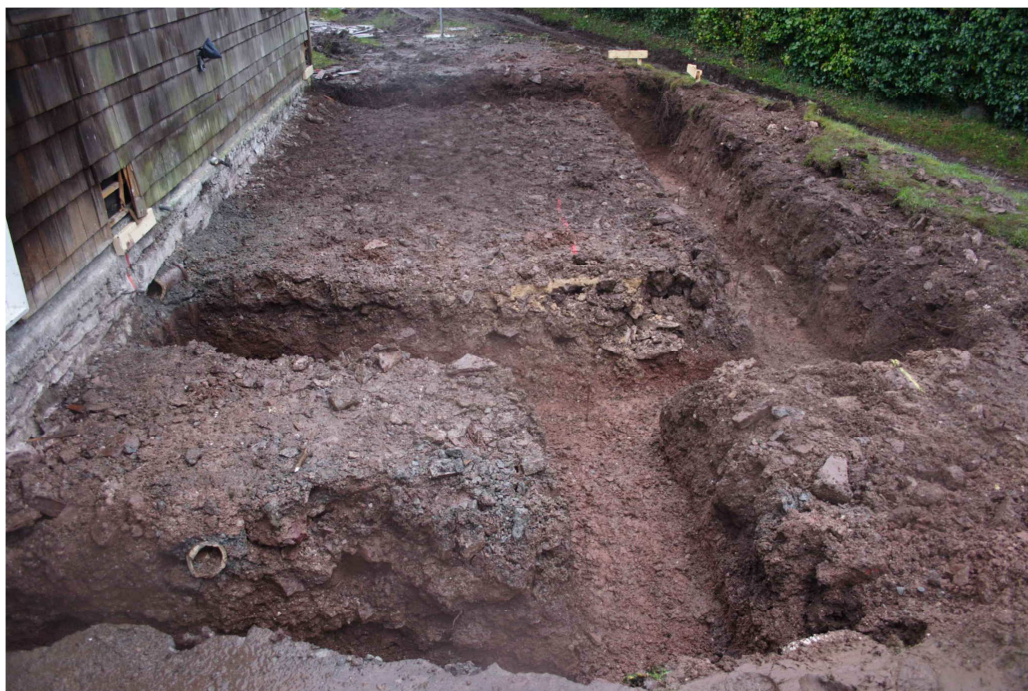
Photo 6: Northern area following excavation.
