# **LLANGRANNOG SEWER OUTFALL, CEREDIGION: ARCHAEOLOGICAL WATCHING BRIEF**

Prepared by Dyfed Archaeological Trust  
For: Morgan Sindall Plc

RHIF YR ADRODDIAD / REPORT NO. 2012/14  
RHIF Y PROSIECT / PROJECT RECORD NO. 102641

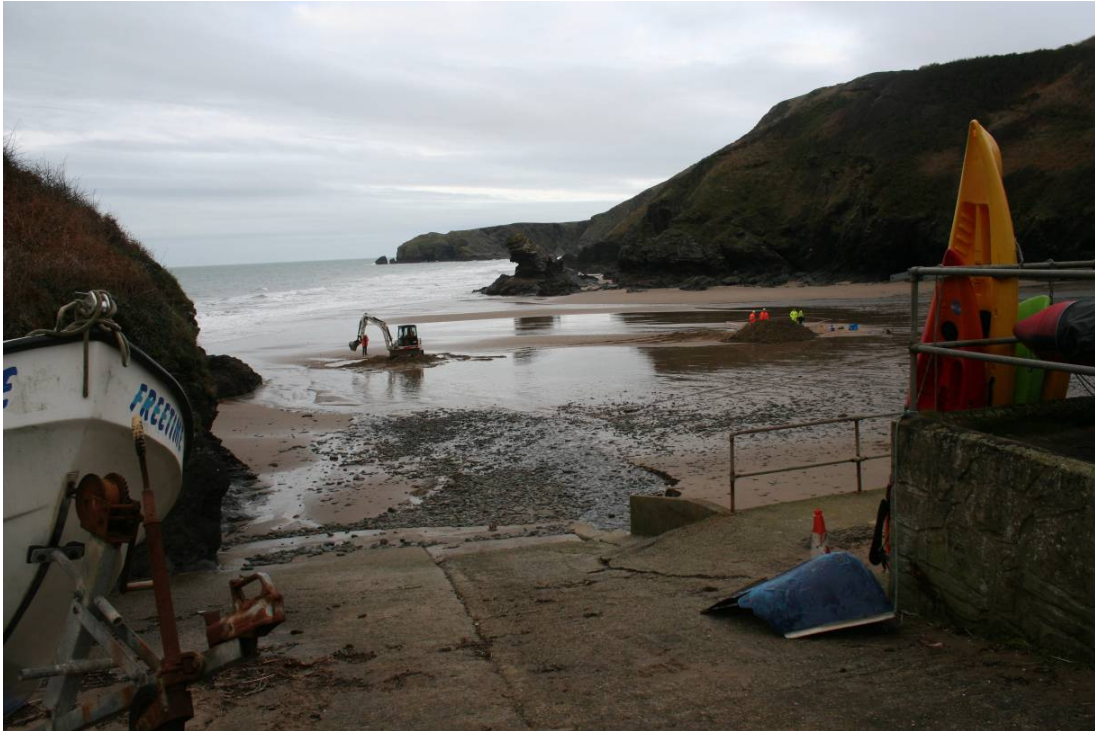
**Photo 3:** Looking north across the beach showing locations of trial-pits A and B. Same view as Photo 2.

- 3.2 The groundworks for this scheme of work involved the location of the existing sewer outfall pipe in order to ascertain its direction and depth below beach deposits at Llangrannog. The test pits were excavated on the beach at Llangrannog (Photo 3).

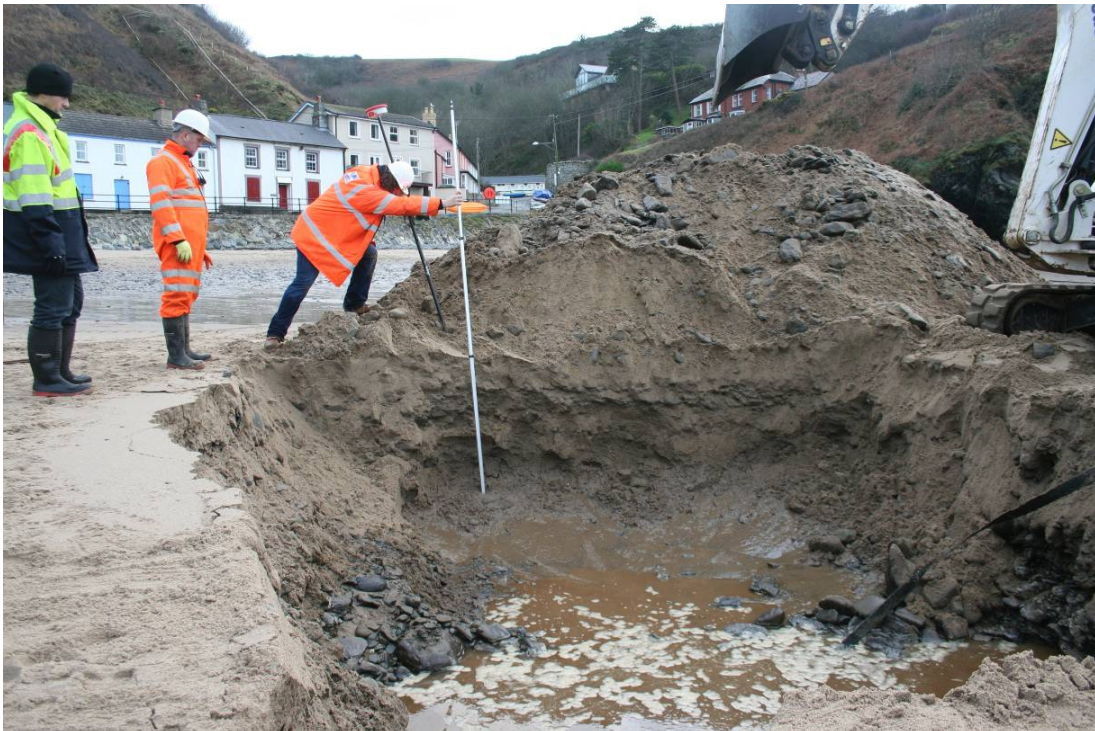
**Photo 4:** Looking south at trial-pit A. The sewer pipe lies beneath survey staff.

##### **4.1 Trial Pit A (Photo 4)**

- 4.1.1 Trial-pit A measured approximately 4m by 5m and averaged 1.8m deep.
- 4.1.2 In section the topmost layer comprised of approximately 0.35m of sand beneath which an accumulation of ungraded gravels continued for 1.45m depth to the bottom of the pit.
- 4.1.3 The crown of the pipe was recorded at NGR 231011.79E, 254211.40N at a depth of -1.05m O.D.
- 4.1.4 No archaeological features or peat deposits were present (Photos 4 and 5), either within the test pit or in its edges.

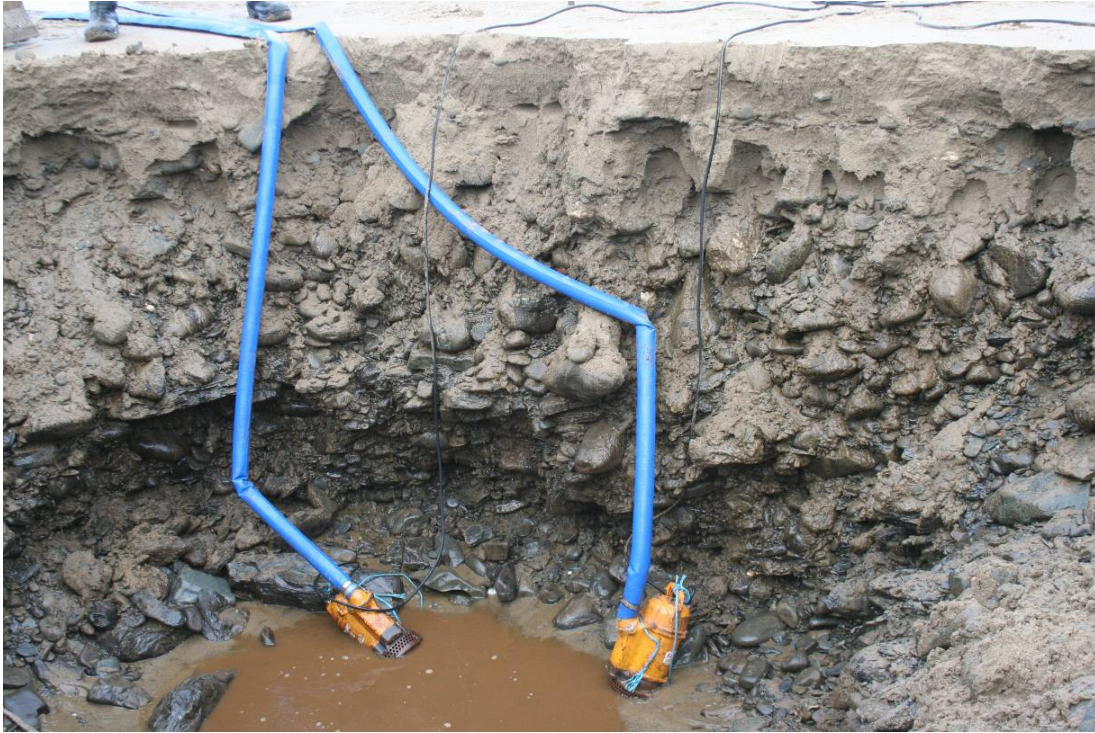
**Photo 5:** Looking north; trial-pit B.  
Typical profile of ungraded gravels beneath sand deposits.

- 4.2.1 Trial-pit B measured approximately 4m by 5m and averaged 1m deep.
- 4.2.2 In section the topmost layer comprised of approximately 0.4m of sand beneath which an accumulation of ungraded gravels continued for 0.6m to the bottom of the pit (Photo 5).
- 4.2.3 Timber-shoring associated with the laying of the existing pipe was observed in the south section of the pit (Photo 6).
- 4.2.4 The crown of the pipe was recorded at NGR 230977.34E, 254220.01N at a depth of -1.29m O.D.
- 4.2.5 No significant archaeological features or peat deposits were present either within the test pit or in its edges.

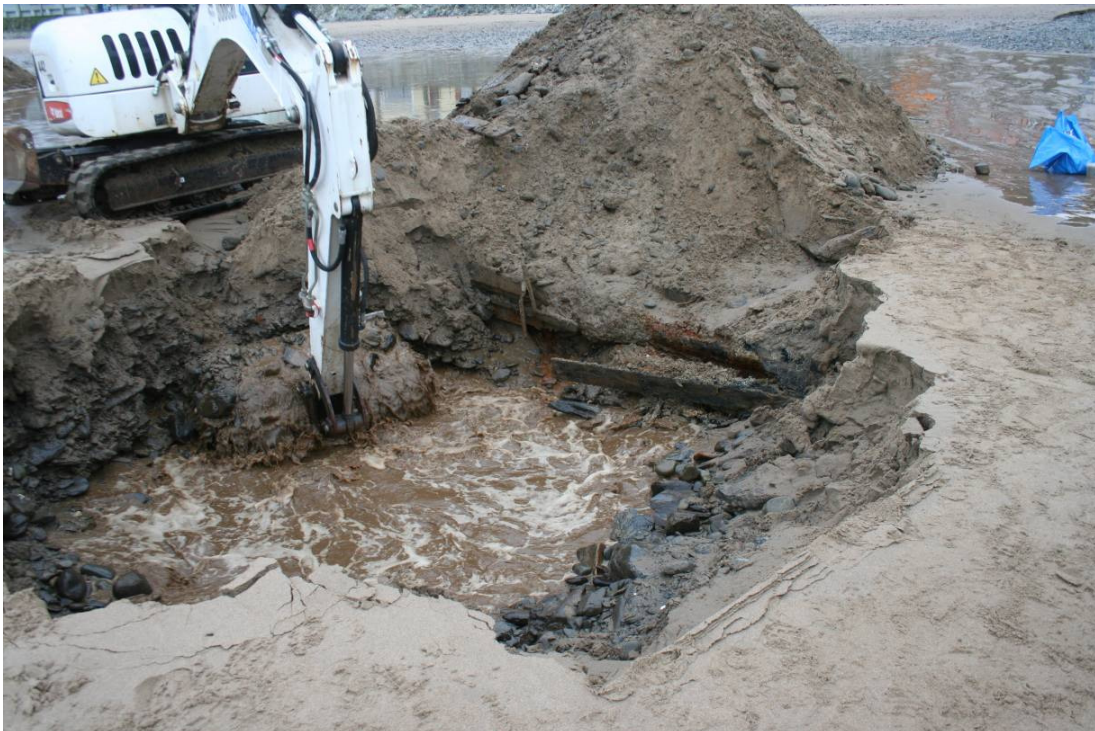
**Photo 6:** Looking south; Trial-pit B. in situ timber-shoring associated with sewer pipe.

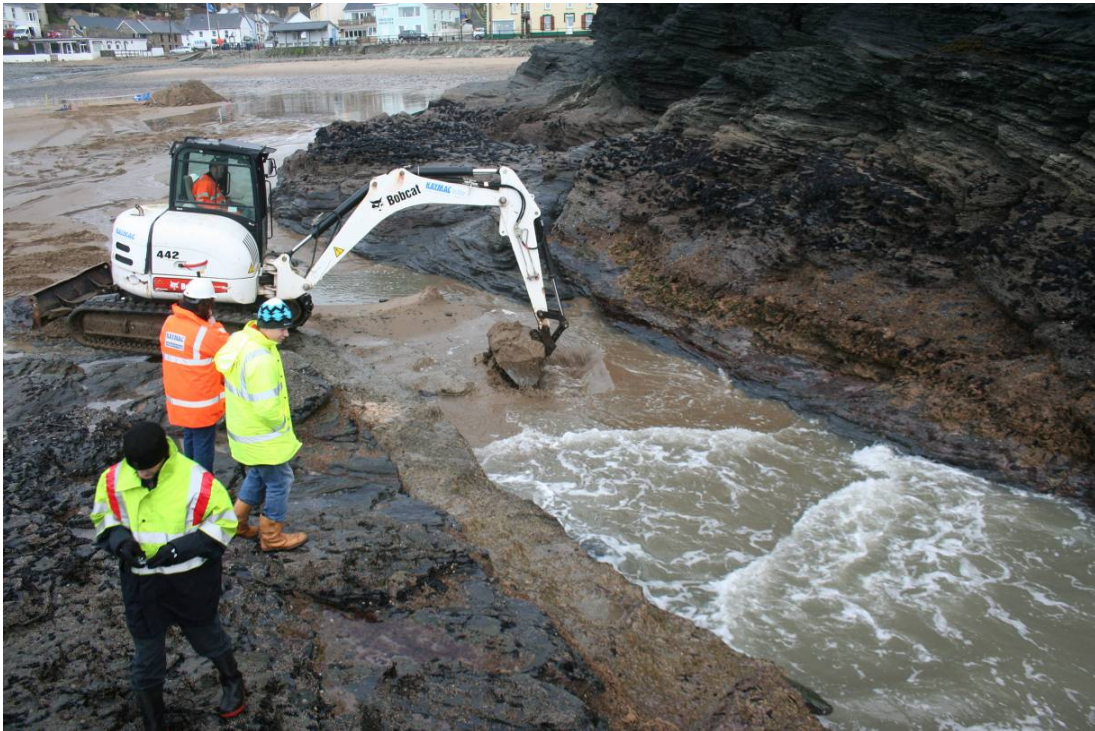
**Photo 7:** Looking southeast along narrow corridor between base of Pen Rhip headland and rock outcrop. Trial-hole D being excavated

- 4.3.1 Trial-holes C, D and E were shallow scoops in the sand (Photo 7). These were excavated along the narrow corridor between the Pen Rhip headland and rock outcrop on the beach.
- 4.3.2 All of the trial holes reached the underlying bedrock. In trial hole C at a depth of 1.59m O.D, in trial holes D at 2.04m OD and in trial hole E at a depth of 2.41m OD.
