# **ST DAVID'S CHURCH, HENLLAN AMGOED, CARMARTHENSHIRE: ARCHAEOLOGICAL EVALUATION (SN 1852 2072)**

RHIF YR ADRODDIAD / REPORT NO. 2012/37  
RHIF Y PROSIECT / PROJECT RECORD NO. 102874

# ST DAVID'S CHURCH, HENLLAN AMGOED, CARMARTHENSHIRE: ARCHAEOLOGICAL EVALUATION

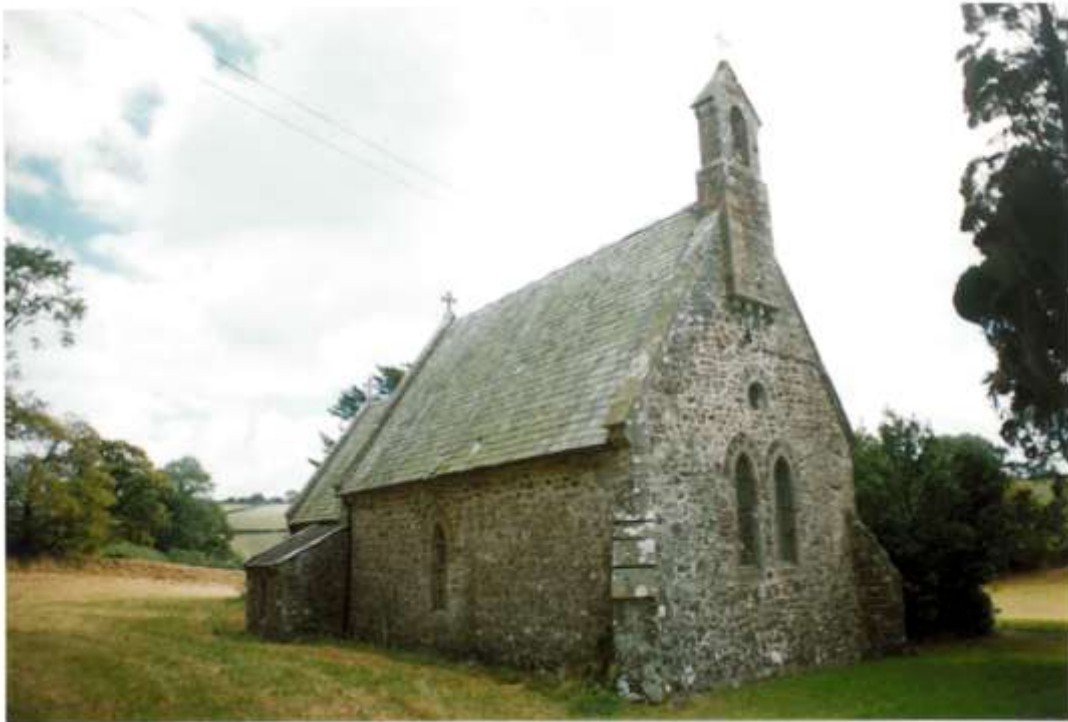
**Photo 1:** St David's Church in 1996 facing southeast, showing evaluation area on left hand side of photograph

*St David, Henllan Amgoed, is a 3 celled church, of small size. It may retain 50% pre-19<sup>th</sup> century core fabric.*

*The present church consists of a 2-bayed chancel, a 3-bayed nave, a south porch and a single-bayed vestry north of the chancel west bay. Construction is in limestone rubble throughout. There is some pre-Victorian pointing, but the walls were largely repointed in the later 19<sup>th</sup>*

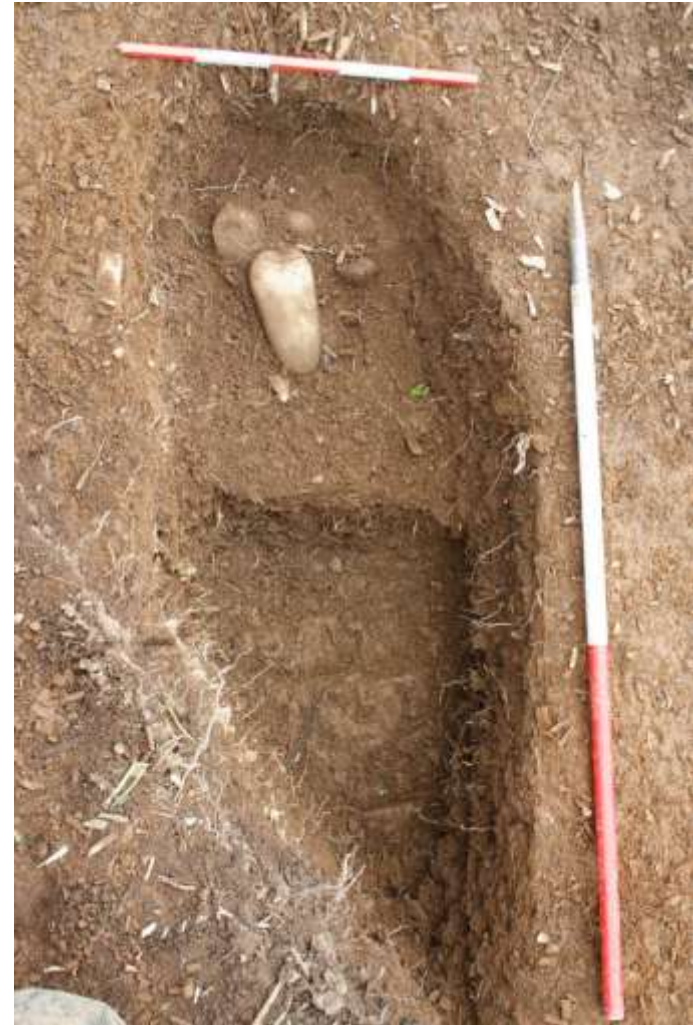
**Photo 6:** Partial excavation of grave cut [110], showing stones at eastern end, facing east

The presence of the water rounded stones and other non-natural stone fragments at the east end of grave [110] were not positioned in a way to indicate they formed part of a stone lining. They were found in the middle of the foot end of the grave, and would have presumably overlain the feet of the deceased. If stones were also present in a similar location at the eastern, head end of the grave, this is likely to indicate that they are of medieval date. This form of burial practice dates from between the 11th and 13th centuries (Daniell, 1998, 158-159). The significance of positioning stones at the head and feet of the deceased is unclear, with one theory suggesting they represent a form of 'punishment' whereby the body would feel the cold uncomfortable stone at the head and feet at its resurrection on the Day of Judgement. Another possibly more appropriate theory is that the stones were a sign of the penitence and humility of the deceased (*ibid*). Alternatively they may have been a deliberate deposition of stones associated with the profession of the deceased, one stone seems to be a whetstone, another having been used as a hammer-stone and score marks on two of the items, although this goes somewhat against Christian principles.

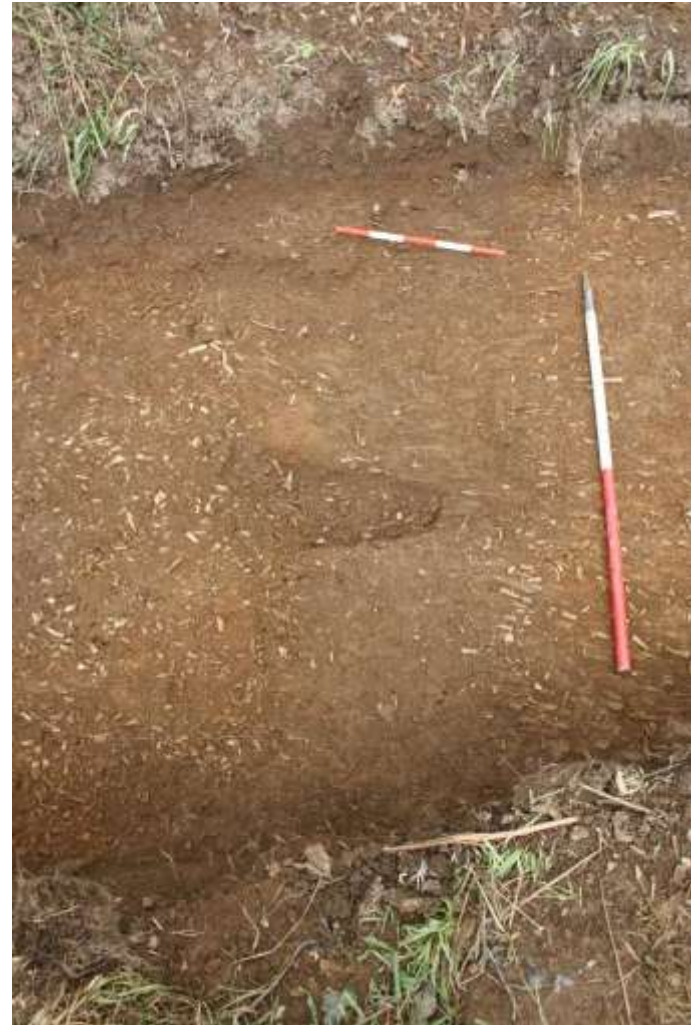
**Photo 10:** Child / infant graves [140], [142] & [144], cutting gully [138], viewing north

The purpose and date of the gully at the western end of the evaluation trench is unclear. From partial excavation and repeated cleaning of the feature, it became apparent that the three child burials cut through the fill of the gully (and thus it is an earlier feature). No finds were recovered from its fill, although a sample of fill has been taken for possible further analysis. Similarly the stakeholes noted close to the child / infant burials were also not dated and their function remains unclear. It is possible they have been formed by root action.

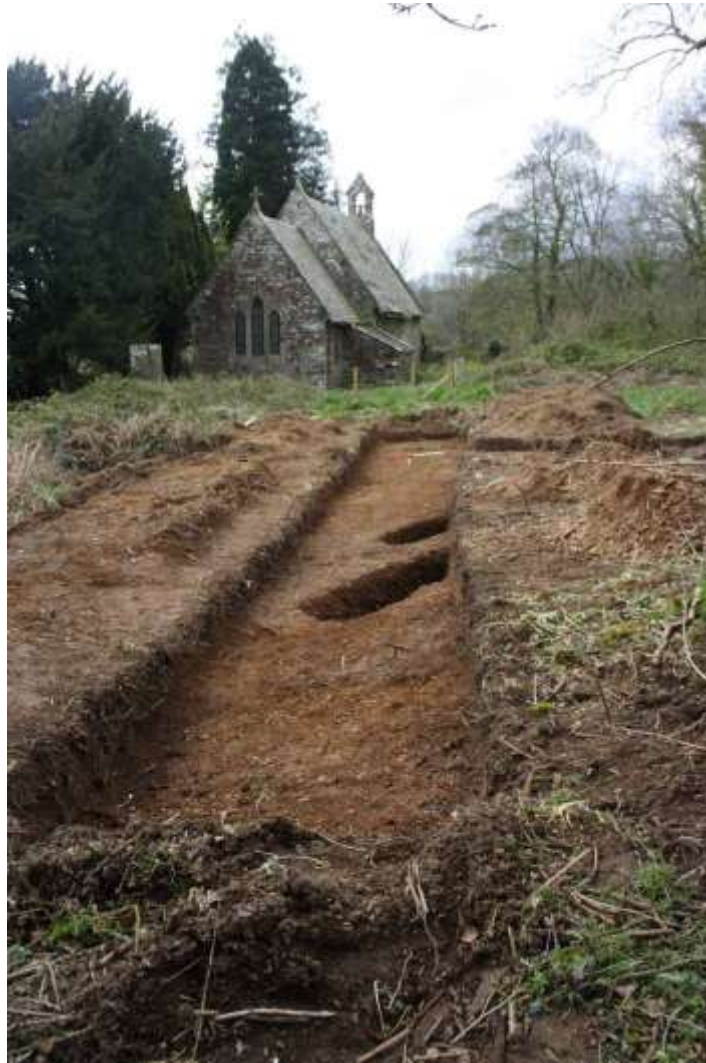
**Photo 13:** View along trench at end of excavation towards church, with absence of graves in foreground of photo (facing west)

No burials were present at both the northern or eastern (Photo 13) ends of the trench. This may indicate the extent of the cemetery, as both trench ends lie closest to the perimeter bank around the churchyard where the original width of the bank or a perimeter walkway around the burials may have been present. A profile was drawn across the perimeter churchyard bank in front of the evaluation trench, in the area where the proposed driveway will access the site (profile m – n Figure 6). This profile demonstrated that the ground level of the churchyard lies less than 1m above the external road level, a smaller difference than originally anticipated. The bank itself rises c.1.10m in height with a width of c.2.40m in this area (Photos 14 and 15). Evidently this perimeter bank seems largely intact around the majority of the churchyard, although has been subject to landscaping along the boundary with The Beeches to the north. It is perhaps best seen along the road leading around the southeastern side of the churchyard (Photo 16).
