**LISBURNE HOUSE,
LLANFIHANGEL Y CREUDDYN,
CEREDIGION:

ARCHAEOLOGICAL
WATCHING BRIEF 2012**

Prepared by Dyfed Archaeological Trust
For: Mr Peter Garson

RHIF YR ADRODDIAD / REPORT NO. 2012/47
RHIF Y DIGWYDDIAD / EVENT RECORD NO. 102932

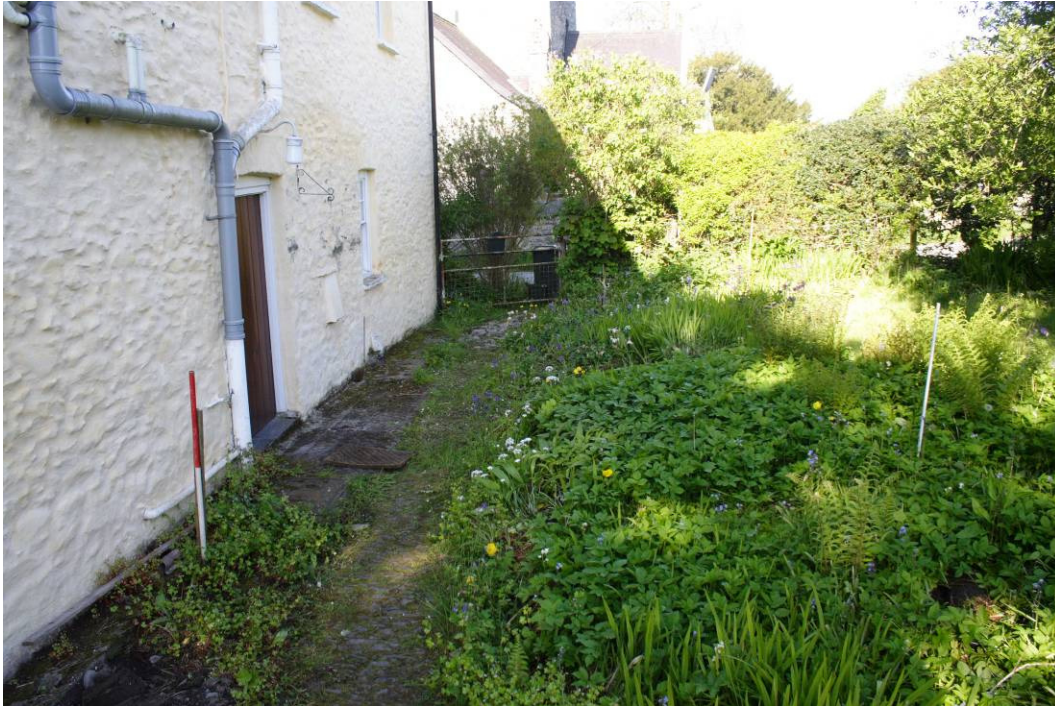
The area of the sun room/conservatory lay on the northern side of Lisburne House. A cobbled path ran along this side of the property (Photo 1) comprised of small thin angular stones with rounded edges, laid vertically to give a rough cobbled surface (locally sourced stone) (Photo 2). The southern edge of the cobbled path has been previously disturbed when modern drainage was inserted and capped with concrete. To the north of the cobbles was a garden area comprising a flower bed rising up to a lawned area (Photo 1).

Photo 1: Site area on northern side of Lisburne House, prior to groundworks commencing

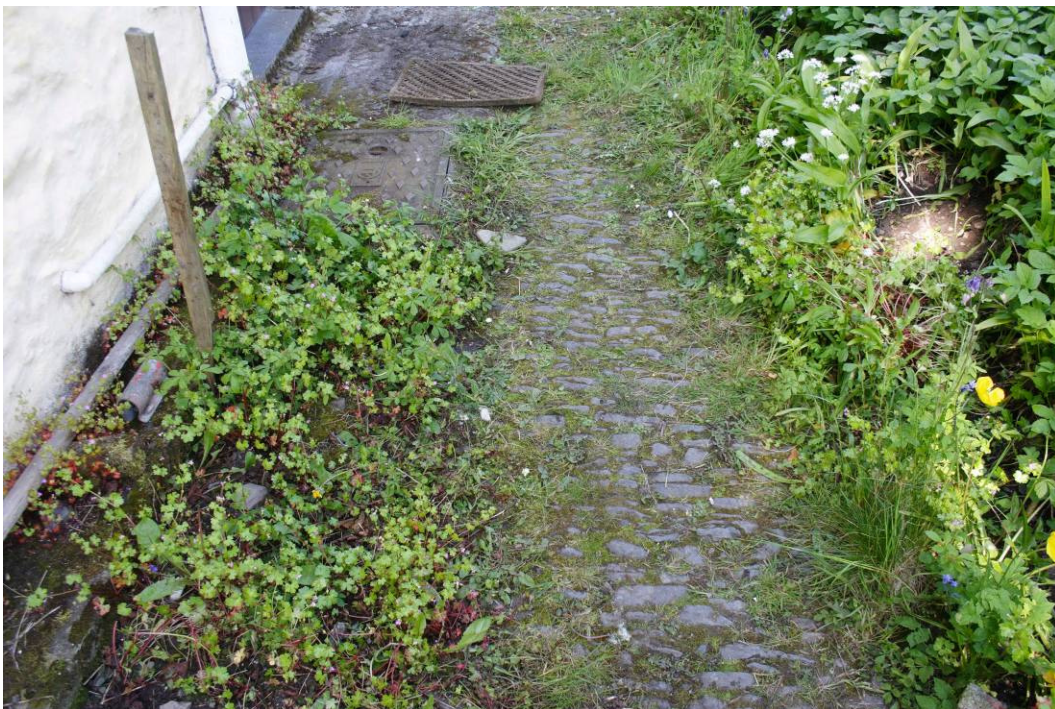
Photo 2: Detail of cobbled pathway on northern side of Lisburne House

On the northern side of the building a cobbled surface was present. This was constructed of partially rounded local stones, presumably collected from the nearby river. It is considered that the surface was contemporary with the construction of Lisburne House in c.1800.

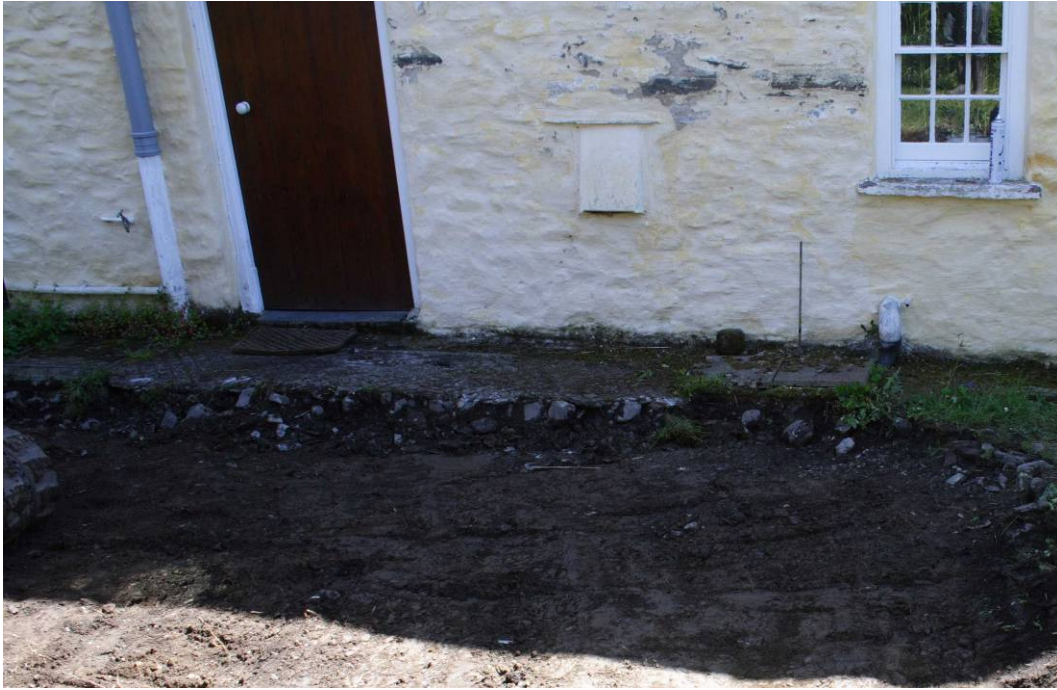
The footprint of the sun room was reduced using a toothless ditching bucket. A toothed bucket was used to remove the cobbled surface and concrete capping to the modern drains. This indicated that the cobbled path was a 0.12 – 0.14m deep layer of rounded stones laid upright in a sandy clay soil matrix set on top of a levelled area of ground (Photo 3). Natural underlying soils were not fully exposed, a thin spread of compacted soils with a few fragments of late 18th/19th century pottery being present above them.

Photo 3: Concrete capped drainage runs adjacent to Lisburne House following removal of cobbles

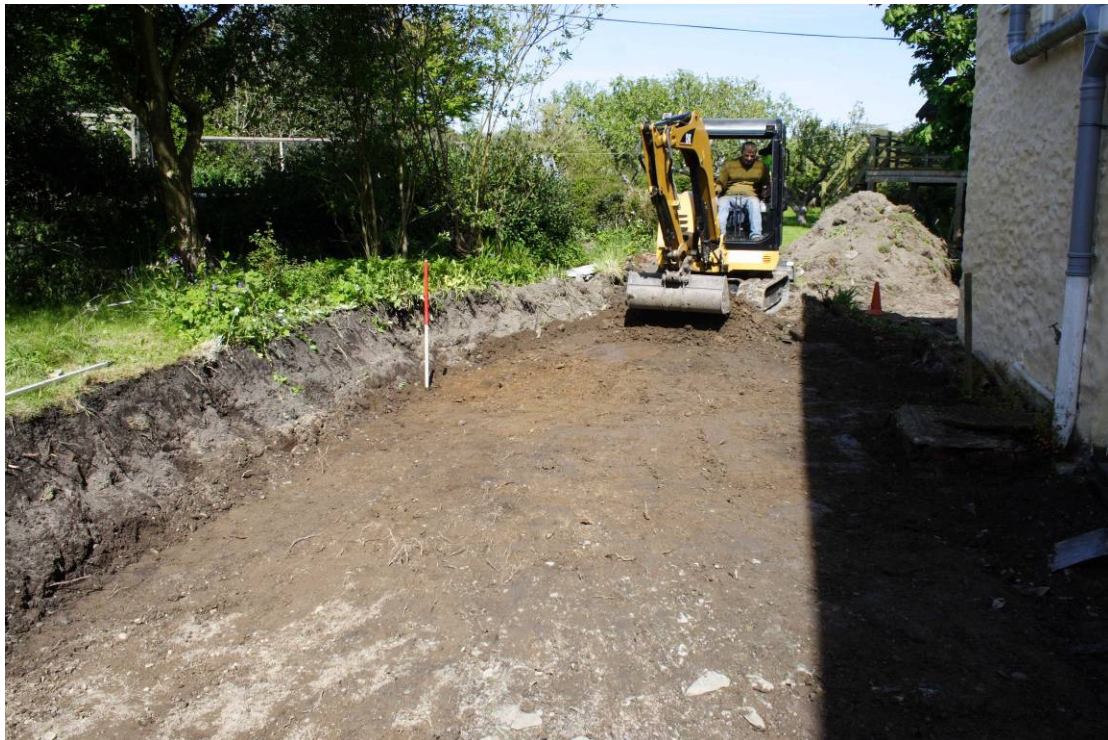
Photo 4: Fully levelled area for sun room to north of Lisburne House, with patch of exposed underlying natural soils to in front of scale

The remainder of the area stripped for the sun room demonstrated a depth of garden soil, varying from c.0.15m to 0.75m, generally increasing in depth from the southern edge adjacent to the cobbled surface to the northeast (Photo 4). Only one area of clear undisturbed natural ground was encountered at this level in the north eastern part of the stripped area, otherwise a spread of topsoil/ploughsoil covered the natural. The layer contained quantities of 19th and 20th century ceramics and glass bottles, presumably having been originally discarded as waste and subsequently mixed through the soil during cultivation. The layer was only partially removed when the foundation trenches around the perimeter of the sun room/conservatory were excavated. These showed that the layer was quite shallow. As the layer was not fully removed, it was not possible to determine if any archaeological features were present.

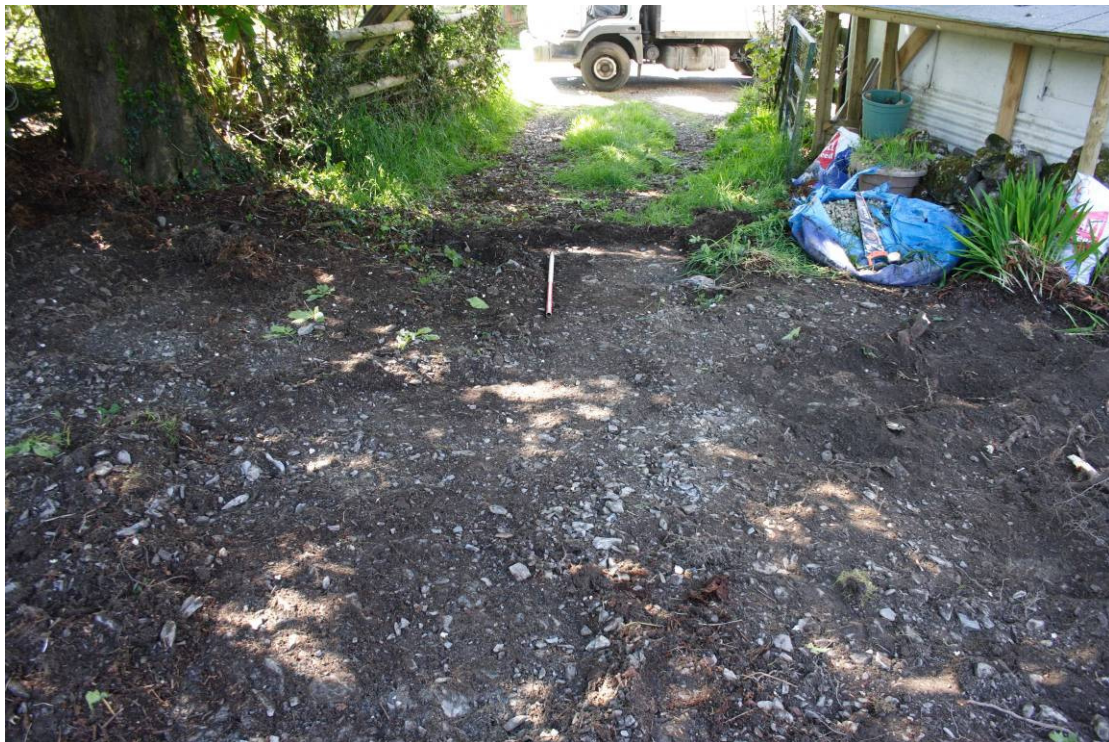
To the southeast of Lisburne House an area containing compacted crushed stone was recorded. This spread ran across an area along the southern edge of the garden (Photo 5). It roughly corresponded with the location of the former building that stood on this part of the site as noted above. No indications of any structural remains or building stone were found within this part of the site.

Photo 5: Area of compacted crushed stone in southeastern part of garden area, viewing south along existing driveway adjacent to garage

The edge of the compacted stone spread was not well defined, being very uneven and patchy. To the west where exposed nearer to the house, a soil containing far less soil was present, which was very friable. This contained numerous fragments of pottery of 19th century and later date, as well as pieces of broken ridge tile of an identical type that are still present on Lisburne House. No definite features were present in this area, but due to the friable nature of the soils it is likely that the area had been used for cultivation or flowerbeds in the recent past.

The area off compacted stone to the southeast of Lisburne House would seem to lie within the area of the former cottage shown on earlier maps and illustration of 1889. It is presumed this formed a solid base for the floors of the structure as opposed to a yard area as its location would correspond with the house. The lack of building stone found within the topsoil or visible in the surrounding garden area or any evidence for foundations could indicate that this adjacent cottage was constructed with clom walls (a mix of clay soils and binding material). There are a number of examples of known clom buildings in the vicinity. The lack of any roofing slate or roofing tiles within this area may also confirm that the building was thatched, as implied on the 1889 illustration.

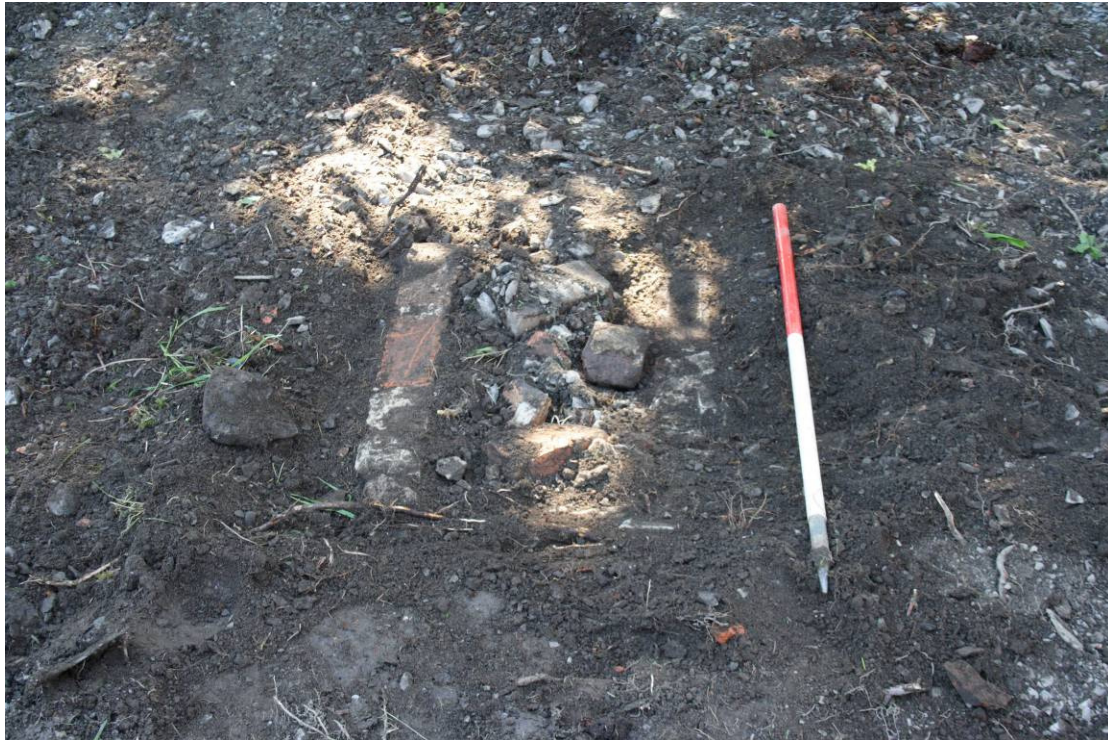
Drain runs leading from the existing septic tank across the garden area to a small brick lined chamber to the east of the house were also noted (Photo 6). Much of the area between the existing septic tank to the northeast of the house and this chamber had been previously disturbed by the insertion of the drainage features.

Photo 6: Brick lined chamber viewing south

A series of drainage features were also present in the garden to the north and east of the house, including the existing septic tank and brick lined chambers. These are of low archaeological interest.

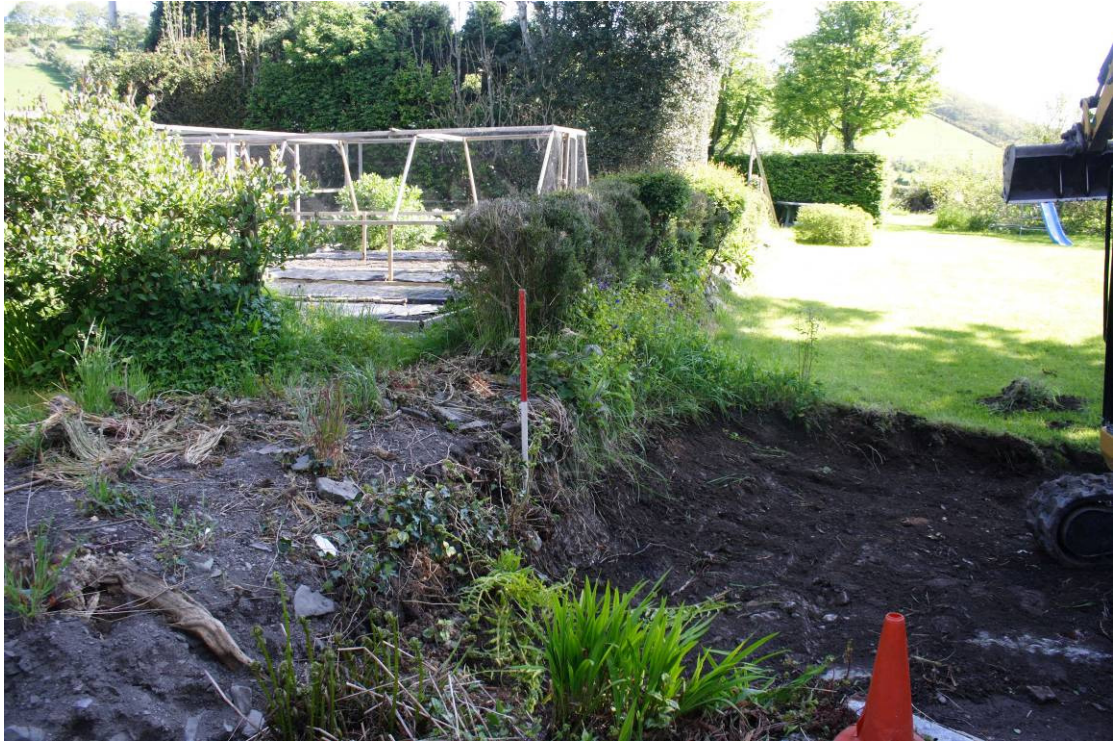
At the northern edge of the machined area was a small hedgebank, lined with stones on its faces (Photo 7). This hedgebank demarcated a boundary present on earlier mapping. As part of the works it was necessary to remove a small section of the bank. No finds or dating evidence were recovered from the feature. The bank was a maximum of 0.60m in height, much of it topped with a small, probably ornamental, hedge.

Photo 7: View northeast along hedgebank boundary running to the northeast of Lisburne House (Septic tank below cone in foreground of photograph)

The small hedgebank projecting to the northeast from the northeastern corner of Lisburne House is indicated on the earlier maps of the site area. The boundary may be one that was present prior to the building's construction or could have been constructed at that time to separate the garden to the north of the house from the gardens of the cottage to the southeast. Following the demolition of the cottage, the gardens were taken over by Lisburne House and the boundary became more of a garden feature than functional boundary.

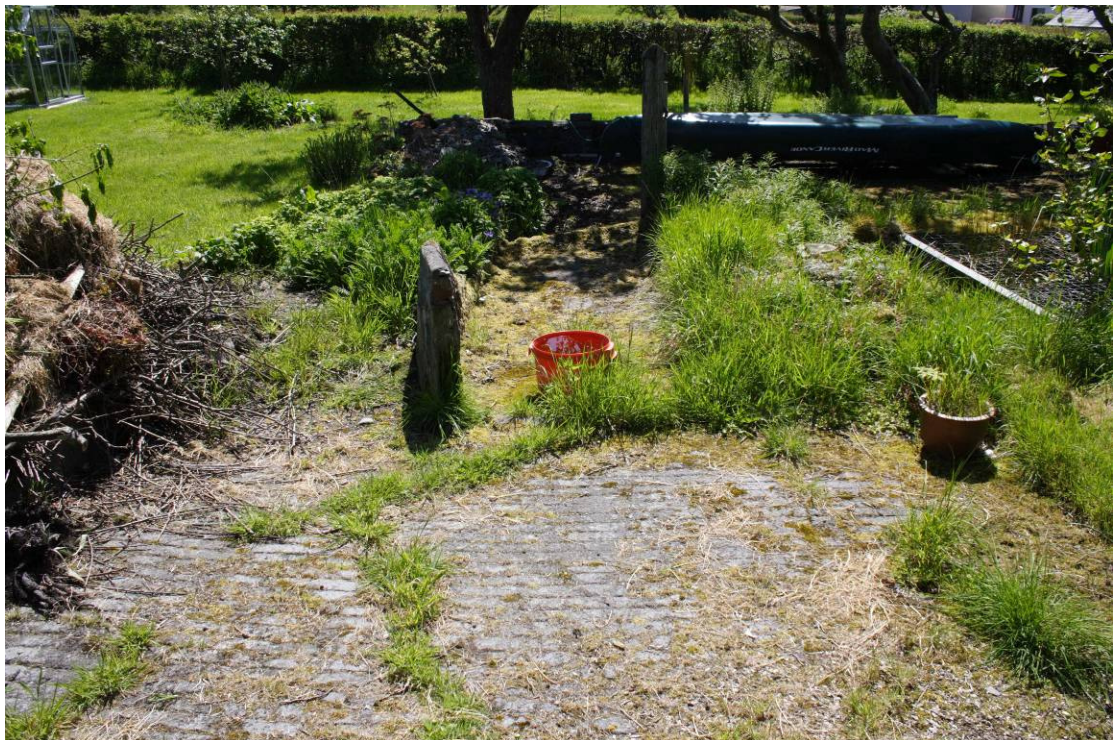
During the watching brief it was noted that the remains of a former agricultural building stood in the garden (Photo 8). It was visible as an area of brick flooring with low walls surviving around it. Its layout suggests it was for livestock and may be a former pigsty. The materials used in its construction, which included a lot of concrete, may suggest a 20th century date for the building. Within the garden it was also possible to see the remains of the former terrace of houses visible on the early Ordnance Survey maps of which only the house at the northeastern end now survives (Tymawr). Also in the adjacent garden was a former railway goods carriage used as a shed.

Photo 8: Former agricultural building within the garden of Lisburne House, facing east
