# NANTYGELLI FARM WIND TURBINE, CYNWYL ELFED, CARMARTHENSHIRE: ARCHAEOLOGICAL WATCHING BRIEF

Prepared by Dyfed Archaeological Trust For: Mr John L. Thomas

RHIF YR ADRODDIAD / REPORT NO. 2013/64 RHIF YR DIGWYLLIAD / EVENT PROJECT NO. 105809

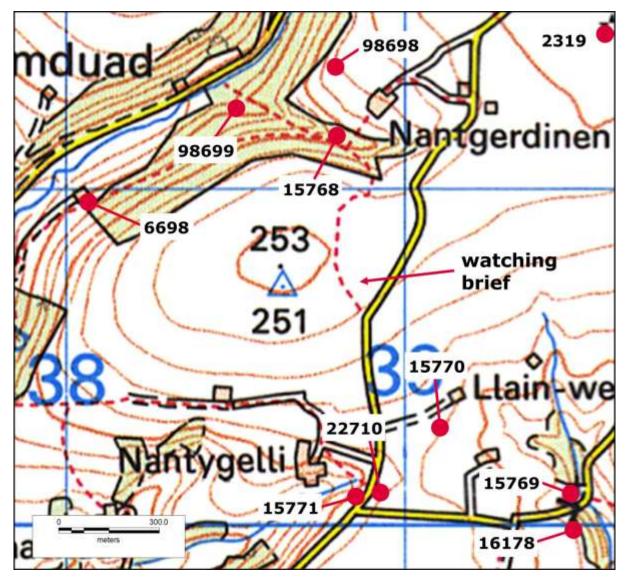
Figure 3: Known archaeological sites (red circles) in relation to the development site

**Table 2:** Known archaeological sites in proximity to the development site (Figure 3)

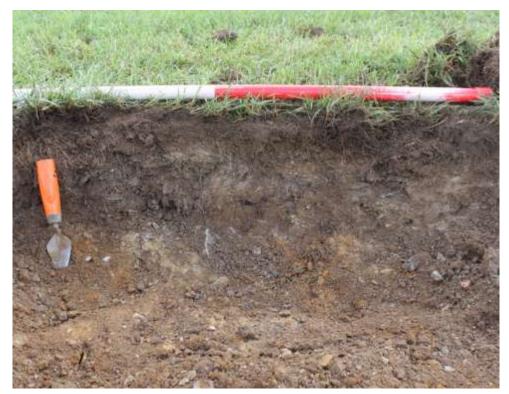
**Photo 1:** Looking east: representative soil profile of access track.

- 4.1.1 Beginning at the southernmost corner of the field, a right-angled strip, 4m wide and 128m long in total was reduced down to the top of the natural superficial geology deposits.
- 4.1.2 The topsoil was situated directly above the natural geological deposits with no discernible intervening subsoil. A basic stratigraphic sequence was revealed within the area, comprising an average depth of 0.2m of topsoil consisting of a mid-brown, clay-silt with occasional small shale fragments, overlying an orangey-brown, silty-clay natural interleaved with degraded Ordovician Mudstones (Photo 1).
- 4.1.3 No archaeological features or deposits were revealed during the excavation and no finds were recovered.

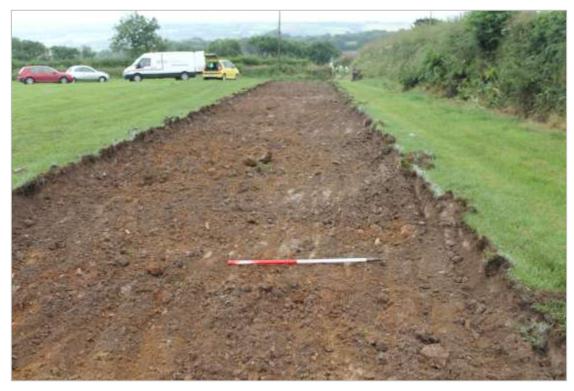
**Photo 2:** Looking south along access track.

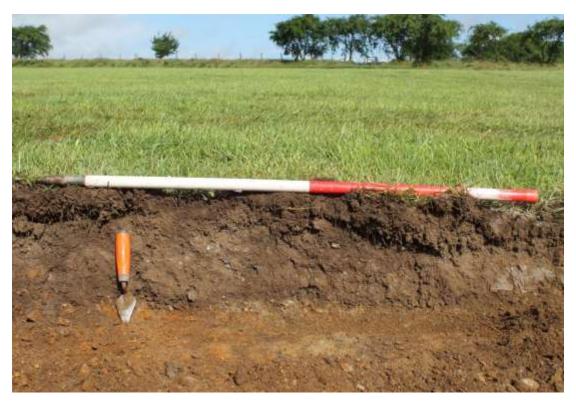
**Photo 3:** Looking north: representative soil profile at assembly area.

- 4.2.1 The assembly area formed a rectangle approx. 22m by 16m with the turbine base, measuring approx. 6m by 5m, attached to its eastern side.
- 4.2.2 The stratigraphic sequence revealed in this area comprised an average depth of 0.24m of topsoil consisting of a mid-brown, clayey-silt with occasional small shale fragments overlying an orangey-brown, silty-clay natural, interleaved with degraded Ordovician Mudstones.
- 4.2.3 No archaeological features or deposits were revealed during the course of the excavation and no finds were recovered.

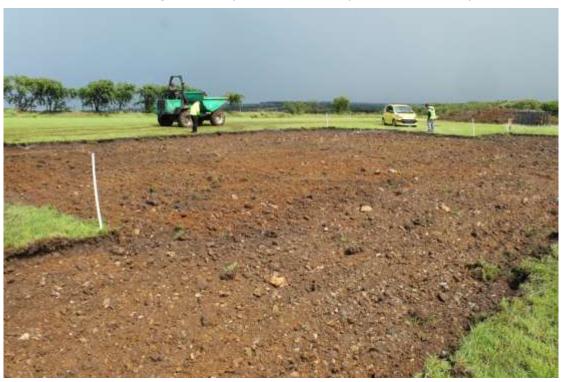
Photo 4: Looking north east along assembly area.

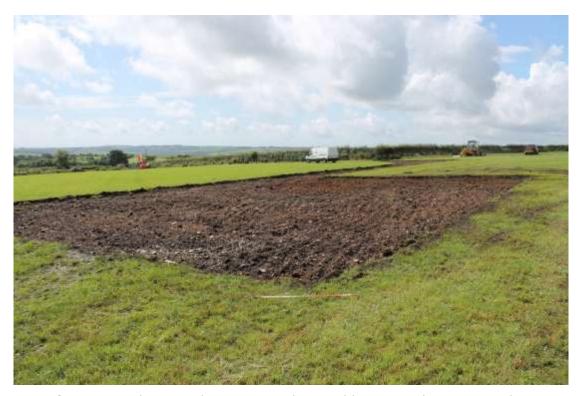
**Photo 5:** Looking south west toward assembly area with access track in background.
