**ROAD REALIGNMENT SCHEME A4075  
GREENHILL/GLENSIDE:  
ARCHAEOLOGICAL WATCHING  
BRIEF 2015  
(NGR SN 0147 0262)**

Prepared by DAT Archaeological Services  
For: Atkins

RHIF YR ADRODDIAD / REPORT NO. 2015/24  
RHIF Y PROSIECT / PROJECT RECORD NO. 108471

Tachwedd 2015  
November 2015

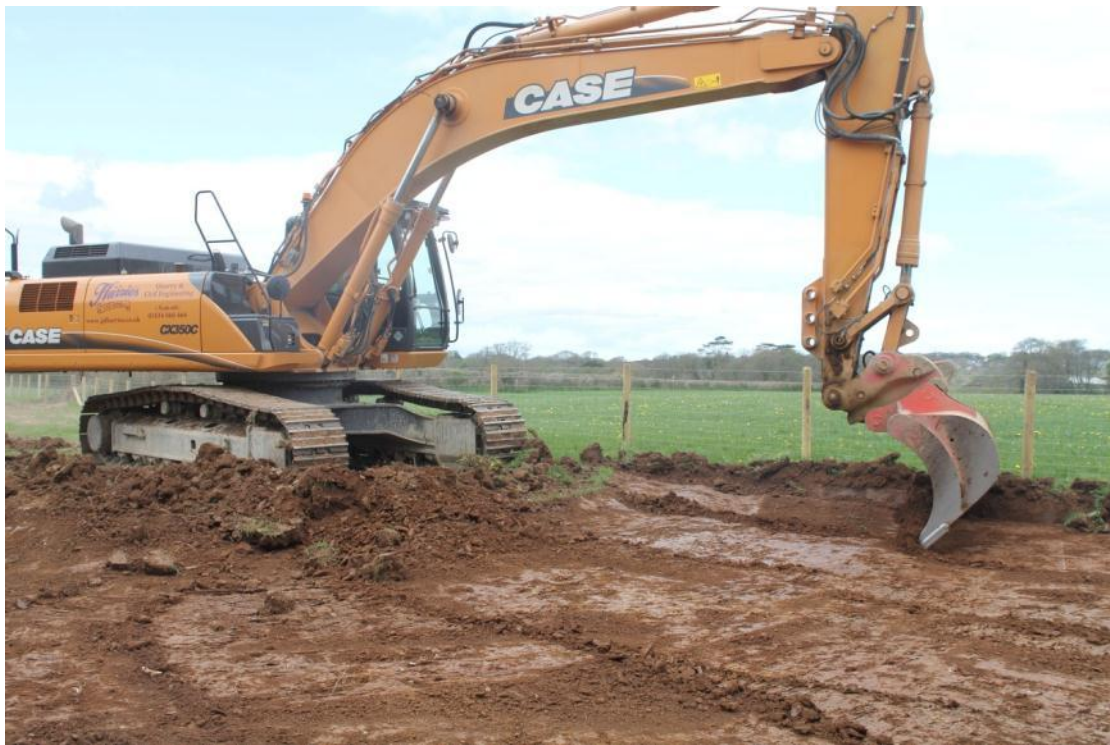
- 4.1 Observation of the topsoil strip for the road corridor demonstrated that the topsoil was between 0.30m and 0.40m thick across its entire length (Photos 4 & 5). It comprised a dark brown (slightly reddish) clay silt soil with occasional finds of modern pottery, which were noted but not retained.

**Photo 4:** General view of topsoil stripping

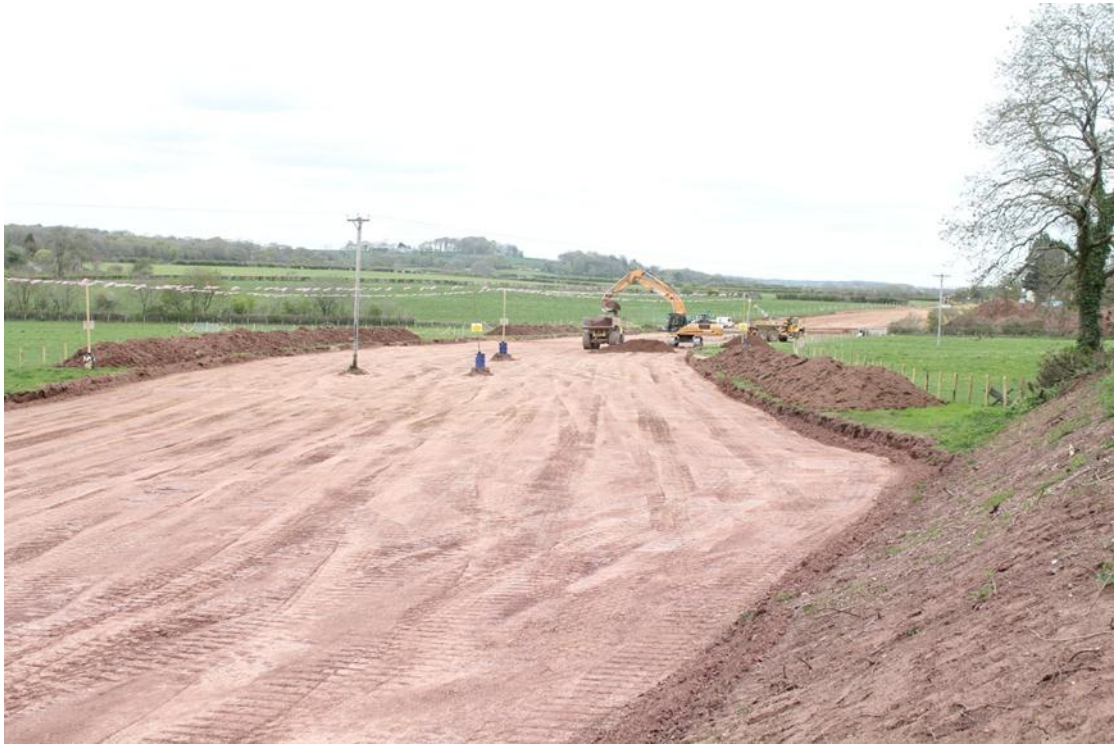
- 4.2 The underlying natural ground consisted of a reddish brown silty clay with frequent inclusions of small to medium sized angular stones. The majority of the topsoil strip exposed the underlying natural geology, but in some areas a thin interface of material between it and the topsoil was left.

**Photo 5:** View west across the road scheme after topsoil removal.

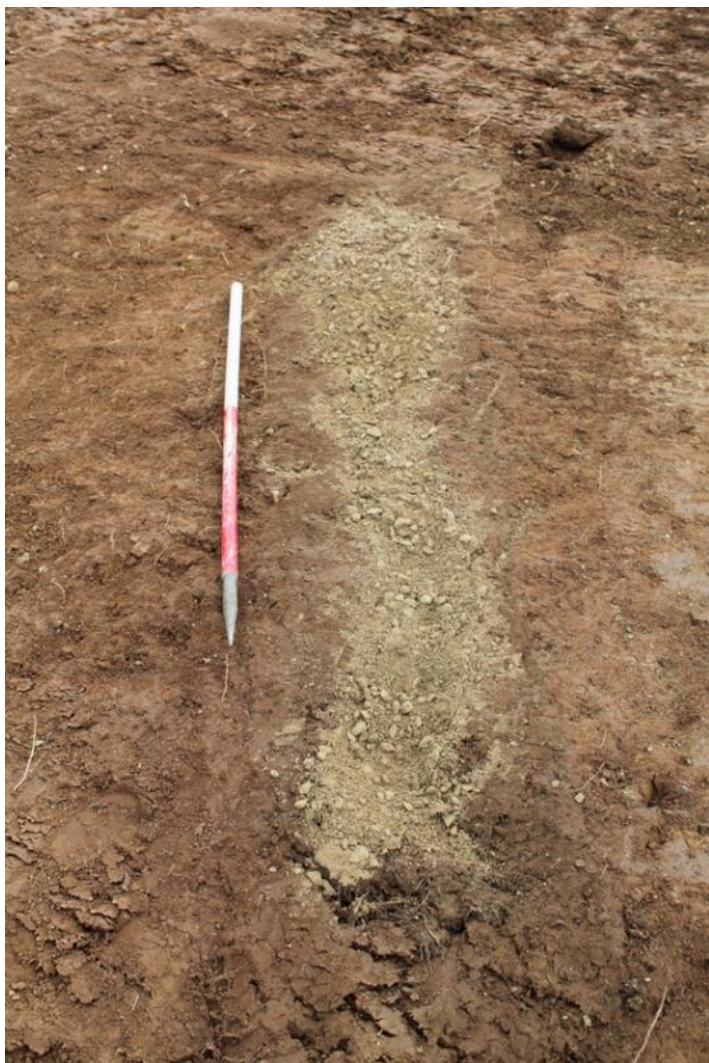
- 4.3 To the west of the road corridor the natural bedrock was observed below the topsoil strip, a reddish limestone (Pembroke Limestone Group).
- 4.4 At the most westerly end of the realignment scheme near Nash Lodge the attending archaeologist observed a linear feature aligned east to west apparently backfilled with an imported material consisting of grit and sand. The linear feature was approximately 2.0m in length and 0.25m wide. The feature was excavated by the archaeologist and upon completion it would seem that the feature was the result of root action because of the unusual undulating and irregular appearance of the cut once excavated. However it does appear that it was intentionally backfilled with an imported material and the reason for this is unknown (Photos 6 and 7).

**Photo 5:** Linear feature before excavation, clearly backfilled with imported material

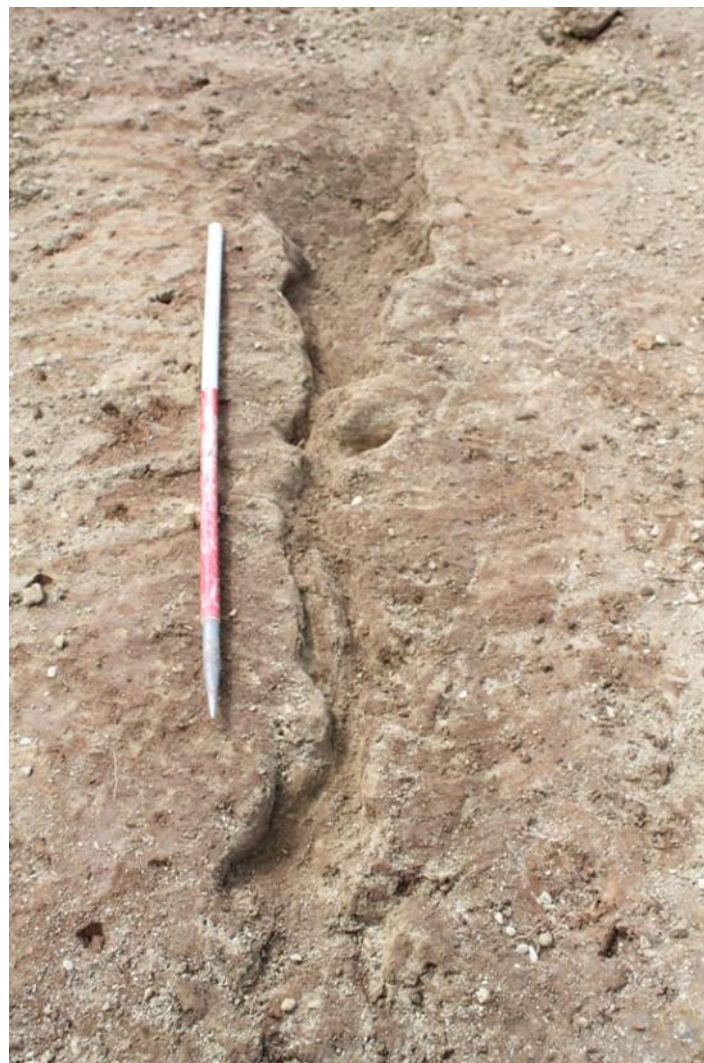
**Photo 6:** Linear feature after excavation, possibly the result of tree root action due to the undulating appearance.

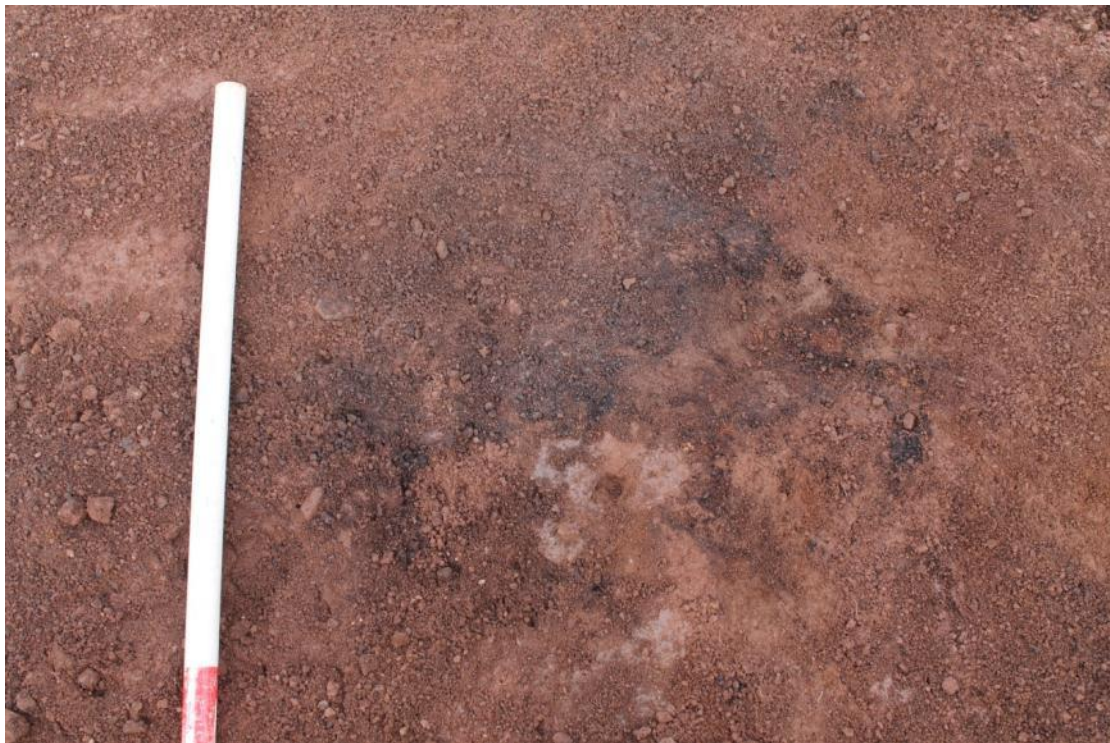
- 4.3 A number of areas of possible burning were identified in the central area of the road alignment. These appeared to be thin lenses of burnt material and frequent burnt stones lying directly on top of the natural substrata. Photo 7 shows an example of one of these areas of burnt material which covered an area of approximately 0.5m in diameter and was amorphous in shape. The other areas of burning were mostly of similar appearance and dimensions. Referring to the geophysical survey results, the areas of burning do appear to correlate to areas identified as possible magnetic disturbance on the survey. Burning would cause such results on a gradiometer survey. It is possible that some of these patches were mineral deposits, such as iron panning, which could again affect the results on a gradiometer survey.

**Photo 7:** Example of an area of burnt material.

- 5.3 A number of areas of burning were identified in the central area of the road line and these appeared to consist of a thin lens of burnt material lying on top of the natural strata. These appear to correspond in location to areas of amorphous magnetic variation highlighted in the geophysical survey and such a response may be attributed to these areas of burning. The reason for this burning is not known. Some of the areas of burning may have been associated with natural accumulations of minerals (iron panning).

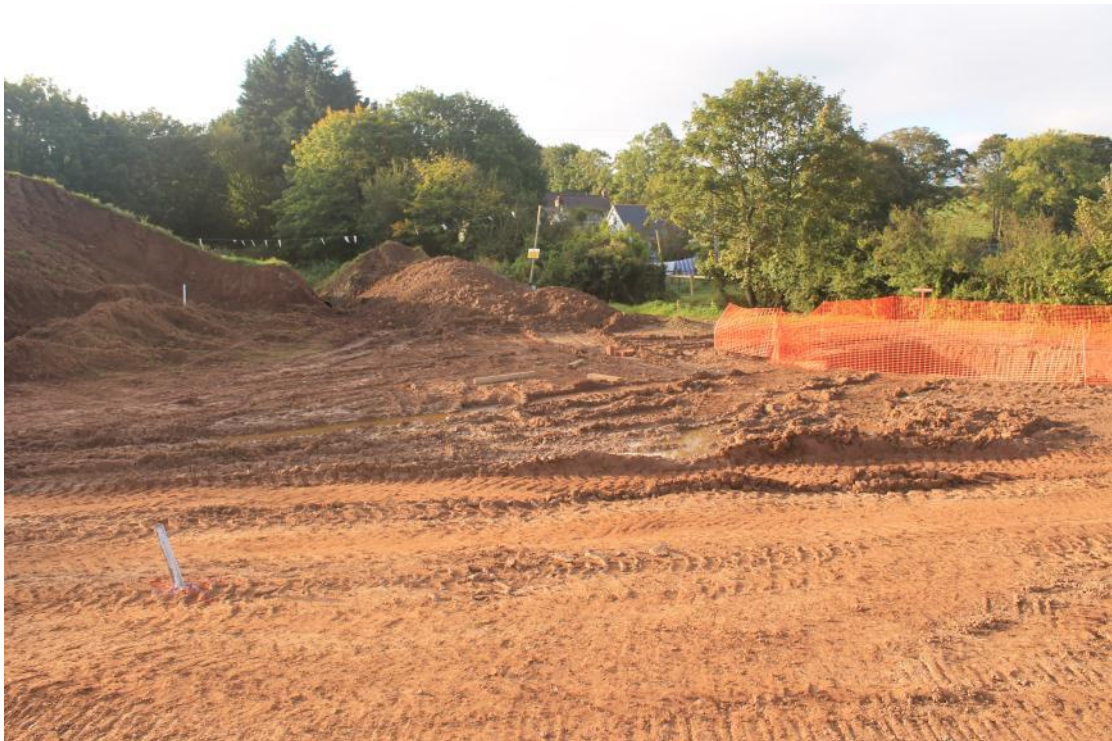
underlying ground surface, including the removal of topsoil above the pond area (Photo 8). A large drain, culvert connection and other associated features had also already been excavated and inserted around the attenuation pond prior to the archaeologist attending the site (Photos 8 – 10). Observation of the pond prior to the start of its excavation demonstrated that its entire area had already been stripped of topsoil and that the exposed surface was that of the underlying natural geology. The exposed area was heavily disturbed in parts with vehicle tracks which could have obscured underlying archaeology. No artefactual finds, patches of charcoal or other indications of archaeological deposits were observed across this area and it seems unlikely that any significant remains had been present, although it is not possible if any such remains may have been present beneath the footprints of the excavated culvert connector and drain.

**Photo 8:** View south across area of attenuation pond prior to its excavation, showing remains of topsoil heap to left, vehicle tracks and culvert connection to right behind orange fencing

- 5.4 The topsoil heap from the road line strip had been placed on top of the site of the attenuation pond, and once it had been removed this led to the pond area also being stripped of topsoil and the area partially covered with vehicle tracks prior to an archaeologist attending the site. The area was observed and recorded, and no archaeological remains were identified within the area. This may have been due to a lack of significant archaeological deposits being present, archaeological remains had been very shallow and removed by the groundworks, or archaeological remains were obscured by the disturbed ground surface. A number of deeper water management features had also already been inserted around the pond.

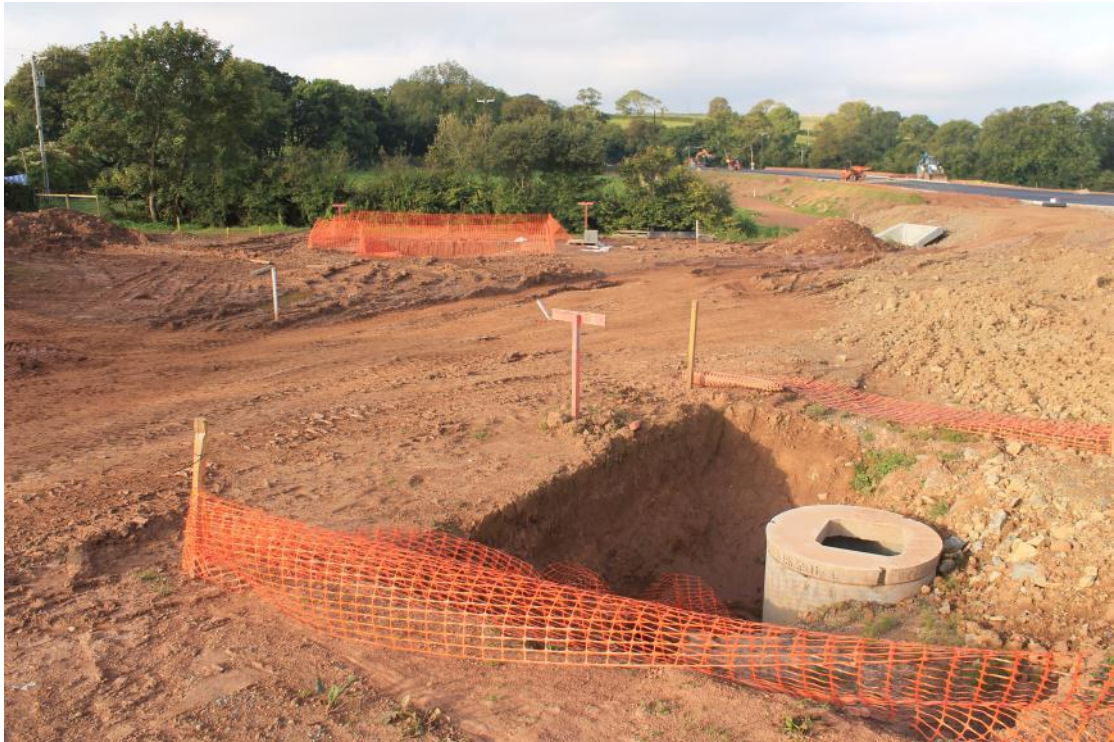
**Photo 9:** View west-southwest across area of attenuation pond prior to excavation, showing drains and culvert connection (behind orange fencing)

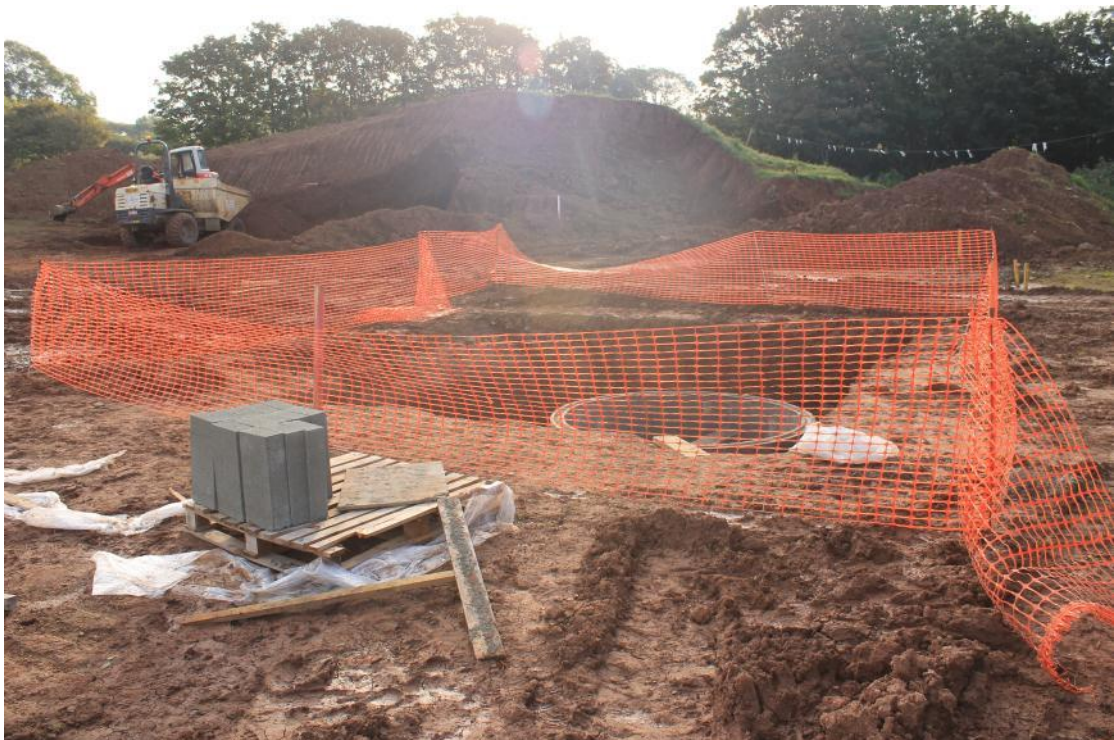
**Photo 10:** View southeast across area of attenuation pond with culvert connection in foreground and spoil heap to rear
