# **A4075 ROAD IMPROVEMENTS, CAREW, PEMBROKESHIRE: ARCHAEOLOGICAL WATCHING BRIEF**

**(NGR SN 04683 03621 to SN 04606 03268)**

RHIF YR ADRODDIAD / REPORT NO. 2015/44  
RHIF Y DIGWYLLIAD / EVENT RECORD NO. 108557

## **A4075 ROAD IMPROVEMENTS, CAREW, PEMBROKESHIRE: ARCHAEOLOGICAL WATCHING BRIEF (NGR SN 04683 03621 to SN 04606 03268)**

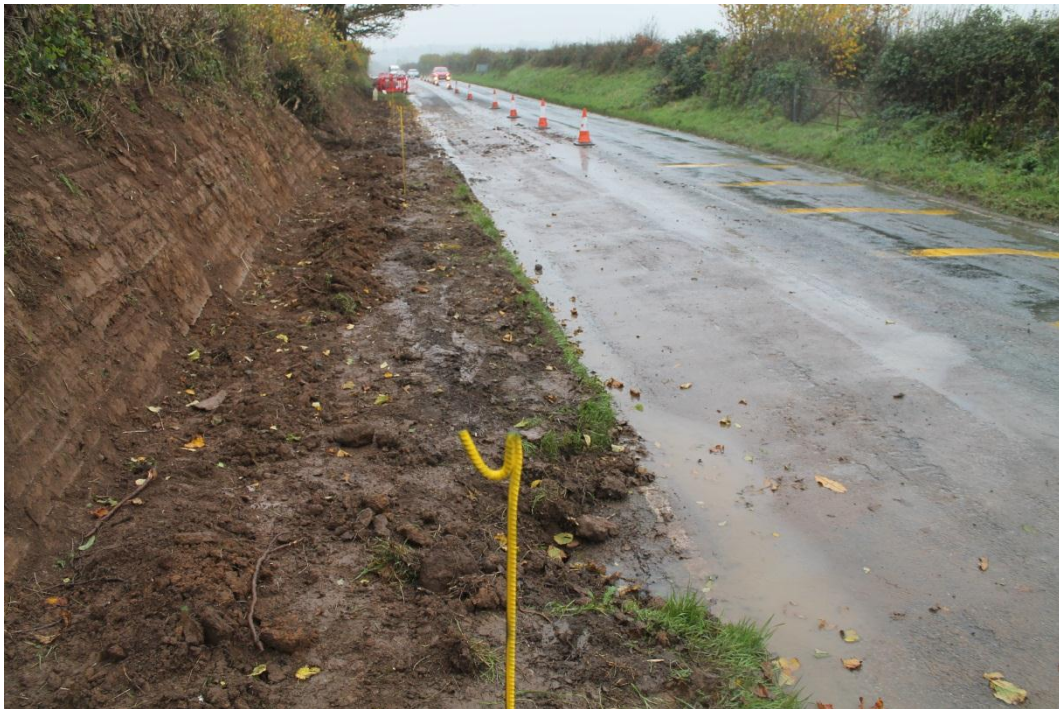
Photo 1: View south along eastern side of A4075,  
showing cut edge of existing hedgebank

5.3 Following this the methodology for the road widening involved a simple method of cutting the road facing edge of the existing hedgebank and moving the spoil behind (Photos 1 & 2).

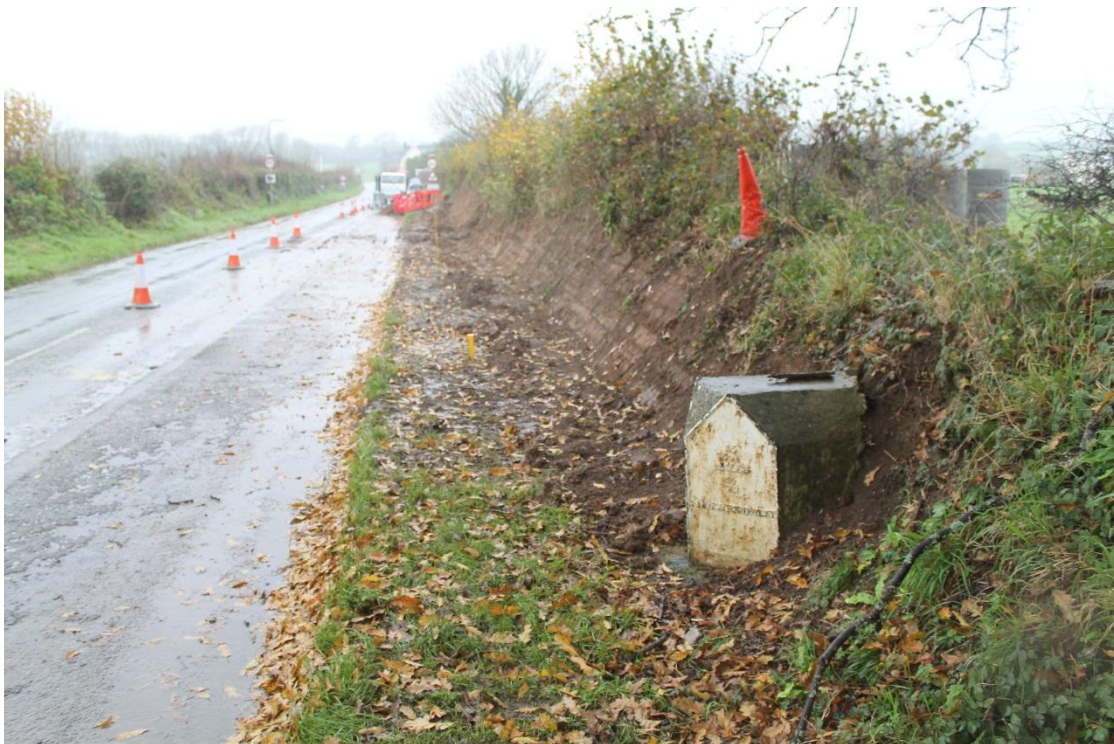
Photo 3: View north along eastern side of A4075  
showing cut edge of existing hedgebank and location of milestone

5.3 At the southern end of the widened stretch of road lies the grade II listed milestone (Photos 3, 4 & 5). This was carefully removed during the road widening works for replacement following completion of the road scheme.

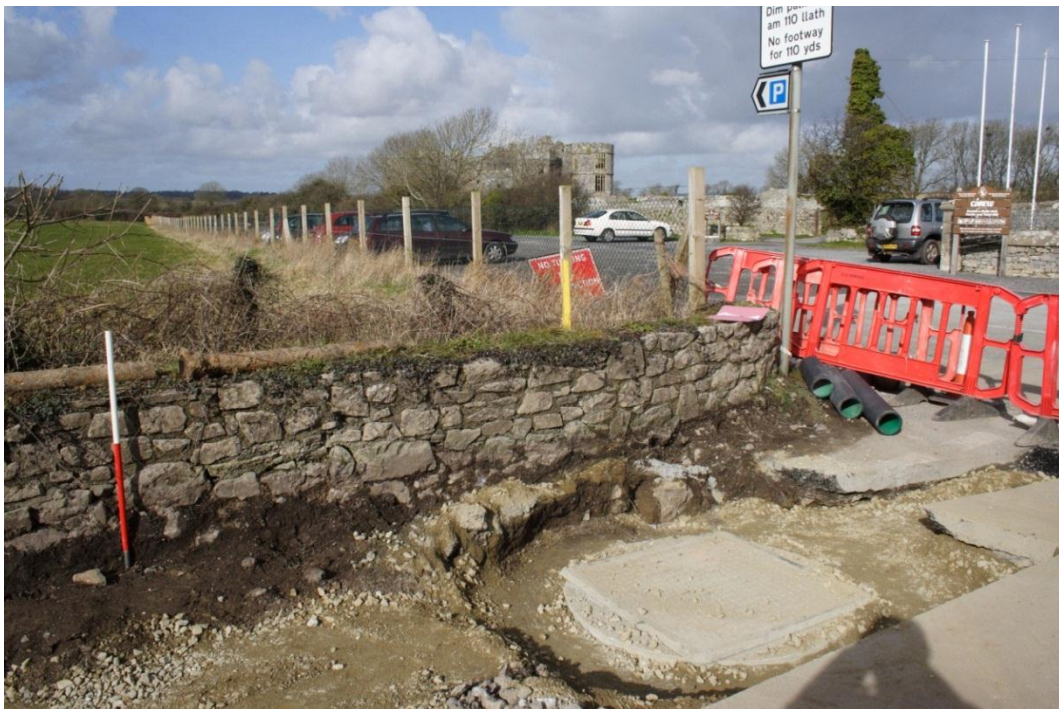
Photo 6: Stone wall along western edge of A4075 at junction with  
Carew Castle car park

- 5.4 The area located along the western edge of the A4075 included removal of a verge bank so that the road could be widened and excavation of an overflow drain (which continued to the pub to the north). Running parallel to the western edge of the road is a low stone wall which has been said to have possible medieval origins. For this reason the wall was carefully avoided by the works and remained and has not been affected by the groundworks (Photo 6).

- 5.5 The wall was roughly 0.8m in height and made of rubble stone. The wall had either been repointed or possibly rebuilt in modern times. The size of the wall and its location is not typical of a stone boundary wall or field boundary that one would expect to date from the medieval period and it may actually be a post-medieval or modern construction.

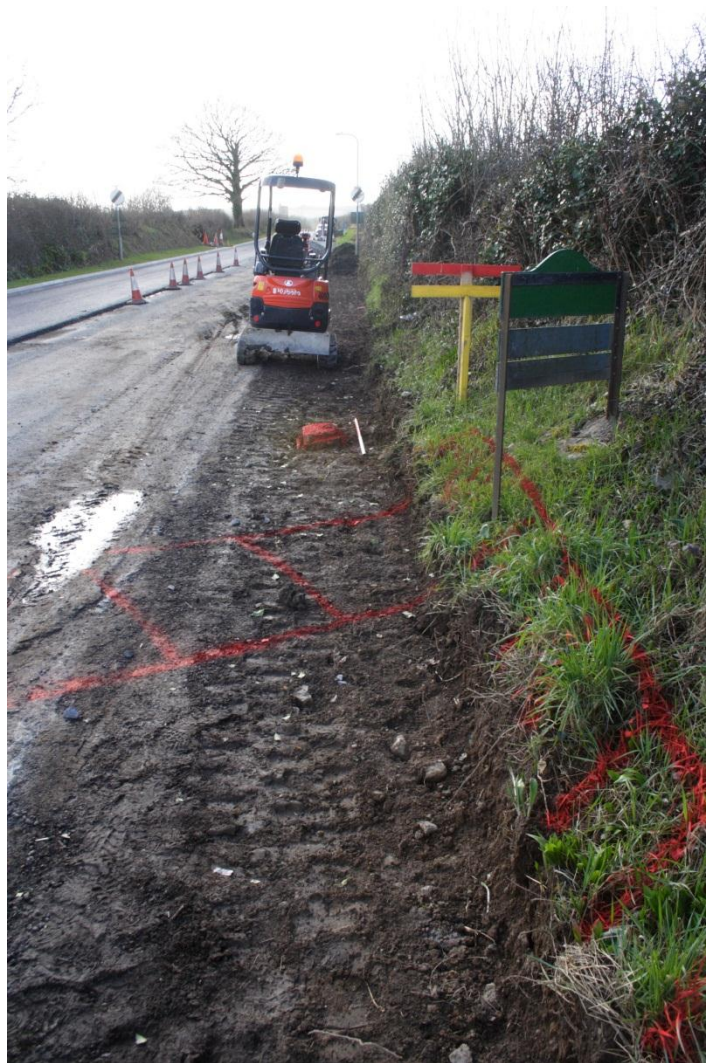
Photo 7: View south along western side of road showing removal of eastern edge of hedgebank and tarmac road surface

- 5.6 The majority of the works undertaken involved the removal of the western edge of the existing tarmac surface of the road and the removal of the face of the low earth bank which had formed on the front of the stone wall at the northern end of the route and the front of a hedgebank further to the south (Photo 7). The exposed surface contained road make up deposits to the east and remnants of topsoil to the west of a depth of between 0.25 – 0.35m deep, which overlay an undisturbed, mid-brown clay silt natural for the most part. The east side of the trench consisted of a stone hard core material forming the road makeup.

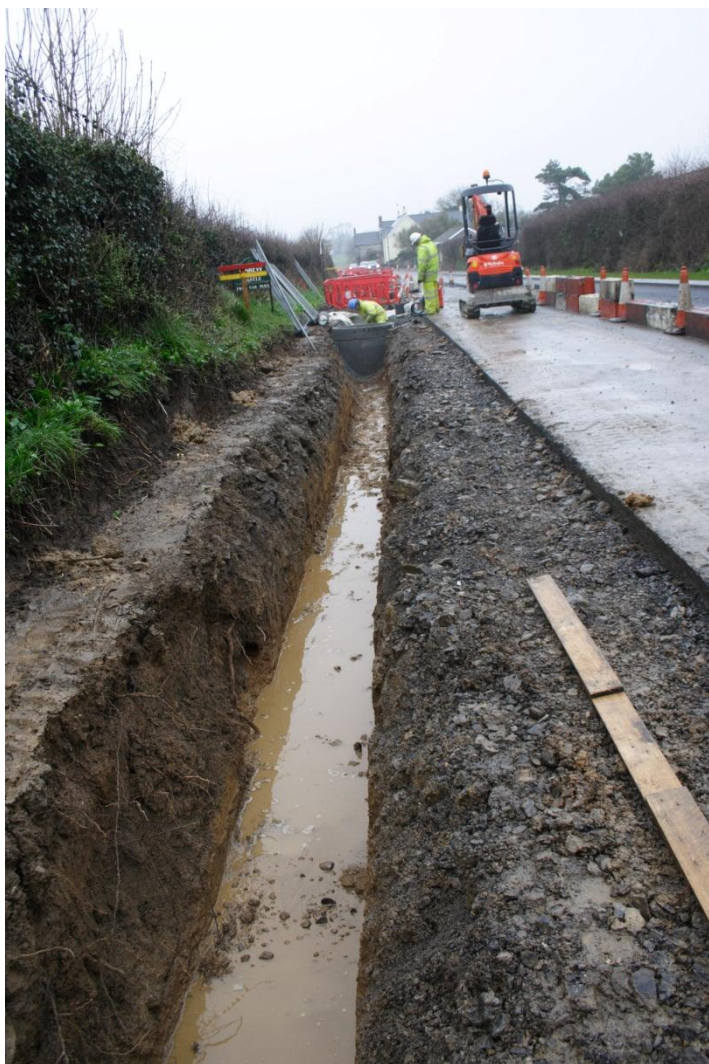
Photo 8: View north along excavated drainage trench on western side of A4075

- 5.7 A drain was then excavated through the western half of the stripped area. It was on average excavated to a depth of 1.20m and was 0.60m wide (Photos 8 & 9). Along its route a number of inspection chambers were inserted which were around 1.5m square (Photo 10).

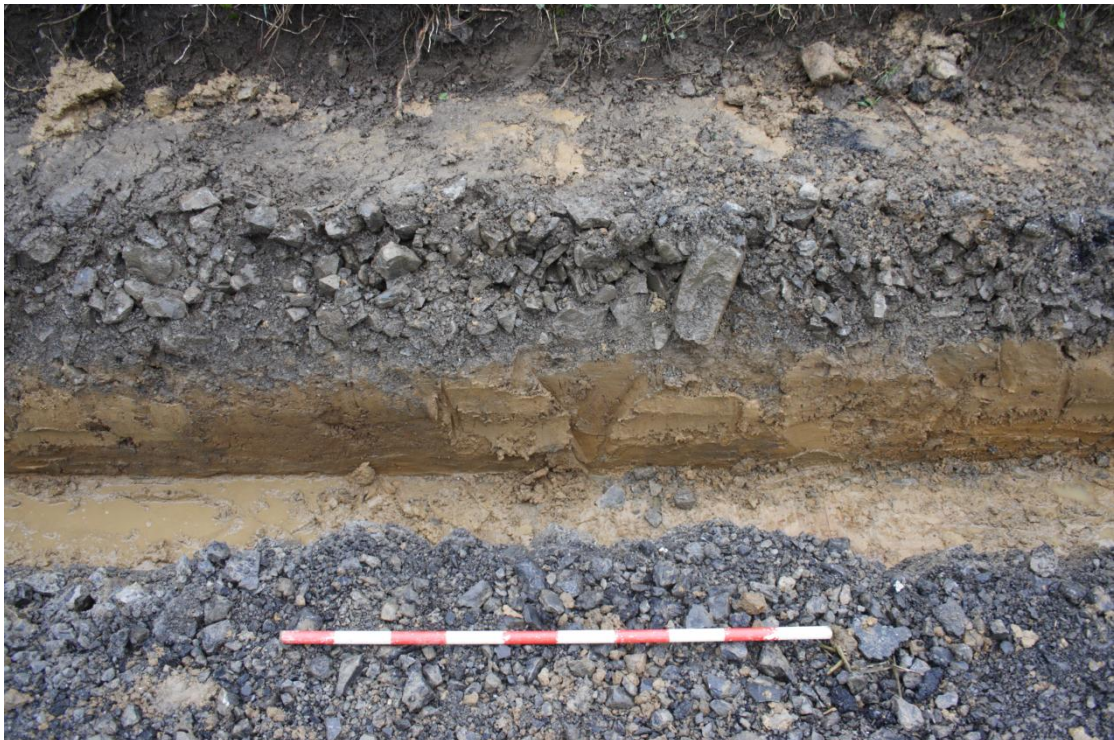
Photo 11: East facing section through drainage trench showing depth of stone backfill for former water pipe

- 5.8 It was noted that the new drainage trench approximately followed the line of a disused metal water pipe that was still present below (a piece of pipe is visible on the left hand side of Photo 9 which had been removed from the trench). This drainage trench had been backfilled with a mix of crushed stone and spoil excavated from the original trench (Photo 11). It was on average 0.8m in depth and around 0.6m in width.

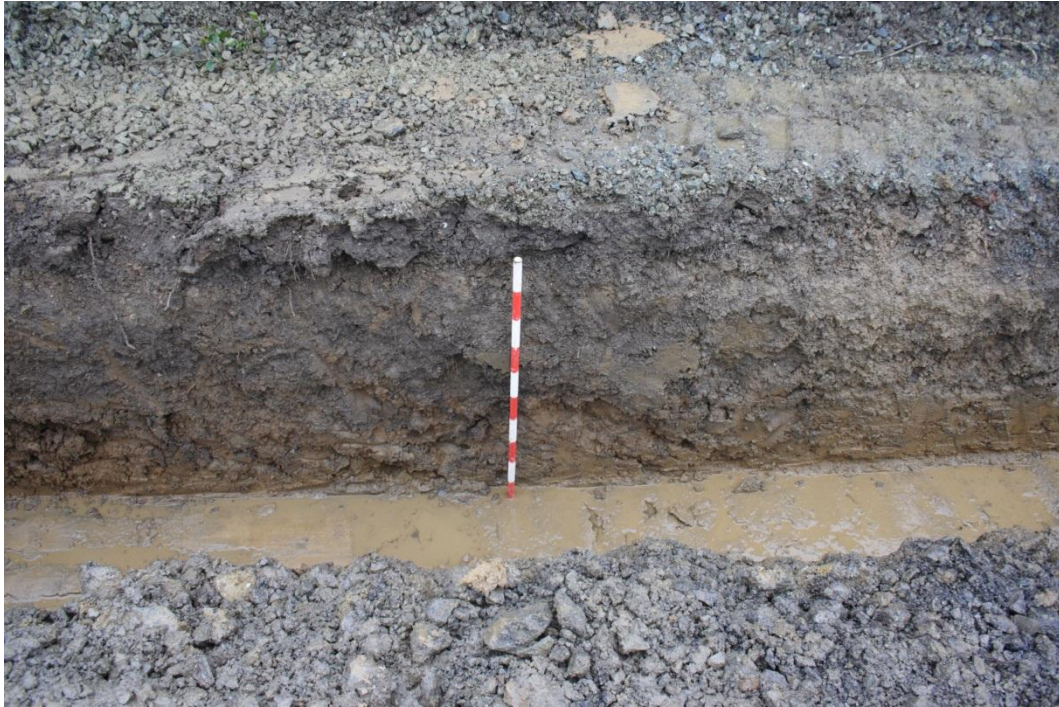
Photo 12: West facing section of drainage trench showing road make-up layers above natural ground

- 5.9 On the eastern side of the drainage trench the depth of make-up layers for the existing road were visible, on average lying to a depth of 0.6m below top of the trench. The layers appeared to be of modern date and suggest the road has been totally re-laid in the latter part of the 20<sup>th</sup> century (removing any earlier surfaces) or widened on its western side. Below the road layers was the undisturbed natural geology comprising a mid-brown silt clay with occasional areas of bedrock (a weathered and crushed brown stone rab).

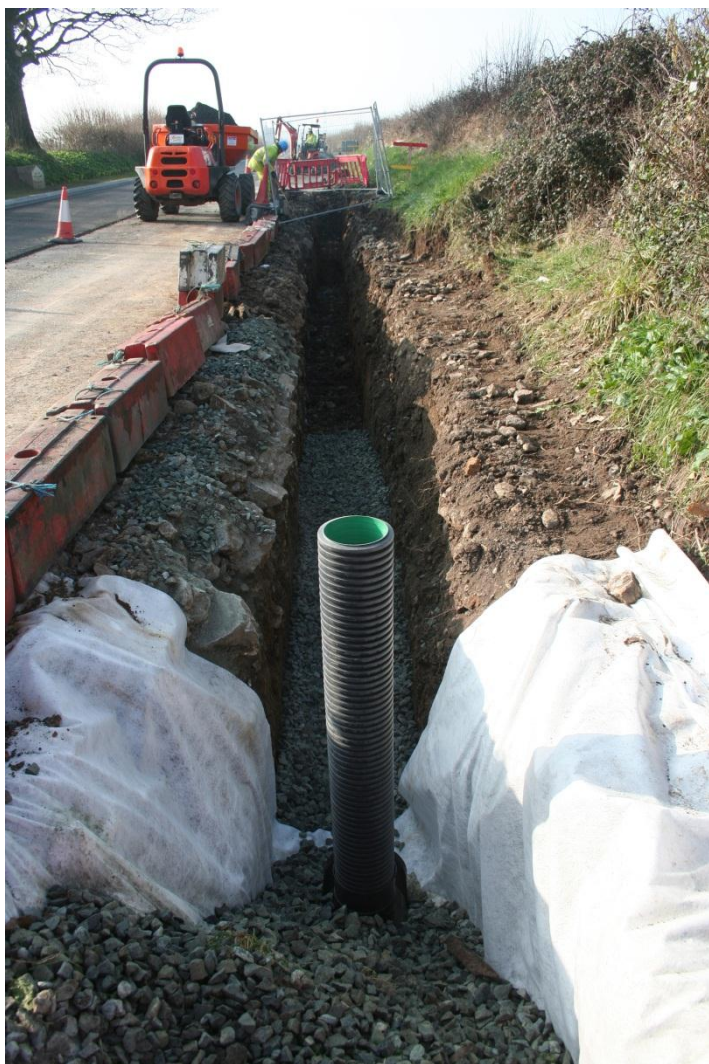
Photo 13: Backfilling of the drainage trench, viewing south

- 5.10 The road works on the western side were carried out in short sections, with the road line stripped, the drain excavated and then the trench backfilled before moving on to the next section. Once the drainage trench and inspection chambers had been dug out a geotextile layer was placed in the trench and a thin layer of crushed stone was laid in the bottom (Photo 13). The drainage pipe was then laid on this and connected to the concrete lined inspection chambers. The drainage trench was then backfilled to the top with crushed stone and sand and the area levelled off prior to the final road surface being re-laid over the top (Photo 14).

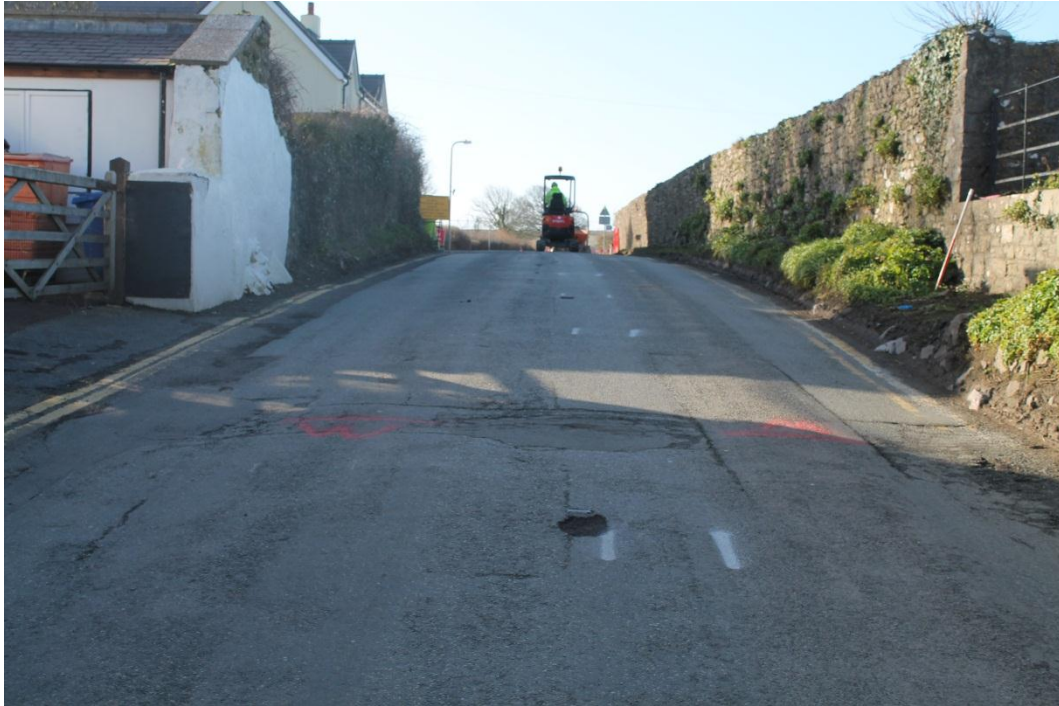
Photo 15: View south along A4075 showing white lines marking line of drainage trench through existing road surface

- 5.11 The drainage trench was also excavated to the north of Carew Castle Car Park running directly through the existing road line. A road closure order was in place during excavation of the drain (Photo 15).

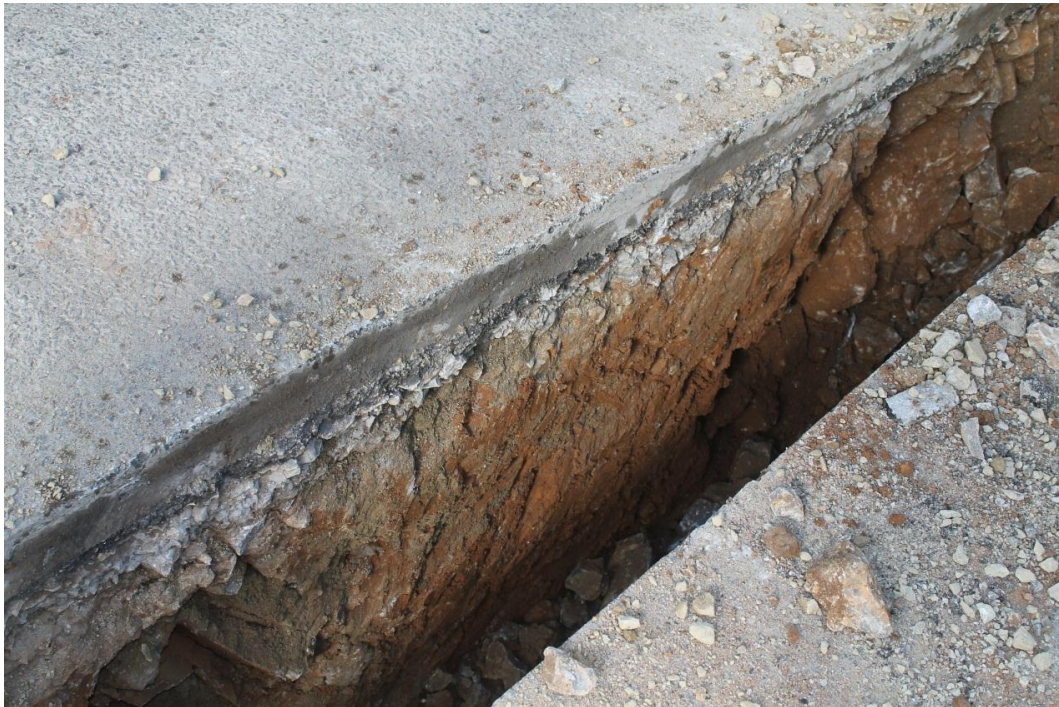
Photo 16: Drainage trench between Carew Castle and Carew Inn at the northern end of the road improvements showing road surface directly upon bedrock

- 5.12 It was evident that the existing road surface and make-up layers were relatively shallow sitting directly upon an outcrop of the underlying natural bedrock (Photos 16 & 17).
- 5.13 The attending archaeologists did not observe any significant archaeological deposits or remains within any of the excavated trenches.
