EASTGATE LEISURE QUARTER, LLANELLI, CAMARTHENSHIRE ARCHAEOLOGICAL WATCHING BRIEF 2011

Prepared by Dyfed Archaeological Trust
For: Britannia Construction Ltd

RHIF YR ADRODDIAD / REPORT NO. 2012/4
RHIF Y PROSIECT / PROJECT RECORD NO. 102590

EASTGATE LEISURE QUARTER, LLANELLI, CARMARTHENSHIRE ARCHAEOLOGICAL WATCHING BRIEF 2011

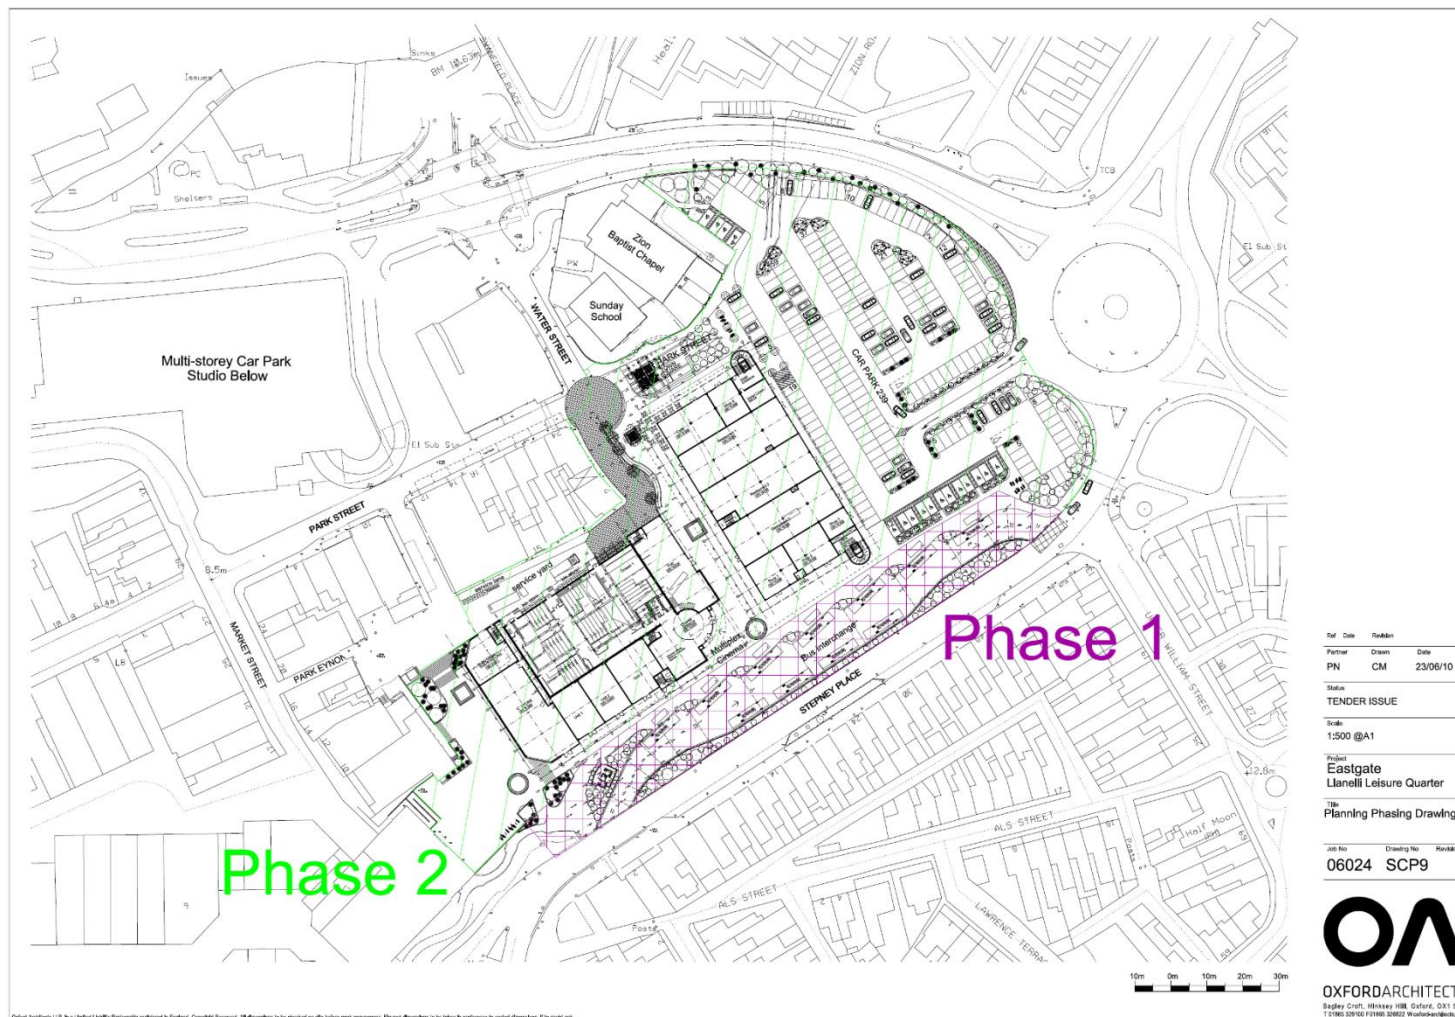
Figure 2. Plan of development site, created by Oxford Architects for Henry Davidson Developments, provided by Asbri Planning. Plan not to original scale.

- 3.2 The development was undertaken in two phases (Figure 2). Initially Phase 1 involved the development of land south of Water Street, including the cutting of new service trenches and the removal of deposits along a strip c.10m wide adjacent to Stepney Terrace down to formation level. These works were observed on the 10th, 14th and 15th of June 2011.

- 4.1.2 Initially service trenches and test pits were excavated to examine subsurface deposits all along the north-western edge of the area covered by Phase 1 (Figure 2). A large strip, c.10m wide, was subsequently excavated down to formation level along the long south-eastern edge of the area. This excavation removed modern development levels and cut into naturally occurring subsoil deposits below.

- 4.2.2 Foundation trenches were excavated under the footprint of the two large buildings in the western half of this area, as indicated in Figure 2. Services trenches were also excavated across the area.

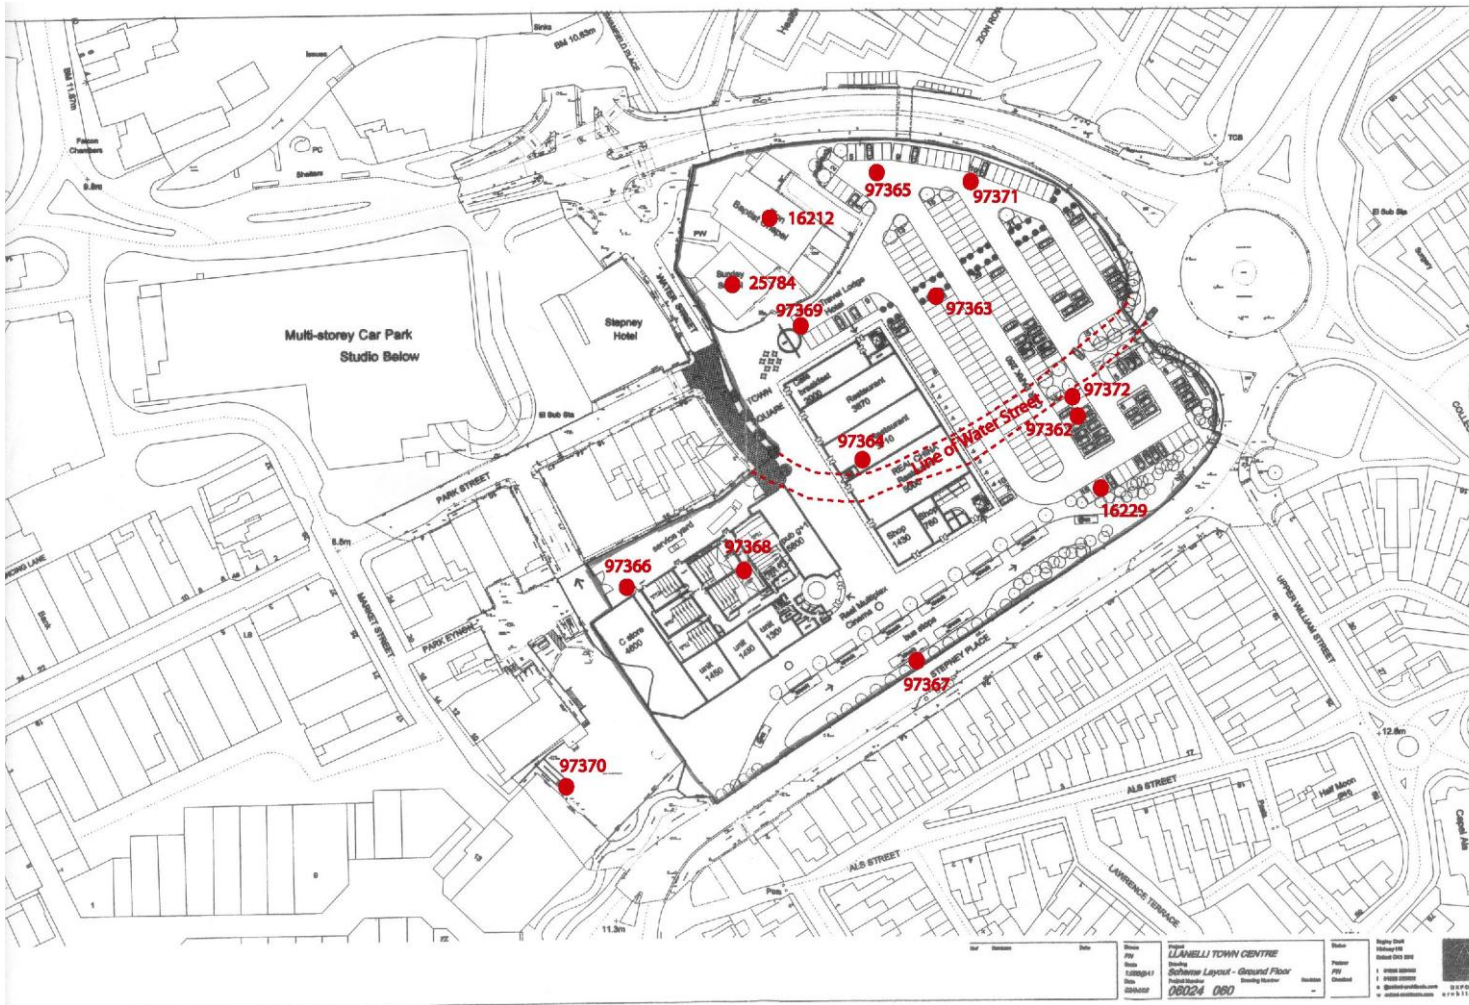
Figure 3. Plan of development site overlaid with locations of archaeological sites (in red). Plan created by Oxford Architects for Henry Davidson Developments, provided by Asbri Planning. Plan not to original scale.

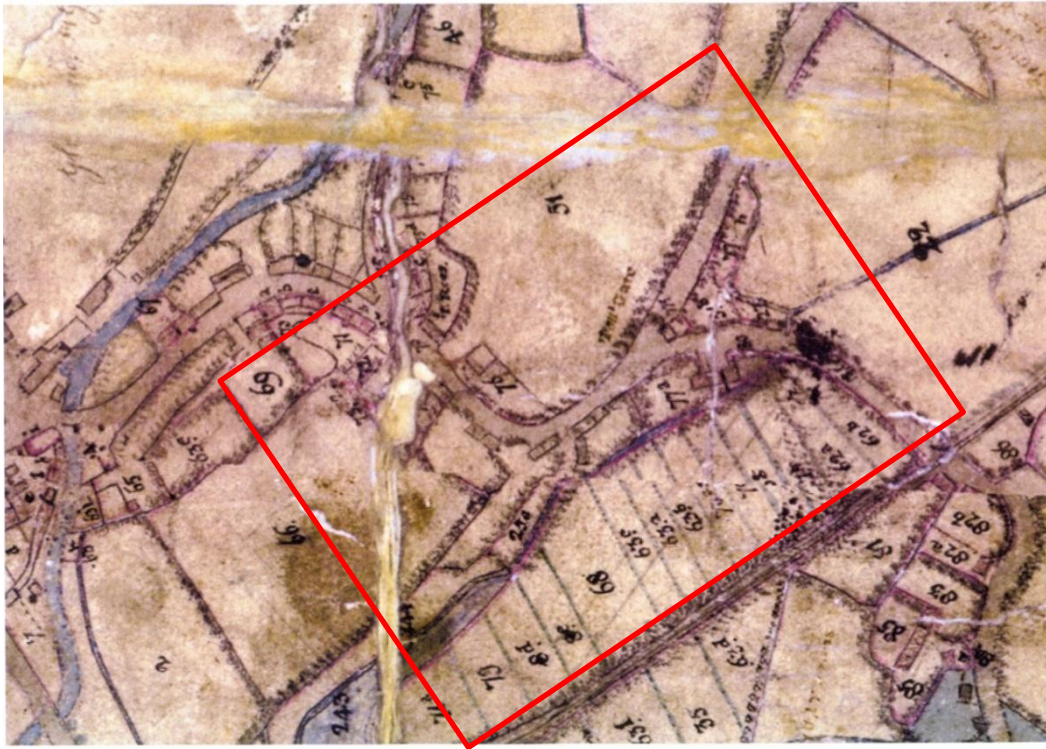
Figure 5. Extract from the Cholmondeley map of Llanelli in 1814 showing an approximation of the development area outlined in red. Map provided by Carmarthenshire Record Office.

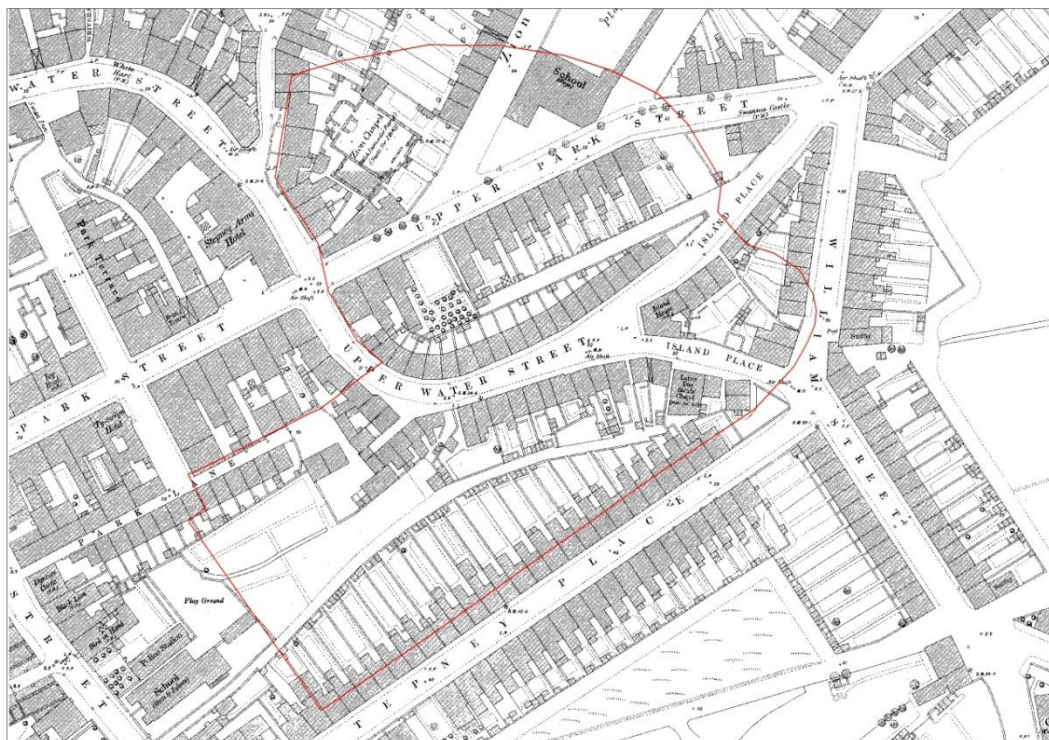
Figure 8. Extract from the 1st edition Ordnance Survey 1;500 map of 1880 showing an approximation of the development area in red.

- 4.1.5 Fragmentary remains of two walls were recorded just below the car park surface in the service trench that ran along the north-western edge of the area covered by the Phase 1 works. The first wall (photo 8) consisted of a thin (0.25m to 0.3m wide) mortared masonry wall incorporating brick fragments, presumably of 19th century date. The shallow foundations and narrow width may indicate an internal wall or superficial structure, presumably associated with the outhouses visible at the back of the rear garden plots of the 19th century terraced houses that formerly lined the north side of Stepney Place (Figure 8).

- 4.1.6 The second wall (photo 9) was only partially revealed in the section of newly cut services, and remained otherwise undisturbed. It consisted of a short stretch of large dressed mortared masonry, with an attached rougher mortared masonry wall. The location and alignment may suggest this wall formed part of the boundary wall to the rear of 19th century terraced houses lining Stepney Place (Figure 8).

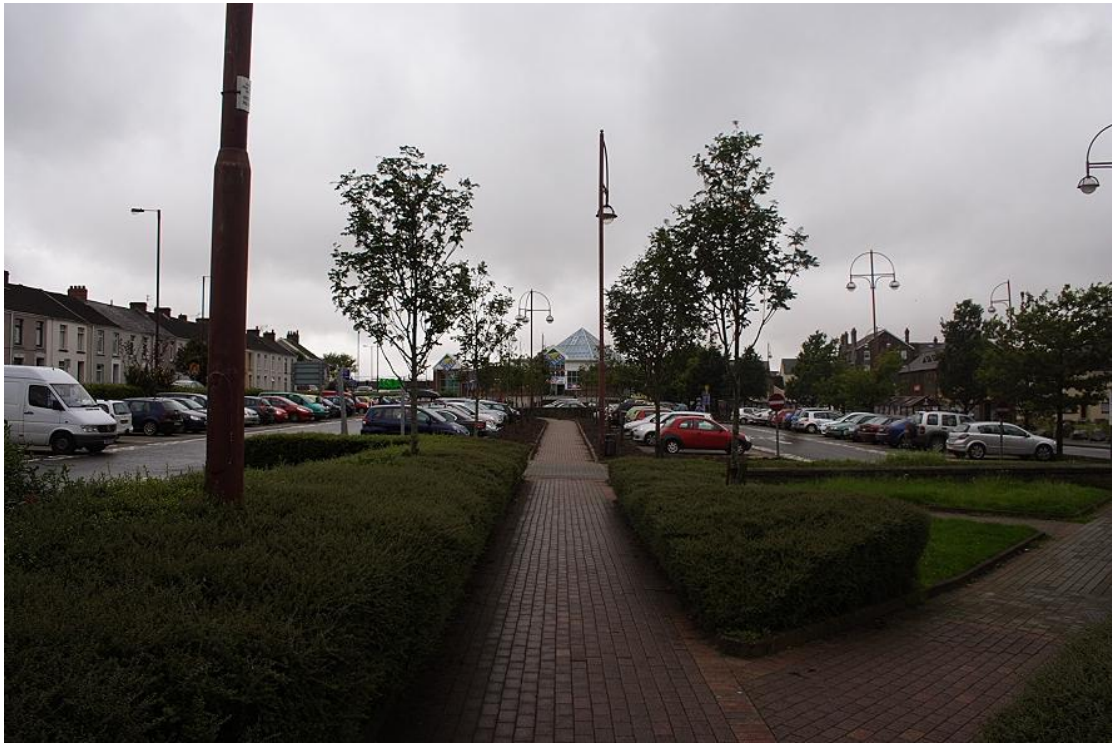
Photo 1: The development area prior to development. Photo taken in 2009.

- 4.1.1 Prior to the development this area was occupied by a car park (photo 1). The DBA had identified a row of 19th century terrace housing, including a chapel site, within this area.

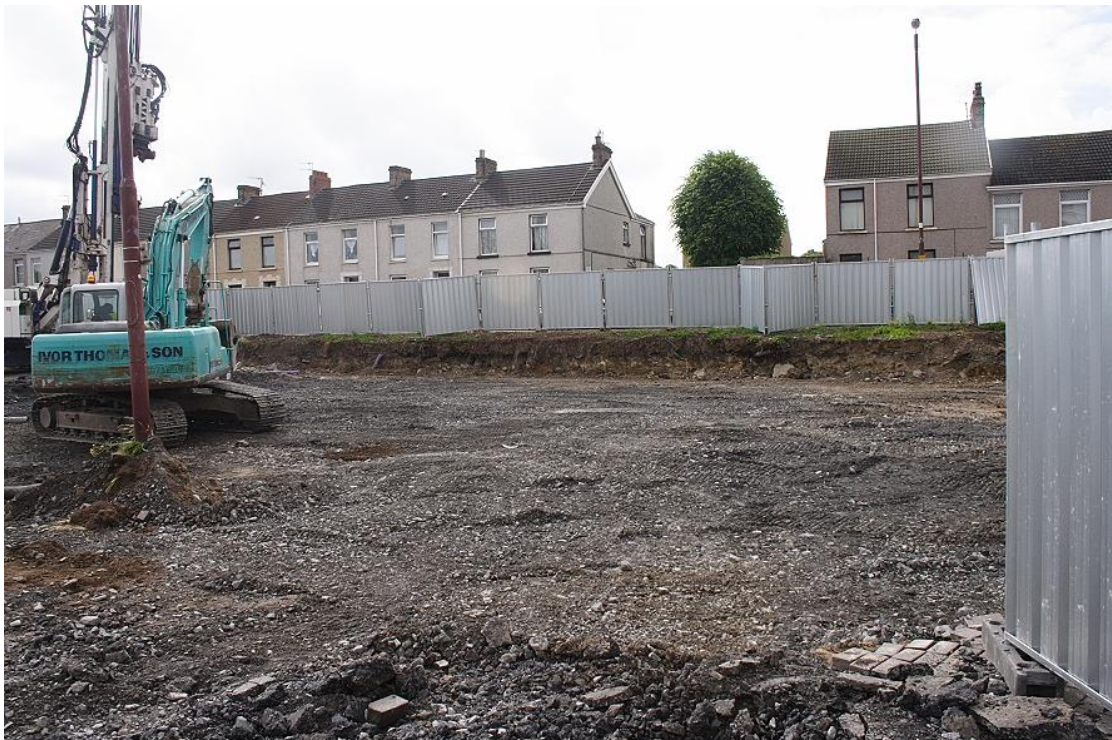
Photo 2: The development area after removal of car park surface. The terraced buildings visible line the southern side of Stepney Place.

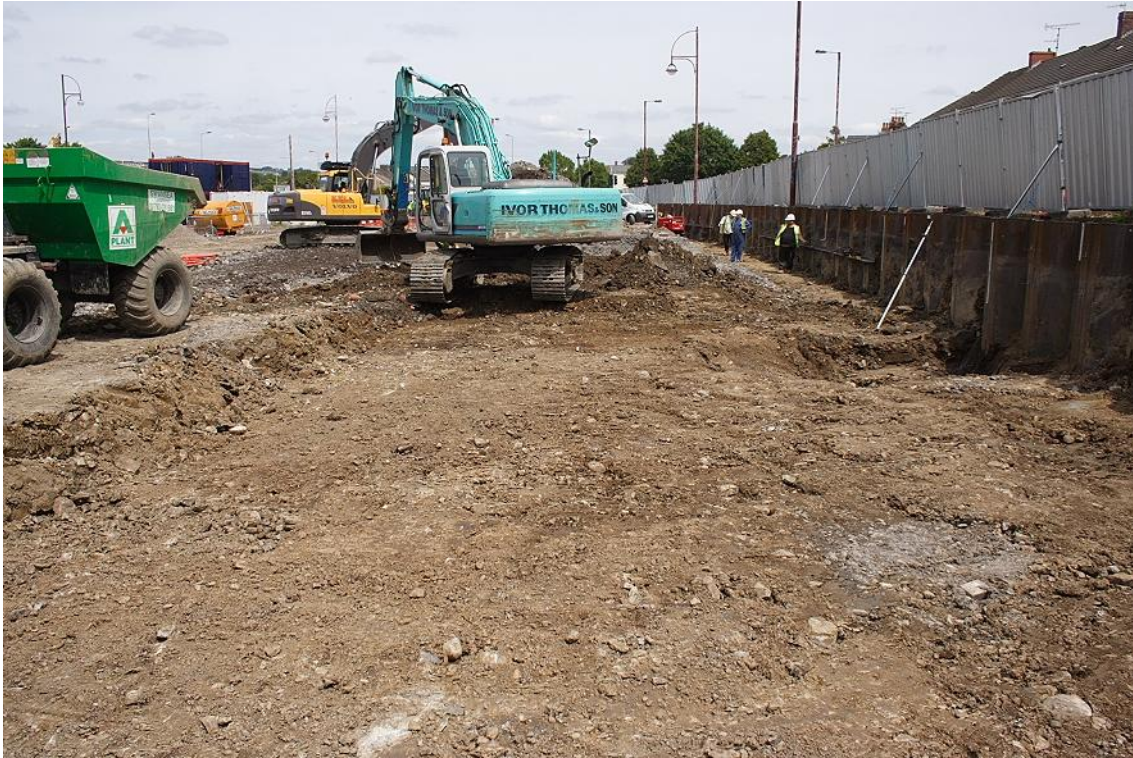
Photo 3: The southern edge of the development area during phase 1 ground reduction to formation levels.

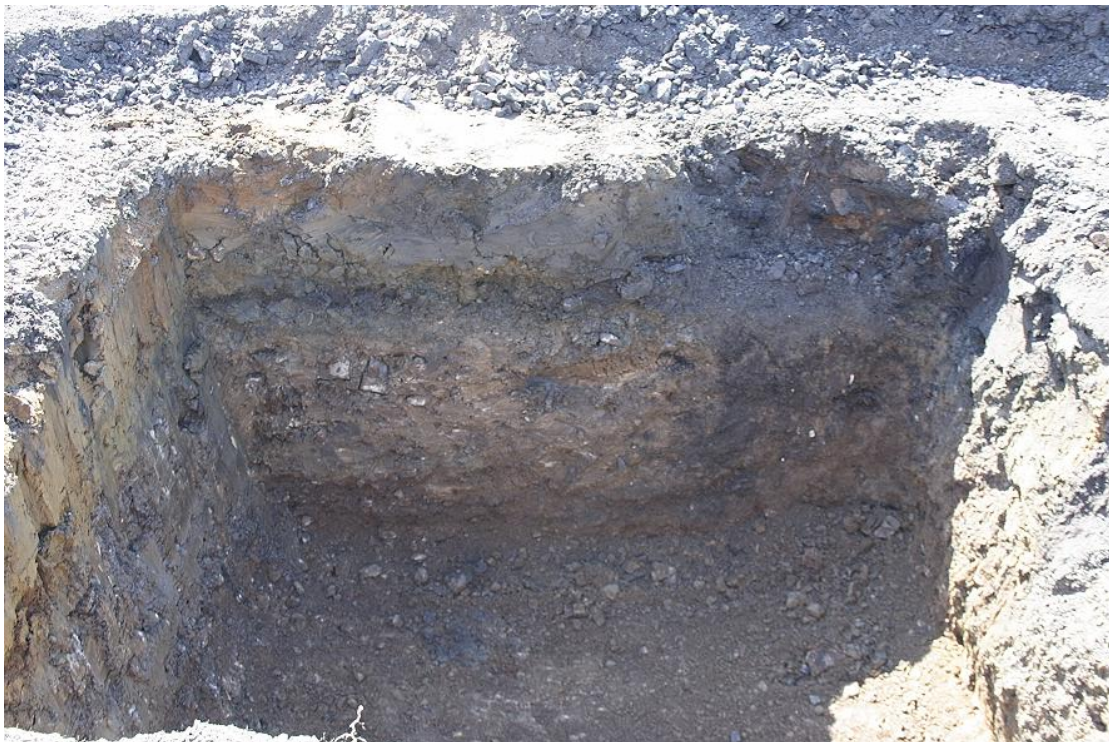
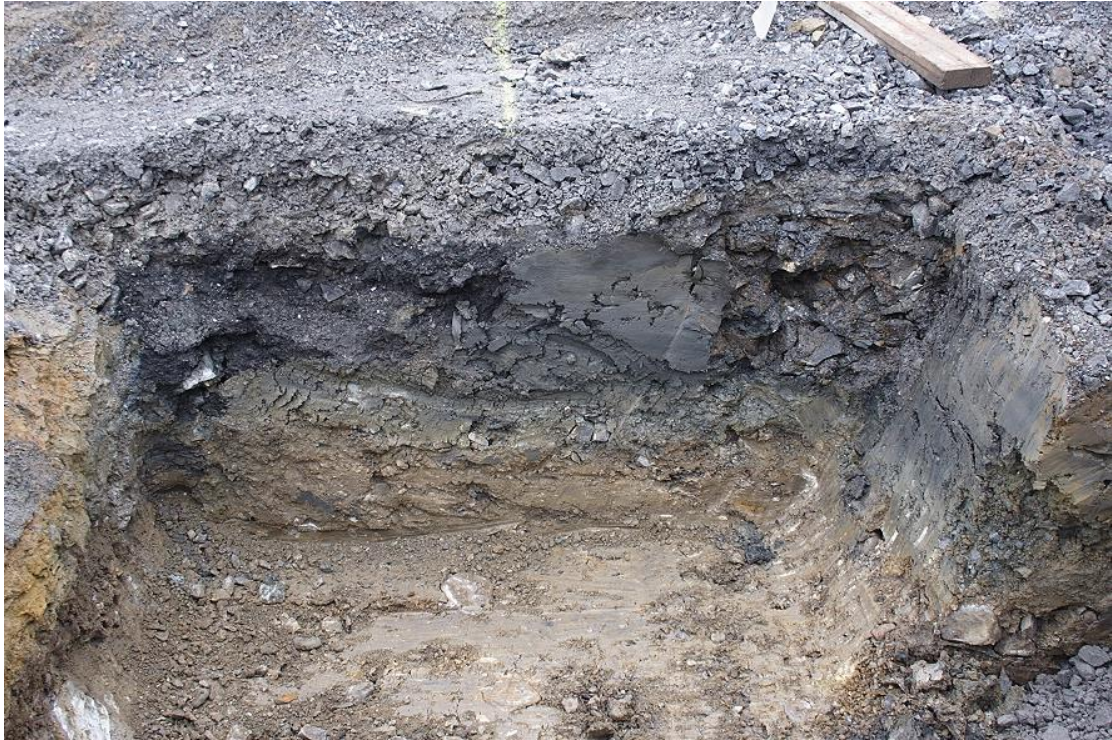
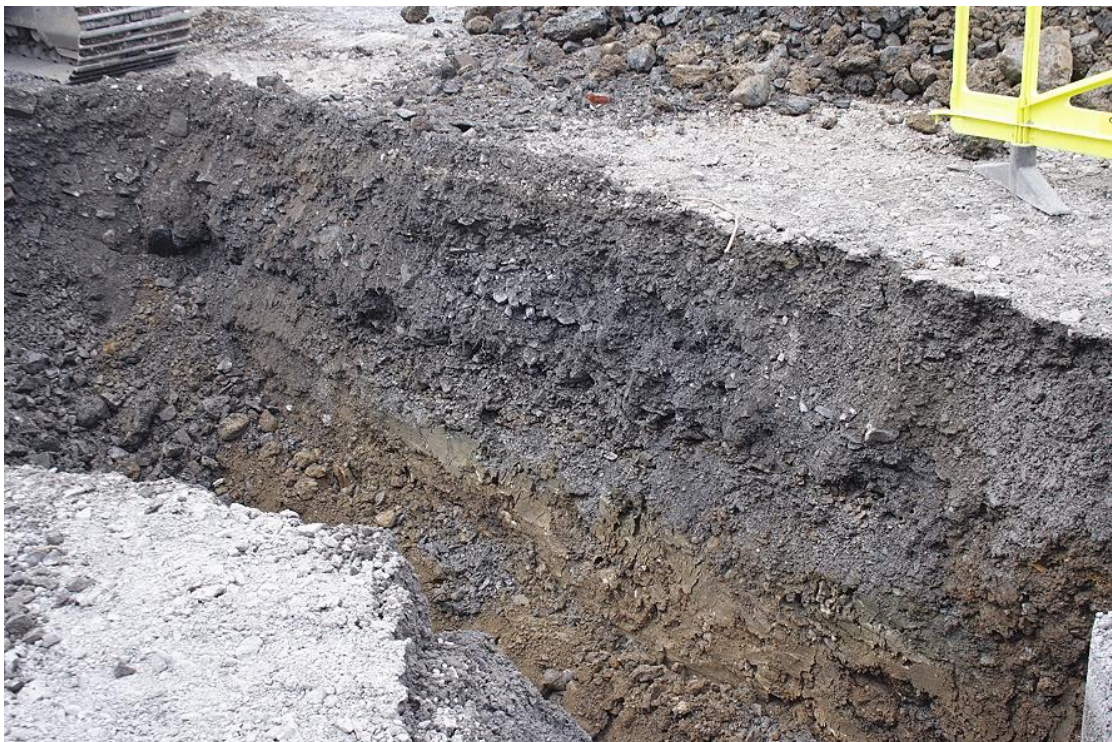
Photo 4: Section through one of the phase 1 test-pits, showing make-up deposits overlying natural subsoils.

Photo 5: Section through one of the phase 1 test-pits, showing make-up deposits overlying natural subsoils.

Photo 6: Section through one of the phase 1 service trenches, showing make-up deposits overlying natural subsoils.

- 4.1.3 The service trench and test pits revealed a substantial deposit of imported stone and building demolition debris underlying the car park surface (photos 4–6). In patches there also appeared to be some imported silty-clay deposits, or possibly redeposited subsoil deposits forming part of the make-up layers.

- 4.1.8 Across the area revealed by the strip excavation naturally occurring subsoil deposits were recorded under the modern make-up layers, consisting of light yellow-brown to mid orange-brown sandy-clays with large to very-large rounded boulders, an apparent fluvio-glacial deposit (photos 4–7).

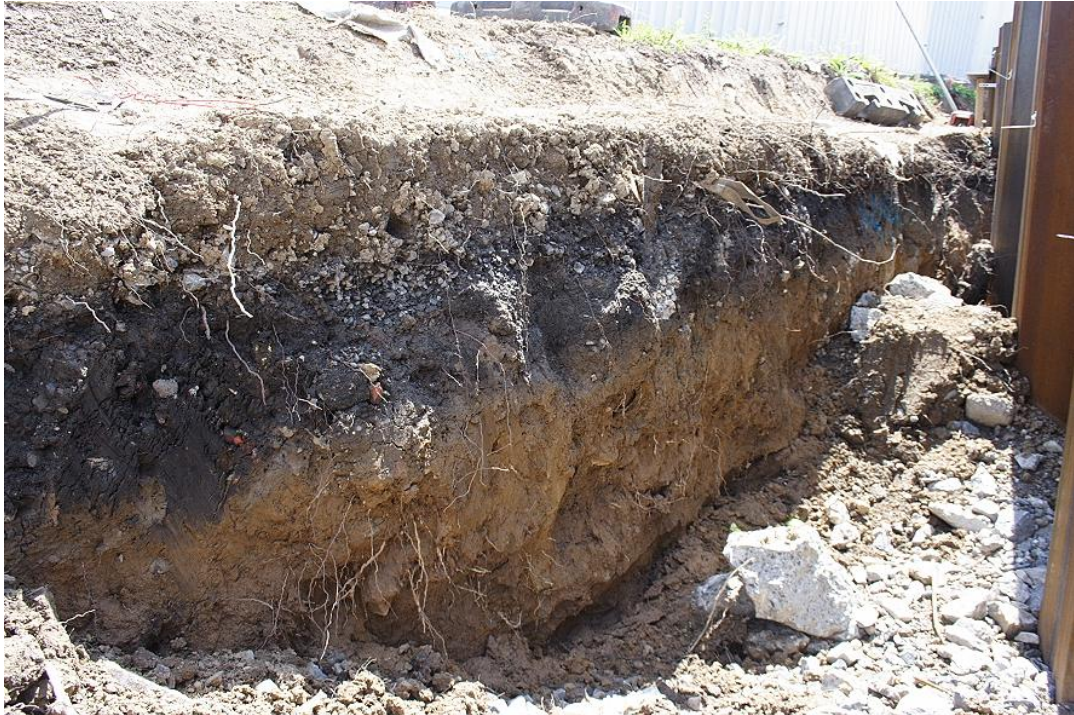
Photo 7: Typical section through deposits revealed along the southern edge fo the development area.

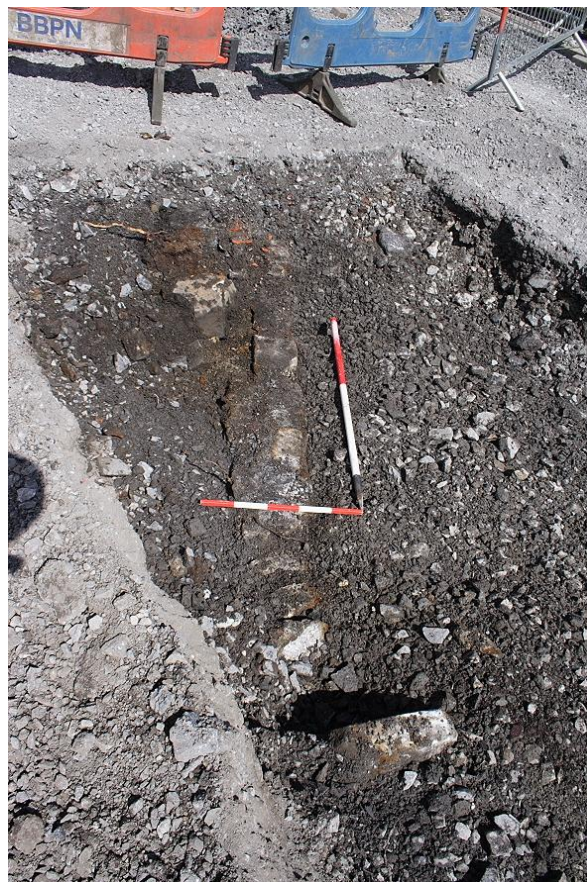
Photo 8: Remains of a mortared masonry and brick built wall revealed during phase 1 clearance works. 1m and 0.5m scales.

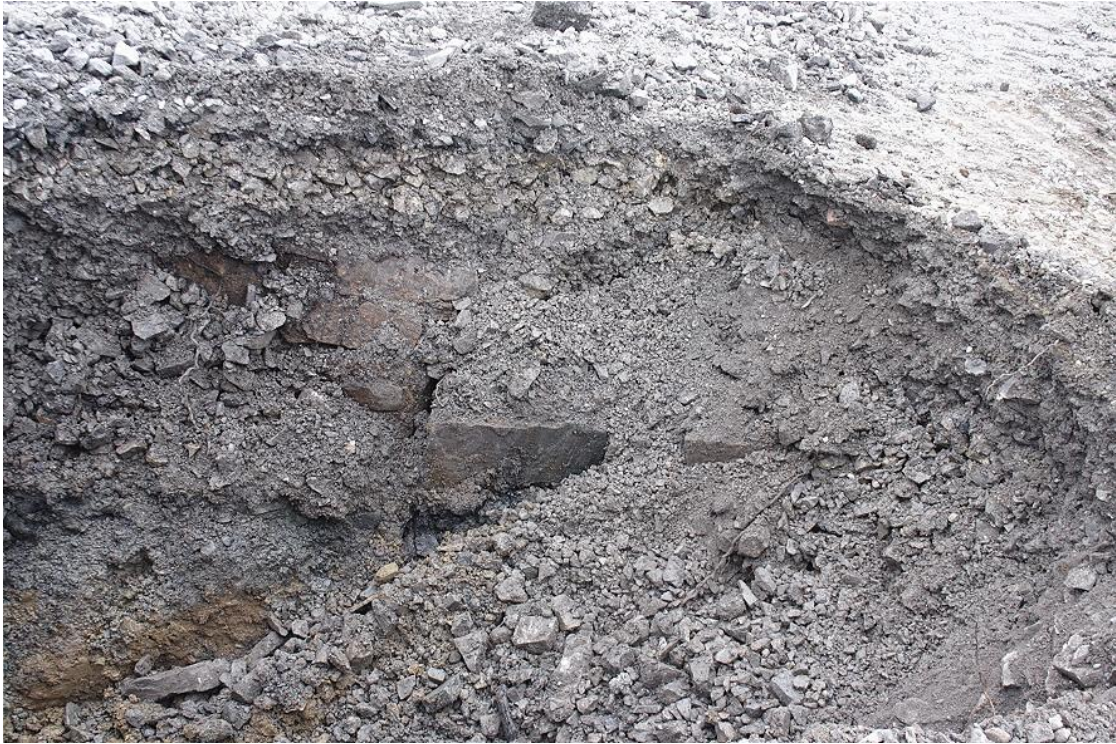
Photo 9: Remains of a mortared masonry wall revealed in the section of a phase 1 service trench.

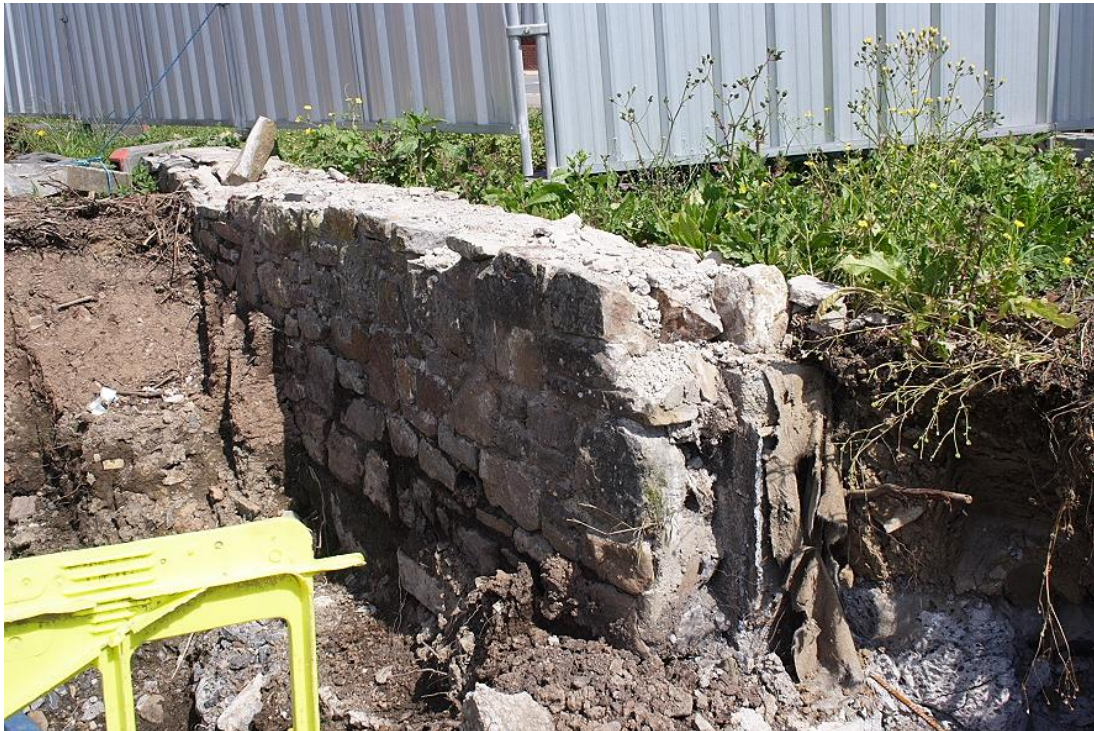
Photo 10: Former wall remains towards the southeastern corner of the development area. Appears to have formed part of the late 20th century car park enclosure, but may also be associated with the 19th century terraces.

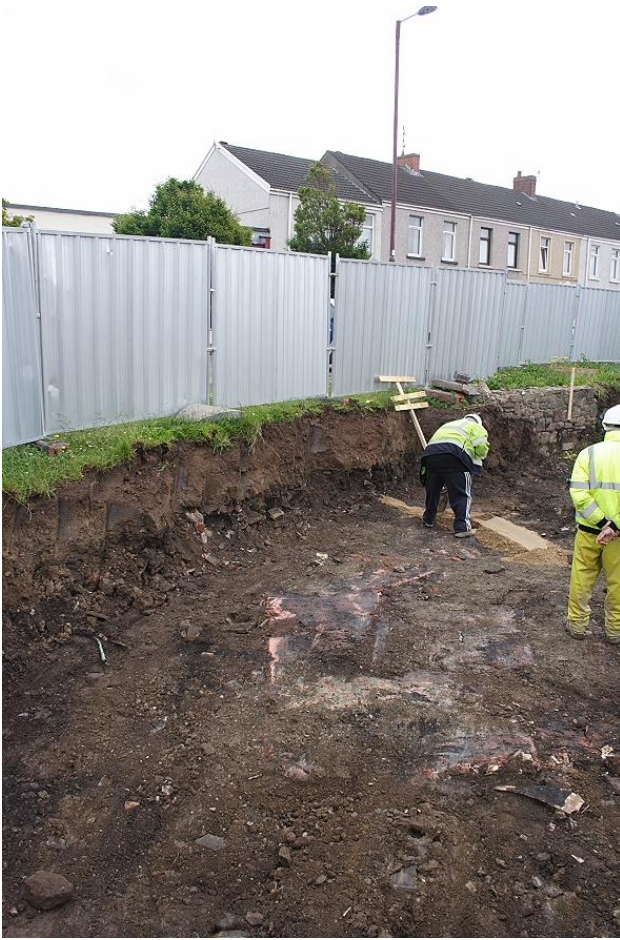
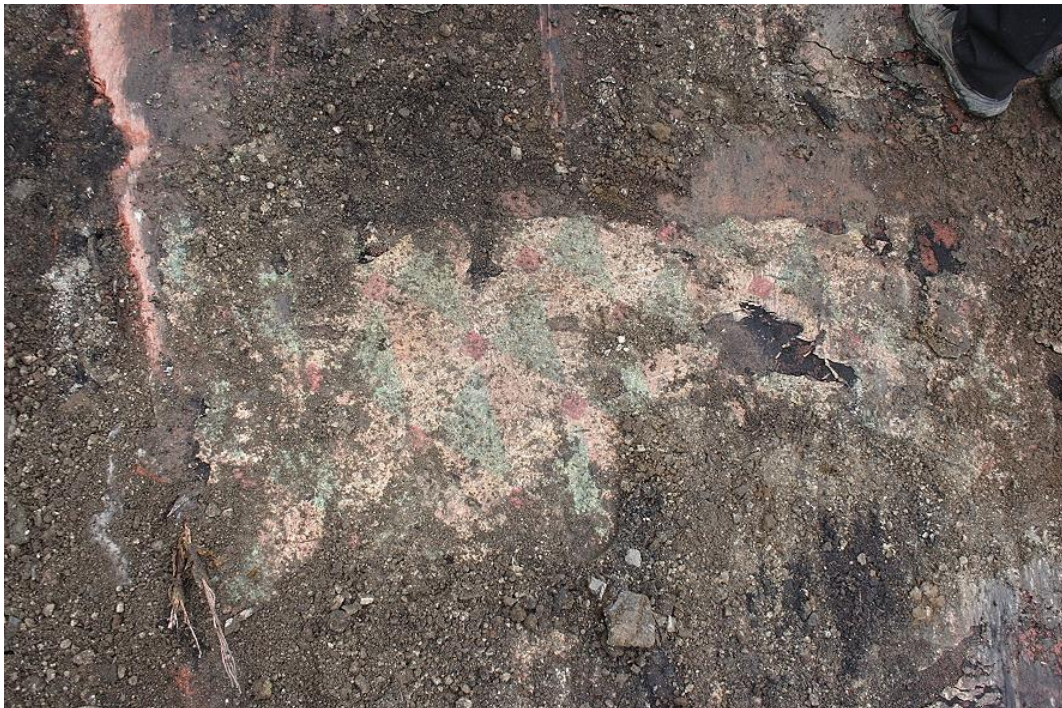
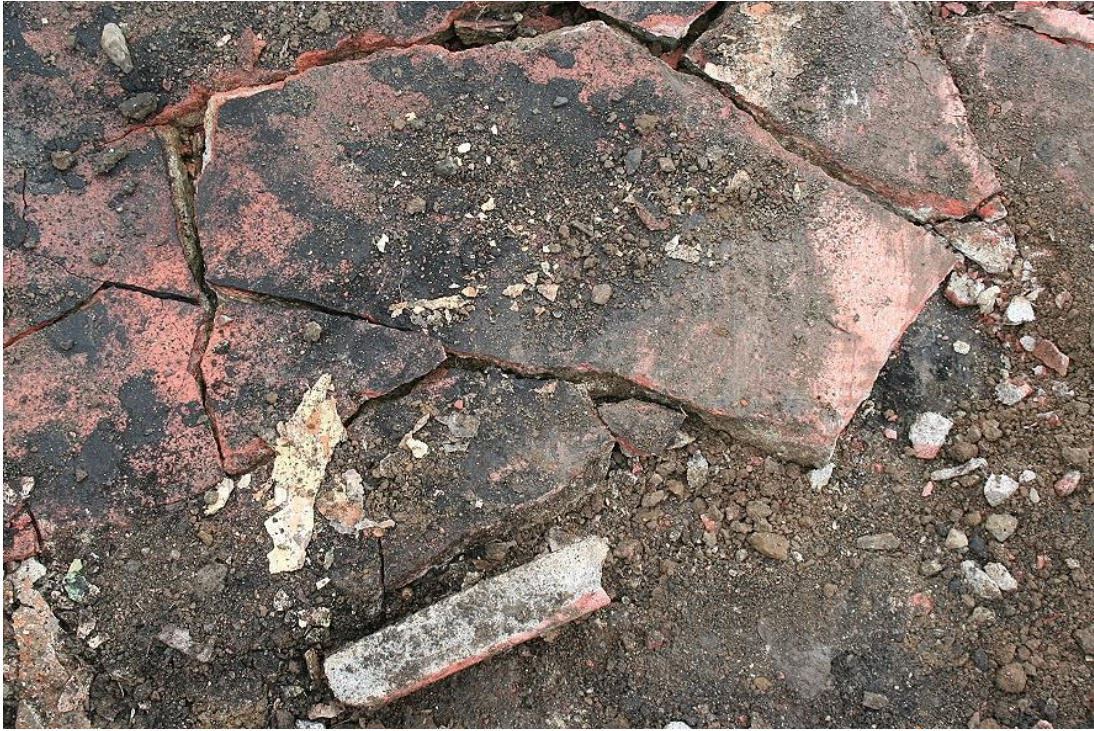
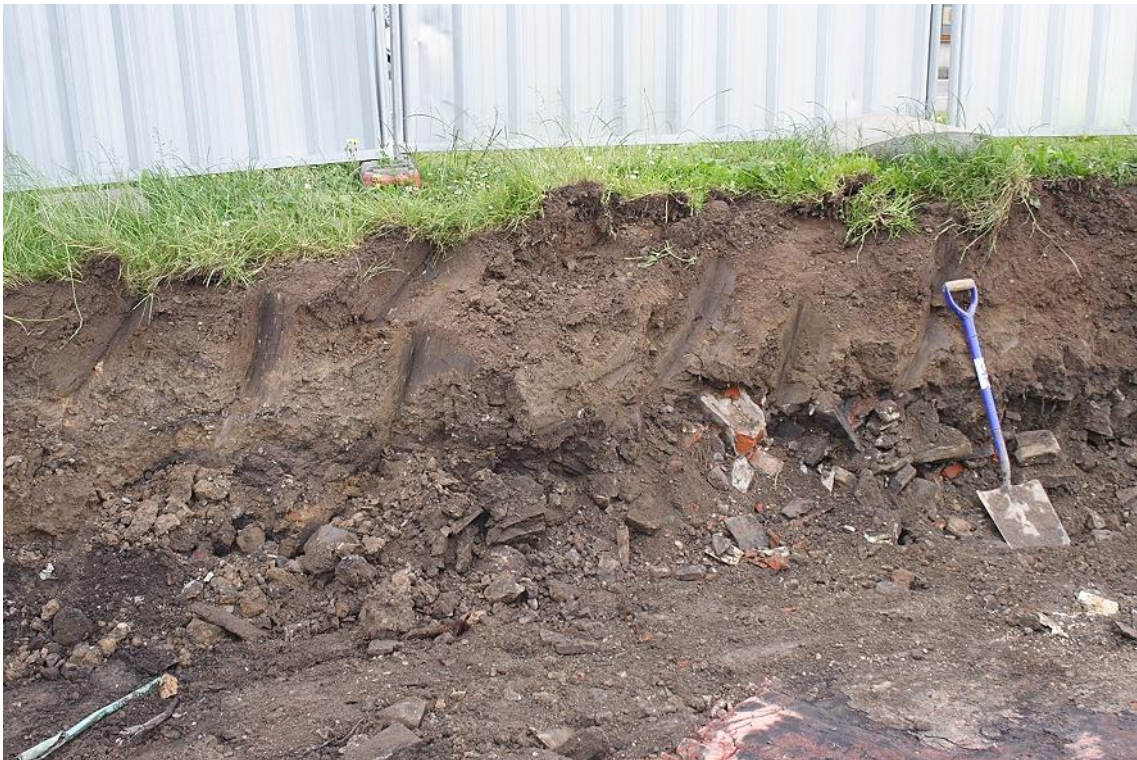
Photo 11: Internal surface of one of the former terrace houses of Stepney Place revealed in the southeastern corner of the development area.

Photo 12: Remains of lino attached to the internal surface.

Photo 13: Concrete floor level of the internal surface.

Photo 14: General 20th century demolition rubble overlain by topsoil in the southeastern corner of the development area.

- 4.1.7 At the eastern end of the strip excavation, at a depth of c.0.8m below current ground level, were the fragmentary remains of a concrete surface (photos 11–14). The surface measured c.4m by c.3m and had fragmentary pieces of lino attached to it. Presumably the remains of an internal floor surface to one of the terraced buildings of Stepney Place (the lino suggesting a kitchen area). The surface was already truncated by previous service trenches, but largely left intact during current development.

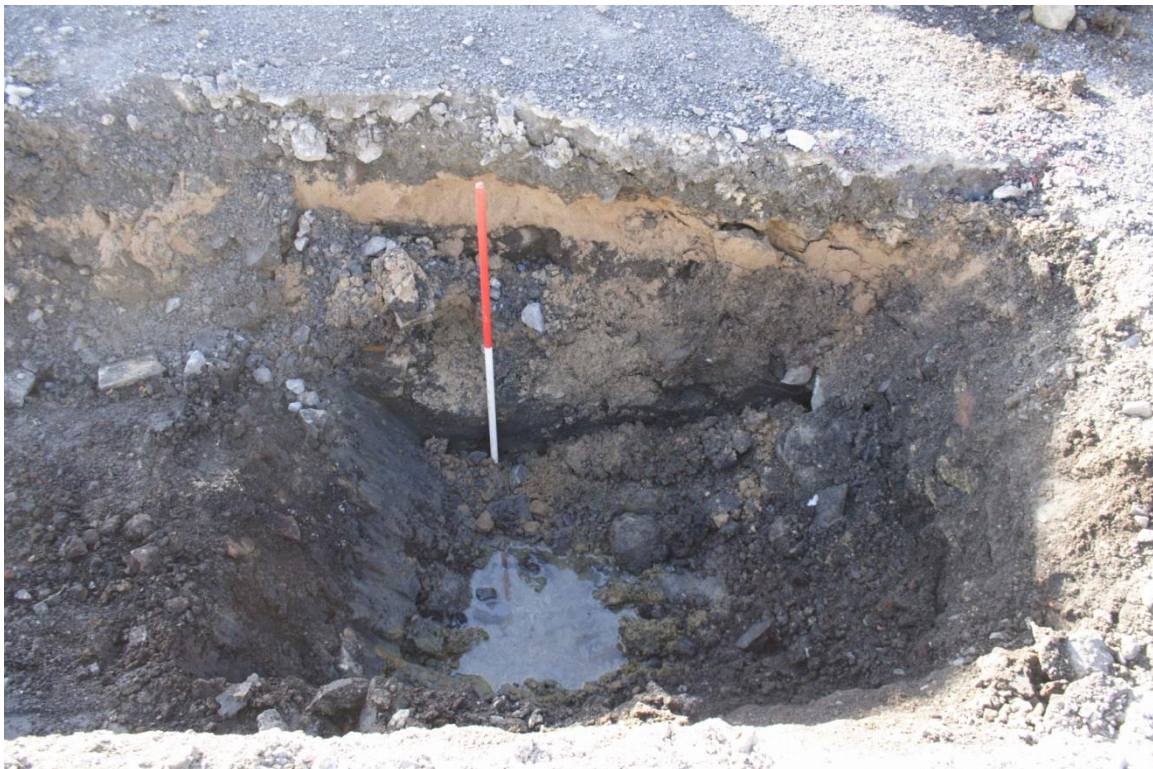
Photo 16: Typical section at the western end of the site, showing make-up deposits overlying demolition material. 1m scale.

- 4.2.3 The trench excavations under the footprint of the westernmost building revealed a make-up deposit c.1m in depth. This consisted of an upper c.0.4m of tarmac and underlying sand make-up deposits. Below this the remaining c.0.6m consisted of mixed stone, cement and soil deposits that appeared to be demolition material (photo 16). This demolition material reduced in thickness to the east. This was presumably from the demolition of the 19th century terraces that were formerly prevalent in this area.

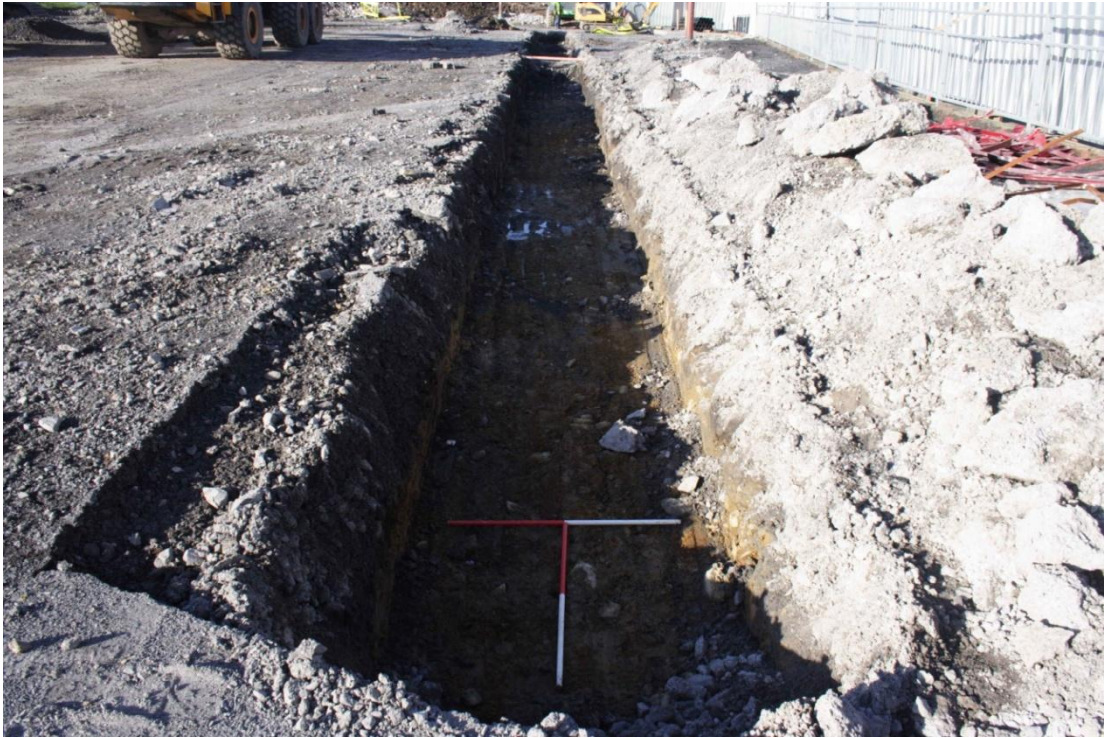
Photo 17: One of the stage 2 trenches, showing the natural underlying subsoils becoming more apparent towards the centre of site, closer to the former line of Water Street. 1m scales.

- 4.2.5 Underlying deposits were intermittently revealed, where they did become apparent they appeared to show a continuation of the yellow-brown sandy-clay subsoils that had been observed in Stage 1 (photo 17). They were more clearly revealed to the east, around the area of what was formerly Water Street, presumably as the 19th century development lessened in this area resulting in a thinner demolition deposit. These subsoil deposits had clearly been truncated by late post-medieval and modern activity and as such it was not possible to gauge any natural underlying changes in levels. Nothing of archaeological significance was noted within this subsoil.

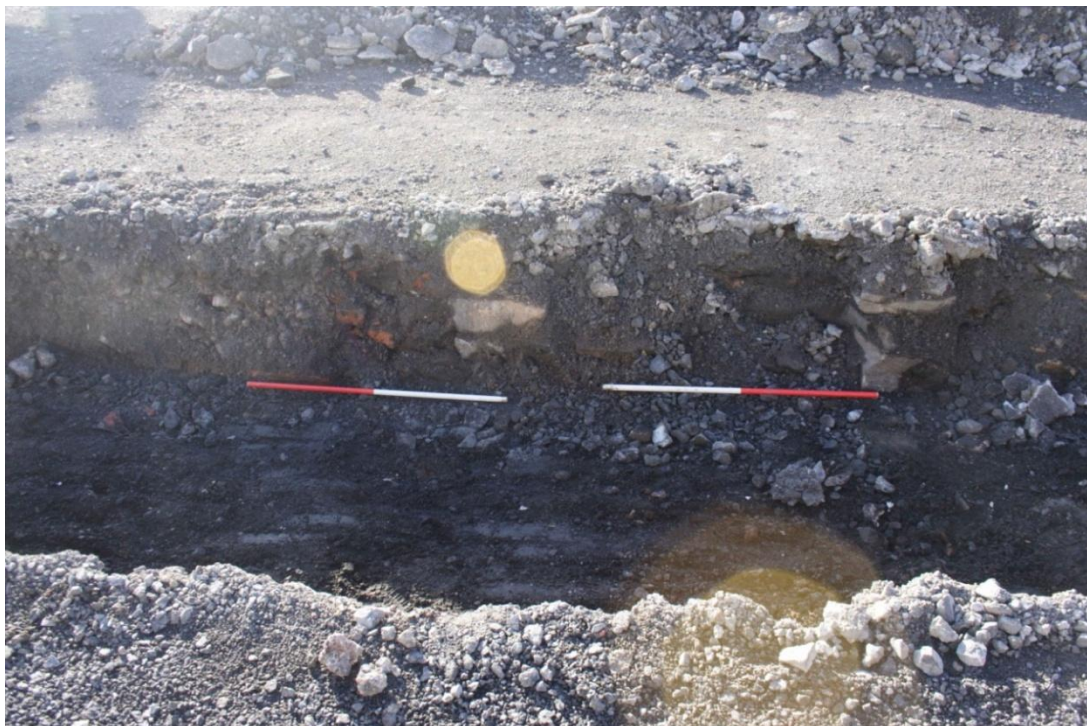
Photo 18: Stone and brick walling amongst the demolition rubble in one of the stage 2 trenches. These remains appear to form part of the former 19th century terracing along Park Lane. 1m scales.

- 4.2.4 Remnants of stone and brick walling were revealed within one of the main services trenches (photo 18) that ran along the southern edge of the westernmost building in Figure 2. The trench ran roughly WSW – ENE, with the walling remnants appearing to run roughly north – south towards the western end of the trench. This appears to line up with mid-19th century terraced housing along the former line of Park Lane. No further building remains were recorded within this demolition deposit.
