# EXCAVATION AT ST PATRICK'S CHAPEL 2014 INTERIM REPORT

DAT Event Record No. 106685

Report No. 2014/26

June 2014

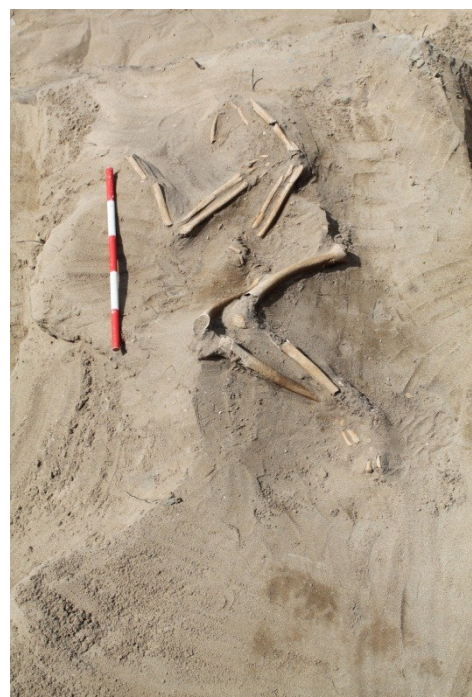
*Skeleton 201.* No grave cut. Not in a cist. Below stone spread 10 and above skeleton 205. Head to the west, but with the head missing (due to erosion). The body was on its back but with the legs and arms slightly flexed. Probably an adult.

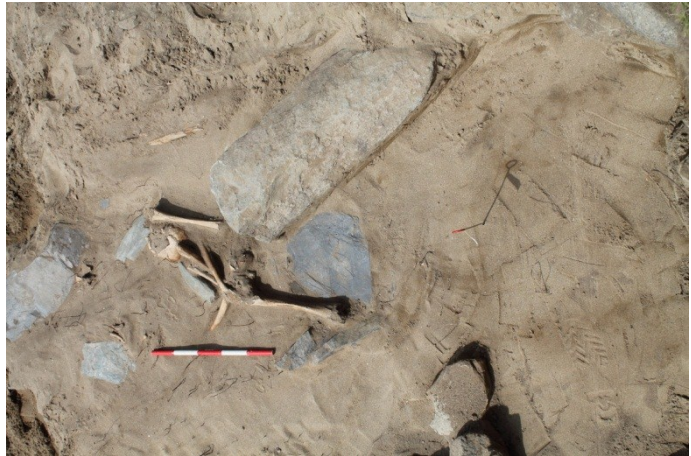
*Skeleton 202.* No grave cut. Not in a cist. Overlies skeleton 207/cist 23. Partial skeleton, largely disarticulated with the bones in a rough heap. Articulation of some bones suggests the body was not entirely de-fleshed when deposited. Adult?

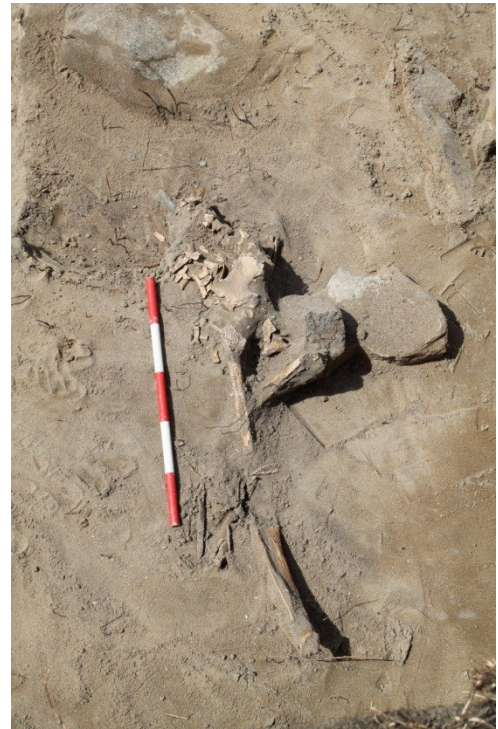
*Skeleton 203.* No grave cut. Covered by a stone spread (11). Head to west. Poorly preserved, with the upper body dissolved. Adult?

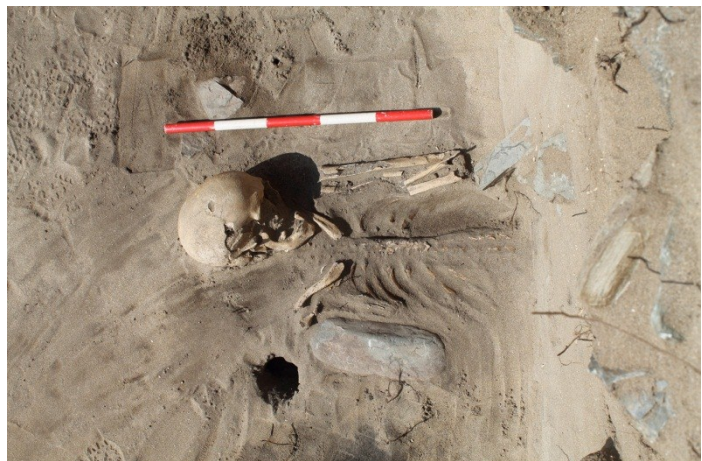
*Skeleton 205.* 0.5m deep grave cut visible in section. Not in cist. Head to west. Supine with left arm crossed over chest. Lower part of skeleton ran beneath edge of site and was left *in situ*. Adult.

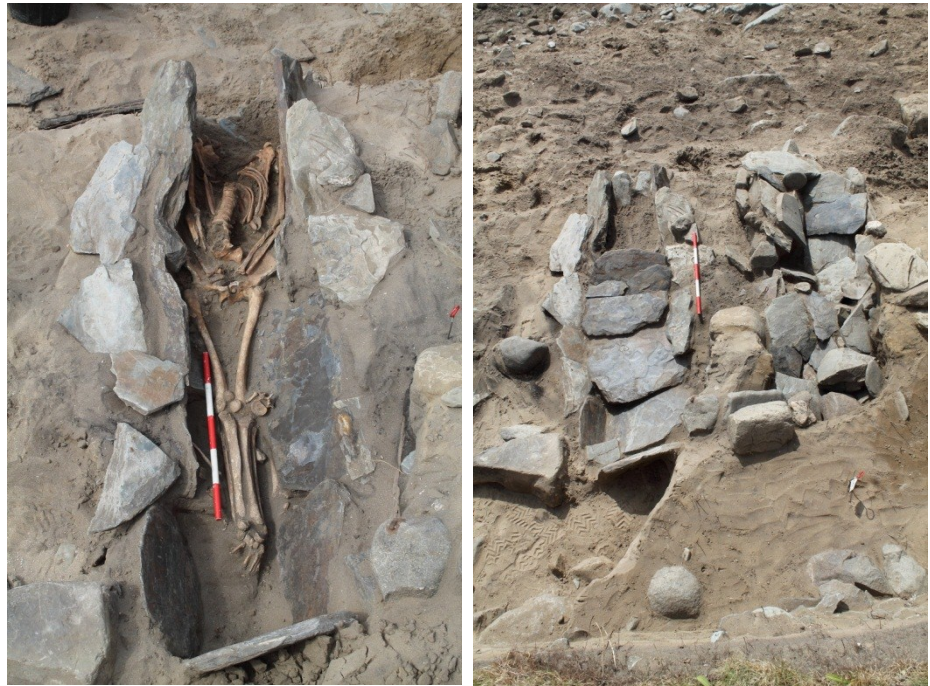
*Skeleton 206/Cist grave 21.* Cist grave with lintel and side slabs, no base slabs. The east end cut into the top of the wall 42, and some of the cist slabs were probably reused wall material. Directly overlay skeleton 210. Head to west. Supine with hands crossed over pelvis. Good preservation. Adult. A sherd of medieval pottery was found in the fill of this grave, possibly fallen in from overlying deposits.

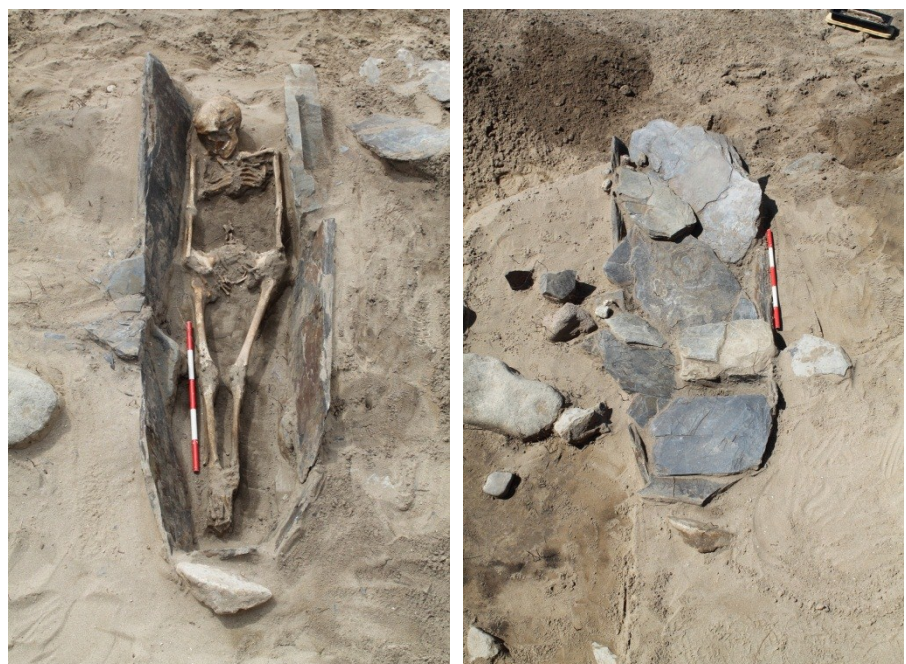
*Skeleton 207/Cist grave 23.* Cist grave with lintel and side slabs, no base slabs. West end of cist missing due to coastal erosion. Head to west. Supine with hands crossed over pelvis. Fair preservation. Adult.

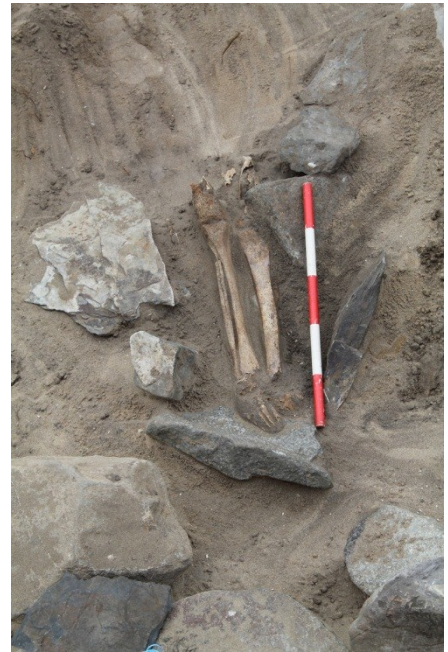
*Skeleton 208/Cist grave 24.* Cist grave with lintel and side slabs, no base slabs. The west end of the cist with the upper part of the body is likely to have been removed by recent human activity. Only parts of the leg bones survive. Head to the west. Adult?

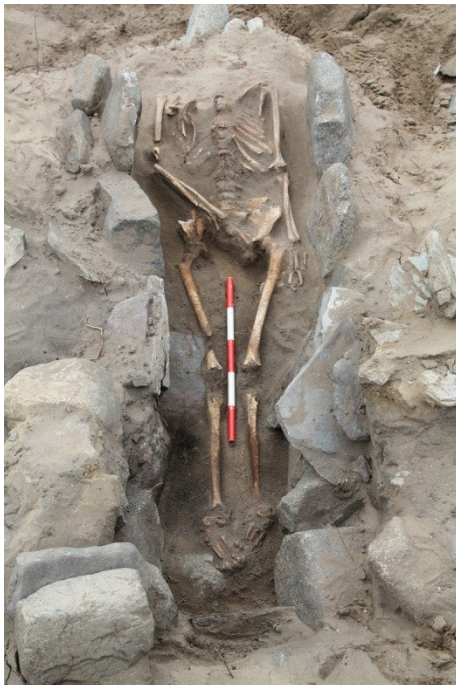
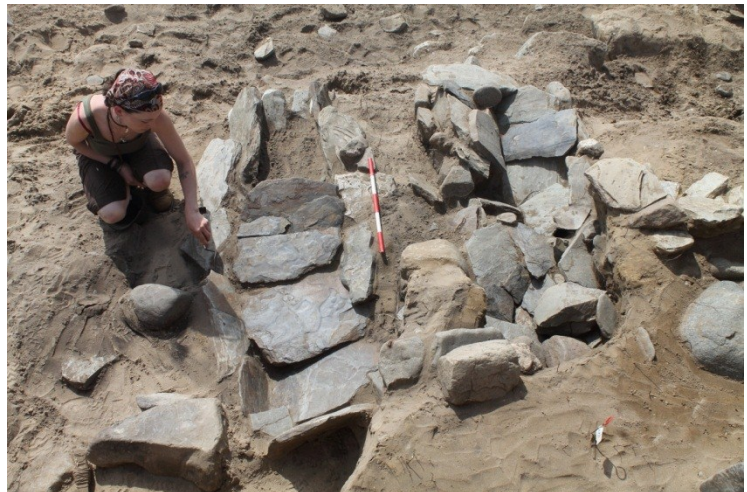
*Skeleton 209/Cist grave 22.* Cist grave with lintel and side slabs, no base slabs. The east end cut into the top of the wall 42, and some of the cist slabs were probably reused wall material. Head to west. Supine with right hand crossed over pelvis, left hand by side. Good preservation. Adult.

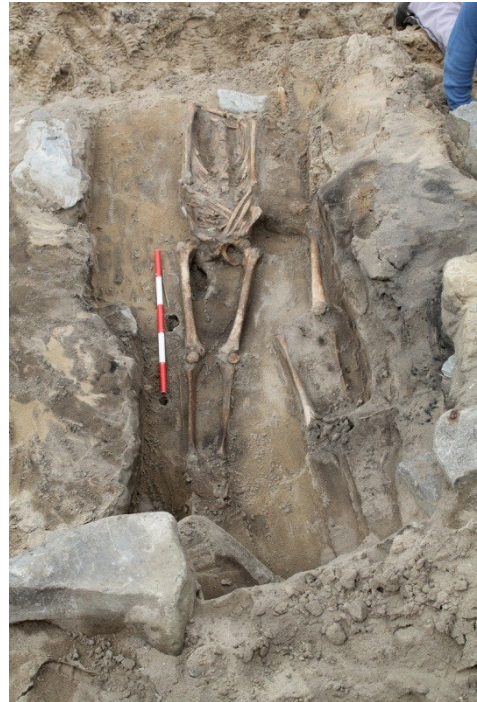
*Skeleton 210.* Not in cist. Directly below skeleton 206/cist grave 21, and later than skeleton 211. Head to west, but missing due to coastal erosion. Supine with hands crossed over pelvis. Good condition. Adult.

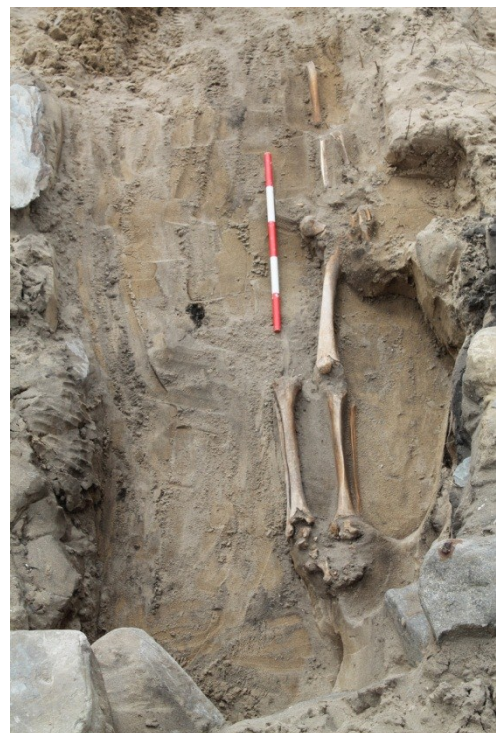
*Skeleton 211.* Not in cist. The right side of this skeleton was cut away when skeleton 210 was inserted. Head to west but missing due to erosion. Supine. Surviving bone in good condition. Adult.

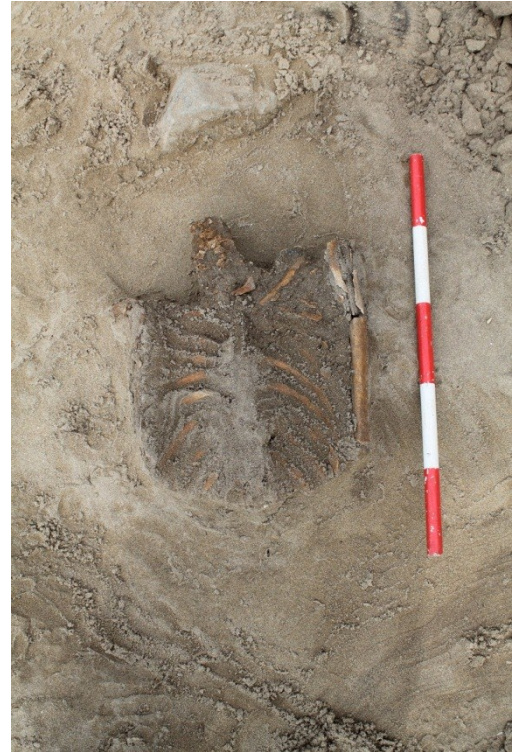
*Skeleton 212.* Not in cist, but under a large boulder and with a boulder at the head end of the grave. NE-SW aligned with the head to the NE. Pre-dating skeleton 203. Poorly preserved with just part of the torso surviving. Juvenile.

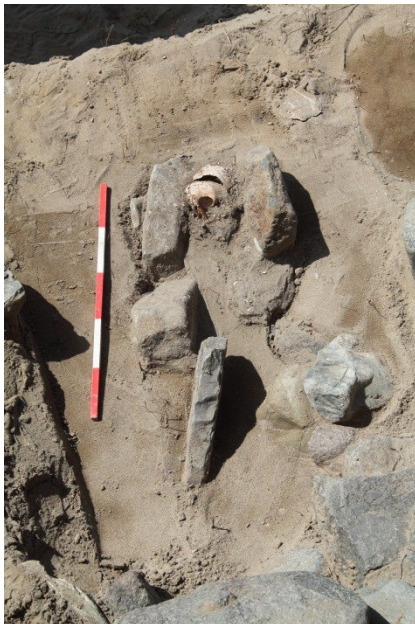
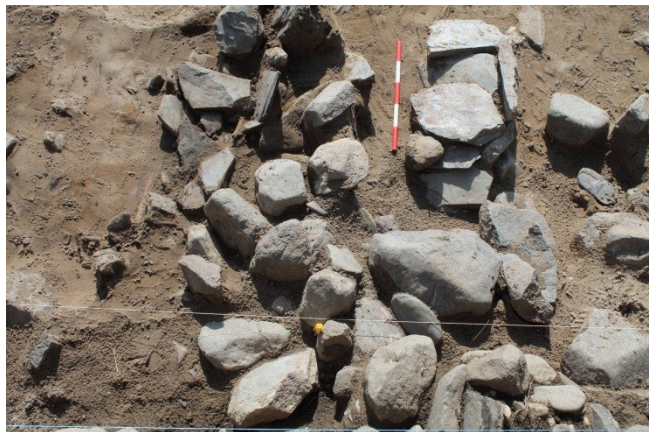
*Skeleton 213/Cist grave 47.* In a small cist, 0.7m long with sides made of rounded boulders and lintel slabs. Head to west. Only part of the skull survived. Infant. A possible pottery sherd (409) came from the fill of the cist grave.

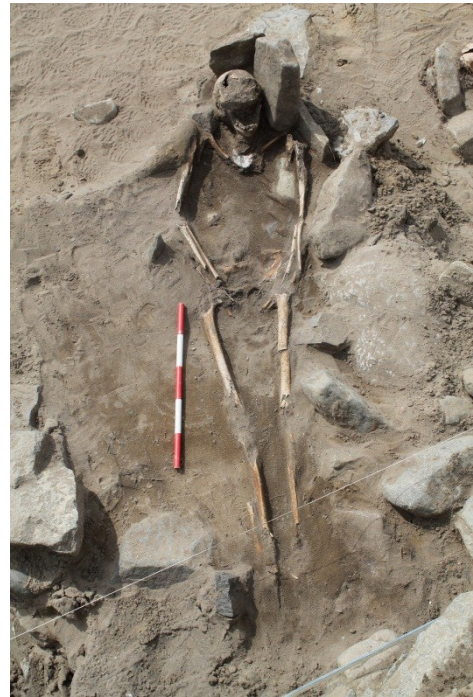
*Skeleton 214/Cist grave 48.* A rough cist grave made mostly from boulders. Cut into the top of the wall 42. Aligned roughly E-W, but a slightly different alignment to the other E-W graves. Head to the west. Supine with hand over pelvis. Variable bone preservation. Quartz stone placed over a clavicle. Adult.

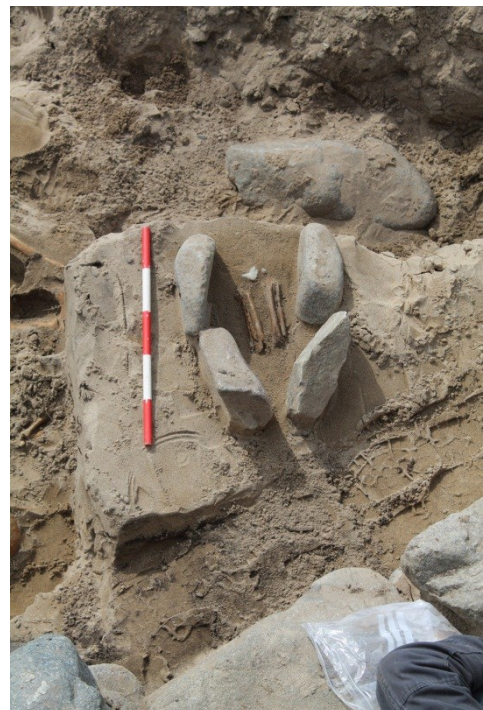
*Skeleton 215/Cist 50.* Only the leg, east end survives – the remainder removed by erosion. E-W aligned with head to west. Only lower leg bones remain. Juvenile?

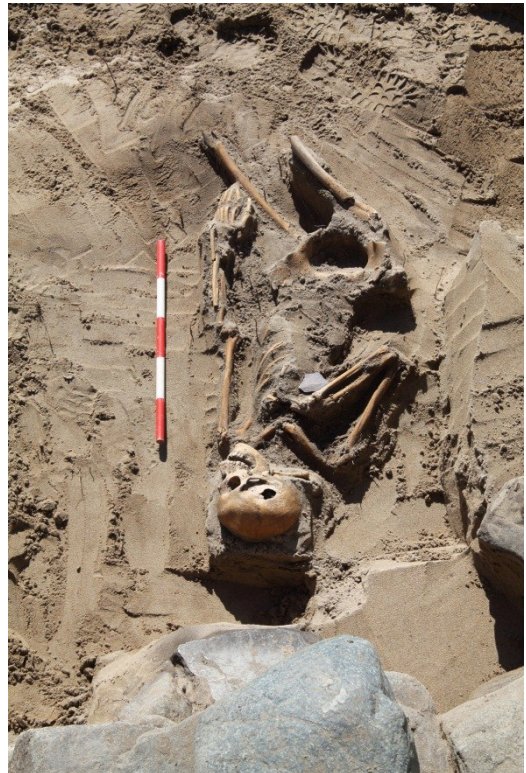
*Skeleton 216.* Not in cist. Partly below skeleton 209/cist 22. E-W aligned with head to E facing south. Arms and legs slightly flexed. Variable bone preservation. Adult. The foot bones of this skeleton may have been removed in February 2014 and included with skeleton 221.

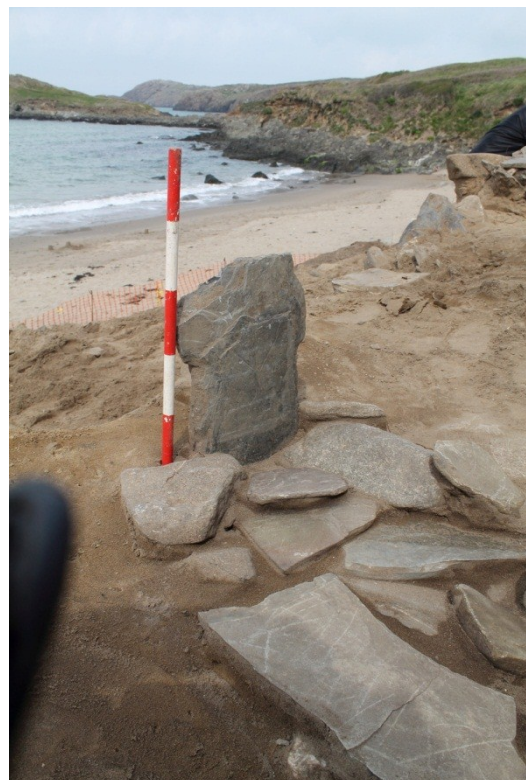
*Skeleton 218/Cist grave 26 with grave marker 27 (Find no. 403).* Cut through wall 42, and using some of the wall stones as part of the cist. The grave was 0.7m deep, with the cist's lintel slabs 0.3m below the top of the grave cut. No base slabs. E-W aligned with head to the west. Supine with hands crossed over the pelvis. Bone in good condition, but lower legs decayed. Skull slightly damaged and distorted due to pressure from lintel slabs. Adult (late 20s?), female. The east end of the grave lay beneath the edge of the site, but all the bone was recovered. The cist's side slabs were left *in situ* at the end of the excavation. A possible copper alloy shroud pin (411) was found amongst the hand bones.

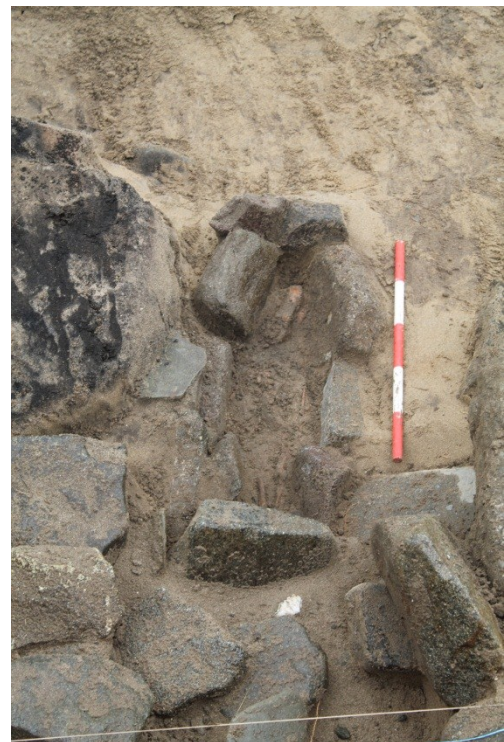
*Skeleton 219/Cist grave 52.* Small cist, 0.7m long, composed of rounded stones. E-W aligned with head to the W. Well-preserved skeleton of an infant, supine. Adult foot bones also in grave.

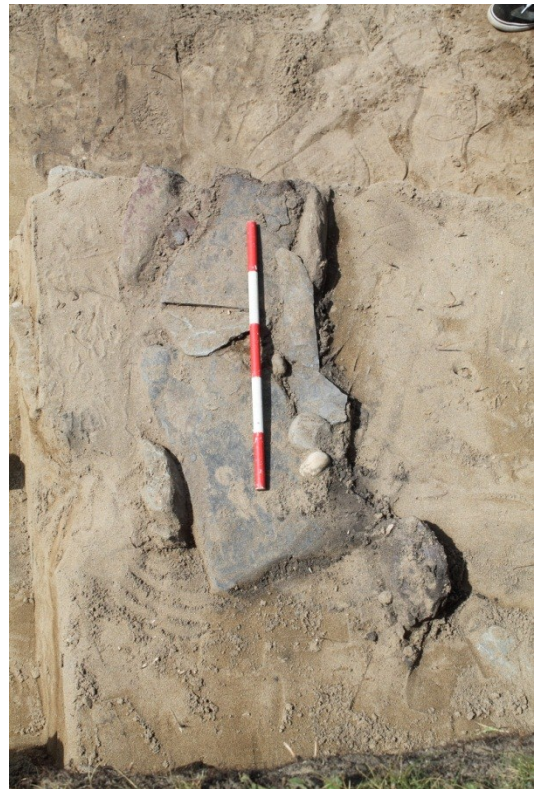
*Cist grave 20.* The east end of a cist grave with lintel and side slabs – the west end removed during the 1970 excavation? No bone survived – possibly removed in 1970?

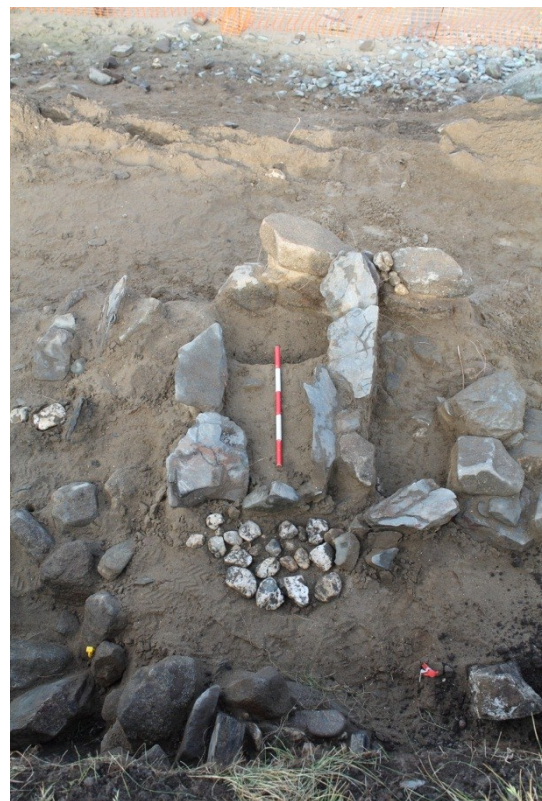
*Cist grave 28.* Small E-W aligned cist grave, 0.88m long. Side slabs of slate and rounded stones. One large lintel slab surrounded by 20 small rounded quartz stones. No skeletal remains. In the photograph the emptied cist grave is shown with the excavated quartz pebbles in a pile. Infant.

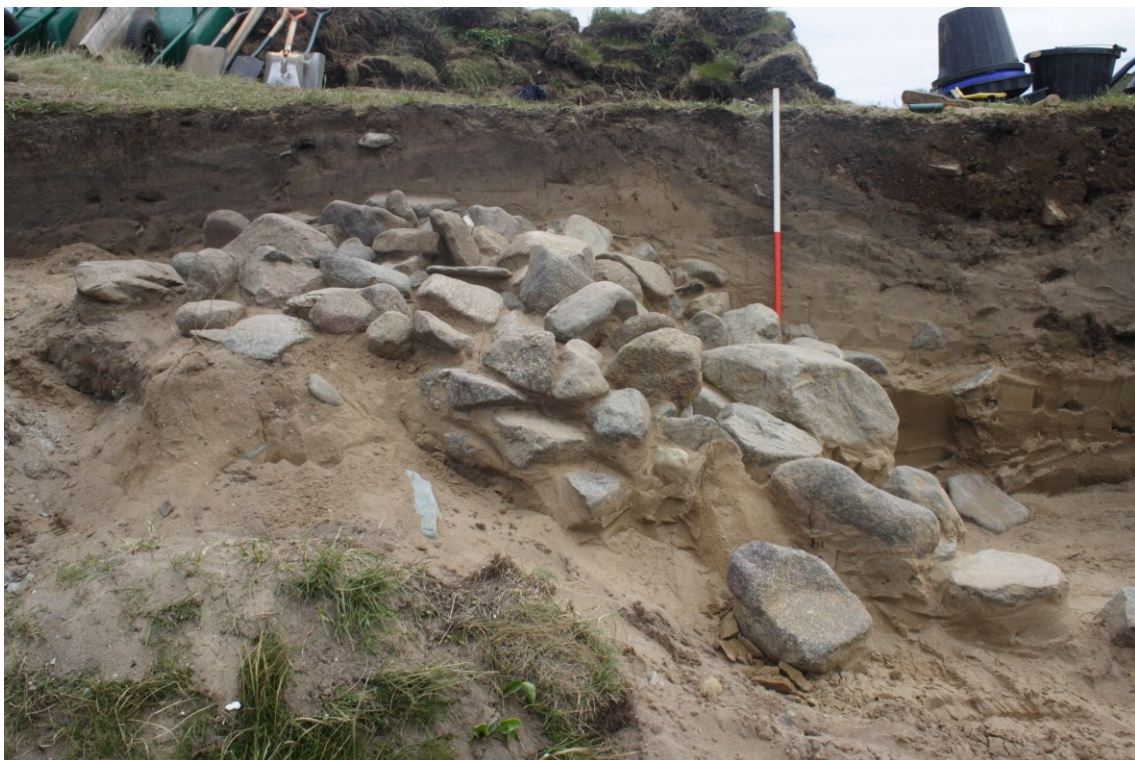
Photograph 6. Stone layer 10 in Trench 1.

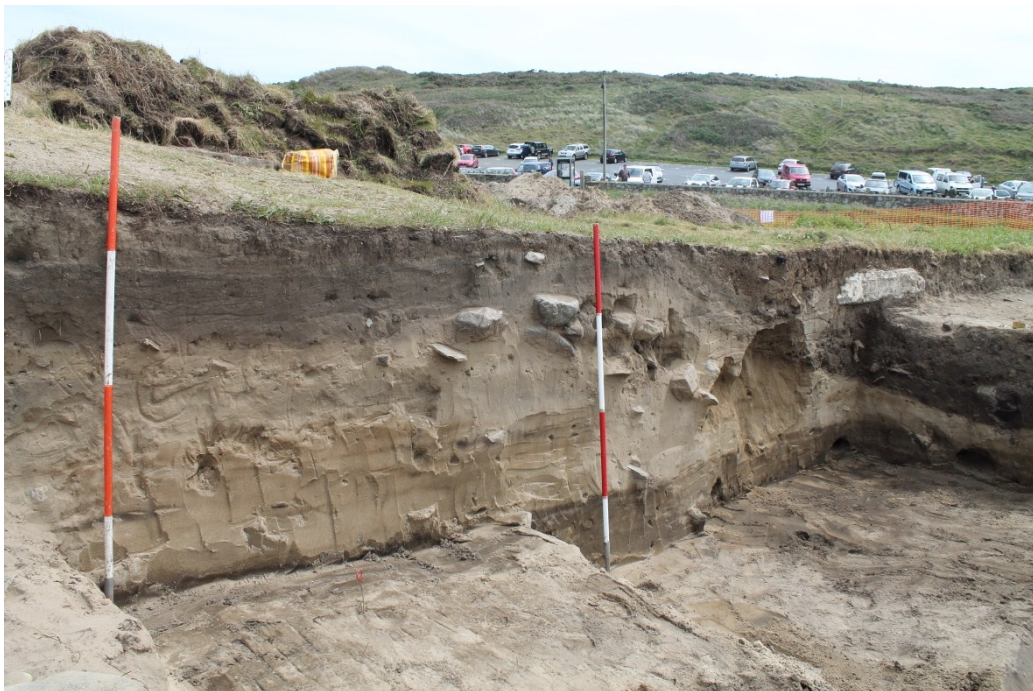
Photograph 9. Photograph of Trench 1 showing the dark soil layer (45) below wind-blown sand.

As noted above there is likely to be an old ground surface preserved beneath the wind-blown sand, but the excavation was not deep enough to find this. Following initial accumulation of sand there was a period of stability during which a soil formed. This soil (45) was a distinct layer, with its black, charcoal-rich surface sharply contrasting with the wind-blown sand above (Photo. 9). Samples were taken from the charcoal-rich areas for possible analysis and radiocarbon dating.

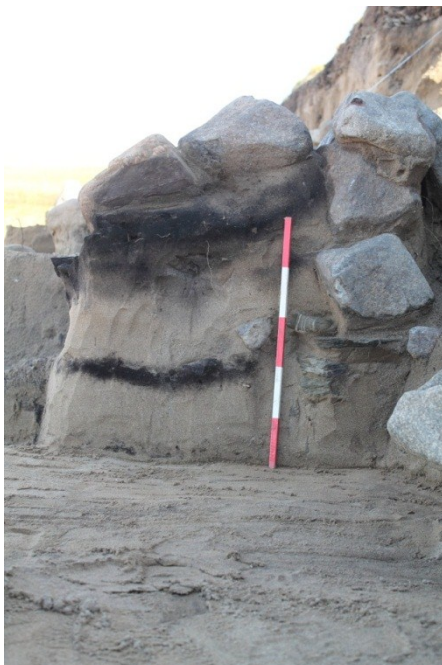
Photograph 11. The face of wall 42 is to the right with wind-blown sand accumulated against it and a dark soil layer 44 at the top of the scale, over which there is tumble from the wall.

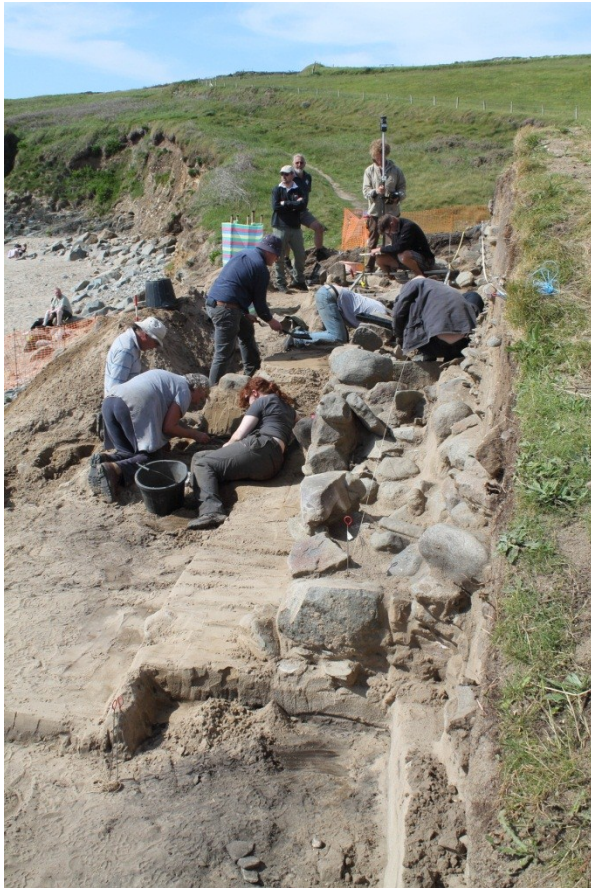
Photograph 12. Trench 1 showing wall 42.

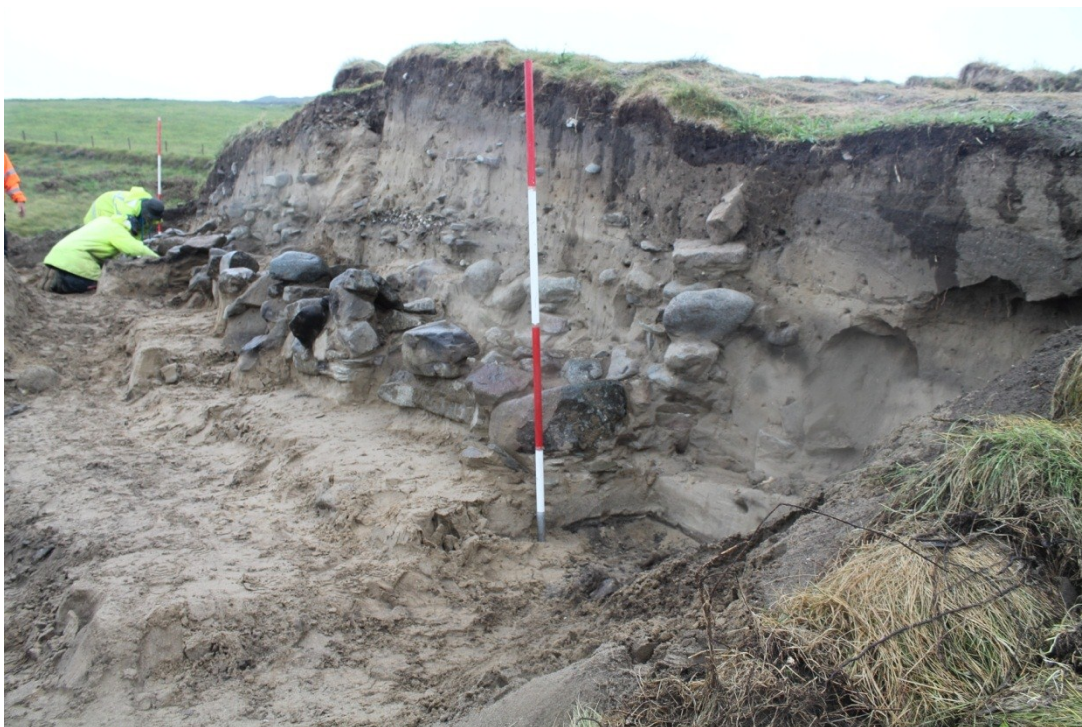
Photograph 13. Wall 42 in Trench 1.

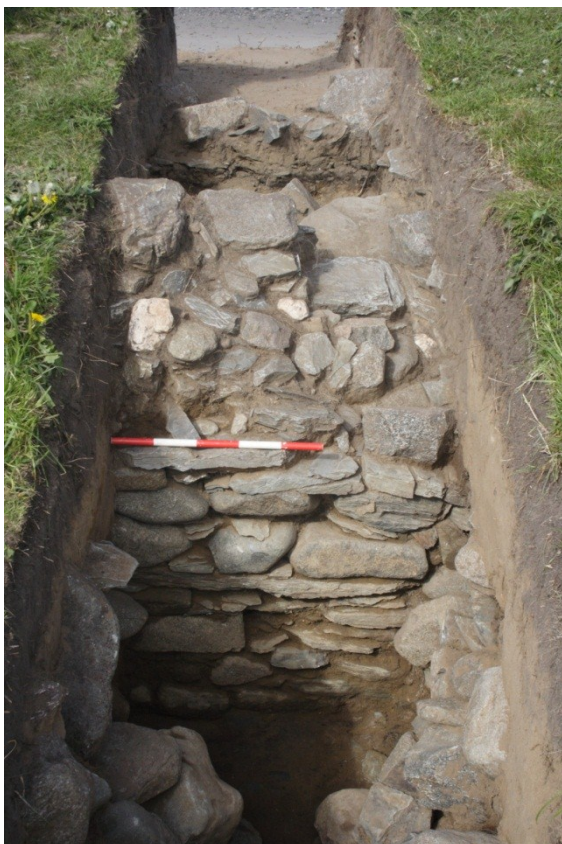
Photograph 15. Wall 9 in Trench 2.

The west wall (9) of the Chapel was 0.74m wide and stood to 1.28m high (Photo. 15). It was constructed from beach boulders and large slabs of quarried slate/shale, with no obvious bonding material. Coursing was random, although some of the slabs formed rough bands. Backfill from the 1924 excavation lay to the east of the wall. To the west lay banded wind-blown sand (13), with at the bottom of the trench at the west end the compacted stony silty-sand layer (19) encountered in Trench 1. Five sherds of medieval/post medieval pottery were found in the banded sand (13), but a clay pigeon and other modern artefacts evidenced disturbance to it.

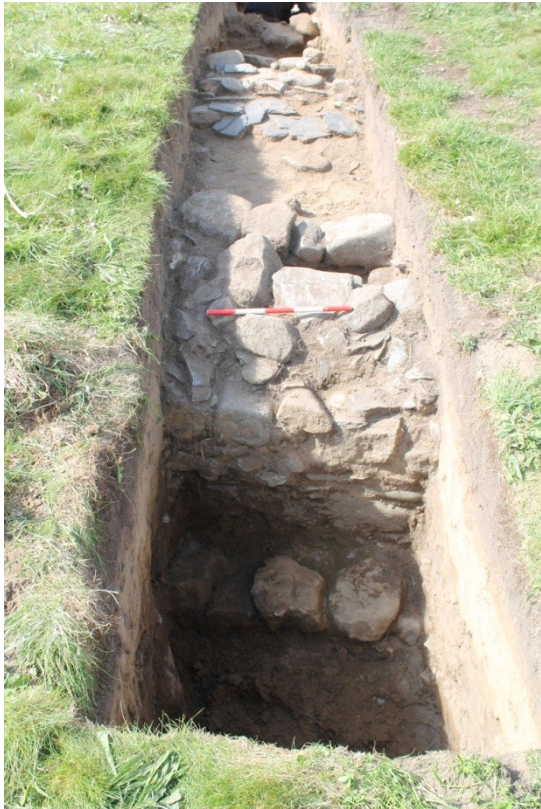
Photograph 16. Wall 17 in Trench 3.

Trench 3 was 1m wide and c. 23m long and ran across and to the north of the north wall of the Chapel (Figs. 5 and 7). Its aim was to assess the condition of the wall and to evaluate the potential for archaeological deposits and features to the north of the wall. The wall (17) was 0.72m wide and 1m high and was constructed from rounded beach boulders and angular slate/shale slabs (Photo. 16). There was no obvious bonding material. There was a 0.38m wide internal foundation offset and a 0.14m wide external foundation offset.

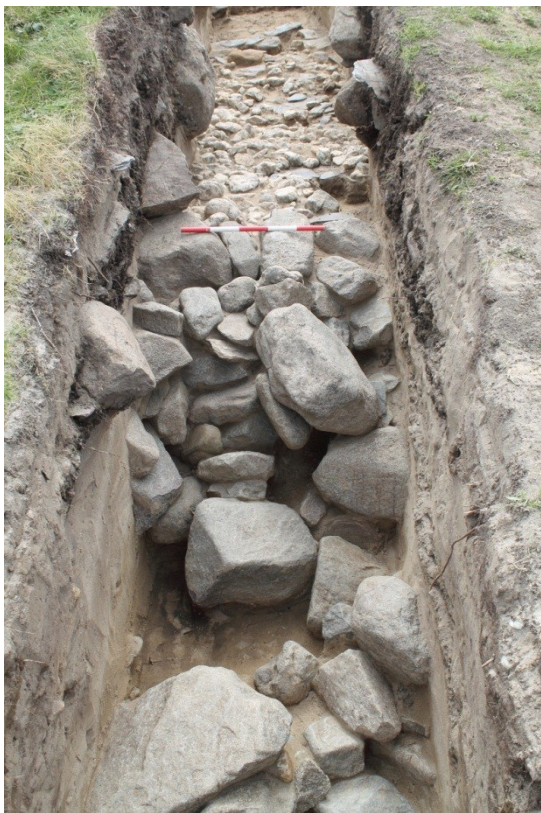
Photograph 17. The revetment wall 15 with the quartz/slate surface 14 beyond.

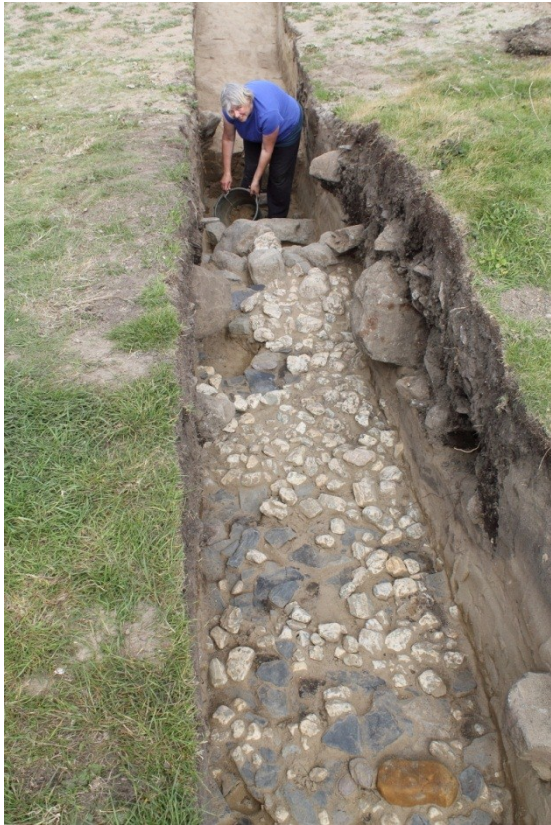
Photograph 18. The quartz/slate surface (14) in Trench 3.

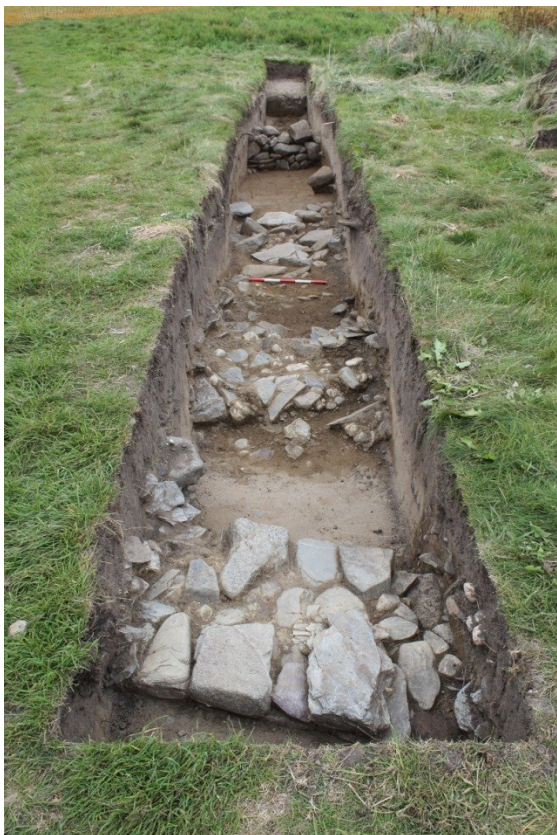
Photograph 19. Trench 4, with the south wall of the Chapel in the foreground, the quartz/stone layer beyond and the dry-stone wall (36) at the far end of the trench.

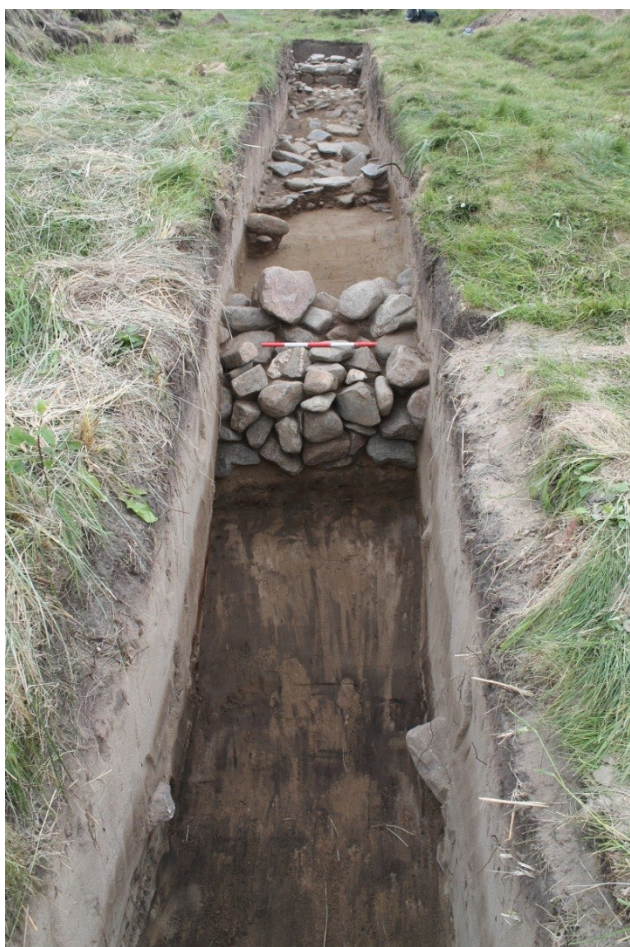
Photograph 20. Trench 4 with dry-stone wall 36 in the foreground.

A dry-stone wall (36 – Photo. 20) constructed from beach boulders lay c. 7.5m from the south wall of the Chapel resting on an old sandy soil (38). A rusty-brown coloured soil had developed against the south side of the wall.

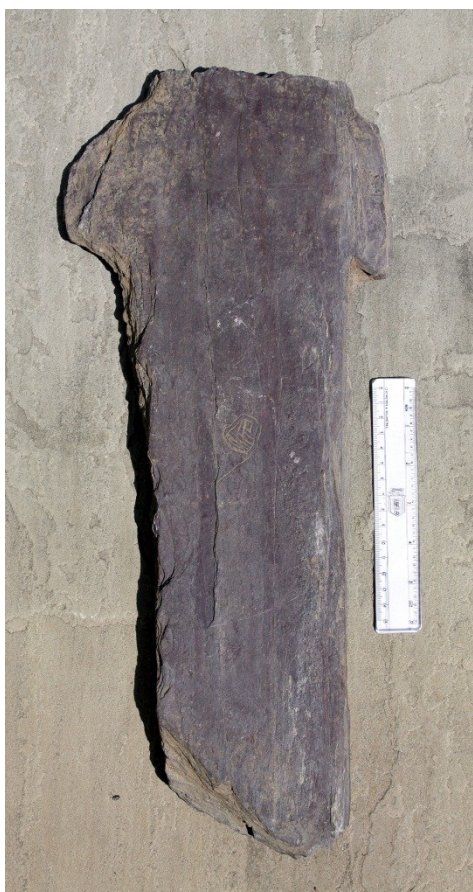
Photograph 23. Cross shaped stone (401) found on the beach below Trench 1.

402. Cross shaped stone, with a lightly incised cross on the face of the stone. A small panel of carved incisions below the cross could be an attempt at knot-work. Purplish coloured ?local slate/shale. 500mm x 210mm x 27mm. Found on the beach immediately below Trench 1 and also certainly eroded from one of the cist excavated cist graves during the winter storms of 2013-14. Photograph 23.

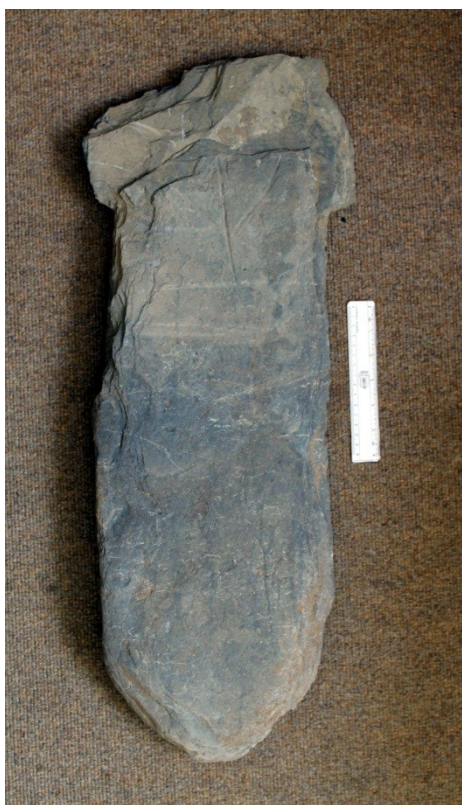
Photograph 24. Cross shaped stone (403) set upright at the west end of cist grave 26.

403. Grave marker. Cross shaped stone with the lower half of a coarse ring-cross incised on the face of the stone. The upper half of the cross is missing as the upper portion of the face of the stone has flaked off at the point where the cross arm was incised. 700mm x 270mm x 45mm. Bluish-grey local slate/shale. Set upright at the head end, west, of cist grave 26. Photograph 24.
