Rhos maen Hir, Standing stone  
1.75m high. Standing. as a  
dd gaterost next to a hedgebank  
in a field on Rhos farm.

Standing stone 1063  
Sketch.

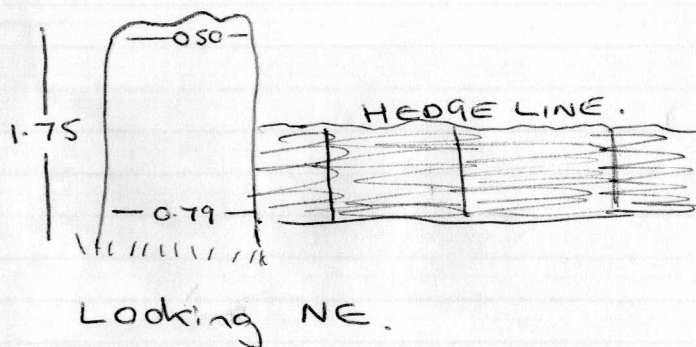
CONDITION OF STONE O.K. HOWEVER THE  
LAND ABOUT THE STONE IS IN A TERRIBLE  
STATE, ESPECIALLY THAT ON THE WESTERN  
SIDE OF THE STONE WHERE FARM  
VEHICLES ARE DRIVEN 'JUST PAST THE  
STONE FOR ACCESS TO THE ADJACENT  
FIELD. THE LAND TO THE EAST OF  
THE STONE IS ONLY SLIGHTLY BETTER.  
SUCH SEVERE EROSION COULD ONLY BE  
PREVENTED IF GATE WERE TO BE BLOCKED  
OFF AND NEW ACCESS POINT MADE.
