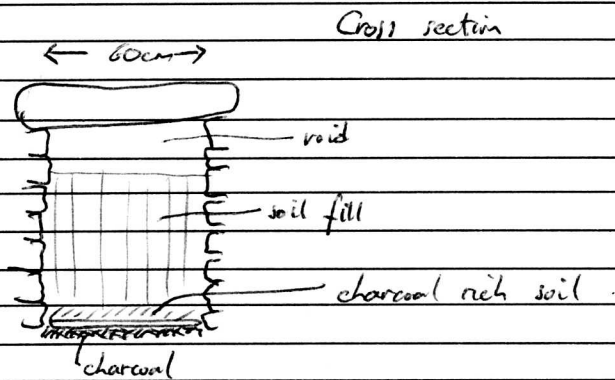
Called out by Mrs Phillips, Llystyn Farm, who owns land around Argoed, 9.7.93. Part of bank bulldozed away whilst constructing a new track. The land rises up steeply behind the bank/wall. The bulldozing had revealed a dry-stone walled chamber built into the bank behind the wall. A large stone  $\approx 0.8 \times 0.8 \times 0.2$  m covered the end of the chamber. The chamber itself was  $\approx 2$  m length internally,  $0.6$  m high wide and  $0.85$  m high. It was copped with large slabs as large as the piece described above. The base was formed with shale slabs over which was a  $5$  cm charcoal rich soil deposit. The remainder of the chamber was filled with a wash - "ploughsoil". Beneath the shale floor slabs was a  $\approx 3$  cm thick charcoal deposit. See sketch below. Mrs Phillips agreed to put the end stone back in place and ~~then~~ not continue to work upon it.

Unsure exactly what this is. Right size for a grave! More probably for storage. A potato clamp?
