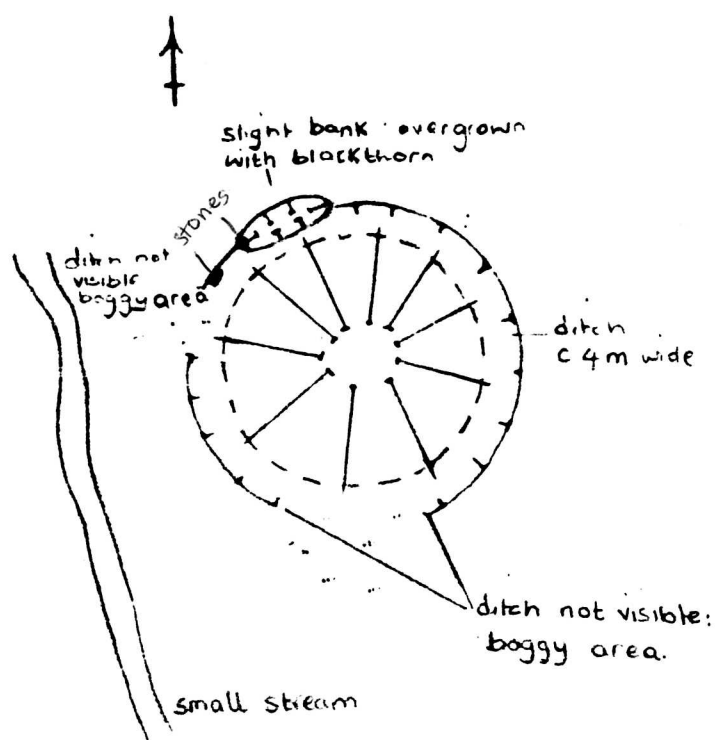
The Motte is still in a good state of preservation but overgrown with trees. It is surrounded by a silted up ditch ~0.3m deep and ~4.0m wide but is not continuous all around the motte where there are wet, boggy areas. Slight bank. The field is quite wet and has an irregular surface, possibly due to old stream courses.

- 2 large stones.

mound diameter base c 40m  
crown c 10m - 11m  
Height c. 5m

The field is under pasture + the motte itself is overgrown with trees and brambles

Mr Maccartney told us that they had plans to build in this field, but land within 30m radius from <sup>the</sup> crown of the motte was to be left untouched.
