Typical,  
Dryslwyn

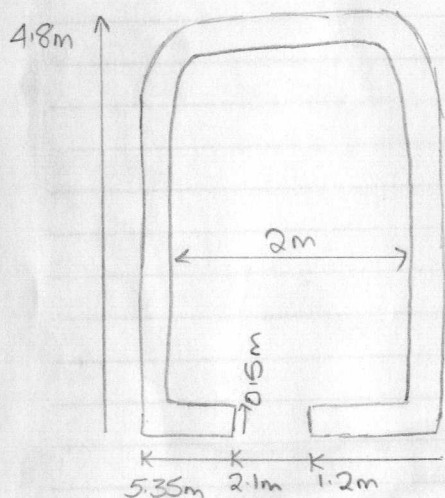
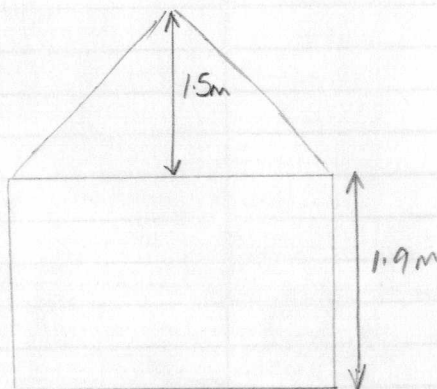
See GPs. 63-47A Facing 245° + 63-48A Facing East.

The stone foundations mentioned above are the remains of a hedge-line. There is no evidence of the existence of a chapel in the main field but the orchard has a small, single-storey building in the SW corner.

The western end of the building has rounded corners and is constructed from clom, a layer of rough stone has been built around the clom.

This could be the 'cawhouse' mentioned by the O.S.
