EXPLORATION TYWI! SITE RECORDING SHEET

Site Name: <u>BETWS Pill Box</u>		PRN: <u>109301</u>	
Community: <u>BETWS, AMMANUEWS</u>			
Site Type: <u>Pill Box</u>			
National Grid Reference: <u>SN 63981 11147</u>			
Sources: (Yes / No):			
Tithe Map ...	OS 1 st ed. ...	OS 2 nd ed. ...	Recent OS ...
Other (Please Specify):			
Date of recording: <u>25/02/2012</u>			
Recorded by: <u>A.D. COOMBE</u>			
<p>Site Description: What does it look like? What is it made of? What do you think it is? Any idea how old it is?</p> <p><u>Type 24 World War 2 Pill Box. Irregular hexagon shuttered concrete construction. Evidence of wood shoring on all walls and roof.</u></p> <p><u>Entrance faces angled road, Betws.</u></p> <p><u>Site now covered in scrub woodland which appears to post date Second World War</u></p> <p><u>Interior (photographed), not examined, as entrance steep and small.</u></p> <p><u>There is no evidence of any fittings associated with doorway or embrasures</u></p>

NW 2 PILL BOX

TYPE 24
IRREGULAR HEXAGON

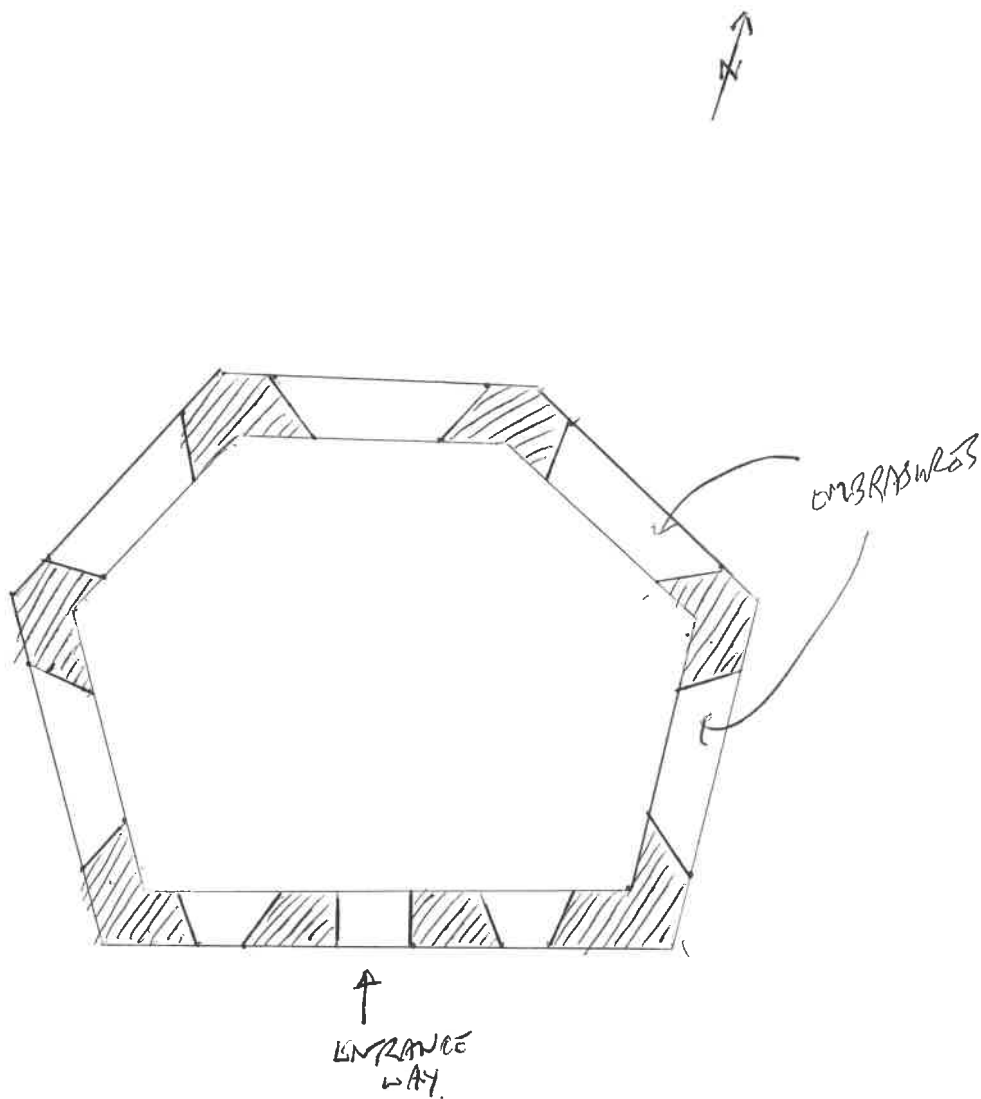
Detailed sketch plan / section: Show direction of North and approximate measurements

BARE CONCRETE
SHUTTERING MARKS CLEARLY VISIBLE
NO DISCERNIBLE INTERNAL DIVISION/WALL
NOT ENTERED BECAUSE OF STEEP
SLIPPERY SLOPE AND SMALL
ENTRANCE.

APPEARS COMPLETE
NO SIGNIFICANT DAMAGE
ROOF NOT EXAMINED IN DETAIL AS
COVERED BY 50cm OF ACCUMULATED
VEGETATION DEBRIS
FLOOR NOT EXAMINED SOME LITTER
AND MUCH VEGETATION DEBRIS
SURROUNDED BY SCRUB WOODLAND
ONE LARGE TREE ABUTTING
EAST FACING WALL WITH
ROOTS PROBABLY UNDERNEATH
