Dave Rogerson
Ecologist and licensed consultant, MICEEM
Broncastell, Ponterwyd, Aberystwyth, SY23 3LA
01970 890 683, 07855386872
License No.: 49458:OTH:CSAB:2013

6/11/14

Re: Bat scoping survey- Out Building at Ffynnon Dderw

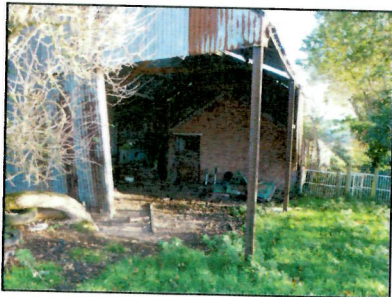
Fig. 1: The front elevation

- The eave of the front gable are relatively sealed, with a few possible access points. The side walls eaves have ample access opportunities as the roof is corrugated. However there is much cobwebbing, suggesting a lack of use.

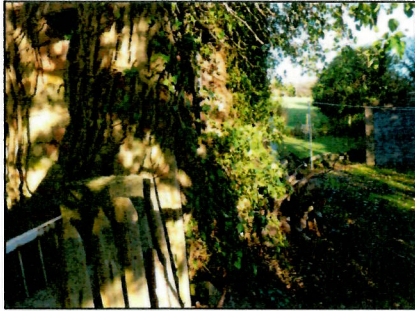
Fig 6: Rear gable note ivy growth

- The external survey found that the walls are made from brick, and are well pointed, although some of the brick are deteriorating. All crevices and flat surfaces were checked for bat sign, none was found. The northern elevation of the out building has a tin shed attached, this could not be inspected as the entrance was from the next door neighbors garden. The southern elevation was checked and found to be well pointed, with excessive ivy growth on the south eastern corner. The rear gable is covered in ivy, this could not be checked as it is in the neighbors garden, however that amount of ivy growth would stop any bats using the area.

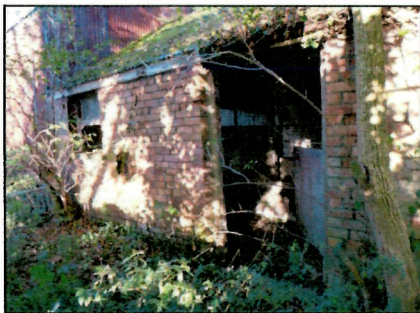
Fig. 8: Southern elevation

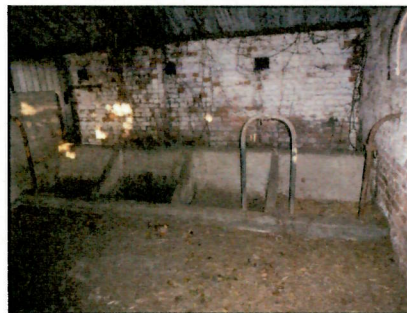
Fig.9: Internal area

- All windows, doors and lintels were checked for bat sign, none was found. Note that the windows are broken providing ample access into the building
- The internal walls are white washed, and there still remains four stalls for cattle, all flat surfaces within the buildings were checked for bat sign, none was found. There are no access points into the walls.
