CWMFELIN BOETH HARDSTANDING NORTH OF ROMAN ROAD CROSSING

POSTSCRIPT TO REPORT

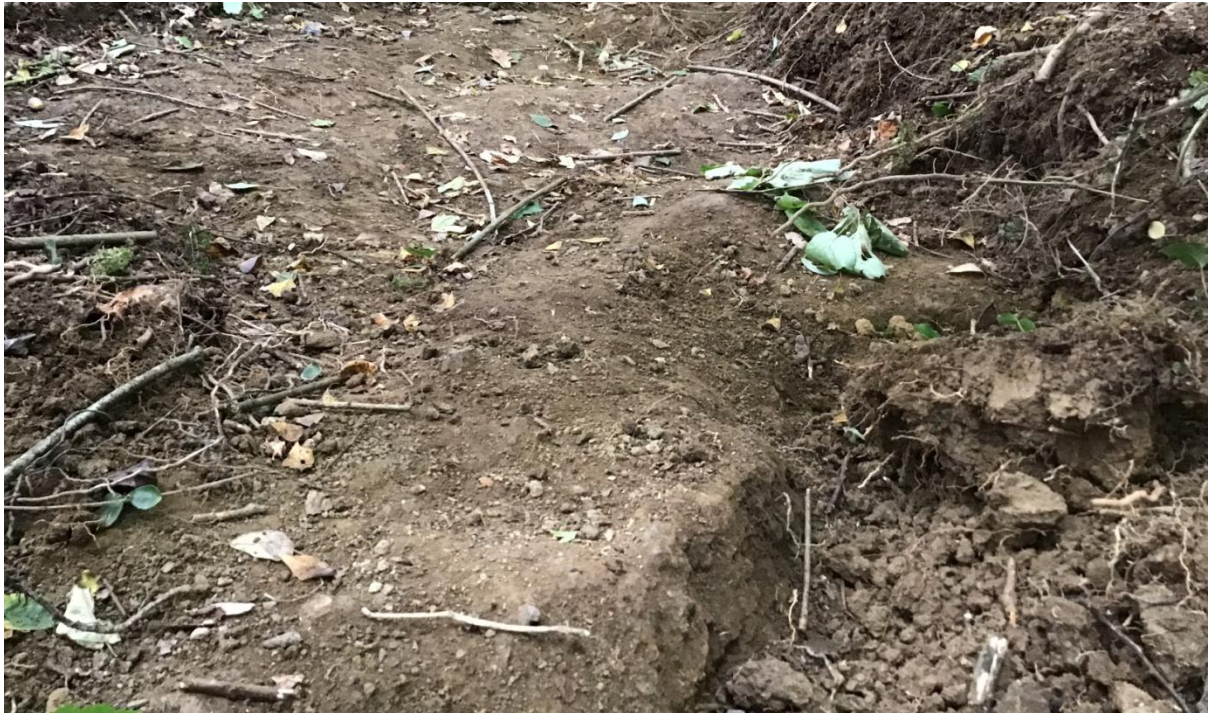
There was a slight rounded ridge in the surface of the hardstanding running north towards the stream from the verges.

This was similar to a ridge you might get in tarmac if a large tree root was forcing its way up. But there were no cracks or road damage. The ridge runs in direction from the bottom left corner to the top right corner in the photo below.

The ridge could indicate a shallow overflow pipe and the zigzag verges could be the edges of pits where there were once tanks or vats of some kind.

This would raise the possibility of a wet process such as a tannery.

Looking under the stream overhangs with a torch to see if any pipe outlets can be seen.

Exploring upstream to see if a leat outlet in the east bank can be found.
