Informed by excavations that began nearly 40 years ago, a village of roundhouses has been built on a Welsh Iron Age hillfort. Harold Mytum found the first house. He and James Meek have excavated its modern reconstruction

The inland promontory of Castell Henllys was home to a community between the fifth and the second or first centuries BC. The settlement was defined not only by topography but also, first, a timber palisade fence, and then an arrangement of banks and ditches whose effect was augmented by steepening the promontory's natural slopes. At the time it was a common form of settlement in south-west Wales. Today, however, the site is unique: it has been partially reconstructed, it is open to the public and, since 1992 when taken over by the Pembrokeshire Coast

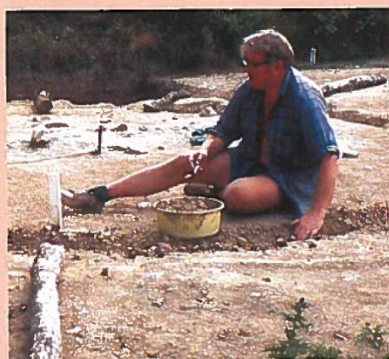
Below: Hugh Foster in 1983 working on a roundhouse reconstruction

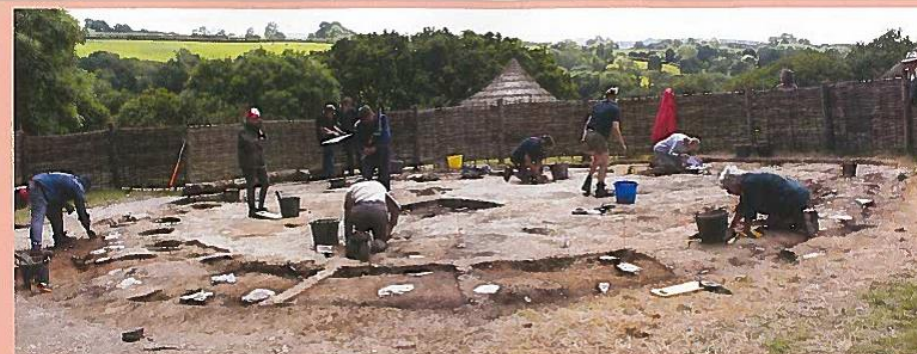
Above: Site of Roundhouse's under excavation in 2017

Excavation revealed how the eaves drip gullies had gradually filled up with debris, and where they were cleaned out – a process not maintained through the whole life of the roundhouse – they were not always dug on quite the same line and depth. Indeed, within the gully we found some of the plastic disks attached to the bundles of thatch that had had to be imported from Hungary at short notice when Hugh Foster discovered that not enough local reed had been harvested to complete the roof. These had survived in the deposits for 35 years, and represent items from the building's construction phase. Interestingly,

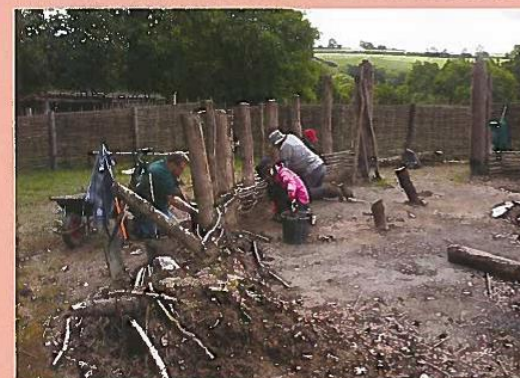
Left: Investigating part of the still-standing Roundhouse's

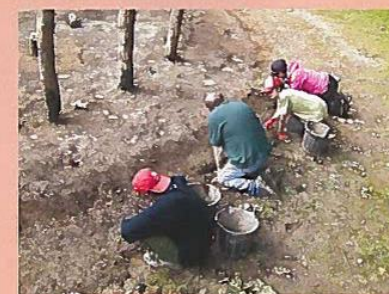
Above: Excavating where the eaves came close to the ground; the ground falls away sharply where water run off the roof

further deposits accumulated in the space between the wall's outer face and where the thatch roof came close to the ground. These were probably partly what remained of daub that was unused during construction or maintenance, or had fallen off the walls, but they also comprised decomposed leaves and dust blown in and settled in the protected location over the 35 years.

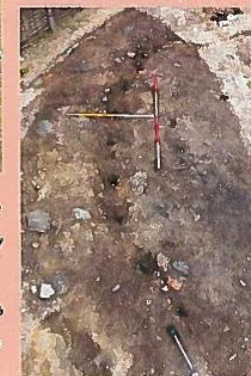
Right: Wall line with postholes of 1982 house reconstruction excavated in 2017 (long scale 2m)

years, the front part of the wall line and the inner ring of posts were replaced, sadly by over-engineered timbers set in much deeper postholes (quite unlike those indicated by the archaeology), with the roof jacked up while this took place. Despite this effort (or perhaps in part at least because of it), the building developed a twisted roof, and flat stones were placed under the timbers to help prop it up, with other timbers added to the roof intended to prevent further movement.

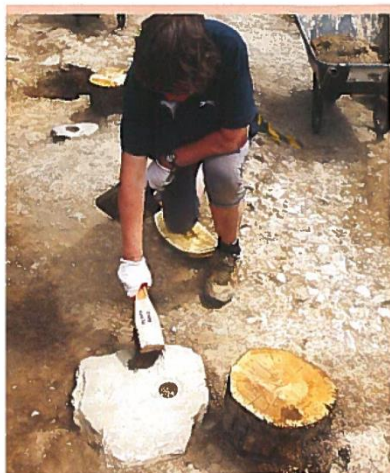
Above: Pivot stones used in the door reconstructions, next to a recently replaced door post

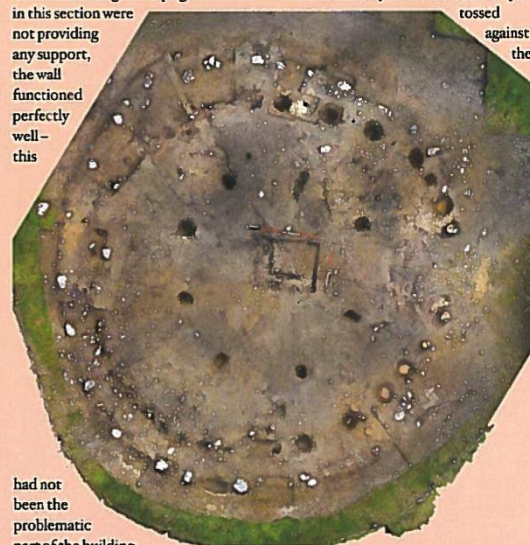
Right: Vertical view of Roundhouse 1 at the end of the excavation; contrast the original reconstruction wall line on left with the later attempt at stabilising the building on right

Parts of the wall were still standing when we arrived, so we carefully dismantled these. The wattle in the replacement wall section was still flexible and was in remarkably good condition, but the uprights, although intact, were already showing clear signs of rotting through at ground level. Those posts from the original building were completely rotted through – the wall was by this stage largely a daub structure. Though the upright timbers in this section were not providing any support, the wall functioned perfectly well – this

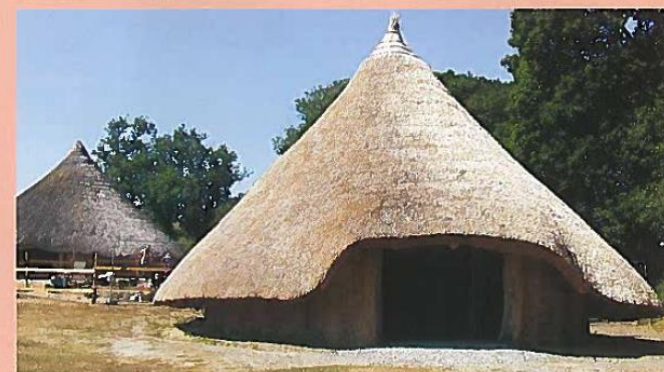
Below: A new reconstructed roundhouse in 2018, on the site of the original reconstruction and the first excavated Iron Age house

reconstructions. It will be rebuilt in 2019, this time in accordance with the original archaeological evidence and combined with our direct experience of decades of buildings management. In a few decades it will have become another valid experiment open to investigation.
