# ROC MUSEUM - POST VISIT FORM.

Post Name CROSSWOOD Final Desig: 13/10 Date of Visit 07/09/00 Time 14:20

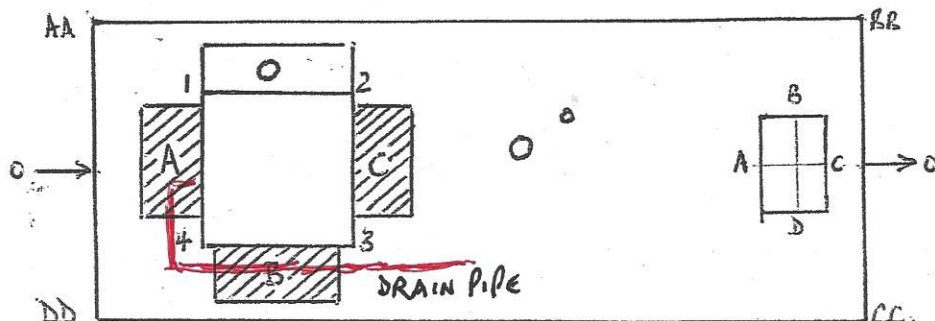
Condition of Post: NEW GALVANISED HATCH EXTERNAL HATCH ALMOST TOO LARGE OVERLAPPED AT 1-4

condition: SOME RUST - PAINT LT GREEN EXCELLENT.

Operational equipment on site: CONCRETE SURROUND BADLY CRACKED

BPE PIPE HAS CONCRETE BASE. GZE ON RAISED BASE

Non-standard features: CUT-OUT BASE OF VENTILATOR FOR AERIAL

FSM PIPE CIRCULAR CONCRETE BASE - PLAIN TOP LOCATED WITH PINS
