# Dolaucothi Forestry, Carmarthenshire

## ARCHAEOLOGICAL SURVEY

**N W Jones**  
December 2006

Report for Forestry Commission Wales

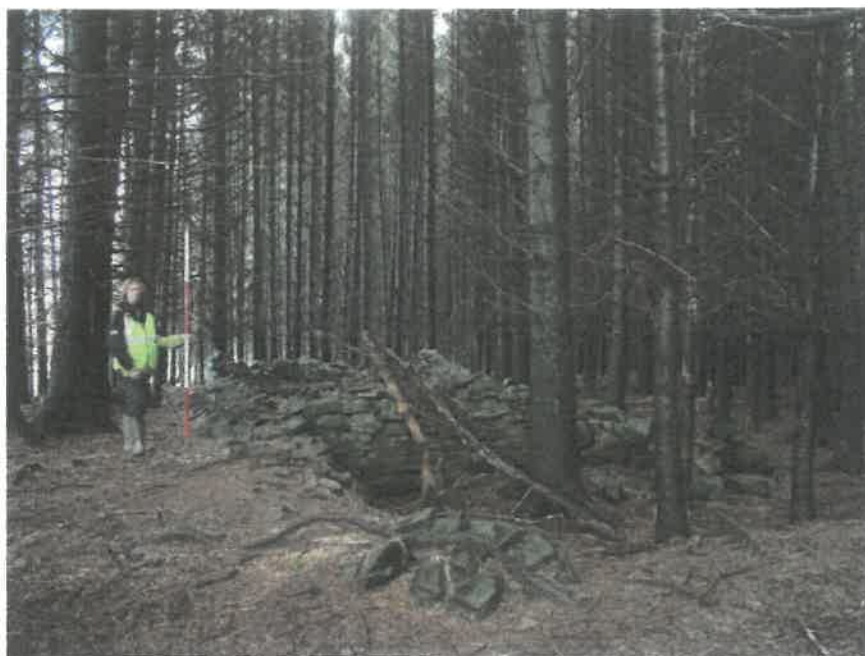
The field survey identified the ruins of a dry-stone walled building measuring 12.9m by 6.3m externally, with the walling surviving to a height of 1.1m. Internally the building is divided into two rooms with a lobby entrance on the south side, opposite the dividing wall which probably contained the fireplace and chimney. A short length of walling projects from the north-west corner, suggesting a lean-to which was cut into the slope. A curving holloway approaches the building from the north-east, although the main access appears to have been via a track from the south, of which there is now no trace. There is a small, walled, garden enclosure adjoining the south side of the building. The farmstead is also recorded with an overall number of PRN 36447.

Saplings and fallen branches within building. Planting is in close proximity.

PRN 30179 Hen Llust. Photo CPAT 2282-002

Clear saplings and branches. Monitor and preserve in situ. Fence during felling operations and exclude site and wider area from replanting.

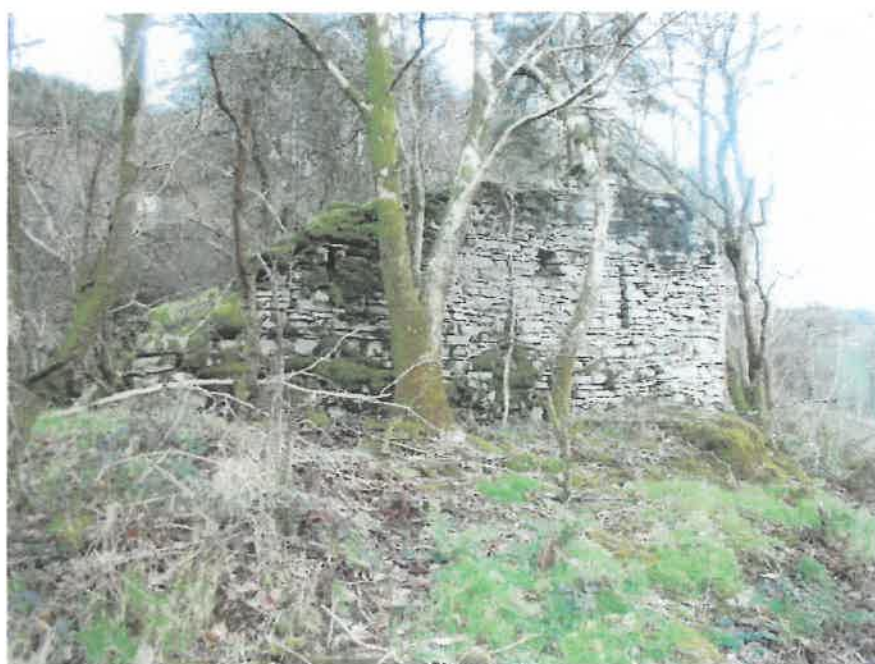
The field survey identified the ruins of a stone-built barn 6.8m wide and at least 8m long, comprising the southern gable with three ventilation slits, standing to 2.5m in height, with walls up to 0.8m thick. There is little evidence for the side walls and no trace of the northern gable. The barn is sited on a level platform with a steep slope below to the south-east and a former track to Blaen Rhisglog on the west. The Ordnance Survey recorded the barn in 1888, but by 1905 the northern gable end had been lost.

Saplings and fallen branches within building.

PRN 62317 Blaen Rhisglog barn. Photo CPAT 2282-008

Clear saplings and branches. Monitor and preserve in situ. Exclude from future planting.

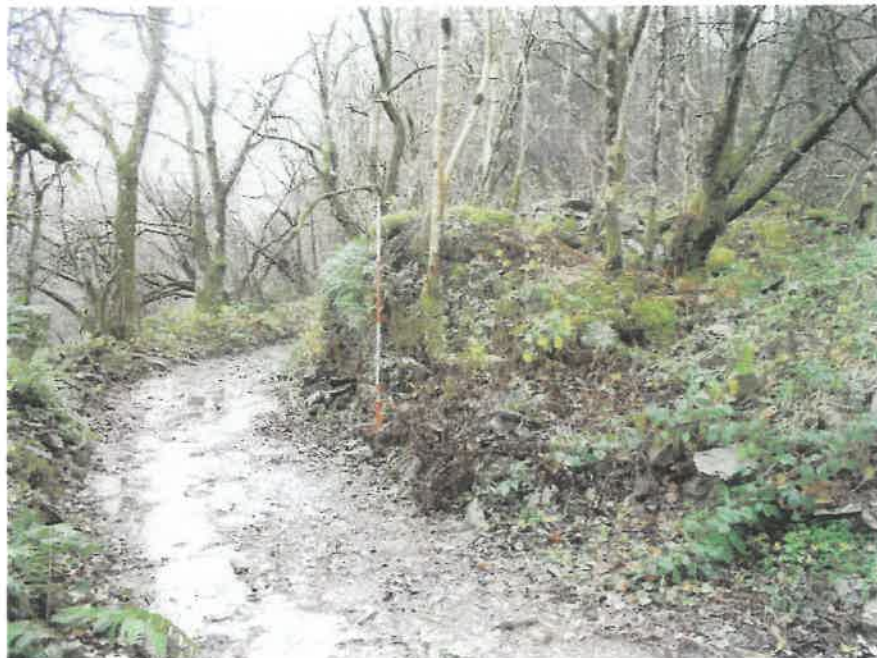
The field survey identified the ruins of a substantial stone-built farmhouse measuring 16.5m by 6m externally and divided into three bays. The house is aligned east to west and the eastern gable stands to a height of 2m above a track. Much of the walling and internal detail was obscured by rubble and vegetation.

Fallen branches and saplings within building.

PRN 30183 Erw-lwyd and adjacent track. Photo CPAT 2282-010

Clear vegetation. Monitor and preserve site in situ. Fence off during any felling operations and exclude from future planting.

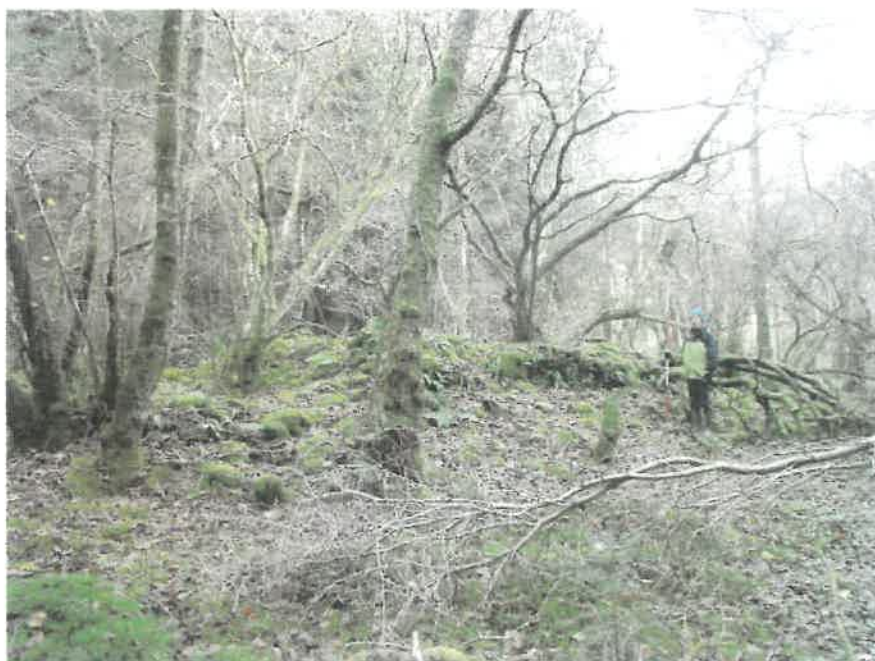
Fallen trees on some of site. Building overgrown.

PRN 6965 Waun-fawr. Photo CPAT 2282-015

Clear fallen trees and saplings. Monitor and preserve site in situ. Fence off during any felling operations and exclude from future planting.

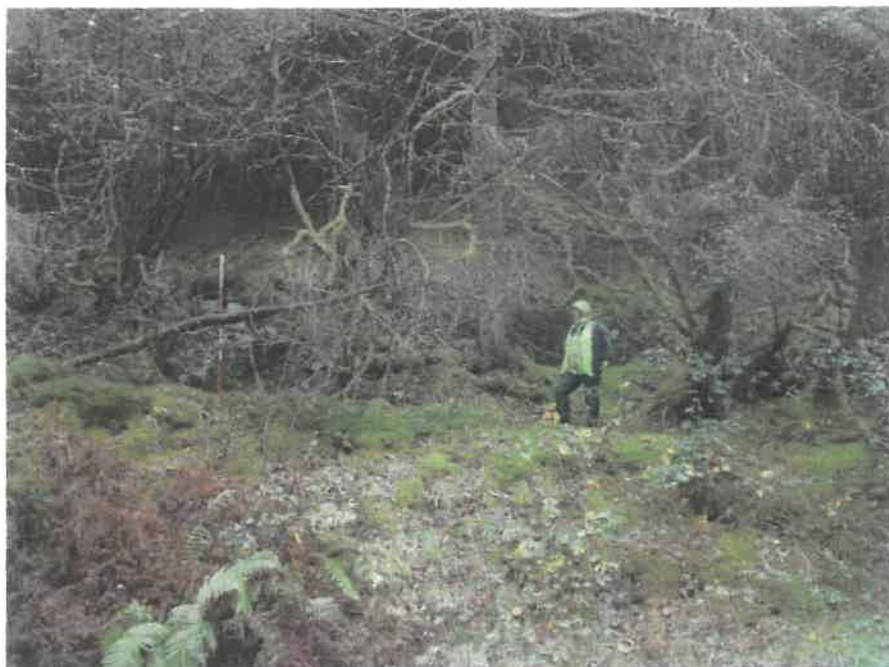
PRN 36437      Grofft building. Photo CPAT 2282-009

Clear fallen trees and saplings. Monitor and preserve site in situ. Fence off during any felling operations and exclude from future planting.

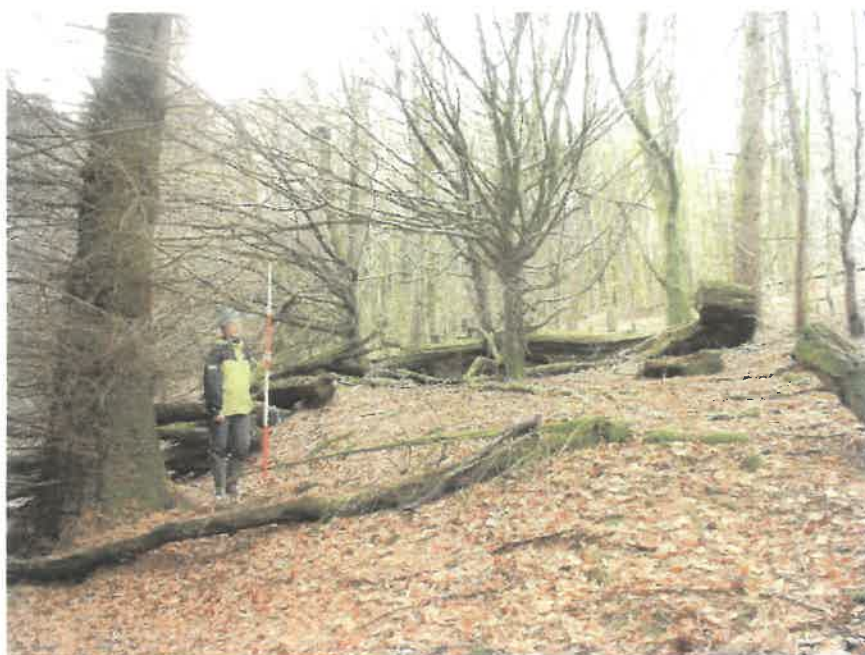
PRN 62323 Cwm-dyfio house site. Photo CPAT 2282-021

Clear fallen trees. Monitor and preserve site in situ. Fence off during any felling operations and exclude from future planting.

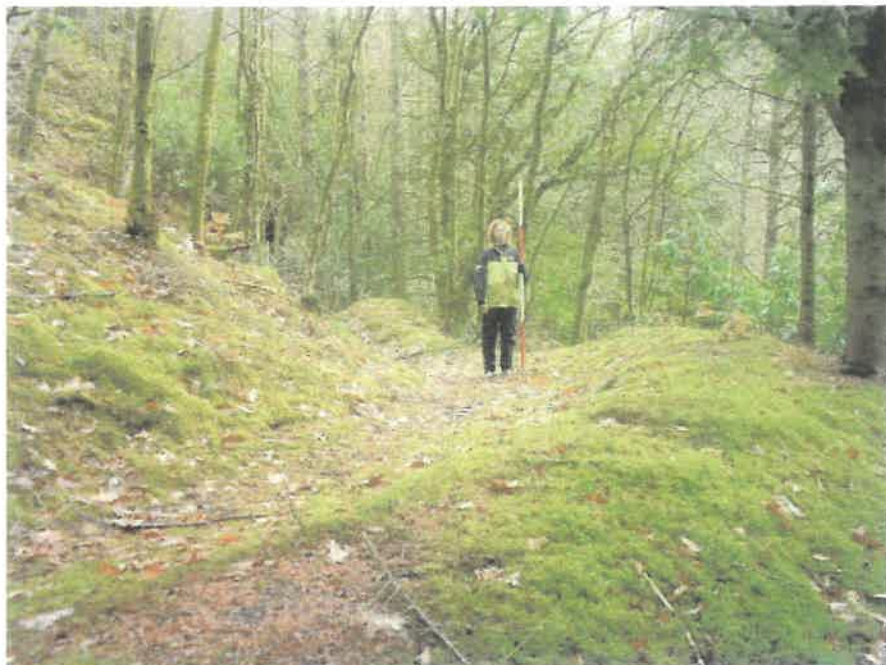
PRN 1948 Allt Cwmhenog Cothi leat. Photo CPAT 2282-027

Carefully remove trees and leave unplanted. Undertake measured survey, monitor and preserve in situ.

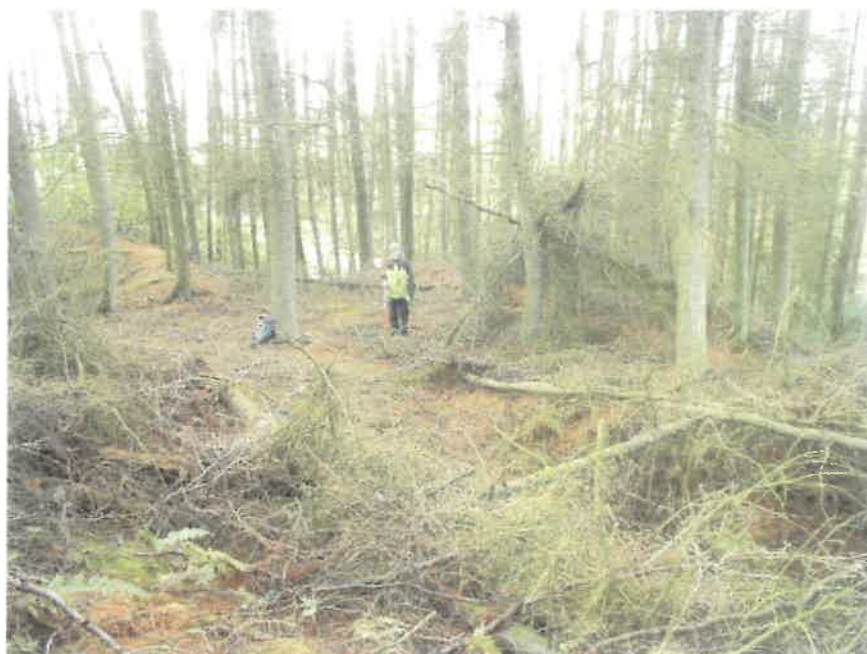
The reservoir is planted with larch and some damage has already resulted from wind blown trees.

PRN 62326 Allt Cwmhenog Tank B. Photo CPAT 2282-033

Carefully remove larch and leave unplanted. Undertake measured survey, monitor and preserve in situ.

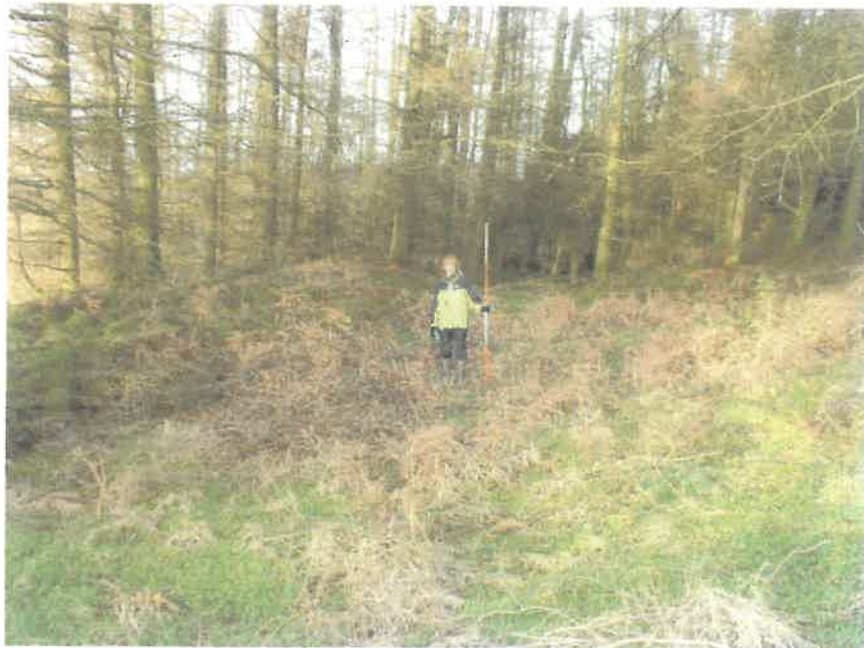
The reservoir is planted with larch and some damage has already resulted from wind blown trees.

PRN 62329 Allt Cwmhenog Tank G. Photo CPAT 2282-037

Carefully remove larch and leave unplanted. Undertake measured survey, monitor and preserve in situ.

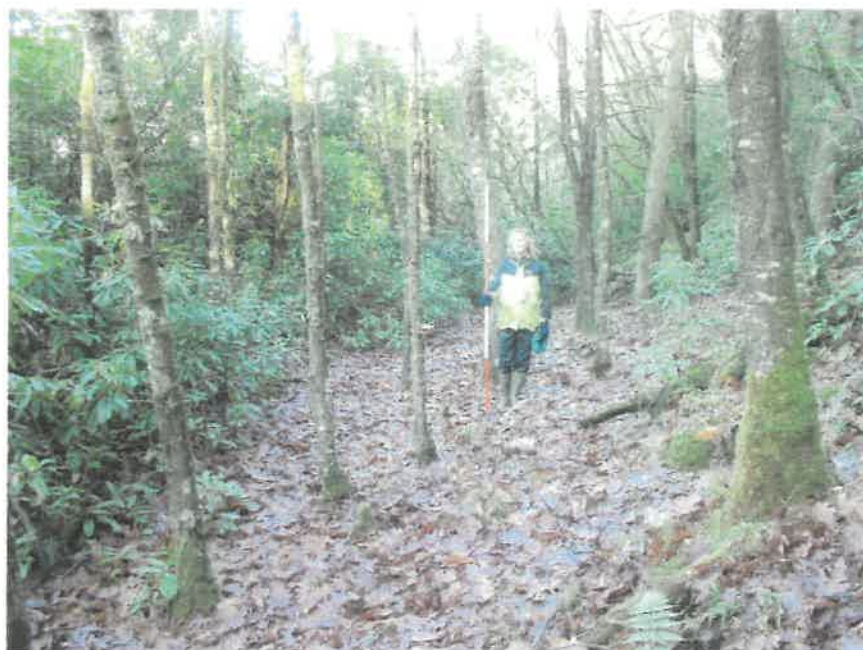
PRN 62330 Allt Cwmhenog Tank Q. Photo CPAT 2282-034

Carefully remove trees and leave unplanted. Undertake measured survey, monitor and preserve in situ.

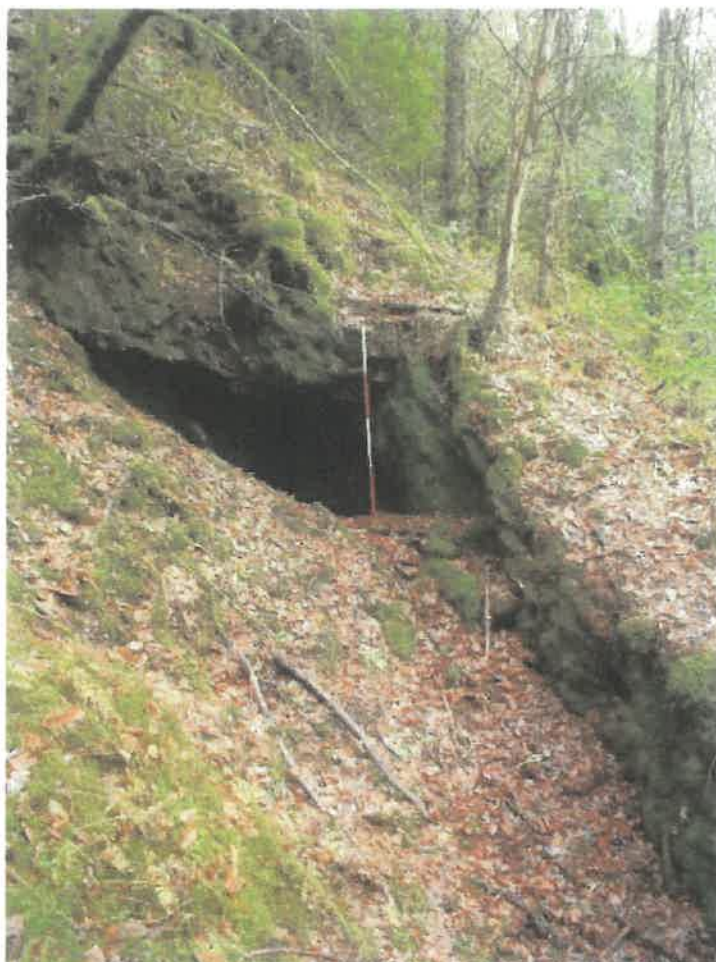
PRN 62334 Allt Cwmhenog Adit 1. Photo CPAT 2282-029

Carefully remove trees and rhododendron and leave unplanted. Measured survey, monitor and preserve in situ.

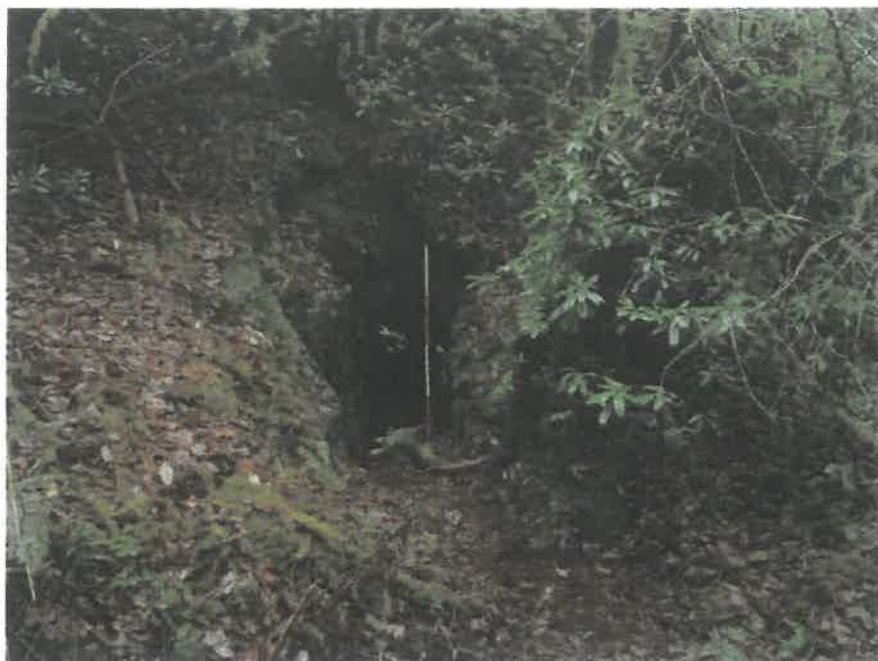
PRN 62335 Allt Cwmhenog Adit 2. Photo CPAT 2282-040

Carefully remove trees and rhododendron and leave unplanted. Undertake measured survey, monitor and preserve in situ.

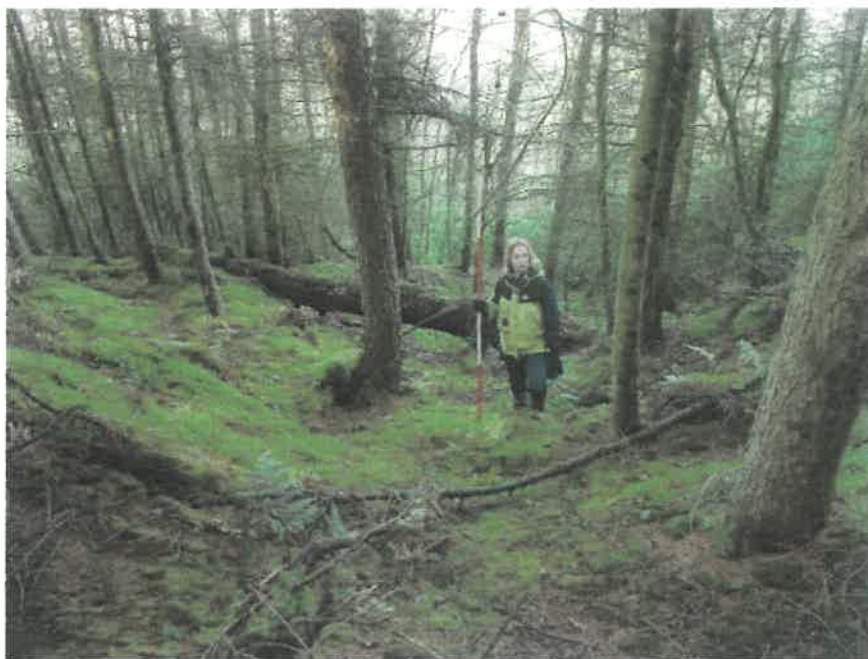
PRN 62338 Allt Cwmhenog Hush 1 with leat PRN 62336 lead off to the left.  
Photo CPAT 2282-035

Carefully remove trees and leave unplanted. Undertake measured survey, monitor and preserve in situ.

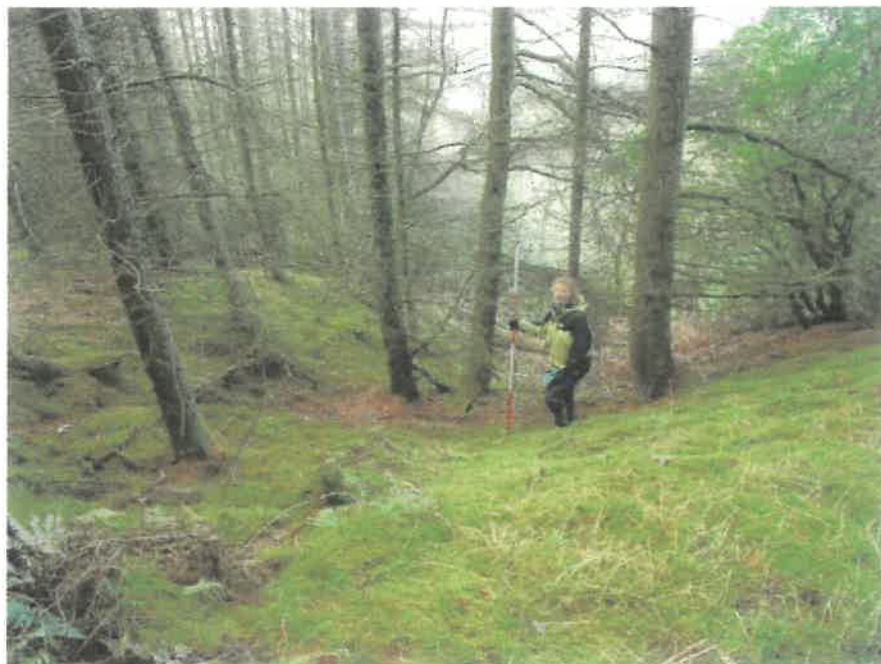
PRN 62339 Allt Cwmhenog Hush 2. Photo CPAT 2282-002

Carefully remove trees and leave unplanted. Undertake measured survey, monitor and preserve in situ.

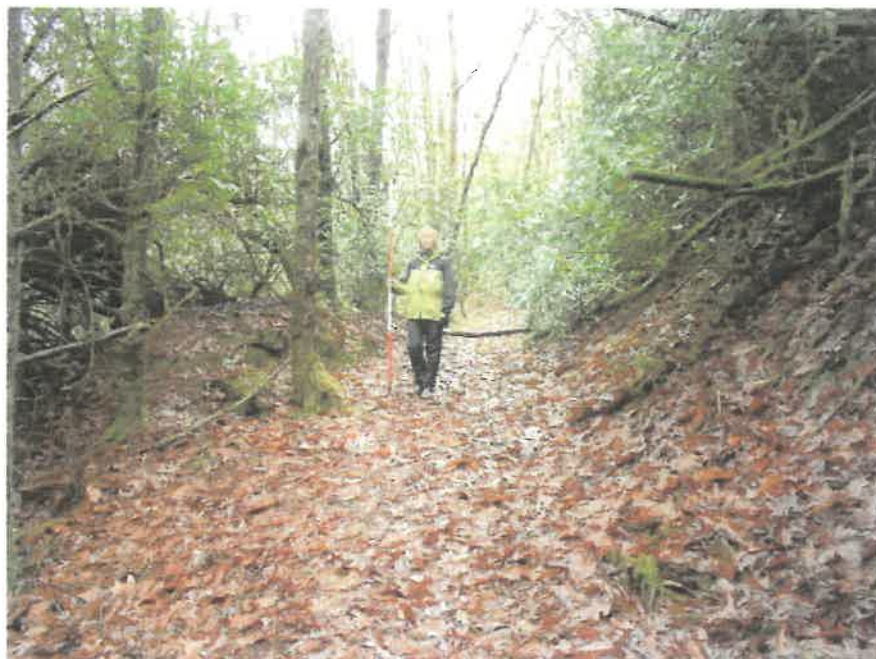
A short section of straight pathway c. 2-3m wide has been recorded as a possible leat branching from the Cothi leat (PRN 1948) above (Plunkett-Dillon & Swanson 1998, 89-90, no. 80398). The recent field survey suggests that this is likely to be part of a track which leads down from the Cothi leat, initially in zigzags, and then at a gradual angle, crossing several of the hushing channels (PRN 62340) below the opencast workings and leading to a platform (PRN 62344). At a point 30m east of the platform the track is joined by another descending from the lower opencast workings (PRN62327). The upper part of the track lies within the area of Scheduled Ancient Monument CM 200.

PRN 62342 Allt Cwmhenog track 1. Photo CPAT 2282-023

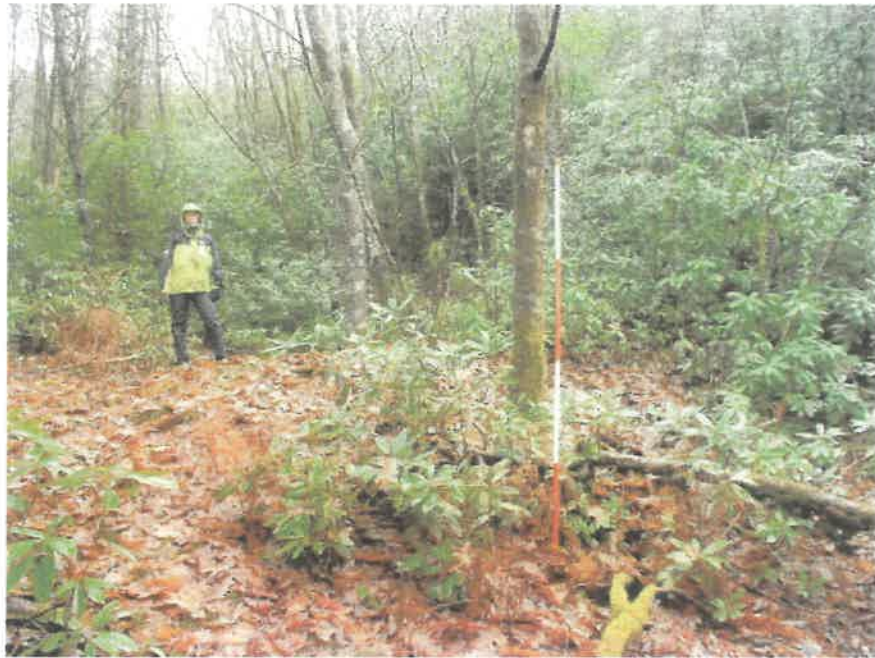
PRN 62344 Allt Cwmhenog platform. Photo CPAT 2282-022

Carefully remove trees and rhododendron and leave unplanted. Undertake measured survey, monitor and preserve in situ.

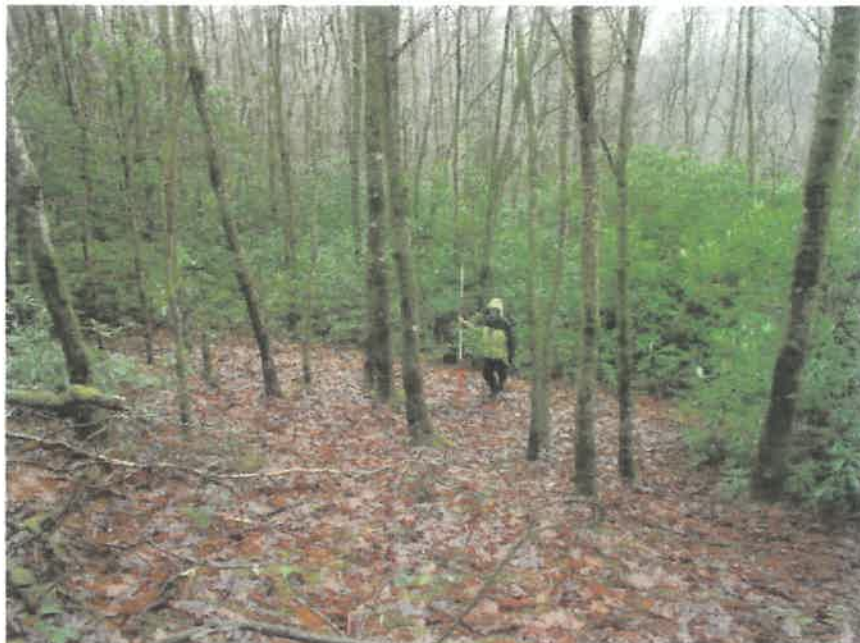
A level terrace *c.* 2.5m wide can be identified running for around 45m, parallel to but below the Cothi leat. Although it has been suggested that this fed water to Tank B (PRN 62326), there is no evidence to support this (Plunkett-Dillon & Swanson 1998, 131, no. 80536).

PRN 62345 Allt Cwmhenog leat 3. Photo CPAT 2282-042

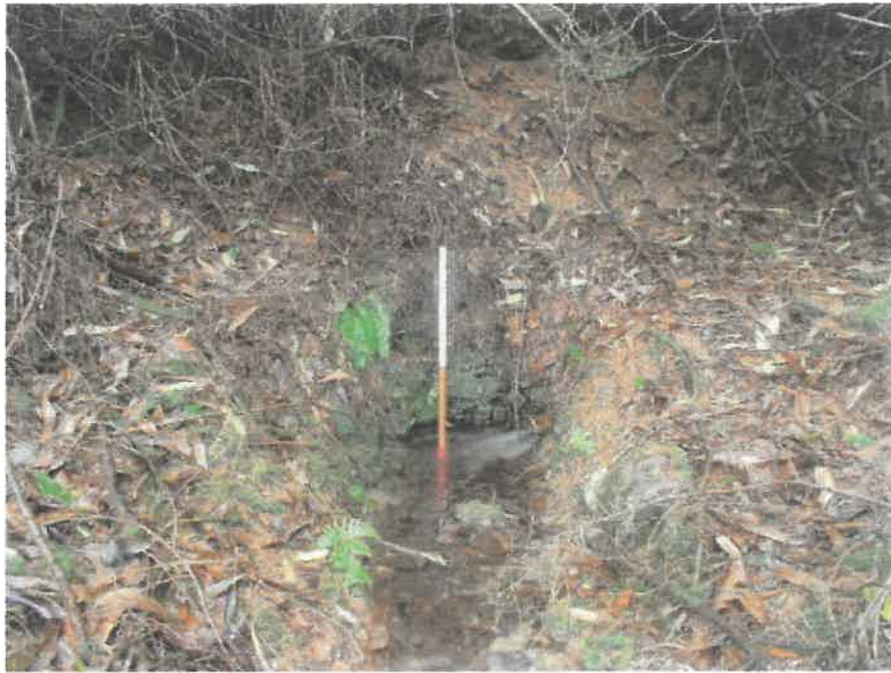
PRN 62348 Allt Cwmhenog Well. Photo CPAT 2282-014

Clear rhododendron. Monitor and preserve in situ.
