**PE011 CARN INGLI CAMP SCHEDULED MONUMENT:**  
**RECONSOLIDATION OF DISTURBED RAMPART COMPLETION**  
**REPORT**

**Prepared on behalf of the Pembrokeshire Coast National Authority by Tomos  
Jones, Community Archaeologist.**

**30 June 2022**

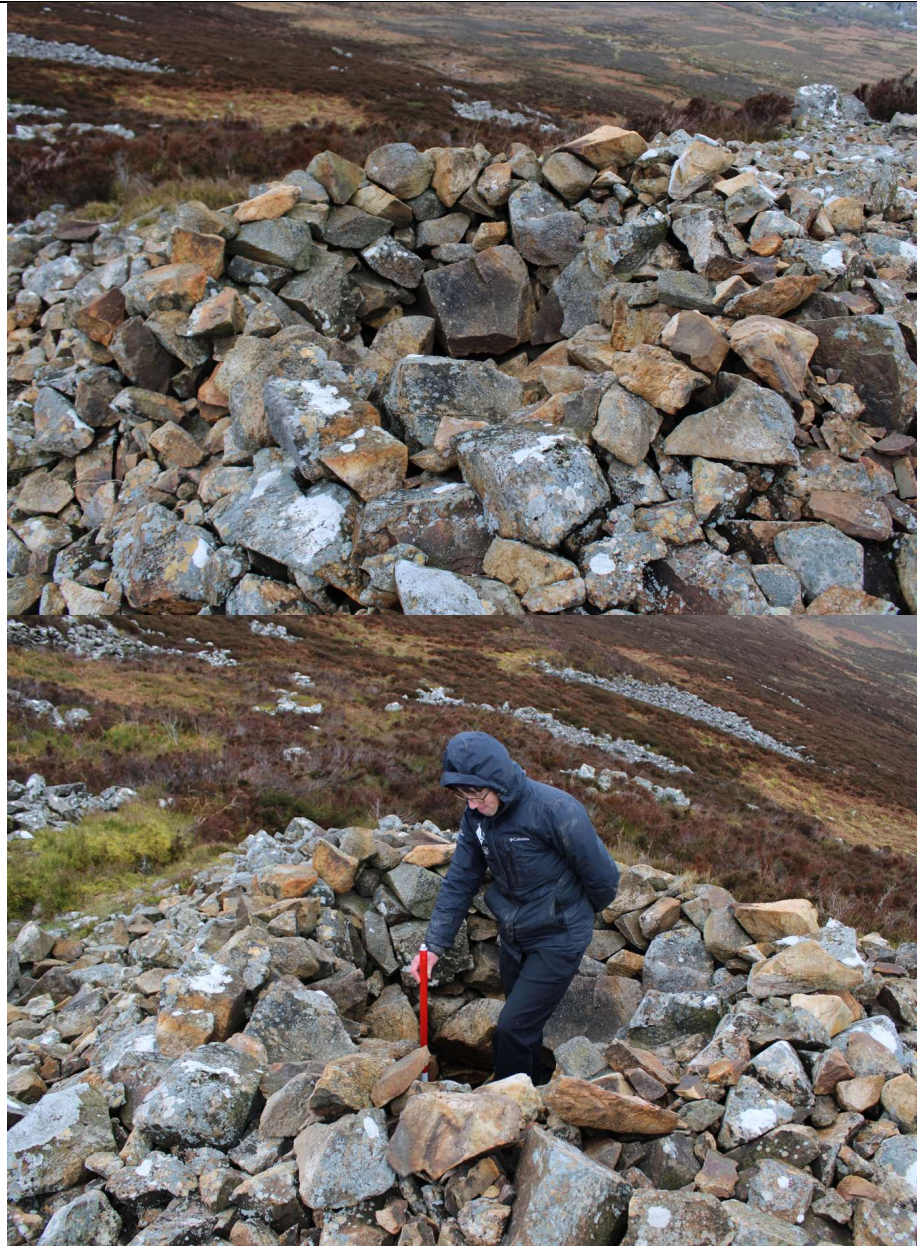
On the 10<sup>th</sup> of March 2022, the National Park Authority community archaeologist and two heritage volunteers identified a depression within one of the ramparts on the north-eastern side of the monument (at location SN 06314 37384) (see figure 1) (see figure 2 for photograph). Upon identifying the disturbance, the issue was reported as a heritage crime to the police by the community archaeologist on the 29<sup>th</sup> of March 2022 (police crime reference DPP/2351/29/03/2022/02/C). In addition, Cadw and the Dyfed Archaeological Trust were made aware of the issue. The community archaeologist also made a request to Cadw to undertake repair work to infill the depression with stones that had been removed. On the 5<sup>th</sup> of May 2022, Cadw provided consent to carry out the work.

**Figure 2: Photographs showing depression in one of the north-eastern ramparts. In the bottom image, the ranger is holding a 1m ranging rod from the base of the depression to indicate depth.**

- Disturbed stones adjacent and forming part of a rim around the depression were used to infill the depression. As part of the infilling process, stones with lichen present on the surface of stones were used face up to cover the top of the infill.
- Photographs showing before and after are provided below (figure 3).

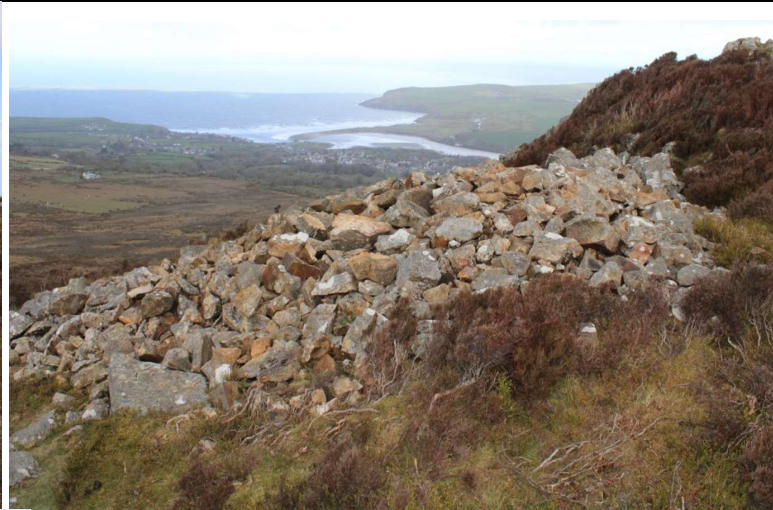
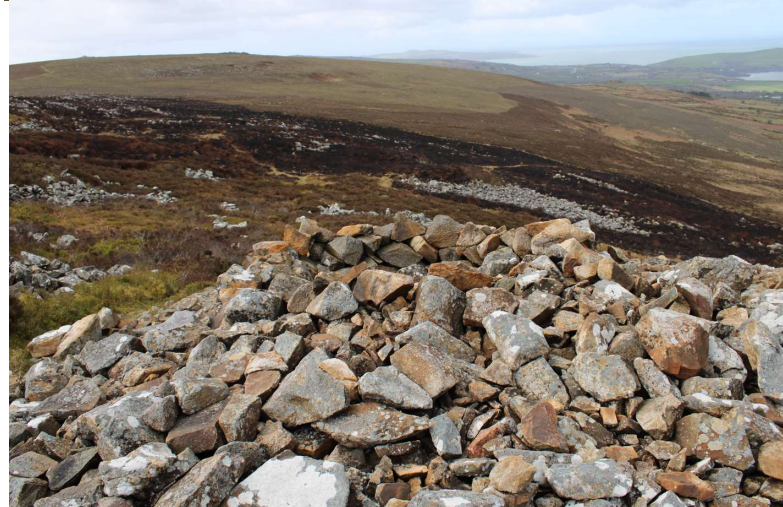
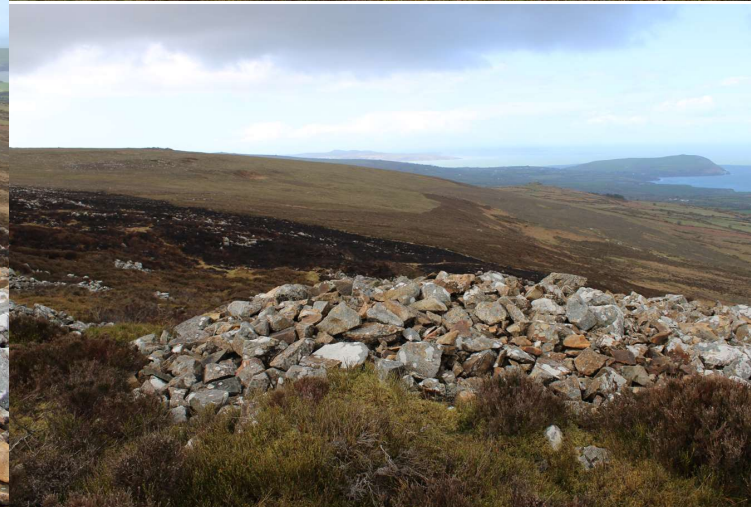
**Figure 3: Photographs showing the rampart with the depression (top left – looking north, bottom left – looking west) and after infilling (top right – looking north, bottom right – looking west).**
