PE544 CARN BRIW ROUND CAIRN SCHEDULED MONUMENT:
RECONSOLIDATION WORK OF CAIRN

Prepared on behalf of the Pembrokeshire Coast National Authority by Tomos Jones, Community Archaeologist.

03 October 2022

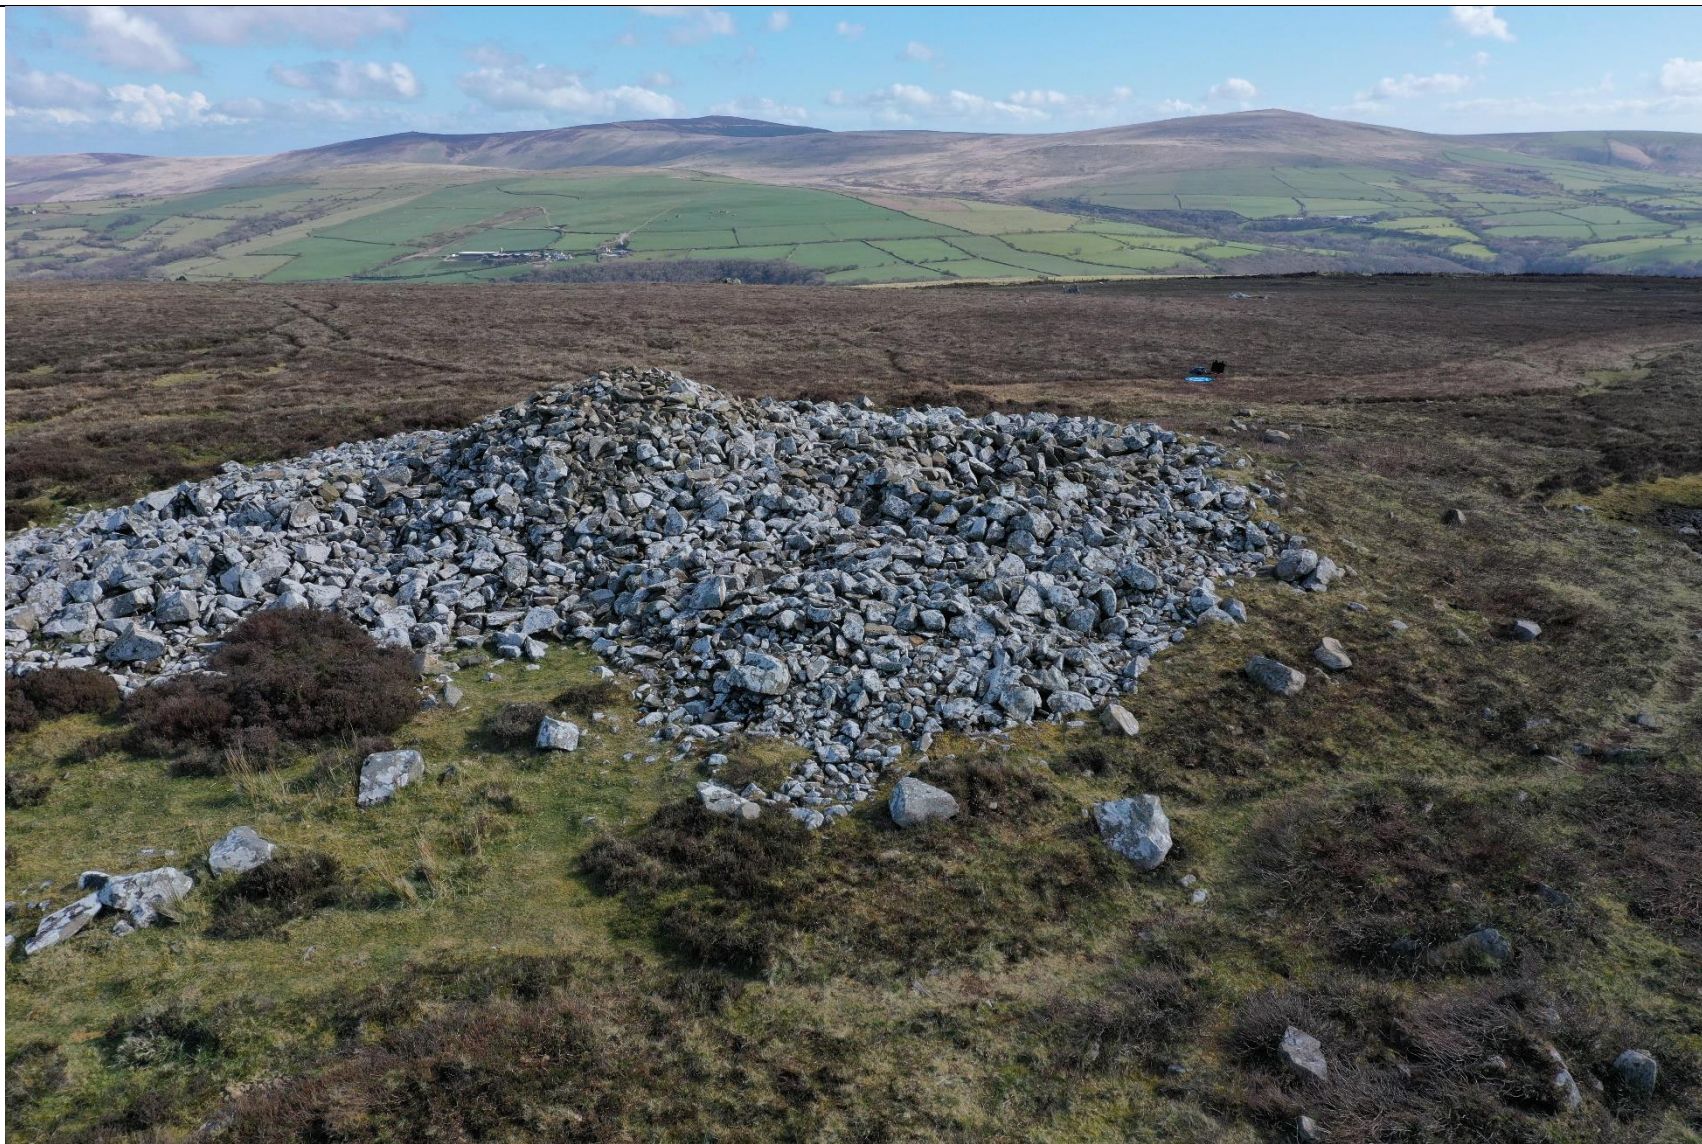
Figure 3. Monument towards south after reconsolidation work.

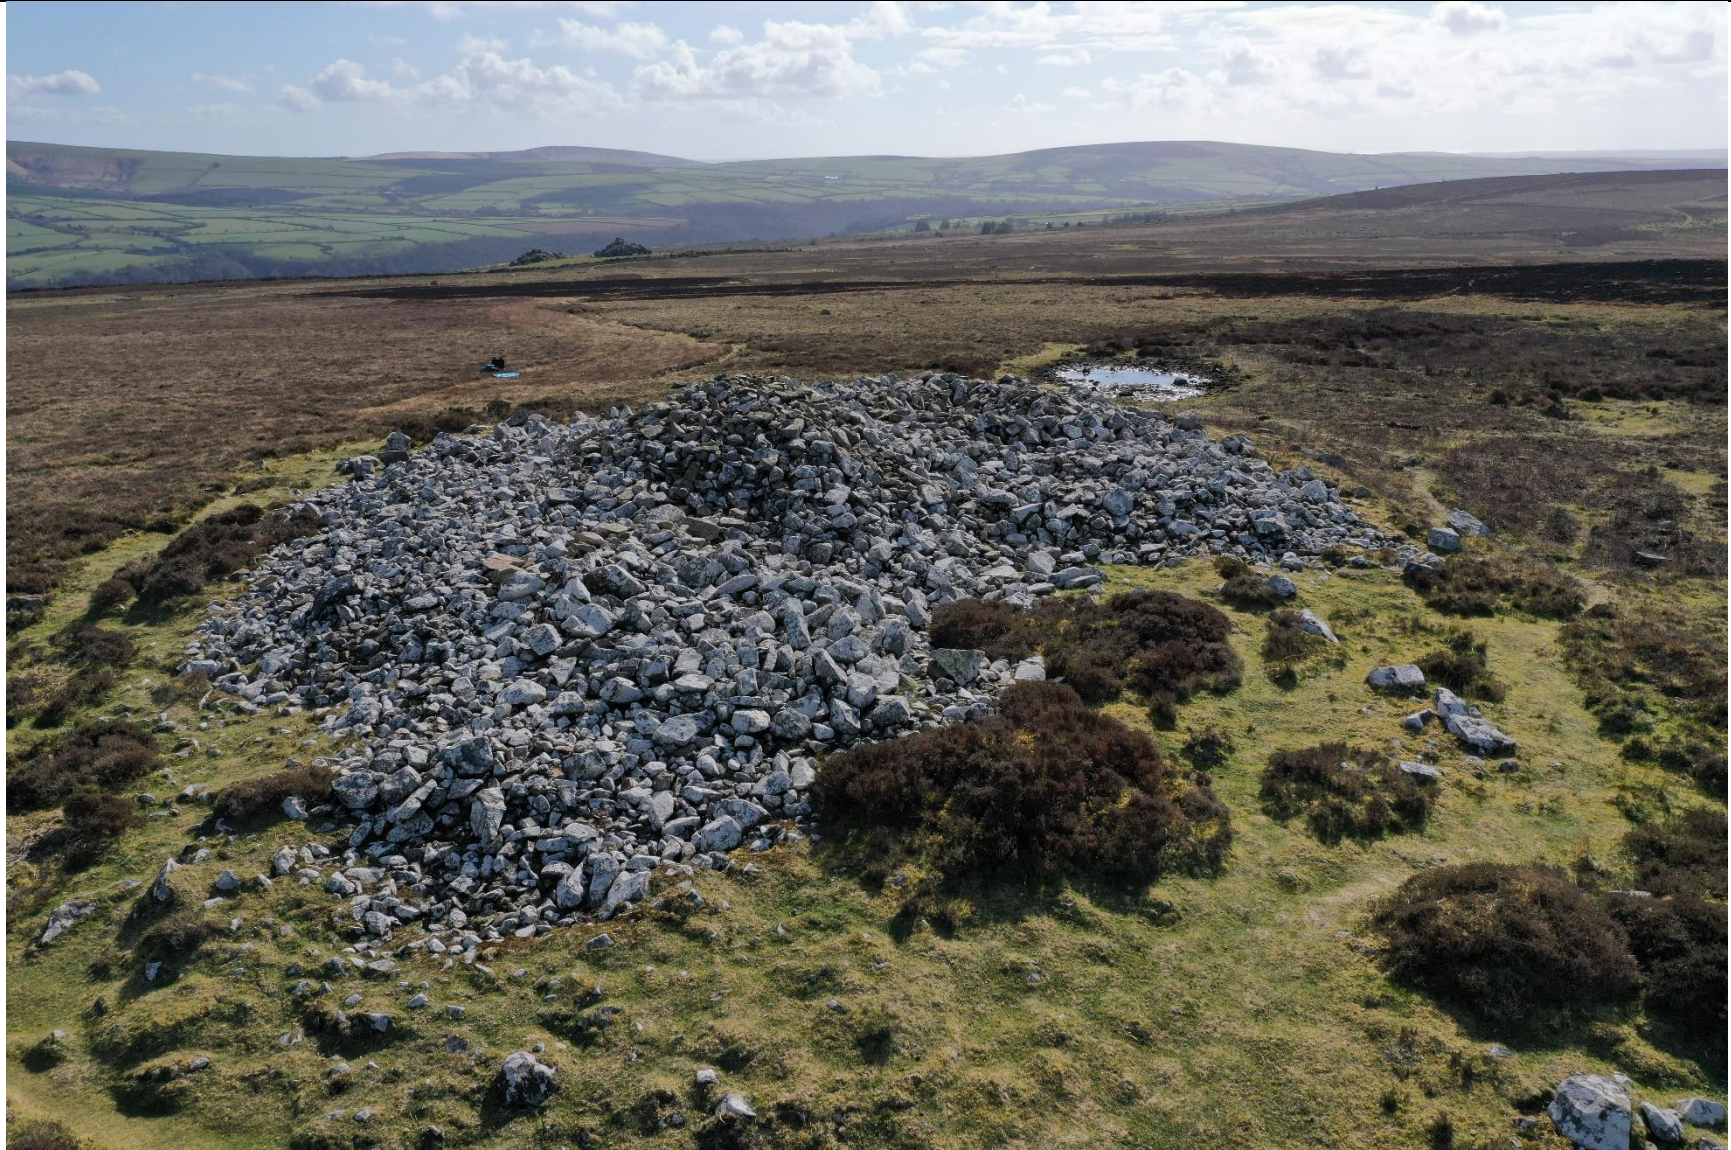
Figure 5. Monument towards west after reconsolidation work.

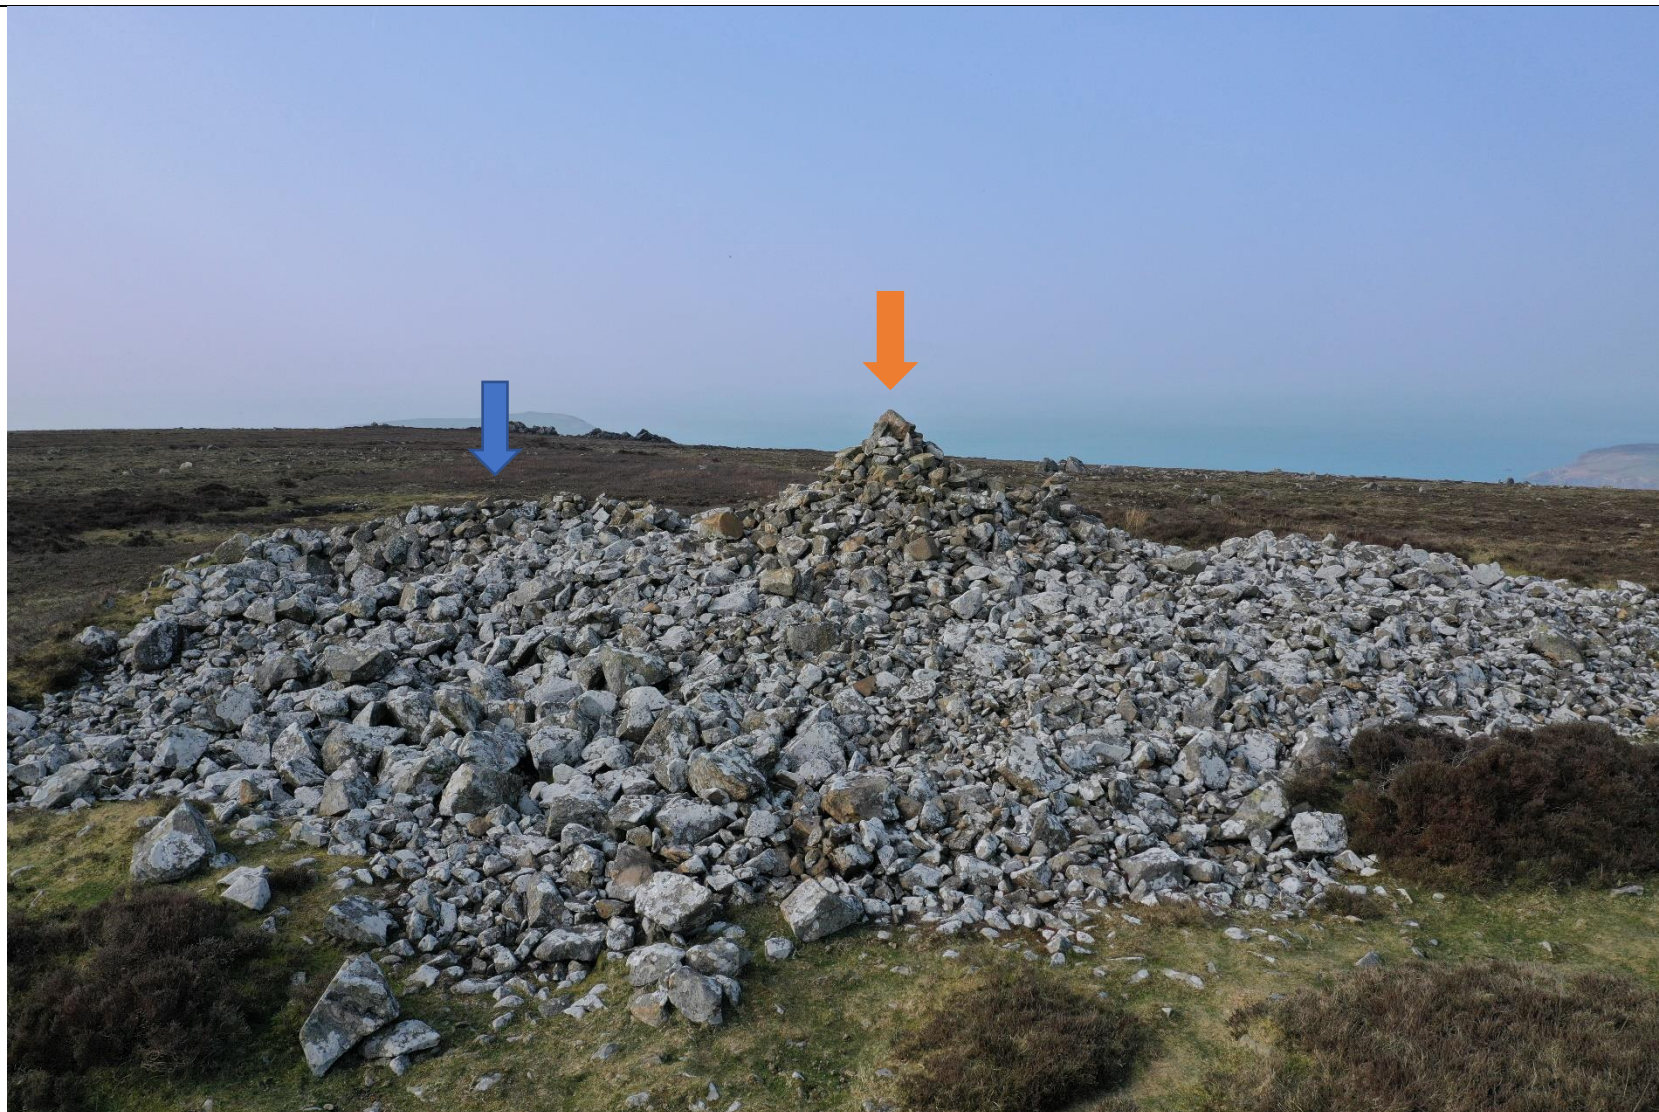
Figure 6. Monument towards north prior to reconsolidation work. Peak indicated by orange arrow and location of rim and depression indicated by blue arrow.

- In relation to the peak of the cairn (see section 3), stones were carefully removed to reduce the height of the peak. It is likely that disturbance had been ongoing for a significant amount of time in this area, as such only a degree of reduction took place. Once the height had been reduced, stones with lichen were placed at the surface facing upwards. This meant the cairn looked less disturbed, this will hopefully discourage or at the very least limit future disturbance. Stones removed from the peak were redistributed across the cairn with lichen side of stones facing upwards.

- In relation to the rim and depression on the southern side of the cairn (see section 3), stones composing the rim were carefully removed. The stones were then placed in the depression. Stones with lichen on their surface were placed on top. This meant the surface looked less disturbed, hopefully discouraging or at the very least limiting future disturbance.
- A general walk over the cairn surface took place to identify stones that had been disturbed, indicated by the absence of lichen on the surface of stones. Any identified disturbed stones were turned over, so that lichens were facing towards the sky (see example in figures 14 and 15).
- Photographs showing before and after are provided in section 3.

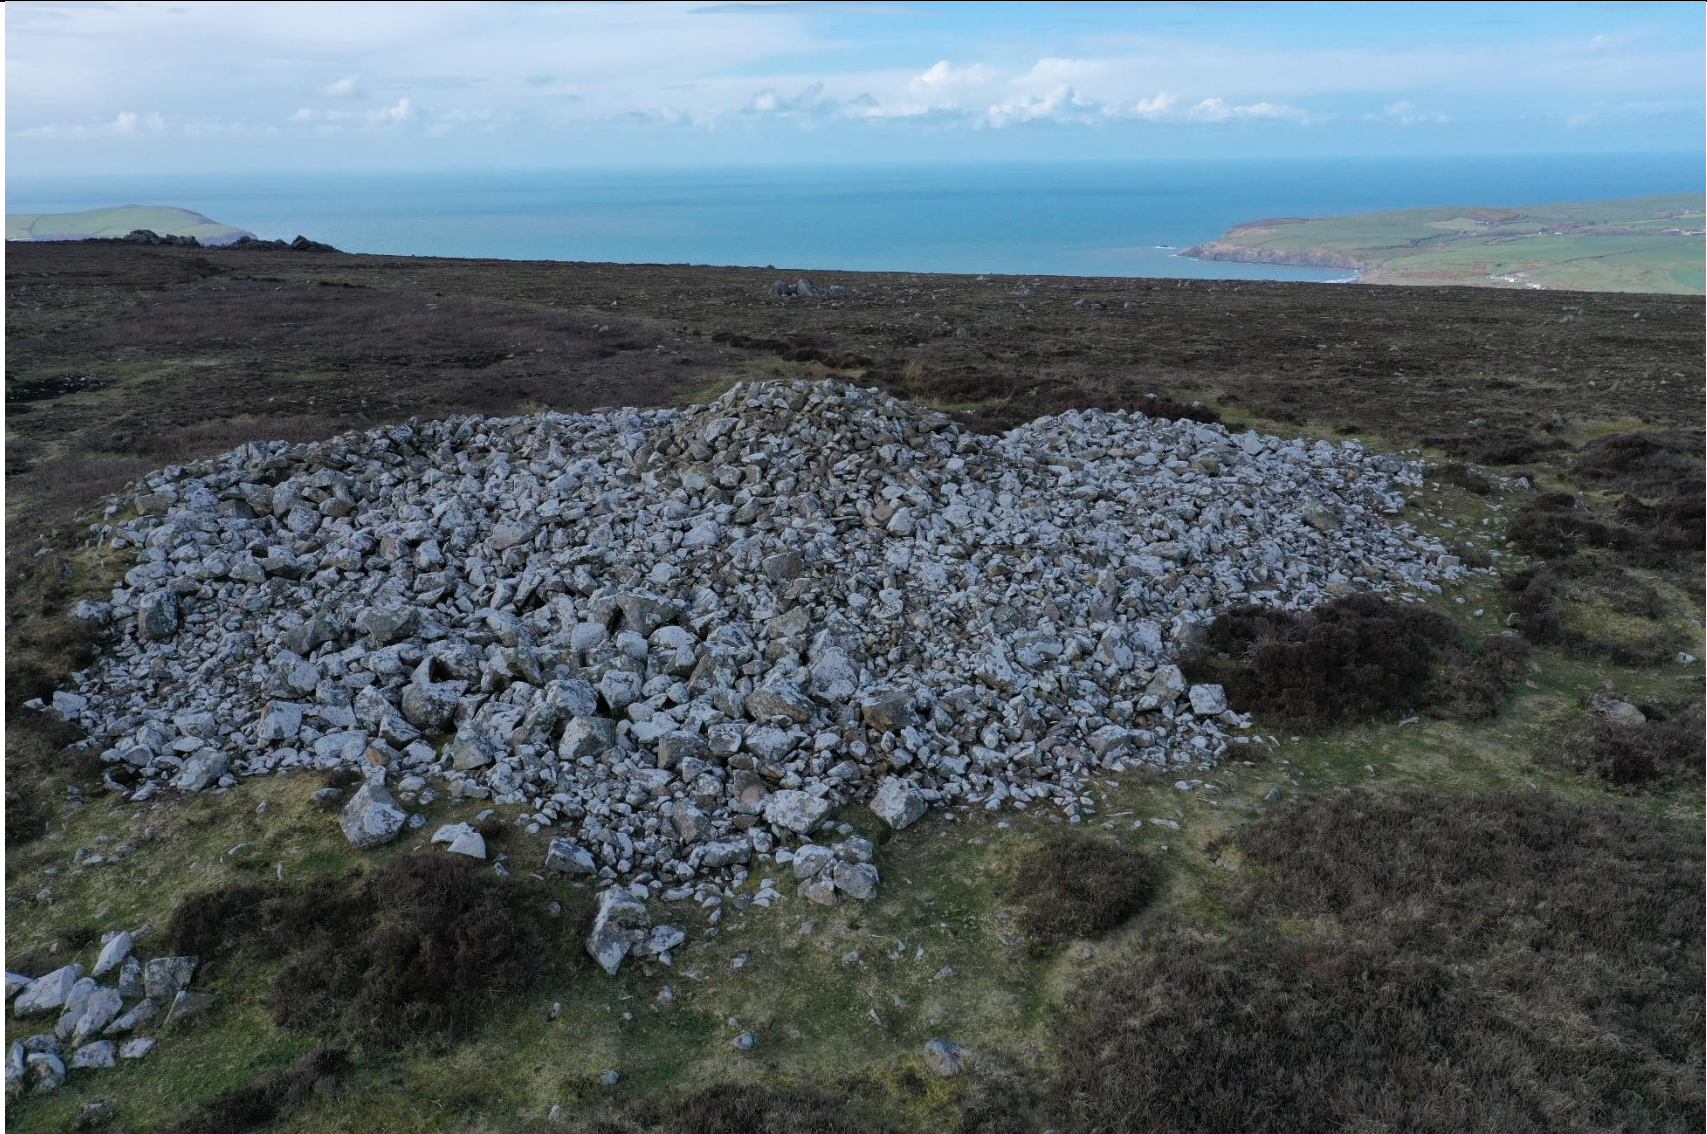
Figure 7. Monument towards north after reconsolidation work.

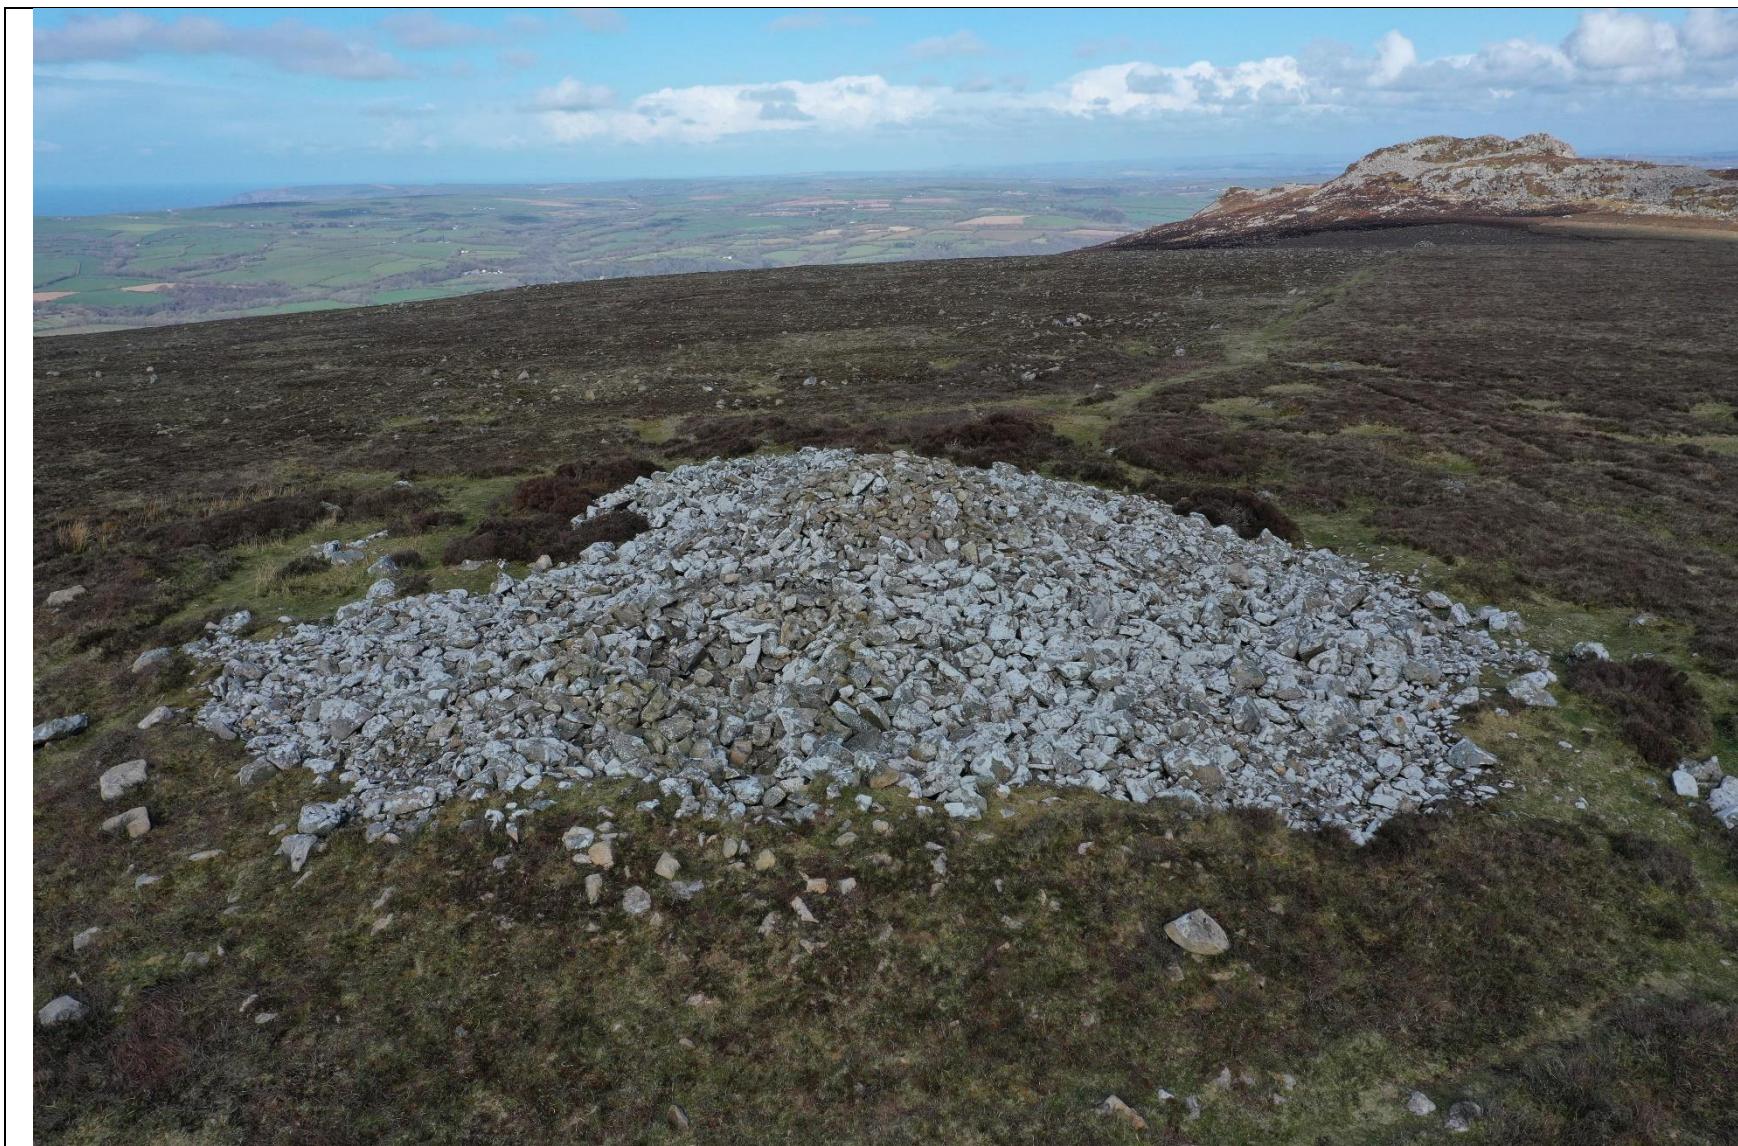
Figure 9. Monument towards north after reconsolidation work.

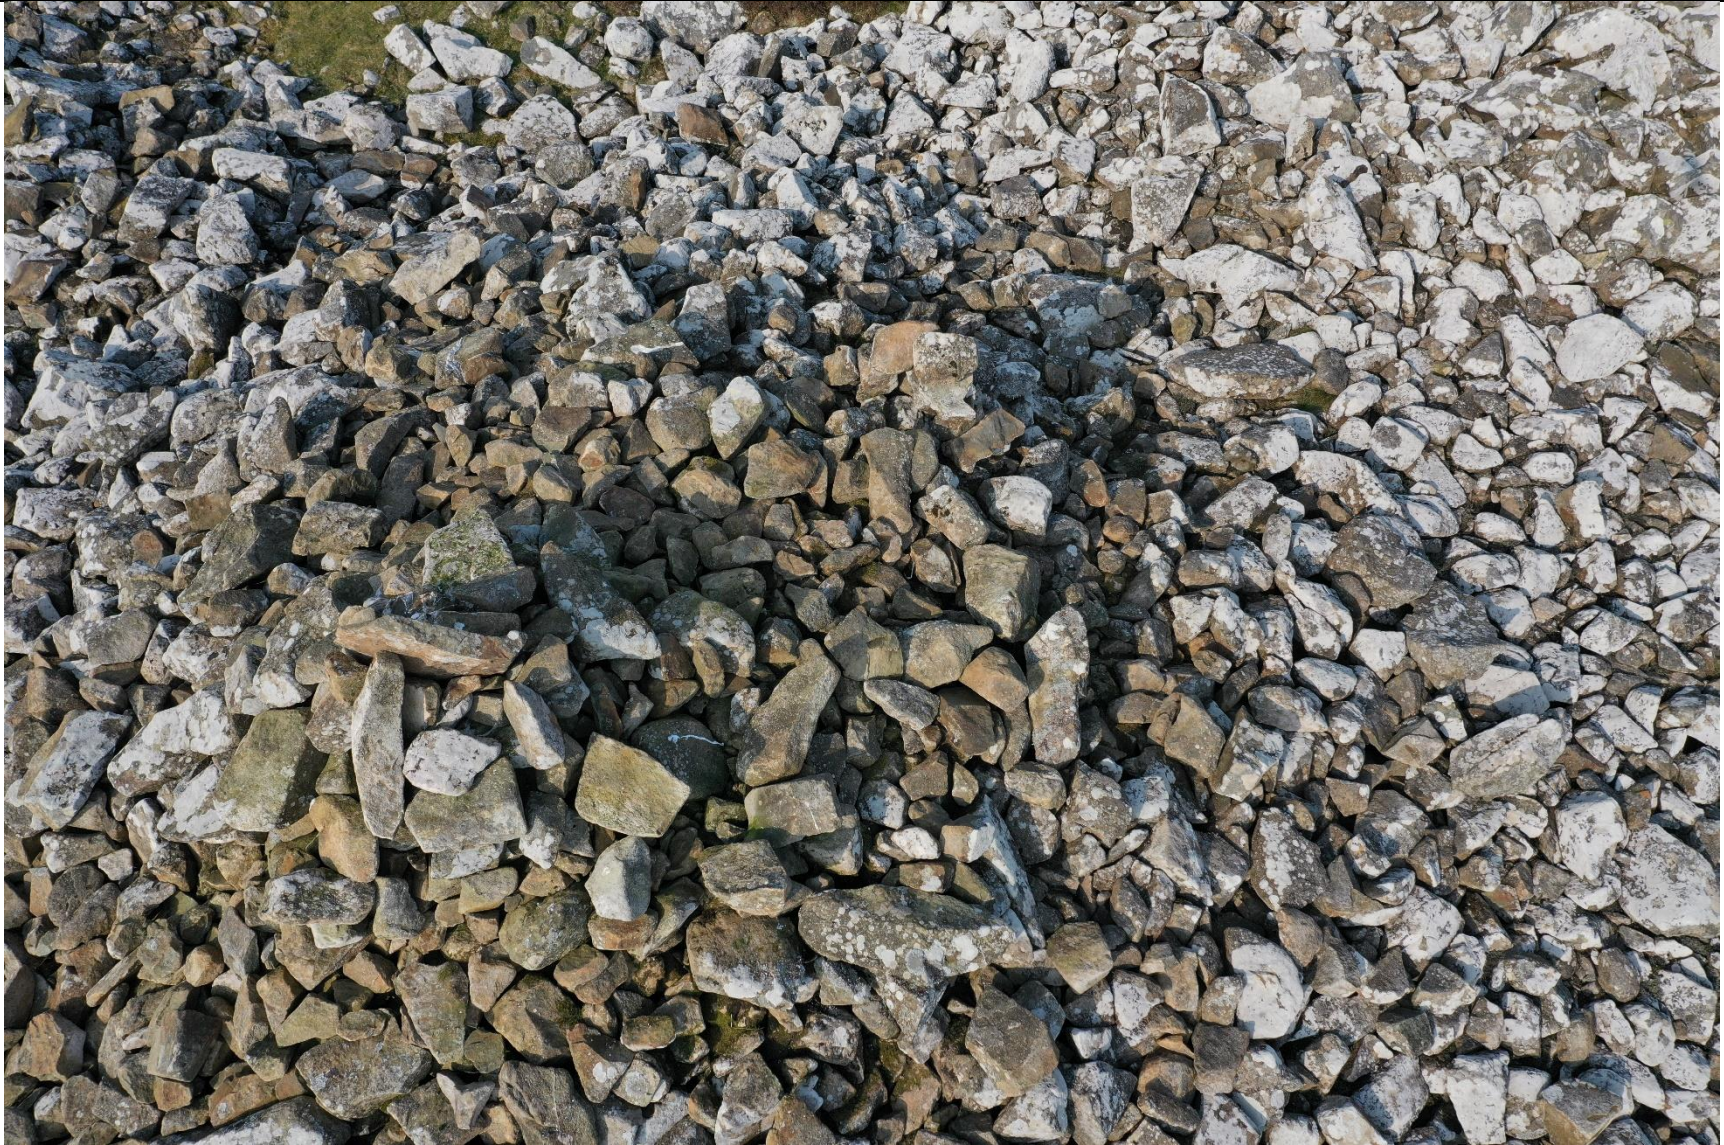
Figure 10. Aerial view of peak prior to reconsolidation work.

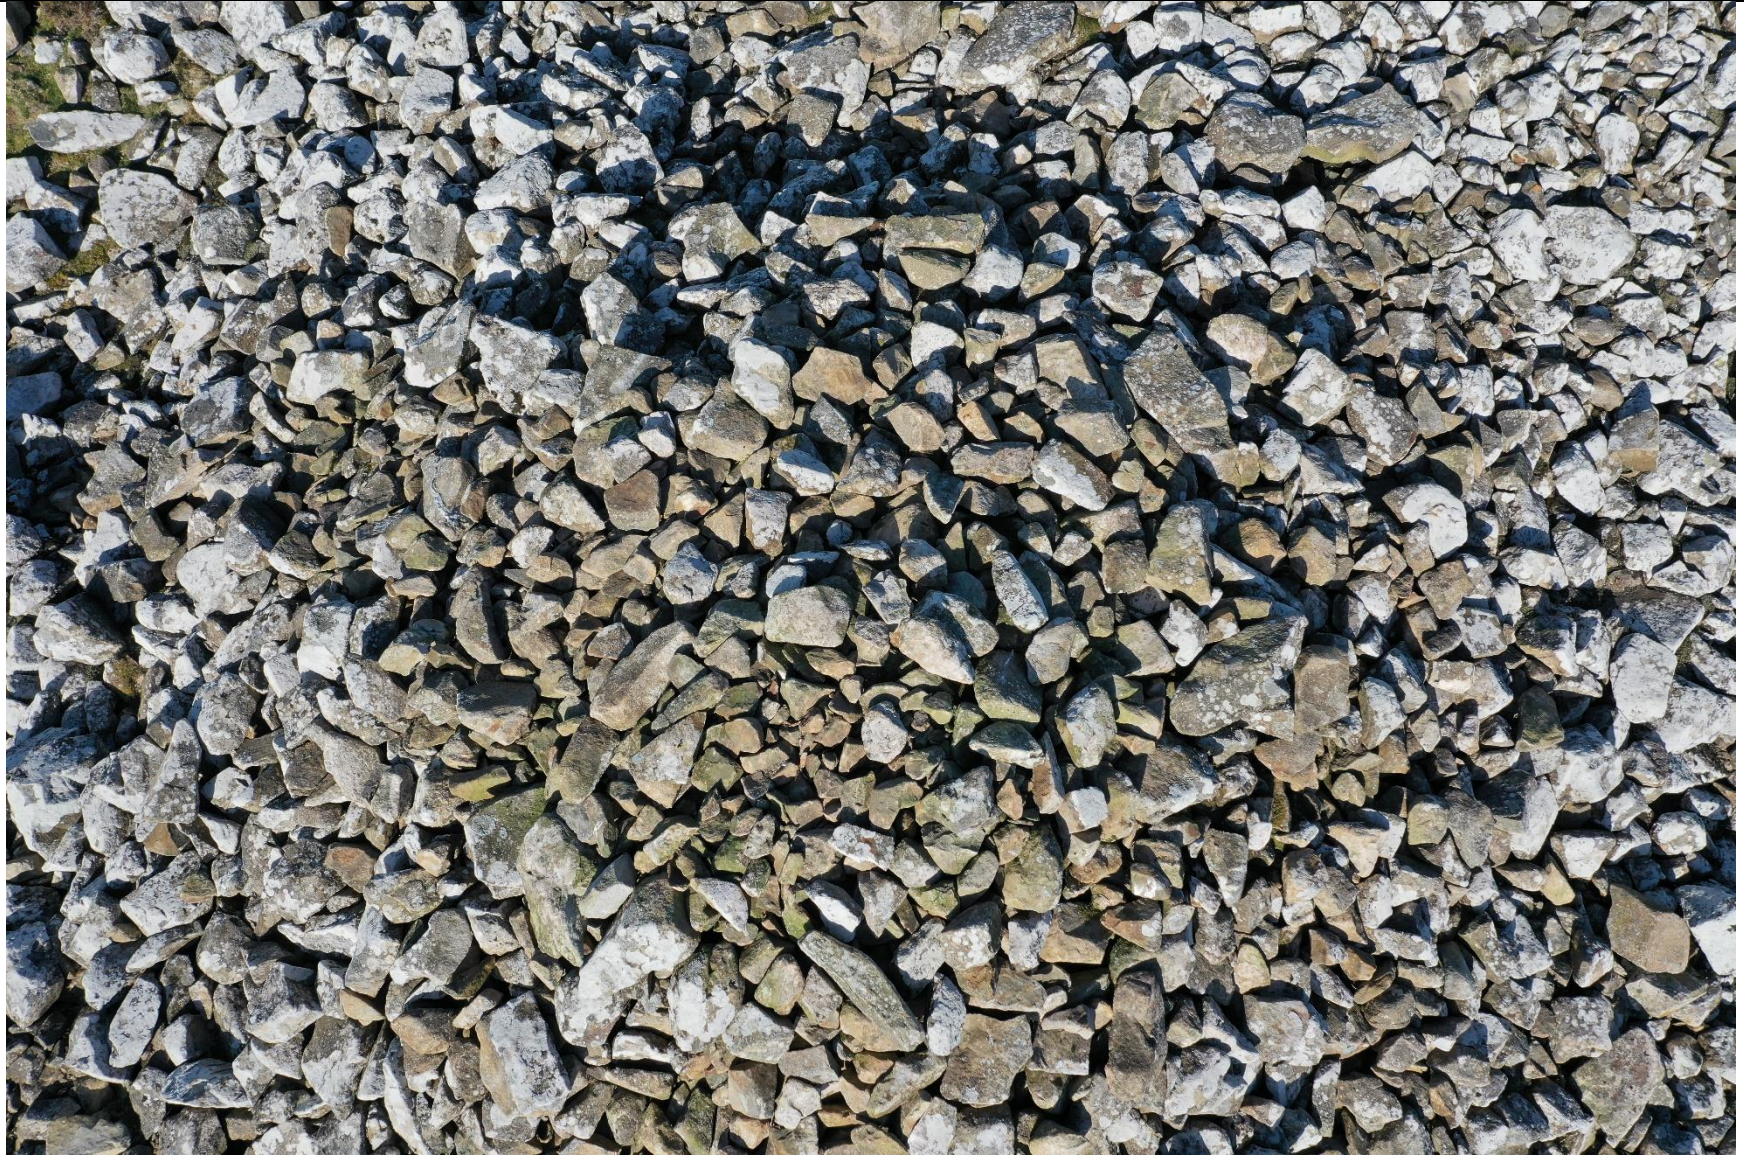
Figure 11. Aerial view of peak after reconsolidation work.

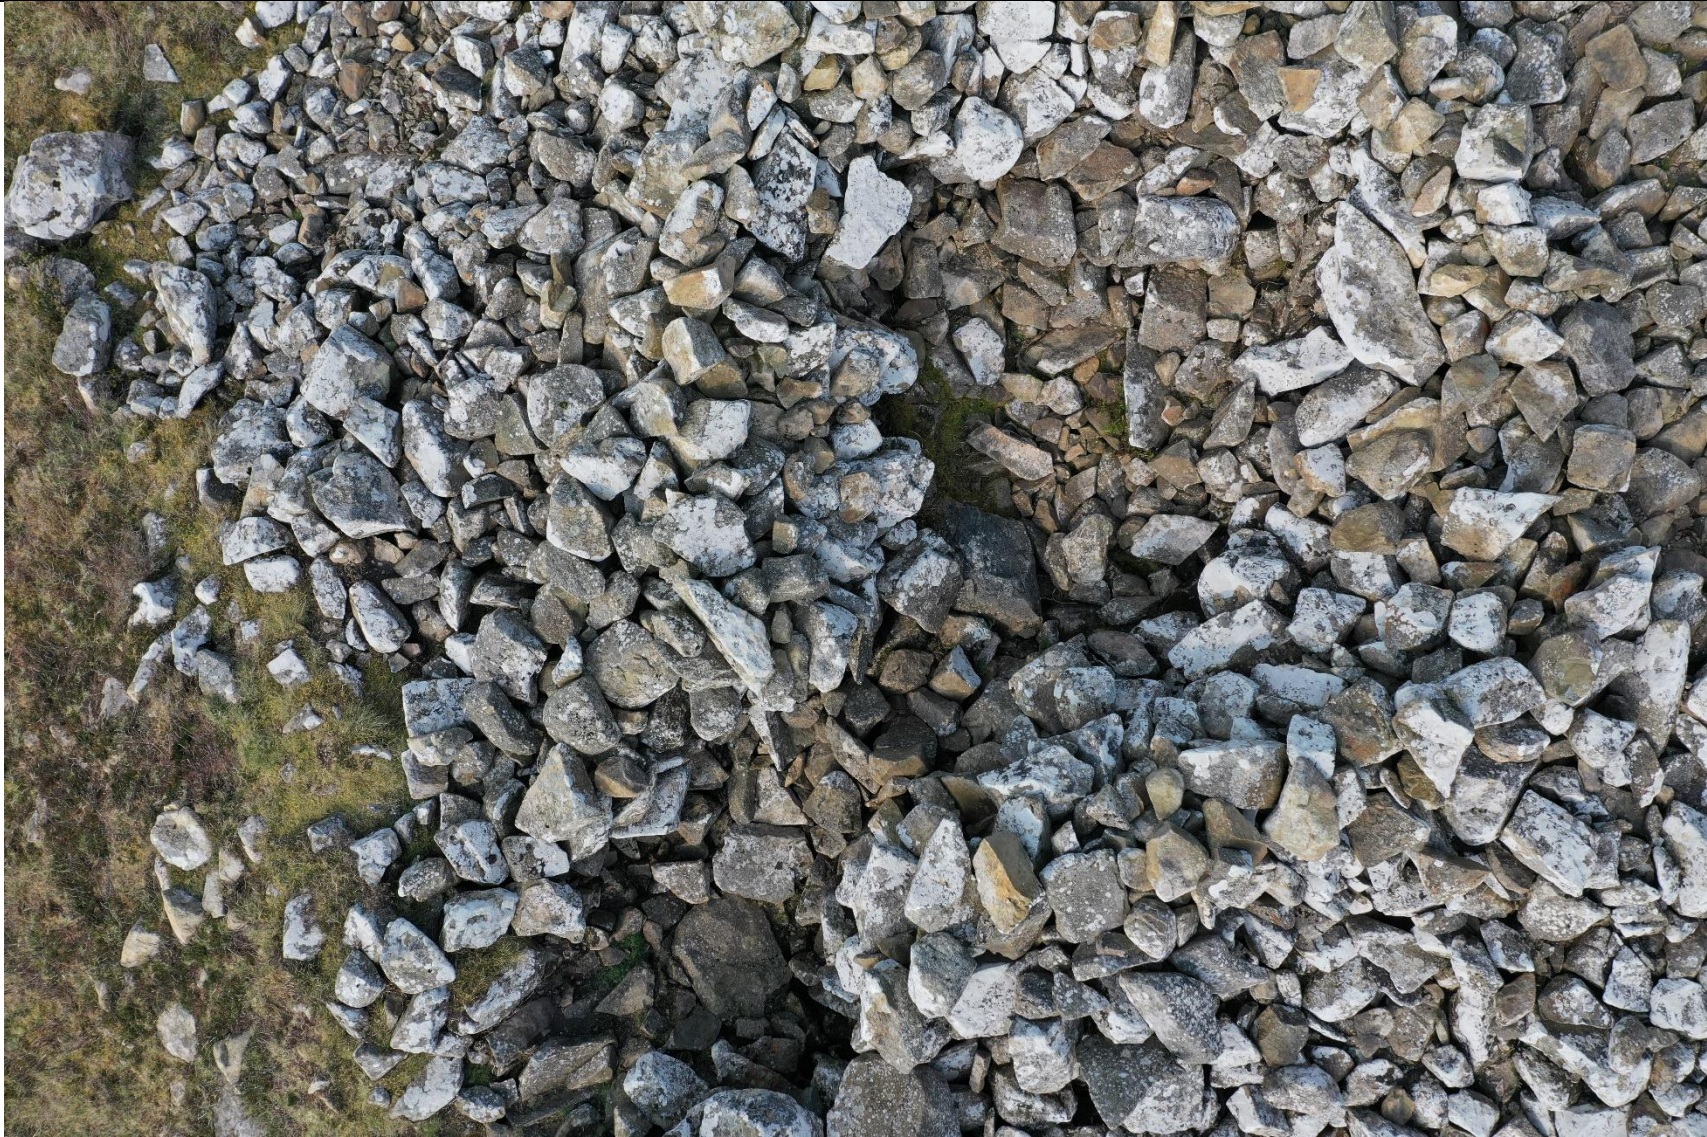
Figure 12. Aerial view of rim and depression prior to reconsolidation work.

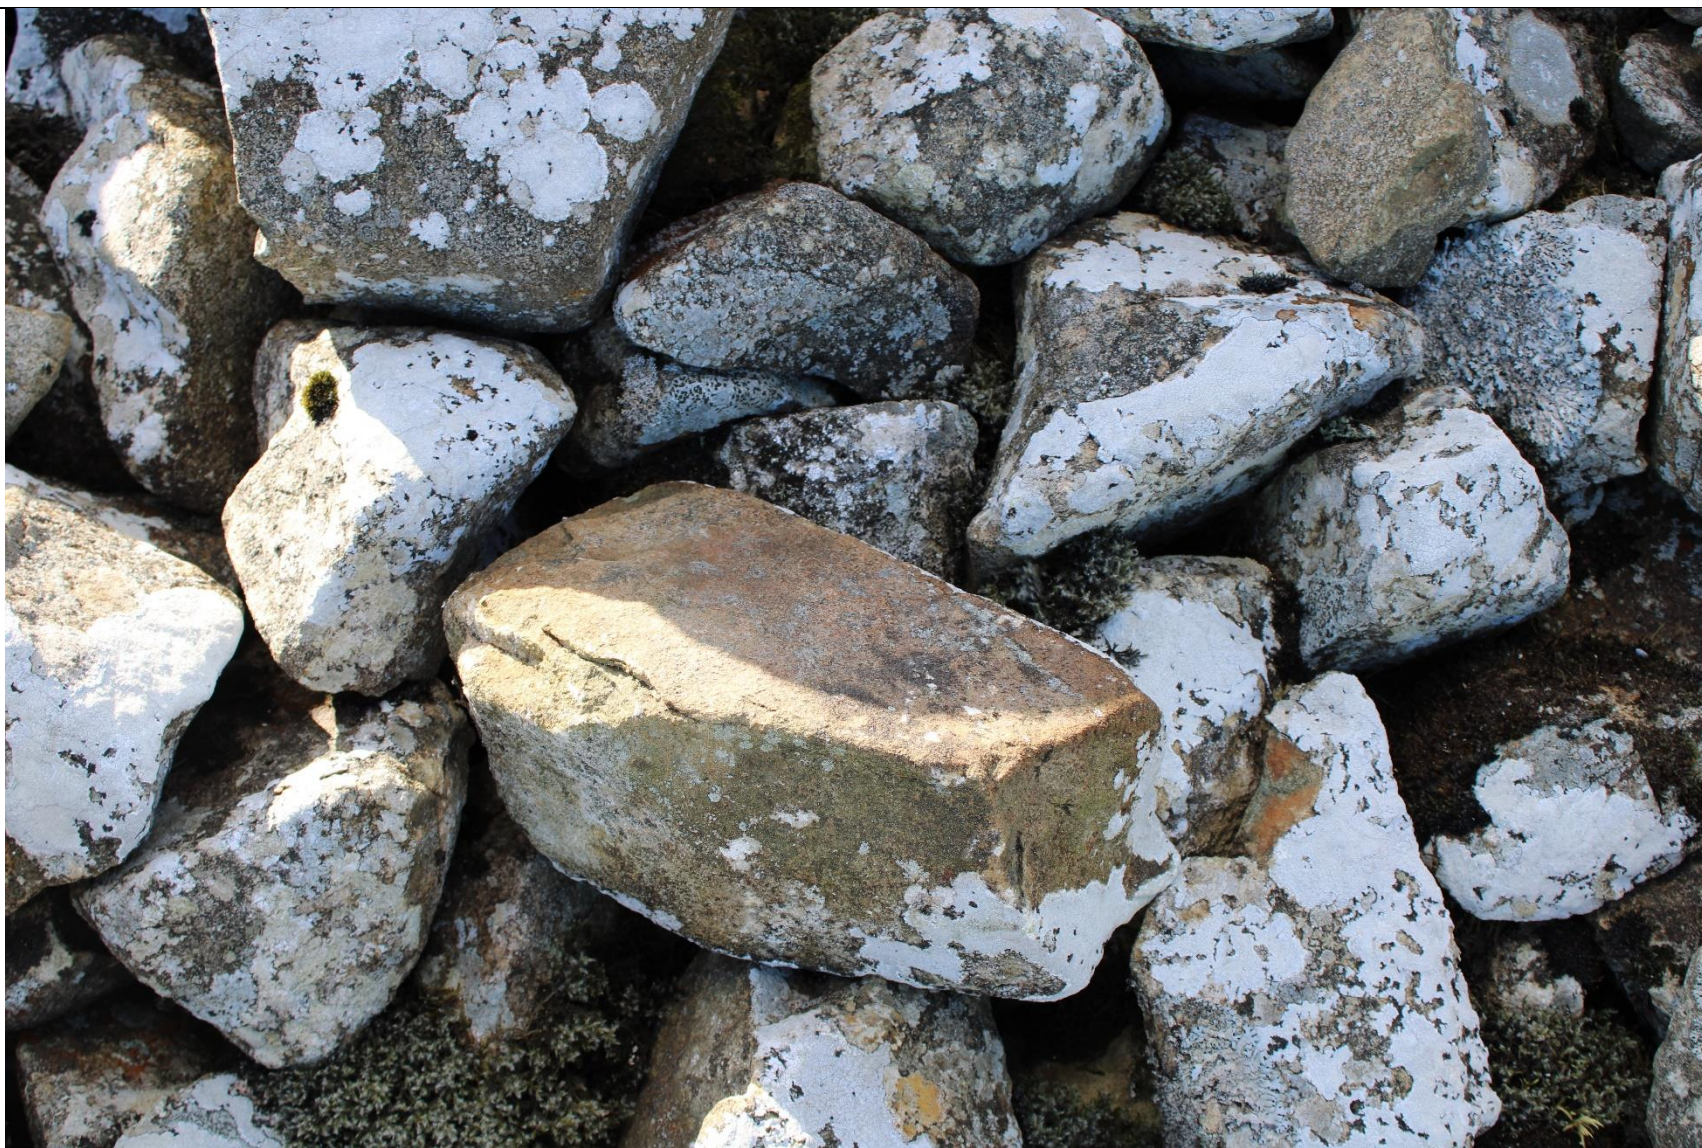
Figure 14. Photo showing example of disturbed stone with lichen facing downwards.

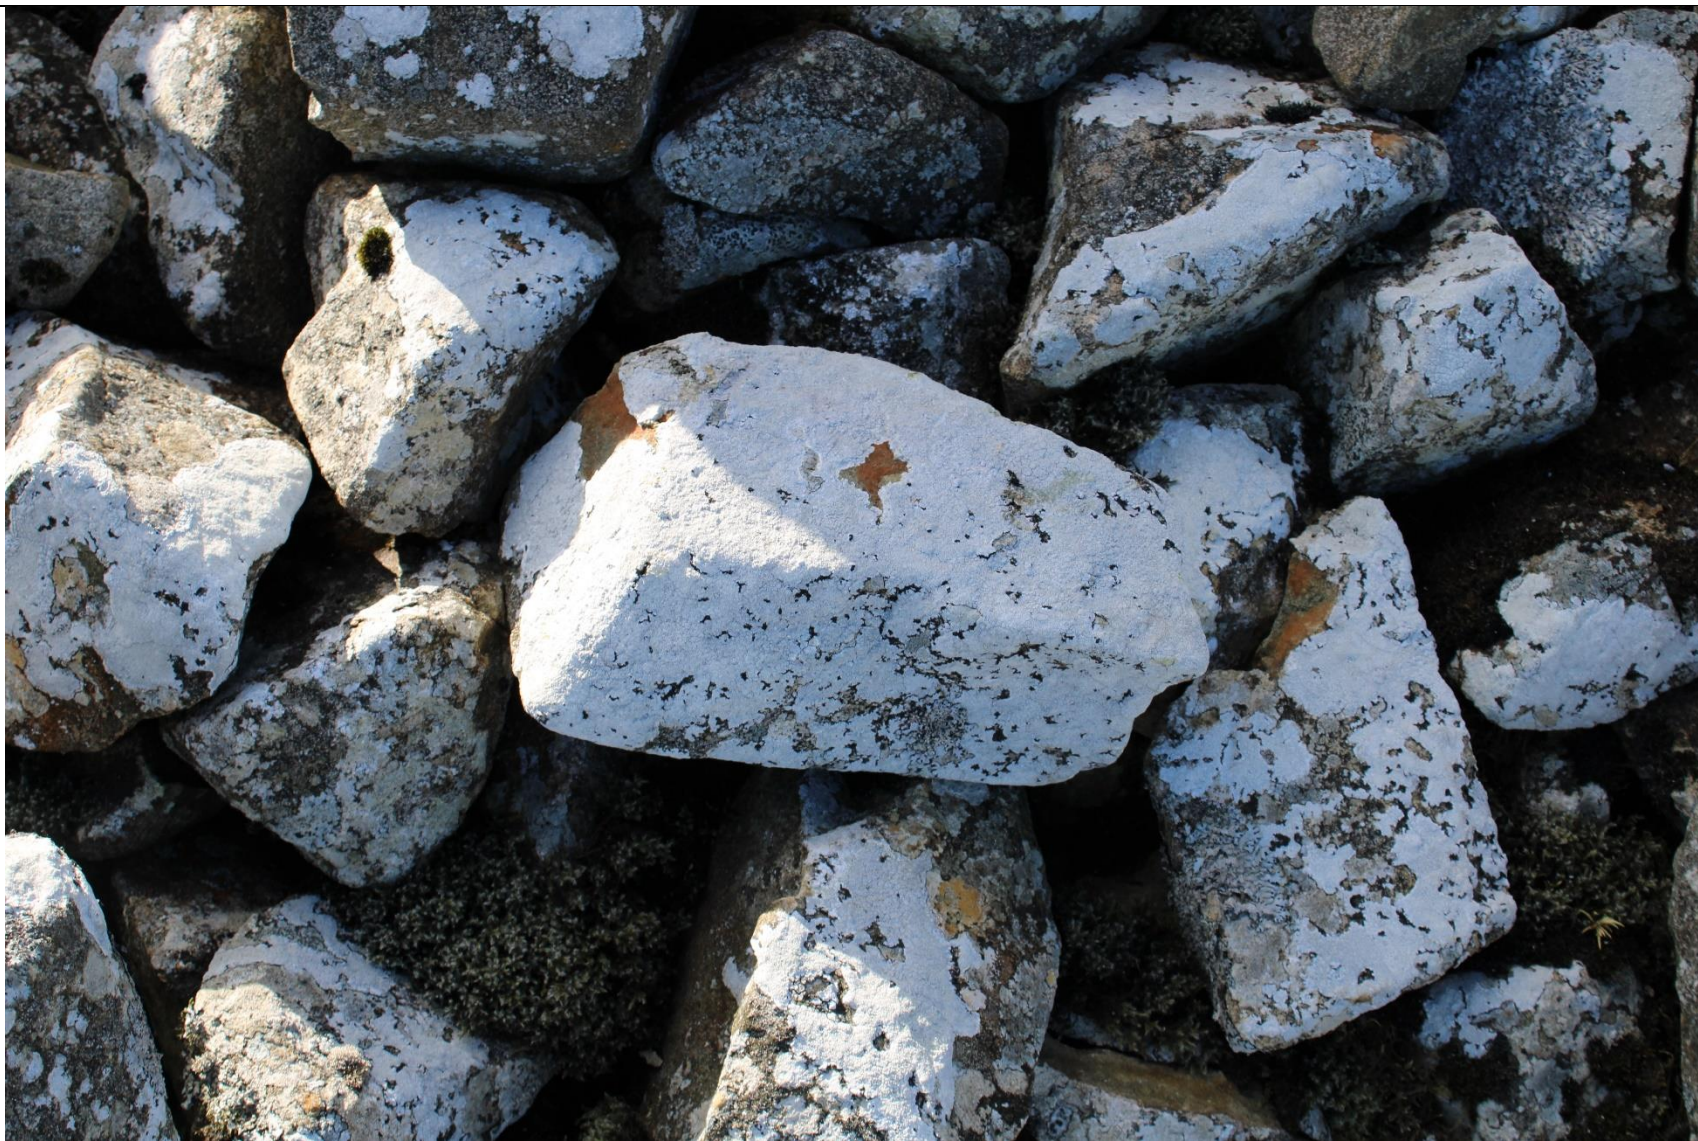
Figure 15. Photo of same disturbed stone in figure 14 turned over so that lichen is correctly facing the sky.

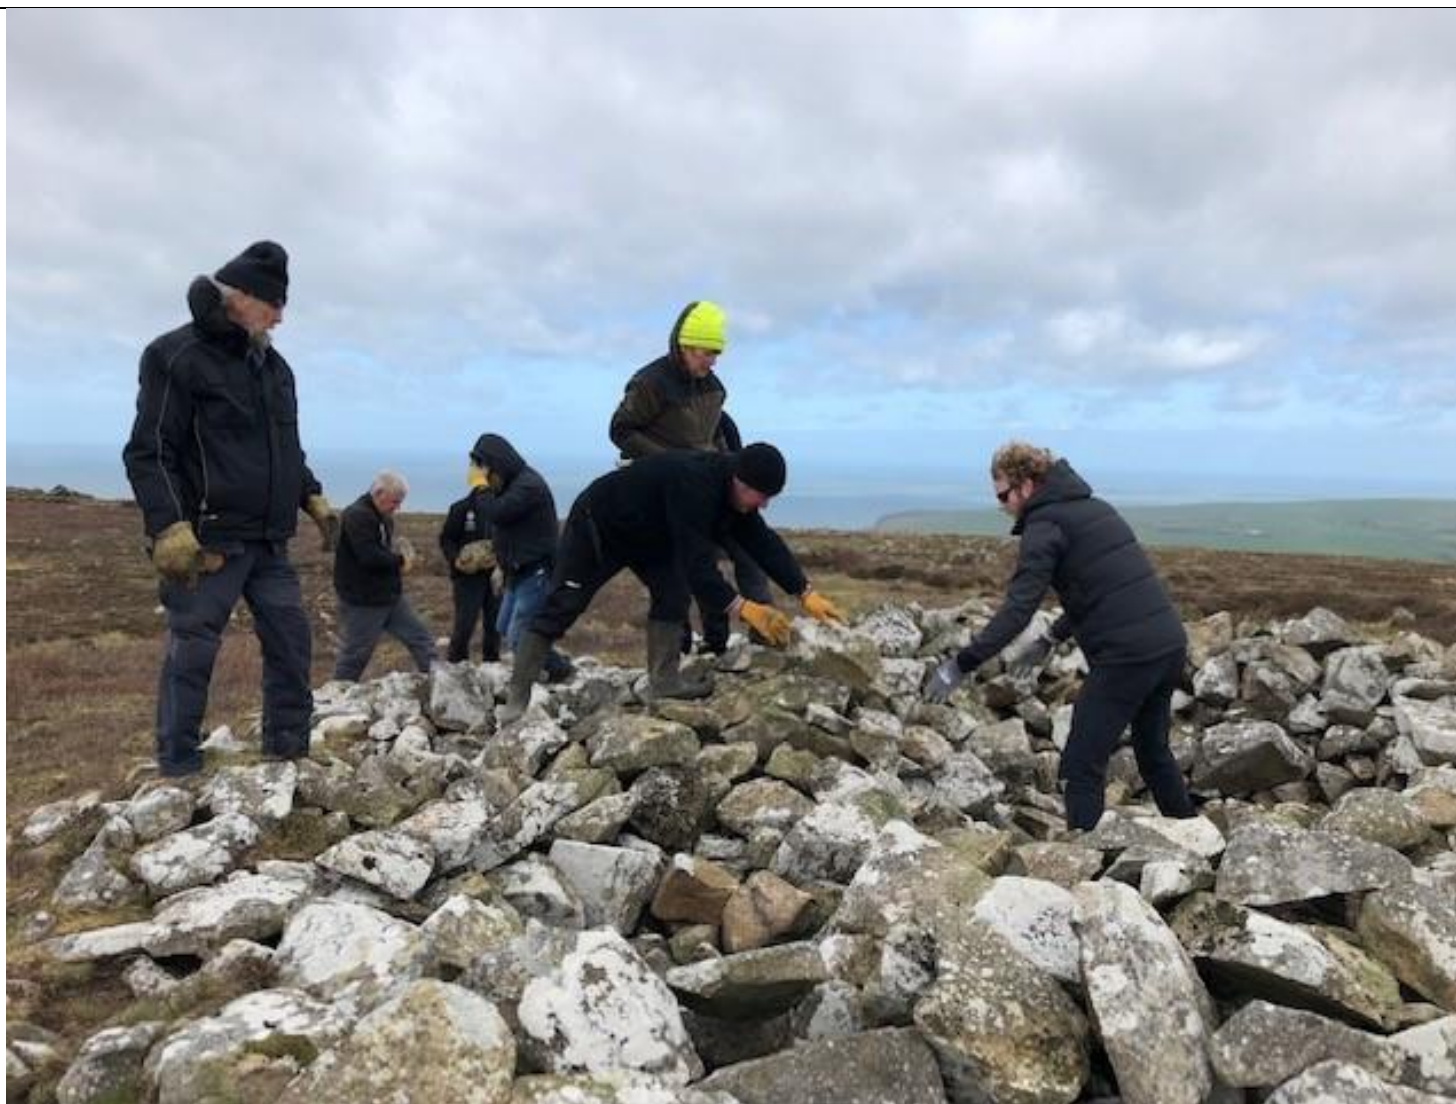
Figure 16. Photo showing the community archaeologist with group of volunteers rearranging stones to minimise the impact of disturbance.

The proposed work was carried out on behalf of the National Park Authority by the community archaeologist with the help of an area ranger and also a group of volunteers on 07 April 2022. The following approach was undertaken:
