ESGAIR FRAITH MINE

ARCHAEOLOGICAL WATCHING BRIEF

**PAT FROST
ARCHAEOLOGICAL
CONSULTANT
REPORT No. 103
FEBRUARY 2000**

**REPORT COMMISSIONED BY
FOREST ENTERPRISE
CANOLBARTH DISTRICT**

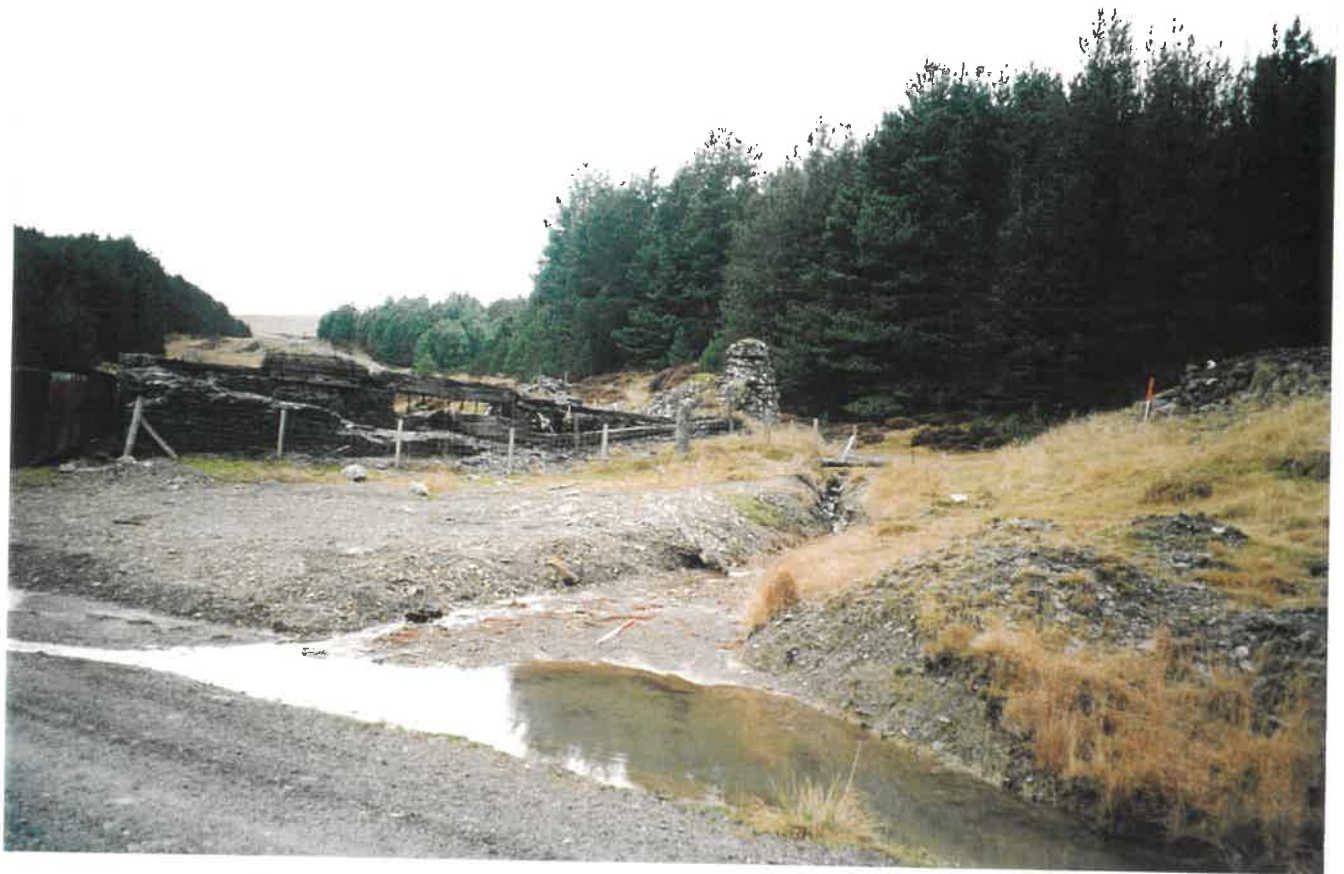
Plate 1: Crusher house wheelpit (*PRN 38065*), prior to works. View from SE shows the flow of water running down-hill from the forestry RUPP. The water has followed the N side of the tramway which is visible on the right side of the photograph.

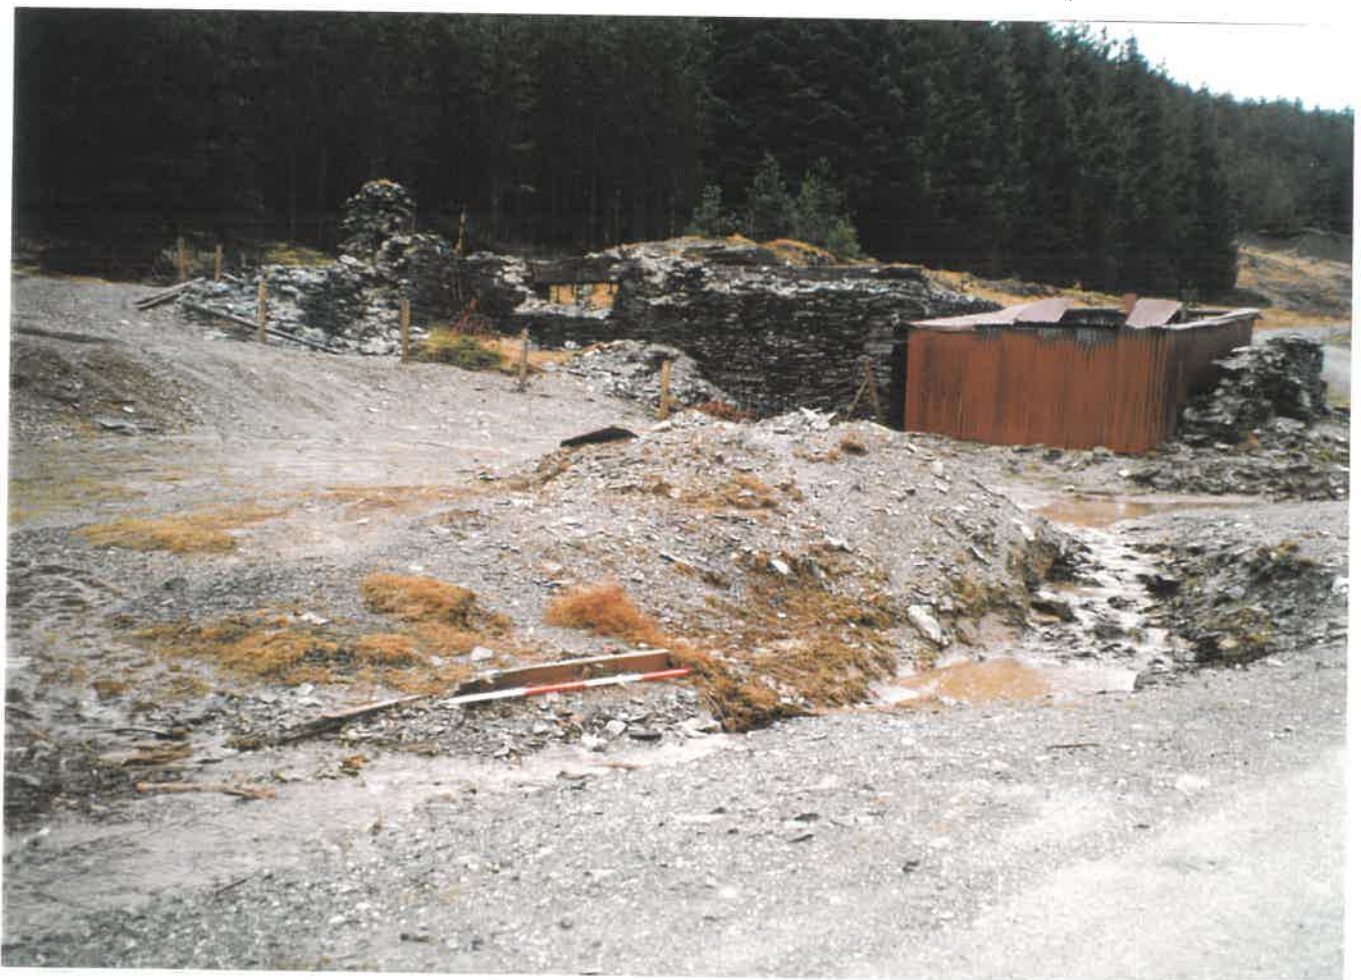
Plate 2: View from east, showing the natural collection point for run-off water, prior to works. 1m ranging pole identifies part of a damaged wooden launder box, N side of the forestry road.

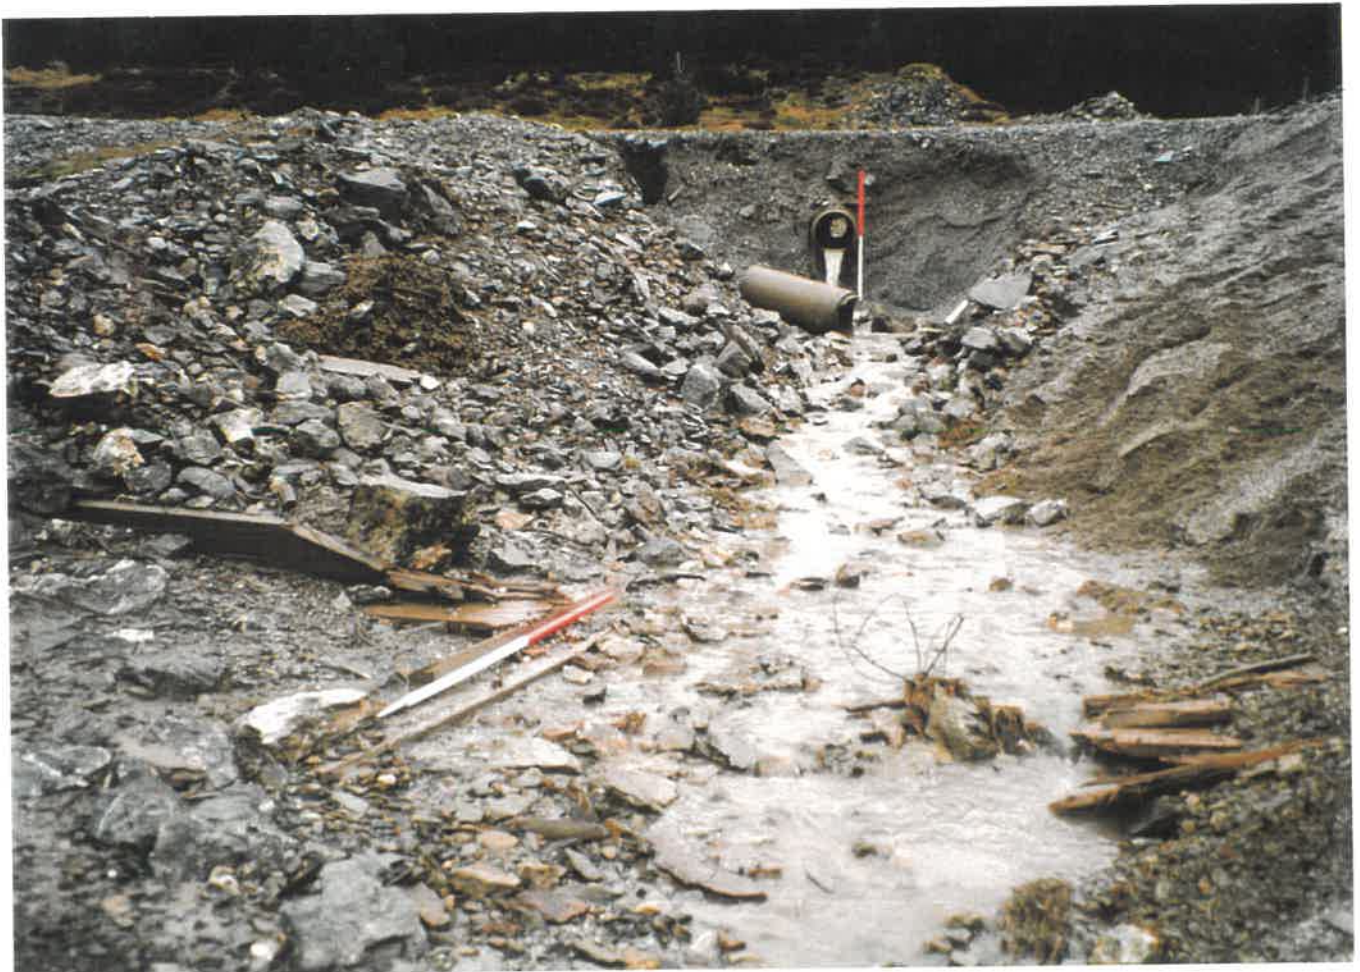
The removal of existent concrete pipe and the re-excavation and enlargement of the cut through the forestry road was monitored 07/02/2000. Plate 3 (*below*) shows the existent pipe in situ and the remains of damaged wooden catch boxes for slimes protruding from the eroding spoil tips. The box protrudes for c.1.9m x 1.2m max. width. Broken timbers can be seen to the right of Plate 3 also.

Plate 3: Dressing floor area at Location 4, prior to works. View from south shows part of a damaged wooden collection box for slimes. 1m ranging pole in the background shows the concrete pipe to be replaced.

The cut through the road was excavated to 1.5m below the present forestry road level. two 6m pipes of 0.5m diam. were laid and the trench was back-filled with the excavated material, made up with stone from Location 5.

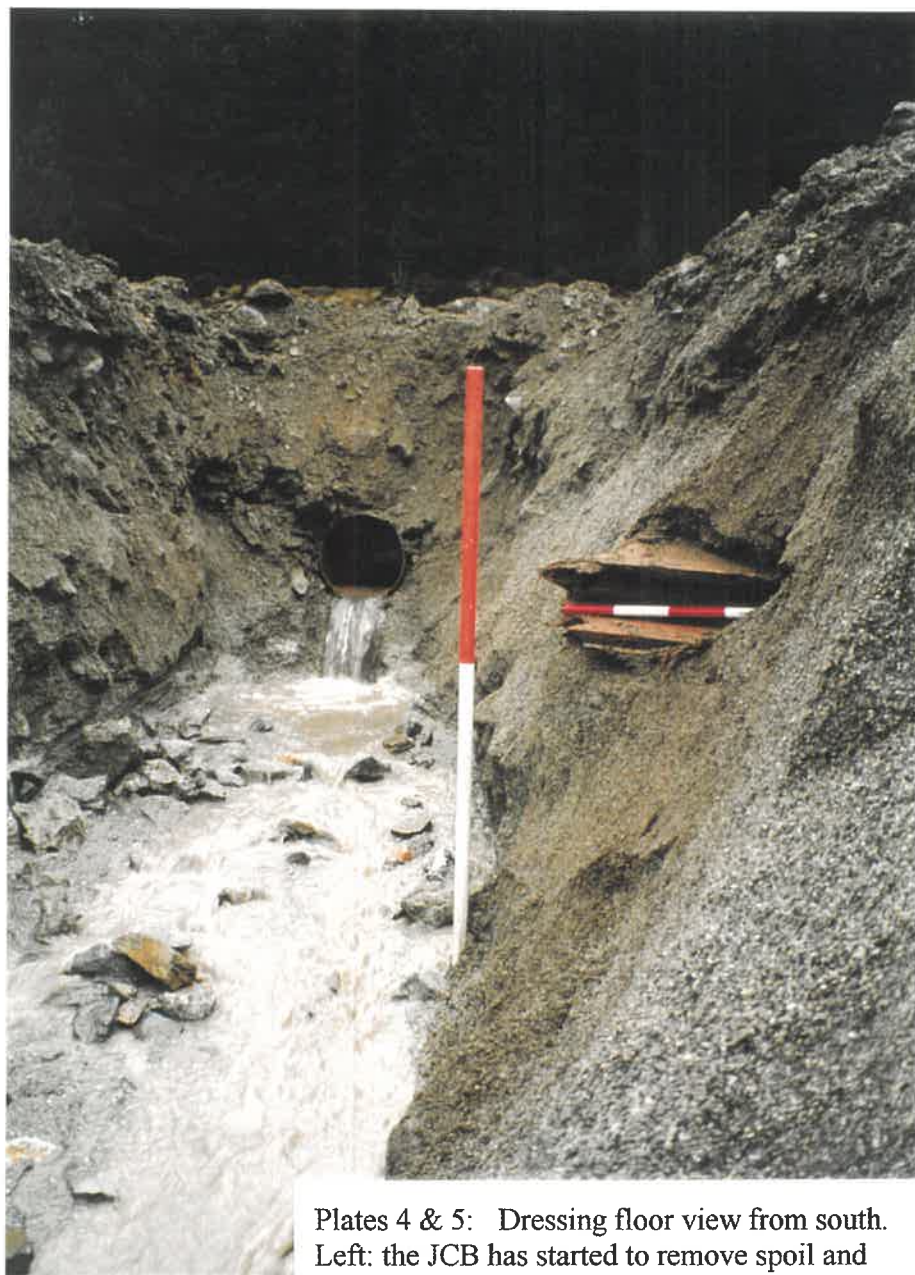
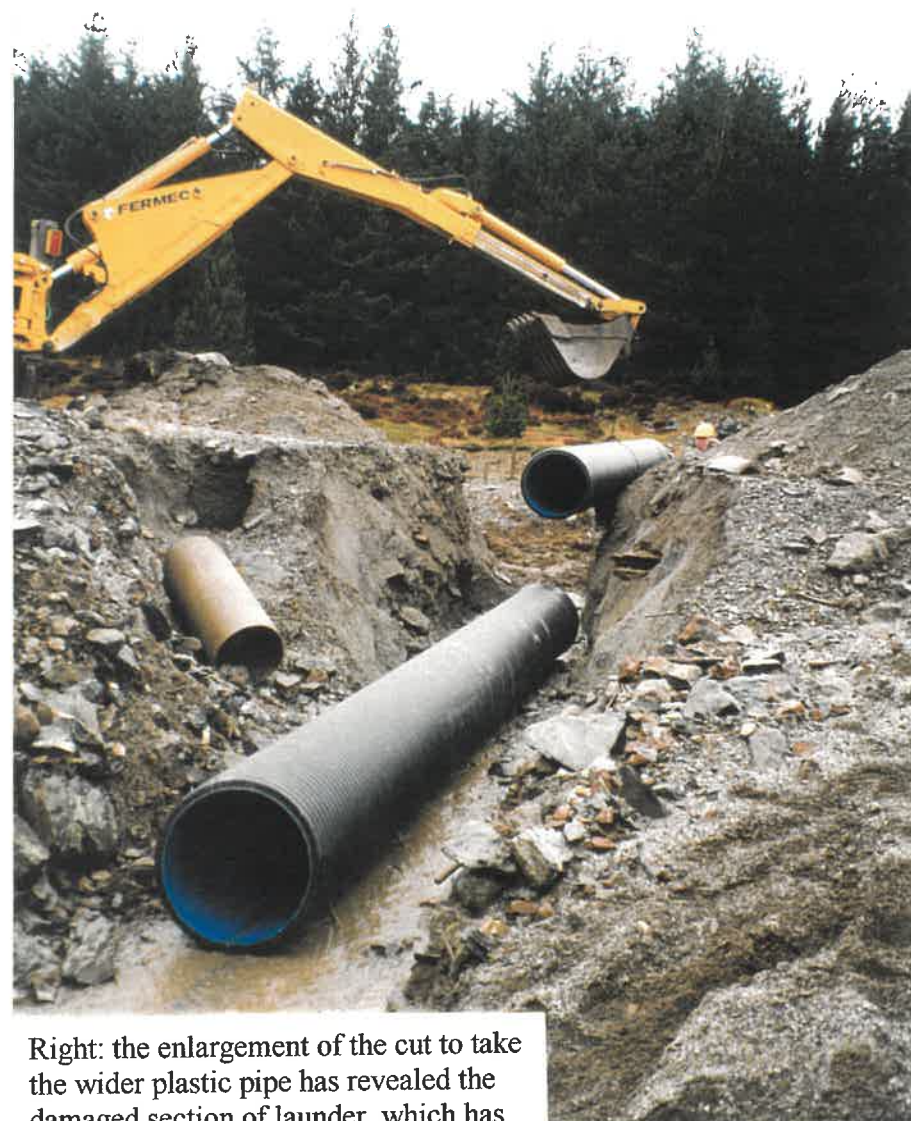
As the work continued, sections of a broken wooden launder became visible in the east and west sides on the enlarged cut. The launder may have already been cut through during the sinking of the first concrete pipe and removal of spoil to form a clear drainage channel. The launder was visible as a section c.0.1m wide x 0.05m high on the N side and protruded for c.0.5m on the east side of the cut. The enlarged re-cut revealed very fine spoil typical of buddle waste.

Plates 4 & 5: Dressing floor view from south. Left: the JCB has started to remove spoil and has revealed a section of damaged wooden launder c.0.5m x 0.1m wide x 0.05m deep, protruding through fine waste.

Right: the enlargement of the cut to take the wider plastic pipe has revealed the damaged section of launder, which has been cut through by the earlier drainage works, when the concrete pipe was laid.

5.6 **Location 4:** The launder revealed during the re-cut, and the depth of fine spoil revealed, suggests that there may still be a considerable amount of buried archaeology on the dressing floor tips, despite previous damage.

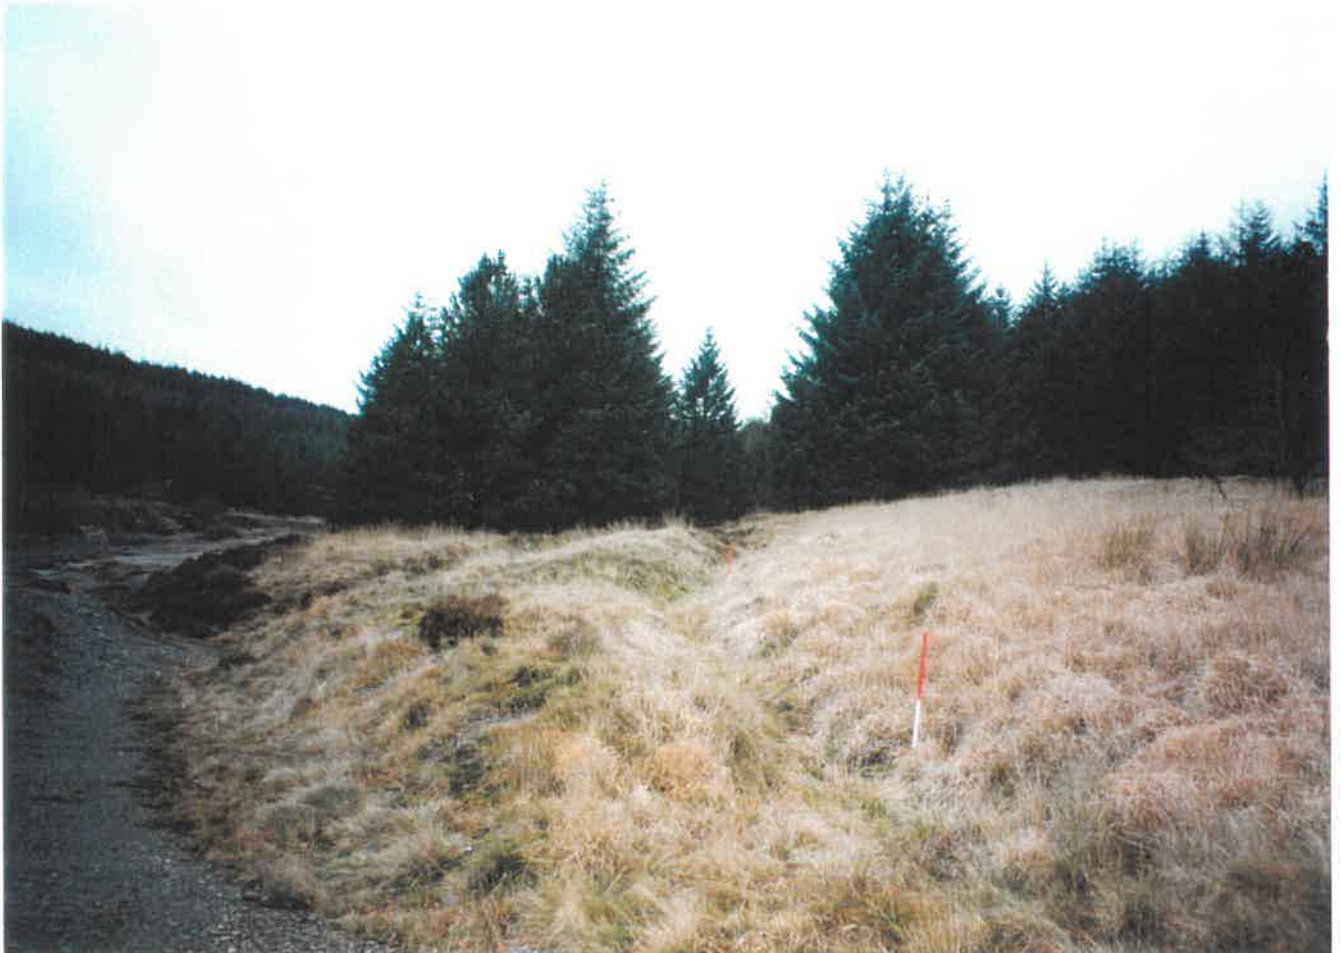
Plate 6: View from east from Location 3, prior to works. 1m ranging poles show the embanked leat/watercourse of upland stream, which has dried up since the flow of water was cut off presumably during forestry work in the 1950s. The dry bed will be utilised as the run-off as outlined in Fig. 1. To the left of the photograph, south of the rough grass, is the line of leat PRN 28195, with its embankment covered in fine waste.

The earthwork embankment photographed on Plate 6, forms the eastern part of PRN 28195, the lower of 2 leats that can be traced from Llyn Dwfn running in a north/south direction along c.400m contour to enter the mine site from the eastern slopes of Esgair Ffraith ridge.

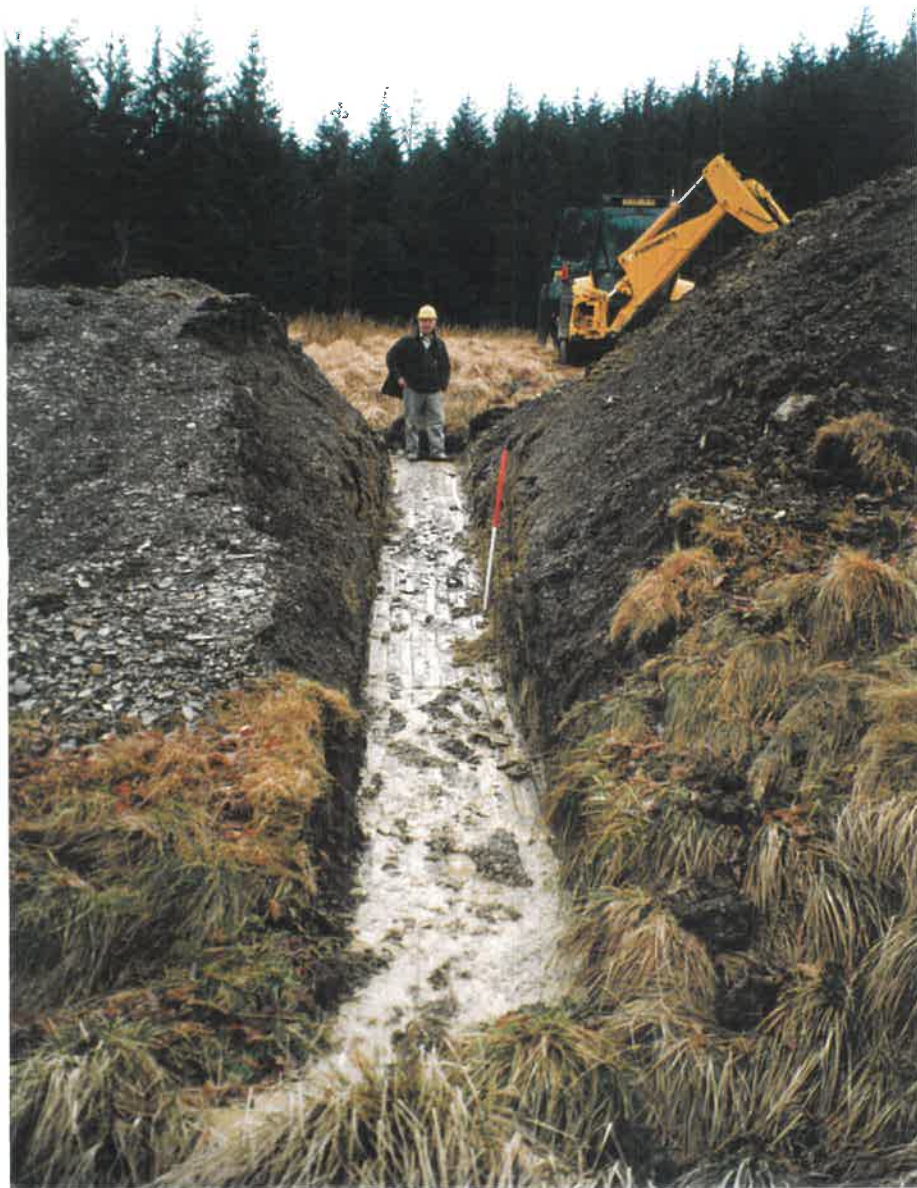
Plate 7: Location 3, view from S, shows cut through the embankment of leat PRN 28195.

The section through the leat bank and its covering of spoil was excavated to a max. depth of c.1.65m to facilitate the laying of two 6m x 0.6m diam pipes.

The section through revealed a max. of:

0.0 to 0.3m - pale yellow silty clay

0.3 to 0.35m - orange/yellow silty clay

0.35 to 0.75m - brownish/yellow silty clay

0.75 to 0.85m - orange silty clay

0.85 to 0.95m - dark brown/black silty clay

0.95 to 1.65m - fine spoil, which was un-vegetated on the surface.

The clay layers had no stone content and are similar to the clay layers recorded in the west facing section of the tramway – See Fig. 5. The spoil layer appears to have resulted from tipping along a natural ridge, which also formed the embankment of the leat PRN 28195.

5.4 **Location 3:** The embankment on the south side of leat PRN 28195 appears to have been constructed on the natural contours of the ridge rising north. It has later been used as a natural tipping platform for fine waste.

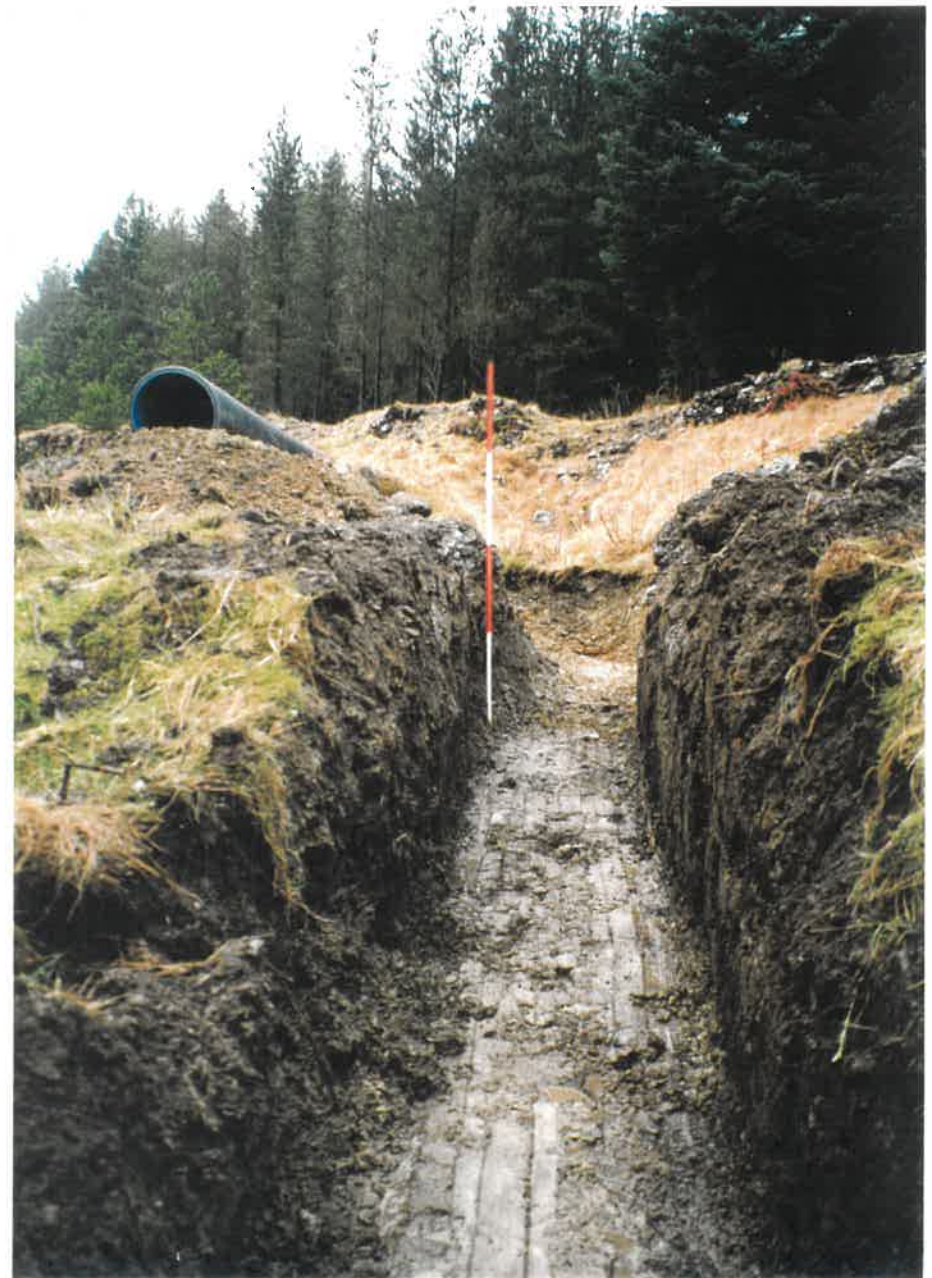
Work at Location 2 was monitored 07.02.2000 and the section through forestry road was excavated through loose shales to a depth of 1.3m to lay two 6m pipes x 0.6m diam. (*see Plate 8*). The pipes were back-filled with the excavated spoil.

It is assumed that the forestry road must have been laid on partly made-up or levelled ground since the course of the natural fall of the upland stream/embanked leat (*see Fig 1*) is interrupted by this road. The excavated section did not cut into a natural clay bed as revealed at Locations 1 & 3.

Plate 8: Location 2, view from S, shows section cut through forestry road, south of the Crusher house tramway PRN 38063.

5.5 **Location 2:** The forestry road was presumably constructed on part made-up ground, since it interrupts the natural north to south flow of the watercourse.

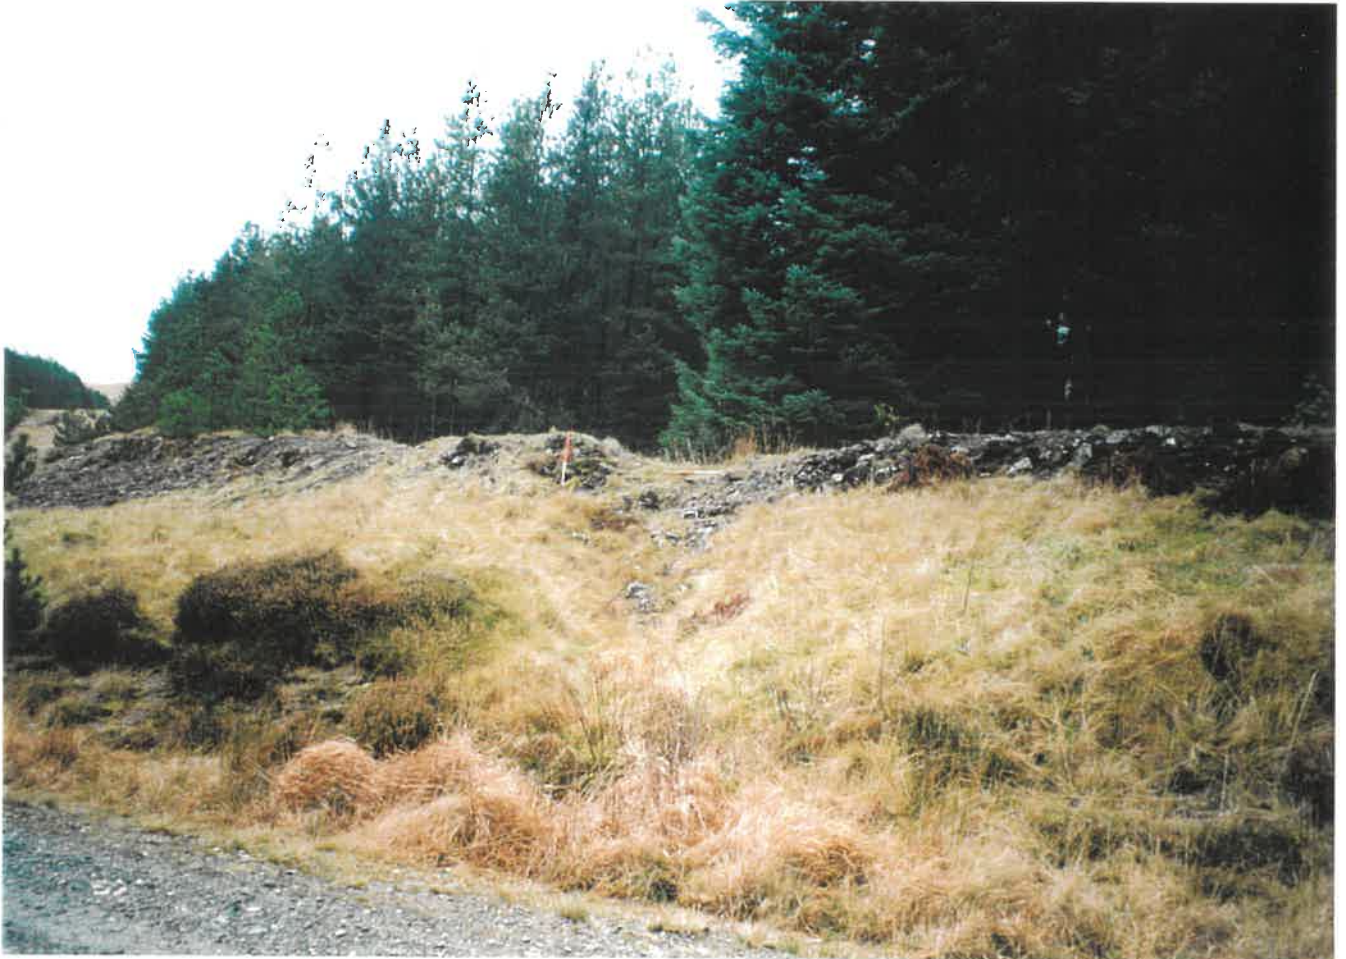
Works, as out-lined in Fig. 1 at Location 1 were monitored 08-09. 02.2000. A section was cut through the Crusher House Tramway, PRN 38063 along the line of the depression featured in Plate 9 below.

Plate 9: Crusher House Tramway, PRN 38063, prior to works. View from south across forestry road shows sunken section of tramway.

5.2 It is assumed that the depression in the tramway as recorded on Plate 9, is due to the collapse of the culvert beneath.

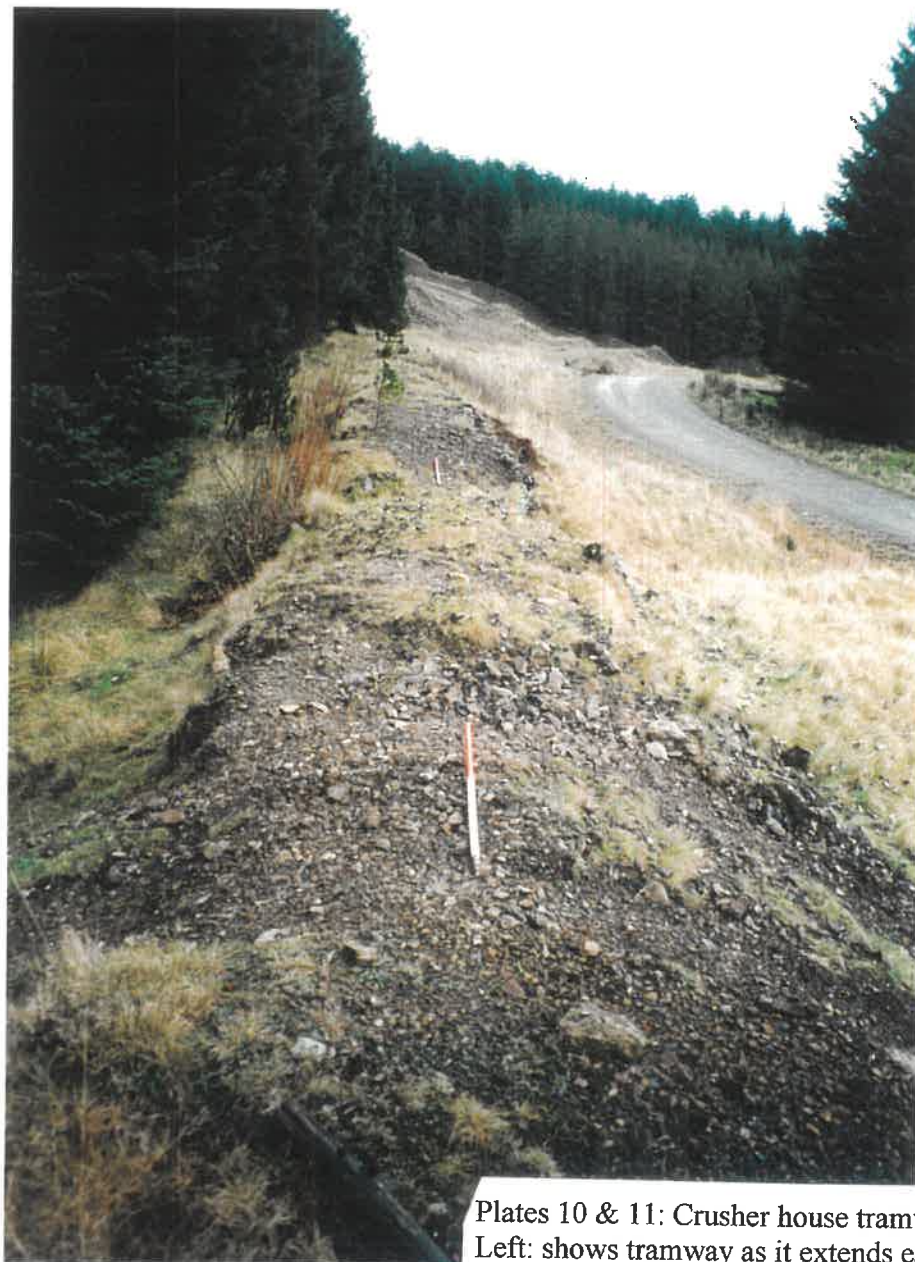
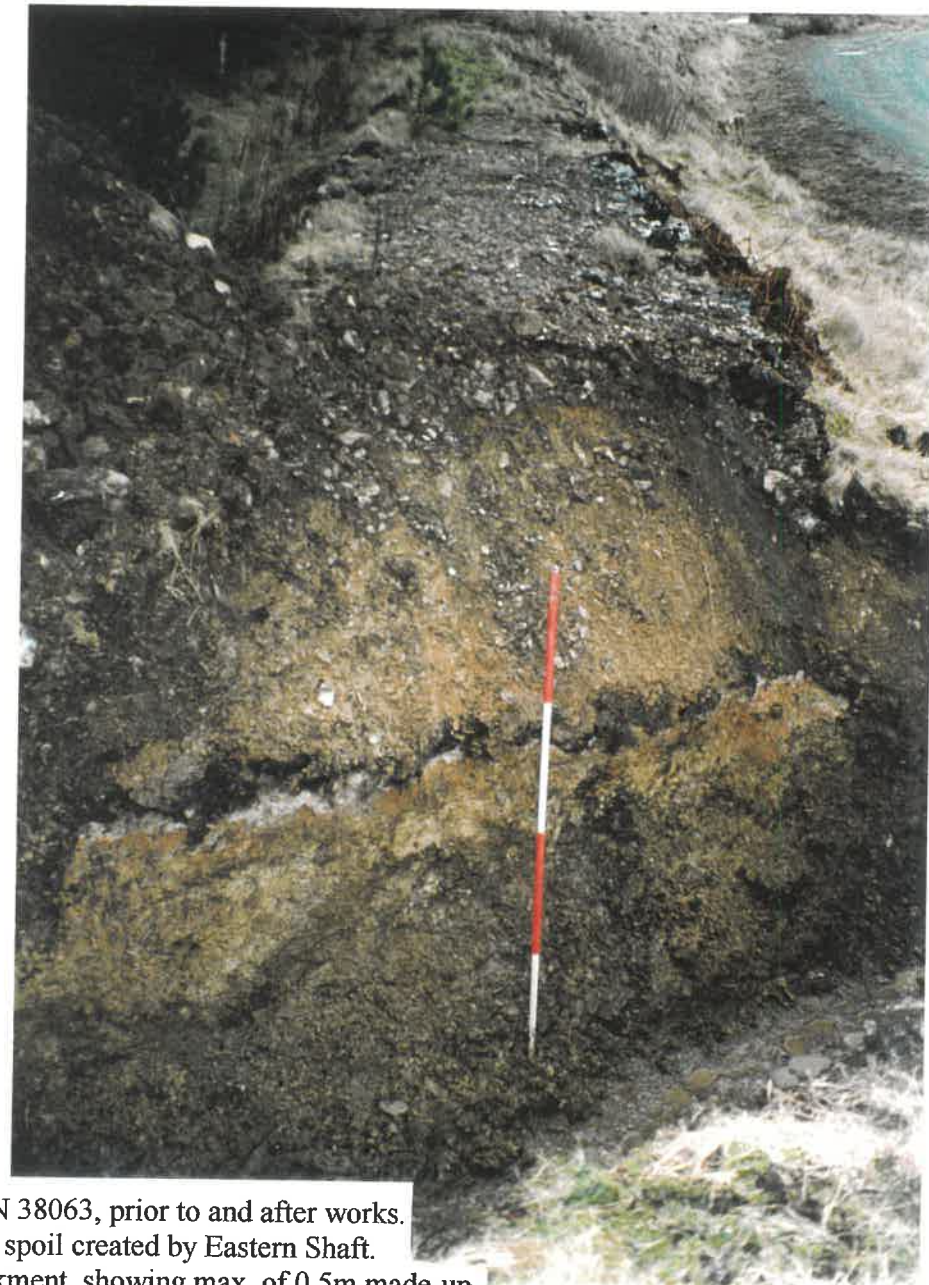
Plates 10 & 11: Crusher house tramway, PRN 38063, prior to and after works.
 Left: shows tramway as it extends east to the spoil created by Eastern Shaft.
 Right: cut through undisturbed shale embankment, showing max. of 0.5m made-up stoned surface for tramway. View from west.

Two 6m x 0.6m diam. pipes were inserted into the excavated cut and the tramway was made-up again with the excavated material. The work at Location 1 was finalised by the excavation of forestry plough-soil on the north side of the tramway to create a new run-off. Following this the former run-off was blocked and the flow of water found its' way out of the pipe at Location 3 within an hour.

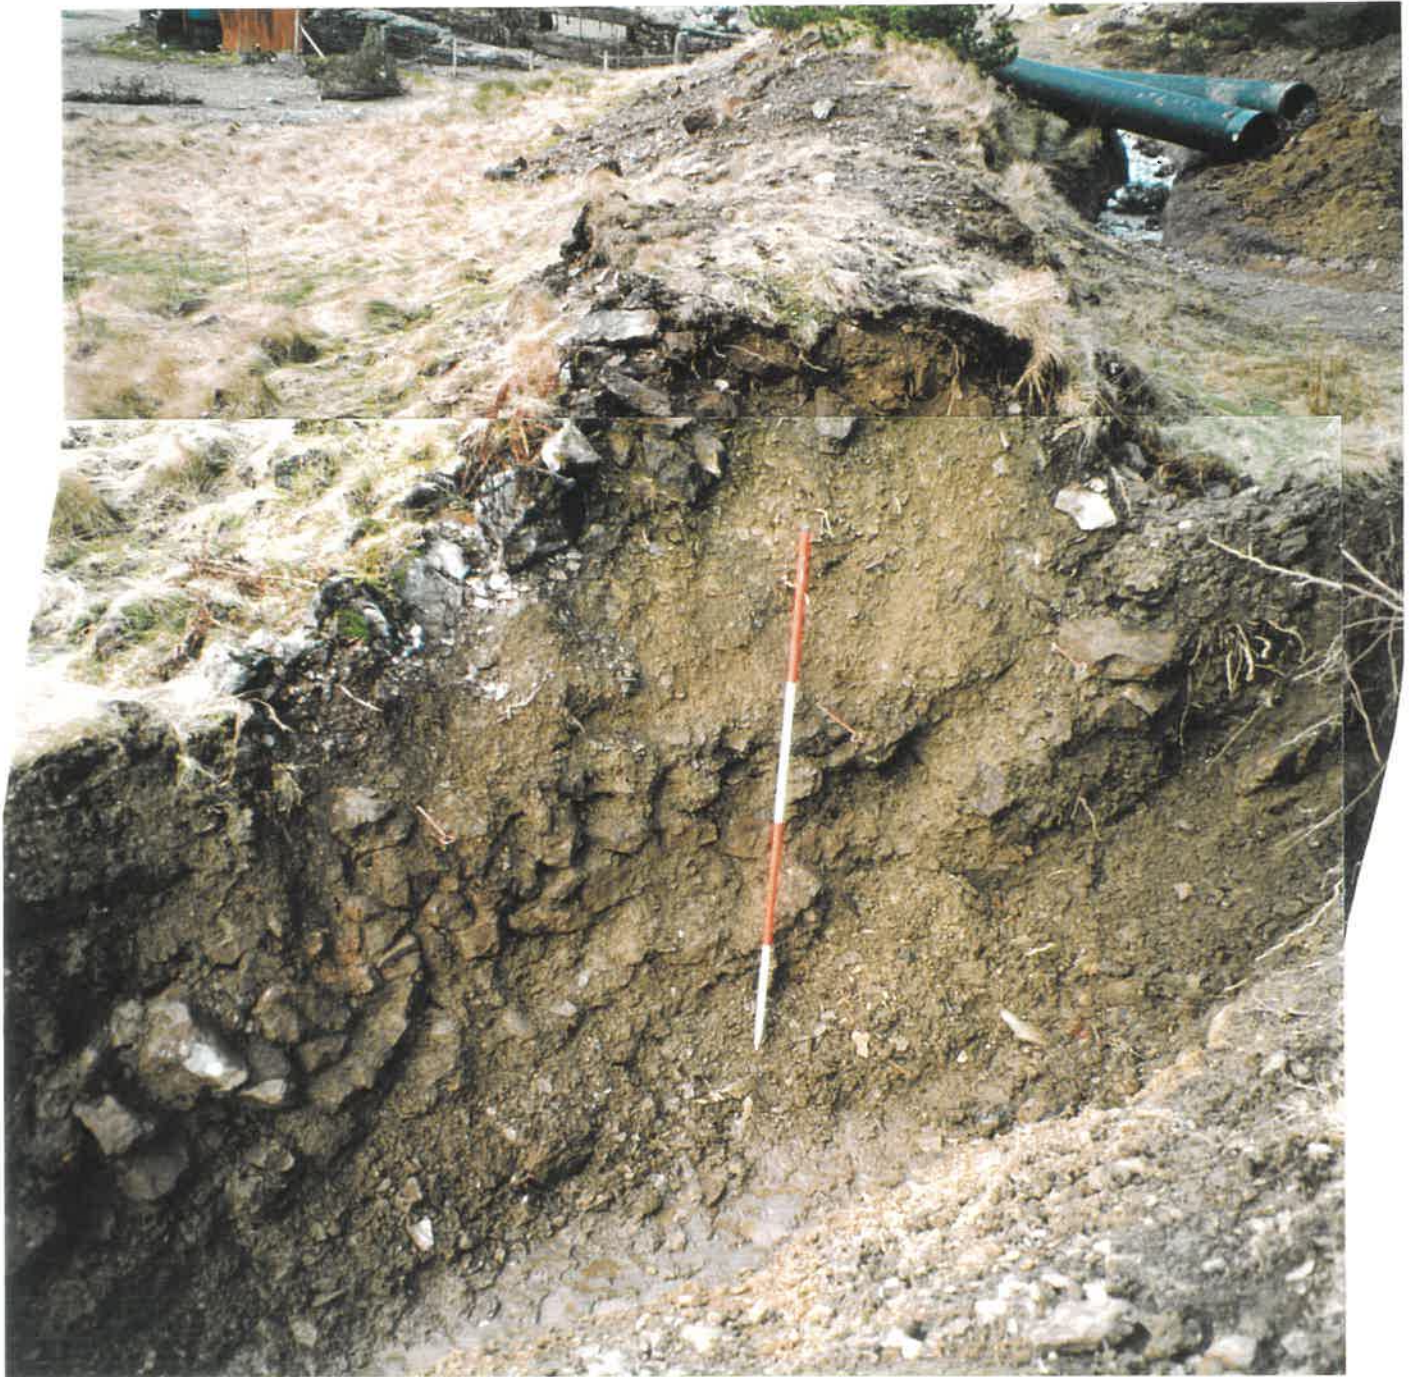
Plate 12: East facing section of Crusher House Tramway, PRN 38063.

Section finally cut to a depth of 2.86m to reveal:

0 – 0.28m max. pale yellow/orange sticky clay natural with no stone, forming the base of the cut (*Context 2 in Sections 4 & 5*).

Max. of 0.88m of rubblestone wall (*Context 9*), which rises to north along the natural south facing slopes.

The wall included 4 pieces of timber (*Context 11*), which appear to have been used as part of the construction, although displaced.

The wall disappears into the section at the north and, where it is abutted by the rich brown forestry plough-soil with loose shale content (*Context 8*).

The bed of the tramway is constructed of vein material, seen in Plate 12 above as calcite and quartz. The difference between the river rubblestones in the buried wall and the stones used in the construction of the tramway can be seen above.

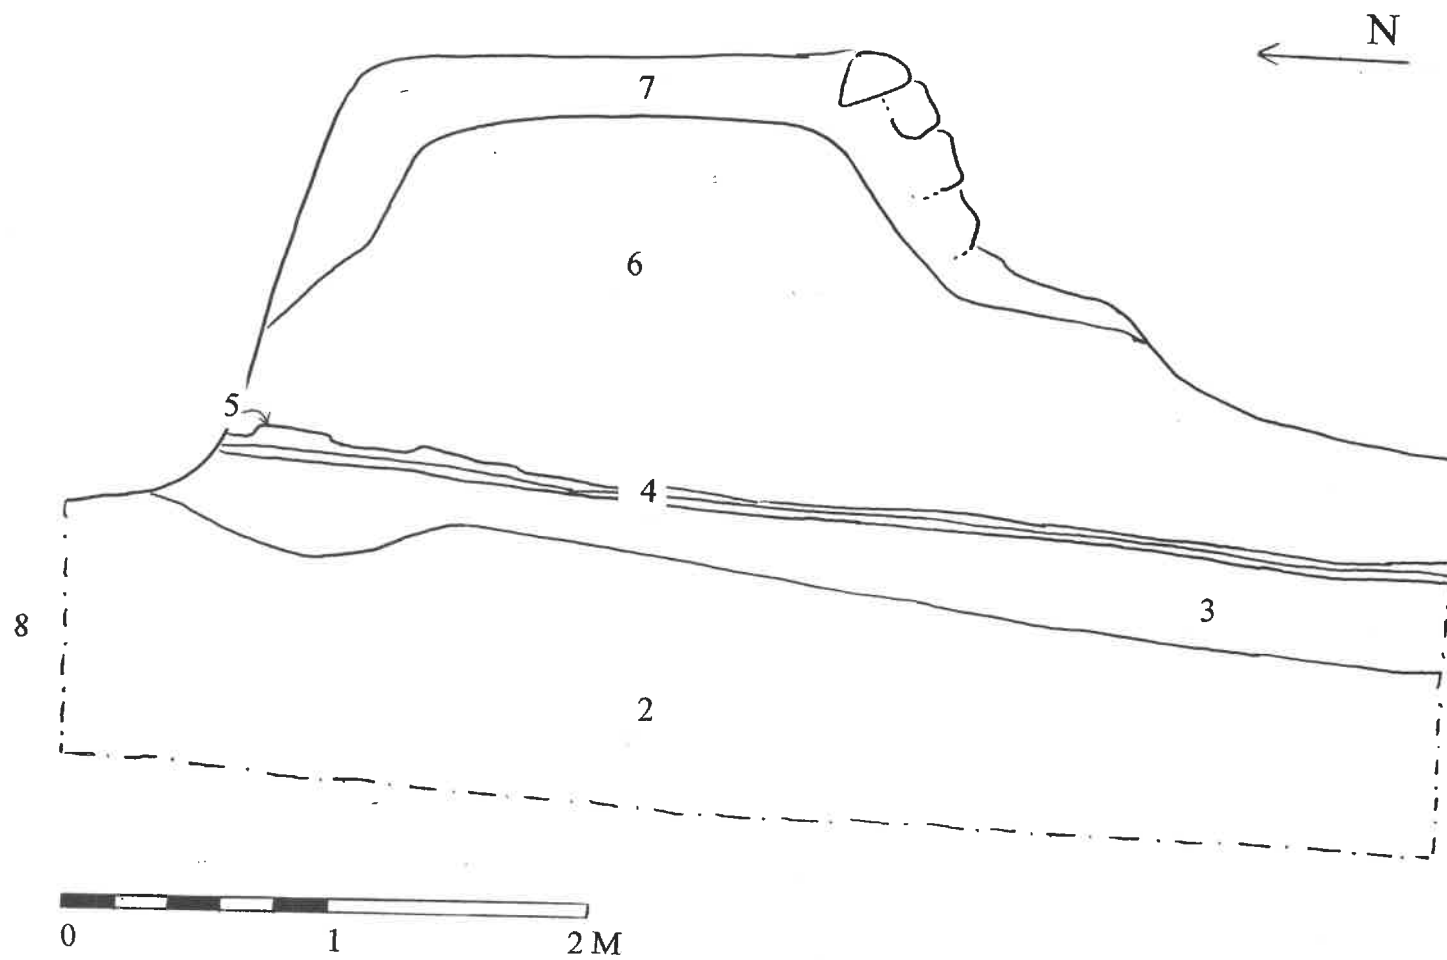
Fig. 5 West facing section of Crusher House Tramway

The section through the tramway was excavated to a max. depth of c.2.86m below the top of the tramway, as recorded in the east facing section (*see Fig. 4; Plate 12*). The cut revealed 2 different sections. The west facing section revealed a clean cut through natural clay layers (*Contexts 2-5*) as previously recorded at Location 3. (*see Fig. 5*). The tramway is presumed to have been constructed on top of a natural ridge, as the ground appears to rise naturally to the north and a layer of shale bed (*Context 6*) lies on top of the clay to a depth of c.1.38m. The bed of the tramway is constructed of stone to a max. depth of c.0.5m on the outer sides, and a bed of no more than 0.3m on top of the tramway. The stones used to construct the tramway bed have presumably come from the sinking of shafts. They contain small amounts of vein material and many are rusty brown in colour indicating a considerable amount of iron carbonate present.

1. Crusher House Tramway
2. Natural clean pale yellow/orange sandy sticky clay with no stone content.
3. Deeper yellow sandy sticky clay with no stone content.
4. i. mid-brown sticky clay
ii orange sticky clay
iii light grey sticky clay
5. Dark brown/black sticky clay – no stone
6. Light brown/yellow loose soil with Fragmentary shales.
7. Stone/shale bed of tramway
8. Rich brown forestry ploughsoil
9. Buried rubblestone wall
10. Thin layers of turf covered topsoil
11. Disturbed pieces of wood
