Land Adjacent to Bedwen, Llanon, Ceredigion

Desk Based Assessment

Planning No.: A220682

Project No.: AD147

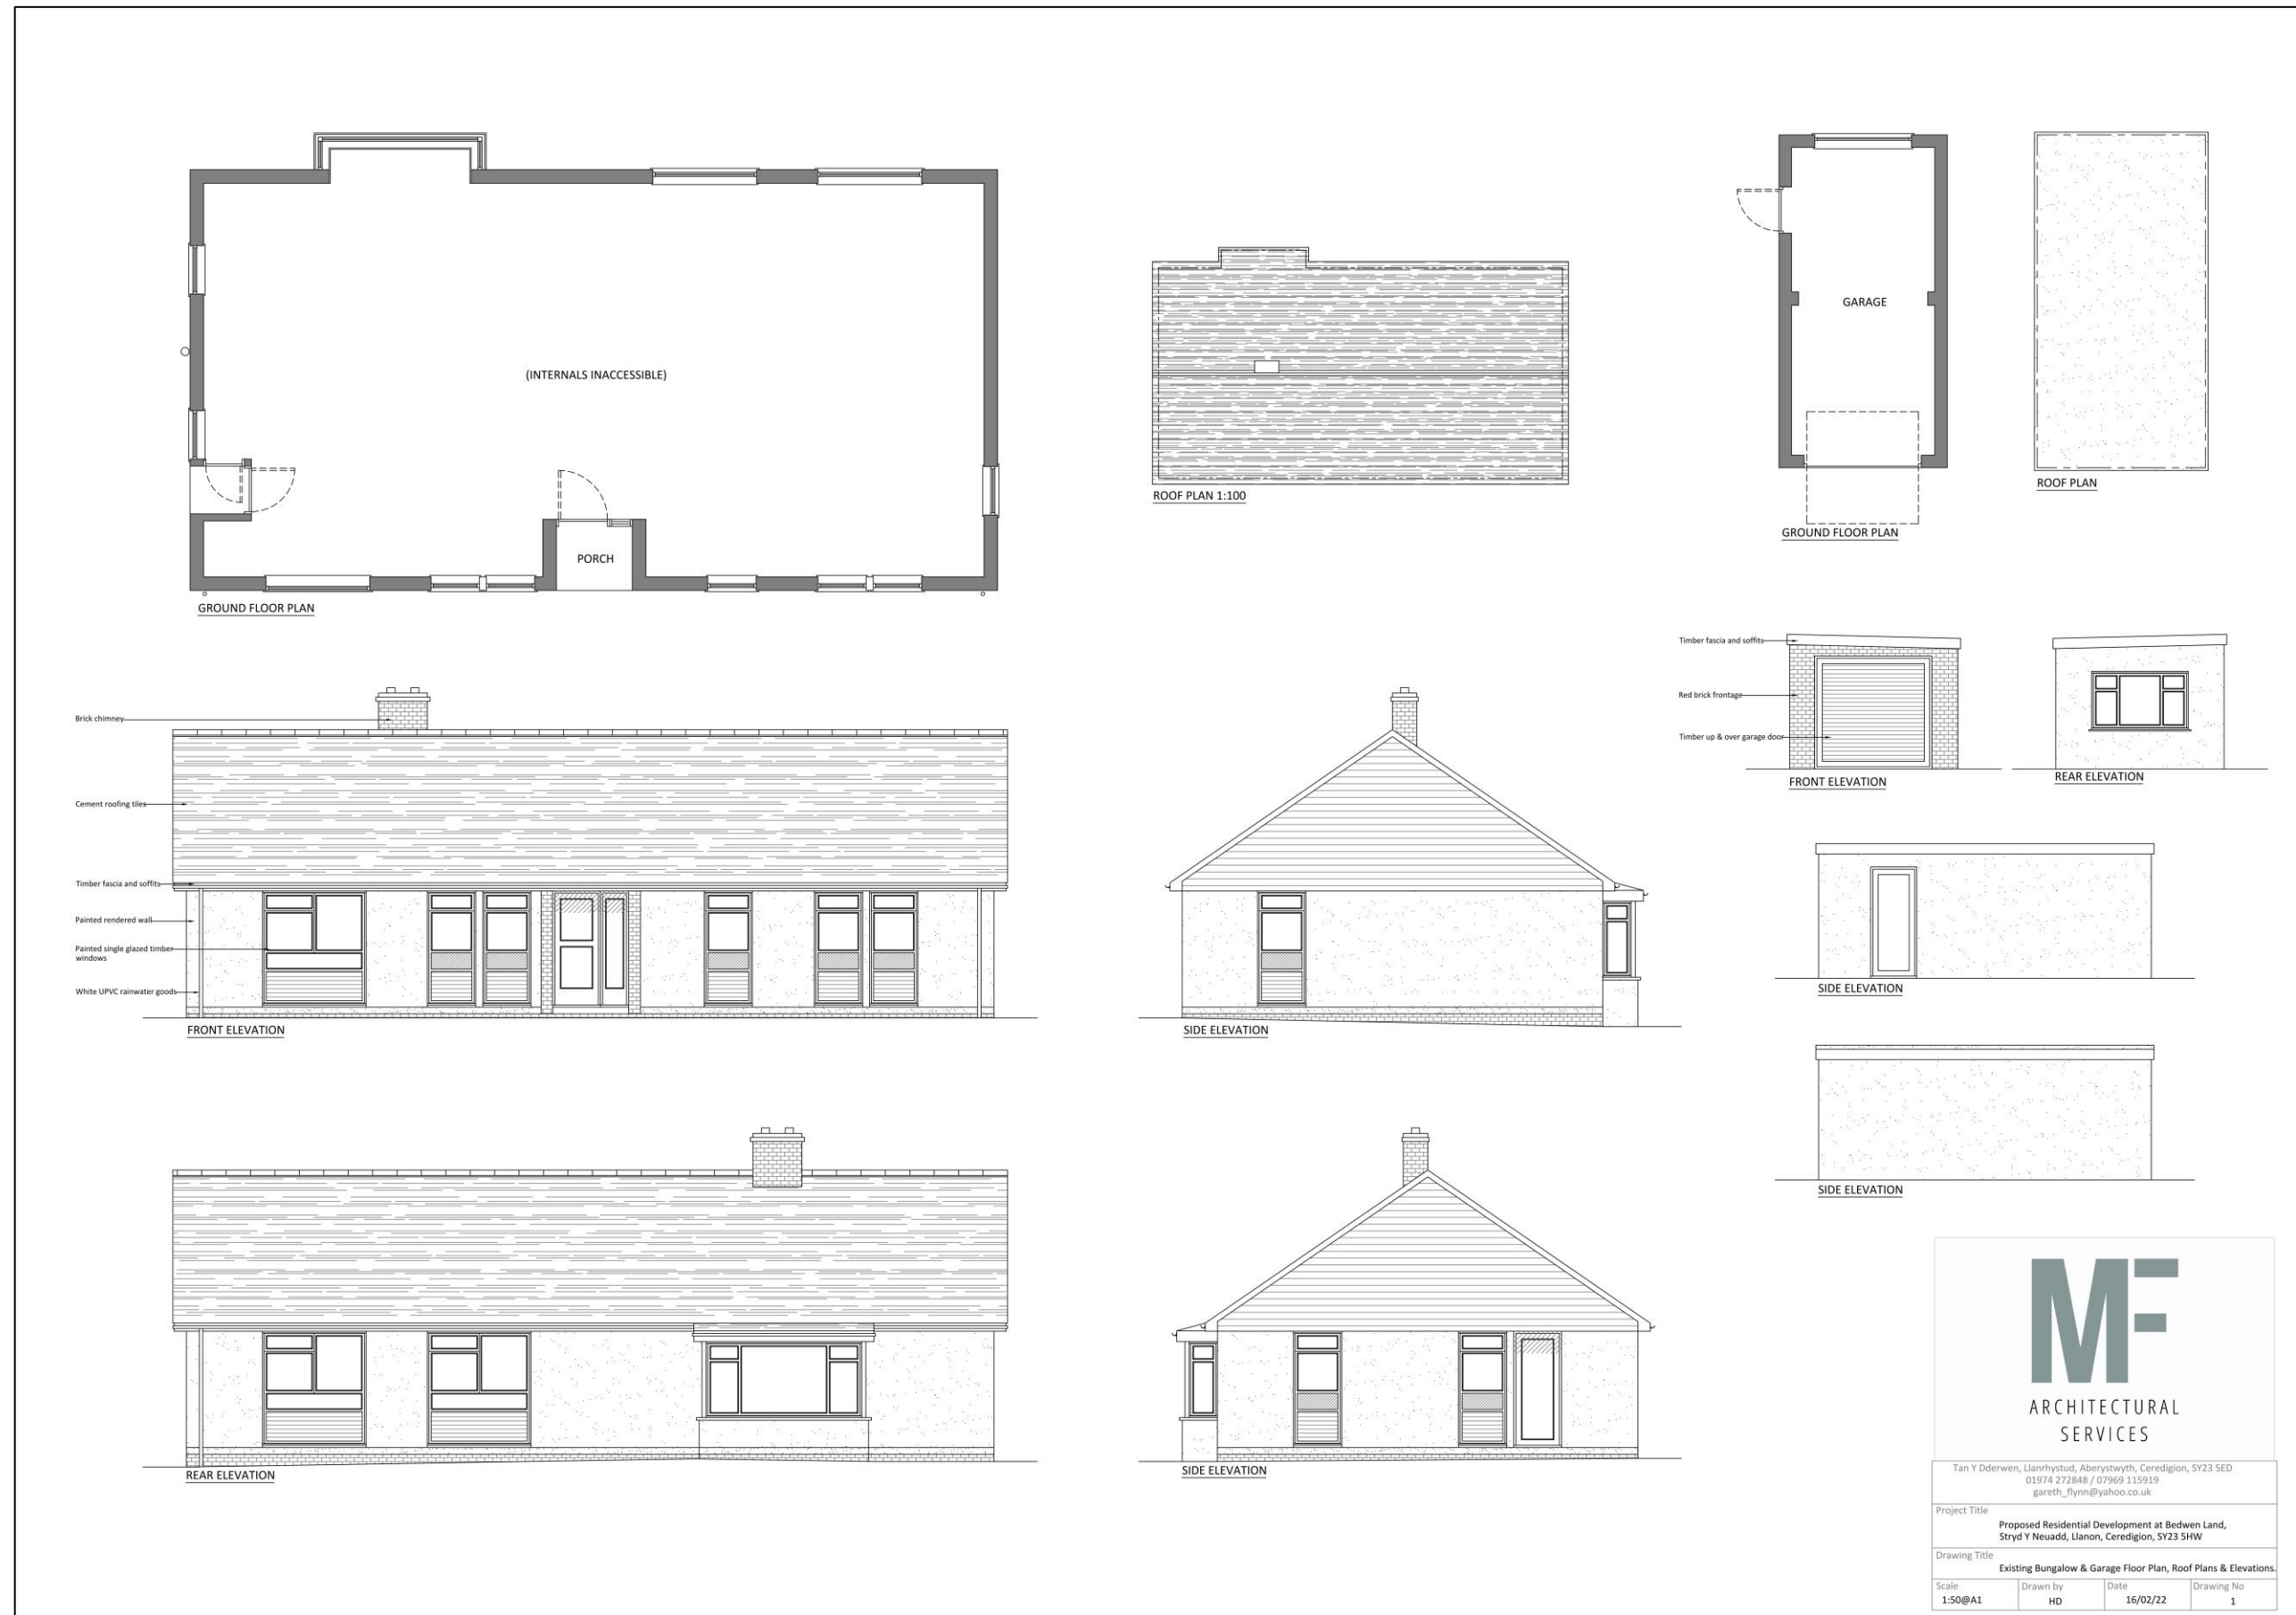
Fig. 5 – Existing dwelling plans and elevations.

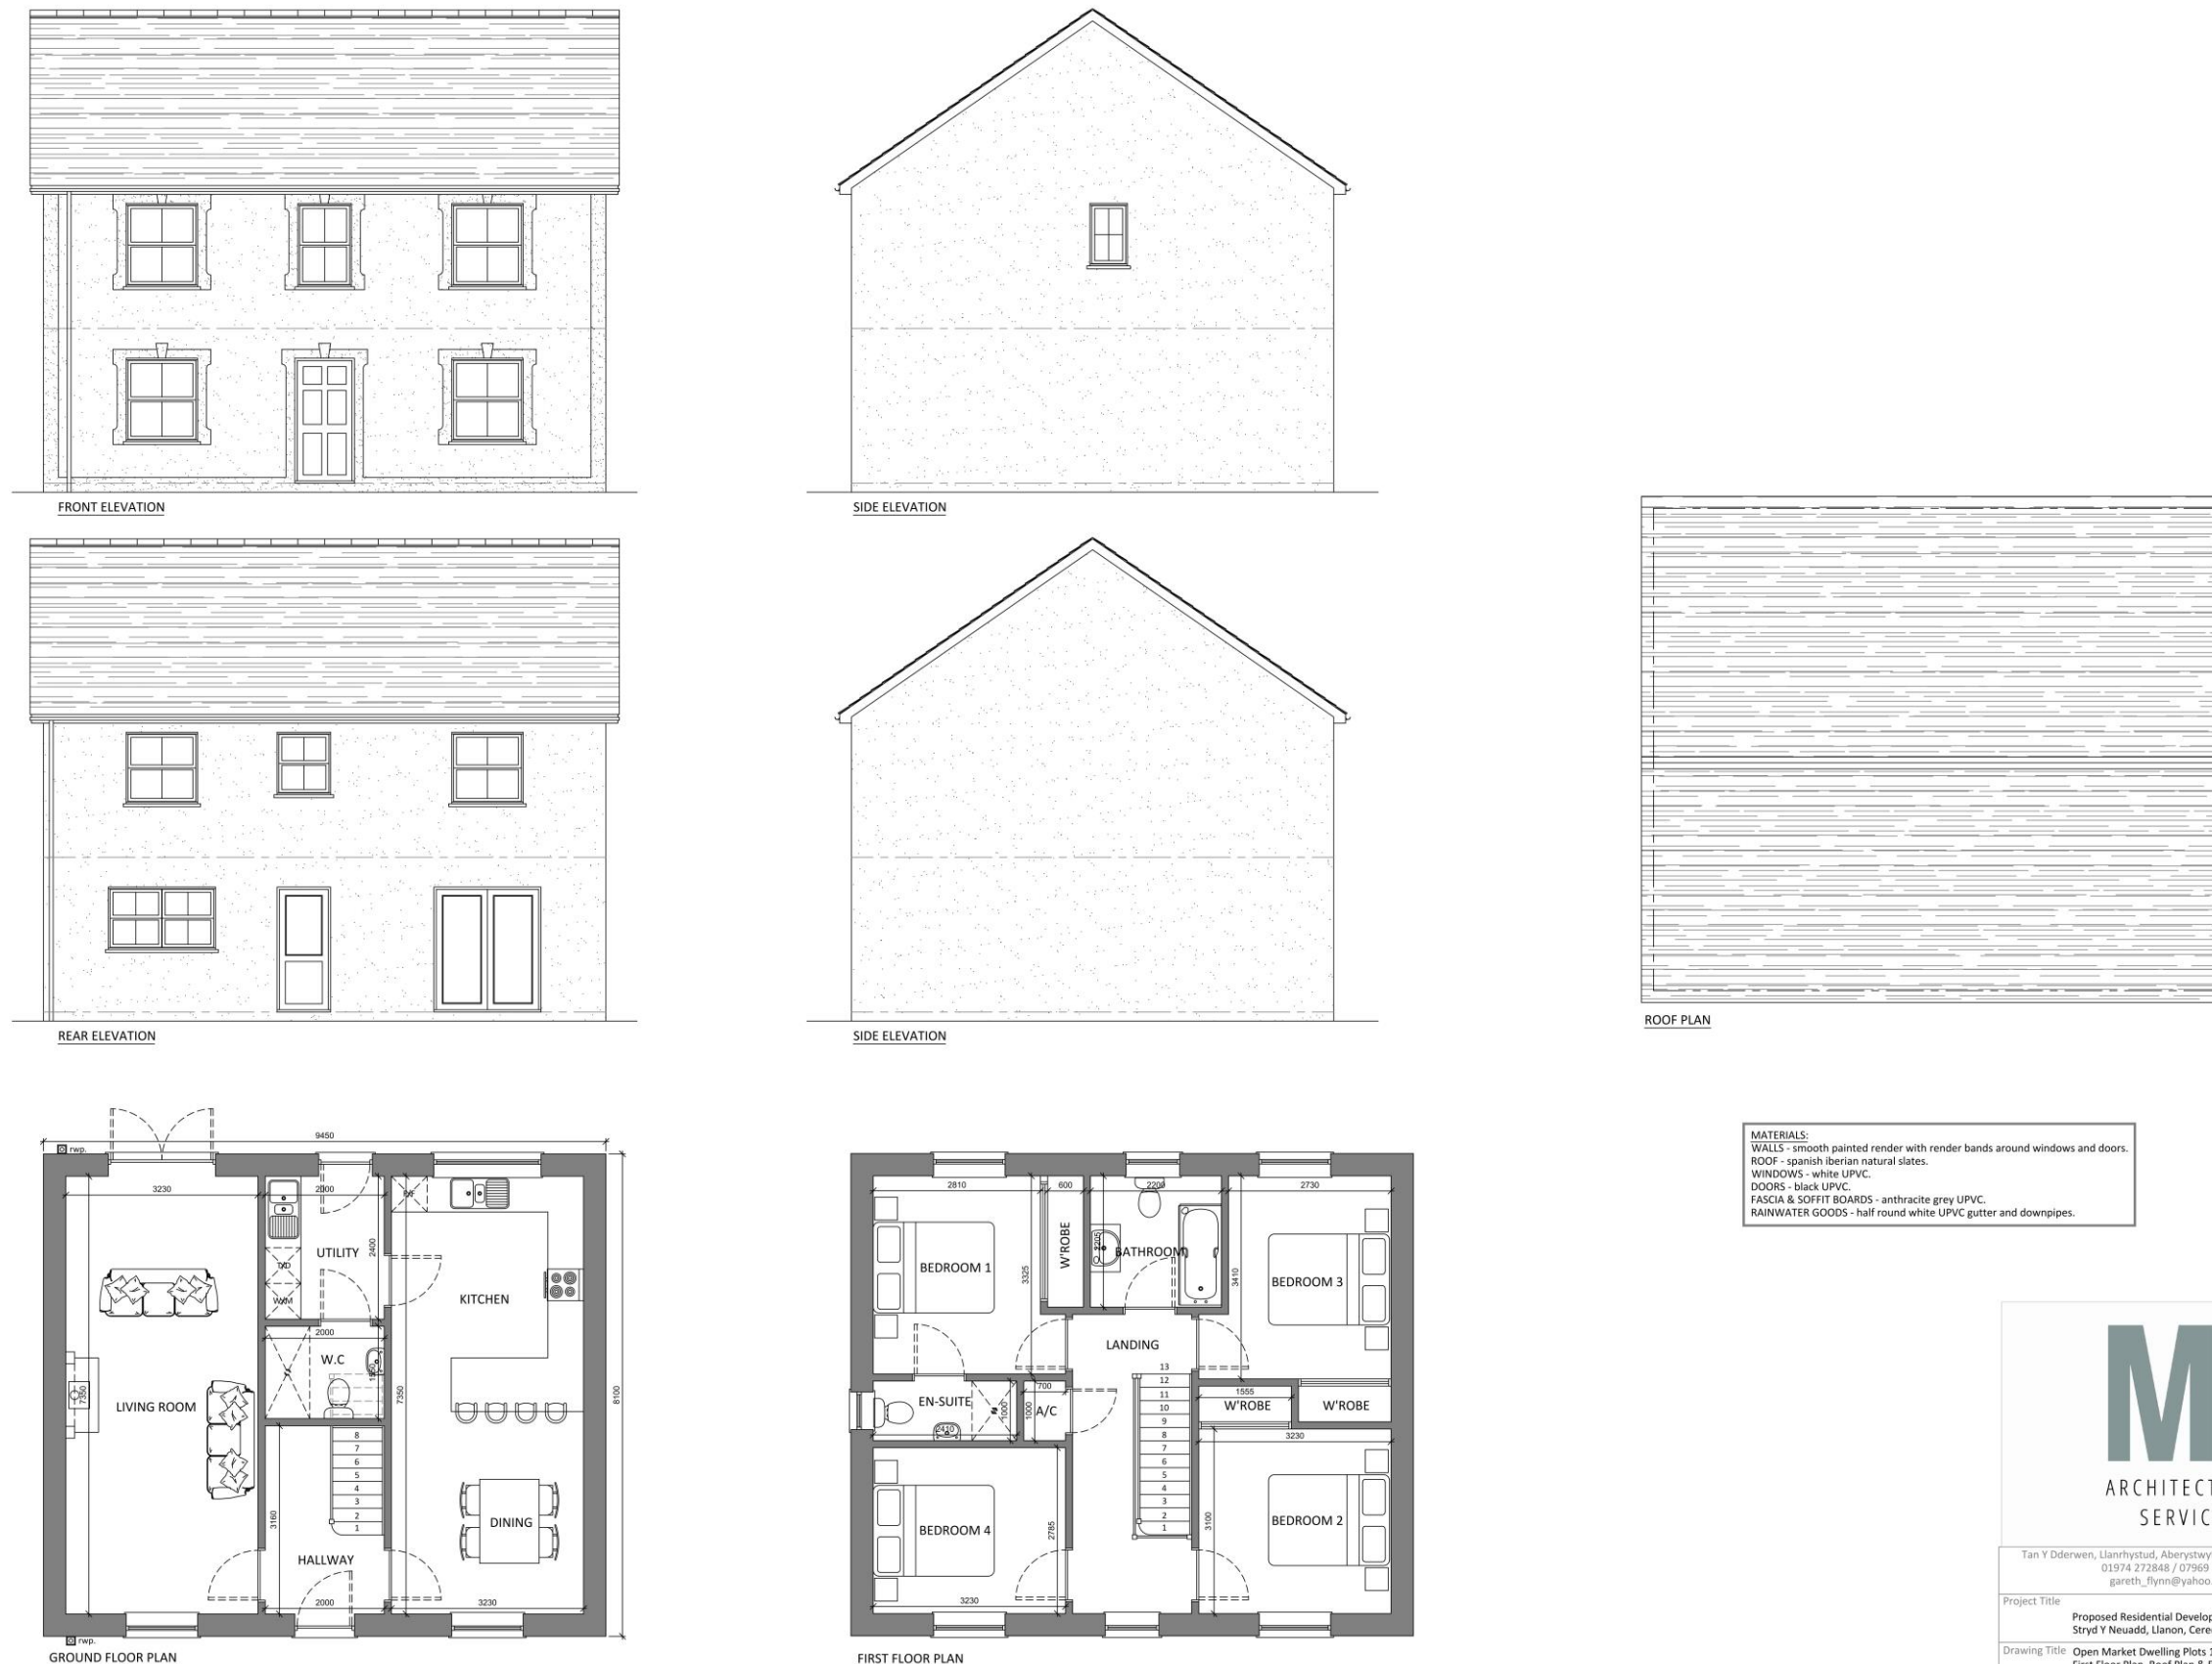
Scale: 1:50@A1	Drawn by: HD	Date: 16/02/22	Drawing No: 2
----------------	--------------	----------------	---------------

Fig. 6 – Proposed Dwelling Plan – 1 & 9

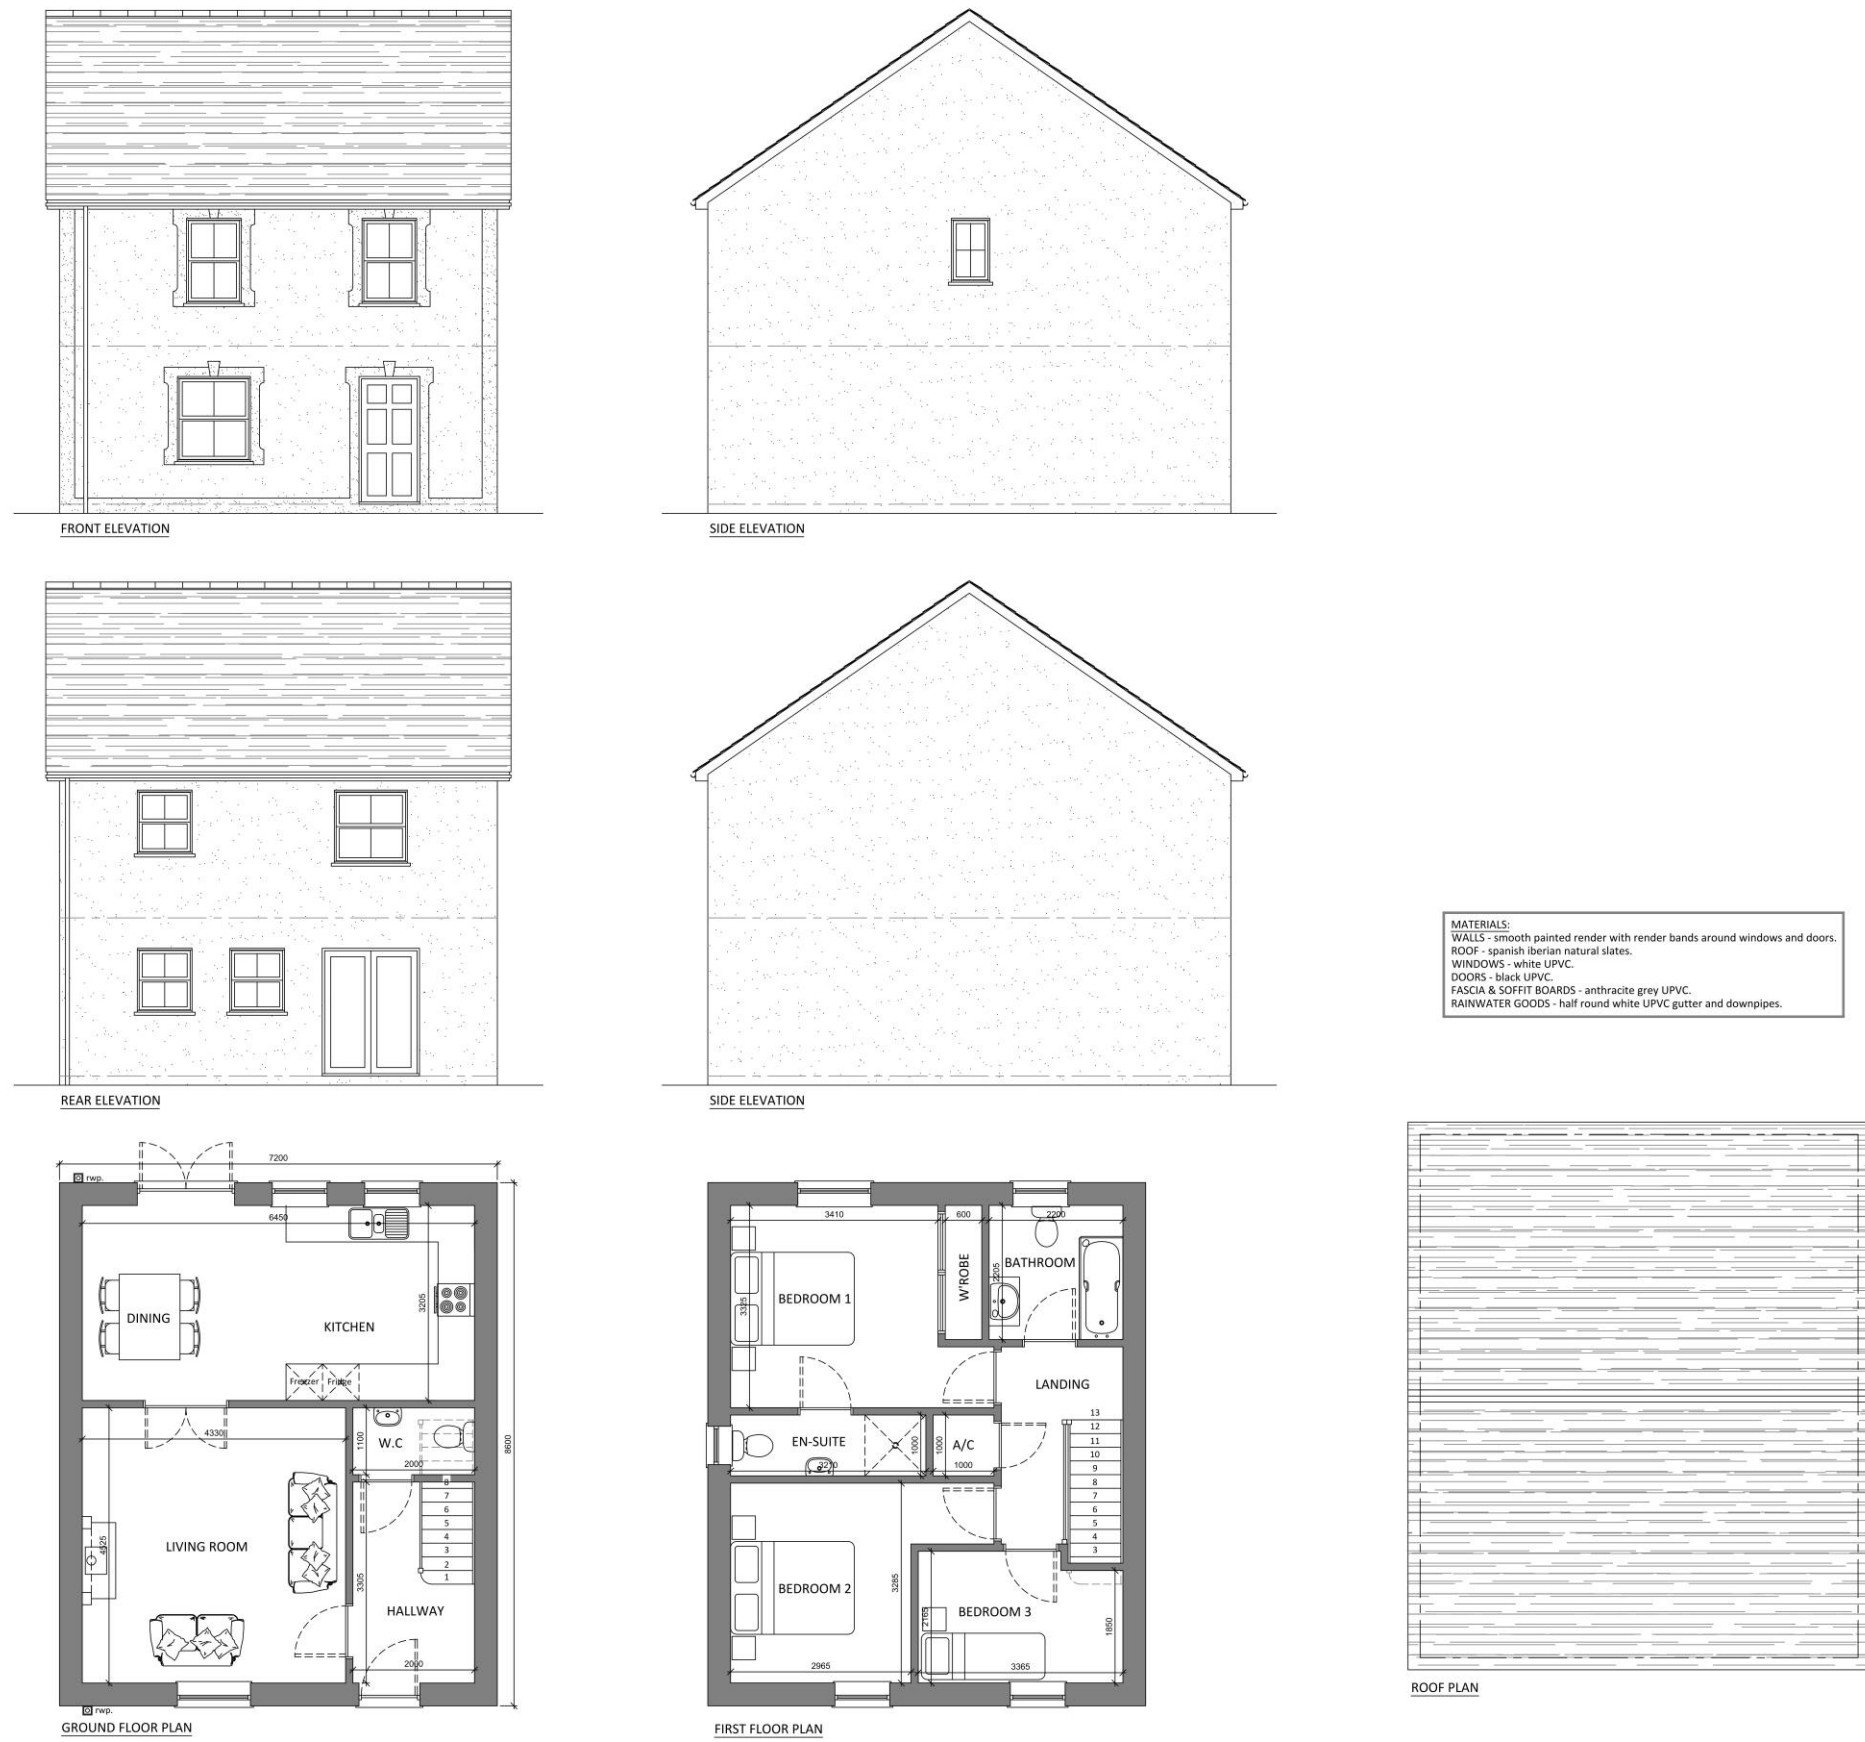
Scale 1:50@A1	Drawn by HD	Date 24/08/22	Drawing No 3
------------------	----------------	------------------	-----------------

Fig. 7 – Proposed Dwelling Plan – 2, 5 & 6.

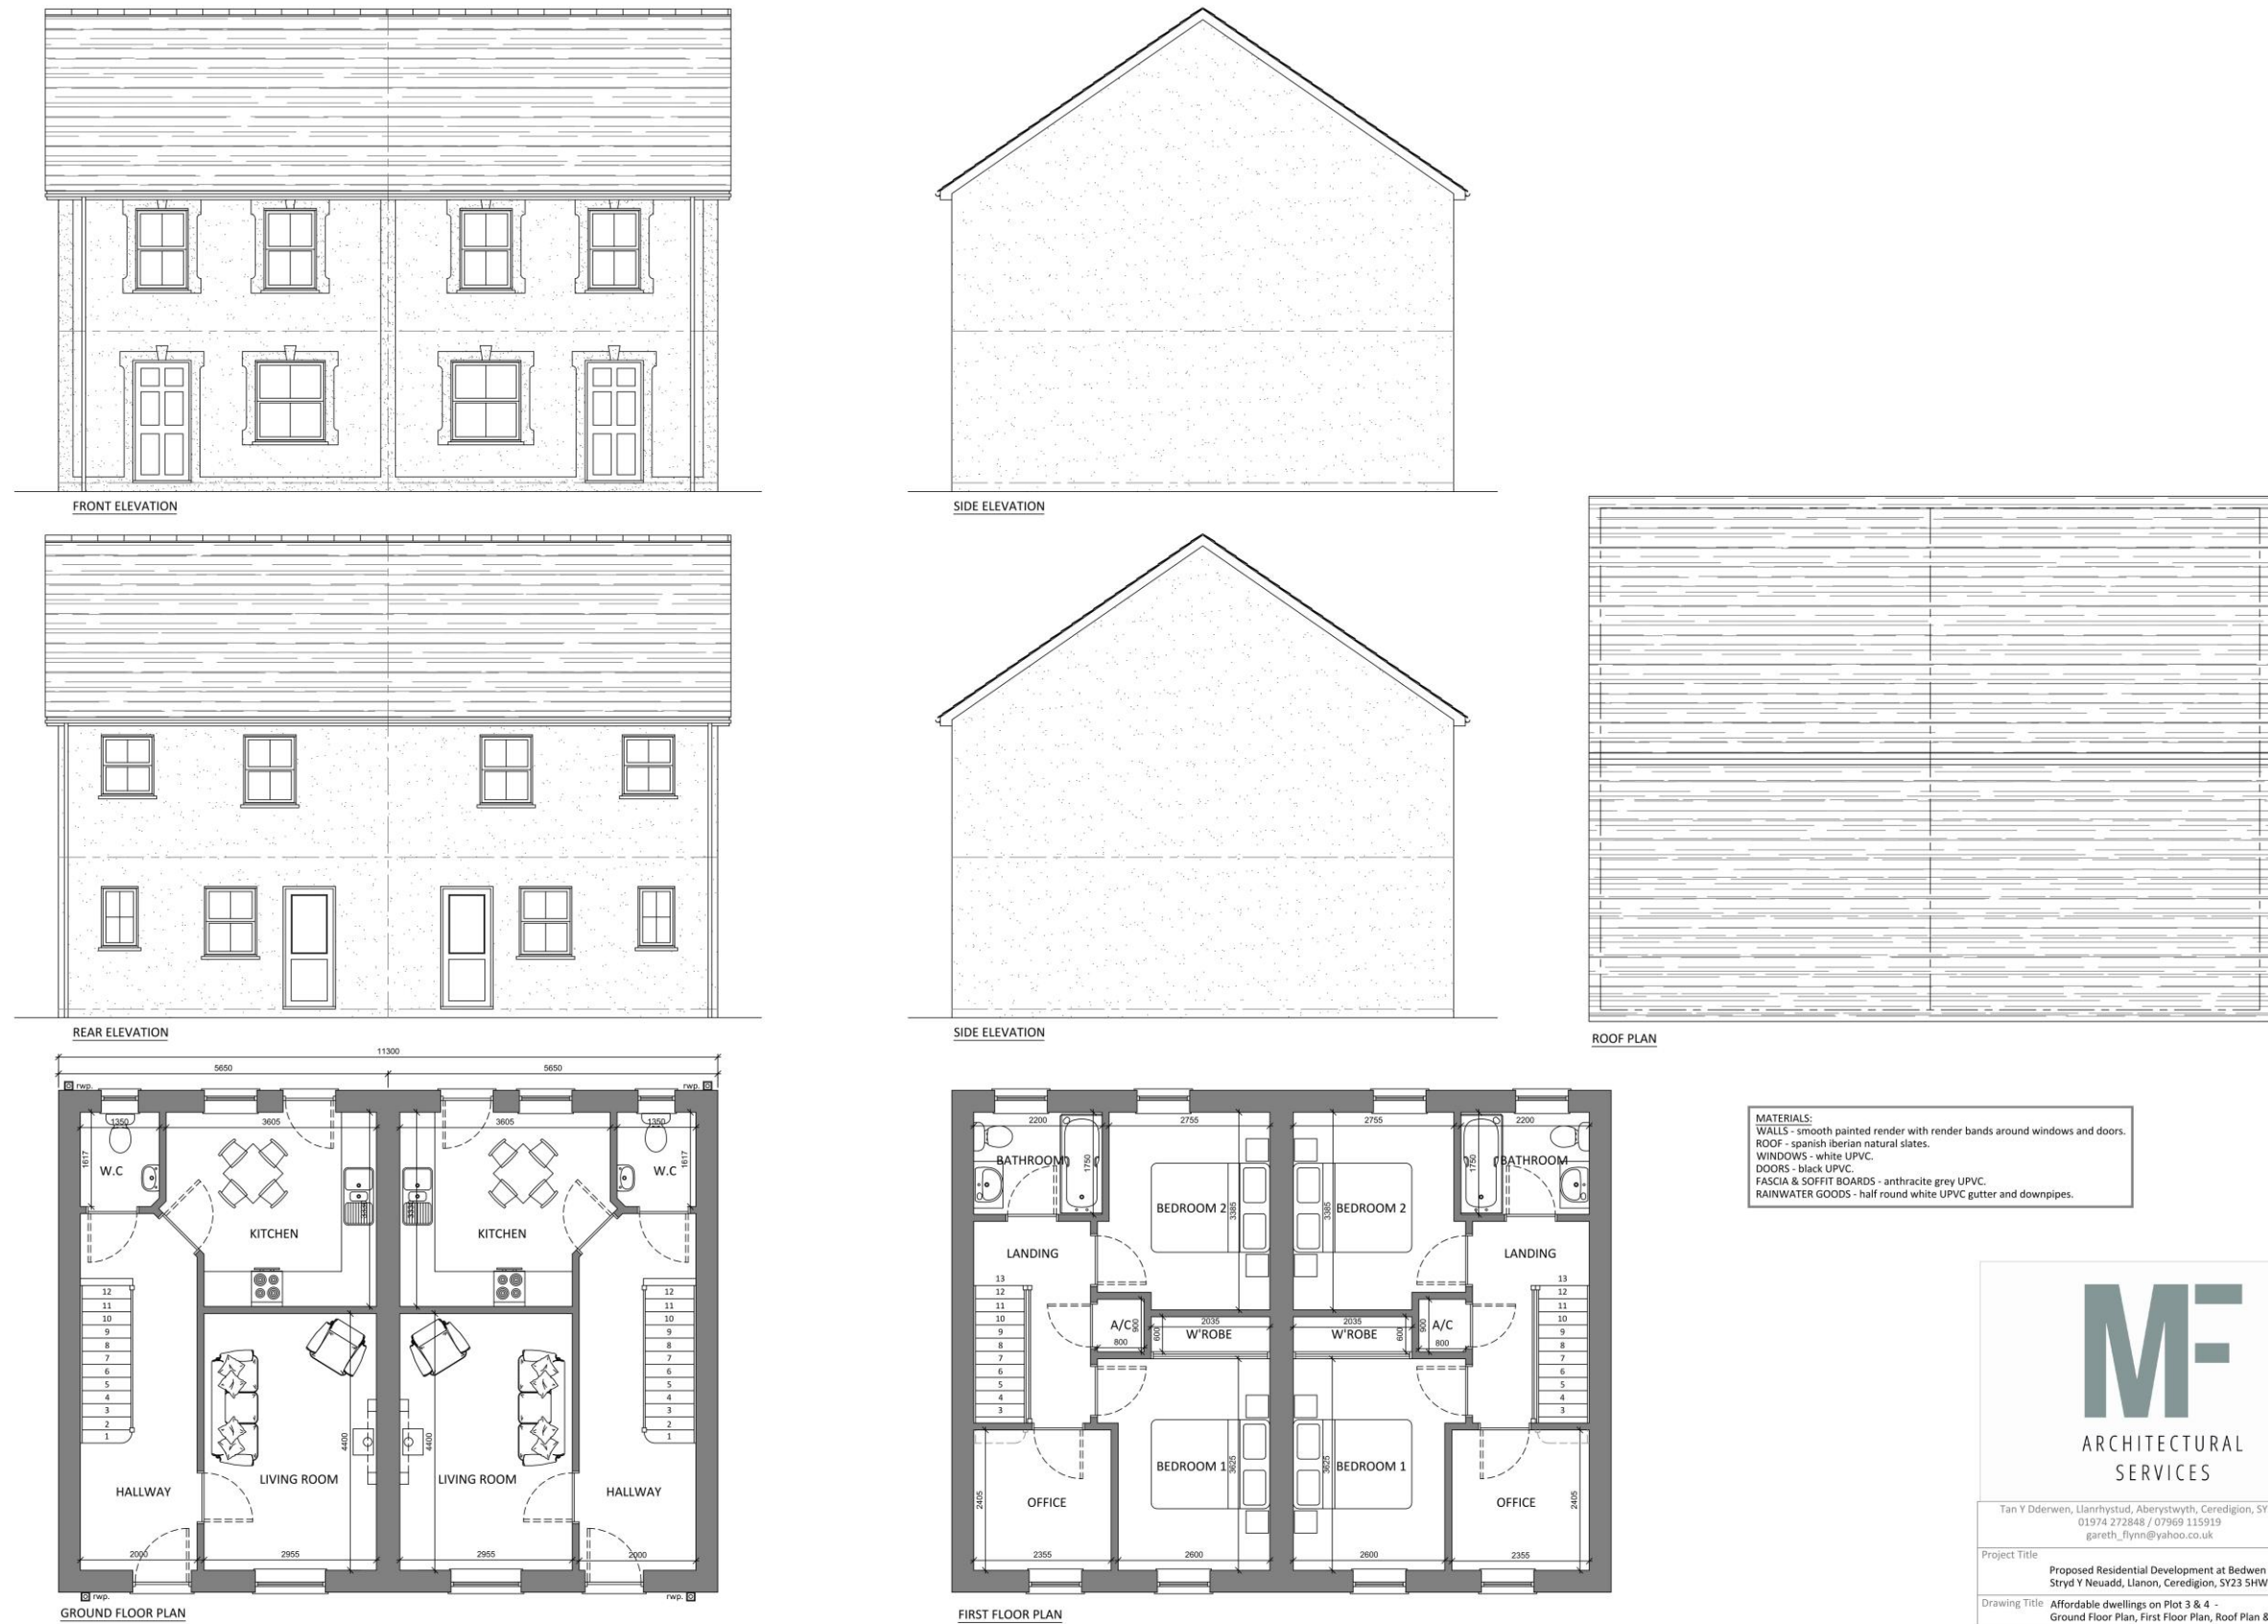
Fig. 8 – Proposed Dwelling Plan – 3 & 4.

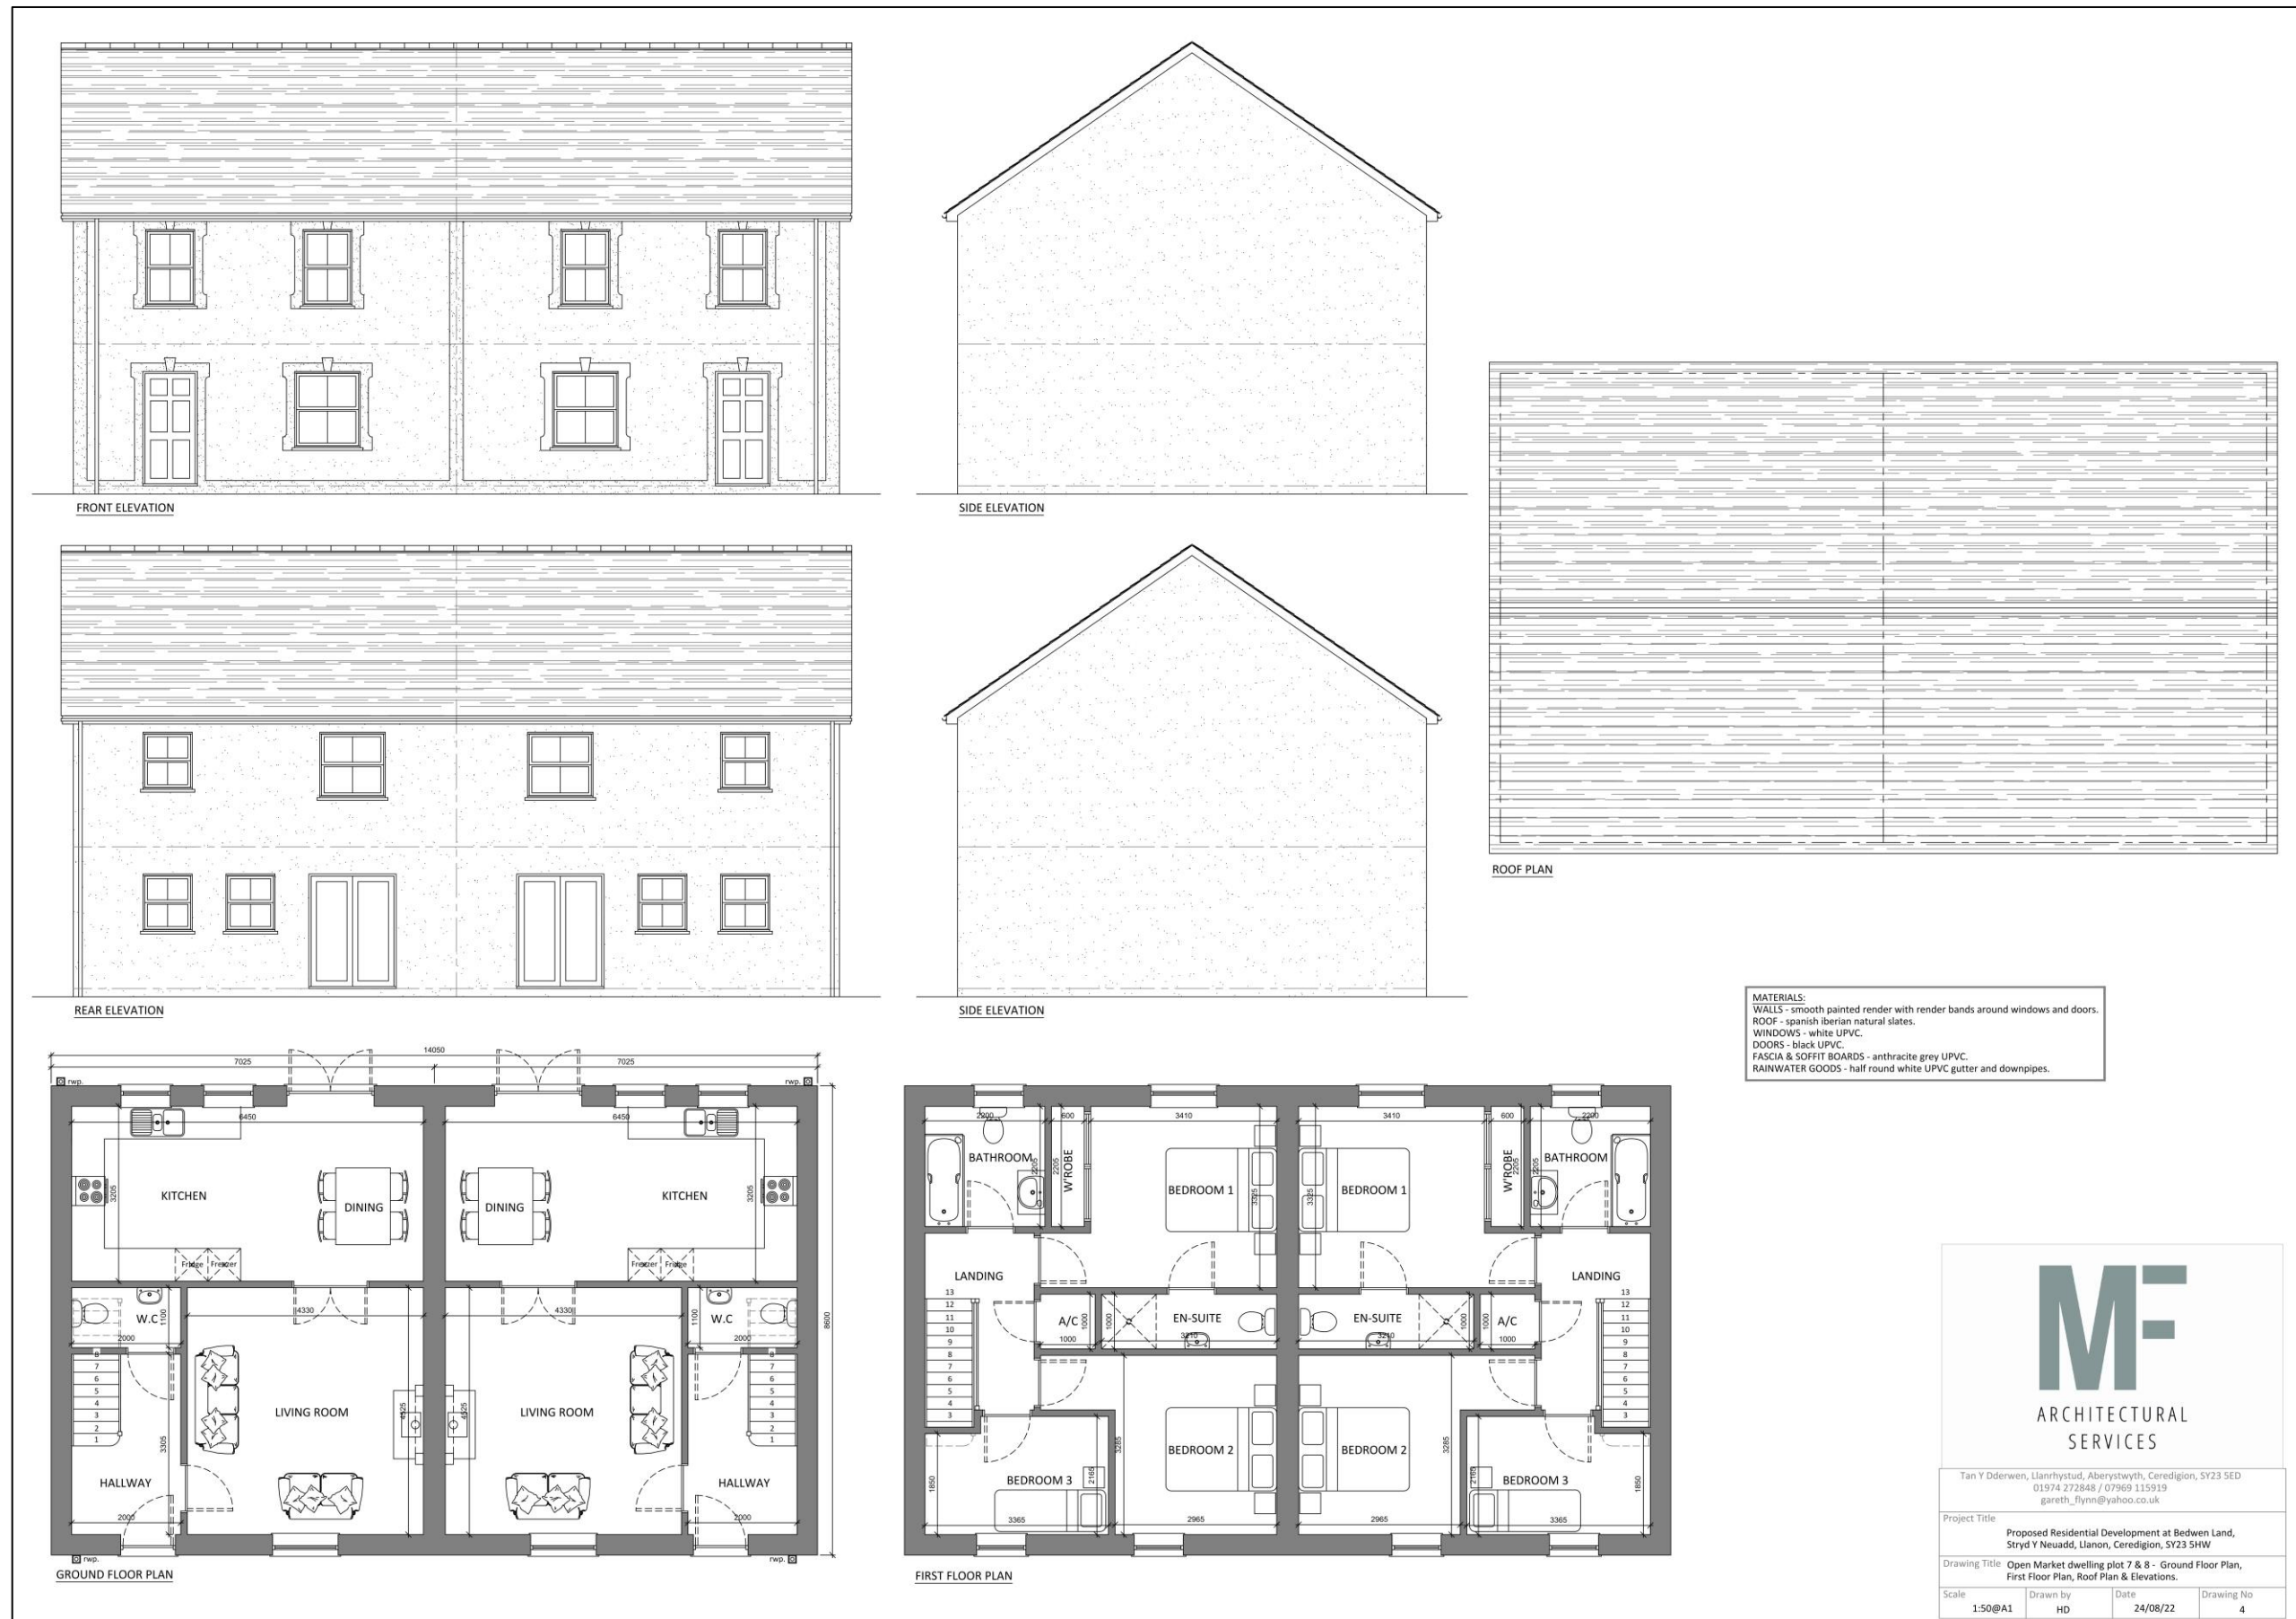
Fig. 9 – Proposed Dwelling Plan – 7 & 8.

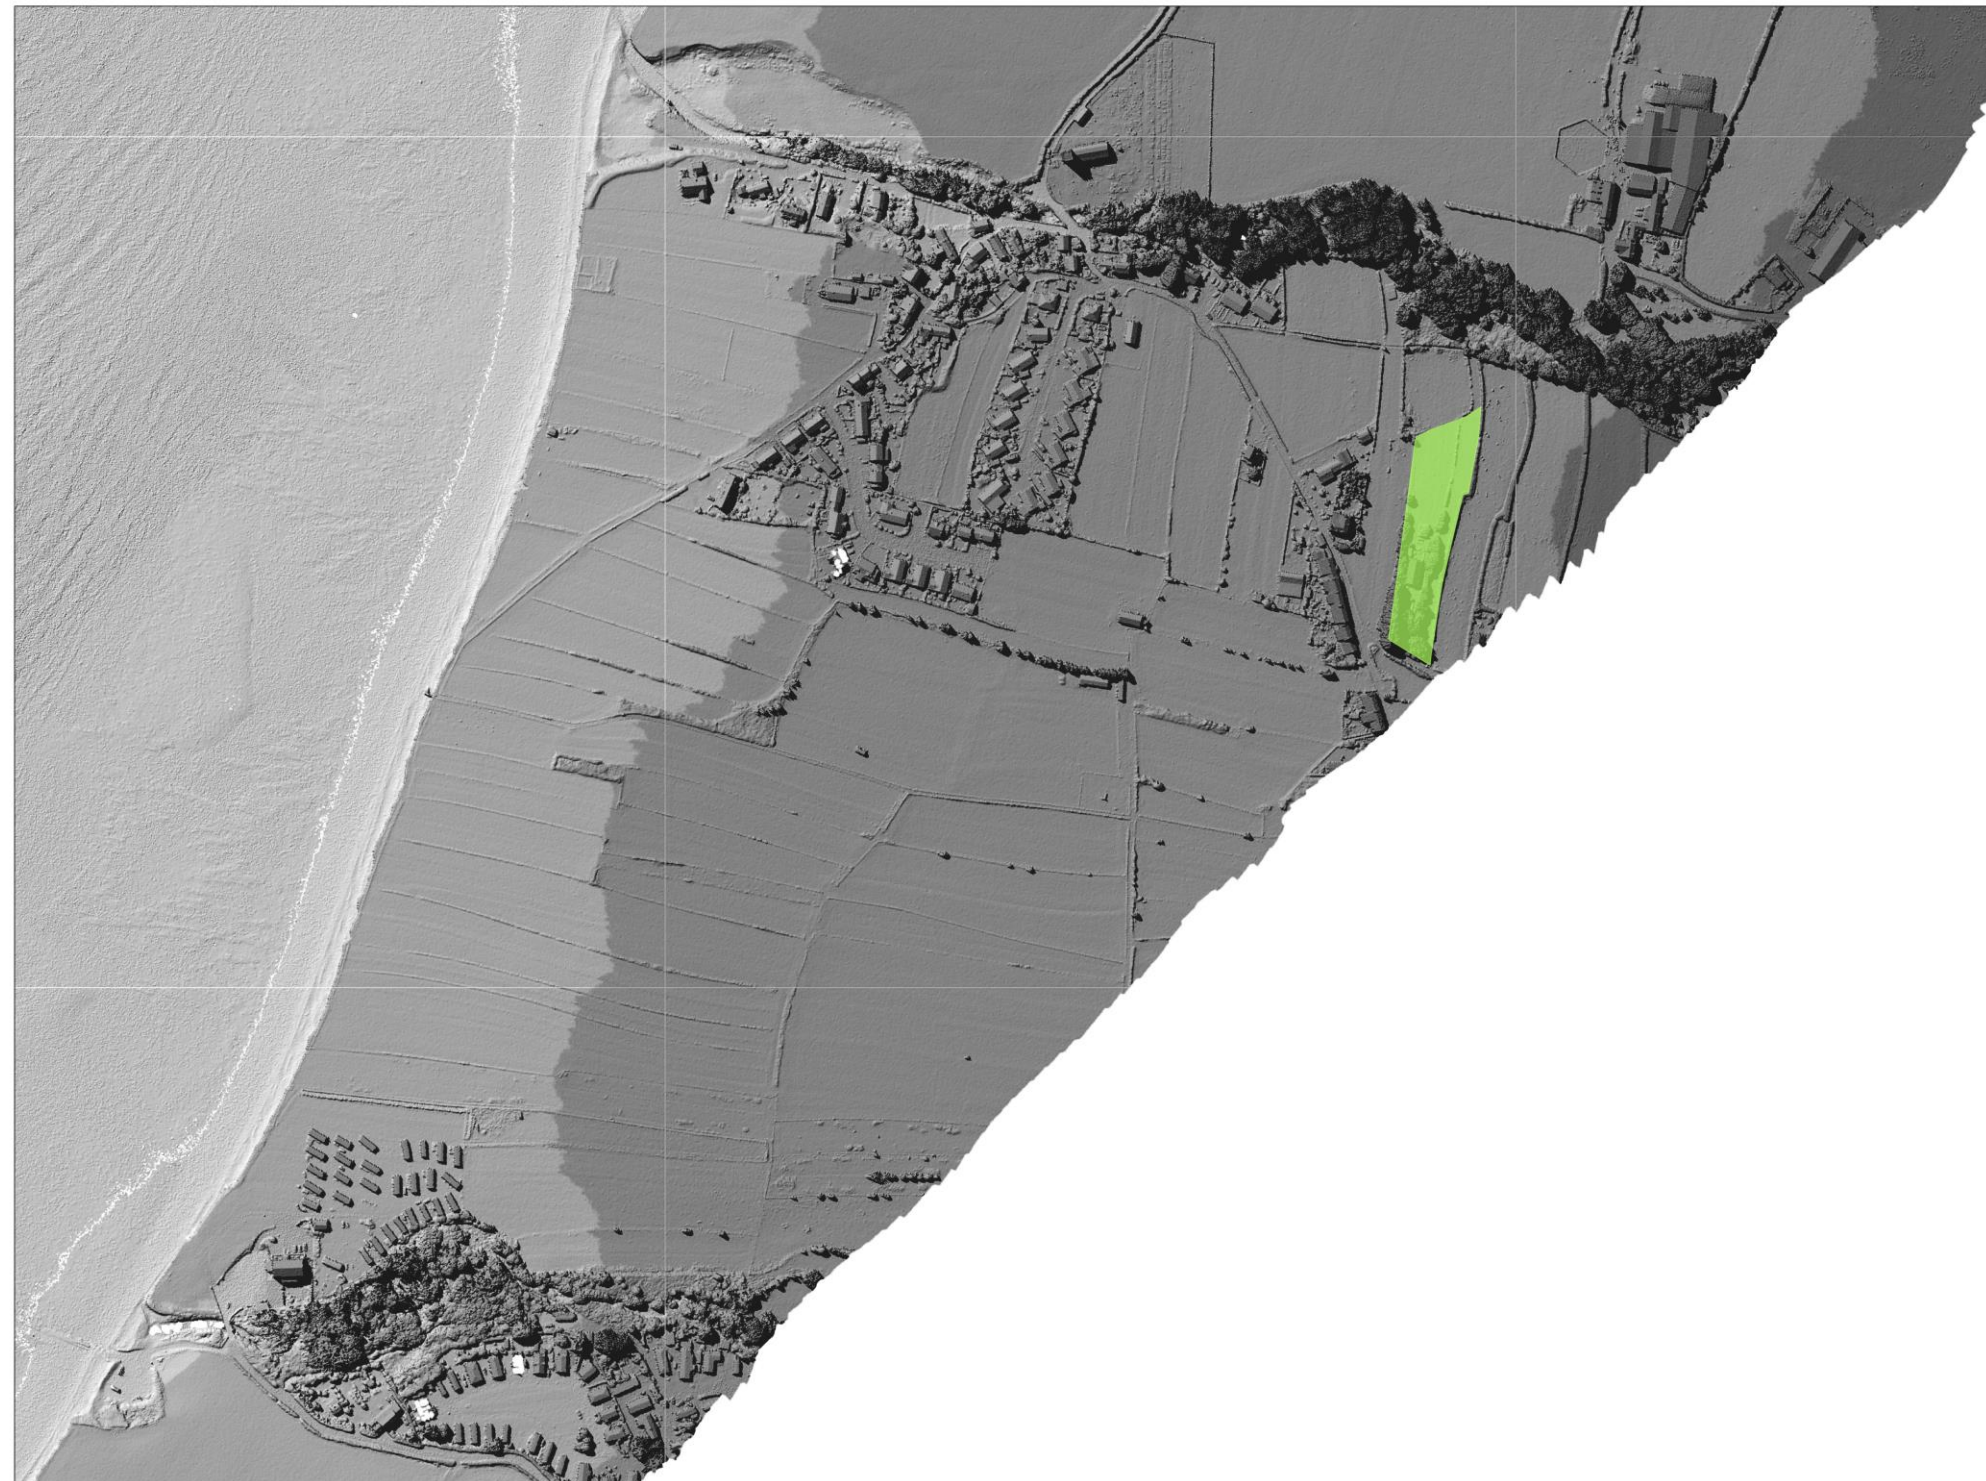
Project Land Adjacent to Bedwen, Llanon	
Drawing Title 25cm LiDAR Survey Data	
Drawn Ross Cook	Scale -
Drawing No. AD147-5	Date Dec. 2022

Fig. 14 – 25cm LiDAR Survey Data.
