Land Adjacent to Bedwen, Llanon, Ceredigion

Desk Based Assessment

Planning No.: A220682

Project No.: AD147

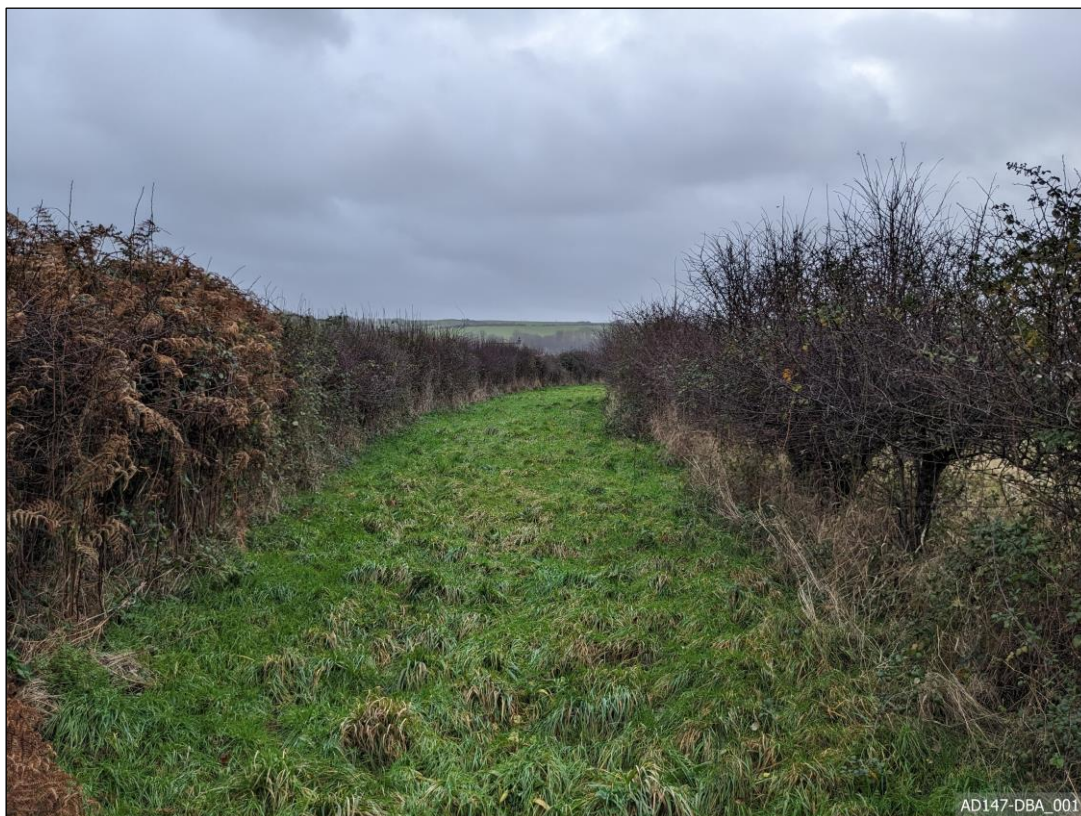
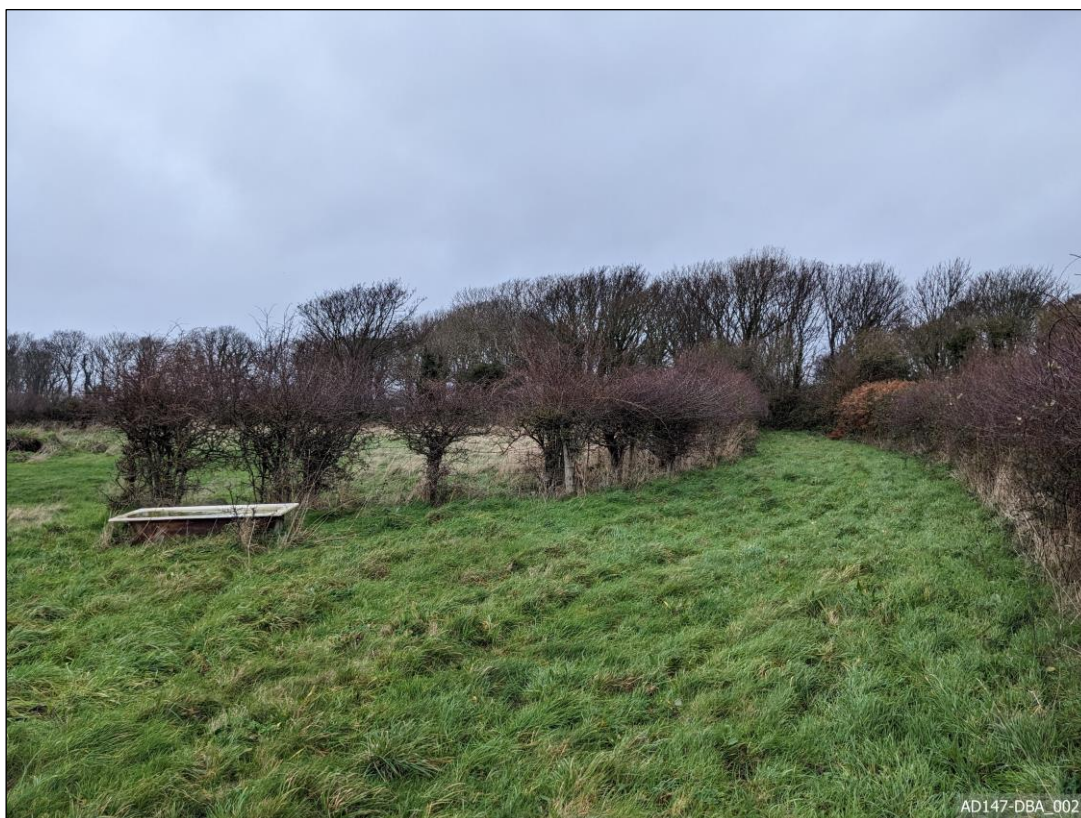
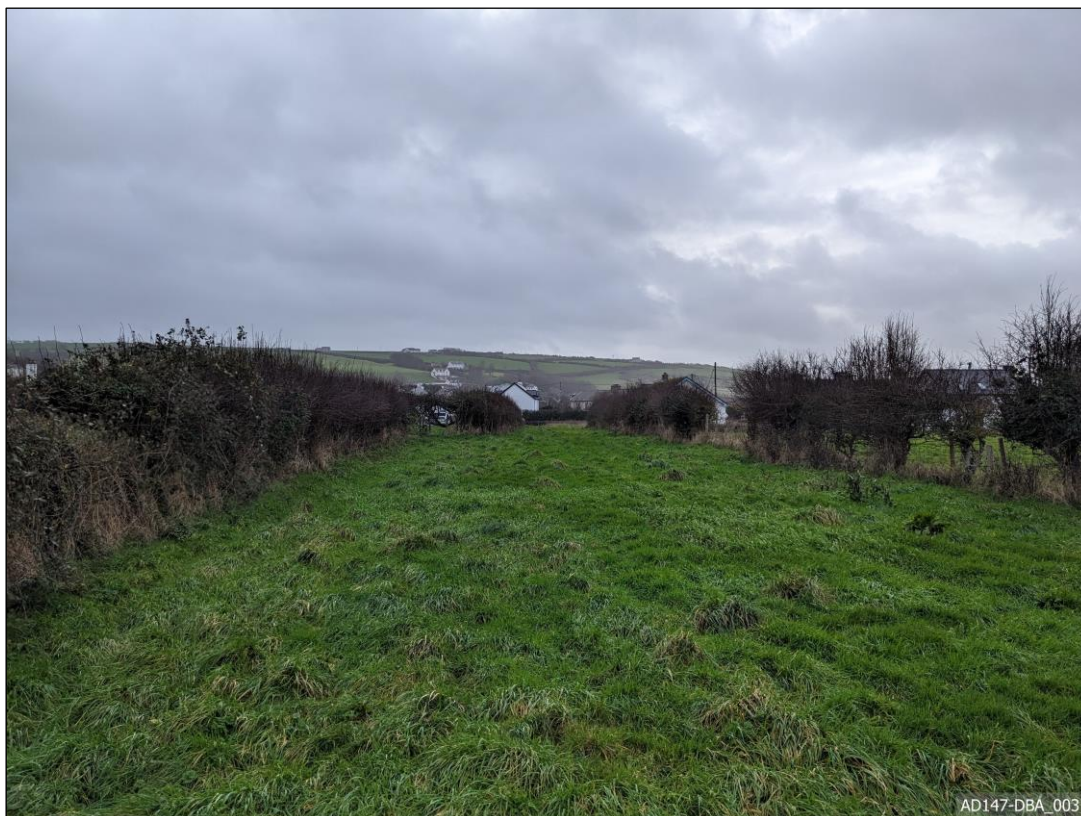
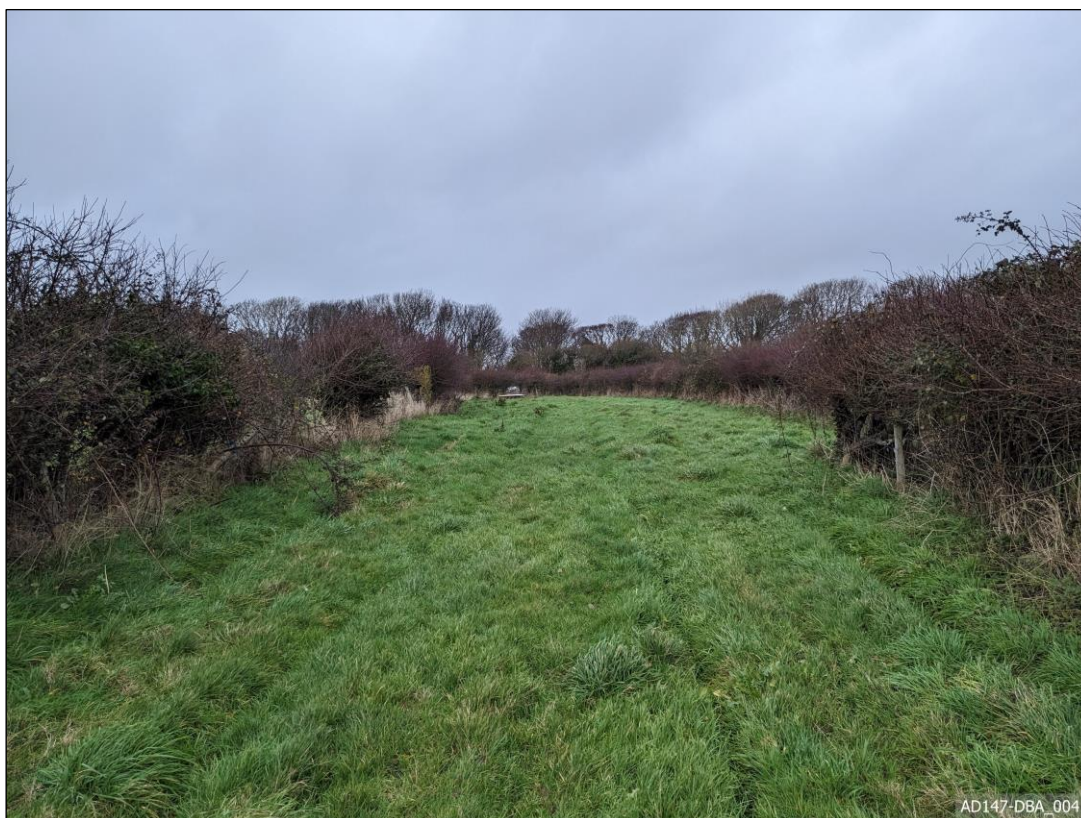
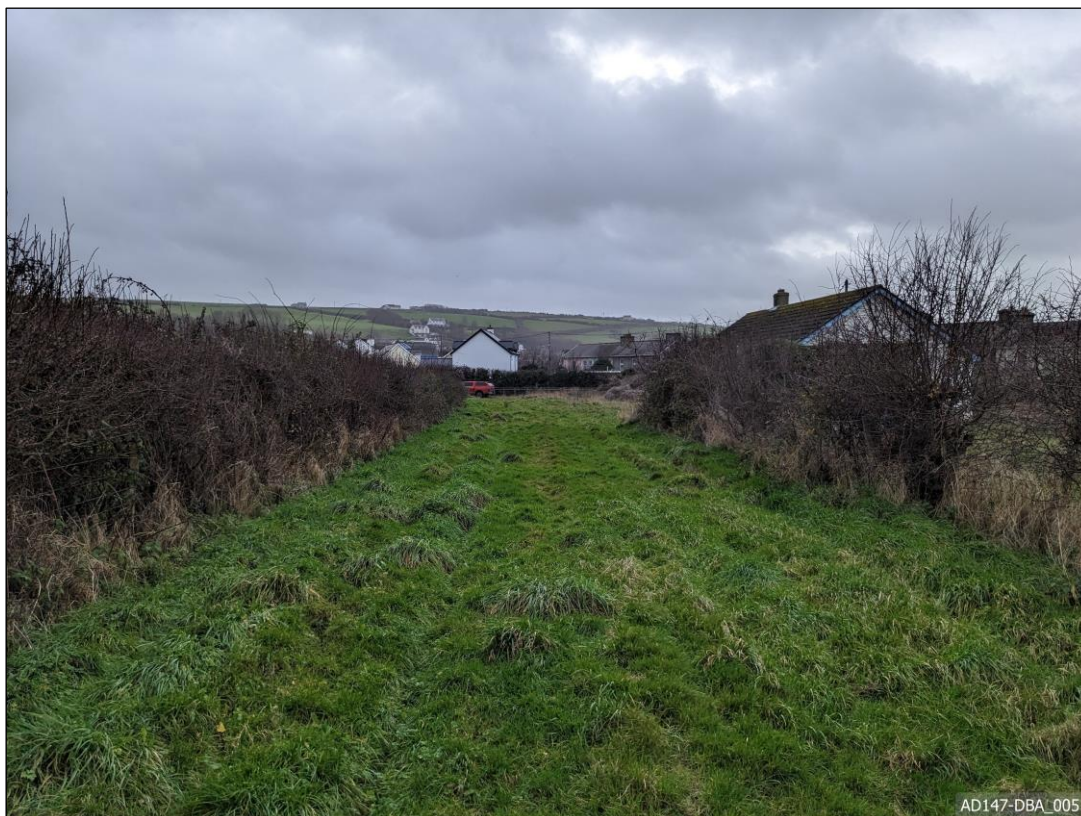
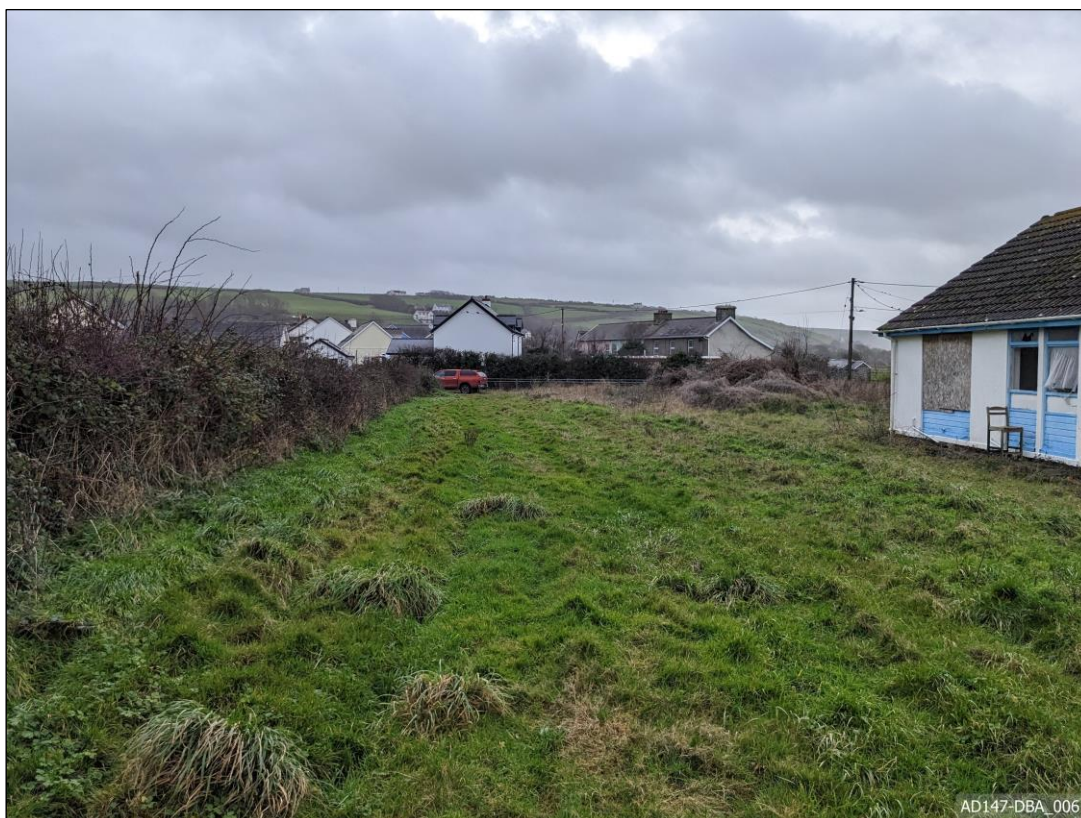
Plate 1 – View south along SF18.

Plate 2 – View north along SF18.

Plate 3 – View south along SF18.

Plate 4 – View north along SF18.

Plate 5 – View south along SF18.

Plate 6 – View south along SF18.

- 6.1.5 Overall, the loss of SF18 through development, it would cause significant impact to one of the last complete strip fields remaining from the medieval landscape of Morfa Esgob.

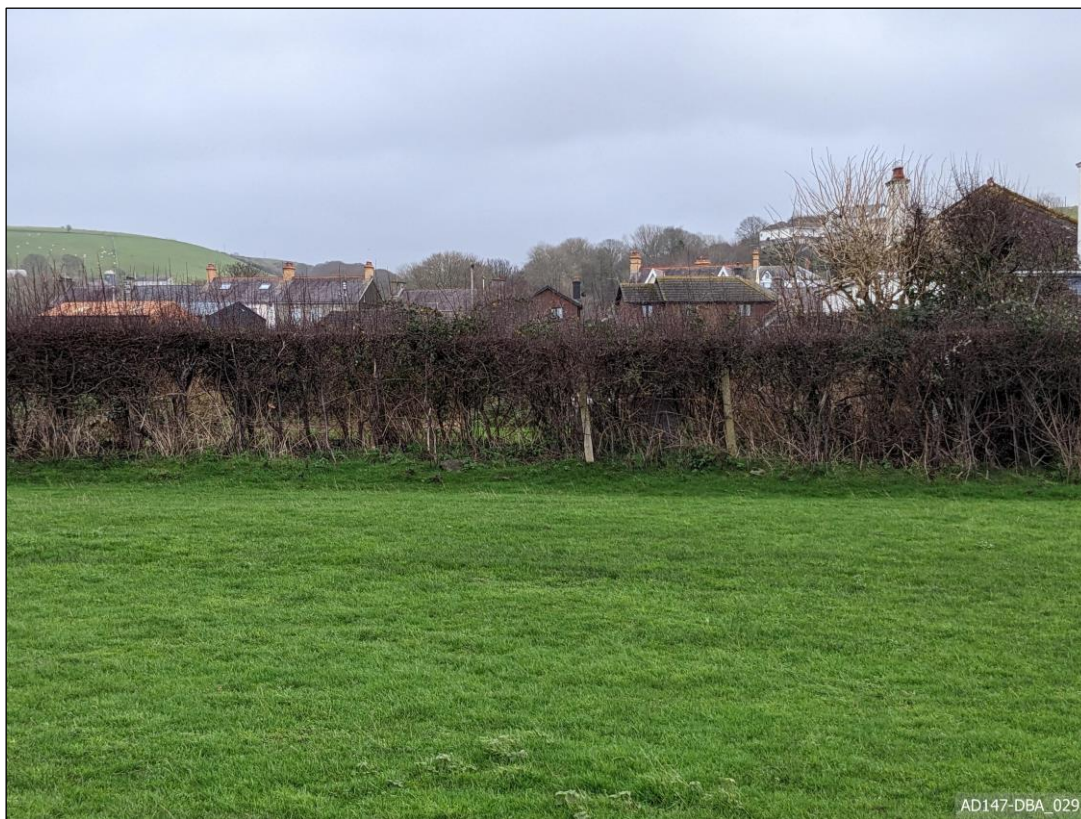
Plate 29 – View showing eastern hedgerow.

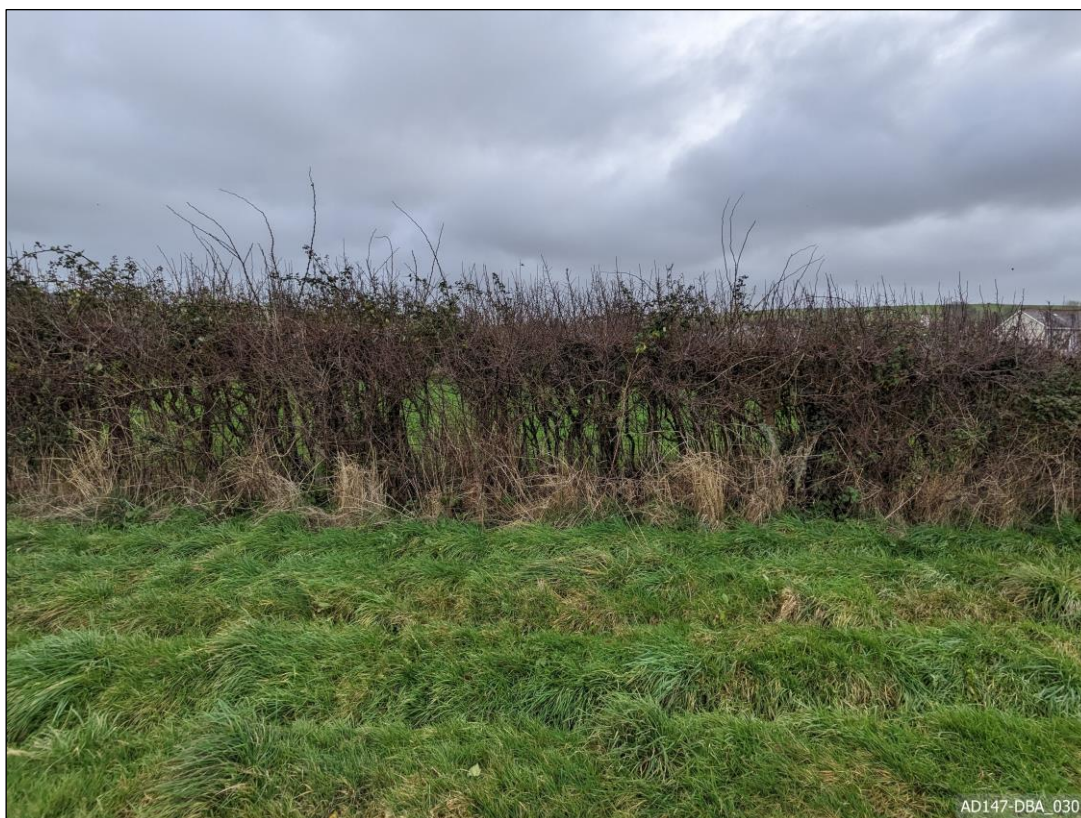
Plate 30 – View showing western hedgerow.
