**DYFED ARCHAEOLOGICAL TRUST
GLASTIR ADVANCED TARGETED ADVICE**

Cwmcoy A0022691

DAT REPORT NO. 2018-42

Glastir Advanced Historic Environment Feature (HEF) Management Plan

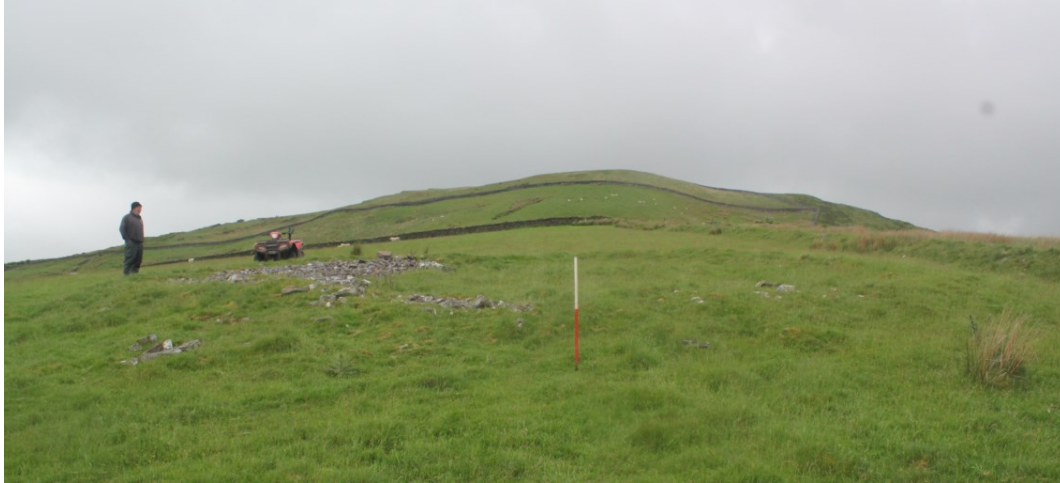
An earth and stone ring, with a bank reaching c0.5m high and around 20m in circumference.

A large quantity of loose stone is collected in a crescent shape around the southeastern side of the monument.

Current condition of the monument is good, it is located in permanent pasture and is in a stable condition.

Figure 1. Ring barrow, looking to the southwest

The monument should remain as it is currently; in a lightly grazed management regime, so that scrub does not encroach over it. It should remain undisturbed, with loose stone neither added nor taken away from the monument.

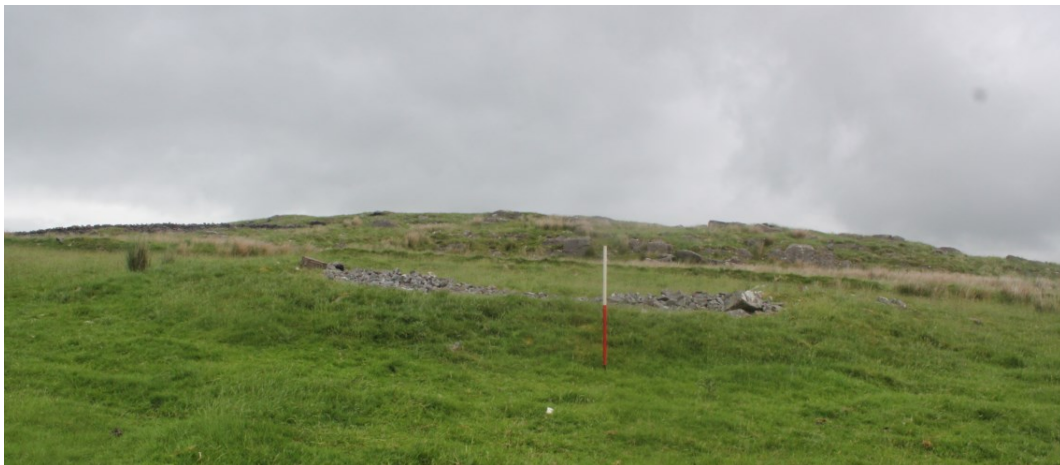
A linear stone and earth field boundary skirt the monument to the northwest, and some of the loose stone may have been built into this later feature. A very well defined monument which lies in permanent pasture. A Pyper 2018.

Figure 2. Ring barrow, looking to the northwest

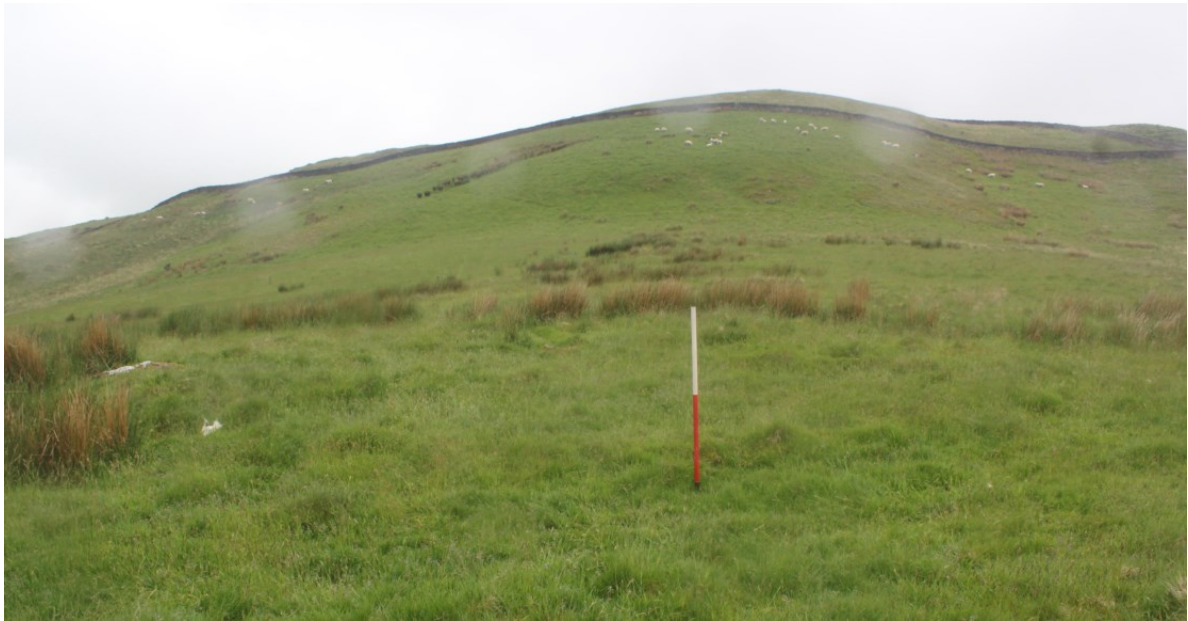
An earthwork ring with a small area of stone exposed, with a bank reaching 0.25m high and around 10-11m in circumference. The monument lies just below and on the southeast side of the ridgetop on a slight slope to the southeast. Extensive views lie to the southeast towards Mynydd Du.

Current condition of the monument is good, although it is less well defined than the other two ring cairns HEFs 315612 and 315628 (PRNs 112713 and 112715), it is located in permanent pasture, with some reeds growing in patches to the southeast side.

Figure 3. Ring barrow, looking to the northwest

The monument should remain as it is currently; in a lightly grazed management regime, so that scrub does not encroach over it. It should remain undisturbed, with loose stone neither added nor taken away from the monument.

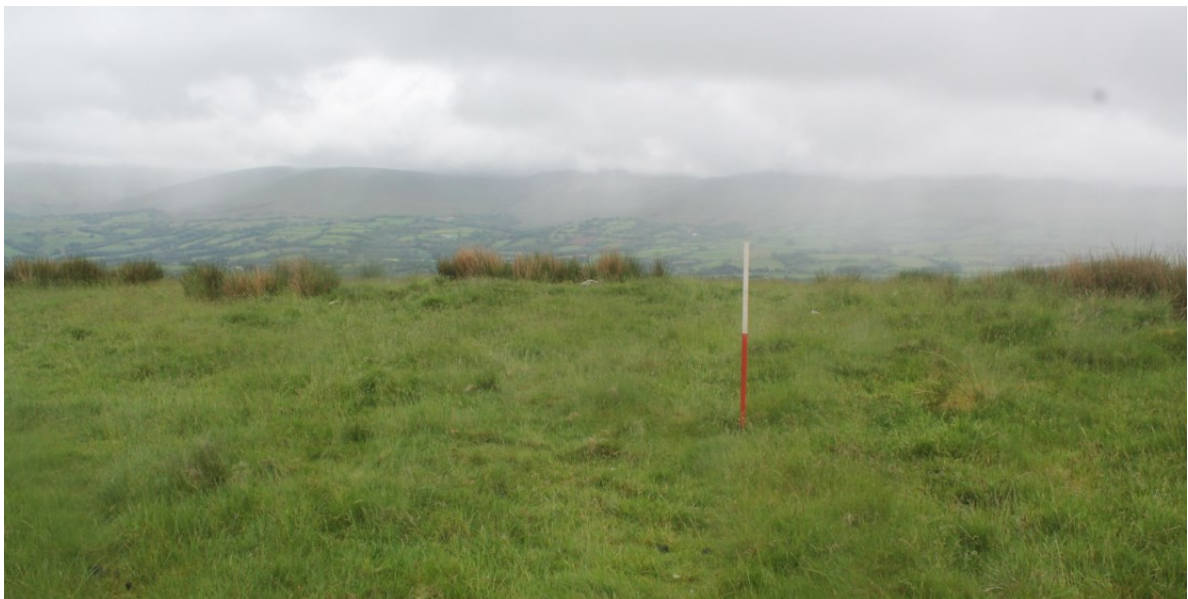
Figure 4. Ring barrow, looking to the southeast

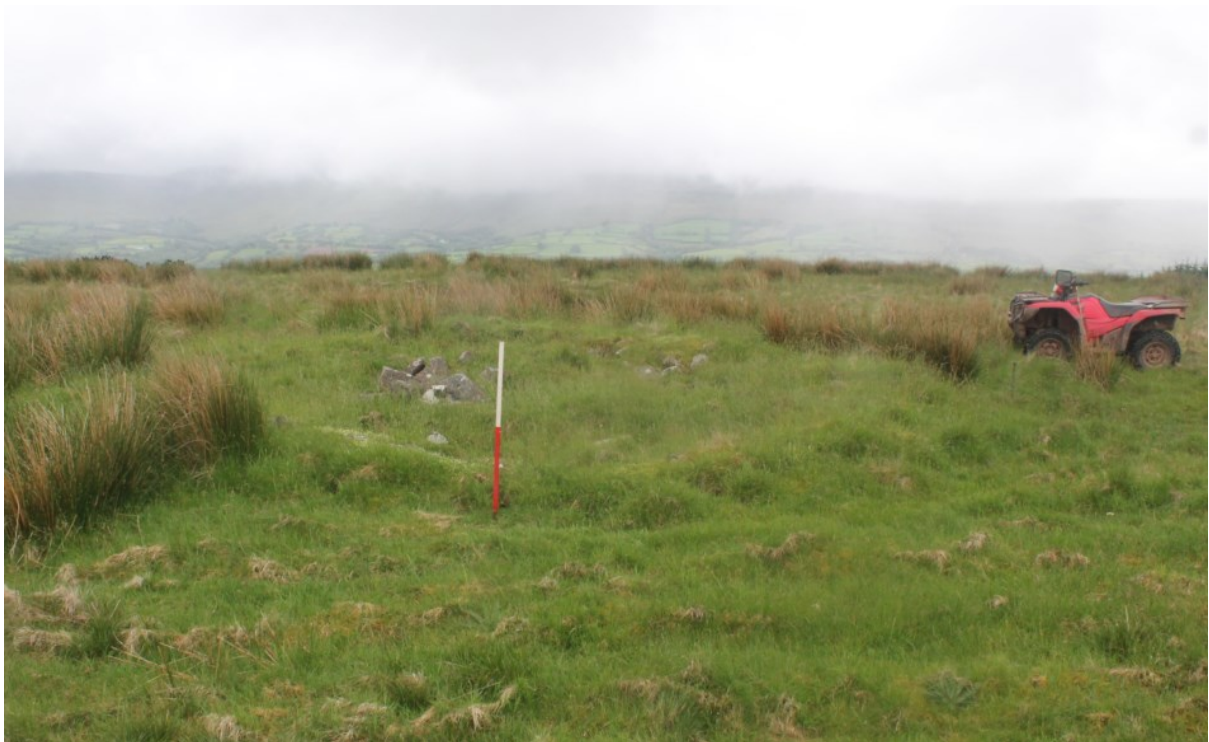
An earth and stone ring, with a bank reaching c.0.5m high and around 10m in circumference. Some loose stone lies in the centre, though a section of the bank displays some built masonry. The monument lies just below and on the southeast side of the ridgetop on a slight slope to the southeast. Extensive views lie to the southeast towards Mynydd Du.

Current condition of the monument is good, it is located in permanent pasture and is stable.

Figure 5. Ring barrow, looking to the southeast

The monument should remain as it is currently; in a lightly grazed management regime, so that scrub does not encroach over it. It should remain undisturbed, with loose stone neither added nor taken away from the monument.

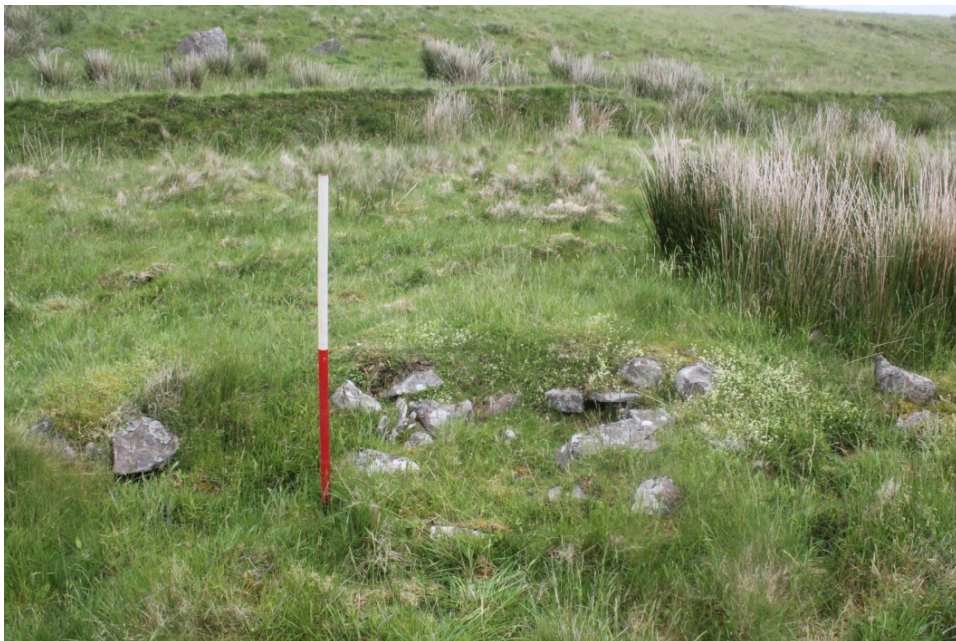
A linear stone and earth field boundary skirt the monument to the northwest, and some of the loose stone may have been built into this later feature. A well-defined section of built masonry/kerbing survives to the north. Lies in permanent pasture. A Pyper 2018.

Figure 6. Ring barrow, showing a section of the masonry bank

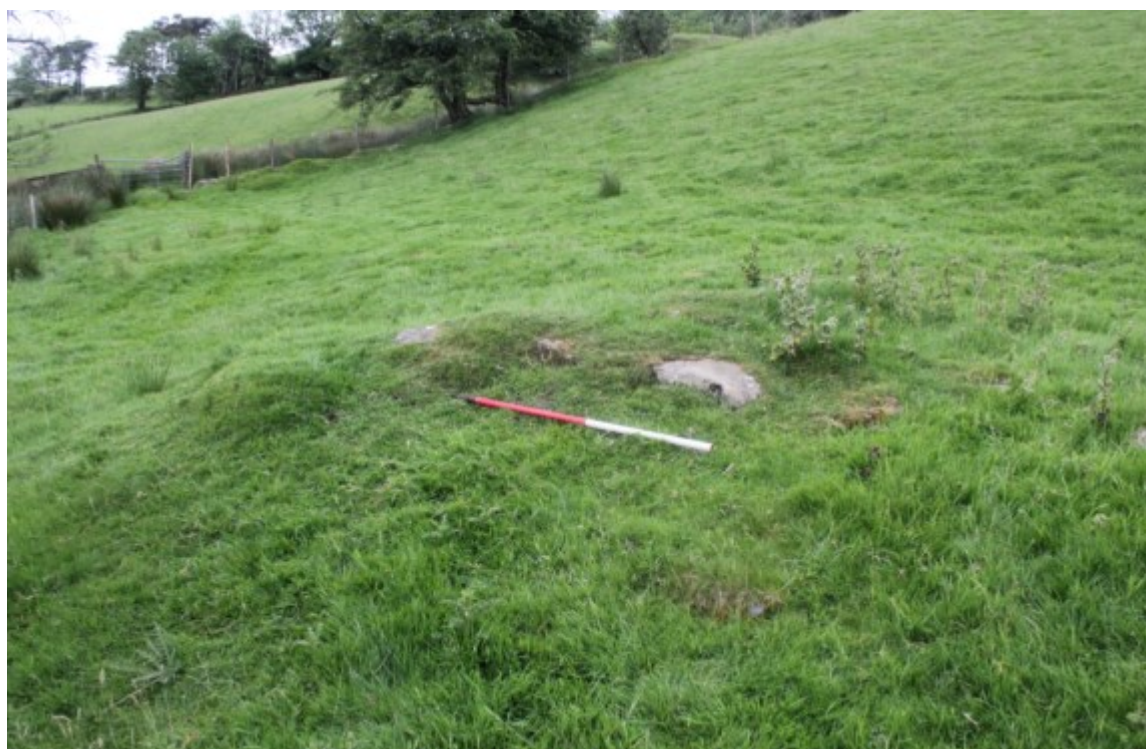
An irregular pile of stones covered by turf, which may represent a clearance cairn, or a disturbed feature such as a field corn drying kiln. Lies to the north of a trackway leading towards Cwmcoy Farmstead. A Pyper June 2018.

Current condition of the monument is good, it is located in permanent pasture and is stable.

Figure 7. Disturbed feature, possible clearance cairn

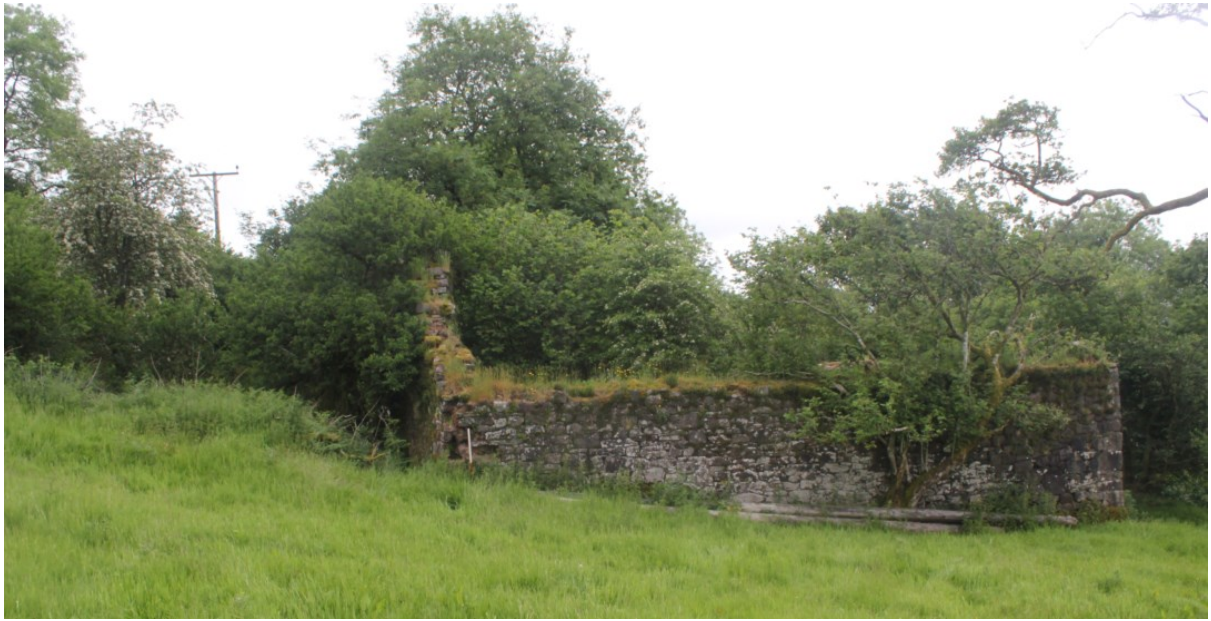
The building is in a ruinous condition, and very overgrown with trees growing within it and against the external face of the walls.

The masonry is liable to damage from excessive vegetation growth.

Figure 8. West-facing elevation

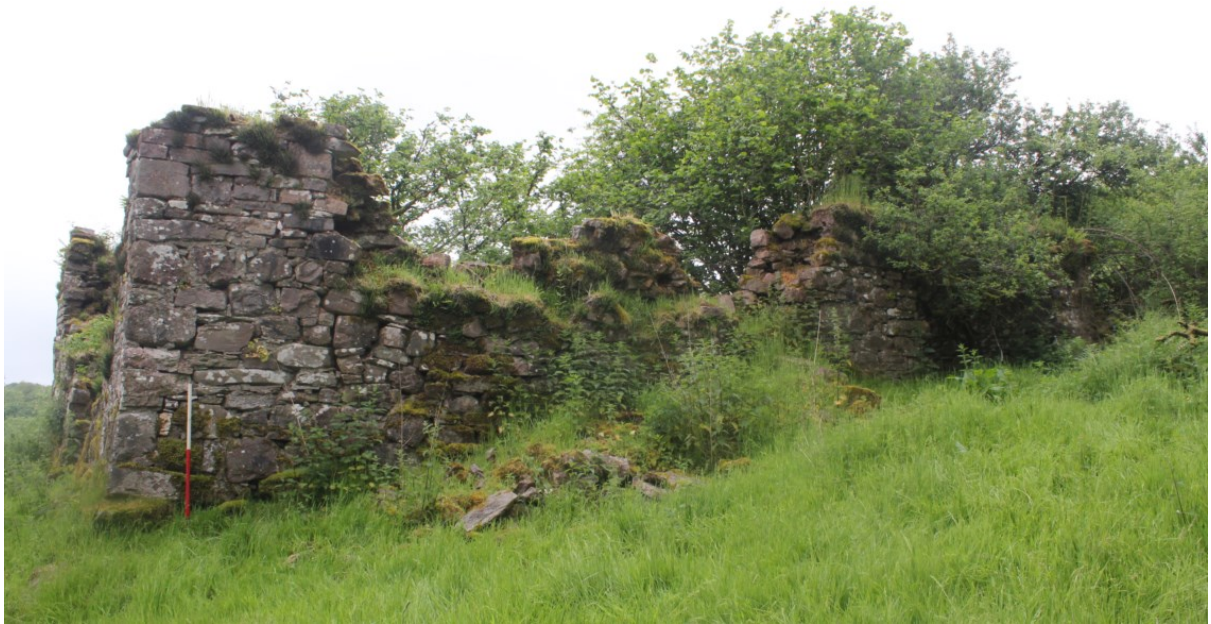
Figure 9. East-facing elevation

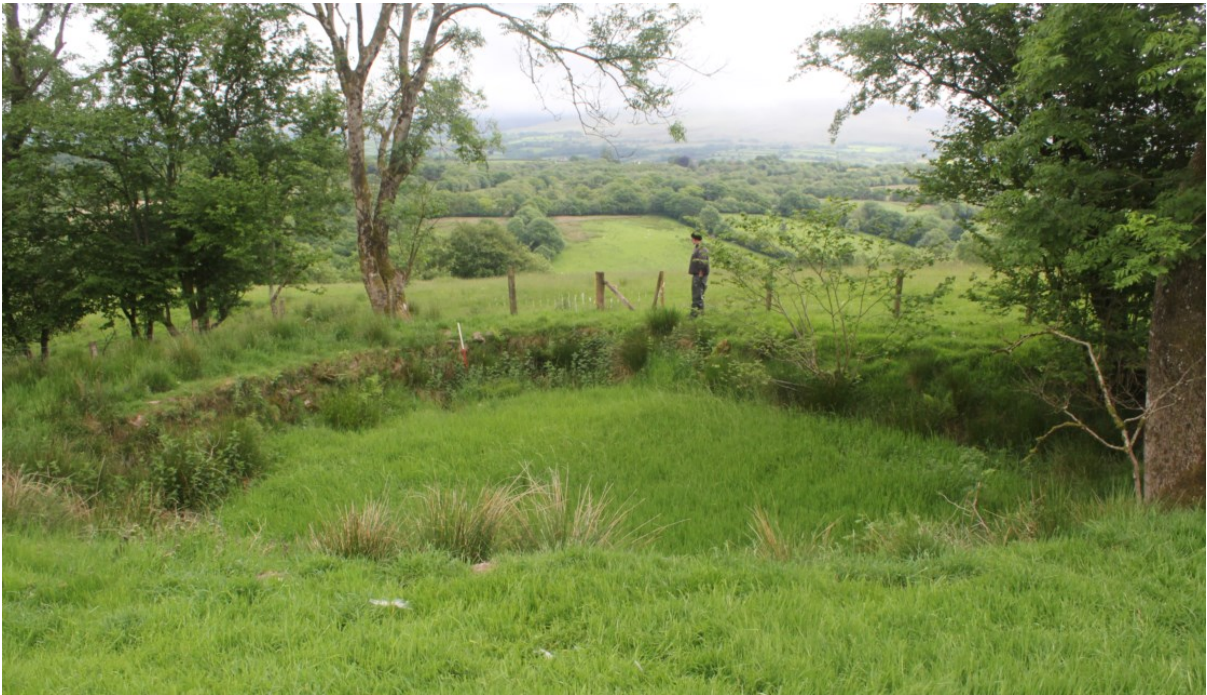
Whilst in a stable condition the pond no longer holds water. The leat lies in pasture.

Figure 10. Looking south towards the dam.

None identified, though repairs to enable it to refill and function as a pond would be beneficial.

Any restoration work must ensure that the historic elements of the pond are retained and protected from damage, including the dam and leat.

To restore the pond to a stable condition and functioning as a pond.

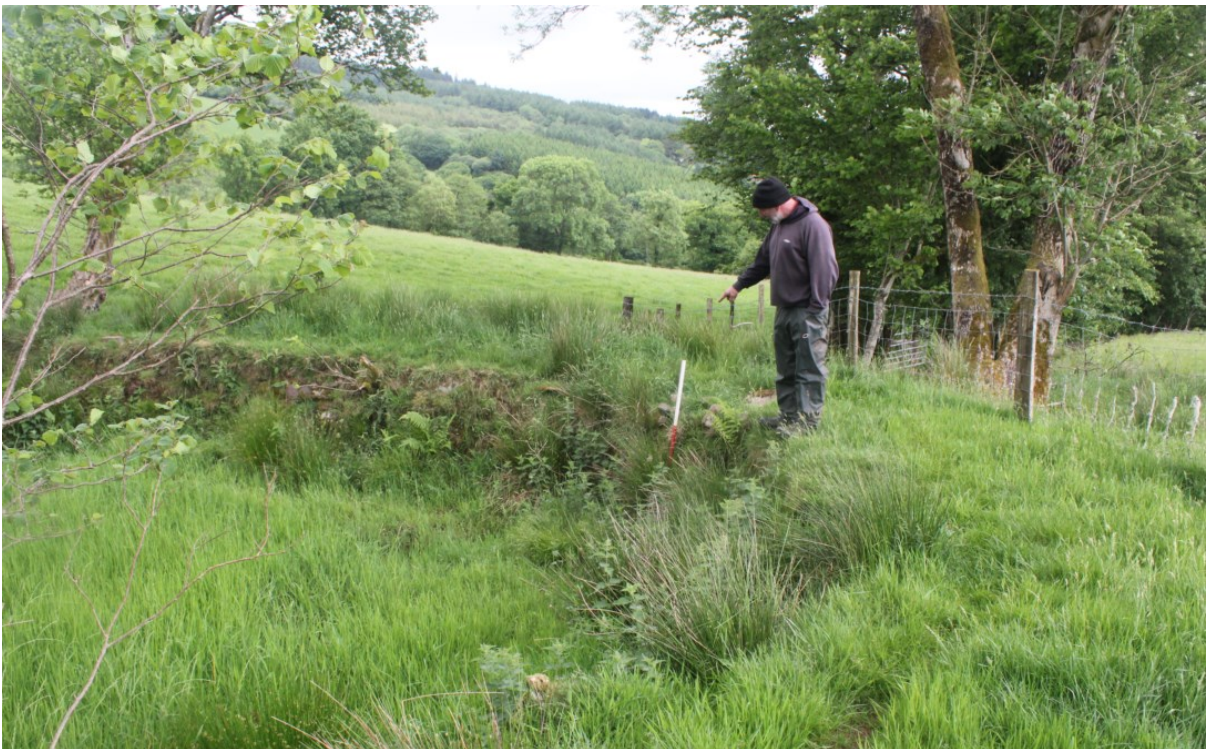
Figure 11. The dam and position of the sluice.

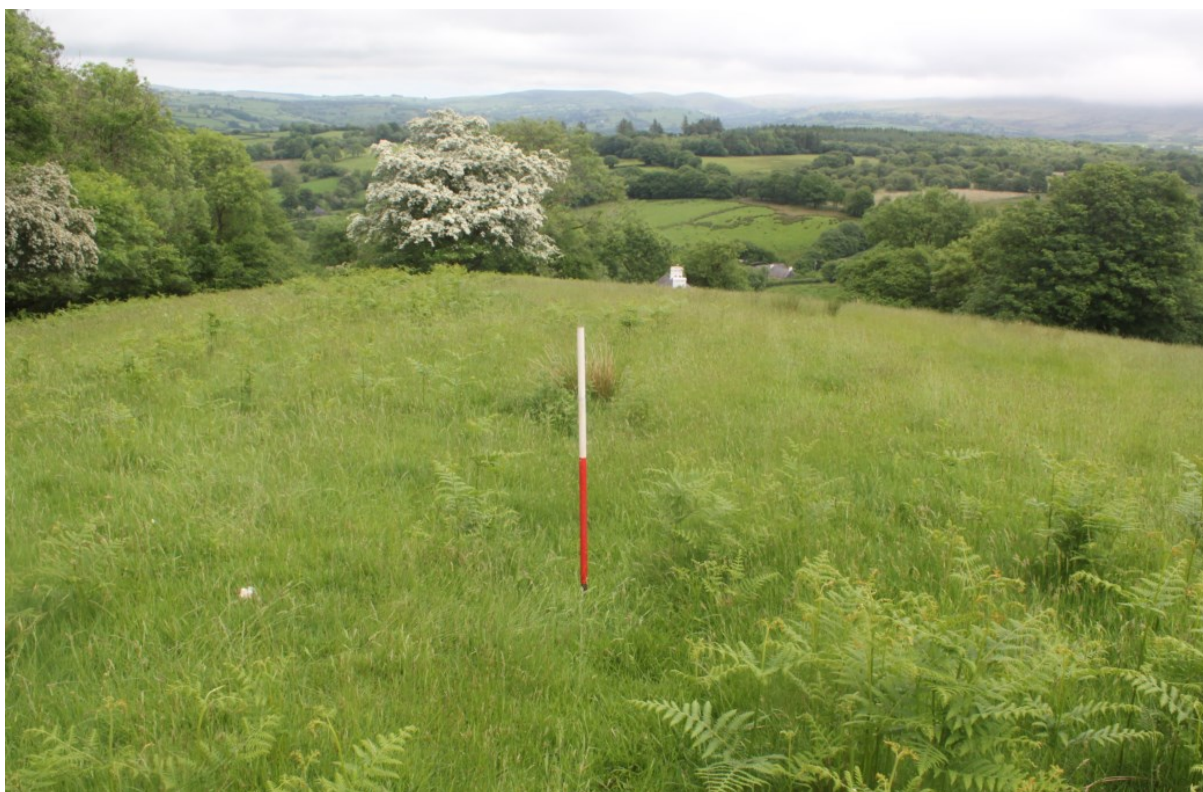
Figure 12. The leat survives as a slight ditch in the field between the pond and farmstead.

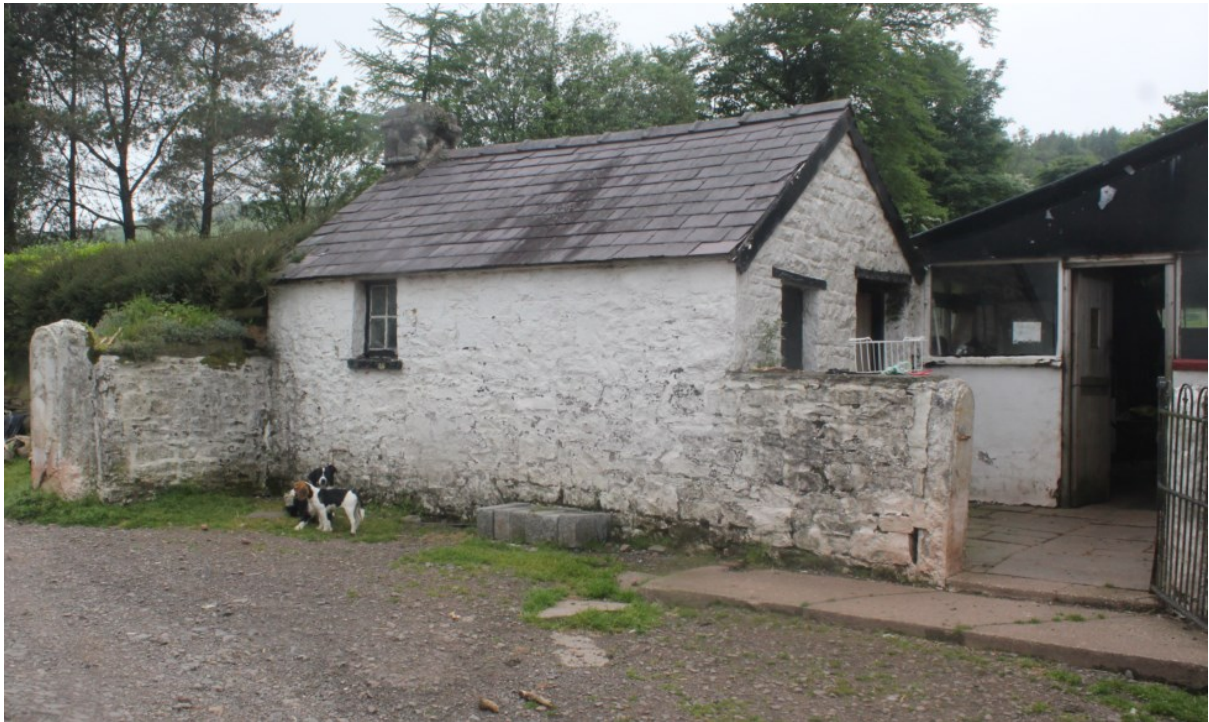
Figure 13. A small outside kitchen adjacent to the farmhouse (PRN 109594)

To retain the buildings in a weathertight condition using traditional materials where possible.

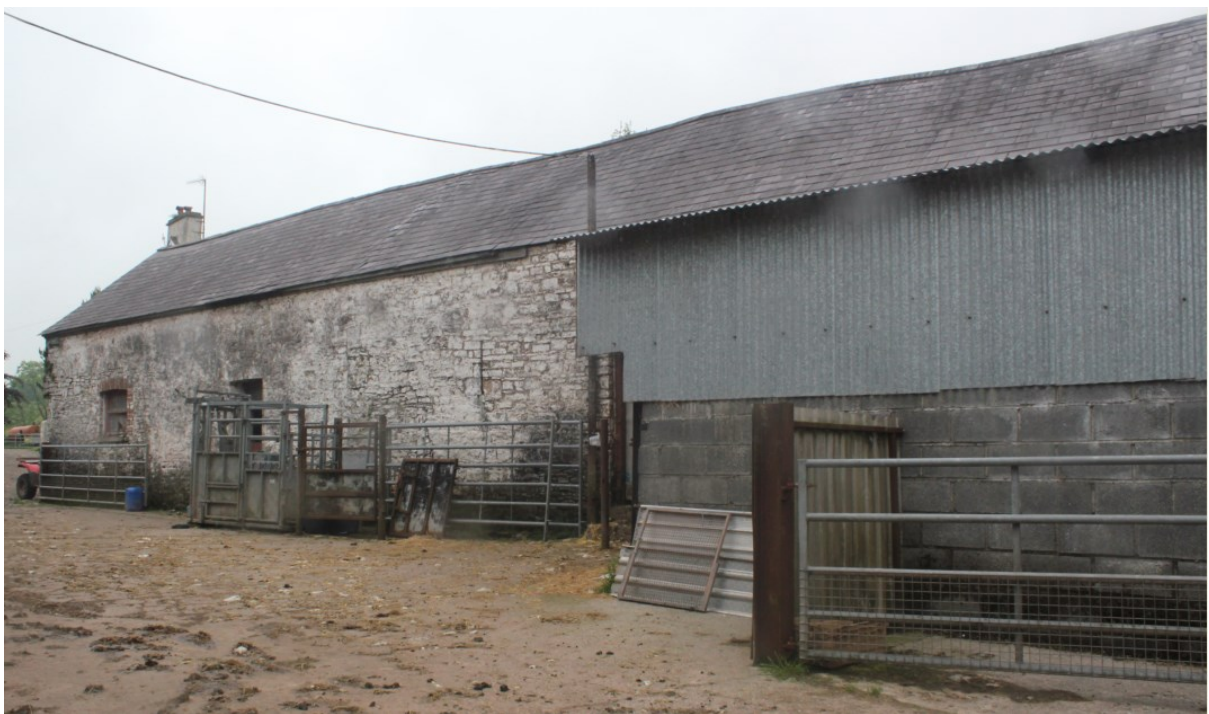
Figure 14. A long farm building, at the southwest end is probably a former cowhouse, (PRN 109595)

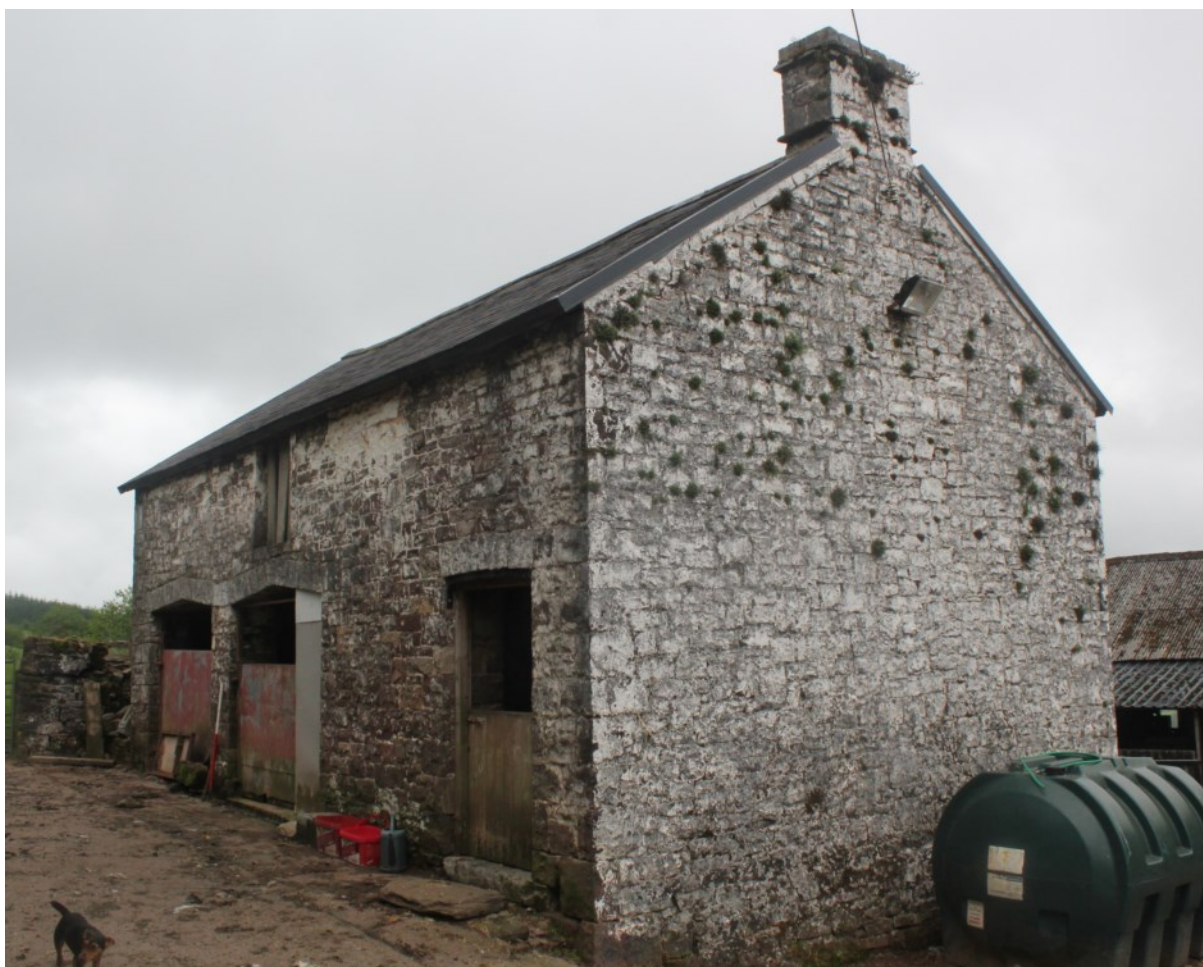
Figure 15. A carthouse and stable, (PRN 112719)

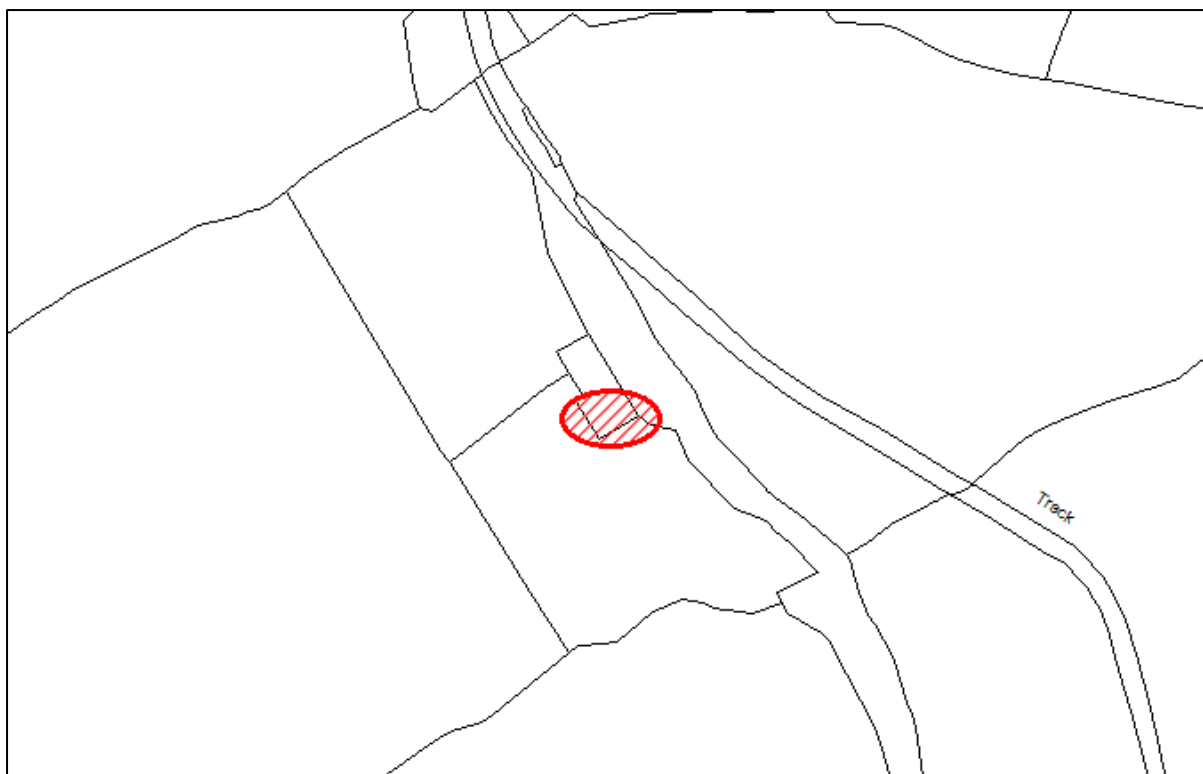
The building is in a ruinous condition and a number of mature trees are growing in close proximity to the upstanding ruined walls and saplings established within the masonry. There is also evidence that the stone quoins have been removed from the ruin.

The masonry remains are threatened by the trees either falling and uprooting or falling on masonry, or from the wind-rock of trees established within the walls.

Areas of tree growth.

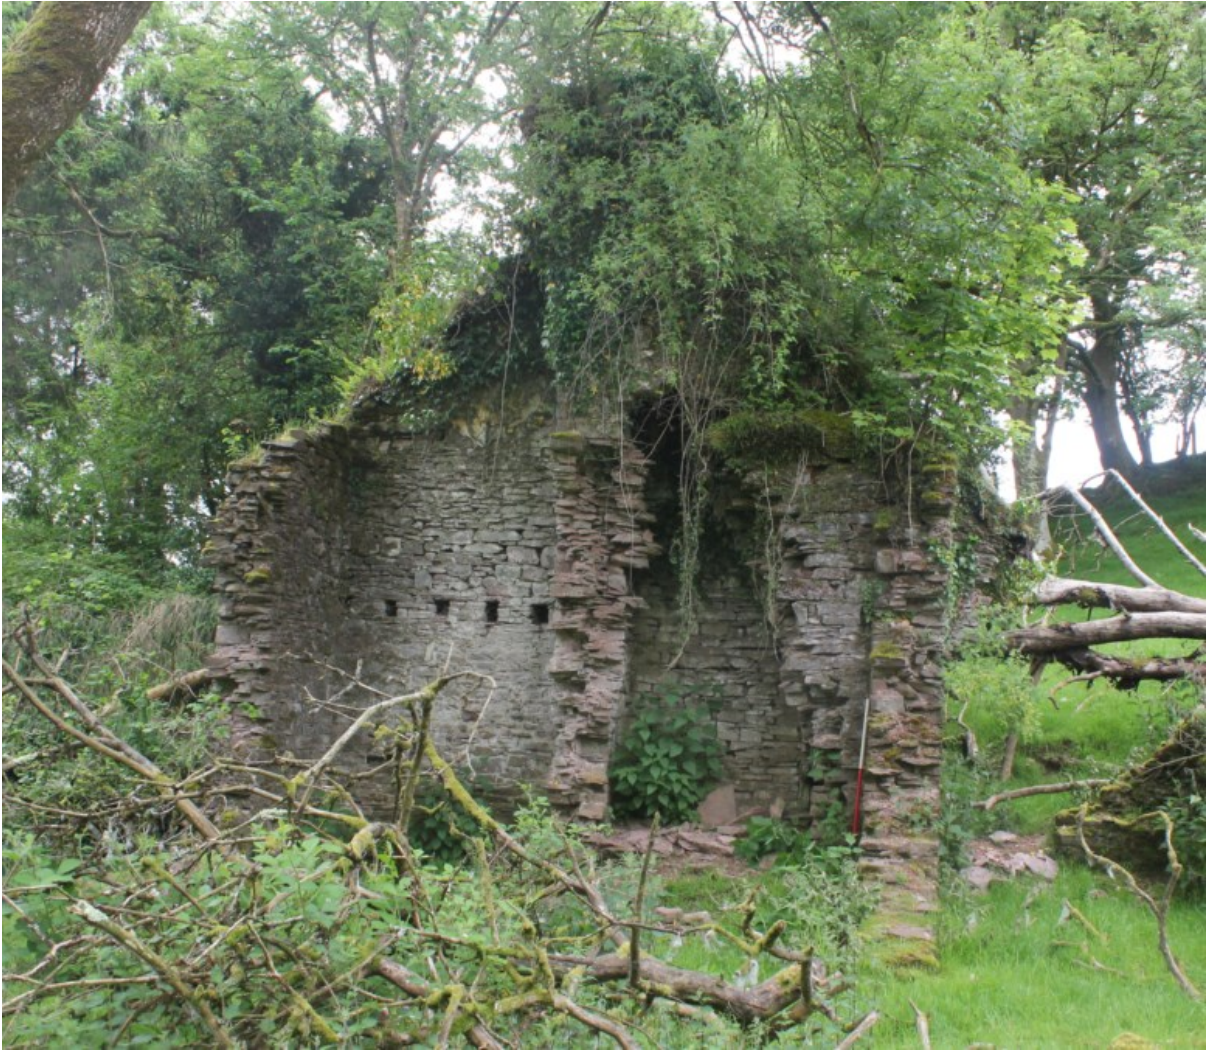
Figure 16. The gable wall of the farmhouse

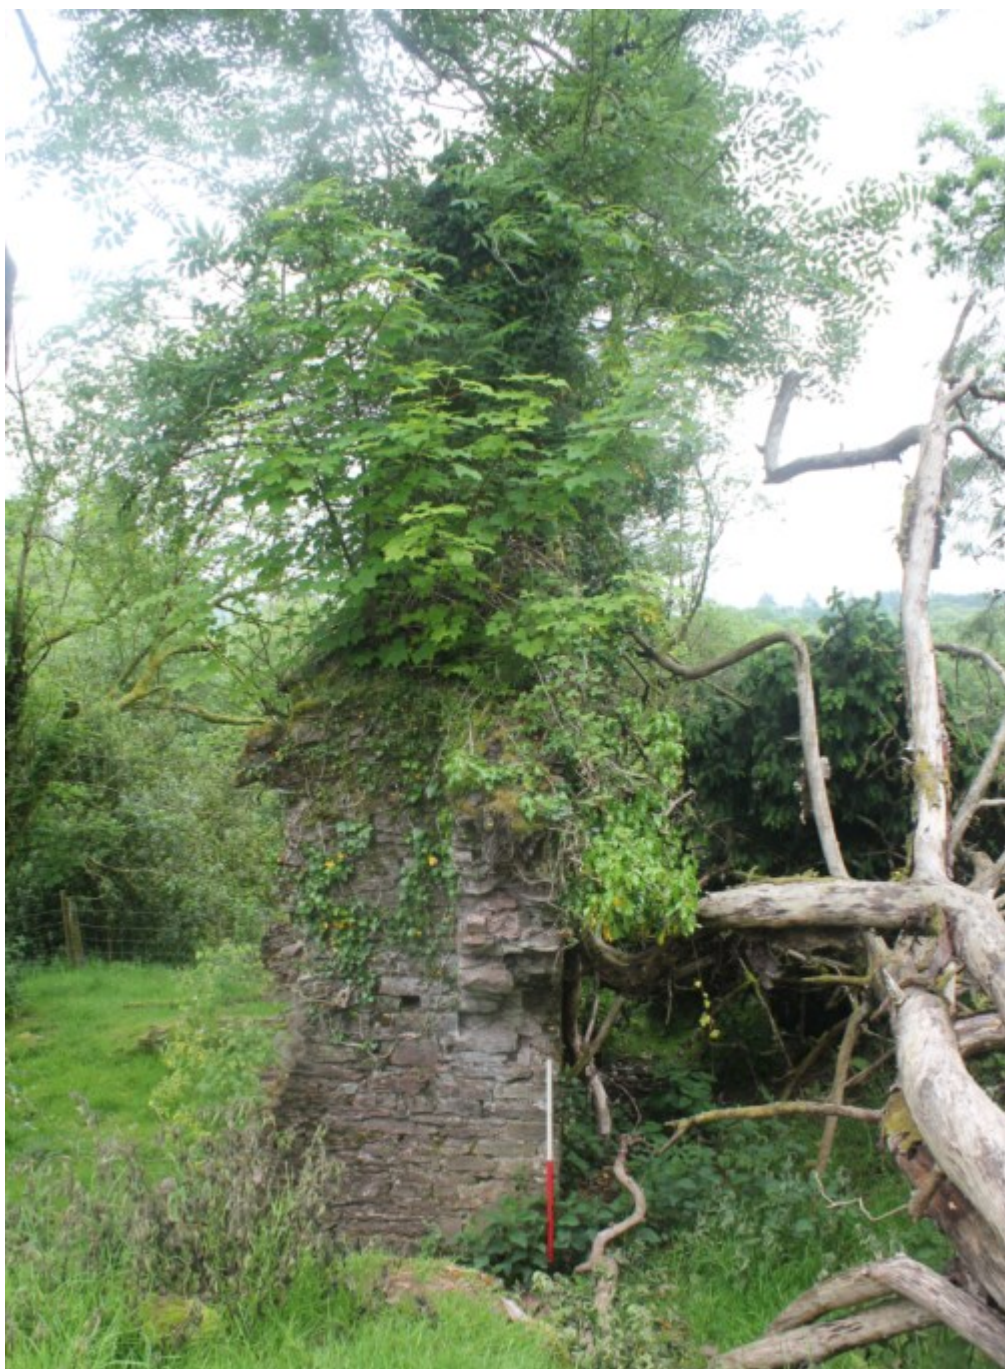
Figure 17. The gable wall of the farmhouse.

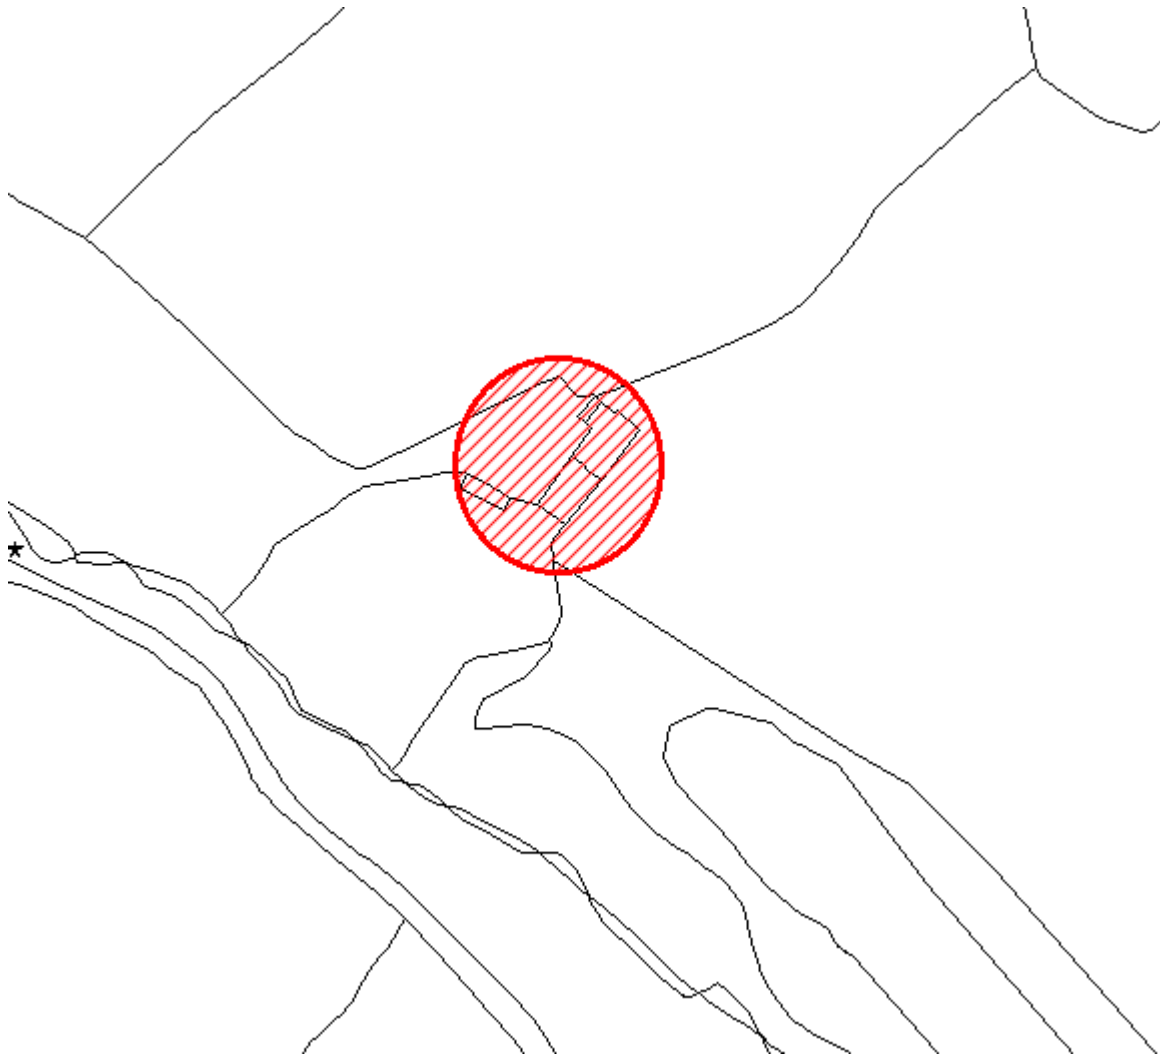
The masonry remains are threatened by the trees either falling and uprooting or falling on masonry, or from the wind-rock of trees established within the walls.

Areas of tree growth.

Careful removal of saplings and tree limbs which threaten the ruin where possible, and without causing further damage to the masonry.

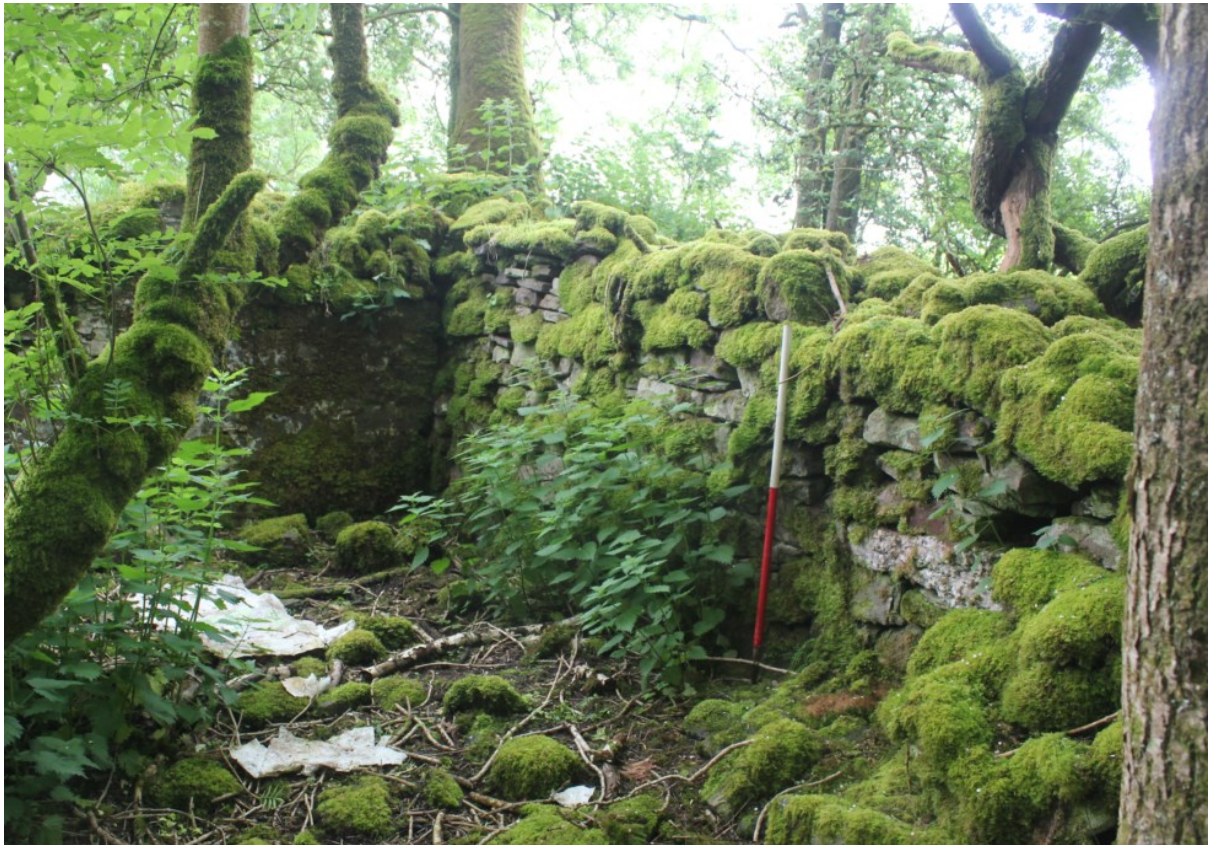
Figure 18. Trees growing within and around the ruin.

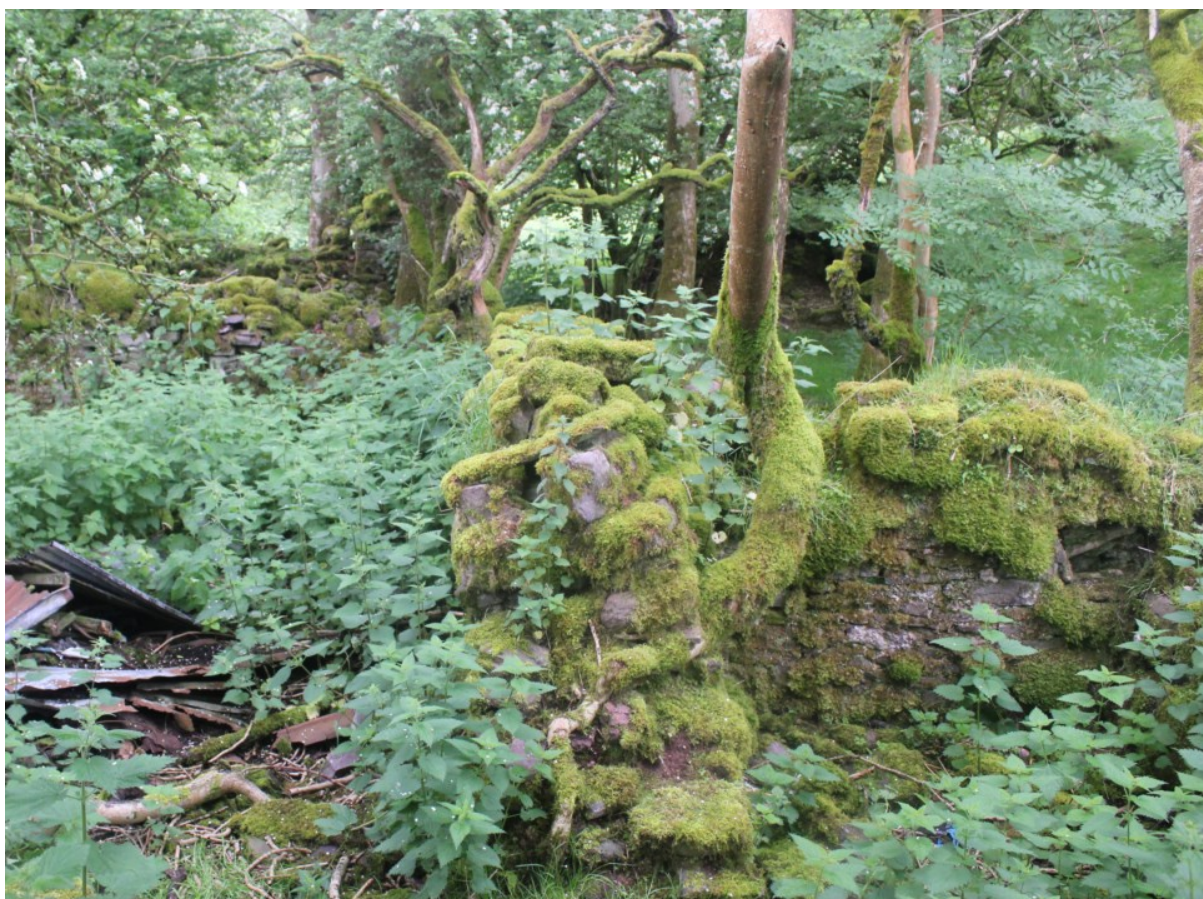
Figure 19. Trees growing within the masonry.
