Frowen Farm, Whitland

Desk-Based Assessment

Report No 1942

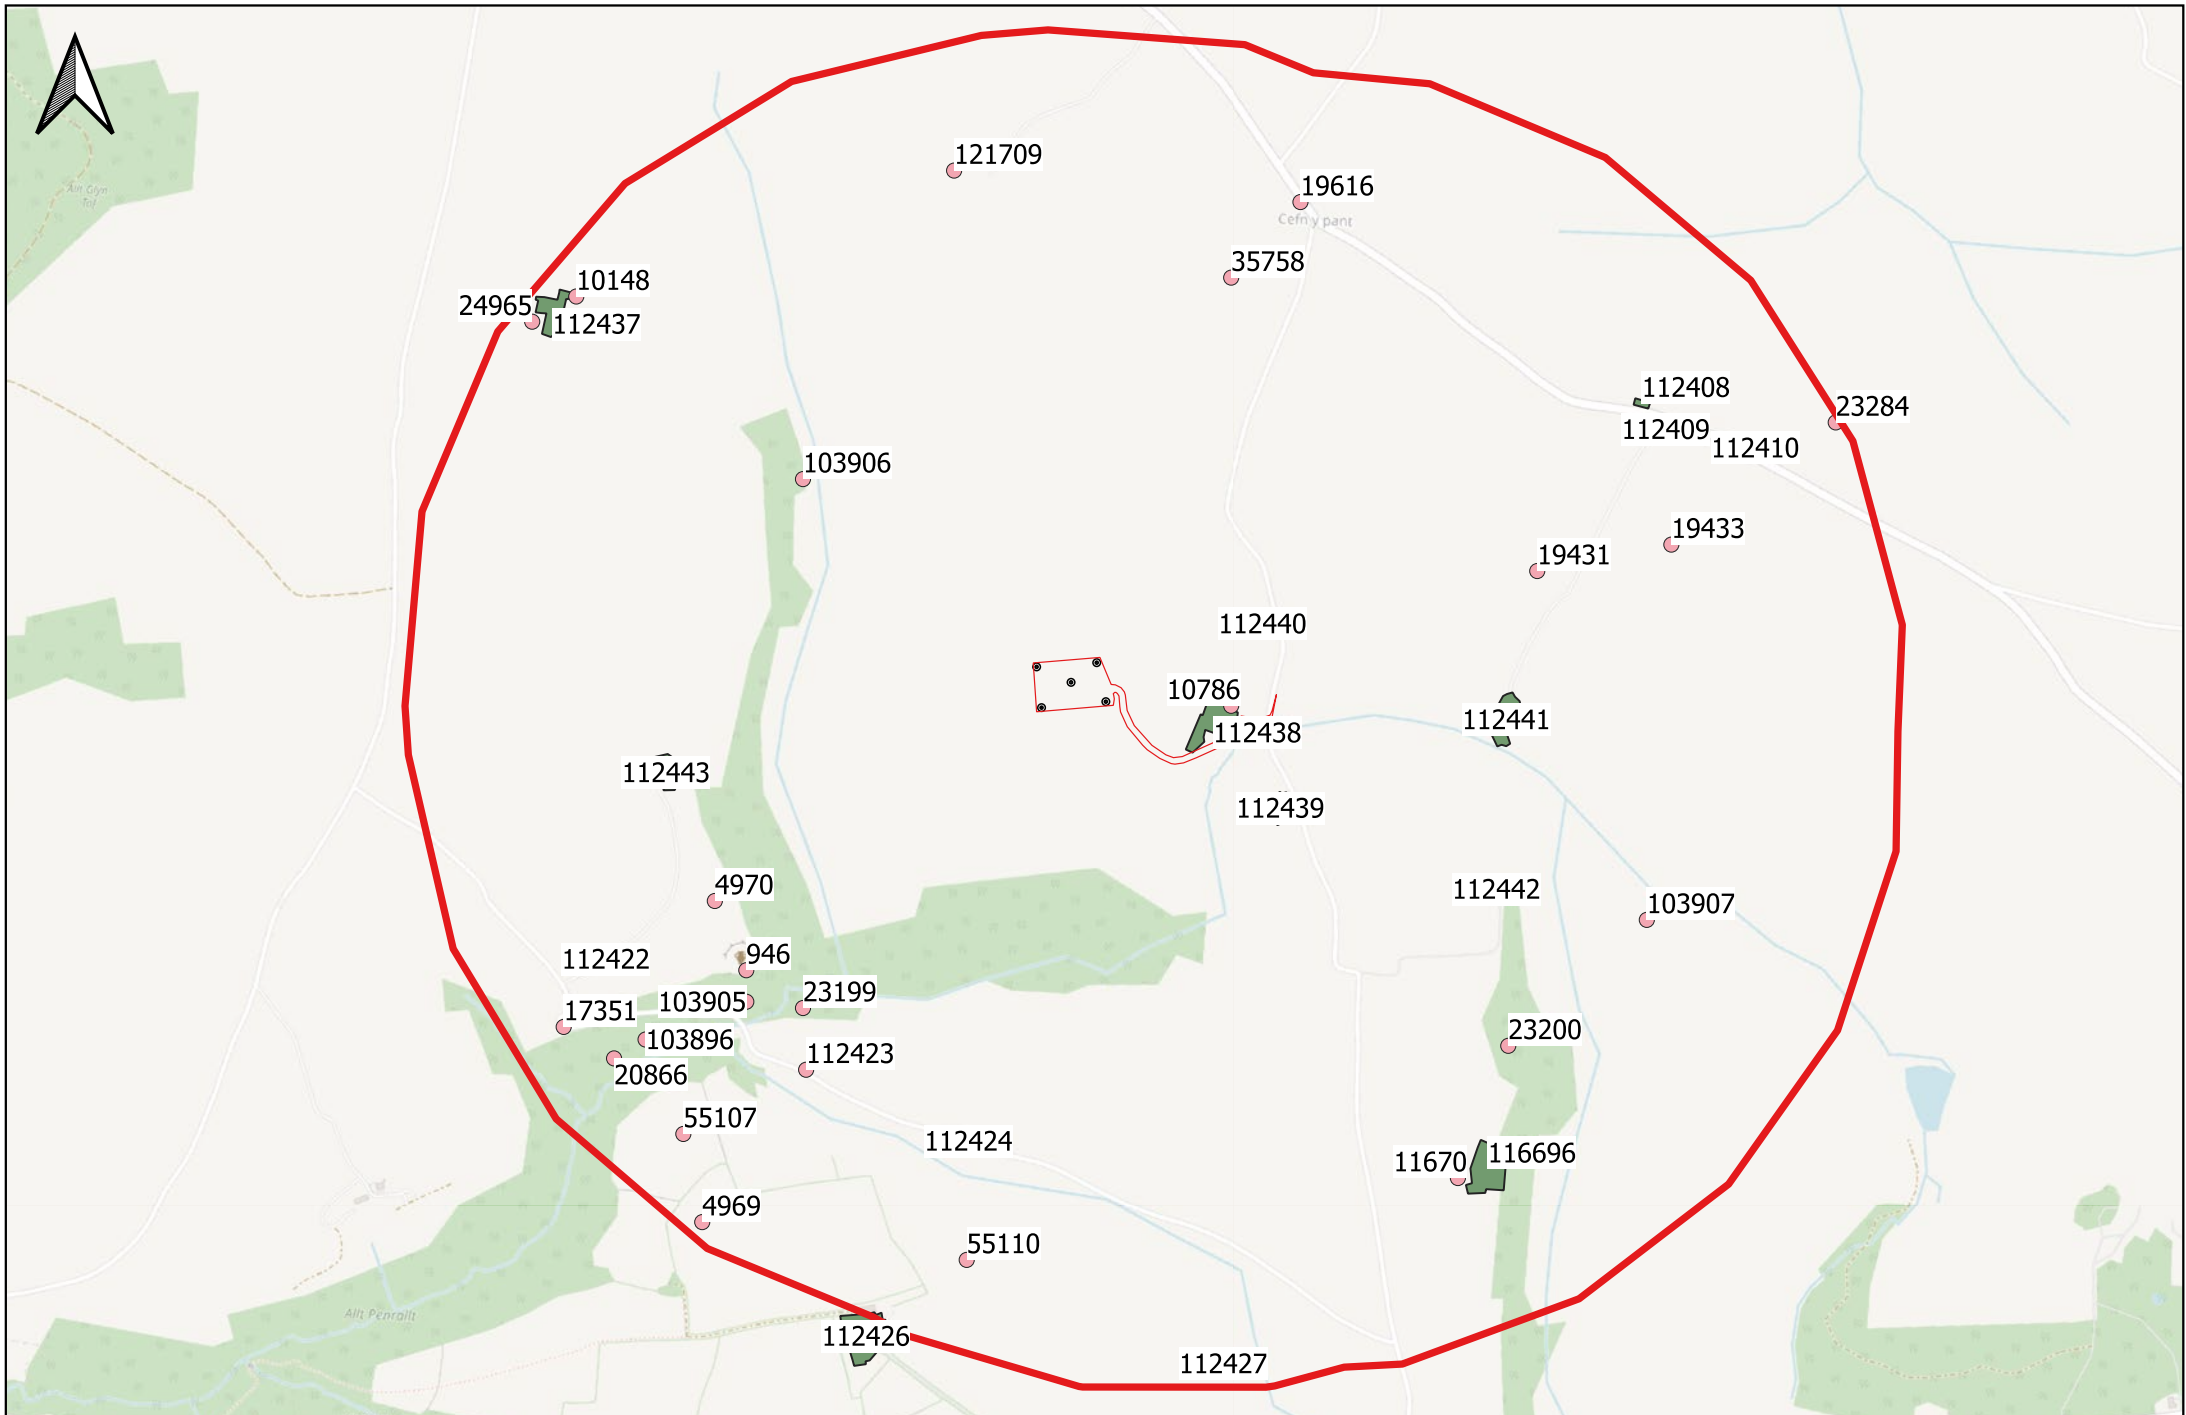
Figure 3. HERs within applied search area.

4.1.10. The HER results document an interesting pattern. The area appears to have been a centre of extraction as noted by the number of quarries and gravel pits identified within the applied search area: PRNs 19433, 23200, 121709 for quarry sites, and PRN 19431 for a gravel pit.

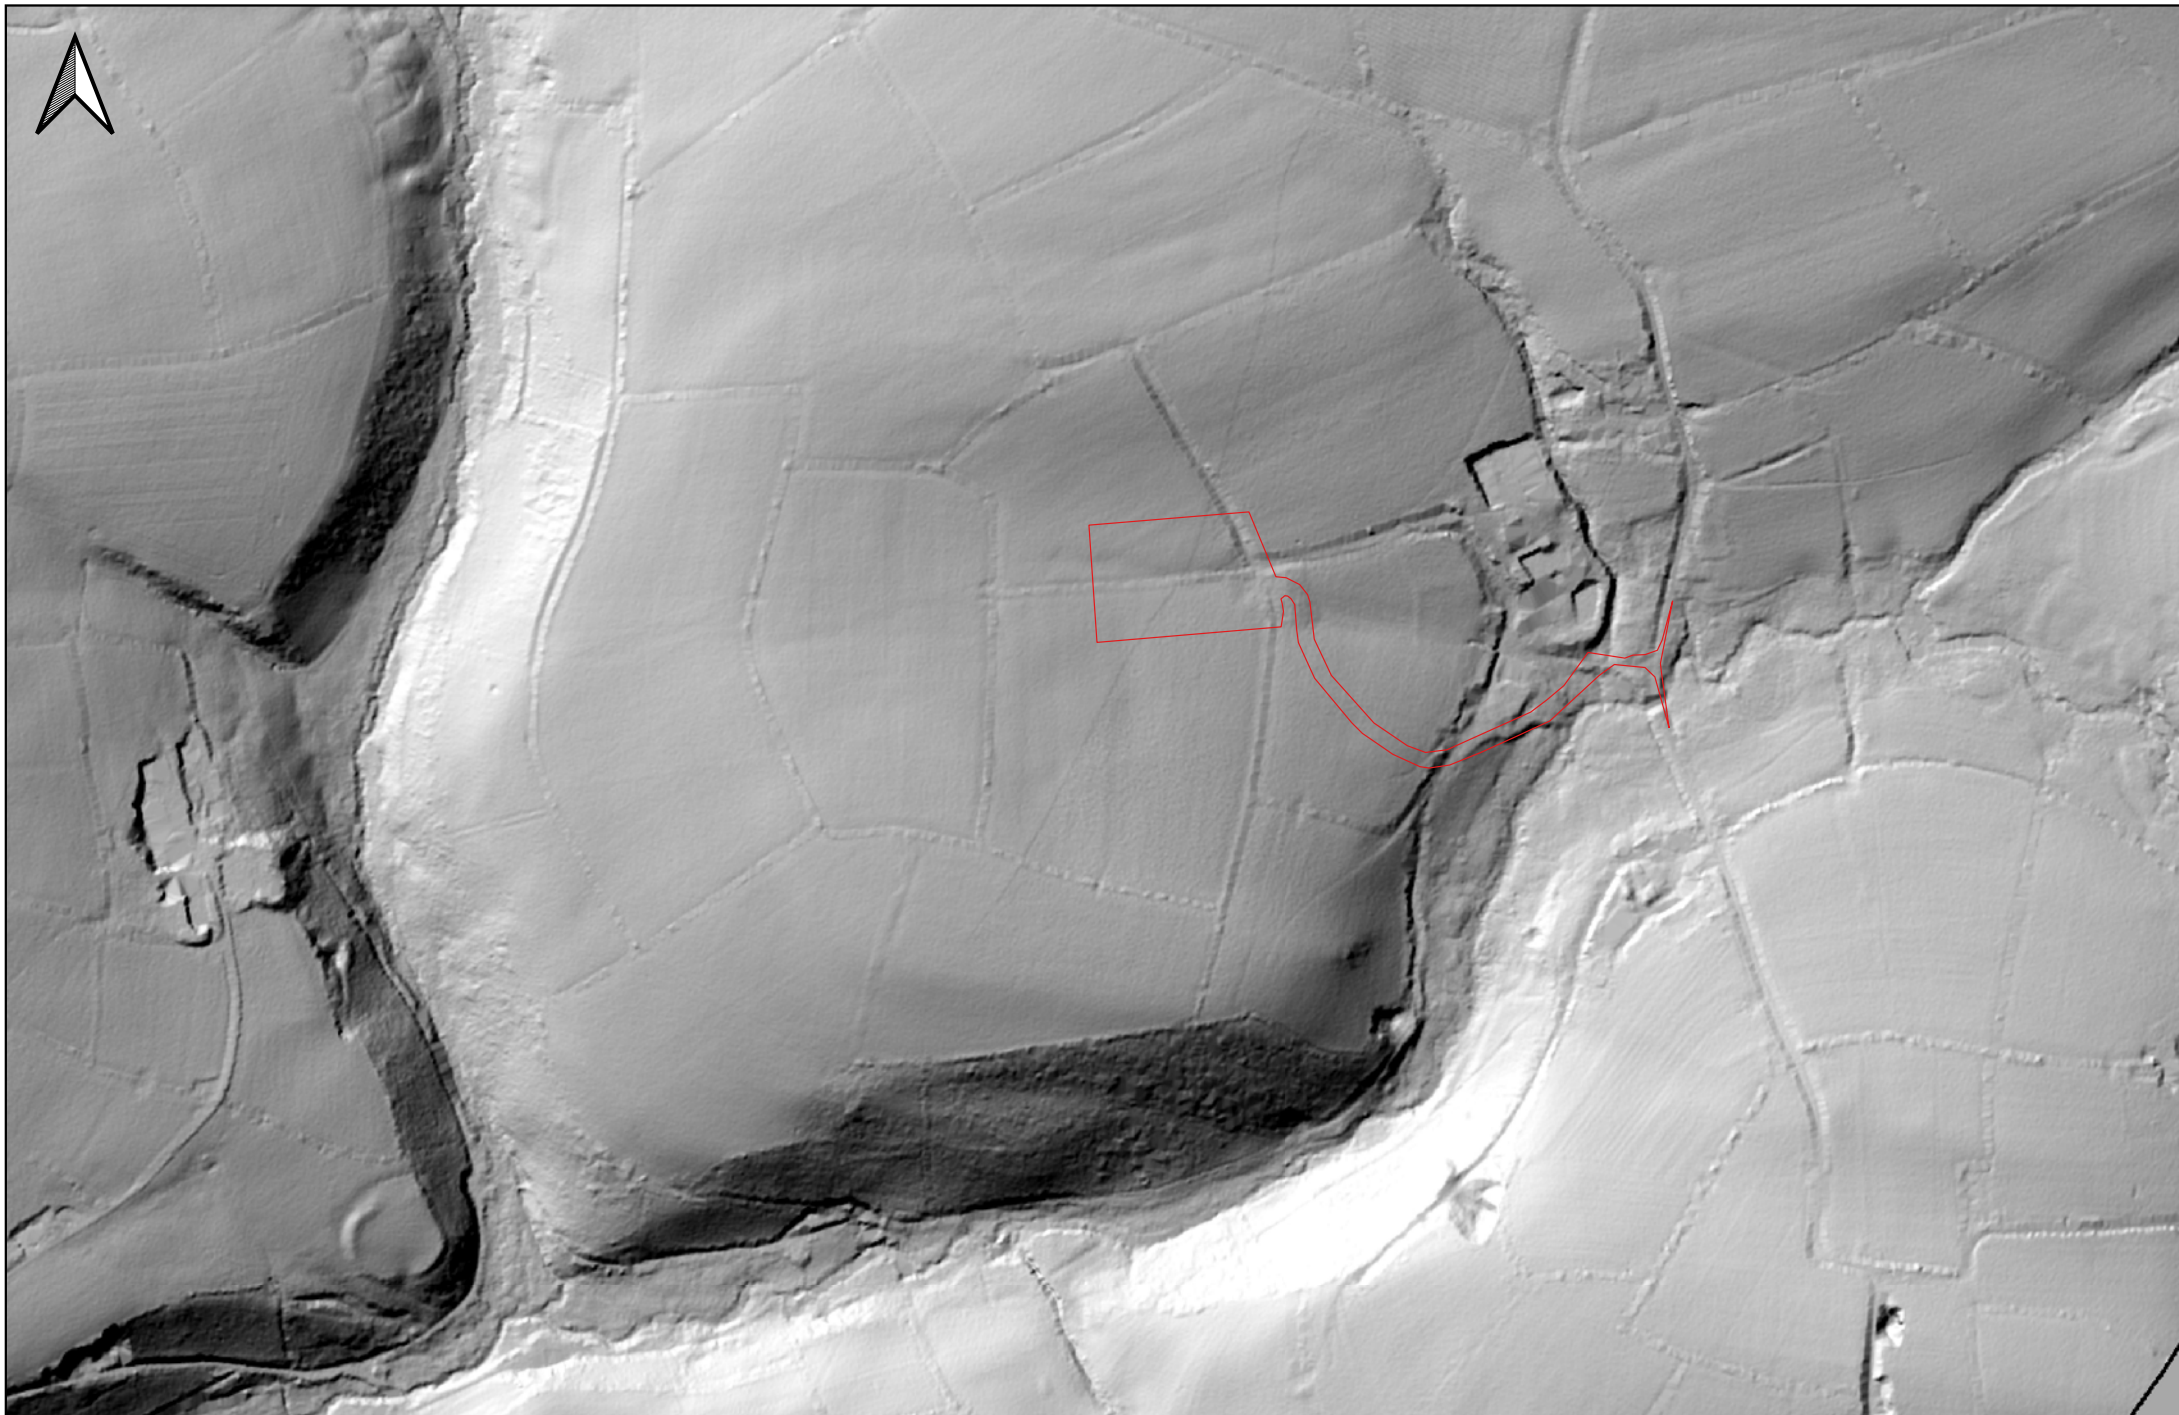
Figure 10. Lidar 1m DTM - Hillshade.

difference is that the previously noted trackway on a north-east to south-west axis appears to be worn heavily or is a permanent mark on the landscape. This could be the likely result of heavy machinery being introduced to the farm, i.e., tractors. There are also further agricultural buildings located within the confines of the Frowen Farmyard.

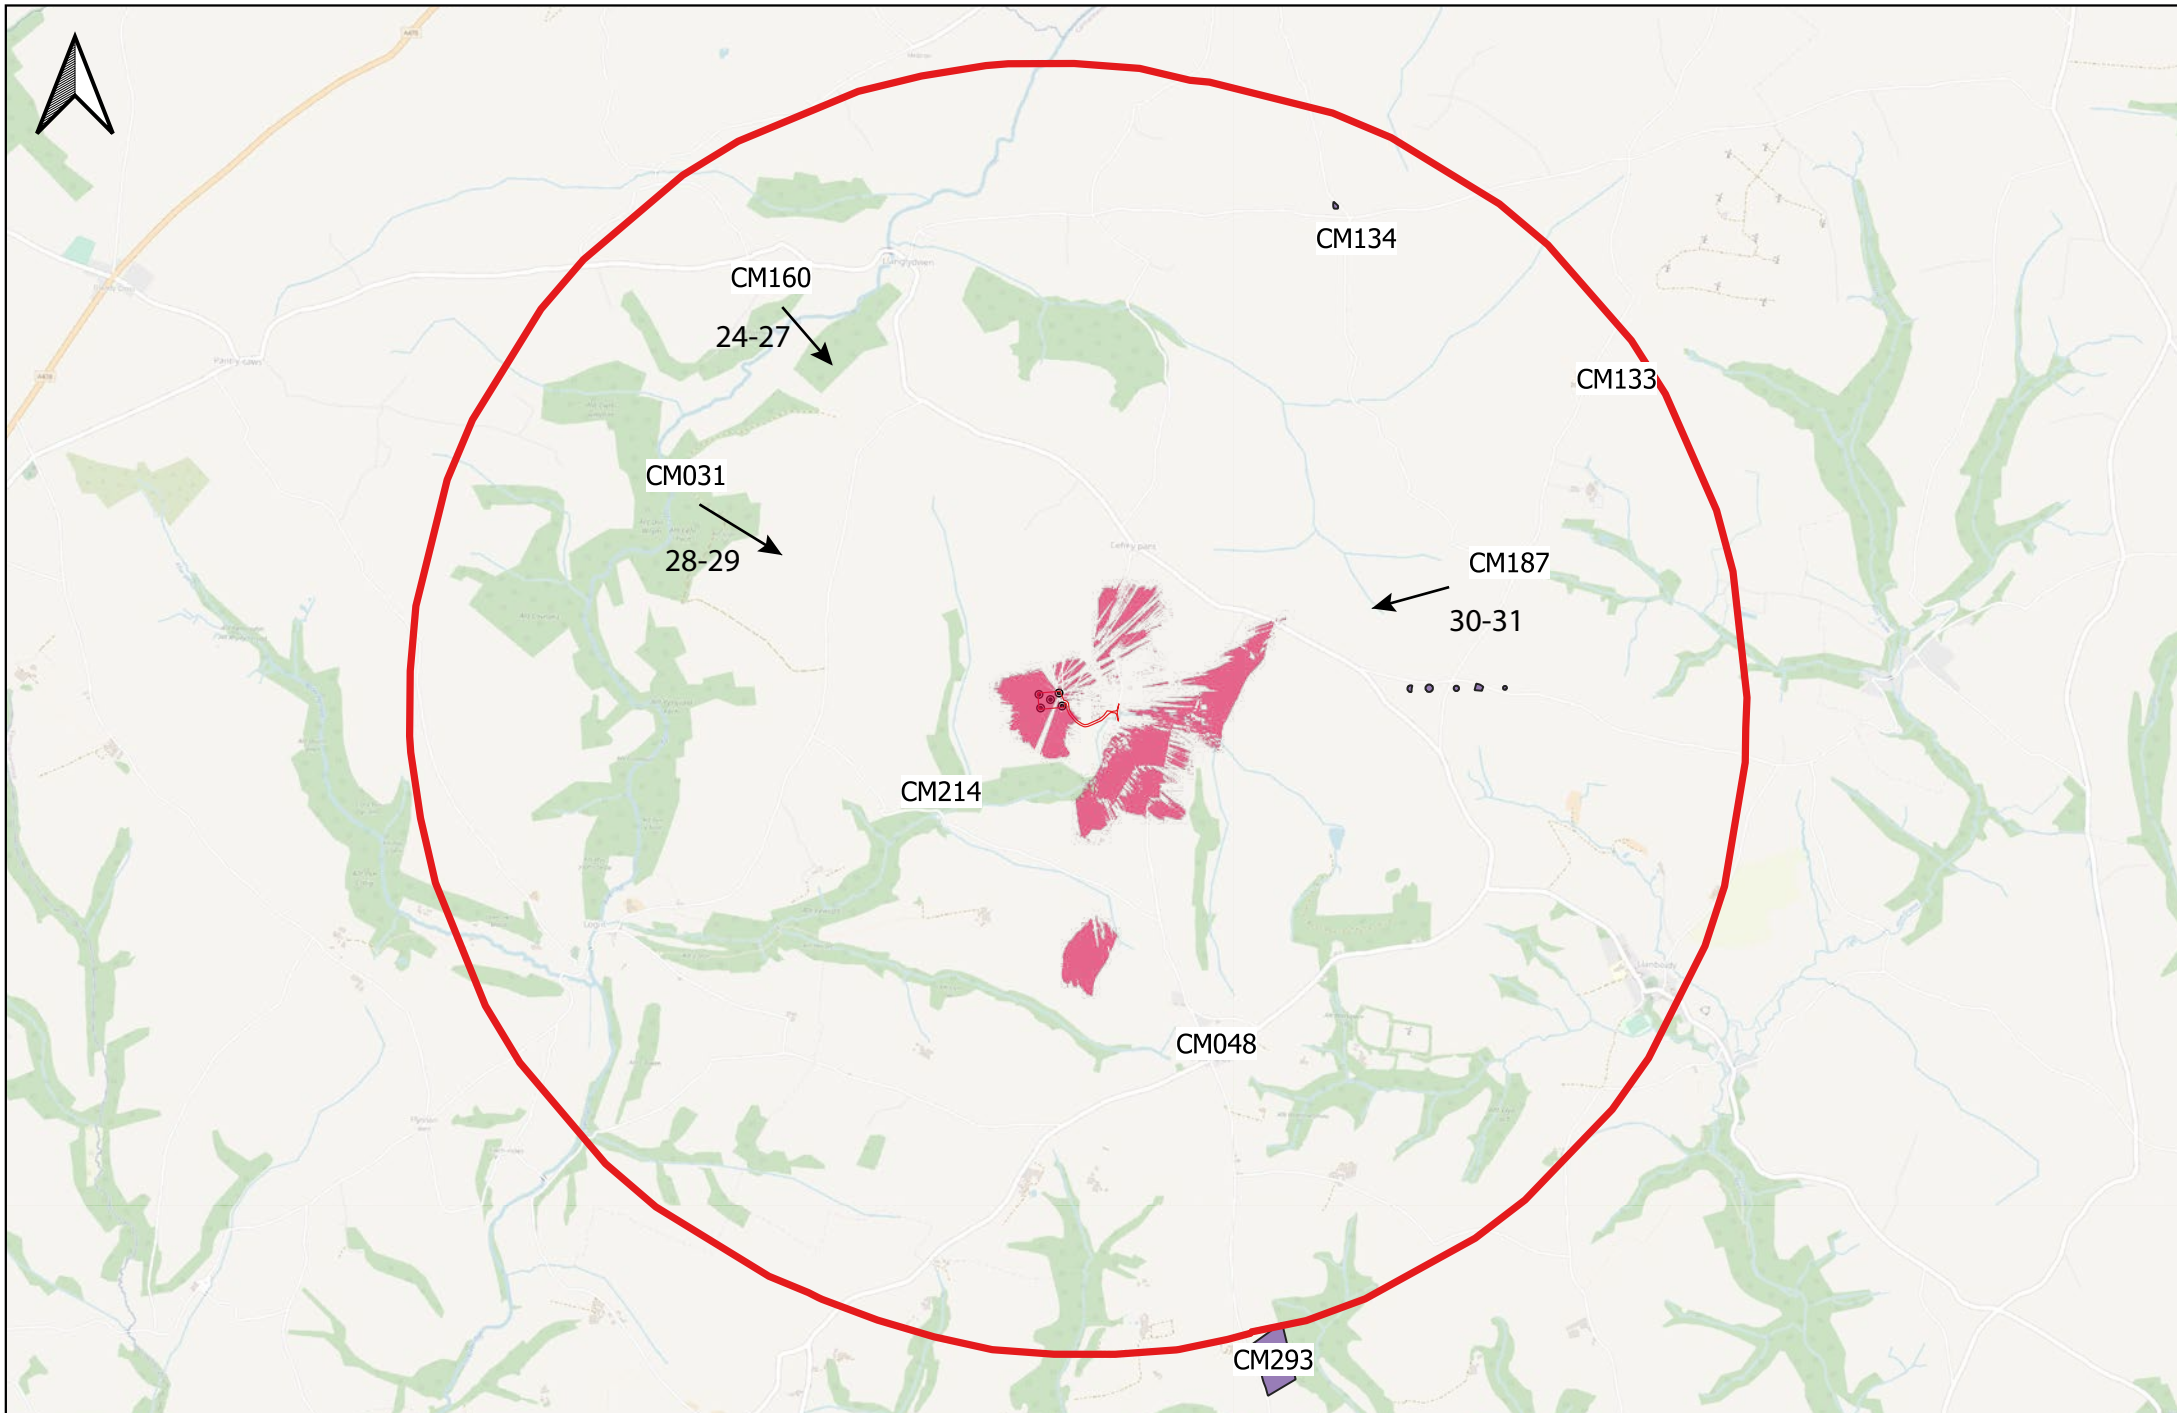
Figure 11. ZTV model - views towards surrounding landscape (pink).

- 5.4.10. The site visit determined that there were no views to or from any designated asset within the study area. This situation was also observed in a ZTV model reproduced in Figure 11 of the present report.
