Llysonen Road, Johnstown, Carmarthenshire

Archaeological Field Evaluation

Report No. 1332

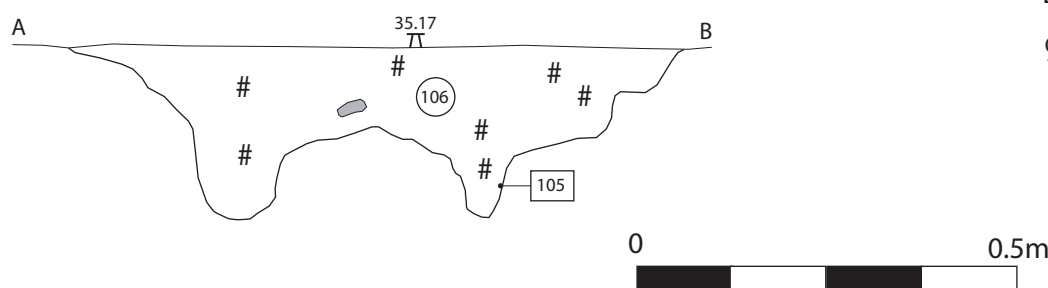
North facing section through root bowl [105]

Cut feature **105** had an irregular shape in plan. The base of the feature was undulating and contained two very deep narrow voids in the base of the feature. The sides of the feature had a gradual slope with one distinct break in slope. The feature measured 0.80m in length by 0.44m in width and 0.21m in depth. A single fill was recorded (**106**)

and it consisted of a light brown silty clay which contained frequent small pieces of charcoal. Due to the irregularity of the features shape and the presence of root action within its base it is likely that this feature is a tree bole.

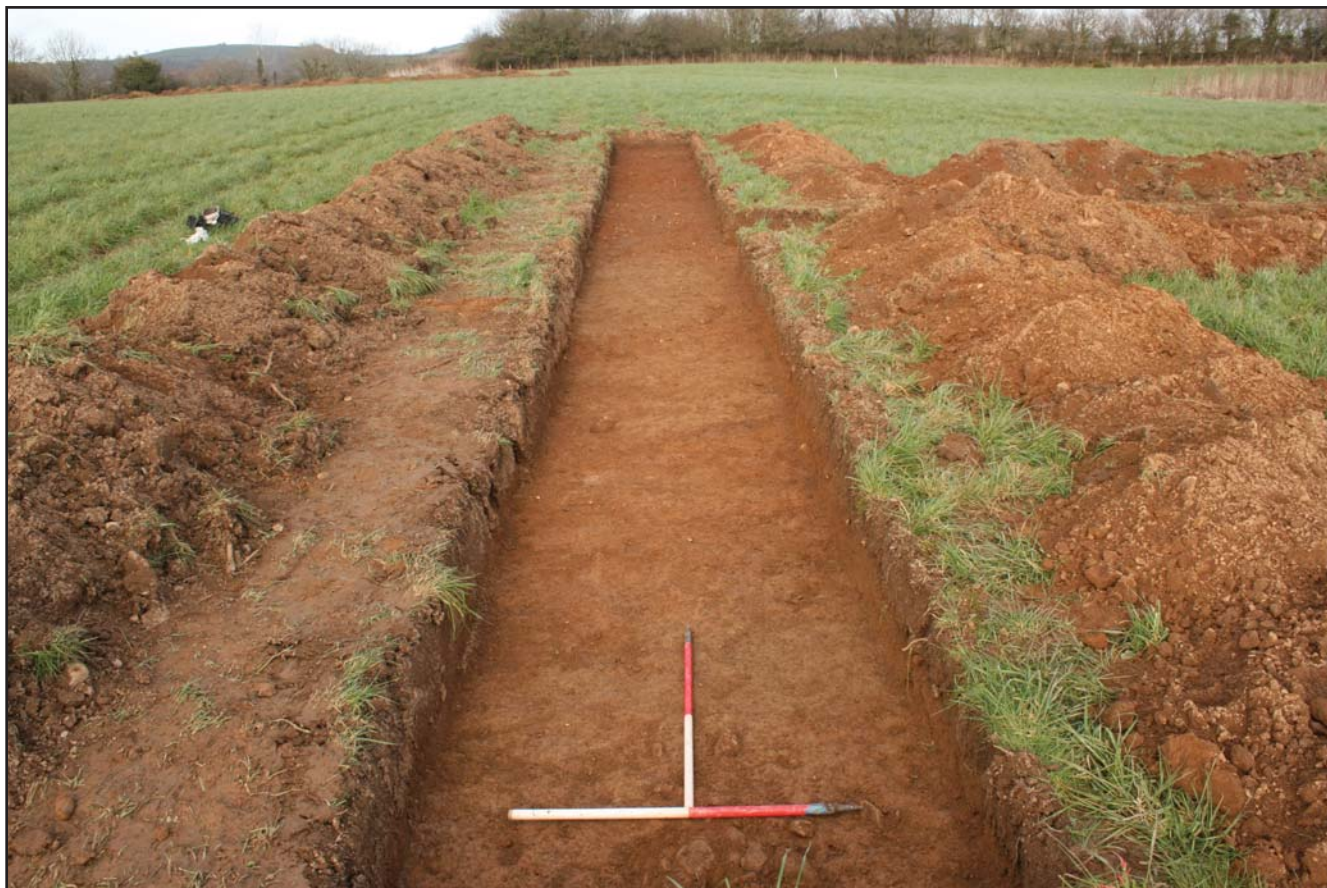
Plate 1. Trench 1. View to the north-east showing natural deposit 102.

Underlying the subsoil a moderately compacted light orangey-brown silt clay natural deposit was revealed (**102**), which contained occasional inclusions of small sub-angular stones. This deposit was a natural geological layer revealed at a depth of approximately 0.30m below current ground level.

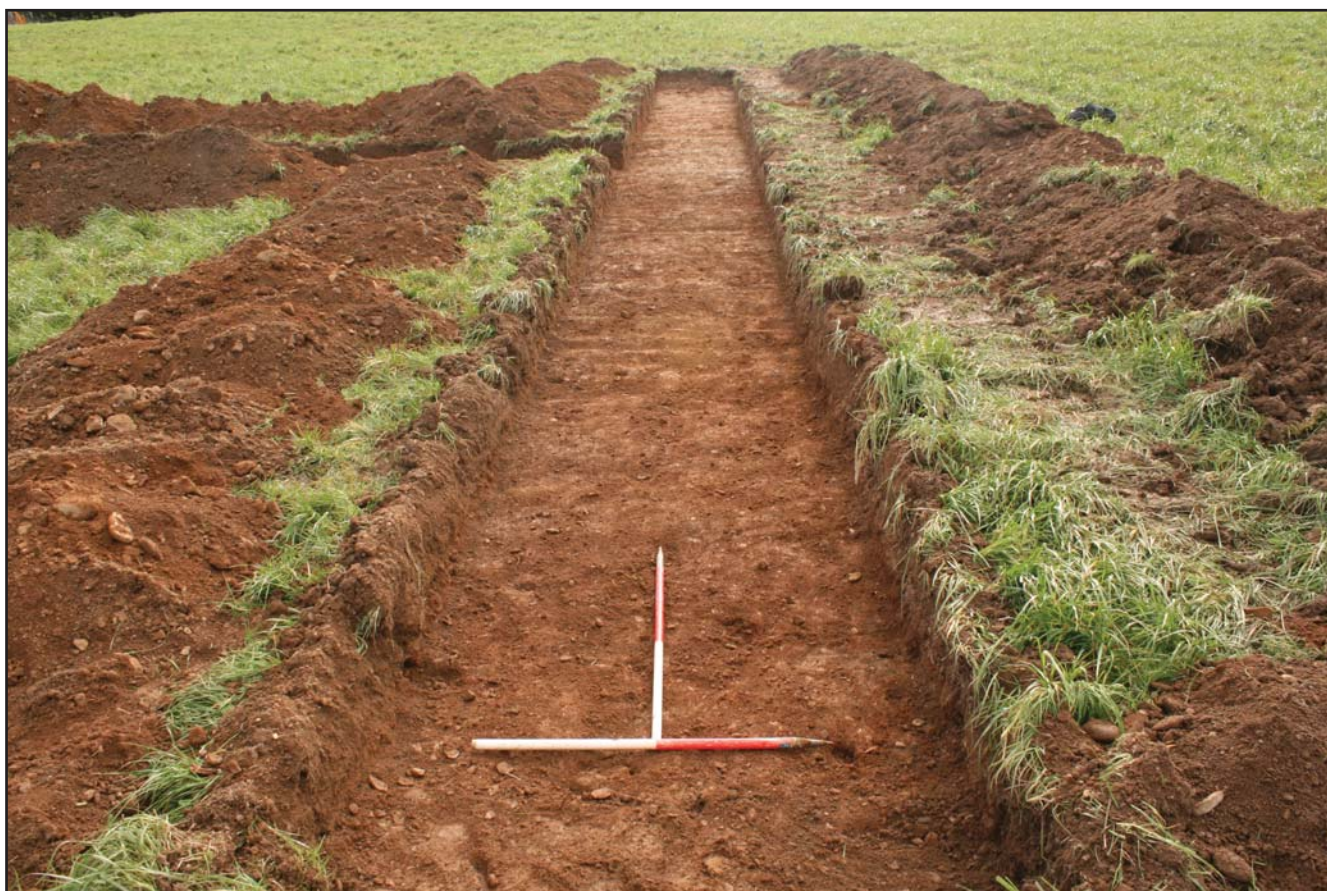
Plate 2. Trench 1. View to the south-west showing natural deposit 102.

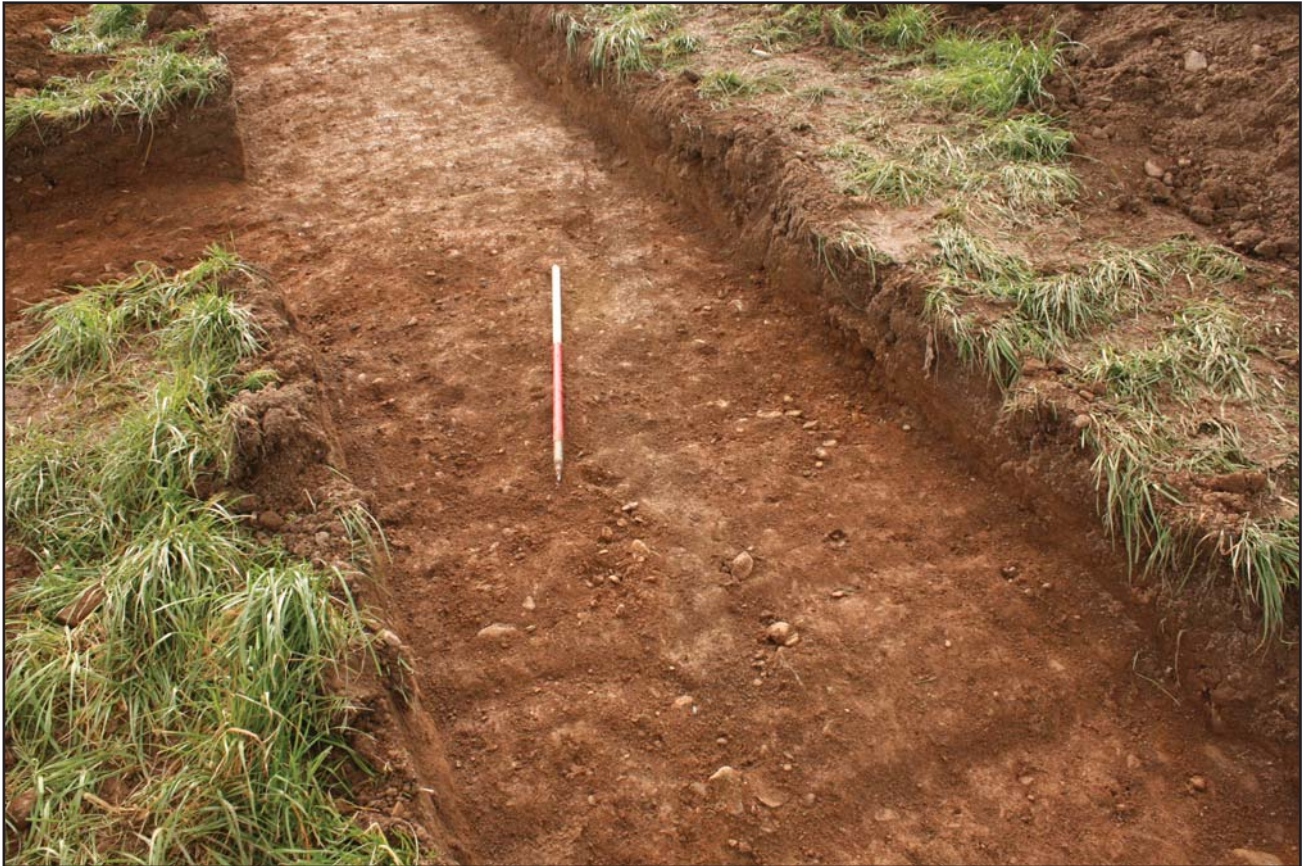
Plate 3. Trench 1. View to the south showing stone deposit 107 and natural deposit 102.

Stone spread **107** was observed within the central 'T' area of trench 1 and consisted of frequent, medium sized (0.06-0.2m) sub- rounded stones which appeared to have been placed within subsoil (**101**). The deposit was recorded as having a maximum depth of 0.20m maximum and is likely to have formed a hard standing within a depression within the field as part of recent farming activity.

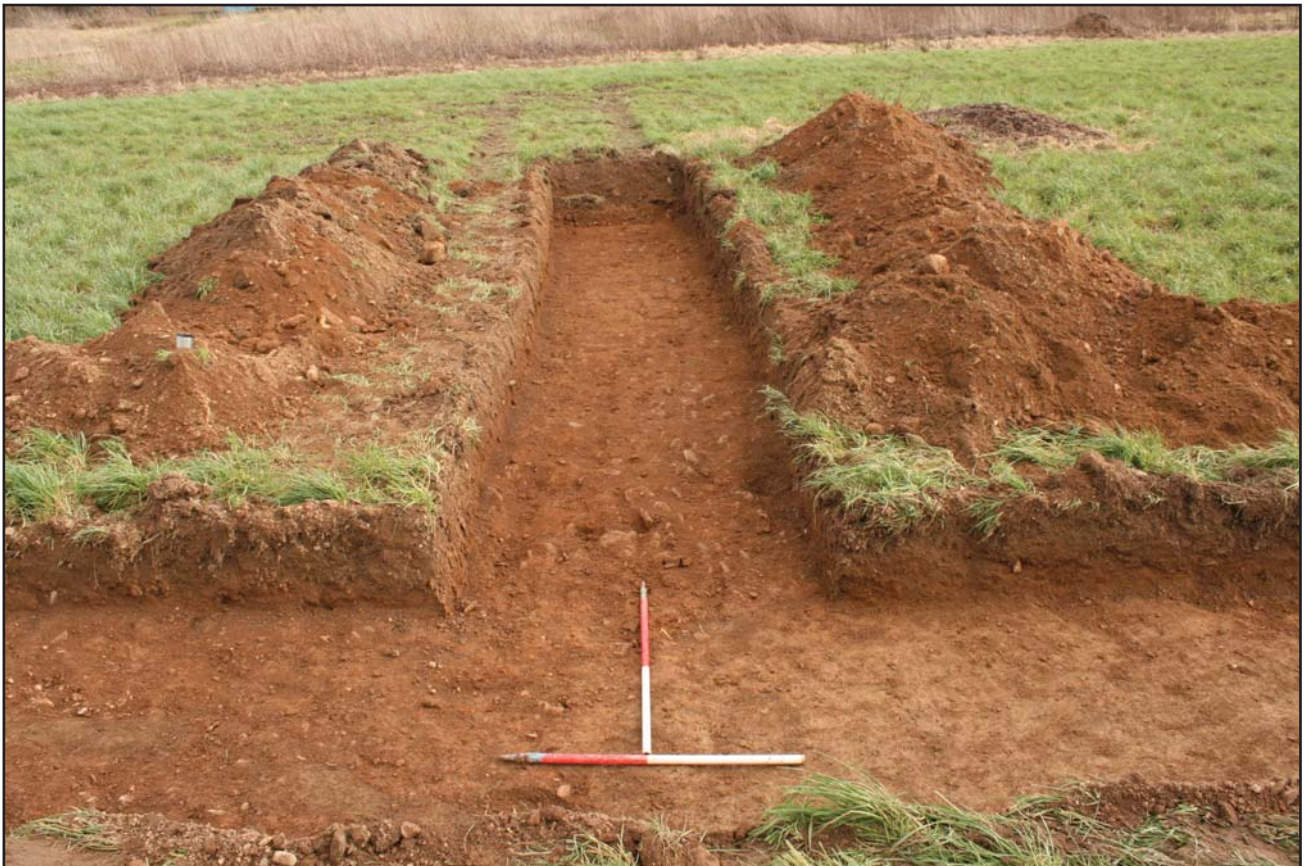
Plate 4. Trench 1. View to the south-east showing stone deposit 107 and natural deposit 102.

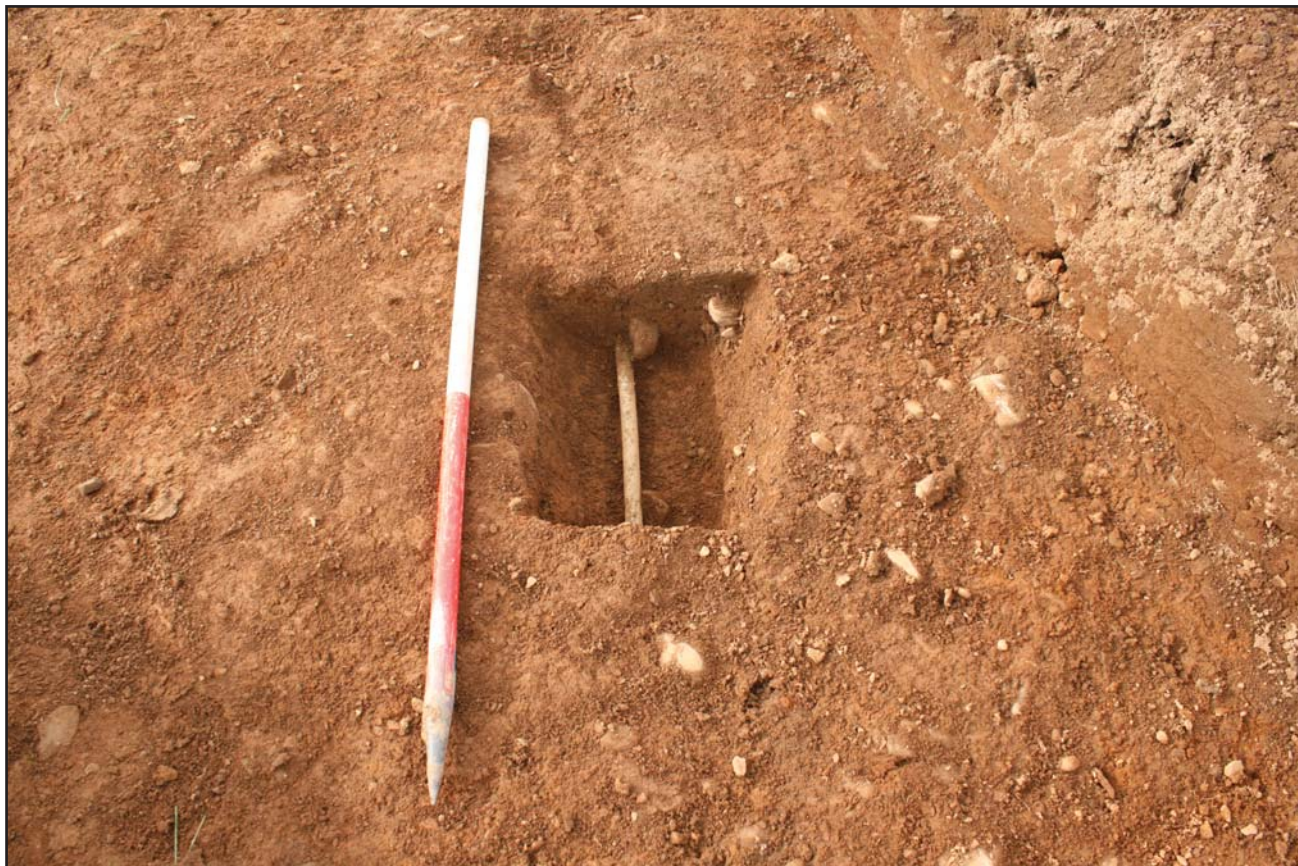
Plate 5. Trench 1. Cut feature 103 containing fill 104 and modern copper water pipe.

Linear feature **103** was aligned east-west and was exposed for a total of 4m in length. The feature measured 0.35m in width and 0.15m in depth. The base of the linear was flat with near vertical cut sides. The feature contained a single fill (**104**). The fill consisted of a compact mid brown clay-silt with frequent inclusions of small rounded and sub angular stones. A single copper pipe was also found at the base of the fill and would indicate that the linear is part of a modern service.

Trench 1 was placed over a rectangular anomaly within the mid-western area of the site which revealed a single modern service likely from a disused modern water trough system. A number of similar anomalies can be seen depicted throughout the geophysical survey and are probably part of the same system. An area of hard standing was also discovered within the central area of trench 1 and is thought to be the remains of recent attempts by previous land owners to stabilise the wet ground conditions found within this area of the field.

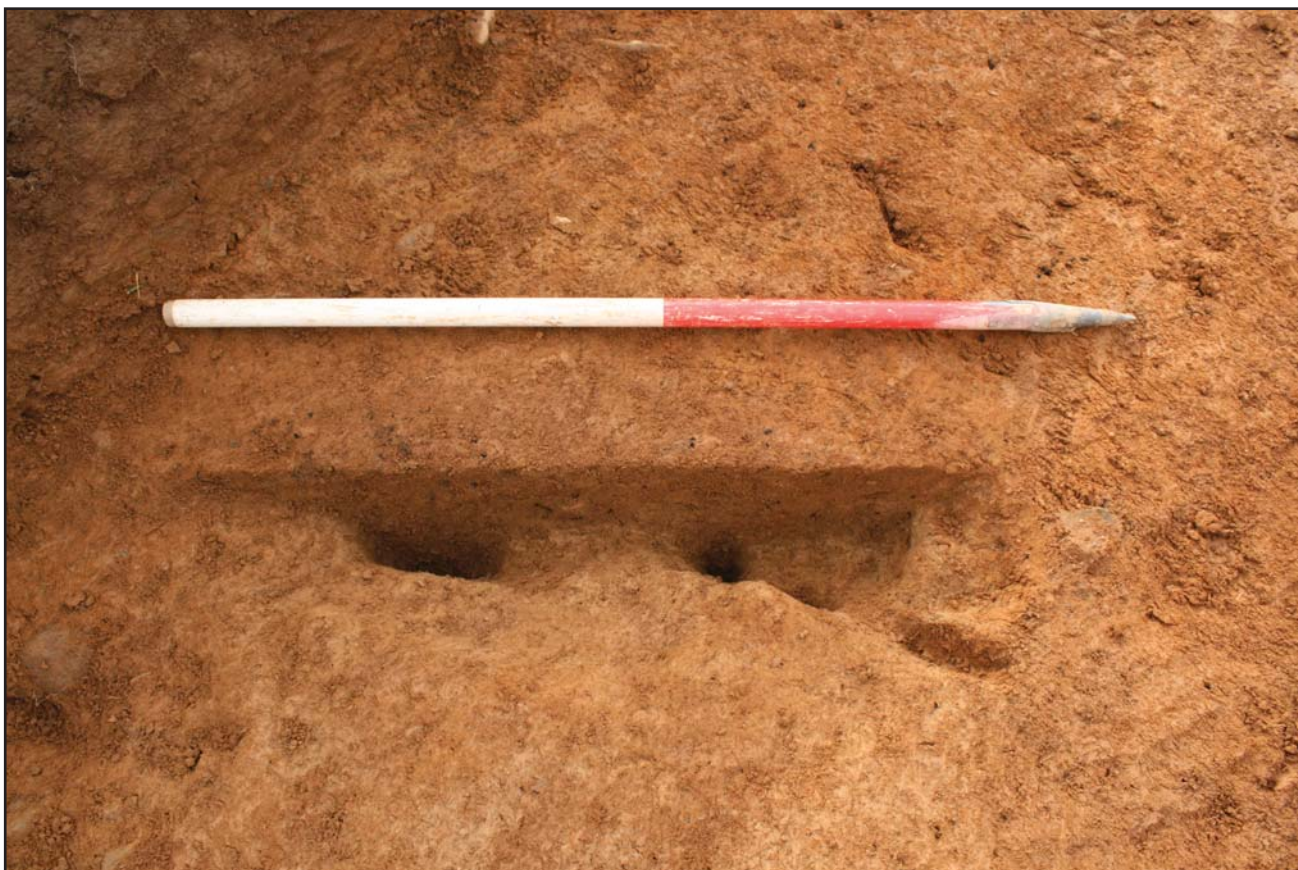
Plate 6. Trench 1. Half section through fill (106) of tree bole (105).

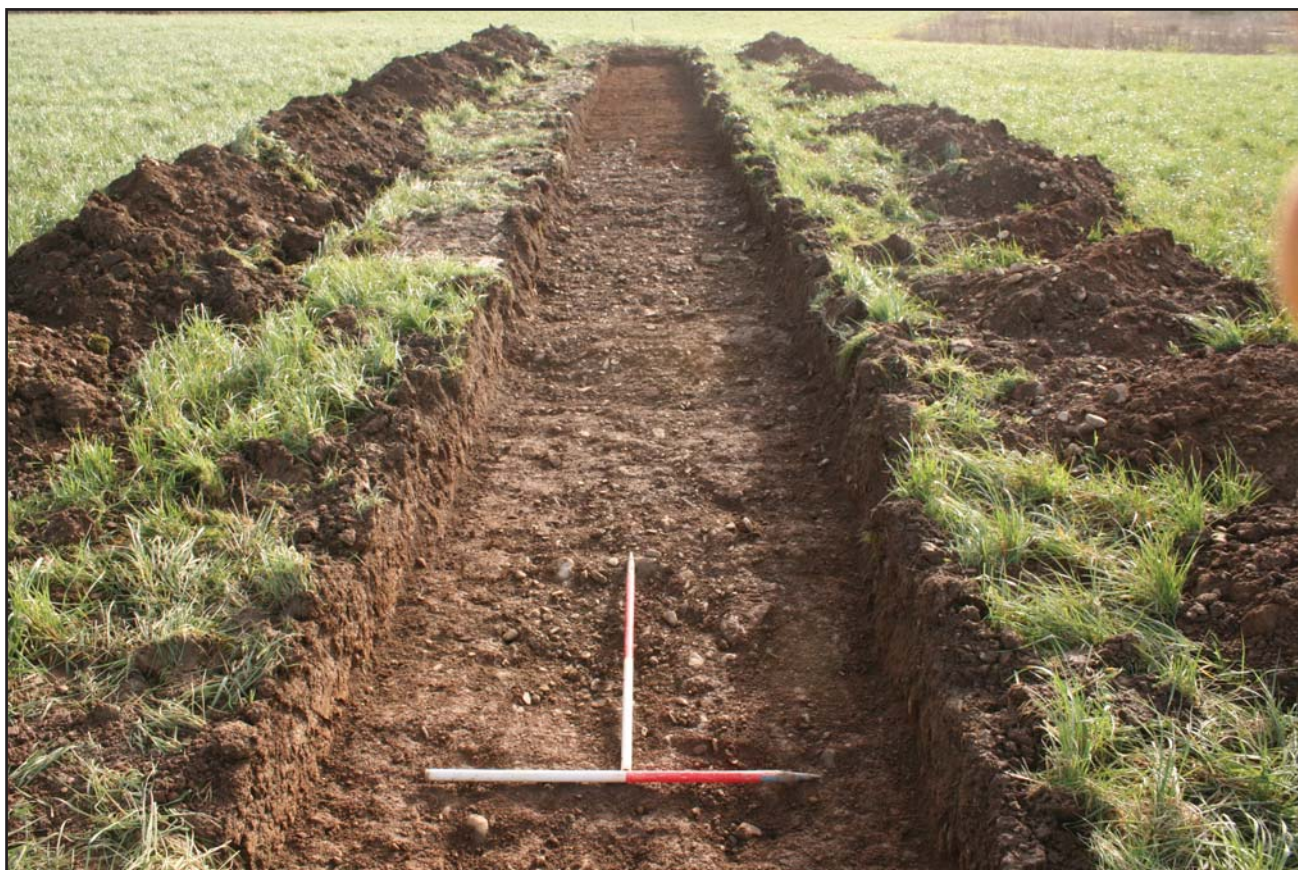
Plate 7. Trench 2. View to the north-west showing natural deposit 202.

Natural deposit **202** was revealed beneath **201** at 0.33m below present ground level and was a moderate to firmly compacted, light, orangey brown silty clay, which contained occasional to frequent inclusions of small (<0.06m) sub-angular stones.

Within the north western end of trench 2 an exposed natural gravel deposit (**203**) was revealed and is likely to be a glacial till. The gravel covered an area measuring roughly 7m in length and is thought to continue either side under natural deposit **202**.

Trench 2 was placed over a circular anomaly in the northern area of the development. Whilst recording trench 2 a broadly circular shaped patch of natural gravels were present within the north western end of the excavation. It is probable that the geophysical survey imaged the natural gravel deposit.
