The Old Infirmary Priory Street, Carmarthen Archaeological monitoring

NAP Archaeology

Location	The Old Infirmary, Priory Street
District	Carmarthen
Planning reference	W/25480
Grid reference	SN 4167 2029
Client	Mr. Dorian Davies
Project number	150901
Report number	150901 – v.2
Date	15/01/2018

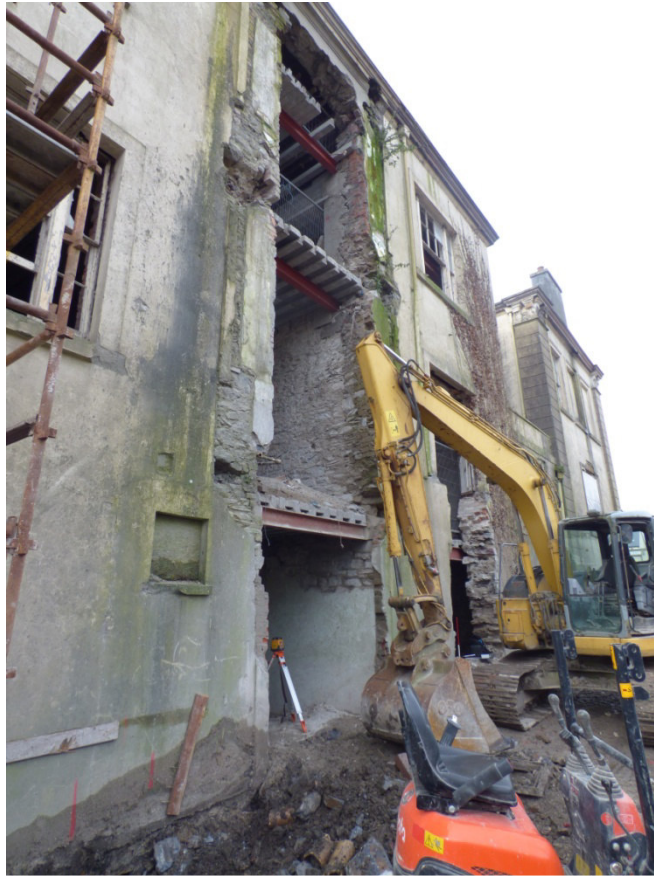
Plate 1: Northeast elevation of Infirmary showing location of Monitoring Area 1

Monitoring Area 1 on the northeast side of the building (Plate 1) and consisted of three trenches, c.0.6m wide. Excavation of the trenches exposed a massive concrete pad that extended beyond the east and north edges of the new foundations. The southern edge of the pad was exposed and where visible it was c.0.75m thick and the base was constructed on the stiff orange clay natural (Plate 2). The base of the pad was c.1.6m below the current ground level and it was covered by 0.7m of modern building rubble and loose soil.

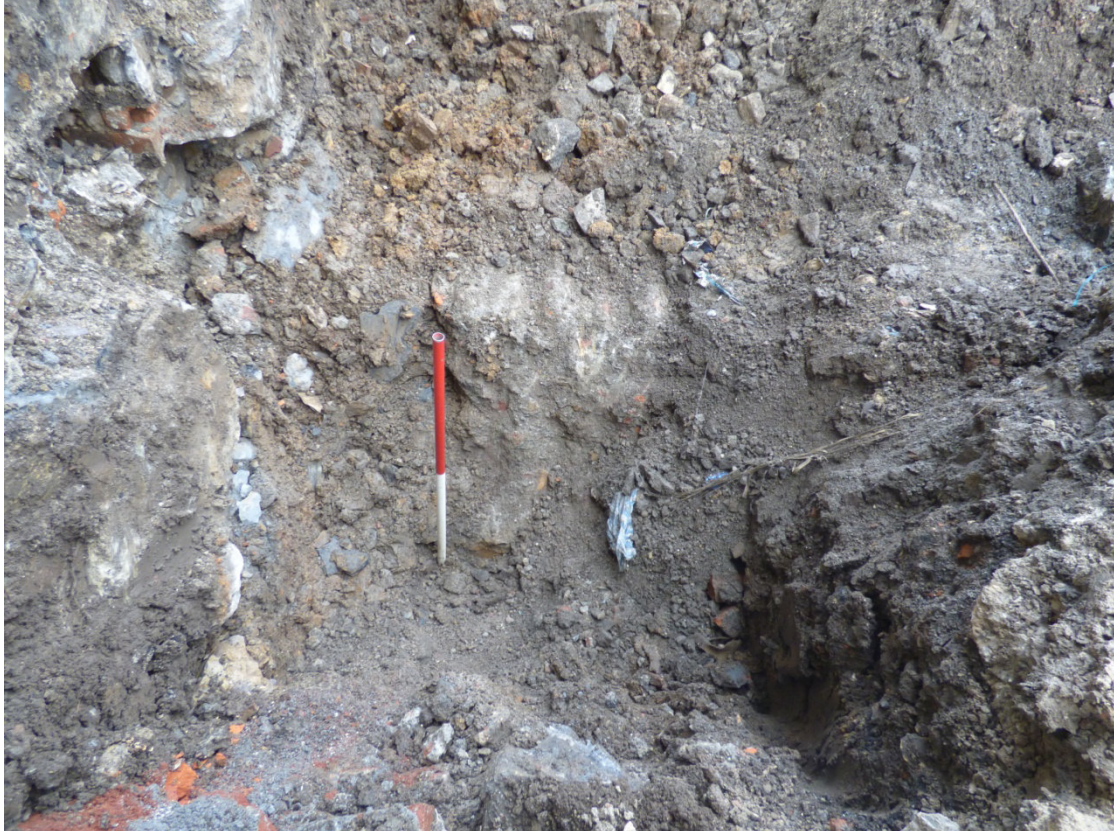
Plate 2: Concrete pad that covered Monitoring Area 1.

The excavations for the pad and its construction had removed any archaeological features and deposits that may have been present.

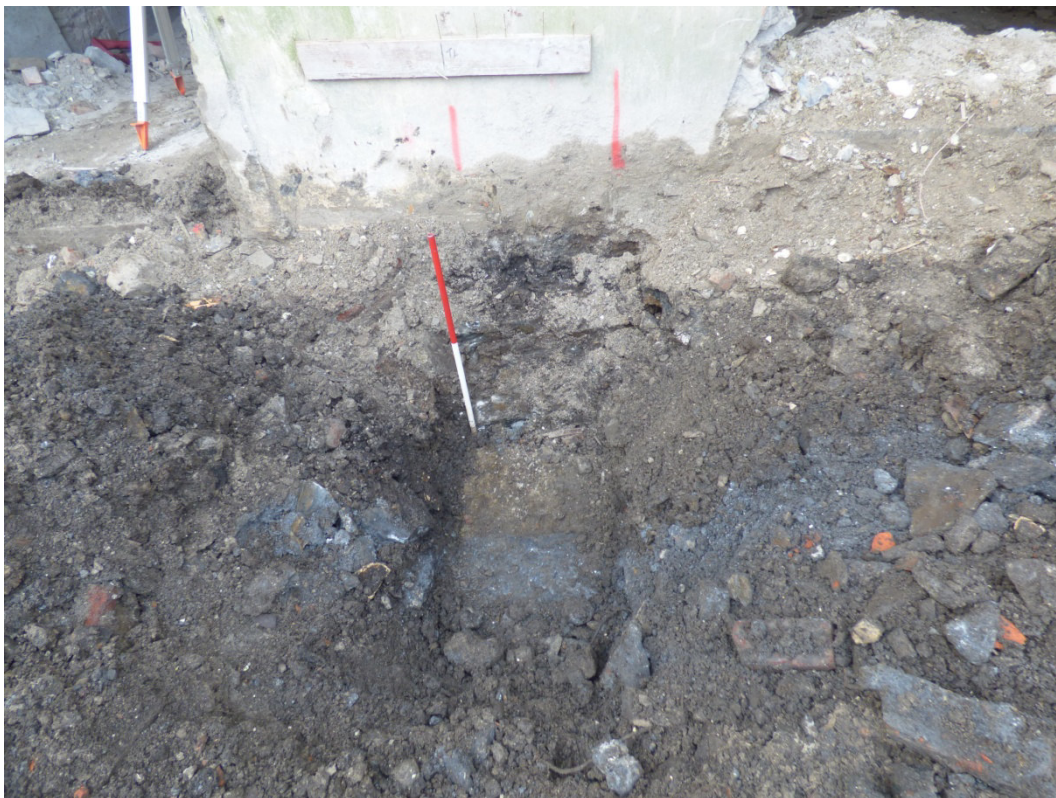
Plate 3: Detail of the concrete pad in Monitoring Area 1 showing remains of former block structure

There were traces of a former stone and block building on the pad (Plate 3), which appeared to correlate with the extension shown in this area on an OS map of 1968, so it appears that the pad was laid as the foundation for the former extension that occupied this area.

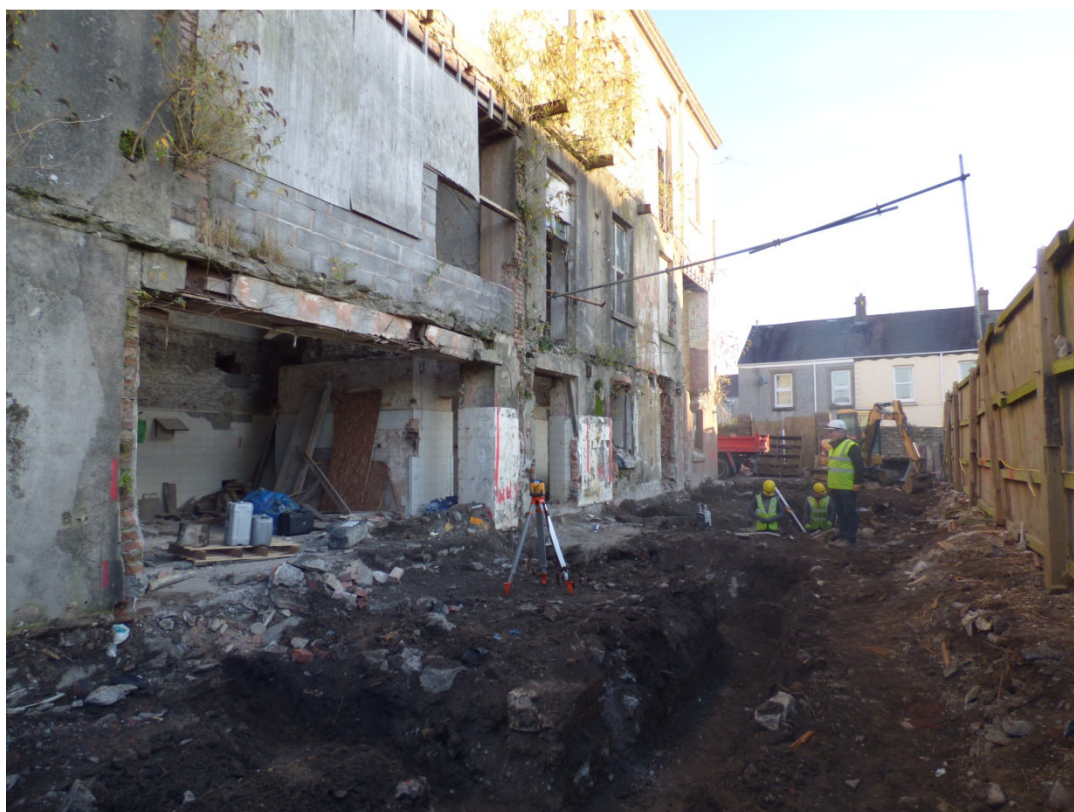
Plate 4: Rear elevation of Infirmary showing location of Monitoring Area 2

Monitoring Area 2 was at the rear of the building and it had the largest footprint of the three new foundations, consisting of a series of trenches c.0.75m wide and up to 1.4m deep excavated to form two rectangular separate blocks (Plate 4). Each block was made up of four trenches (Trenches 1-4 and Trenches 5-8), three short trenches extending out from the rear wall of the Infirmary and a long trench to form the southwest side.

All the trenches were excavated through a layer of loose brown loam and modern building rubble (001) that covered the whole of the area to the rear of the Infirmary building. layer (001) overlay several dumps and layers of clay and rubble (003, 007, 009, 011) that appear to have been deposited during or after the construction of the Infirmary or the later extensions.

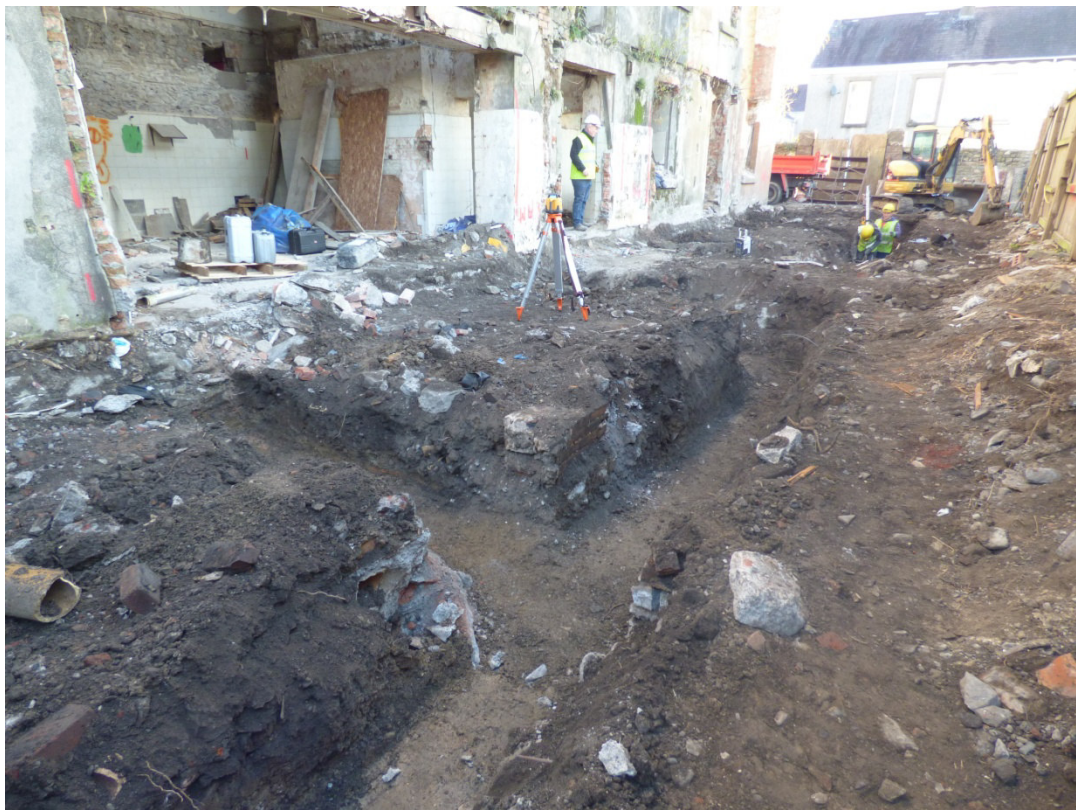
Plate 5: Detail of the excavated foundation trenches in Monitoring Area 2

The excavation for both sets of trenches required the removal of parts of a stone and brick foundation for an earlier extension, a number of services and two large concrete manholes (Plate 5).

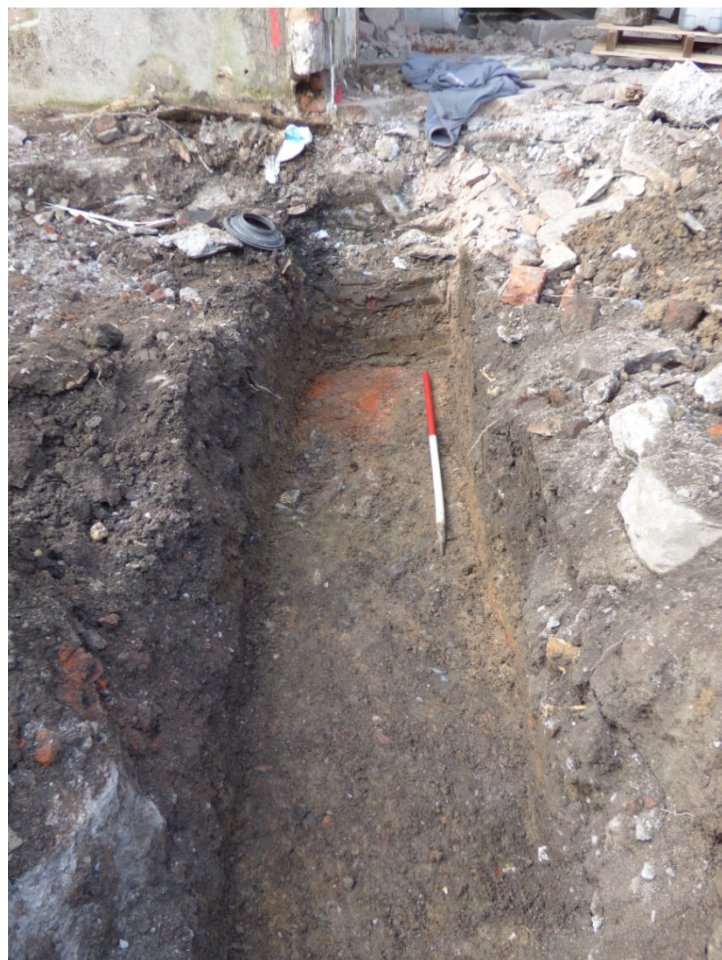
Plate 6: Possible burnt clay exposed in the base of a foundation trench in Monitoring Area 2

A small spread of stiff red/orange/yellow clay, which may have been fire reddened clay (006) was recorded extending below the rear wall of the Infirmary (Plate 6). A spread of small rounded loose stones and shale fragments on the southwest edge of (006) may have been associated, but it was not possible to determine a definite relationship. The position of the clay spread extending below the standing building precluded any investigation, but did confirm that it predates the mid 19th century construction of the Infirmary. It is not certain what period it dates from, but similar deposits are known from the supermarket site next door (Crane 2000, 8).

The monitoring was carried out on all groundworks associated with the redevelopment of the Infirmary building and no significant archaeological features or deposits were encountered, although an area of possible heat affected clay was noted in one of the foundation trenches in Monitoring Area 2.

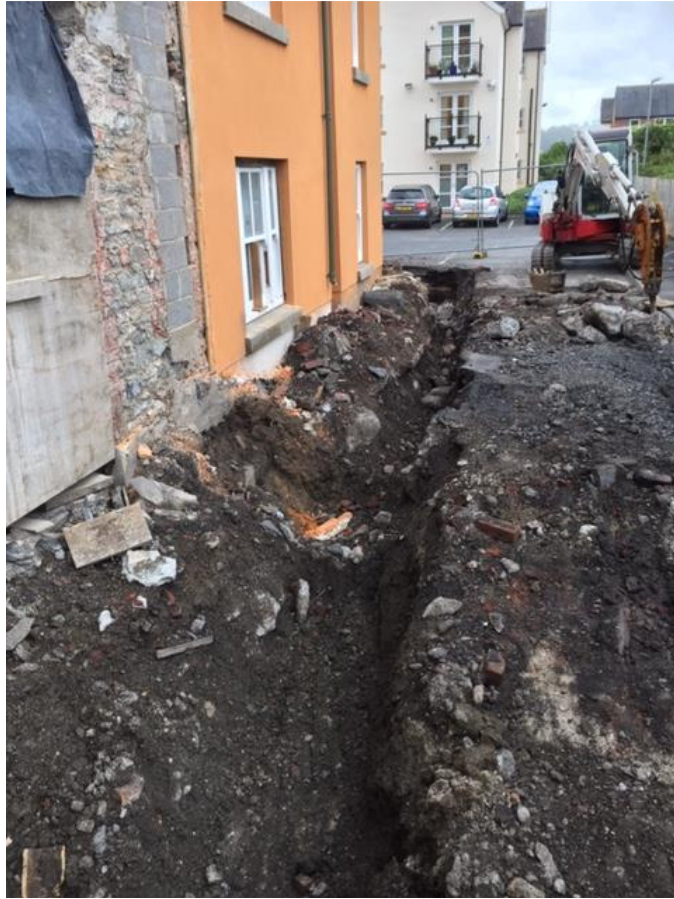
Plate 7: Southwest elevation of Infirmary showing the made ground and concrete pad in Monitoring Area 3

Monitoring Area 3 was on the southwest side of the building and as with Monitoring Area 1 consisted of three foundation trenches, c.0.6m wide and a narrow service trench. Excavation of the foundation trenches exposed a massive concrete pad that extended beyond the west and north edges of the new foundations. The southern edge of the pad was exposed and where visible it was c.0.8m thick and the base was constructed on the stiff orange clay natural. The base of the pad was c.1.4m below the current ground level and it was covered by 0.6m of modern building rubble and loose soil.

The excavations for the construction of the pad had removed any archaeological features and deposits that may have been present.
