## Pentwyncoch Ganol, Tir y Coed Road, Glanaman

Archaeological Building Recording (Level 3)

Report No. 1601

August 2017

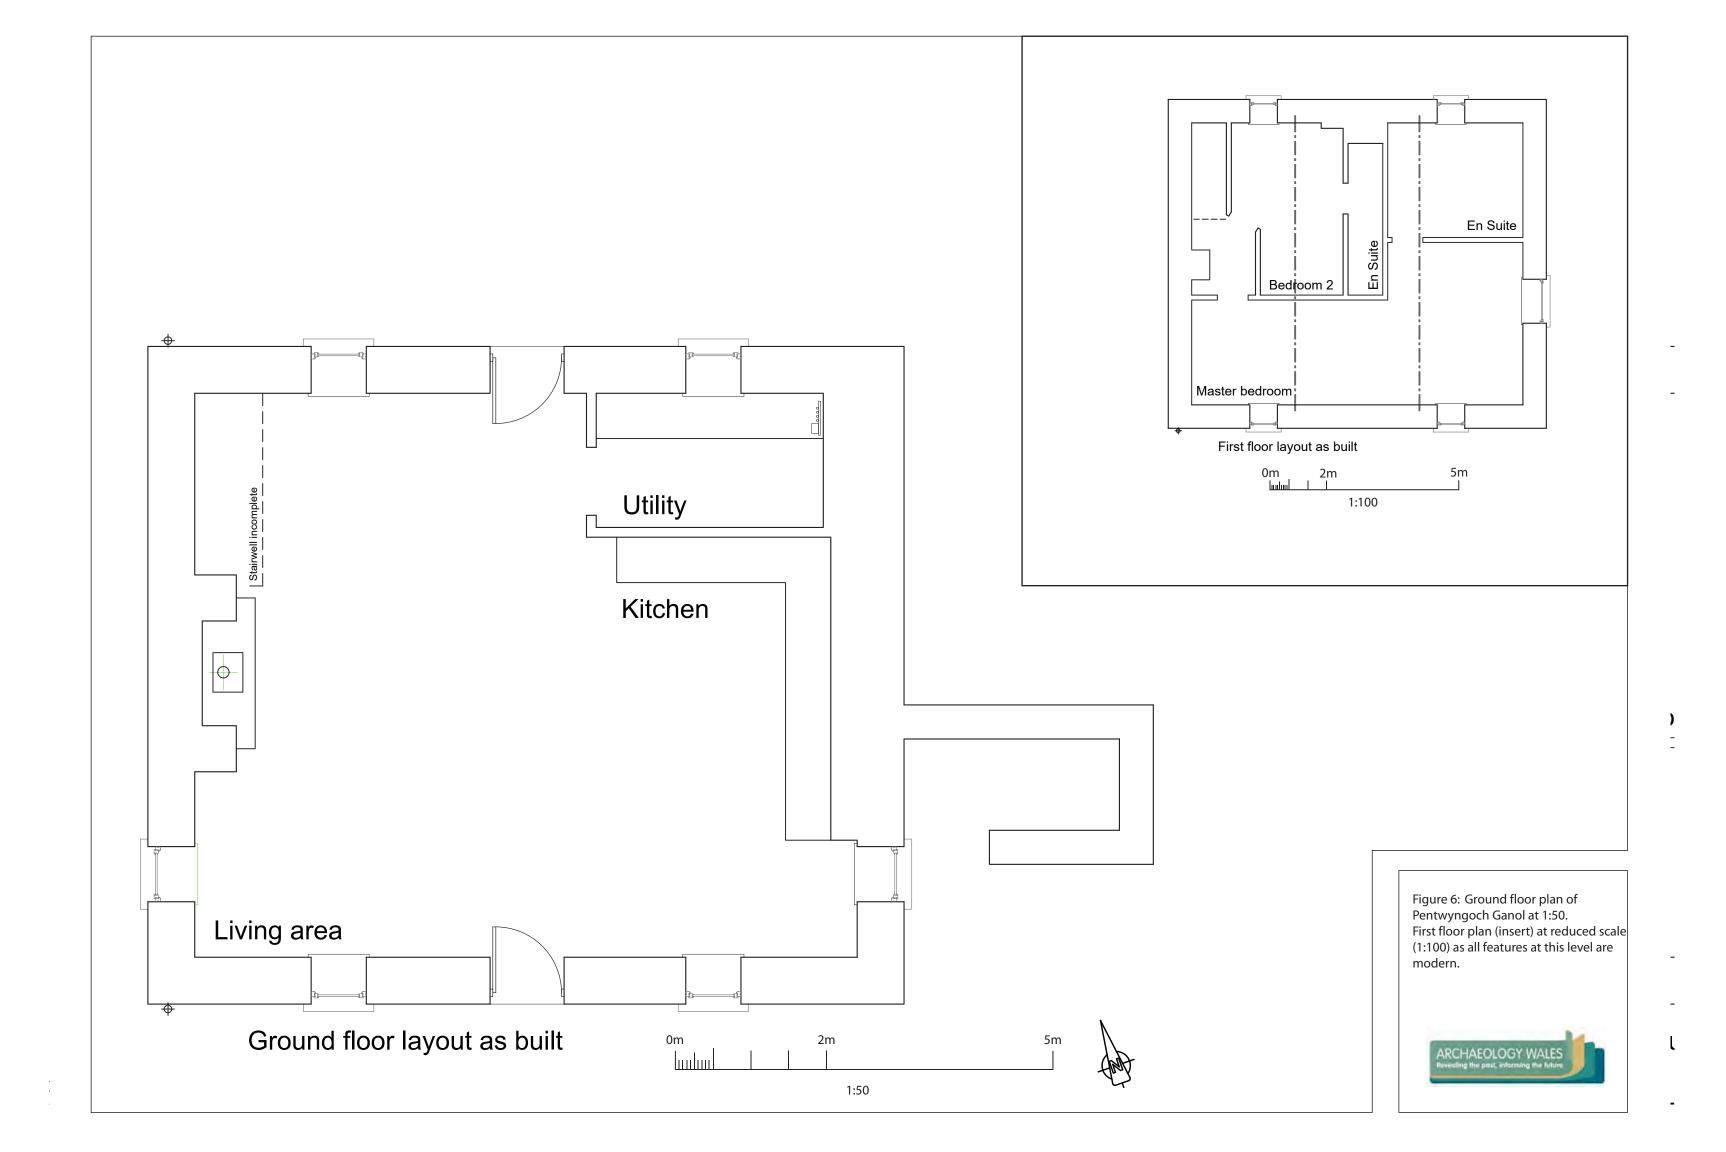
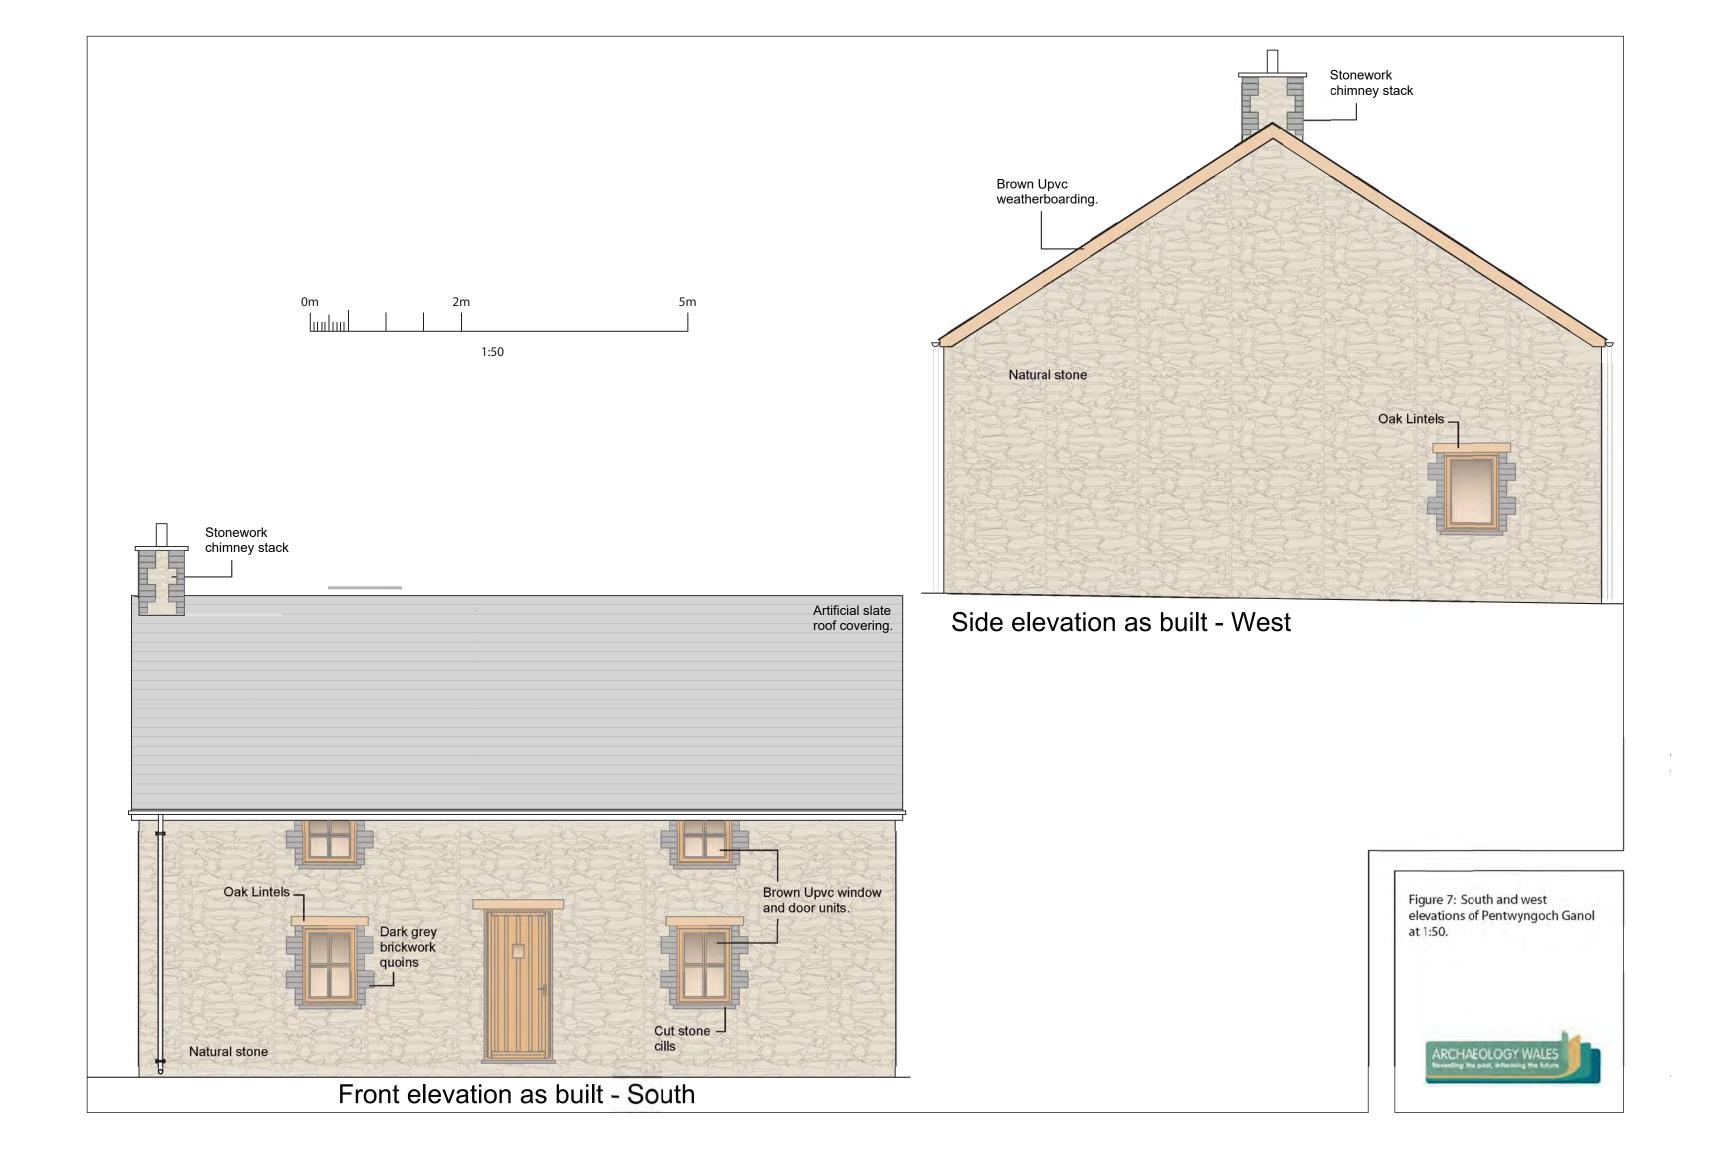
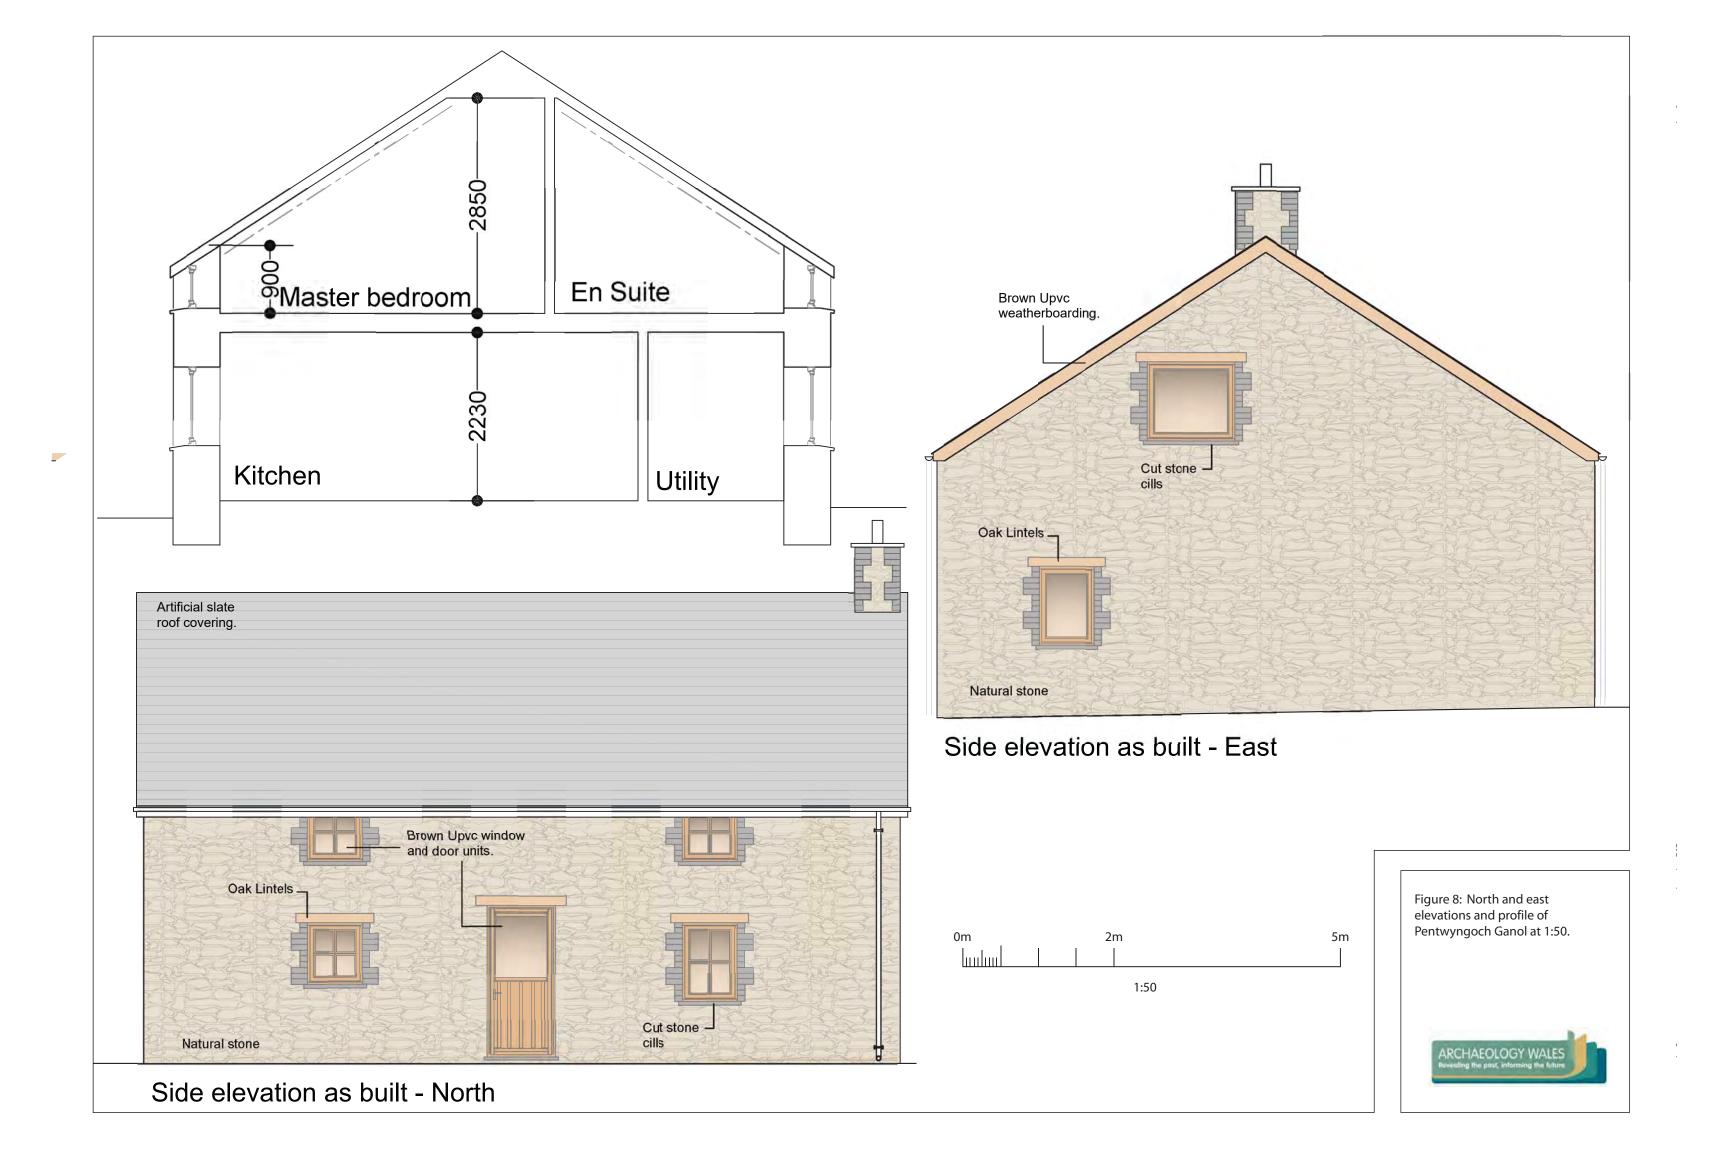
- 6.1.1 Figure 6 shows the existing ground floor and first floor plan of the existing building, Figures 7 and 8 show the elevations and a profile of the existing building. Figures 9 and 10 also show the location and direction from which the photographic plates were taken. The number after each red arrow corresponds to the plate on which the photograph appears.

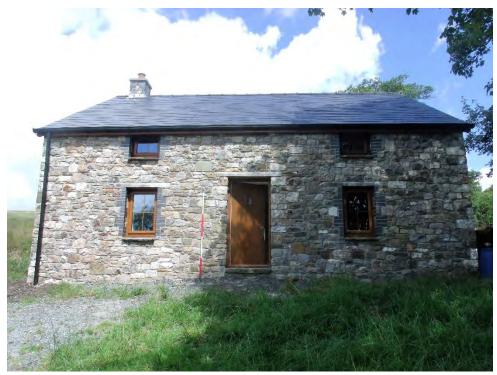
Plate 1: Front (south) elevation, general view; shot facing N. 2m scale.

- edging, with a concrete crown, ceramic flue and lead flashing. As with the roof structure, this chimney would appear to be a modern rebuild.
- 6.2.4 The southern (front) elevation (Plates 1-5) contains a centrally-placed doorway, comprising the single front door to the property. The doorway is topped with a machine-cut, squared, oak lintel, replacing the original brick lintel, and a reused limestone step at the base. A new wood-effect resin door with a small window vent in the centre has been added to the original opening. There are four windows, two on each floor, all 0.8m wide, those on the ground floor being 1.2m high, and those on the first floor 0.6m high. The windows are four-panel awning windows in brown Upvc. The window openings have been rebuilt to the original sizes, with grey-brick edging and machine-cut, squared, oak timber lintels added. The original protruding slate sills have been re-incorporated in the new windows. The roofline projects over the upper windows. Black Upvc guttering runs along the roofline, with a downpipe to the west.

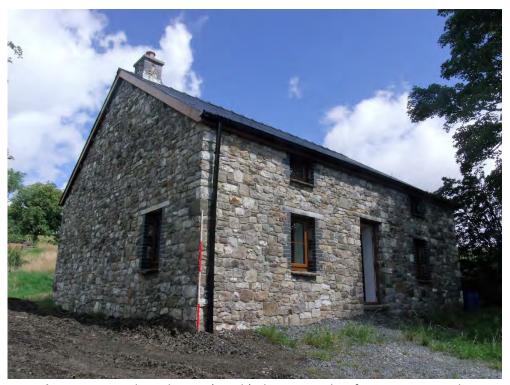
Plate 5: West side and Front (south) elevations; shot facing NE. 2m scale.

- 6.2.5 The western gable (Plates 5-7) is built in the same style as the southern elevation. A new window opening has been inserted at ground-floor level, towards the southern end of the wall. The window measures 1.05m tall, by 0.7m wide, and is a plain awning window in brown Upvc. The window opening is edged in decorative grey-brick, with a modern oak lintel, and reused slate projecting sill.

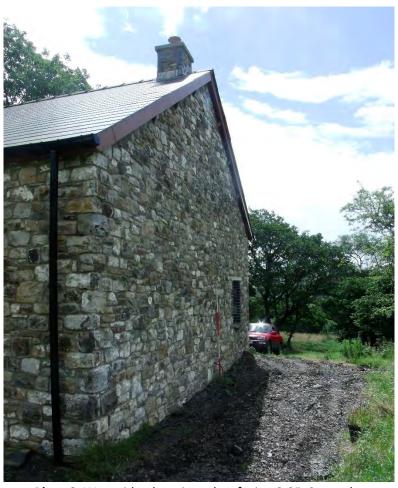
Plate 6: West side elevation; shot facing S-SE. 2m scale.

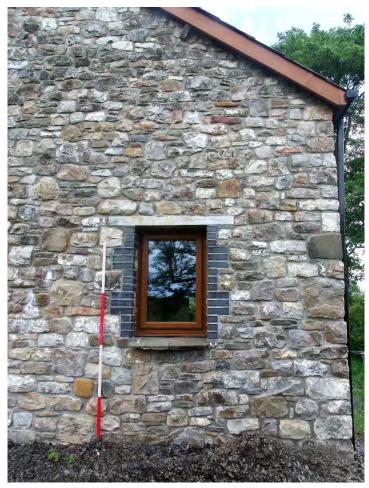
Plate 7: West side elevation, view of window; shot facing E. 2m scale.

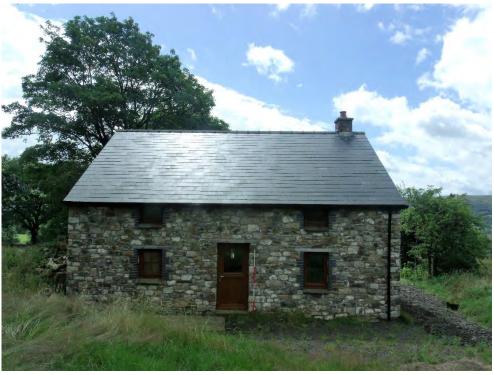
Plate 8: Rear (north) side elevation, general view; shot facing S. 2m scale.

- 6.2.6 The northern (rear) elevation (Plates 8-12) shows a continuation of the same building style, and mirrors the front elevation with a central doorway and four windows, two to each floor. The rear door is a similar brown wood-effect resin, but with a half-window opening. The door opening appears to be original, but with a modern oak lintel and re-used limestone step. The four windows are all 0.8m wide, those on the ground floor being 1.2m high, those on the first floor being 0.6m high. They are all modern brown Upvc four-panel awning windows, with decorative grey-bricks on the sides, modern wooden lintels and protruding slate sills.

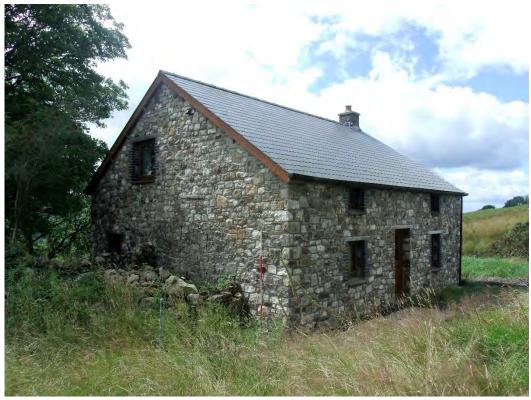
Plate 12: East side and Rear (north) elevations; shot facing SW. 2m scale.

- 6.2.7 The eastern gable (Plates 12-14) continues the same building style, with two newly inserted windows, one to each floor, and both in the southern half of the face. The ground floor window measures 0.7m wide, 1.05m high, and comprises a plain awning window in brown Upvc. The first floor window is 1.1m wide, 1.05m high, also comprising a plain awning window in brown Upvc. Both window openings are in the typical style with decorative greybricks on the sides, modern wooden lintel, and protruding slate sill. The eastern gable wall preserves a section of the original wall prior to repointing. This section, built in the typical randomly coursed, roughly faced, stonework, is bonded in a light buff lime-mortar (Plate 14).

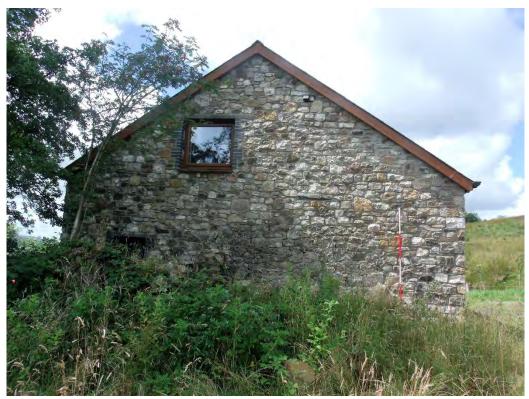
Plate 13: East side elevation, general view; shot facing W. 2m scale.

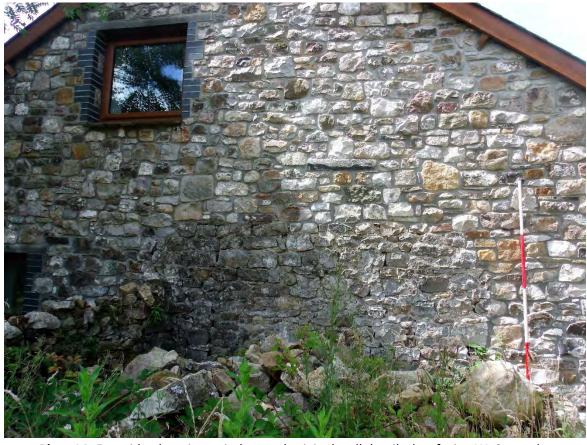
Plate 14: East side elevation, window and original wall detail; shot facing W. 2m scale.

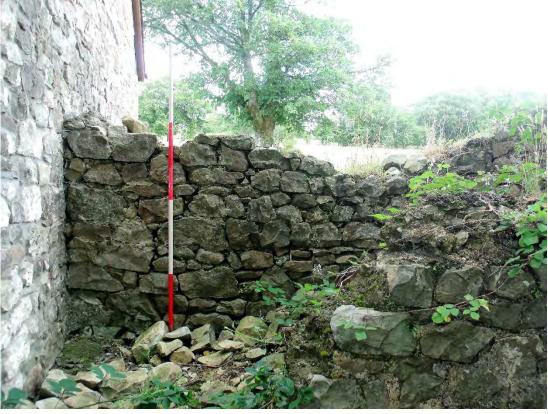
It comprises a lean-to shed to the south and the ruins of an indeterminate structure to the north. The lean-to shed to the south (Plates 18-19) still consists of walls approximately 1.5m high, stone in a random-rubble style with mortar bonding, and traces of cement render on the interior of the southern face (Plate 20). This unit is accessed from the south, it does not appear to have been accessible from the interior of the original house building. The ruined indeterminate structure on the northern side is almost fully covered with vegetation. Both structures butt against the eastern gable wall of the main building.

Plate 18: Lean-on structure, detailed view from S; shot facing N. 2m scale.

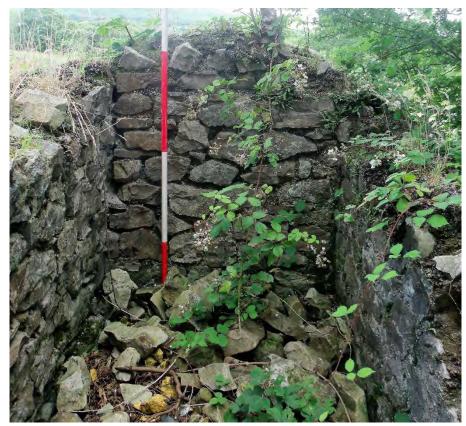
Plate 19: Lean-on structure, detailed view from East side; shot facing E. 2m scale.

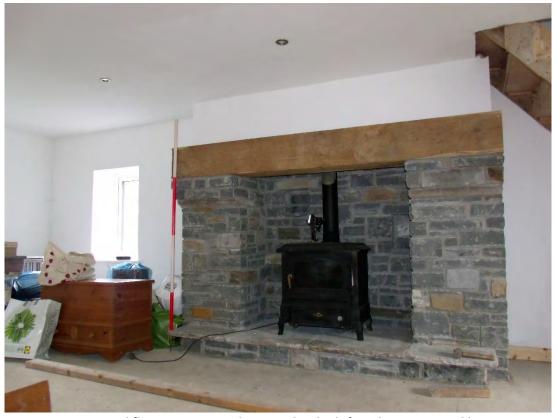
Plate 24: Interior, ground floor; view towards SW with rebuilt fire place in original location. 2m scale.

- Chimneys. Pre-renovation photos indicate a centrally-placed chimney stood against the interior of the eastern gable wall. The chimney stack was stone-built, and covered in cement render, obscuring any original detail. A single ceramic chimney pot topped the stack. This chimney appears to originally have been mirrored by a second chimney on the opposing gable wall, but this had collapsed prior to renovation. The eastern chimney has now been removed, and the western chimney rebuilt in its original position, using stone and grey-brick.

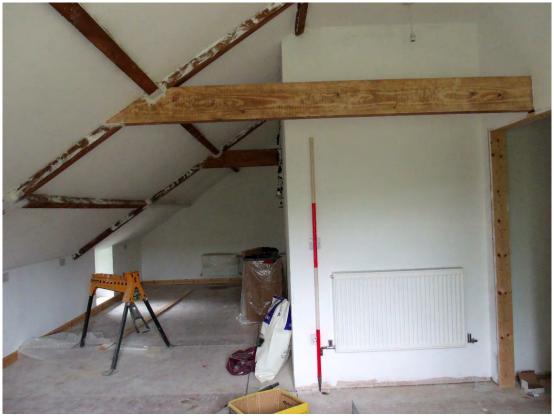
**Plate 33:** Interior, first floor, Room 1, view of trusses; view towards W. 2m scale.

- 6.3.3 The provisional staircase gives access to a small landing (Plates 28-29) from which access can be gained to both Room 1 and Room 2. Room 1 (Plates 30-34) is located to the south of the house, with maximum dimensions of 10m x 8.5m in an L-shape, with 3.5m maximum width. A plaster wall has been built to create a partition with the *en-suite* area fitted to be converted into bathroom (Plate 34). This room has painted plastered walls and ceiling and wooden skirting, and wooden panel floors. The room is lighted by four windows, two at the front face, one at the eastern face, and one at the north face in the *en-suite* area. The room is open to the trusses and beams of the new roof, which are encased in painted plaster.

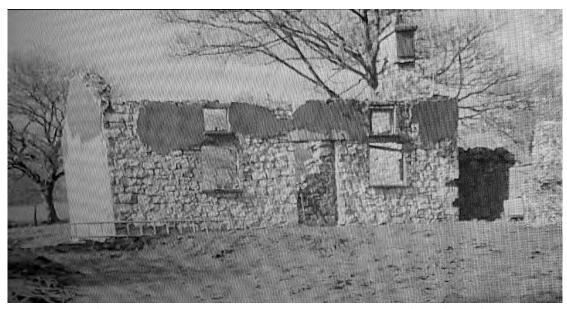
- Window inserts in east and west gable walls. Both walls appear originally to have been featureless.
  - External wall render. Pre-renovation photos (plates 47 and 48) suggest the exterior faces of the walls were at one point covered in dark-grey cement render, which had partly detached prior to renovation. This render may not have been an original feature itself, although original lime-mortar render is a possibility. The walls are now un-rendered.

**Plate 47:** Photo of the house taken prior to renovation work, showing front (South) elevation. Shot facing NNE

- Repointing. Pre-renovation photos indicate mortar had largely weathered and/or fallen out from many of the joints in the stonework. This is likely to have been lime-mortar throughout. The building has now been extensively re-pointed in modern grey mortar.

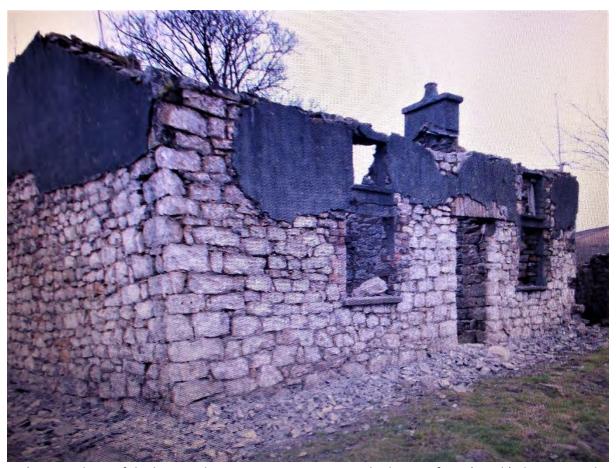
**Plate 48**: Photo of the house taken prior to renovation work, showing front (South) elevation and part of the west elevation. Shot facing ENE
