CAMBRIAN MOUNTAINS ESA, HISTORIC MONITORING

BASELINE 1995

OS 1:1000 SHEET: SM /SN 78	GRID REF: SM/SN 7325 8330
PRN: 8588 SITE NAME: Nant Geltaes	
AIR PHOTO No 87-55-26	LANDSCAPE TYPE: IIb
No GROUND PHOTOS: 7	
DATE SURVEYED: 16/10/95	SURVEYED BY: G. Hopwood.
ACCESS: On unenclosed moorland off minor road between Penrhyn-coch and Pouterwyd.

CAMBRIAN MOUNTAINS ESA HISTORIC MONITORING RESURVEY 1999

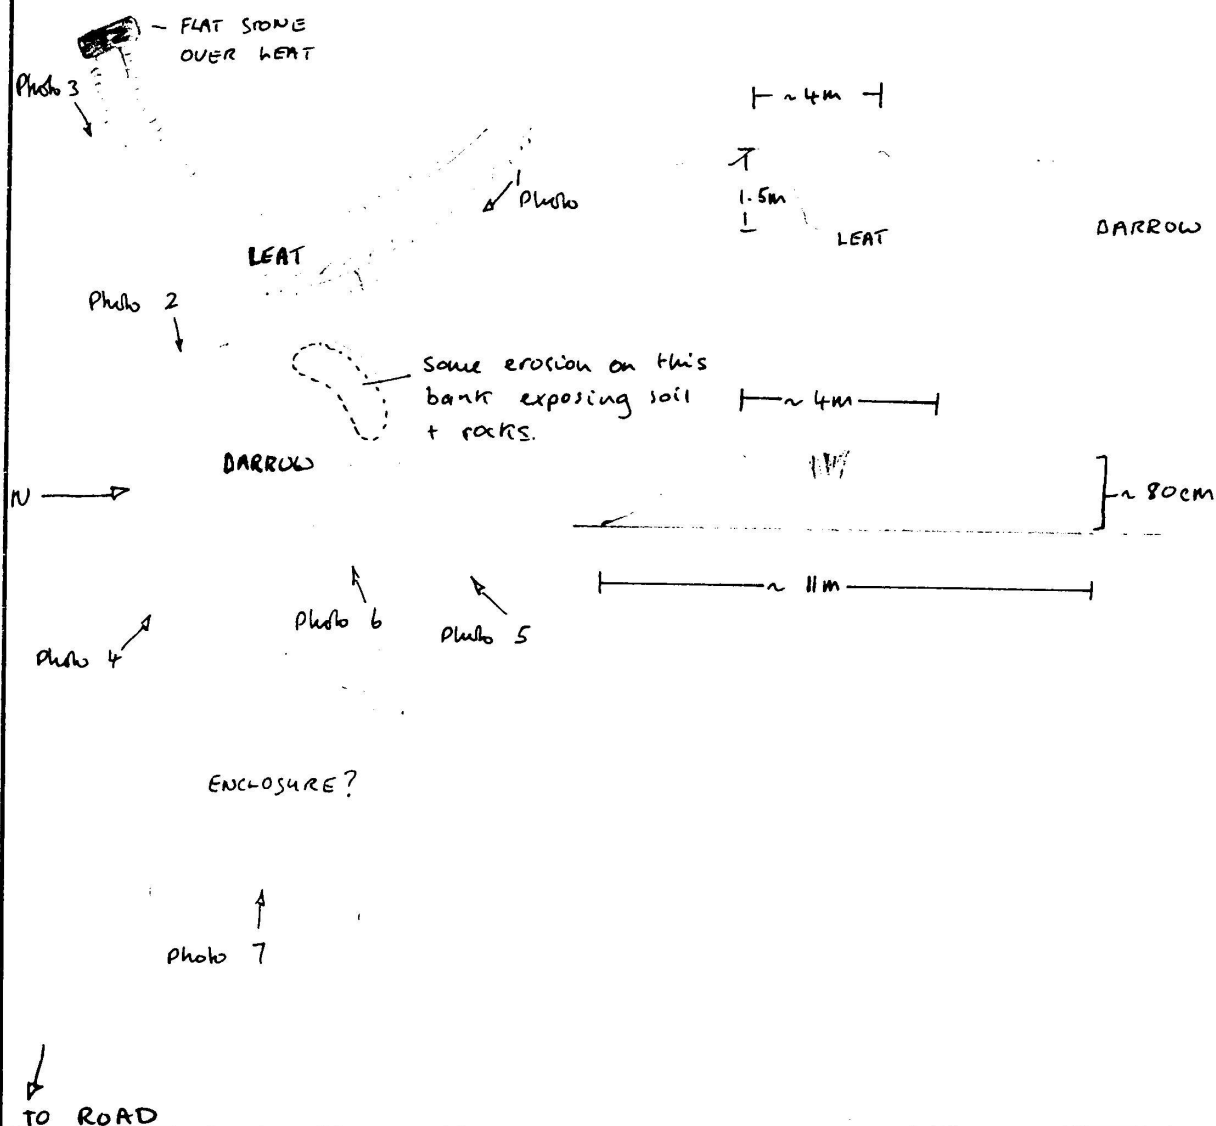
BARROW - Circular mound with a central depression. Approx 11m in diameter, with a max height of 80 cm. Rocks visible where vegetation has been eroded away. Appears in fairly good condition apart from large amount of sheep droppings which suggests

LEAT - Obvious crescent shaped ditch approx 5m West of Darrow. Approx 4m wide by 1-1.5m deep with a raised lip on both sides of ~40cm. Very well defined at this point but fades into flatter, boggy ground to the South West and North West.
