OLD CASTLE WORKS, LLANELLI CARMARTHENSHIRE

ARCHAEOLOGICAL DESK-BASED ASSESSMENT

DESK-BASED ARCHAEOLOGICAL ASSESSMENT

CA PROJECT: 2327
CA REPORT: 07039

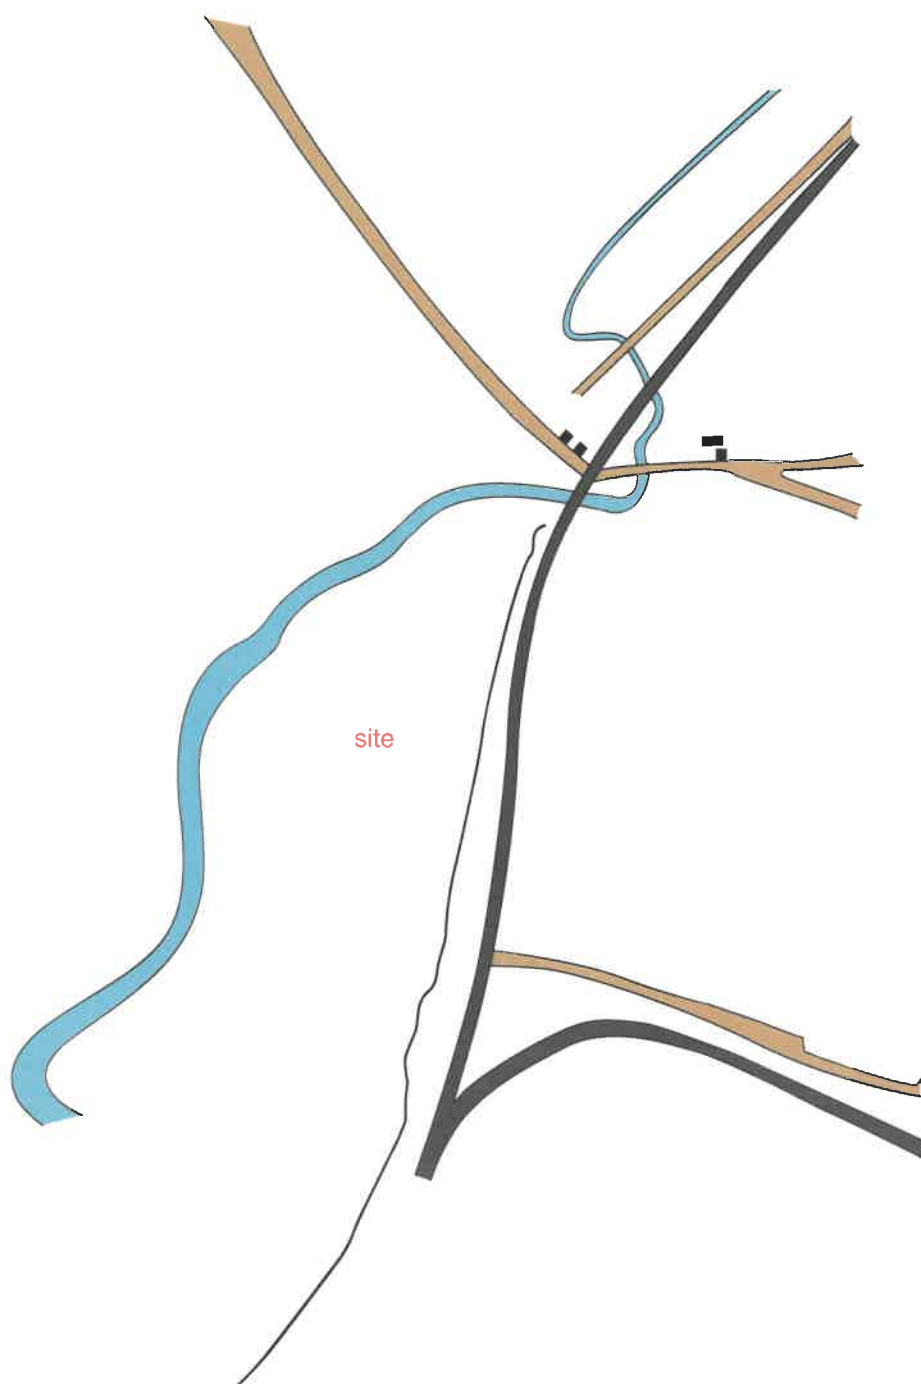
3

**Redrawn extract of the 1842
Llanelli tithe map**

- 4.6.2 One of the earliest detailed maps of the area is the Llanelli Tithe map of 1842 (Fig. 3). Although the site area is illustrated, the Old Castle shafts and associated buildings are not depicted. It is possible that there were no buildings associated with the shafts at this date, but this is very unlikely. It is more likely that details of the Tithe map were based upon earlier survey or mapping, compiled before the establishment of the colliery. The Tithe map is of interest, as it shows the former course of the stream which was later canalised to the west and north of the site. Most of this area appears to have comprised salt marsh at this time, and the colliery buildings, and later tin plate works, were sited on reclaimed land.

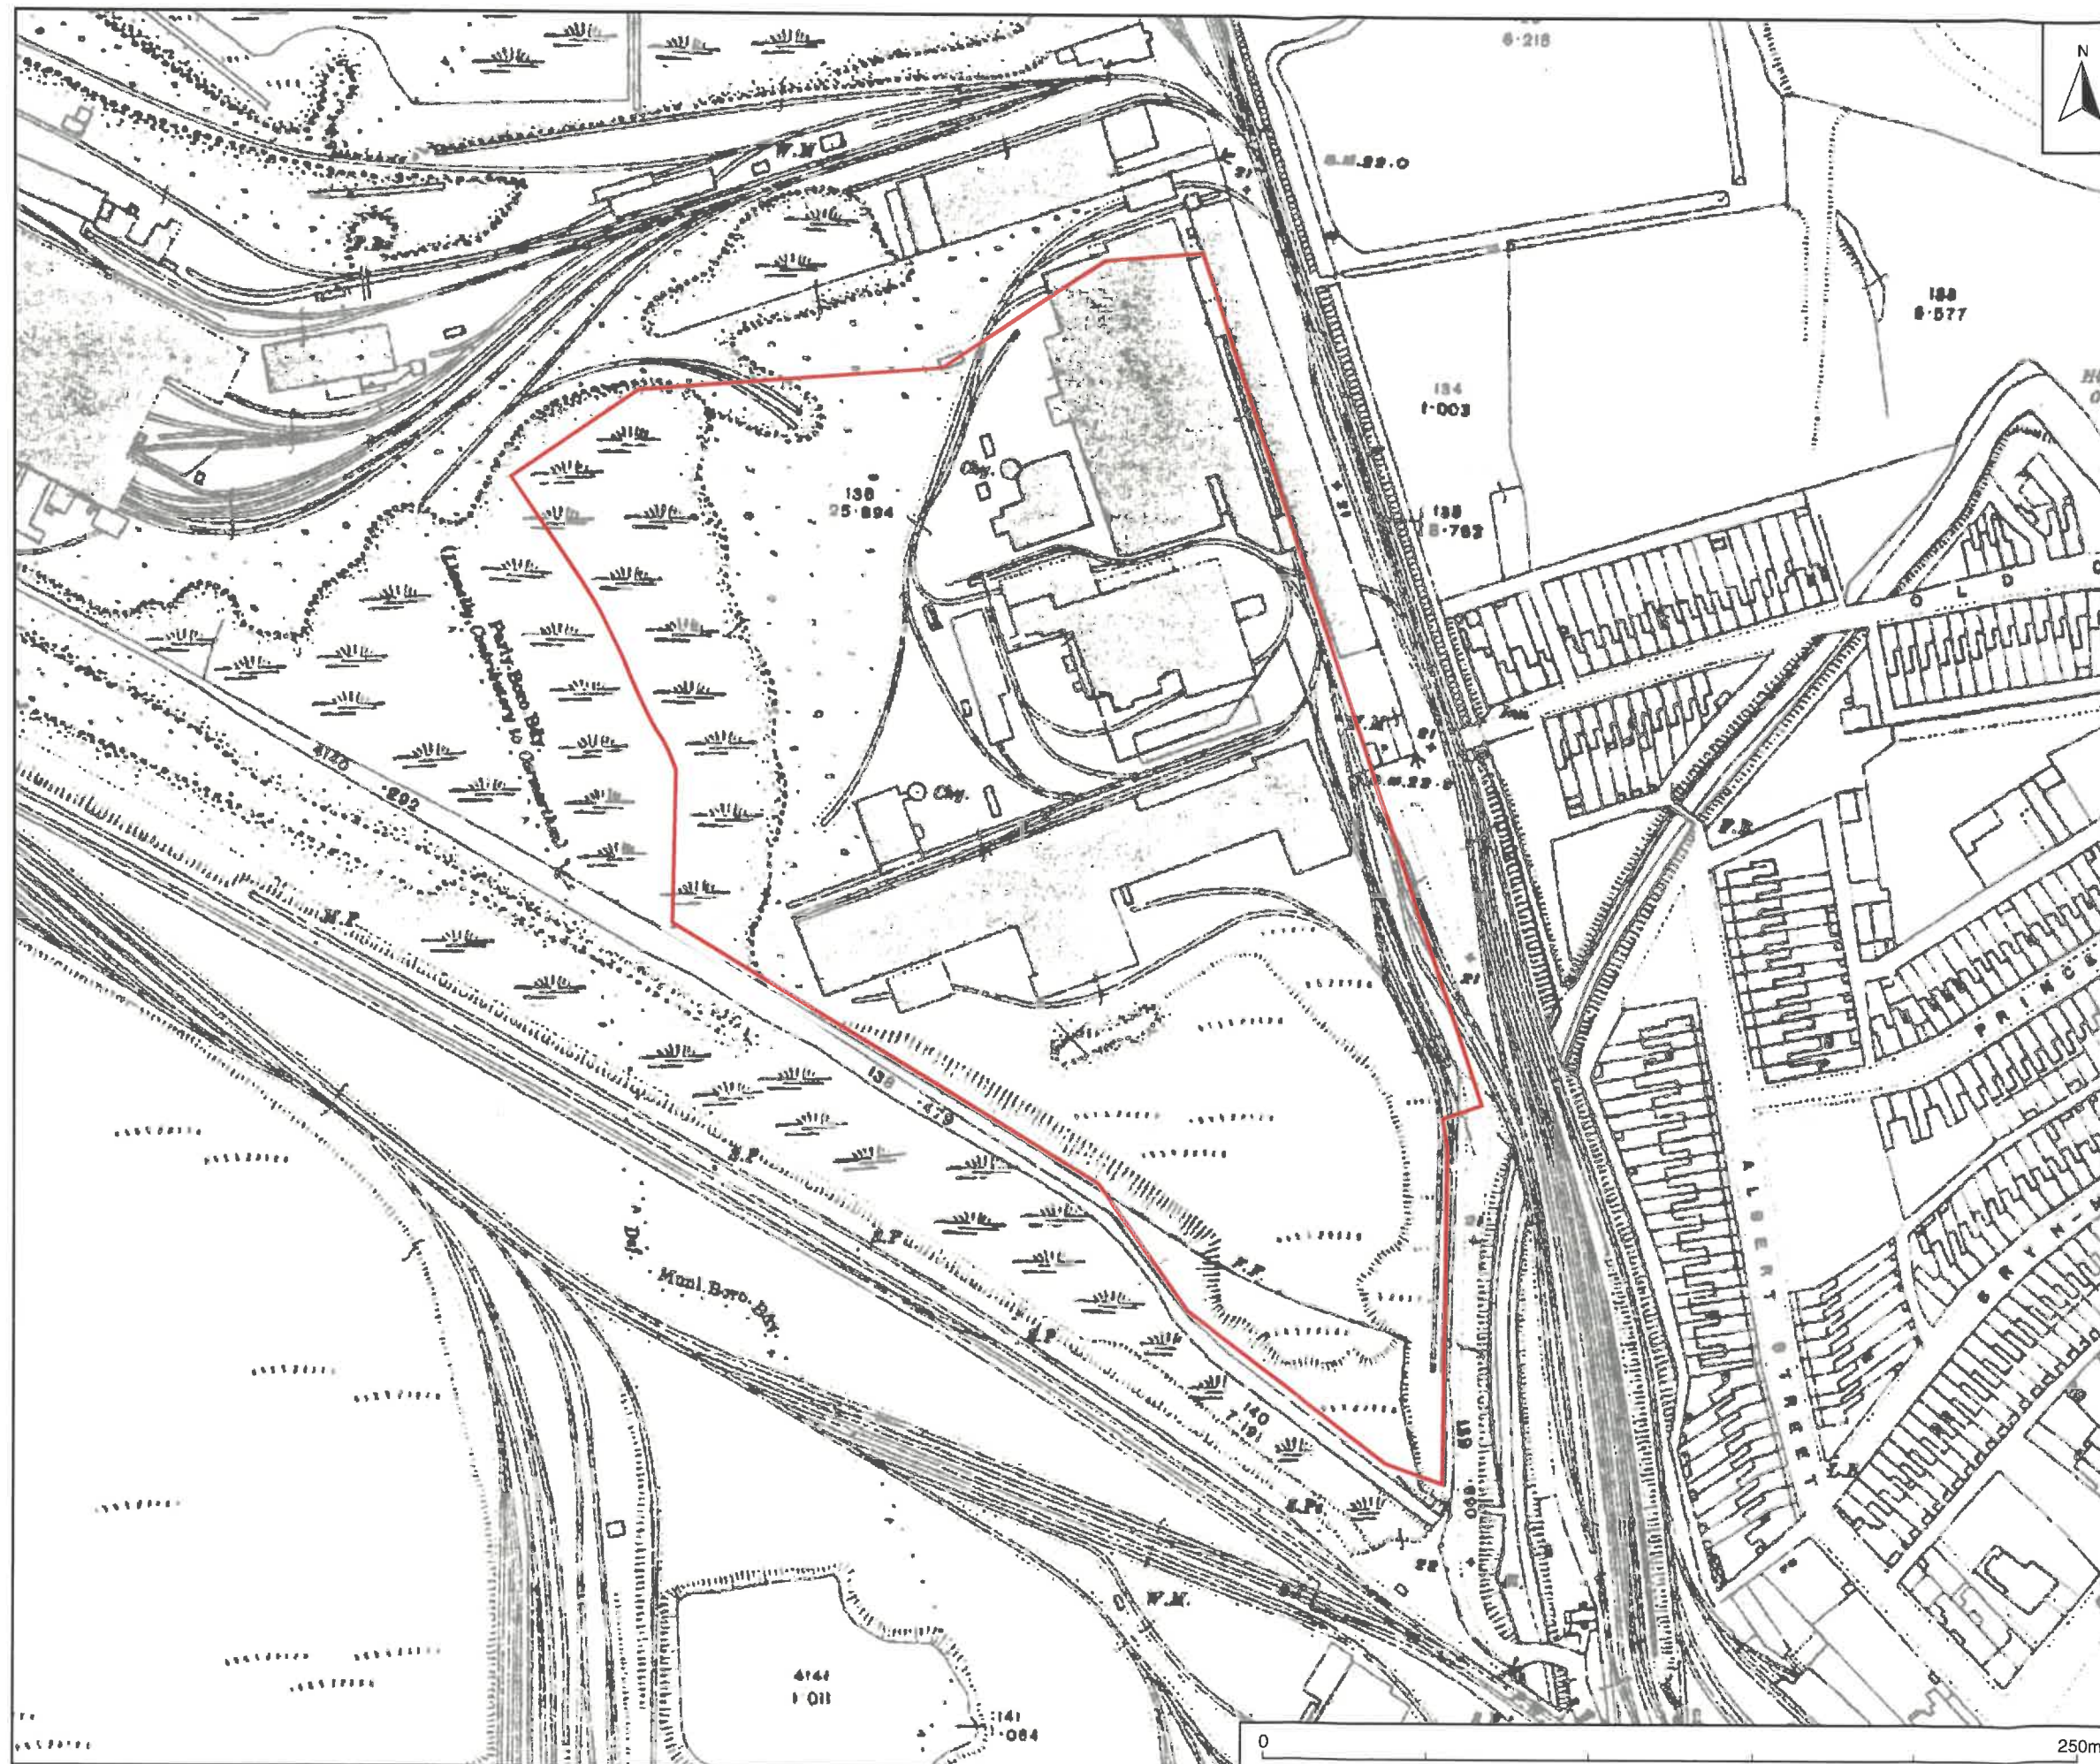
DRAWN BY	SCALE	PROJECT NO.	FIGURE NO.
JE	1:2000@A3	2327	6

FIGURE TITLE
Extract from the 1916 Ordnance
Survey map

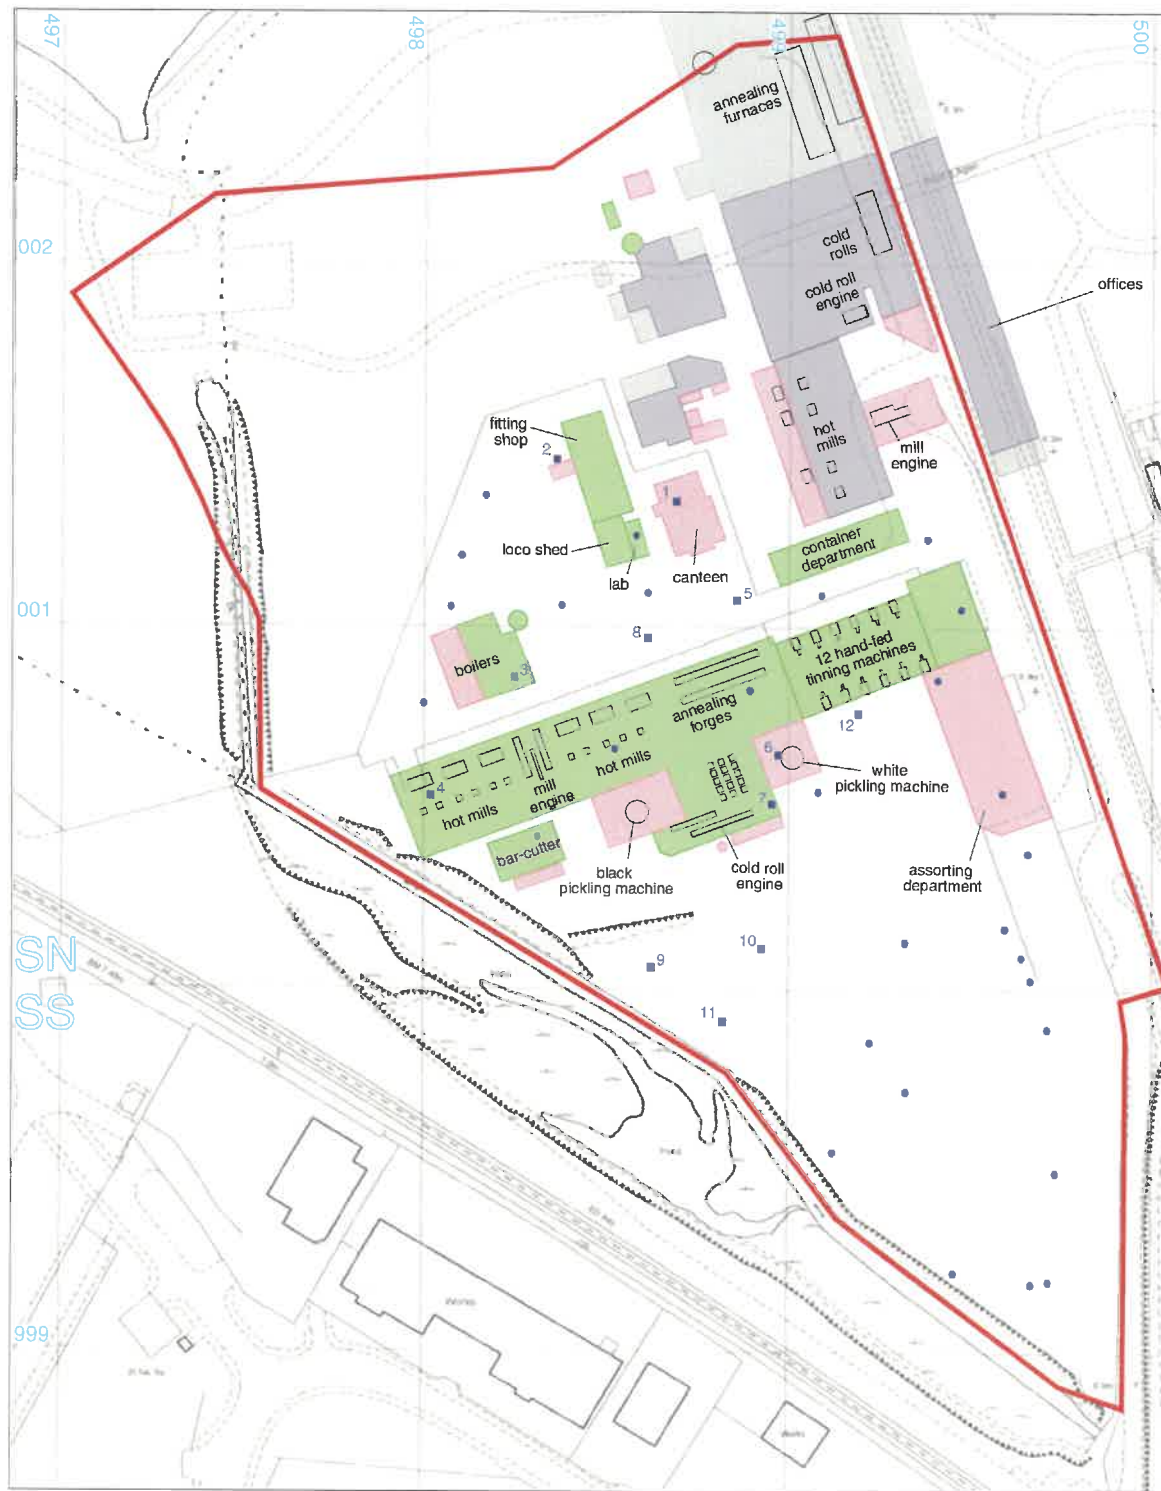
■ geotechnical test pits encountering structural deposits

- 4.6.9 The various operational areas of the extended works are detailed on a plan compiled by The Steel Company of Wales in 1952 (the works had ceased trading as the Old Castle Iron and Tin Plate Co Ltd in 1939; it traded as the Llanelli Associated Tinplate Cos Ltd between 1939 and 1947, and subsequently as The Steel Company of Wales). This has been used with other documentary sources to depict the building usage and constructional phases across the site in the 1950s, towards the end of the works' tinplate production in 1957, in Fig. 9.

- 4.6.11 The surviving tinhouse is illustrated on Fig. 9, along with the hand-fed tinning machines located on the 1952 plan. These were situated within six tinning bays on either side, clear today, each with a hearth (with small blocked windows on either side) and chimney. Two bays in the southern range have had chimneys removed, and three bays in the northern range are partially bricked-up. A heavy iron lintel carries a segmentally vaulted brick ceiling and central rectangular chimney (Cadw 2007). There is a blocked segmentally arched doorway in the centre of the western wall which formerly led to the annealing furnaces and hot mills. Doors in the east wall led to the assorting department. It was constructed of rough rubble walling with a corrugated asbestos and slate roof.

- 5.2.3 Geotechnical works carried out on the southern/central part of the site have included test pits, the locations of which are depicted on Figs 8 and 9 in relation to the building phases. Figs 8 and 9 differentiate between those that recorded structural

- 5.3.4 Later buildings within the complex are much better recorded in terms of internal functionality, as depicted on Fig. 9 based on The Steel Company of Wales plans

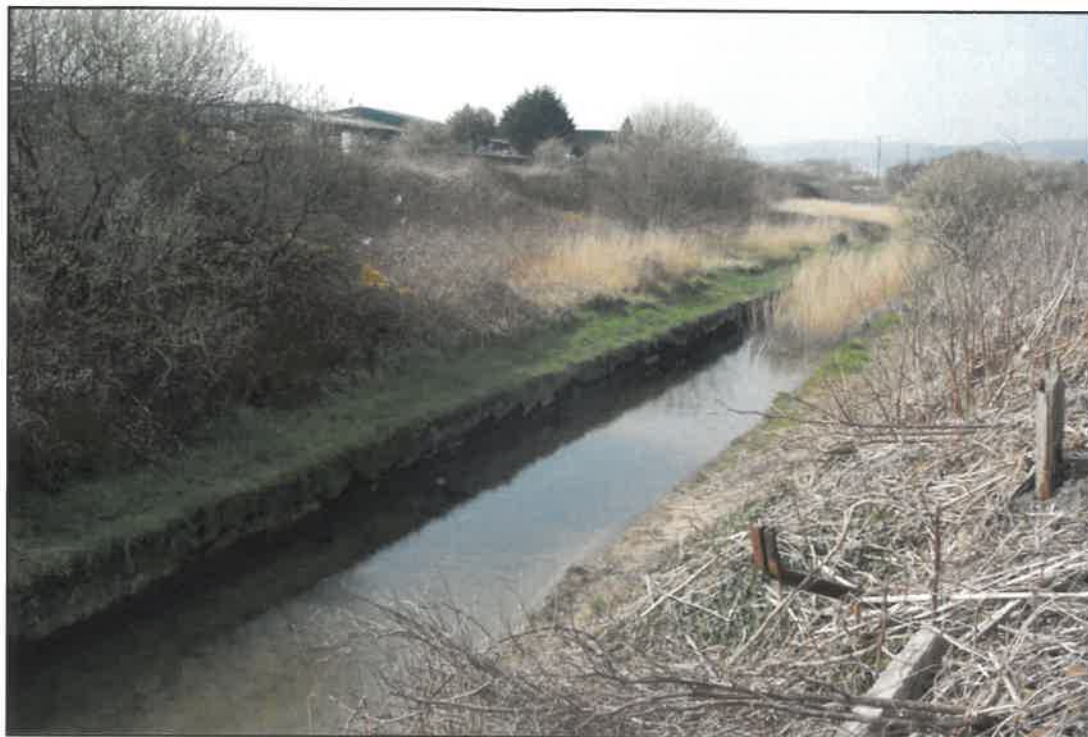
11 Canalised stream facing north-west

4.6.5 At some time prior to 1880 the stream to west and north of the site shown on the Tithe map was canalised (Figs 4 and 11; it now forms the southern and western boundary of the site). It emptied into remaining areas of the salt marsh depicted on the 1880 Ordnance Survey map to the east of the Old Castle Works.

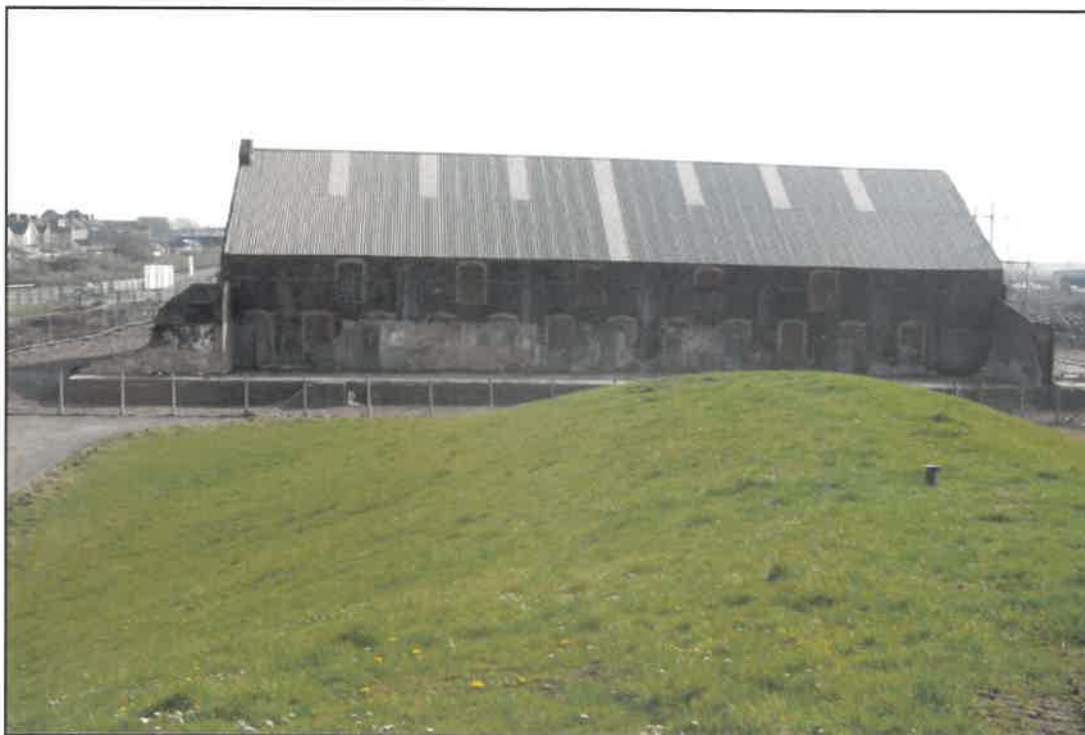
13 Tinhouse facing south

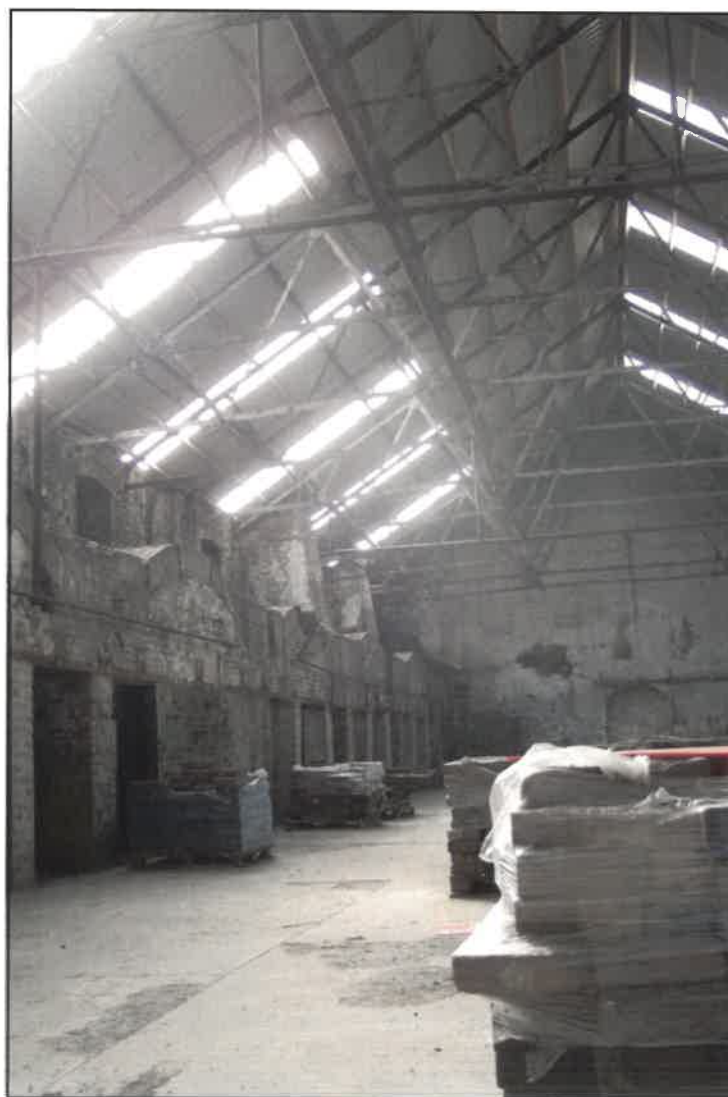
15 Tinhouse facing west (internal)
