**Bridge House,
Bridge Street,
Tenby, Pembrokeshire**

Archaeological Watching Brief

HRSWales
Report No: 142

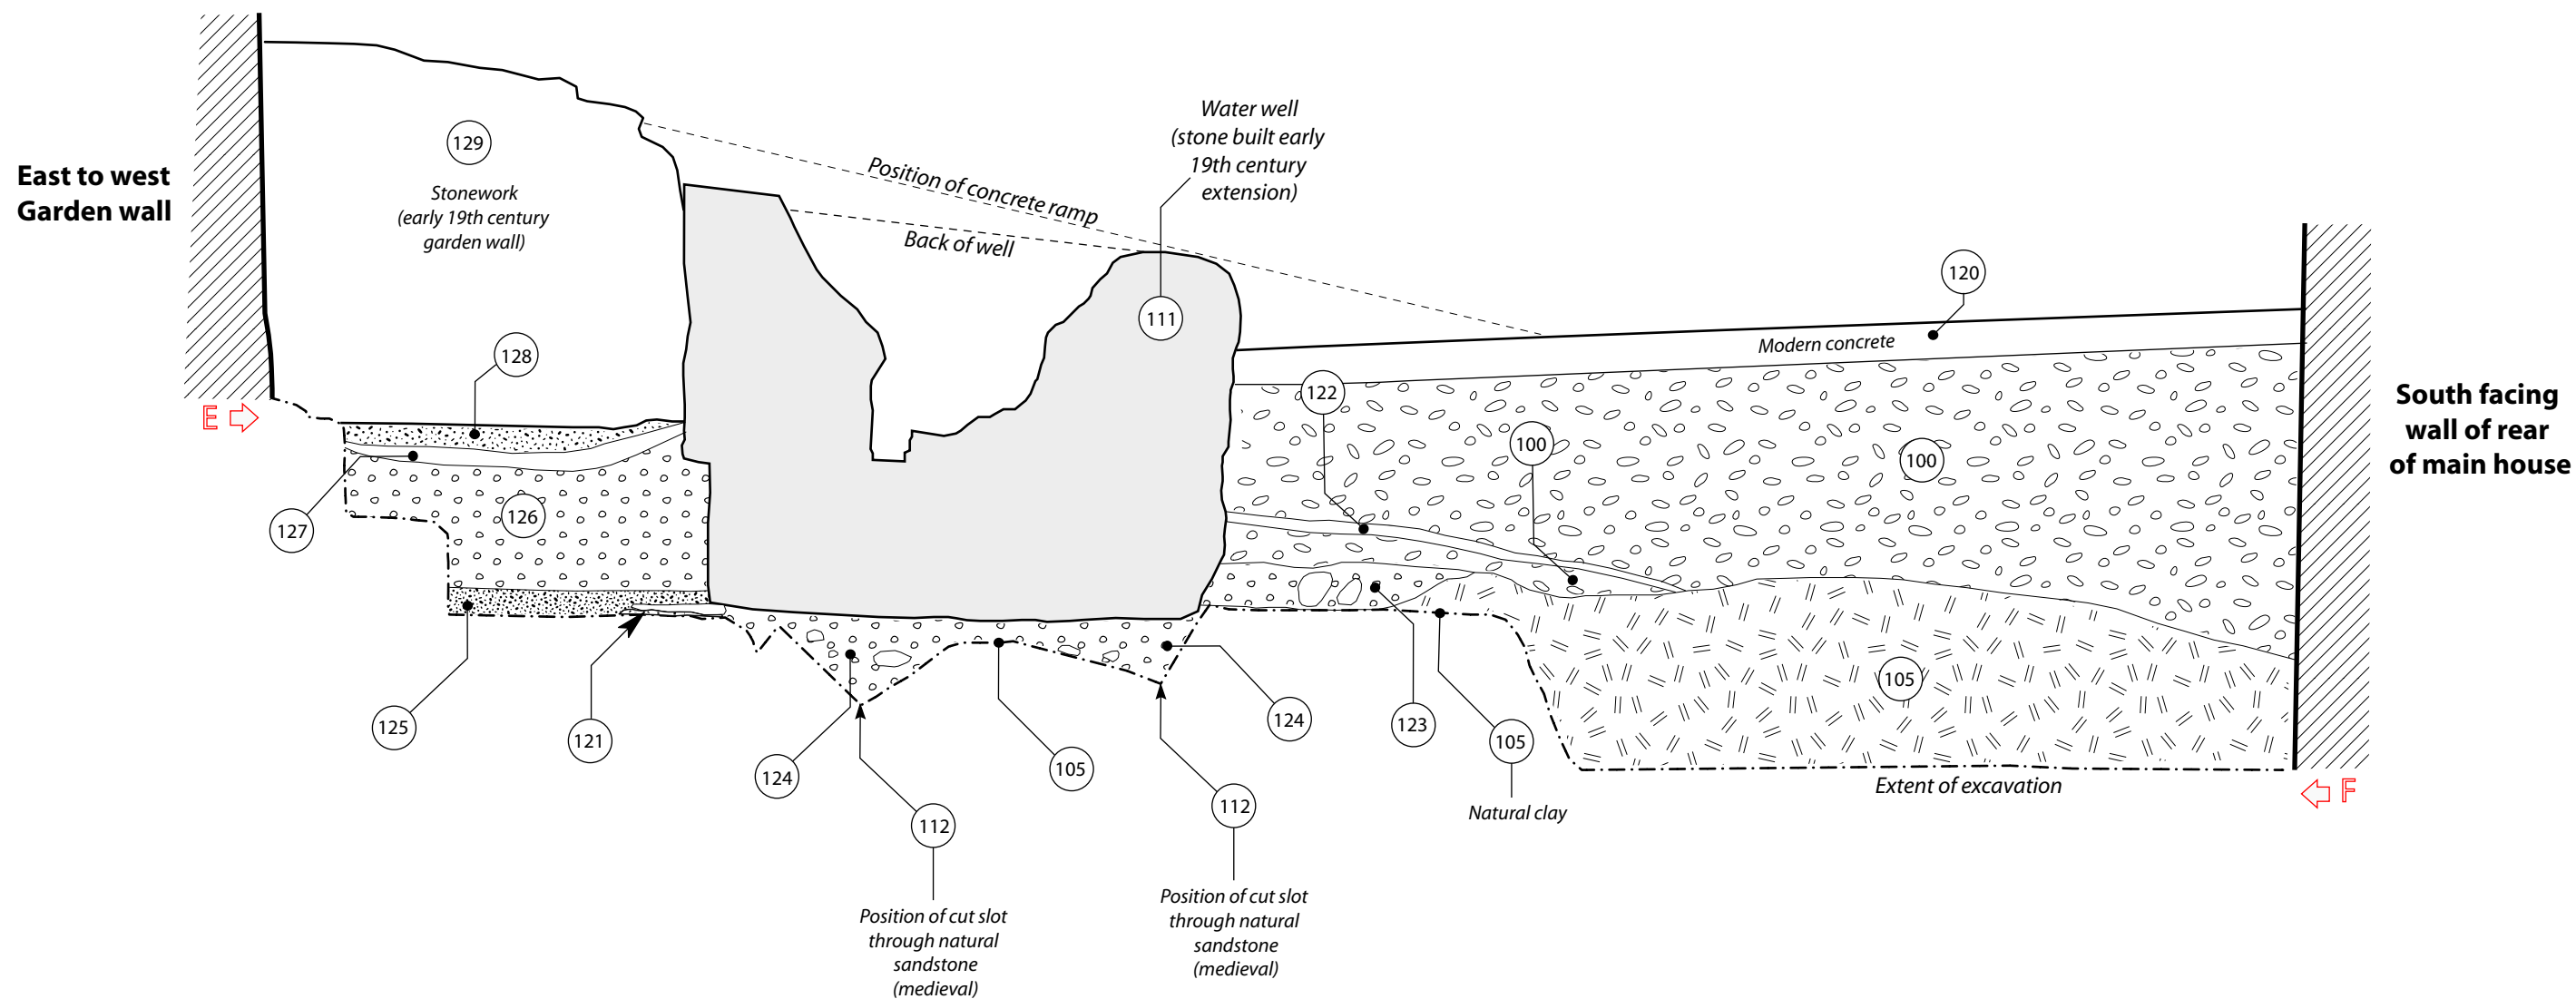
Bridge House, Tenby - South Facing Section E-F

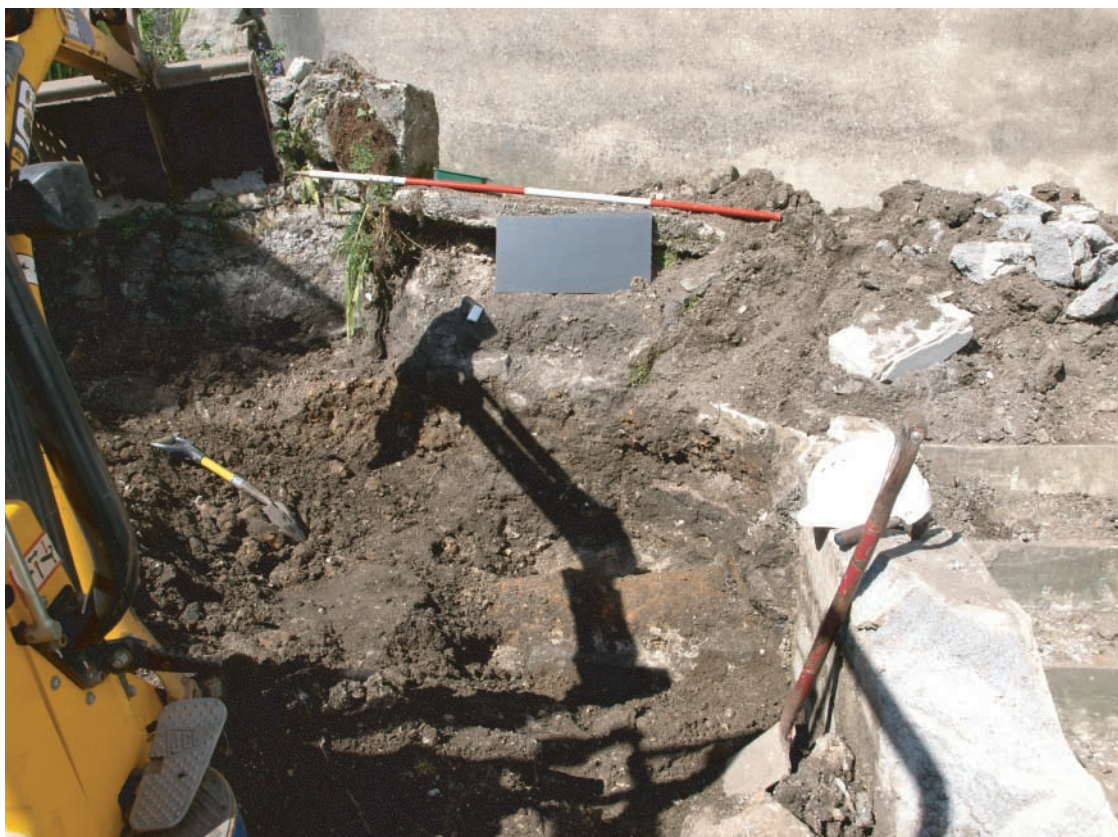
Plate 13. View of concrete ramp covering water well at far southwest end of lower garden area. Looking south west.

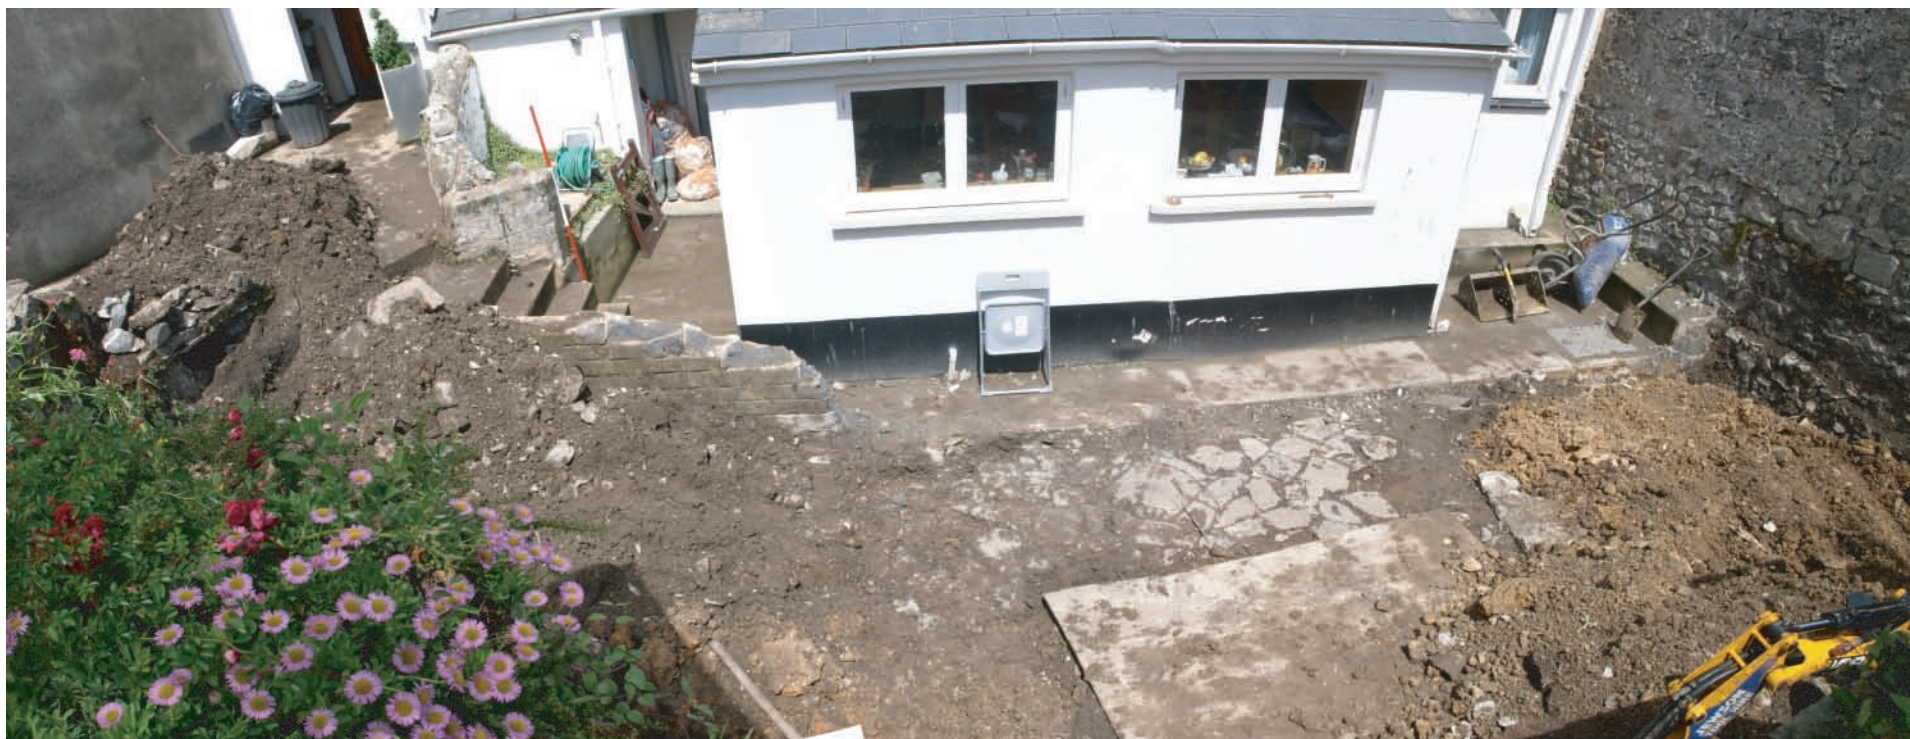
Plate 14. Spliced photo-montage view of lower garden area following partial ground reduction. Note partly exposed stone flagged floor right of centre of photo.

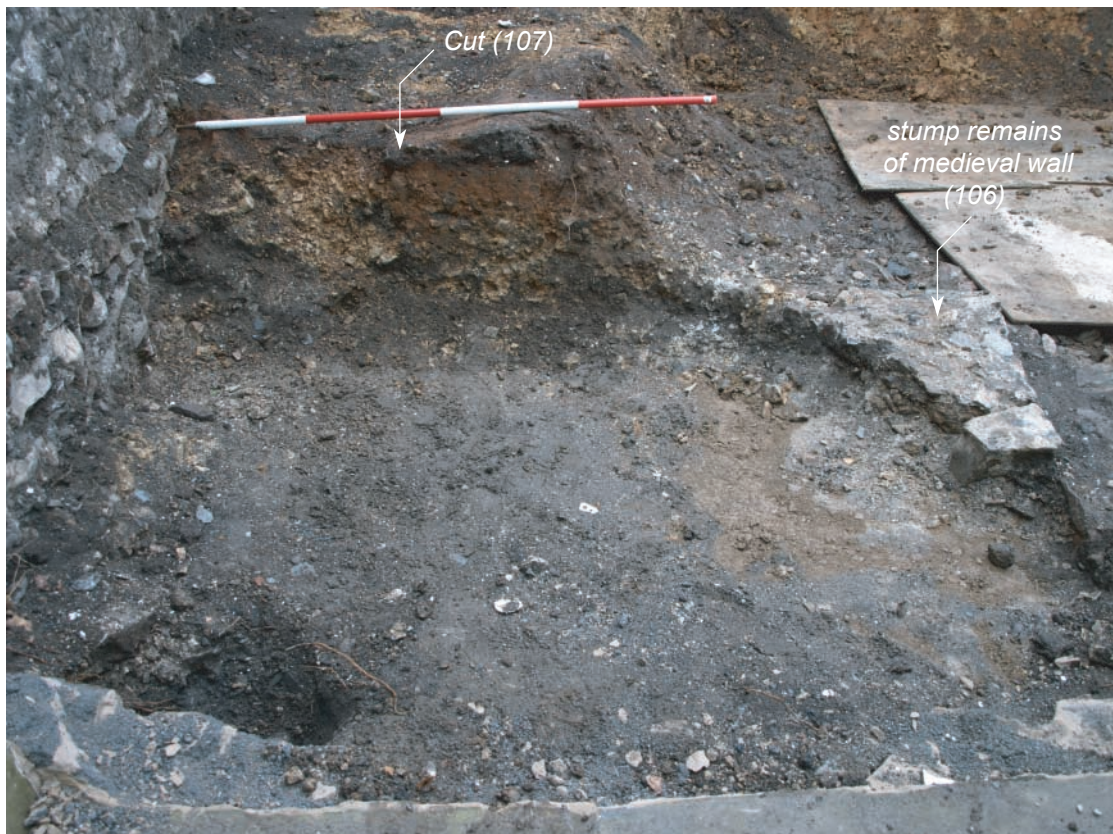
Plate 15. View of cut (107) through natural clay (105) and stump remains of apparent medieval wall (106) at right of photo. Looking south-east-south.

- 4.8 Full excavation of this trench cut (107) gave further support to the suggestion that this trench was indeed a robbed out wall trench and was very probably medieval in date, although no datable finds were found directly within the lower parts of the fill of the trench itself.

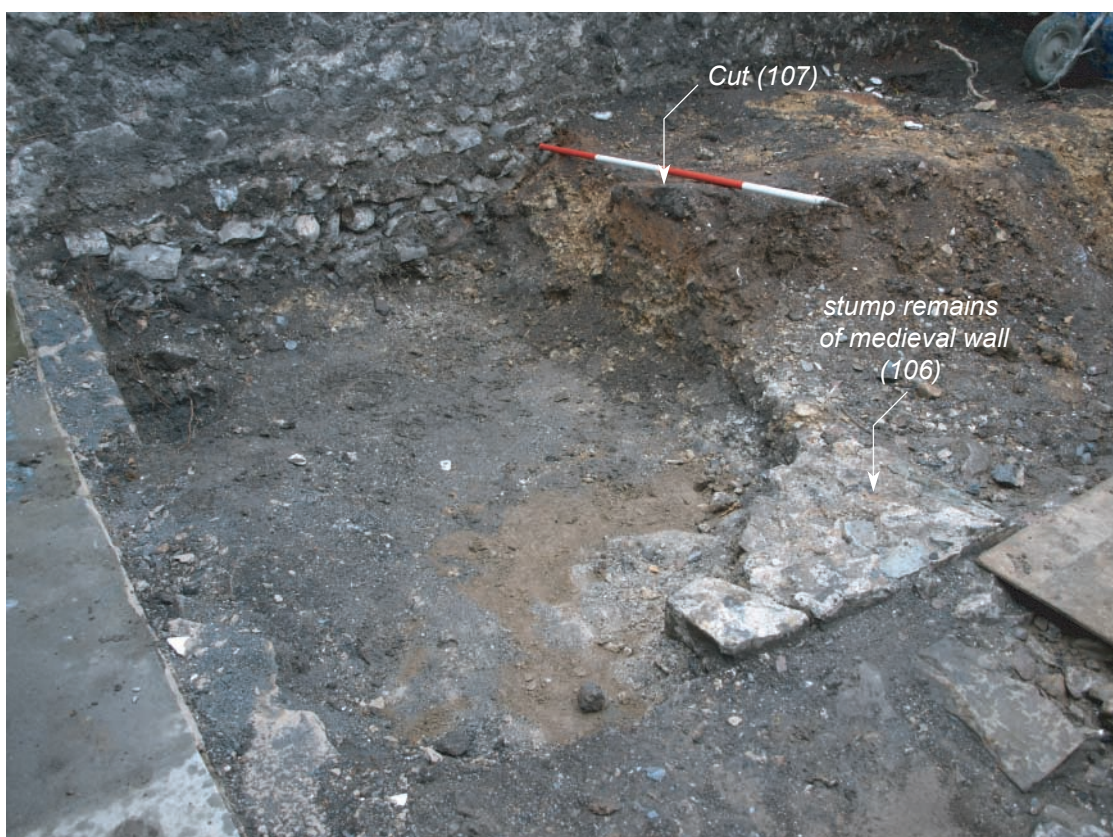
Plate 16. View of cut (107) through natural clay (105) and stump remains of apparent medieval wall (107) at right of photo. Looking east.

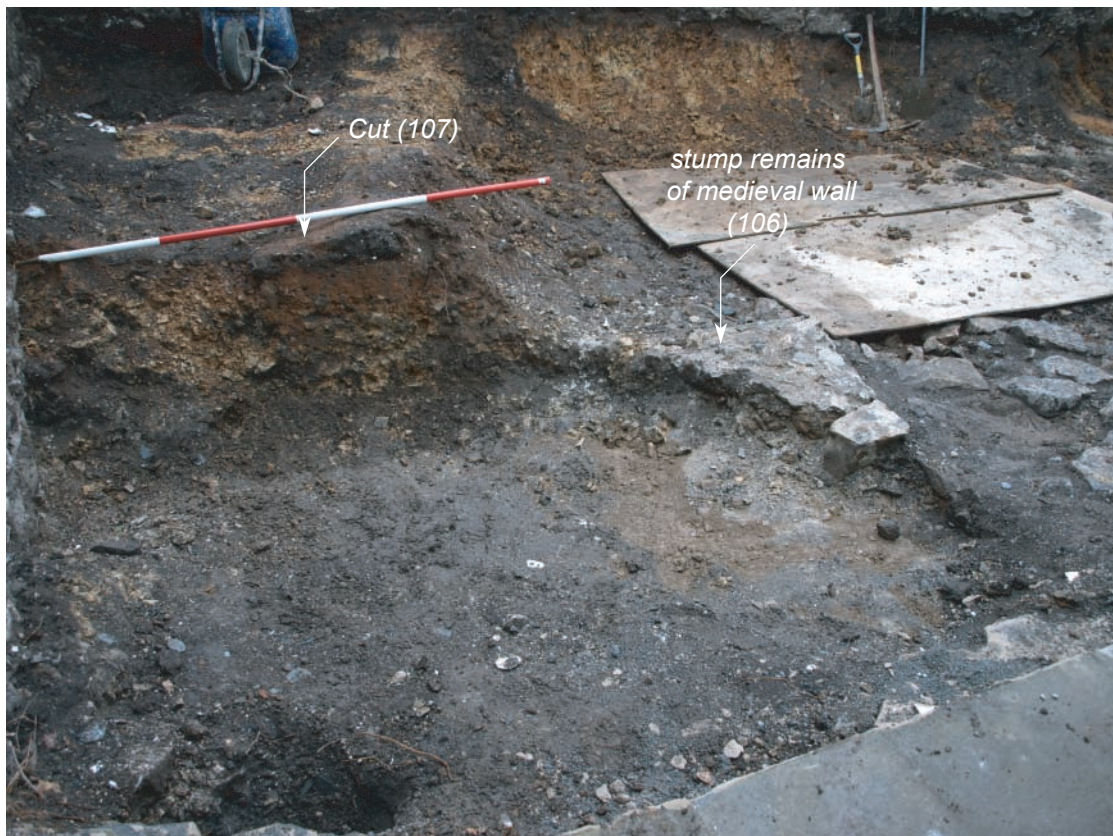
Plate 17. View of cut (107) through natural clay (105) and stump remains of apparent medieval wall (106) at right of photo. Looking southwest.

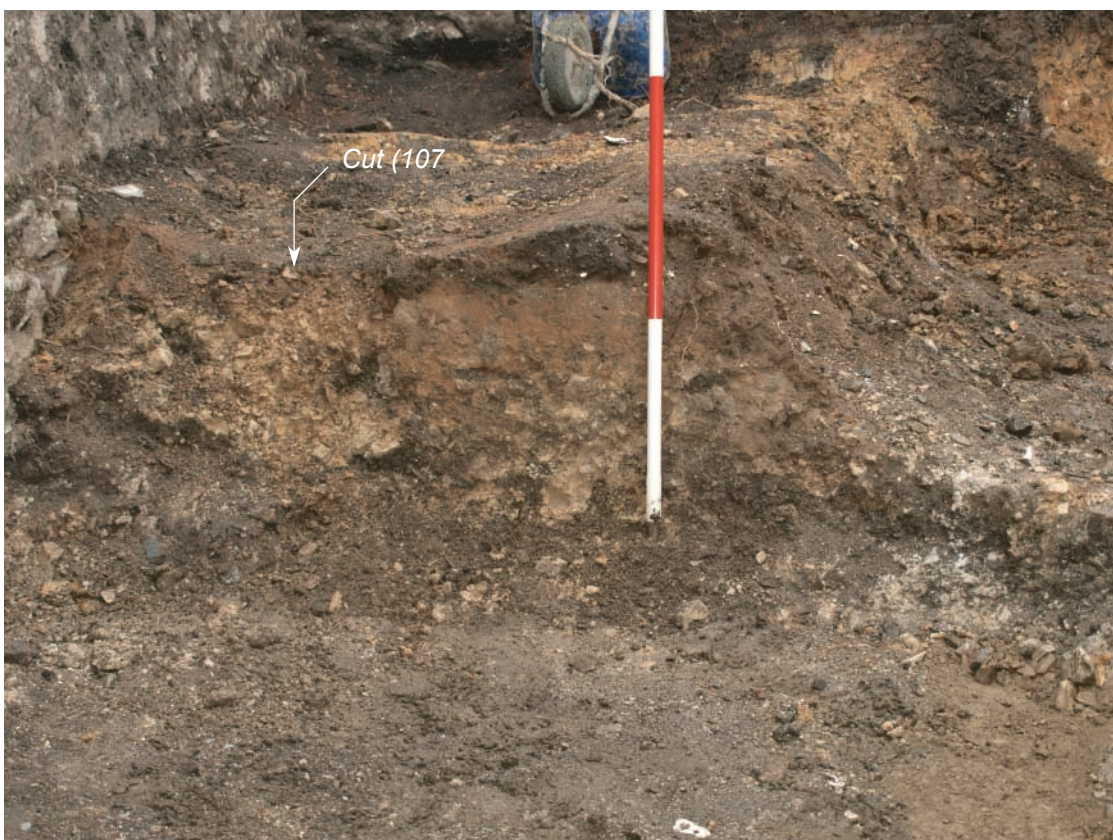
Plate 18. Detailed view of exposed cut (107) through natural clay showing stratigraphic profile. Looking south-south-east.

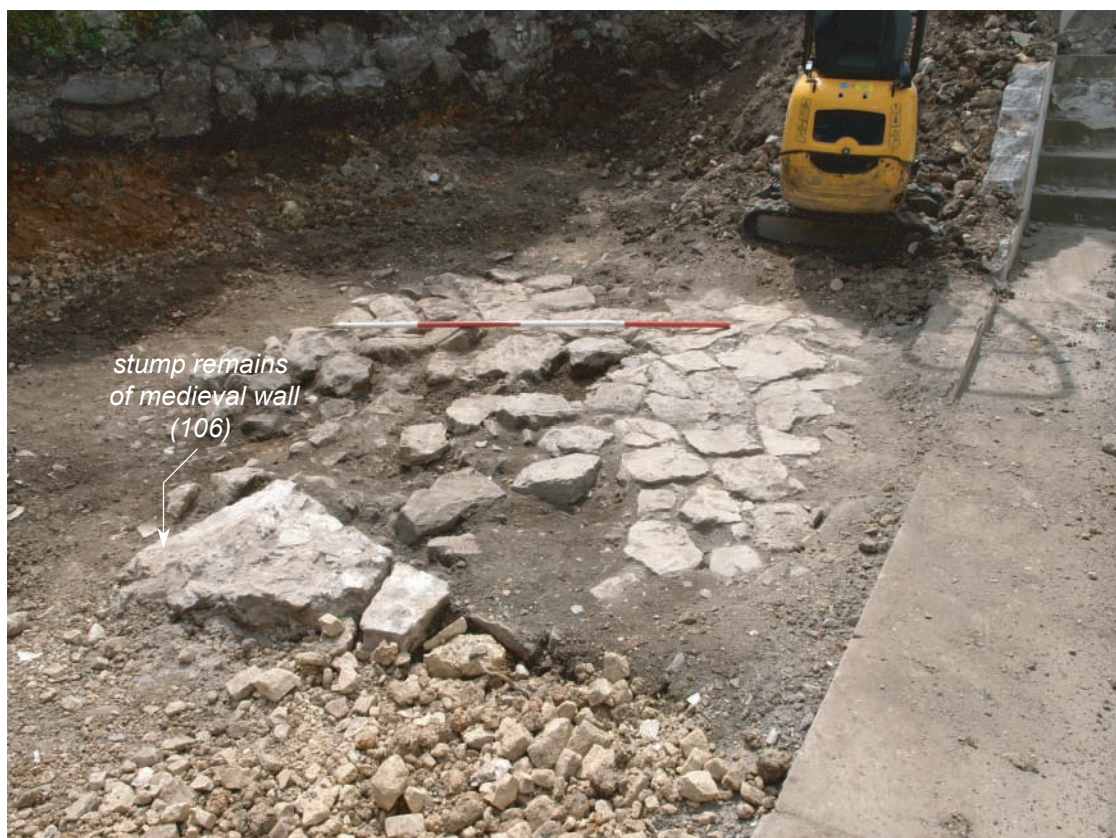
Plate 19. View of stump remains of apparent medieval wall (106) and partial clearance of medieval stone floor (103). Looking southwest.

- 4.13 In the central area of the garden, alongside the remains of the stone wall stump (107), the removal of this *rich* in medieval pottery deposit exposed the remains of a significant irregular stone flagged floor (103). This floor surface abutted the western edge of the wall remains and extended over an area of approximately 4m x 3m. The irregular stone flags were each between approximately 0.08 – 0.12m in thickness and had been bedded into a thin deposit of sand and lime mortar (104), which had been laid directly onto the natural clay/sandstone. A similar mortar deposit was found later beneath a small stone slab next to the well, from which a large base fragment of a medieval green glazed baluster jug was recovered. The overlying 12th – 14th century medieval deposit (102) had been covering only the central and southern area of this stone floor surface and had been well compacted into the cracks and crevices of the floor surface. Given that this medieval deposit was covering the greater part of this floor surface, would logically suggest that this stone floor pre-dates the clearance of this deposit, but it is most likely contemporary in date, being 12th-14th century, but possibly pre 1260, if the charcoal filled deposit is indeed representative of the sacking of Tenby on this date.

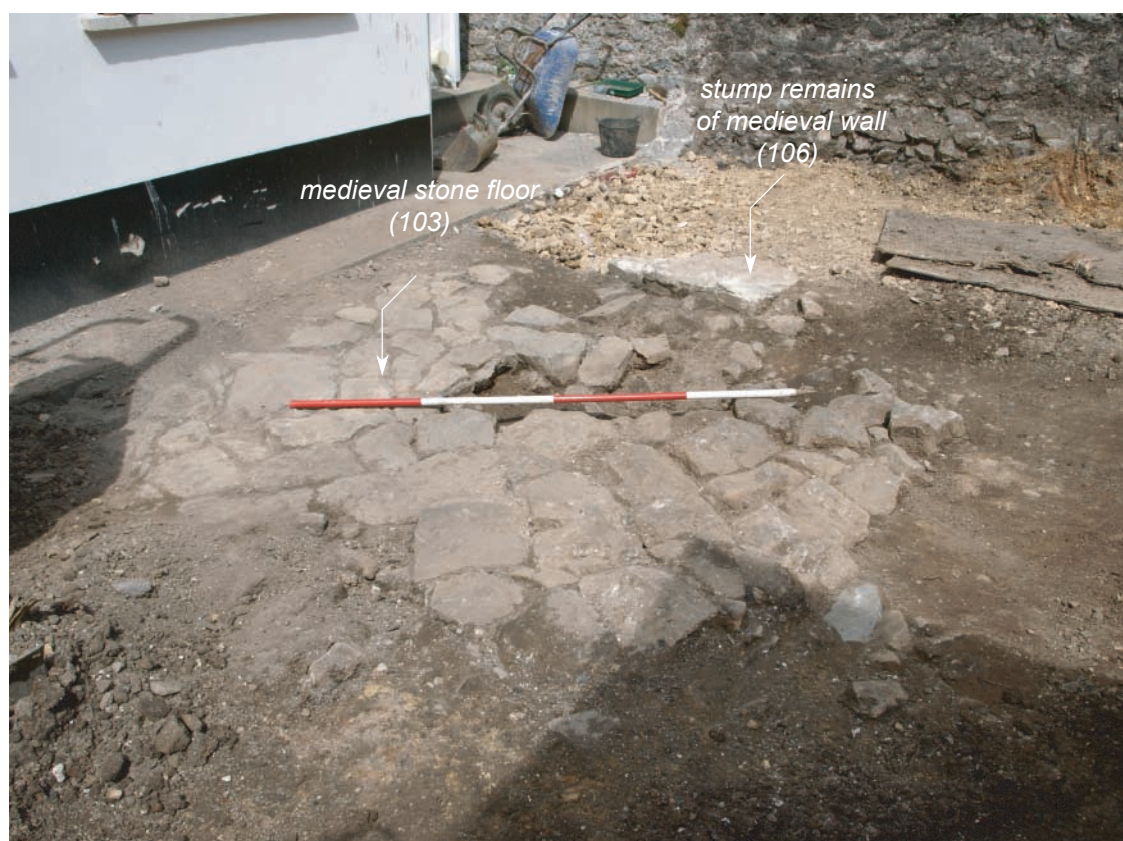
Plate 20. View of apparent medieval irregular stone flagged floor and stump remains of medieval stone wall. Looking east.

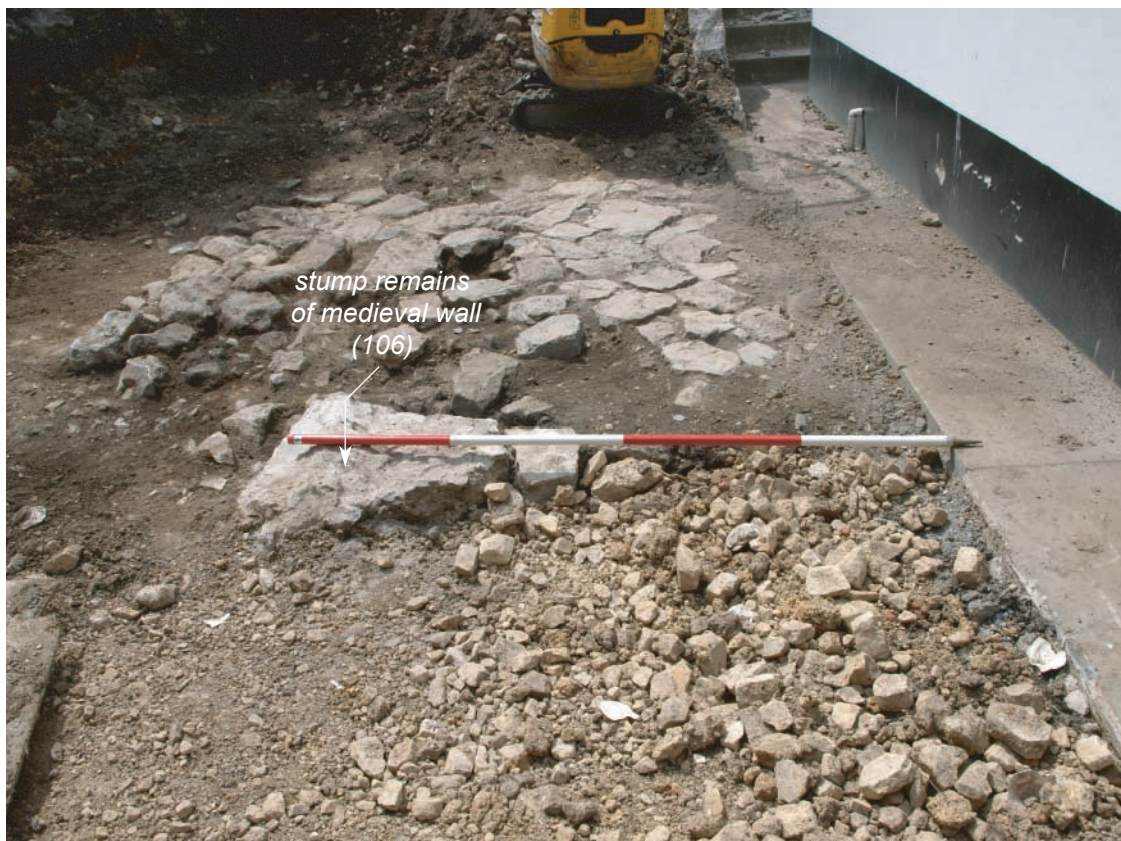
Plate 21. View of stump remains of apparent medieval wall (106) and partial clearance of medieval stone floor (103). Looking southwest.

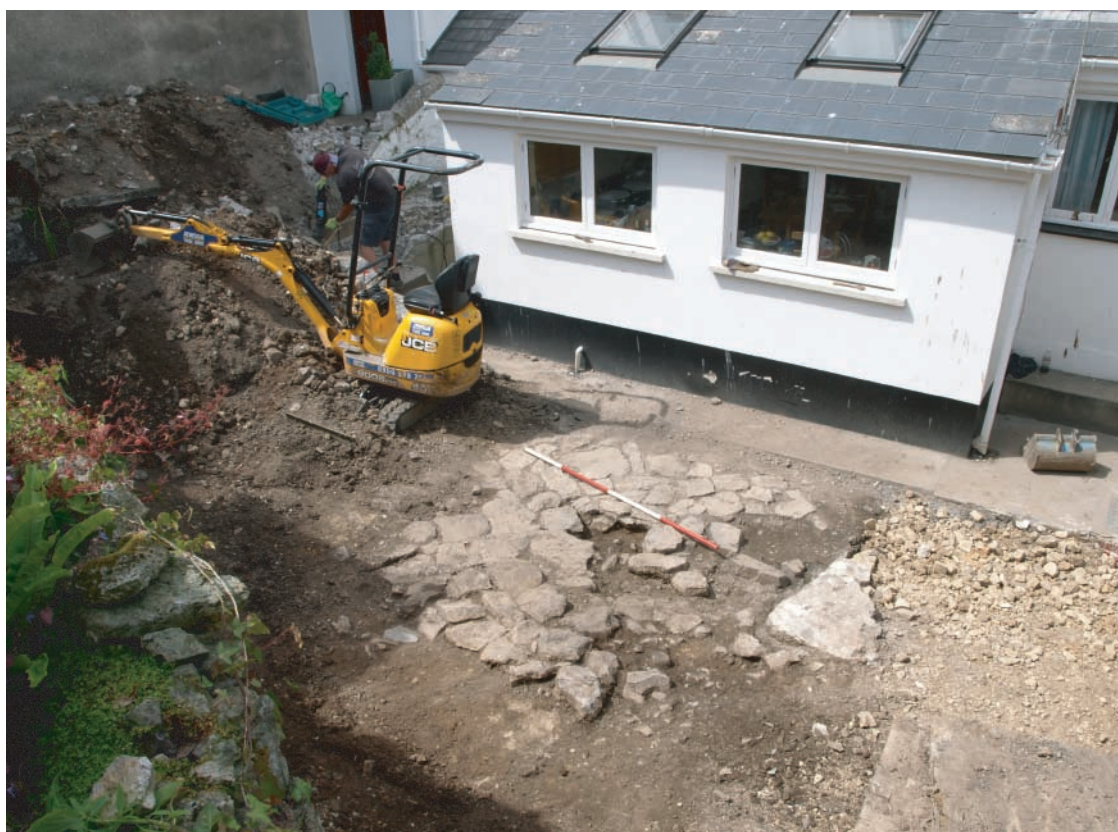
Plate 24. General view of working area following partial clearance of overburden covering medieval stone wall and irregular stone floor. Looking north.

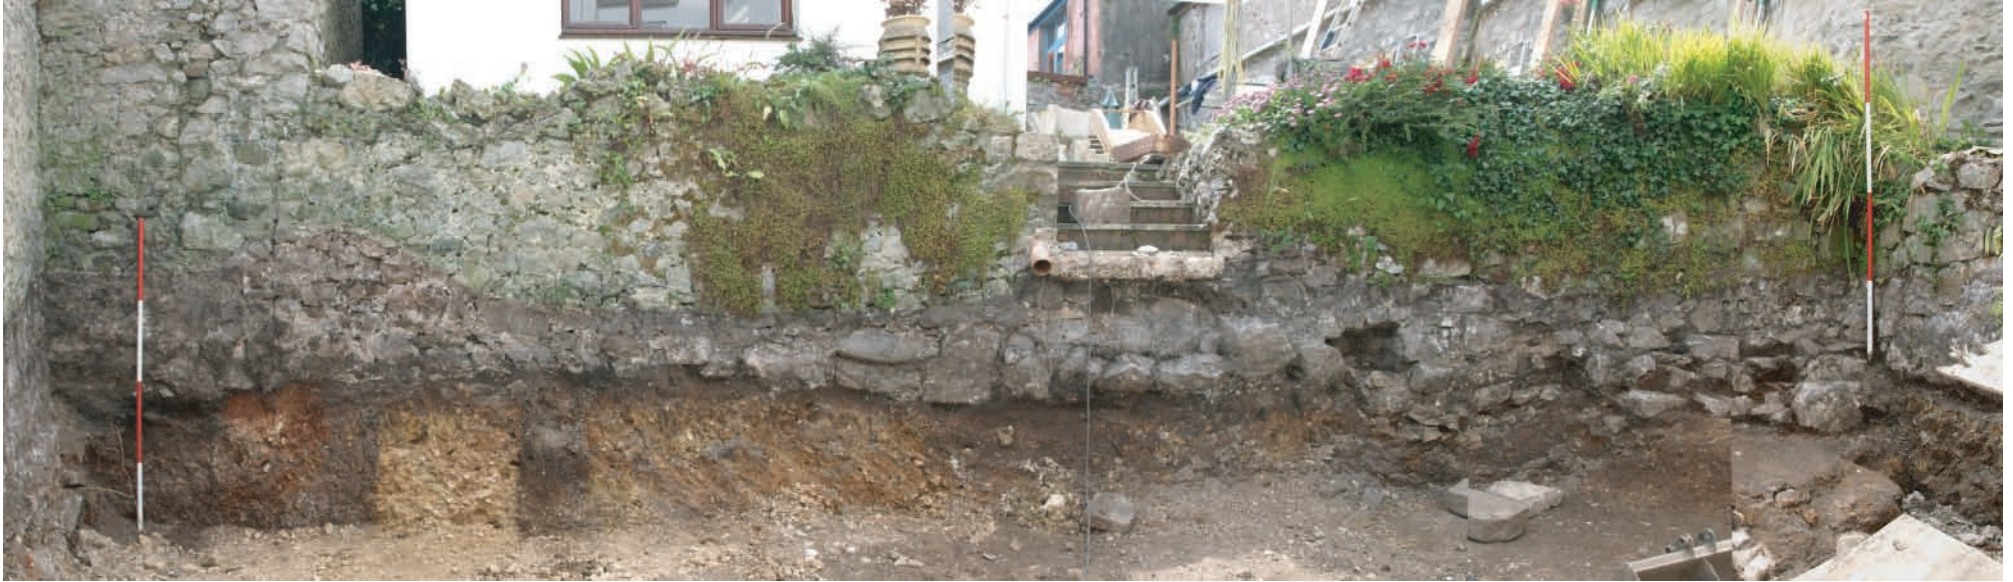
Plate 29. Spliced view of north-north-west facing section C-D following ground reduction work.

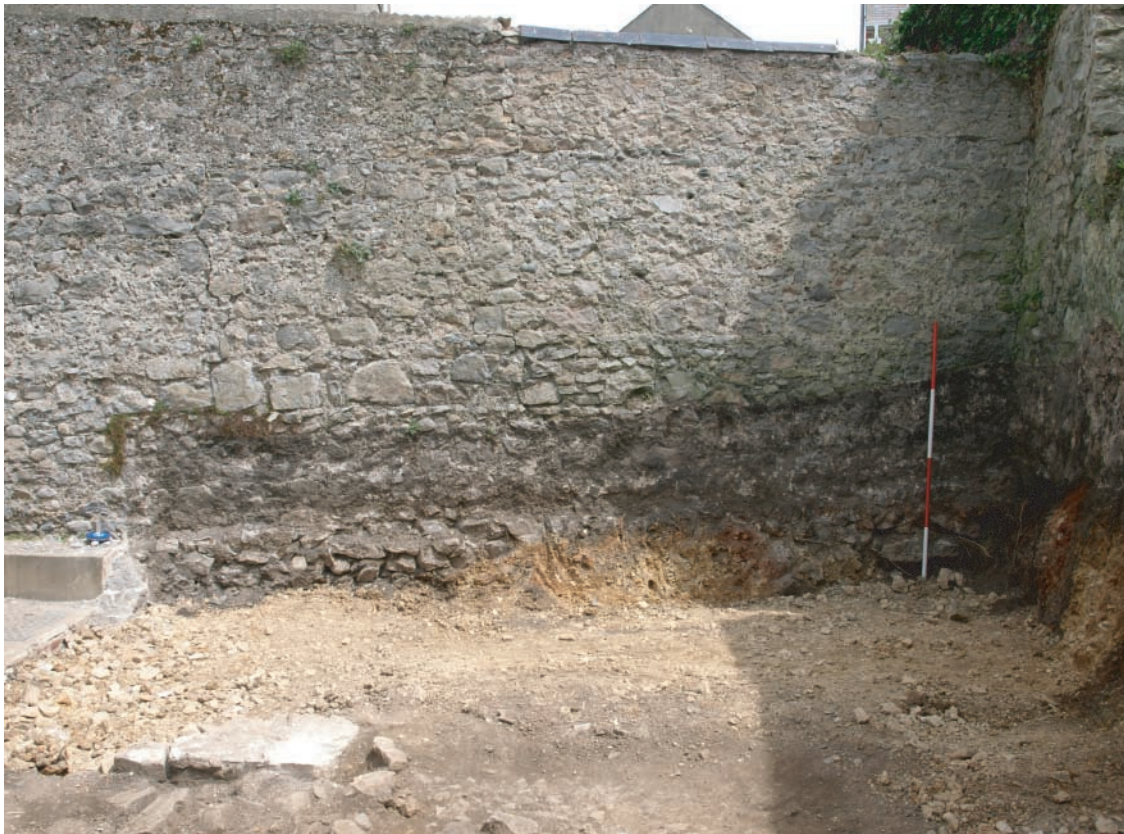
Plate 30. View of southwest facing section (A-B) and garden party wall. Looking northeast.

- 4.27 With regards to the west facing garden party wall (*see Figure 11 – Section A-B*), the ground work for the reduction in ground level revealed that the greater part of this wall, the central part had been built onto the natural clay (105). However, the northern end of the wall had been built within the robbed out wall trench (107). At the southern end of this party wall, excavation revealed that this part of the wall was sitting on top of a late 18th century – early 19th century rubbish tip (115), filled with oysters and pottery and glass fragments (116). This would suggest that this party wall is 19th century in date and was probably built when the neighbouring property on the east side of Bridge House was built.

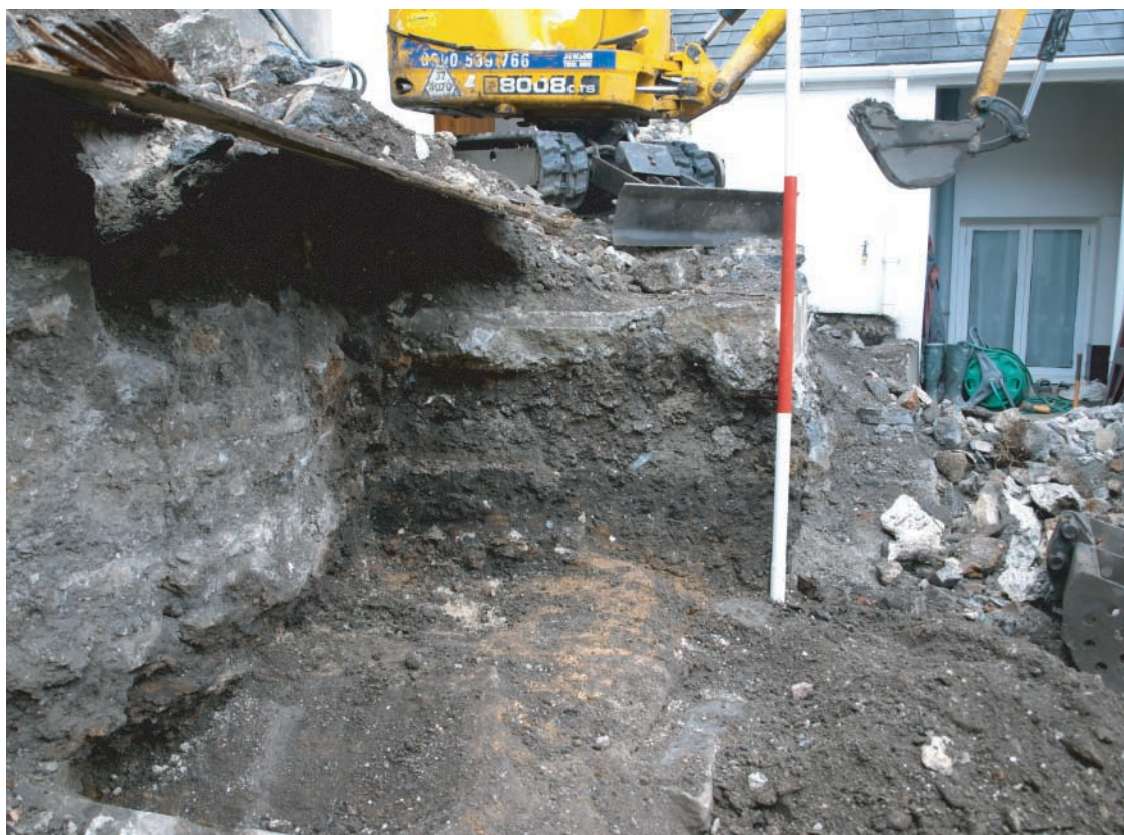
Plate 31. View of exposed south-south-east facing section alongside water well during ground reduction work. Shows build up of deposits from 15th century through to imported early 19th century overburden.

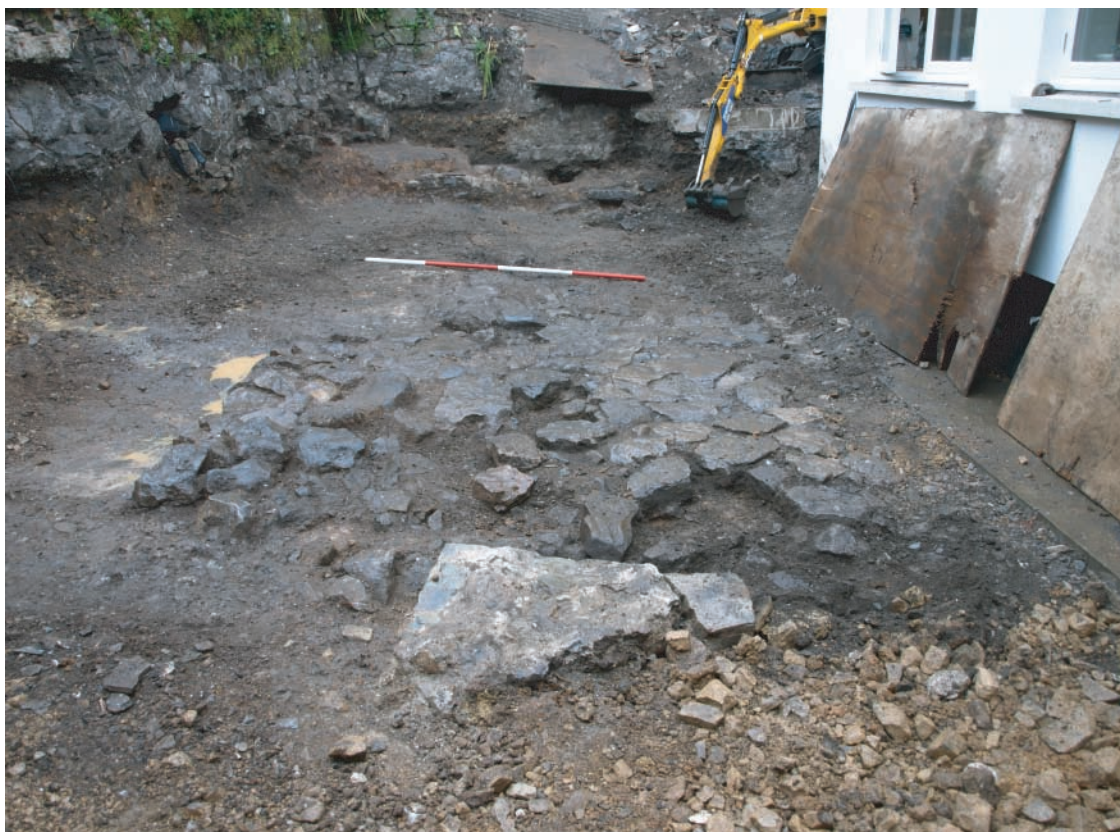
Plate 32. View of remains of medieval wall stump and irregular flagstone floor. Looking southwest towards water well.

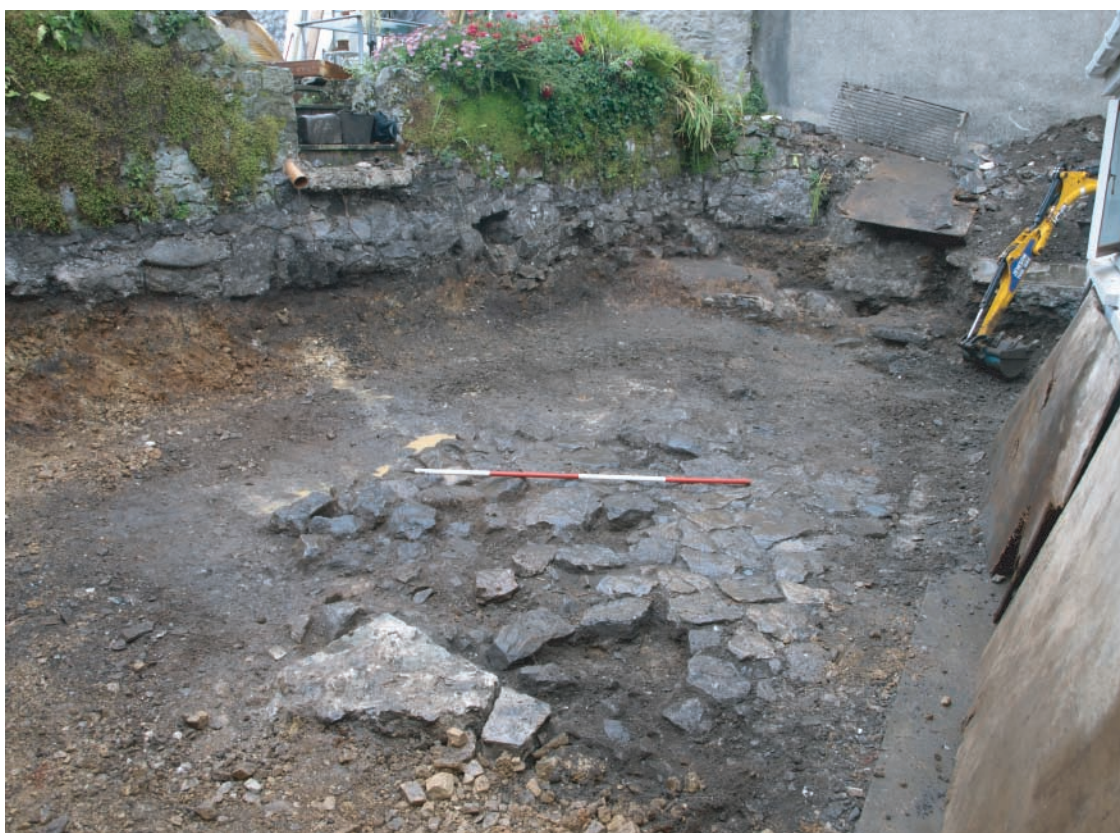
Plate 33. View of remains of medieval wall stump and irregular flagstone floor. Looking west towards water well.

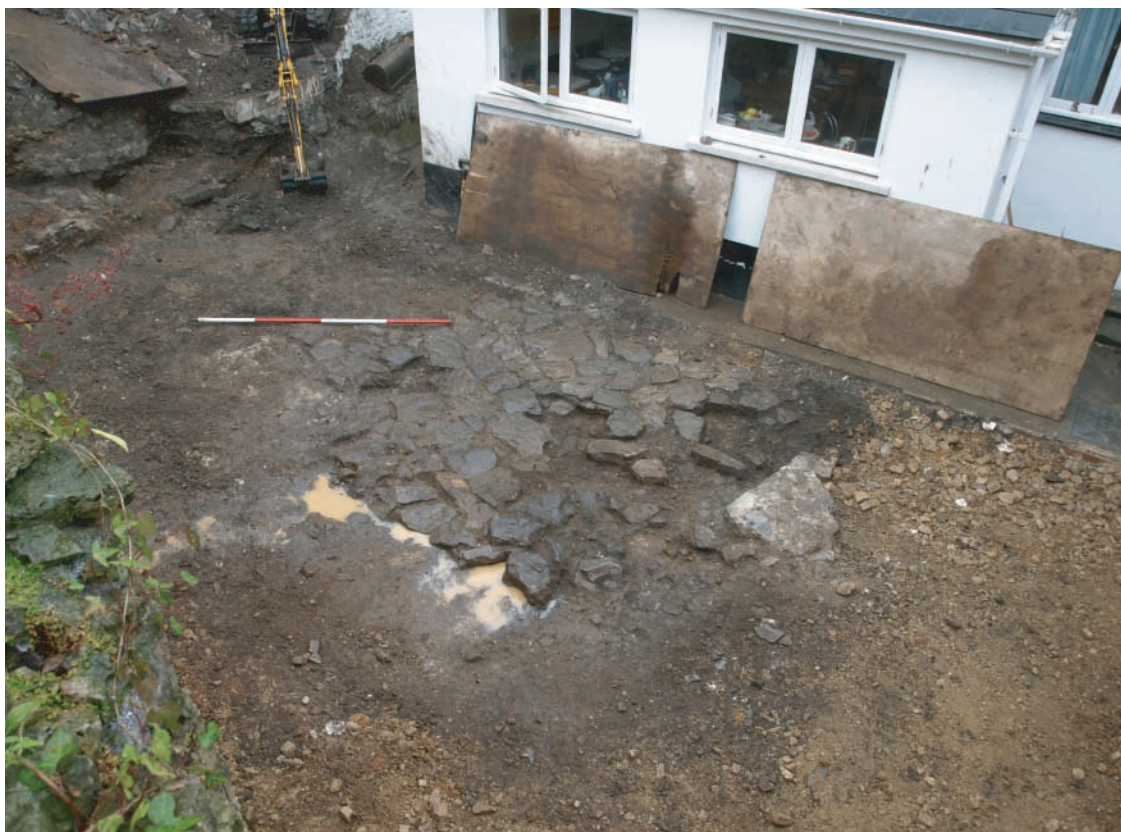
Plate 34. View of remains of medieval wall stump and irregular flagstone floor. Looking northwest.

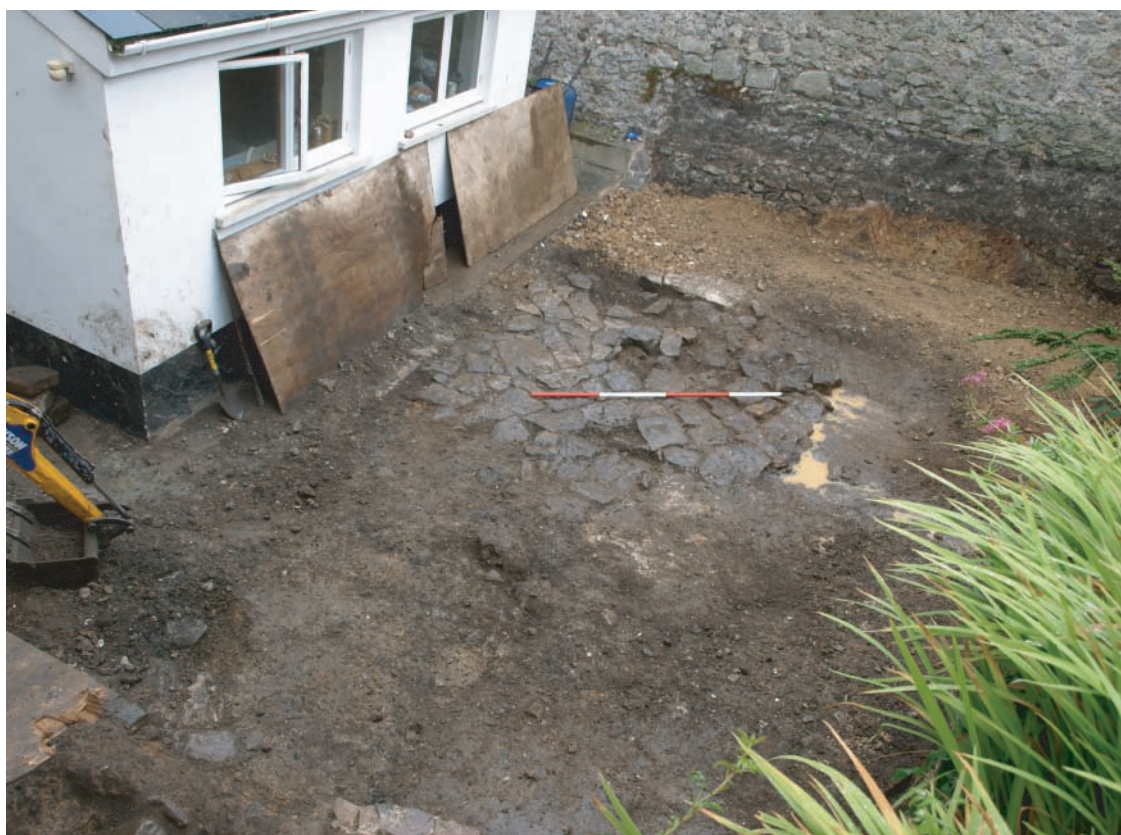
Plate 35. View of remains of medieval wall stump and irregular flagstone floor. Looking northeast.

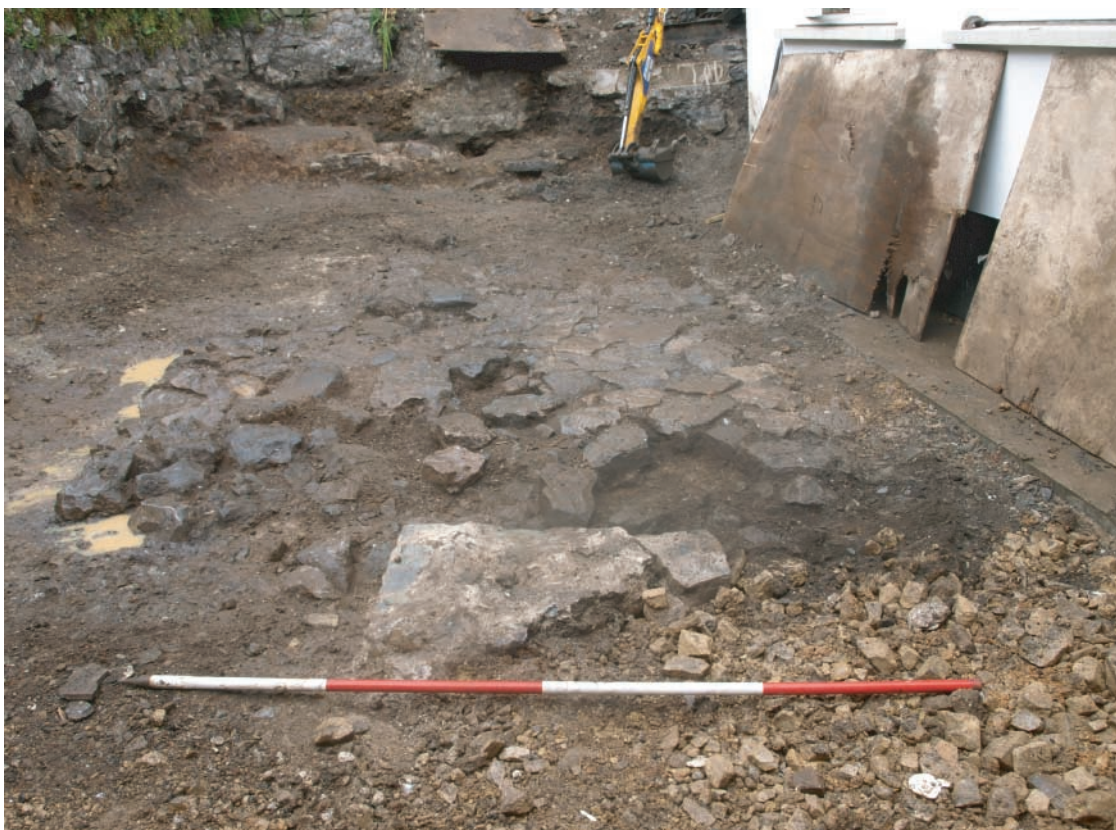
Plate 36. View of remains of medieval wall stump and irregular flagstone floor. Looking southwest.

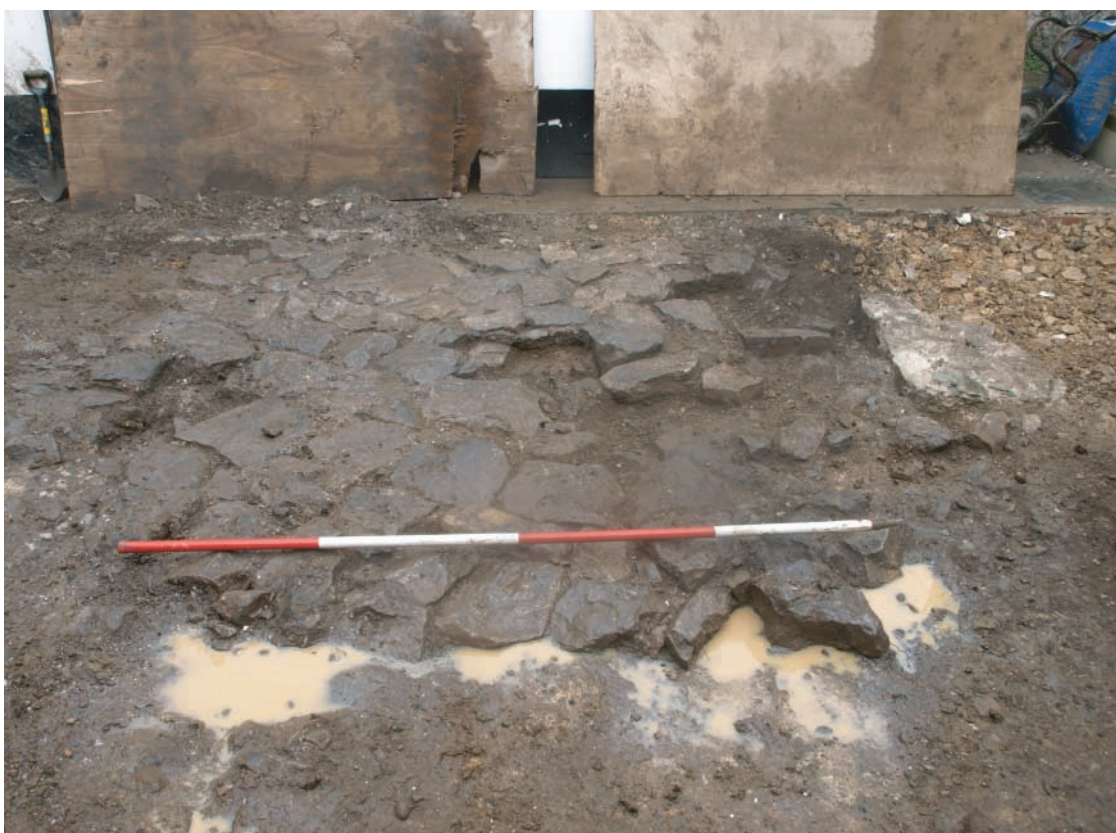
Plate 37. View of remains of medieval wall stump and irregular flagstone floor. Looking north-north-west.
