**Bridge House,
Bridge Street,
Tenby, Pembrokeshire**

Archaeological Watching Brief

HRSWales
Report No: 142

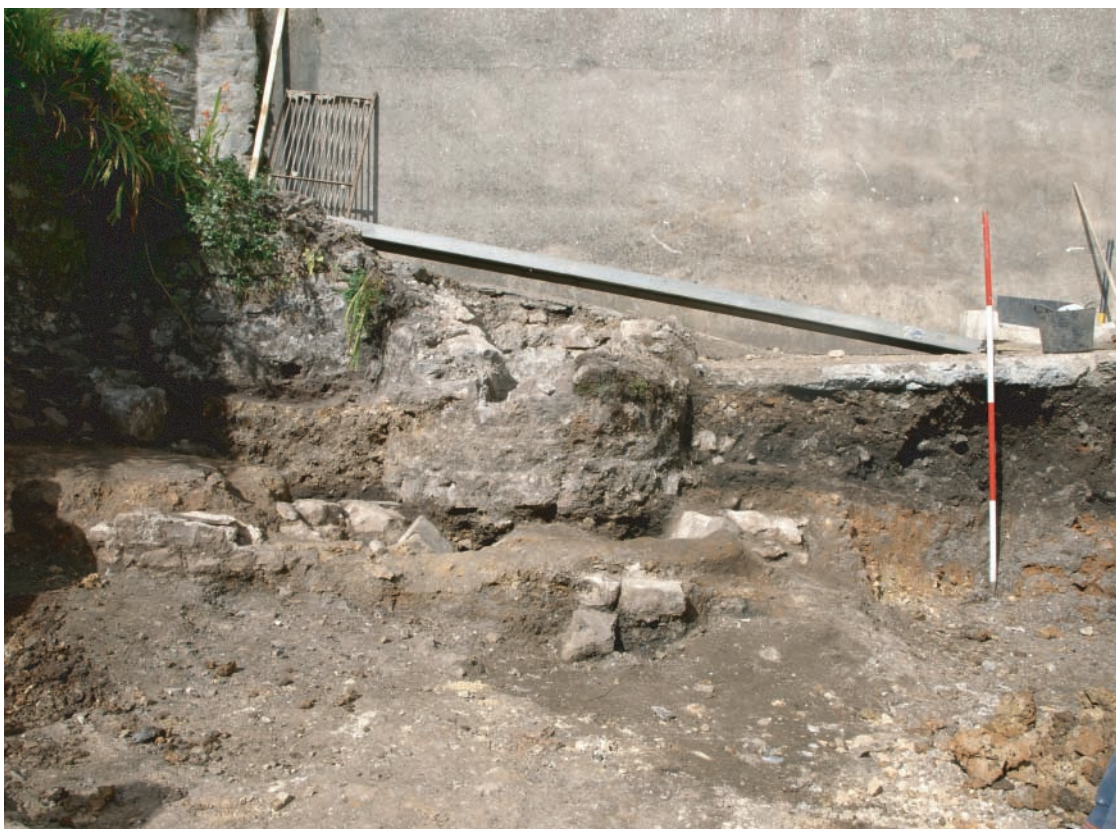
Plate 38. View of remains of stone built water well following ground reduction. Looking southwest.

- 5.5 With regards to the water well (111) exposed from the ground work, this discovery is a very significant and exciting find, given that nothing like this had been found in the town before. At the beginning of the ground work, the presence of this well was known to a number of Tenby residents (*pers comm*). However, it had always been assumed that the well was either 18th or early 19th century in date, given the character of the mortared walling that projected above the ground. However, the reduction of the ground level has revealed a rather astounding discovery, that is, that the upper section of well, the stone head of the well, may have been built onto an opening of a much earlier water well. Excavation around the base of the well on its eastern side exposed the positions of two cut timber locking slots, which were probably constructed to lock a crossed pair of upright timbers into place, so as to hold a cross timber that would have acted as an axle to hold a winding gear frame. As well as probably having been used to also dig the natural clay from the well, this frame would also have been used eventually to draw the water from the well.

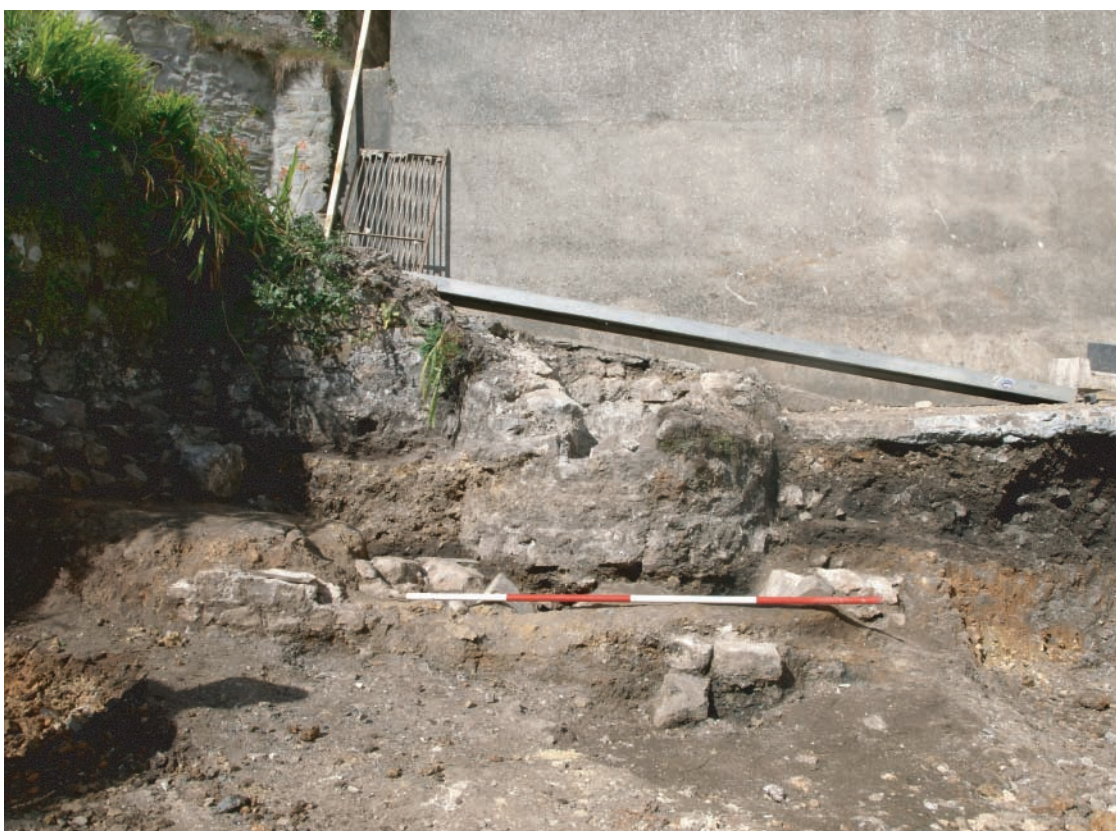
Plate 39. View of remains of stone built water well and natural clay base following ground reduction. Looking southwest.

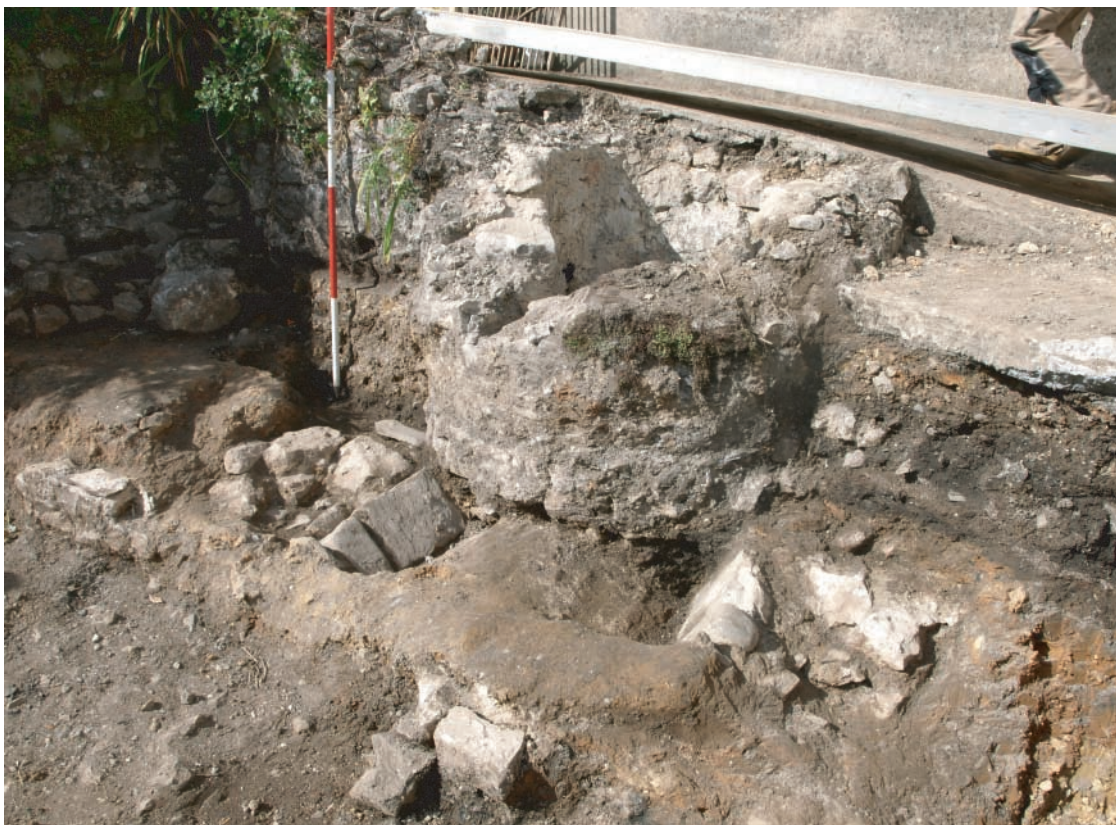
Plate 40. View of remains of stone built water well following ground reduction. Note cut slots at base of well through natural sandstone, which likely acted as locking slots to support a timber 'A' frame. Looking southwest.

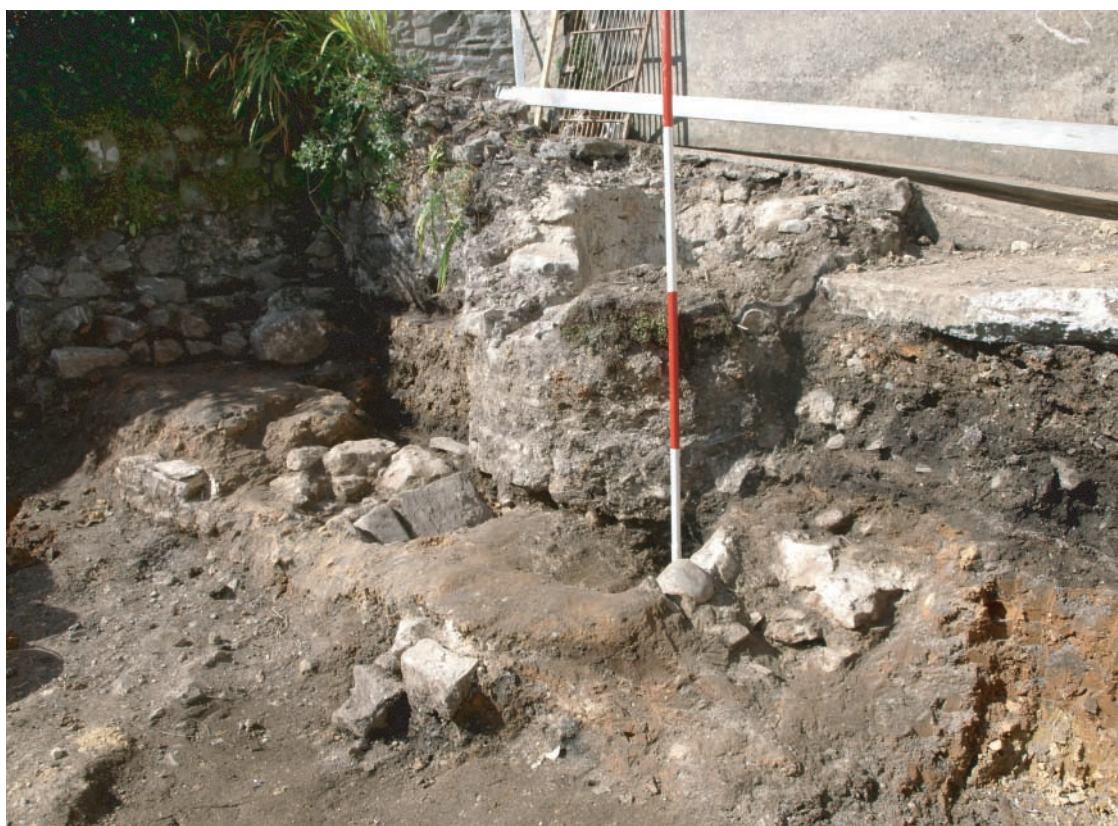
Plate 41. View of remains of stone built water well following ground reduction. Note cut slots at base of well through natural sandstone, which likely acted as locking slots to support a timber 'A' frame. Looking southwest.

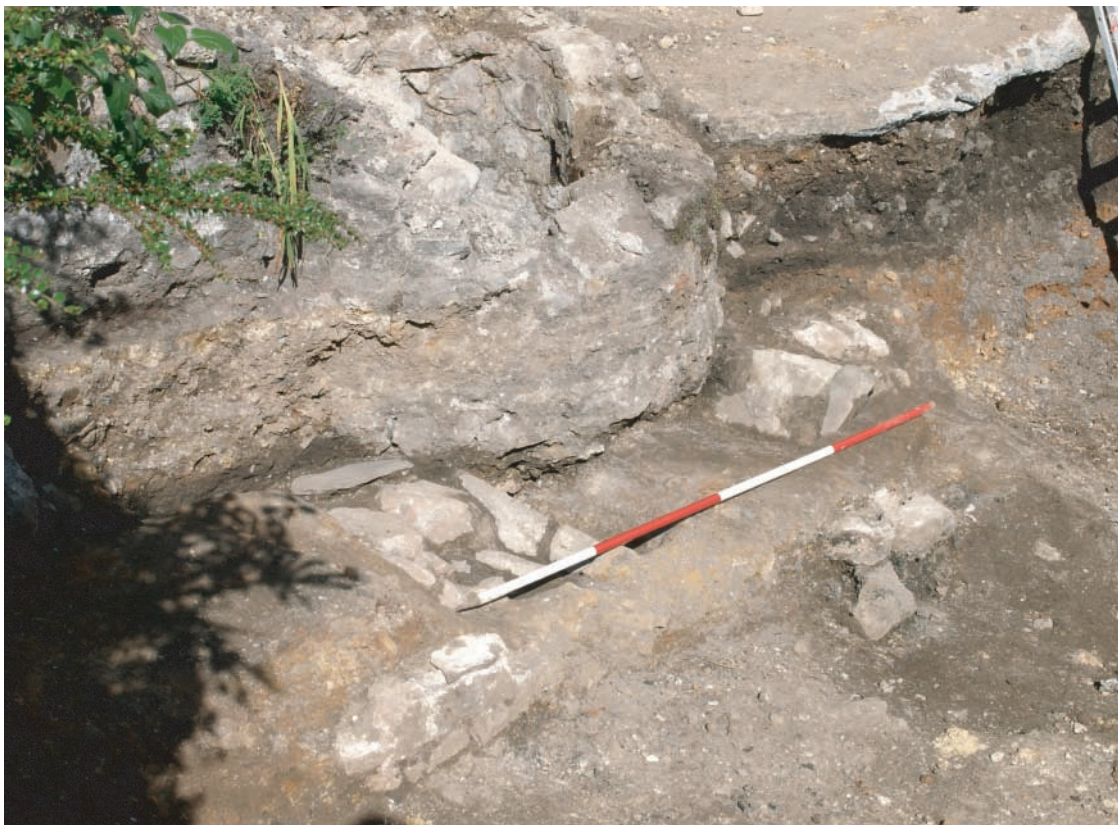
Plate 42. View of remains of stone built water well following ground reduction. Note cut slots at base of well through natural sandstone, which likely acted as locking slots to support a timber 'A' frame. Looking west.

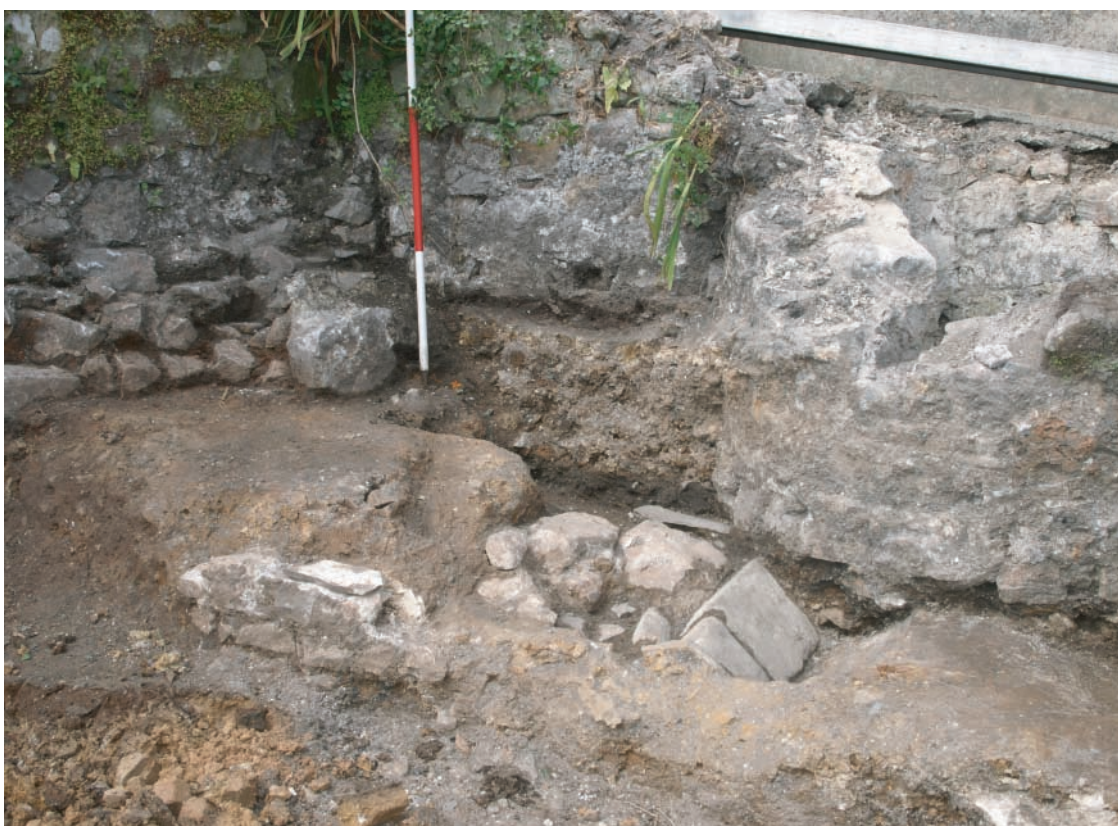
Plate 43. View of southern end of clay bank alongside stone water well. Looking west.

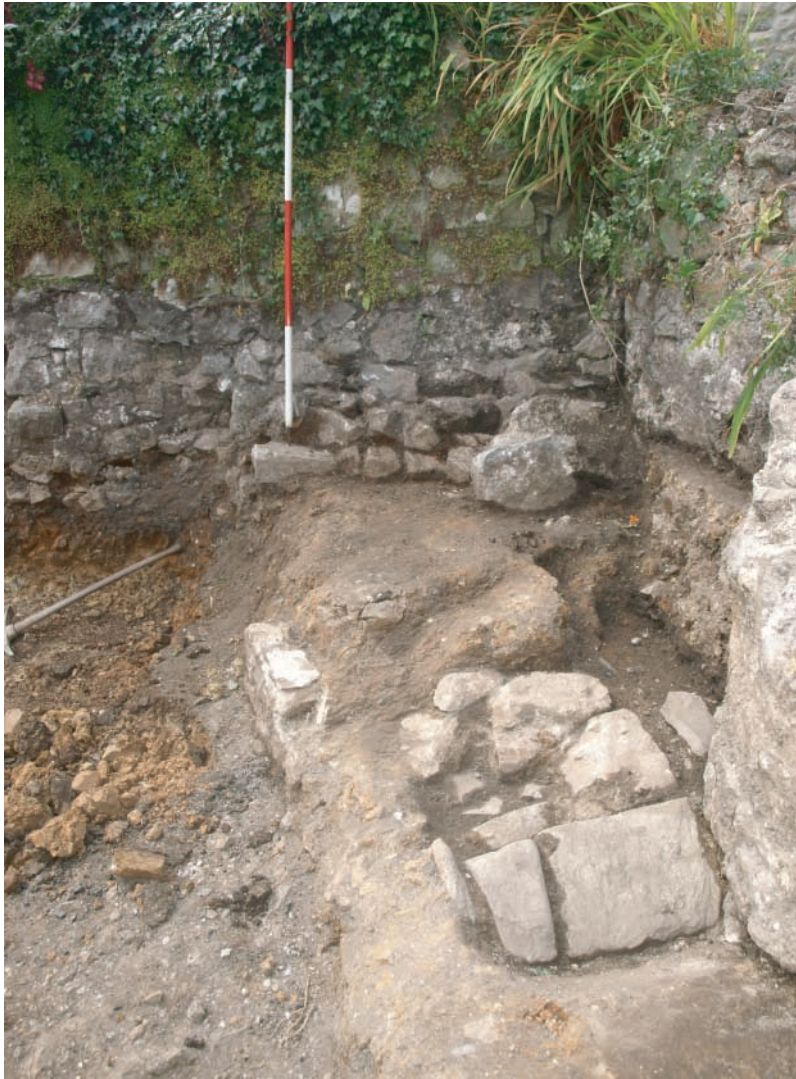
Plate 44. View of clay bank and cut slots alongside stone built water well. Looking south-south-east.

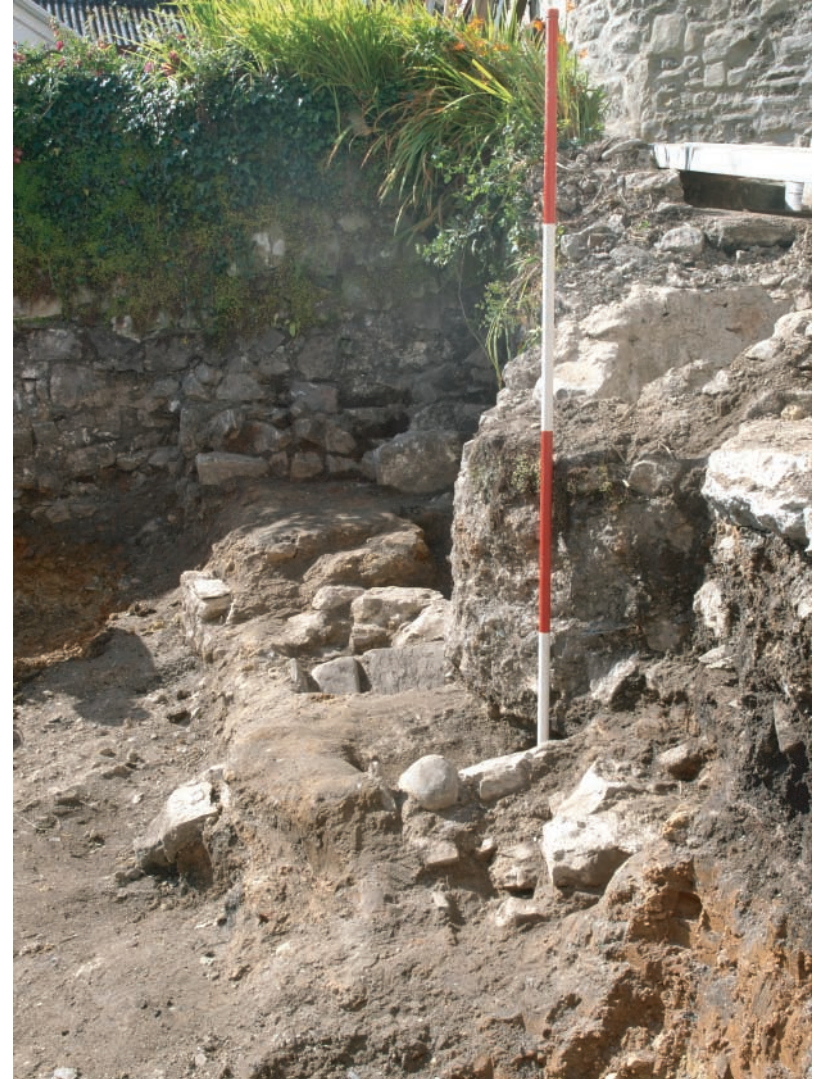
Plate 45. View of clay bank and cut slots alongside stone built water well. Looking south-south-east.

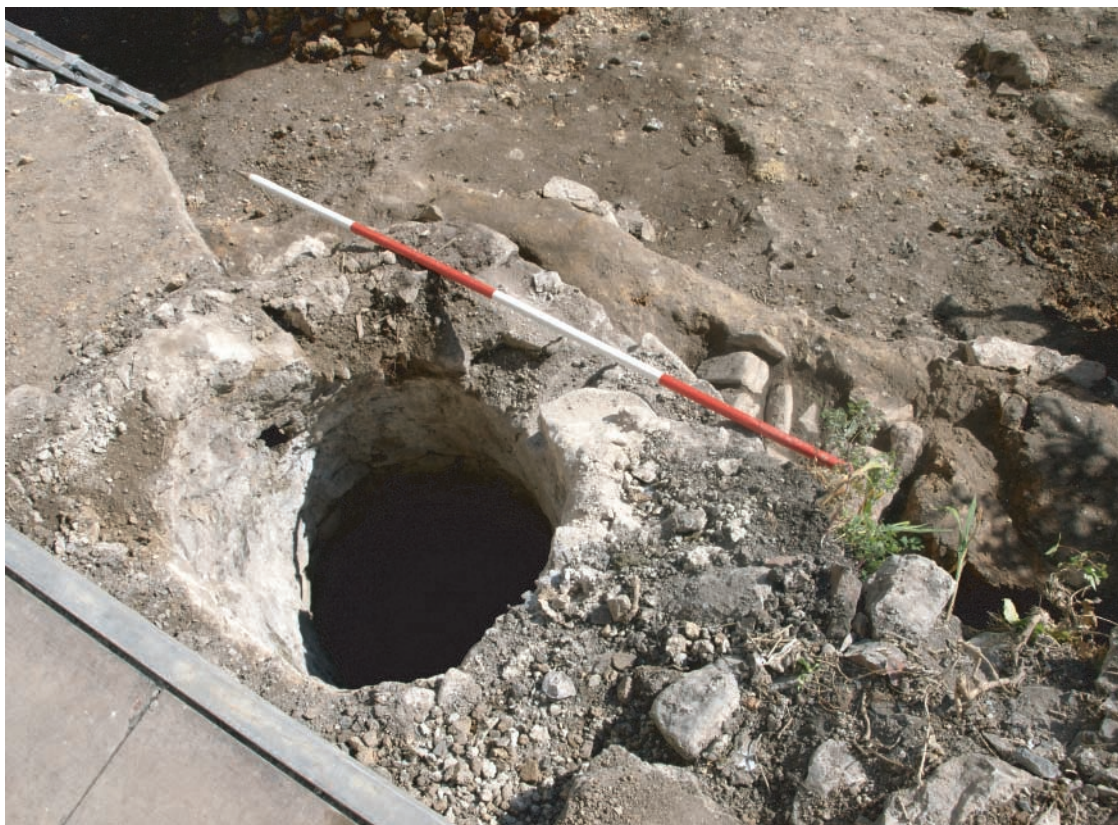
Plate 46. View of top of water well following the removal of concrete cover that acted as a walkway ramp. Looking north east.

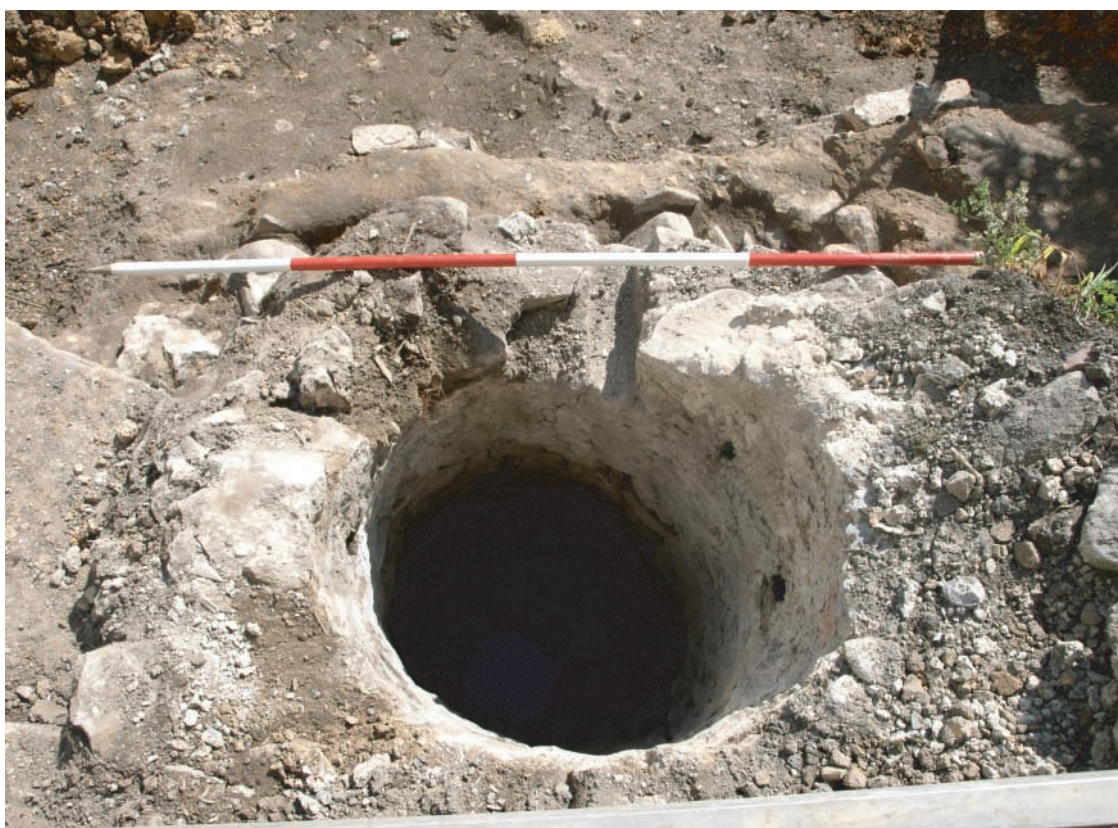
Plate 47. View of top of water well following the removal of concrete cover that acted as a walkway ramp. Looking northeast.

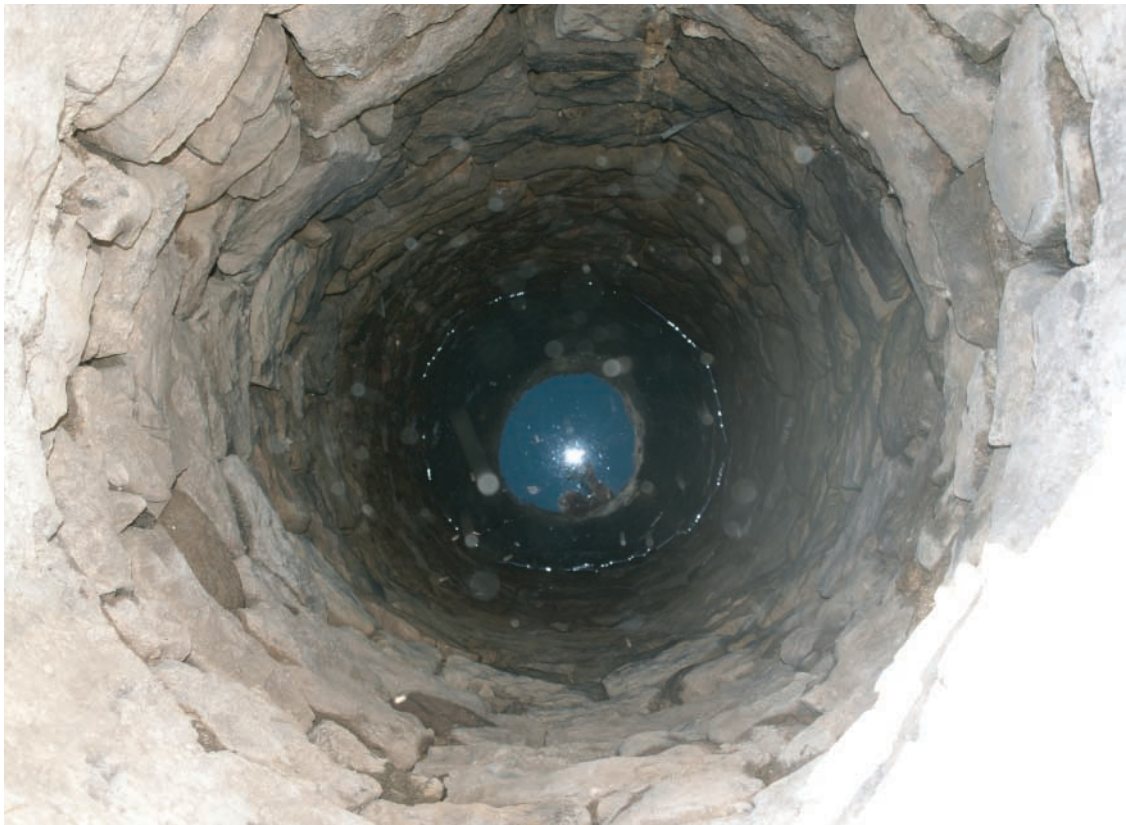
Plate 48. View down stone built well. Approximately 6.7 meters deep.

- 5.7 Unfortunately, due to the fact that the well is still active and due to health and safety concerns, access to the base of the well for dredging was not possible. As a recommendation, to further elucidate the date of the well, as well as offering the possibility of recovering further possibly intact medieval pottery, this dredging work is a desirable piece of work that ideally needs to be undertaken at some other suitable time.

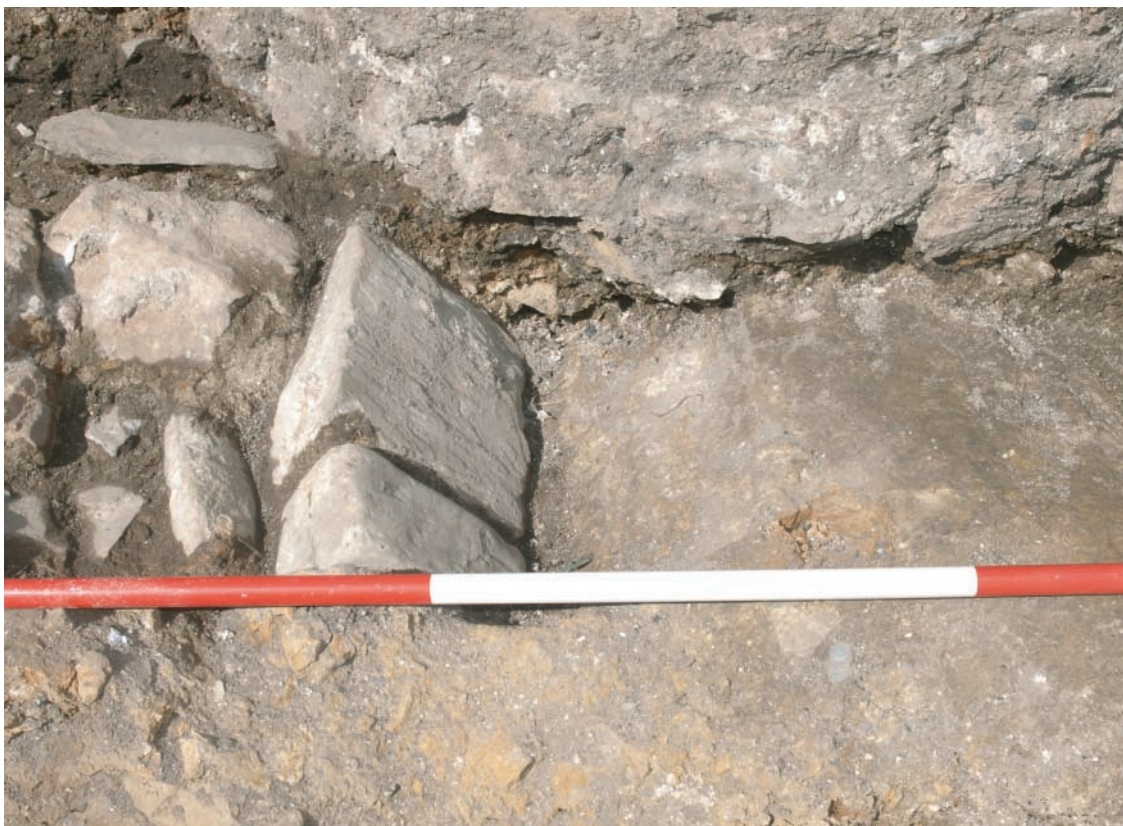
Plate 49. Detail view of cut slot No.1 through natural sandstone with stone blocks. Looking westwards.

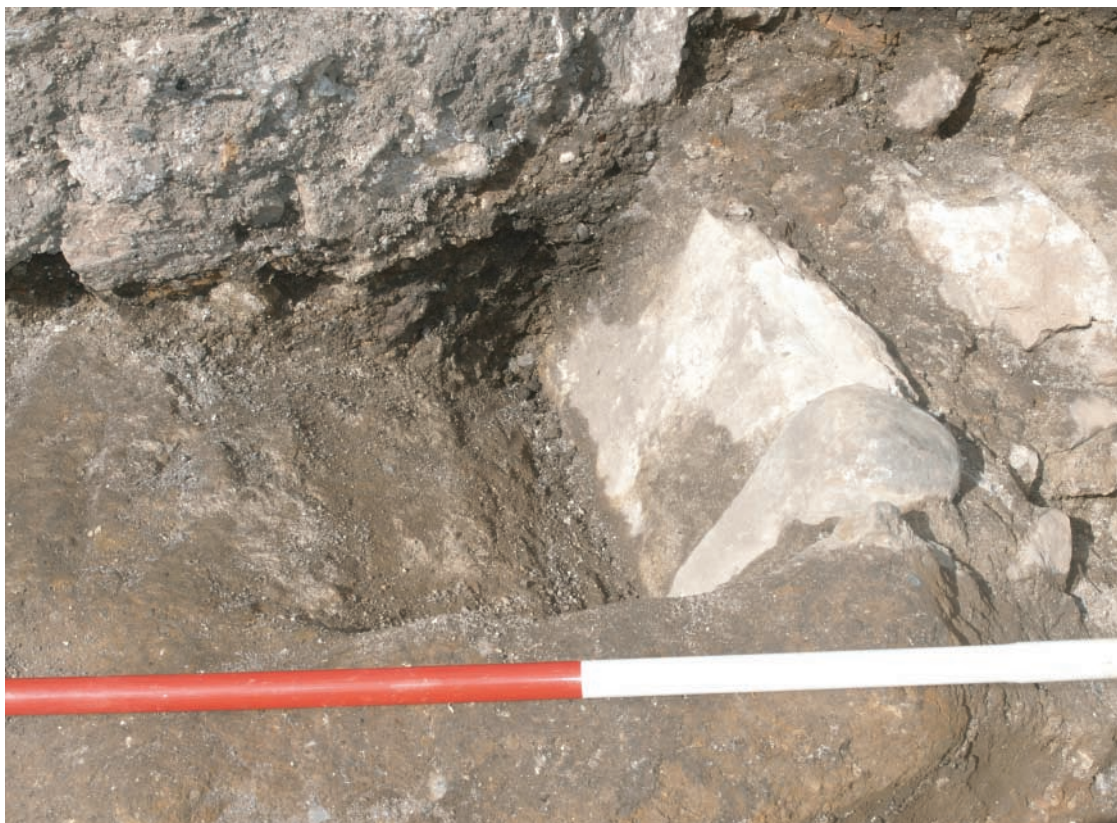
Plate 50. Detail view of cut slot No.2 through natural sandstone with stone blocks. Looking westwards.

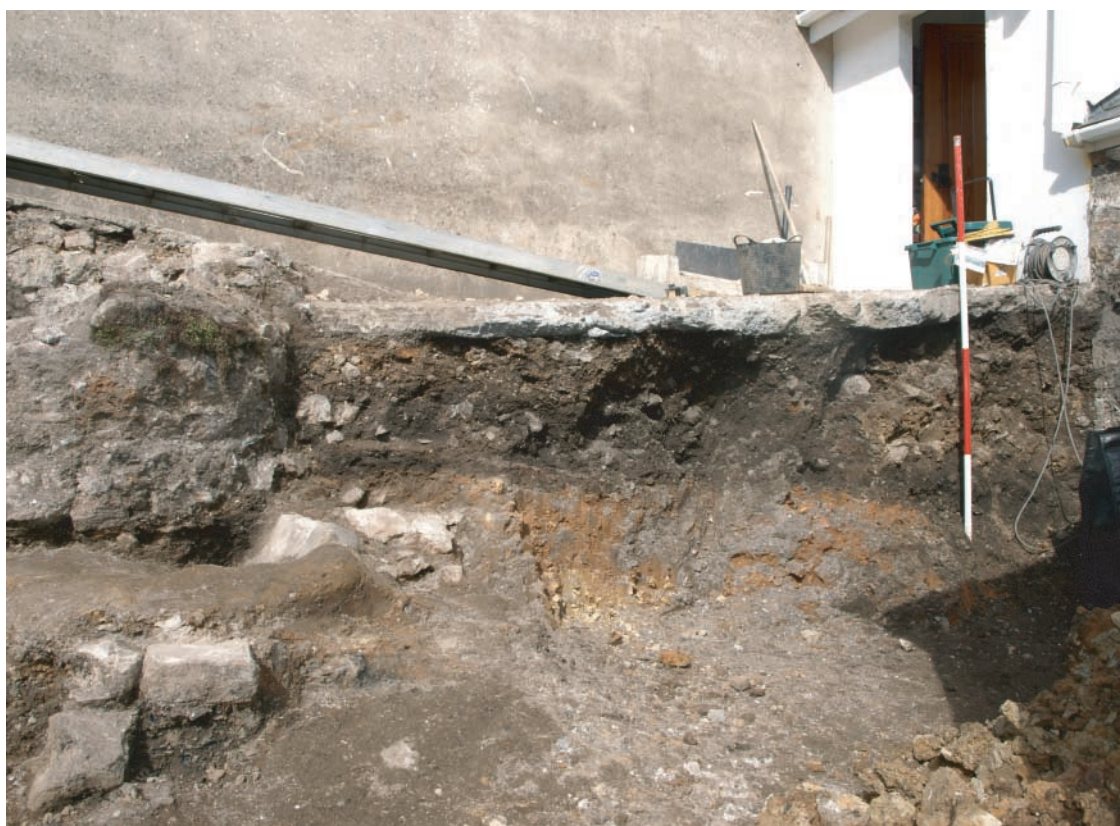
Plate 51. Northern end of northeast facing section (E-F) alongside water well. Looking southwest.

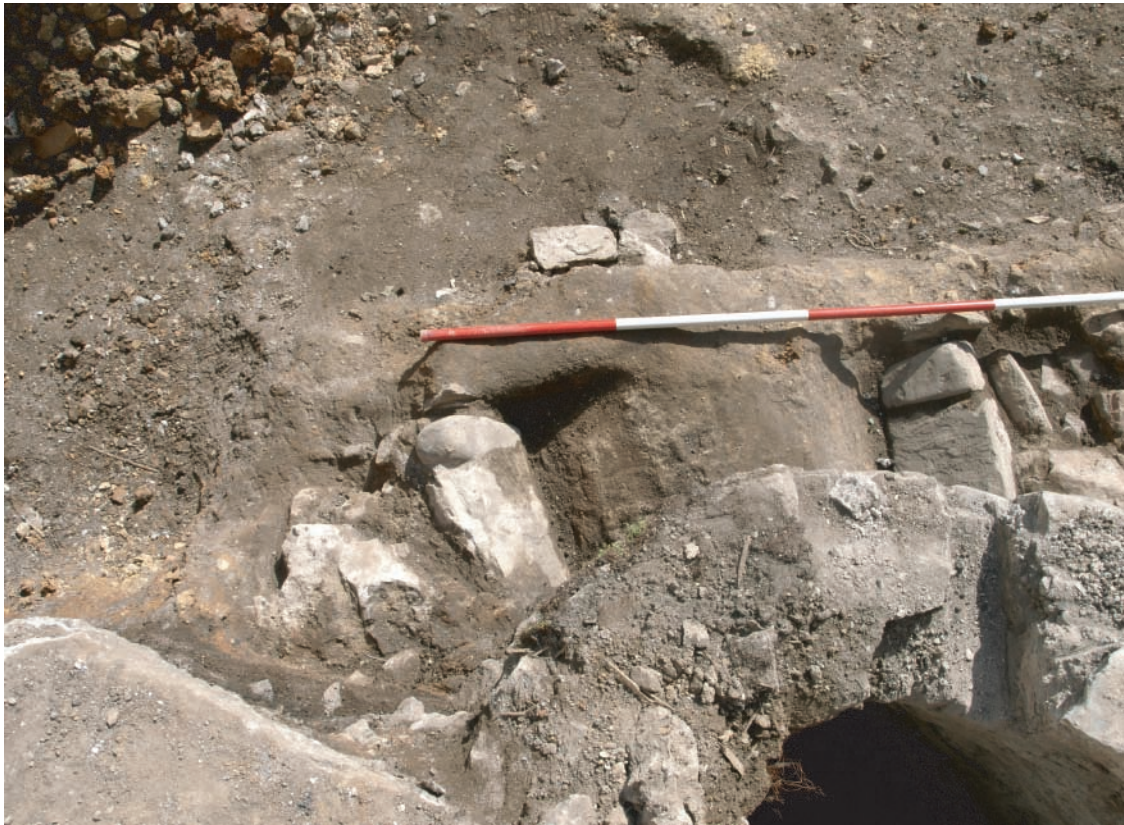
Plate 52. Detail view of cut slots through natural sandstone with associated angled stone blocks, likely intended to act as locking slots for a timber 'A' frame for drawing water from the well.

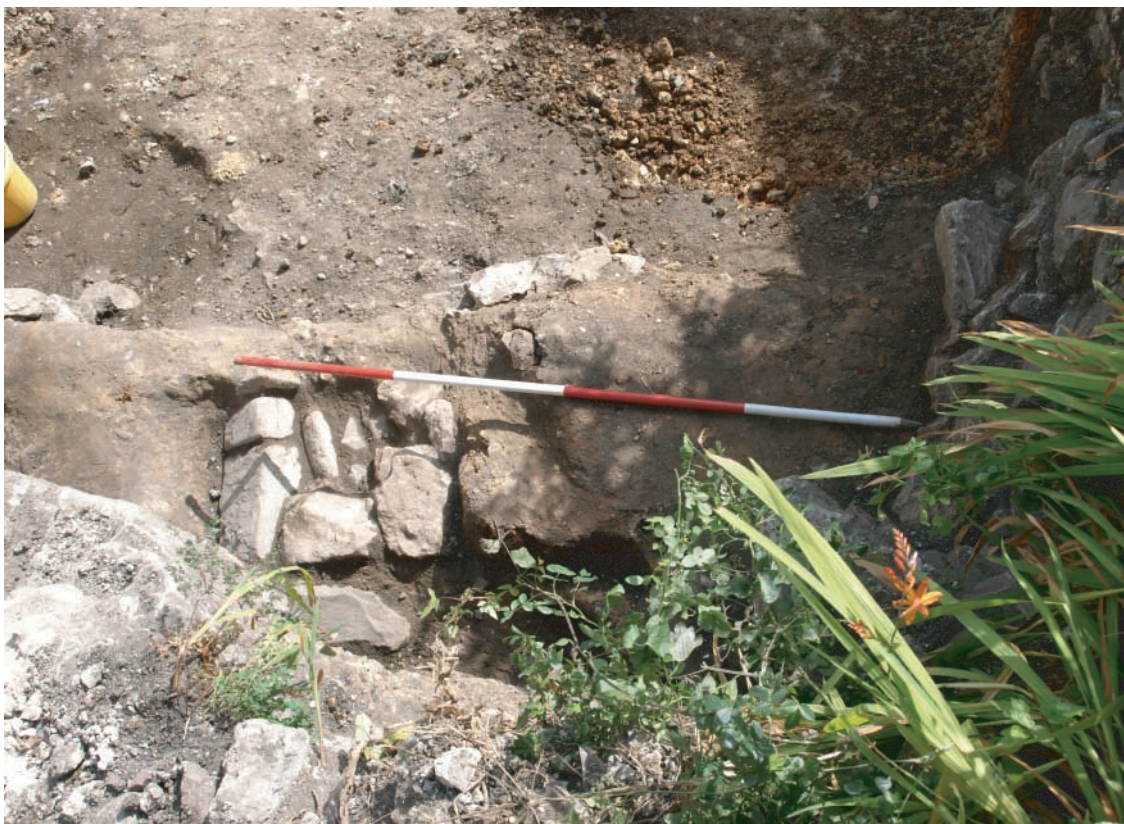
Plate 53. View of southern end of clay bank alongside water well.

- 5.9 Due to the fact that the footings of the east to west running stone built garden wall had become exposed, following consultation with the architect and the site engineer, it was recommended that a narrow ring retaining wall be built up against the exposed footings and natural clay.

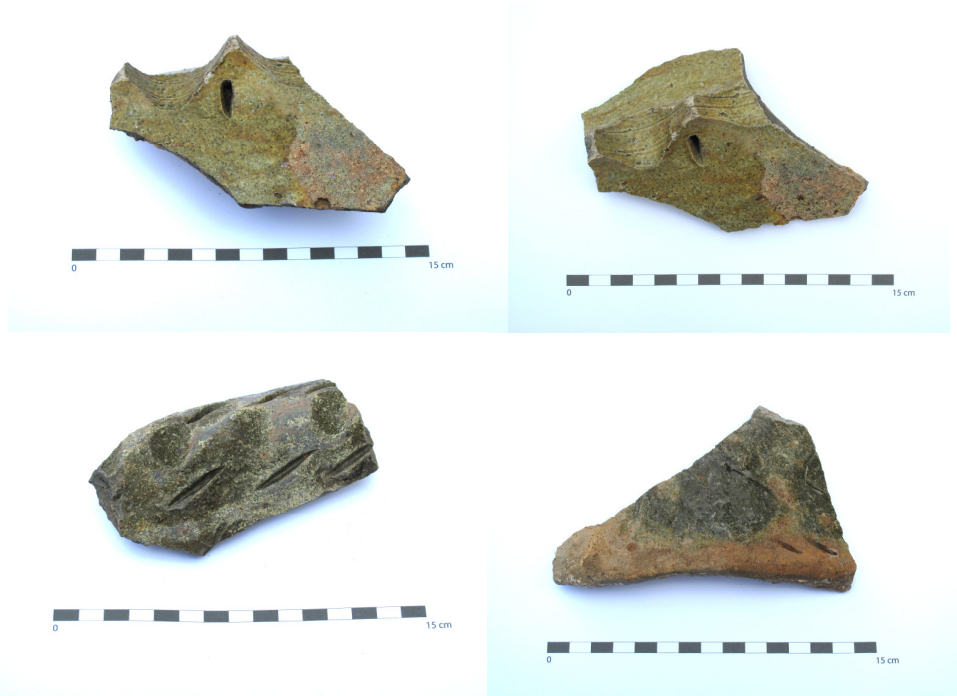
Find No. #	Context No. #	Find Type	Date Range
10	102	Medieval Green Glaze jug base – Grimston Type Ware	Late 12 th – 14 th century

- 4.18 In an attempt to recover some datable material from around the base of the well, a large fragment of a 12th – 13th century base of a glazed jug or *baluster* was recovered. Luckily this fragment was found sealed within some bedding mortar that was holding down a small stone slab that was partly sealed or *pinned down* beneath the stonework of the 19th century well wall extension. This fragment offered further supporting evidence that the original water well is indeed medieval in date and probably is also 12th-14th century.
