Wemyss Lead & Zinc Mine, Pontrhydygroes, Ceredigion.

Archaeological Watching Brief

HRS Wales
Report No: 253

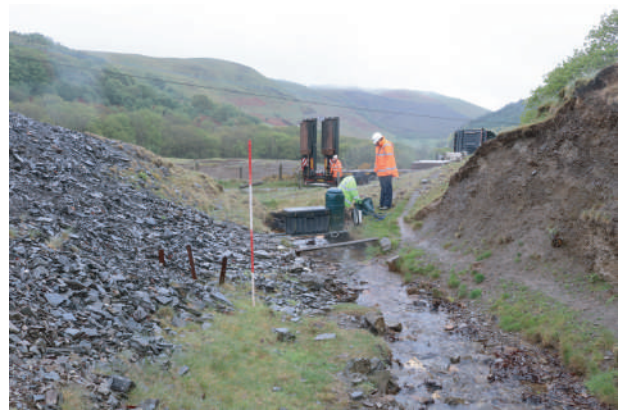
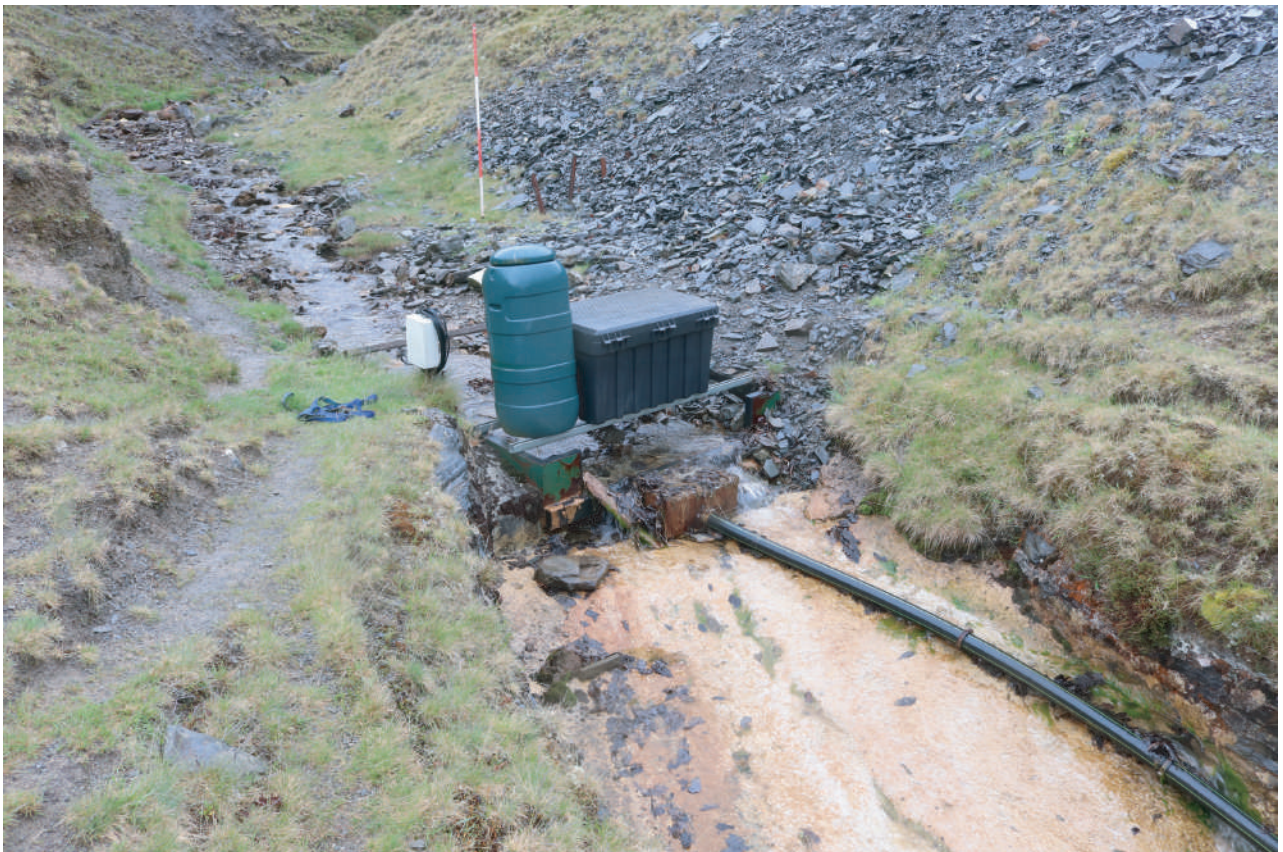
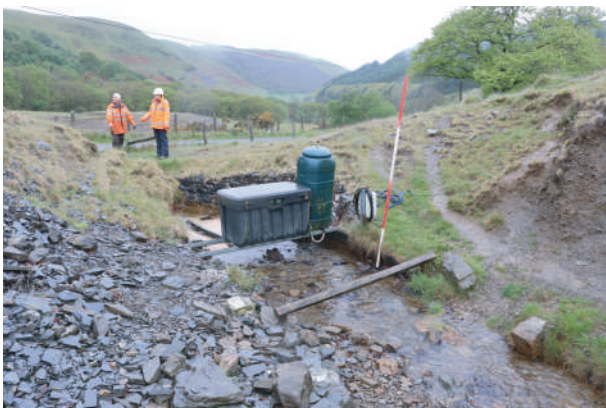
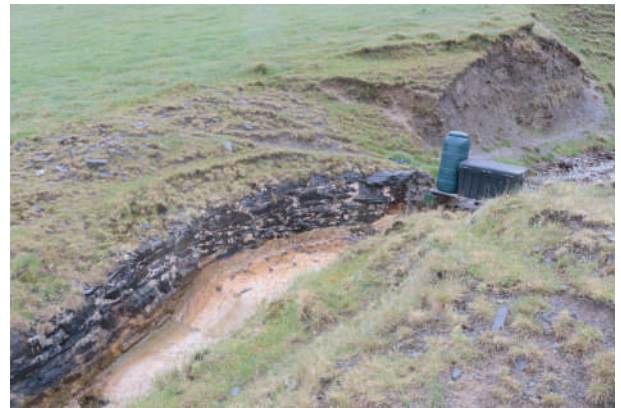
Plate 02. View of existing water flow gauge at discharge point between mine spoil tips. Looking south.

Plate 03. View of existing water flow gauge at discharge point between mine spoil tips. Looking northward.

Plate 04. View of existing water flow gauge at discharge point between mine spoil tips. Looking southward.

Plate 05. View of existing water flow gauge at discharge point and between mine spoil tips. Looking northwesterly.

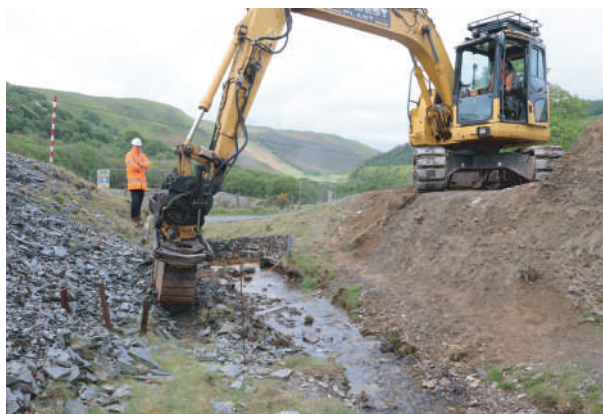
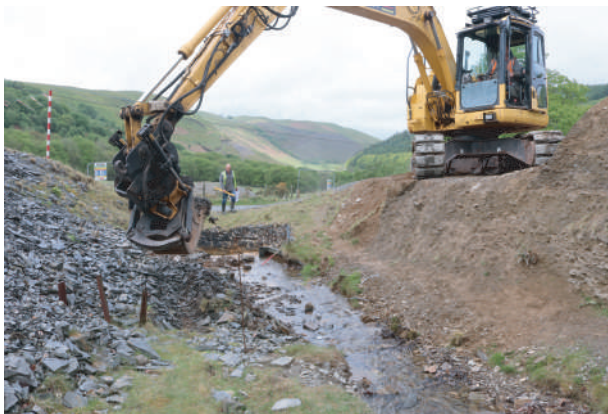
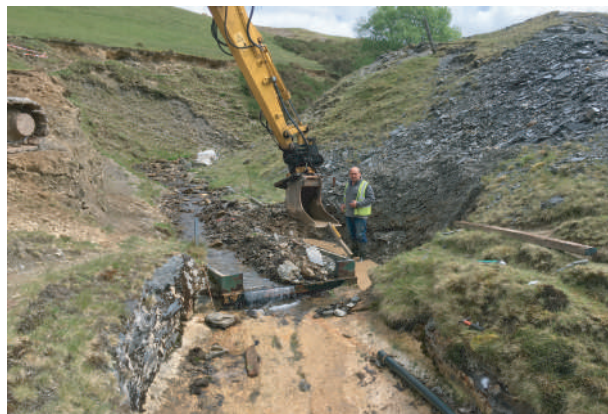
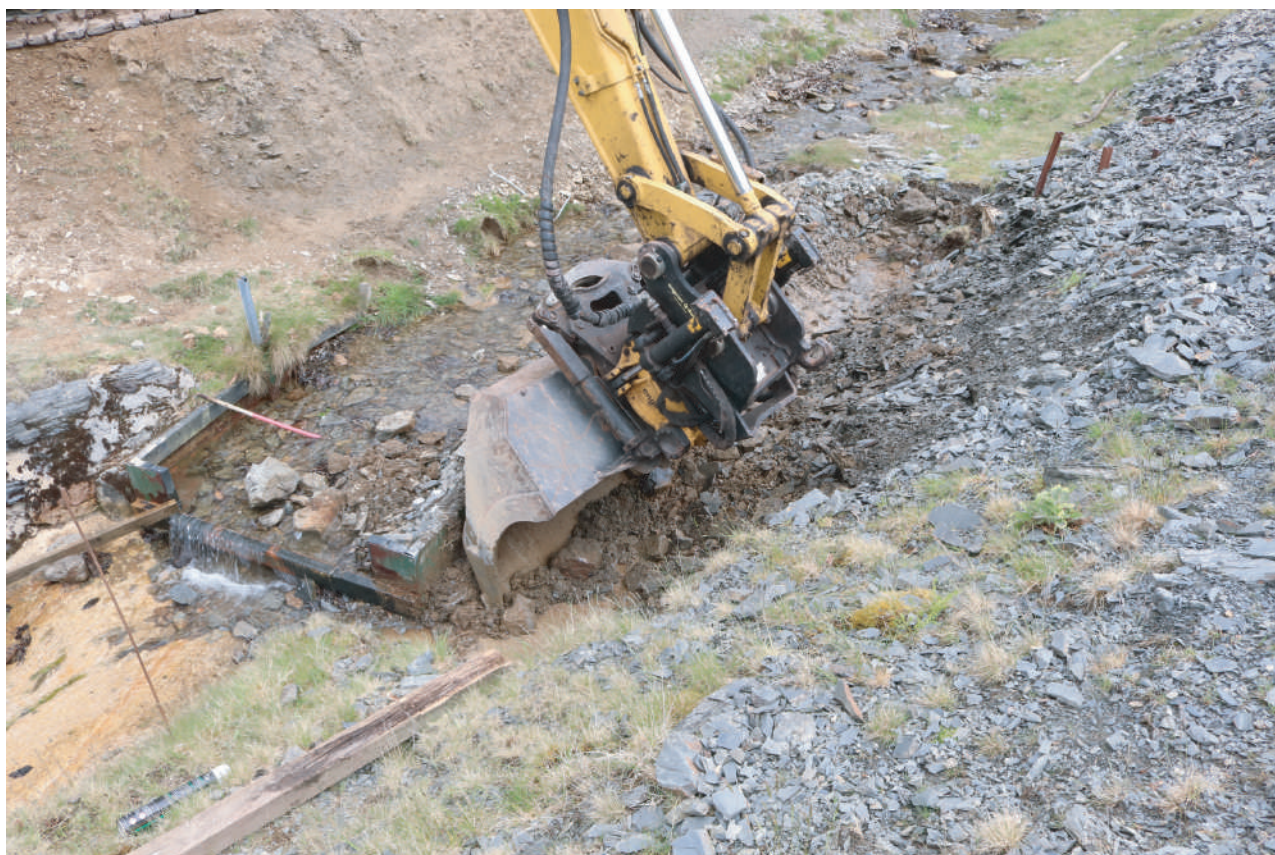
Plate 10. Working shot during removal of part of base of mine spoil tip alongside discharge point in preparation for Gabion baskets. Looking southwards.

Plate 11. Working shot during removal of part of base of mine spoil tip alongside discharge point in preparation for Gabion baskets. Looking southwards.

Plate 12. Working shot during removal of part of base of mine spoil tip alongside discharge point in preparation for Gabion baskets. Looking northwards.

Plate 13. Working shot during removal of part of base of mine spoil tip alongside discharge point in preparation for Gabion baskets. Looking southwards.

- 4.5 Following the completion of the preparatory groundwork and the assessment of the site, the proposed groundwork for the upgraded flow gauge structure commenced by removing part of the base of the spoil tip on the eastern side of the discharge point, approximately 1.5m wide c 3m in length, in order to place the proposed Gabion baskets. This groundwork completely exposed one of the vertically laid former iron tramway rails on the westernmost side, which had completely corroded along its central spine which caused it to snap in two. This rail remnant was put aside and placed along the base of the tip, still being kept on site. The groundwork for the Gabion baskets on the eastern side of the stream did not reveal any further finds, features or deposits of any archaeological significance.

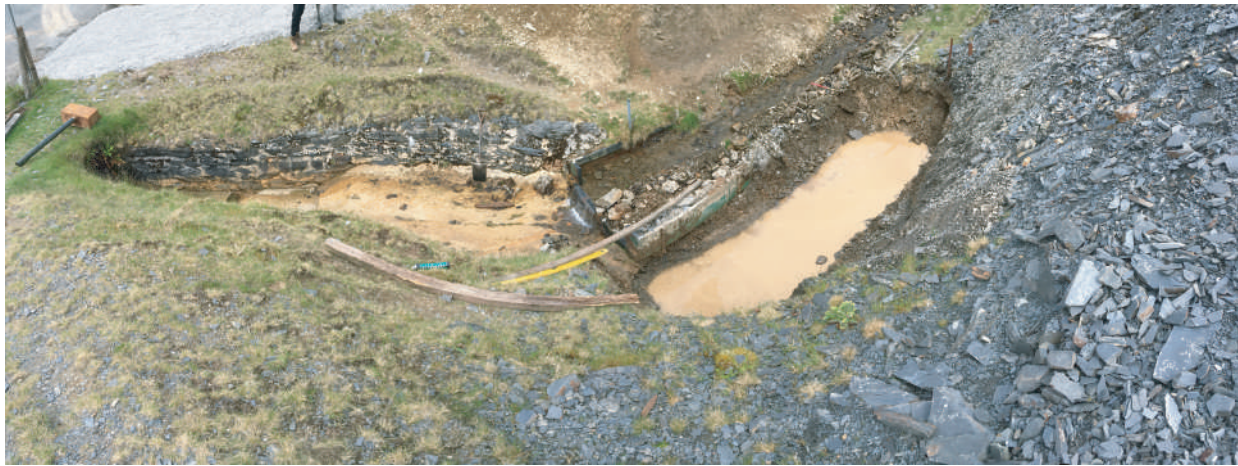
Plate 16. Spliced panoramic view looking west to north of partly dismantled existing flow gauge and area prepared for new Gabion baskets. in preparation for Gabion baskets at base of spoil tip.

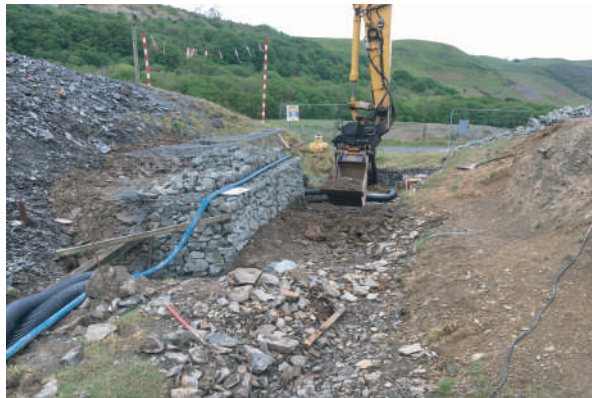
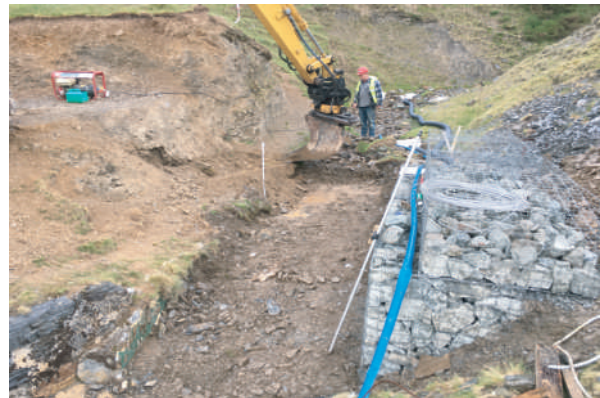
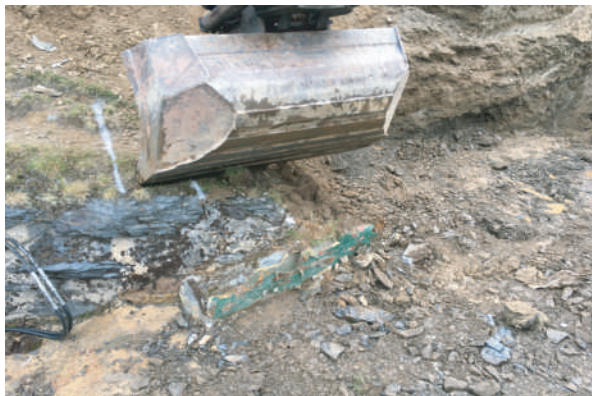
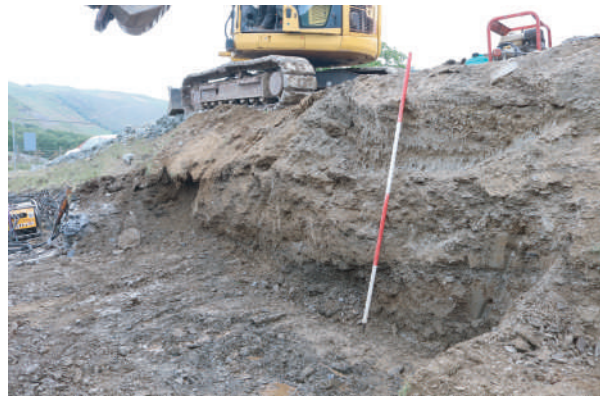
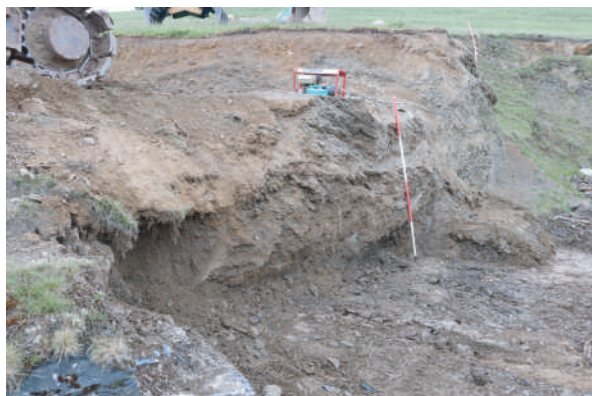
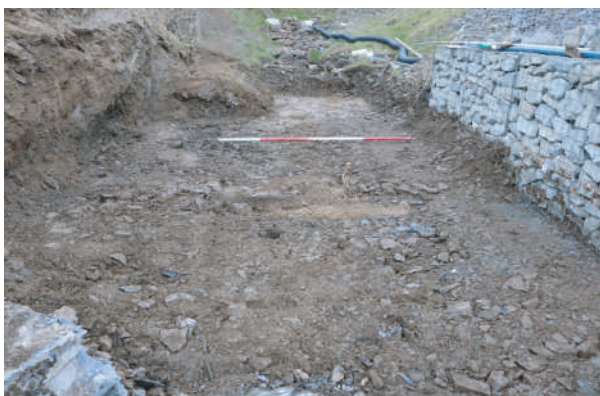
Plate 17. Working shot during clearance of stream bed and western bank in preparation for opposing Gabion baskets. Looking southwards.

Plate 18. Working shot during clearance of stream bed and western bank in preparation for opposing Gabion baskets. Looking northwards.

Plate 19. Working shot during of western bank in preparation for opposing Gabion baskets. Looking westwards.

Plate 20. Groundwork complete on western bank for new Gabion baskets. Looking SW.

Plate 21. Groundwork complete on western bank for new Gabion baskets. Looking SW.

Plate 22. Groundwork complete in stream bed in preparation for concrete and new flume. Looking N.

- 4.6 The next phase of groundwork entailed the reduction of the stream bed to the required level, some 0.40m below the current level and the removal of earth on the western side of the stream to incorporate the western Gabion baskets. This groundwork also had to remove a small section of stone walling on the western side, a section some 0.50m in width. This section of walling appeared to have already been taken down previously, possibly as part of the construction of the existing flow gauge structure. This walling was to be rebuilt again following completion of the construction of the new flow gauge. The groundwork in this location did not reveal any further finds, features or deposits of any archaeological significance. Completion of ground work in this area concluded the archaeological watching brief.

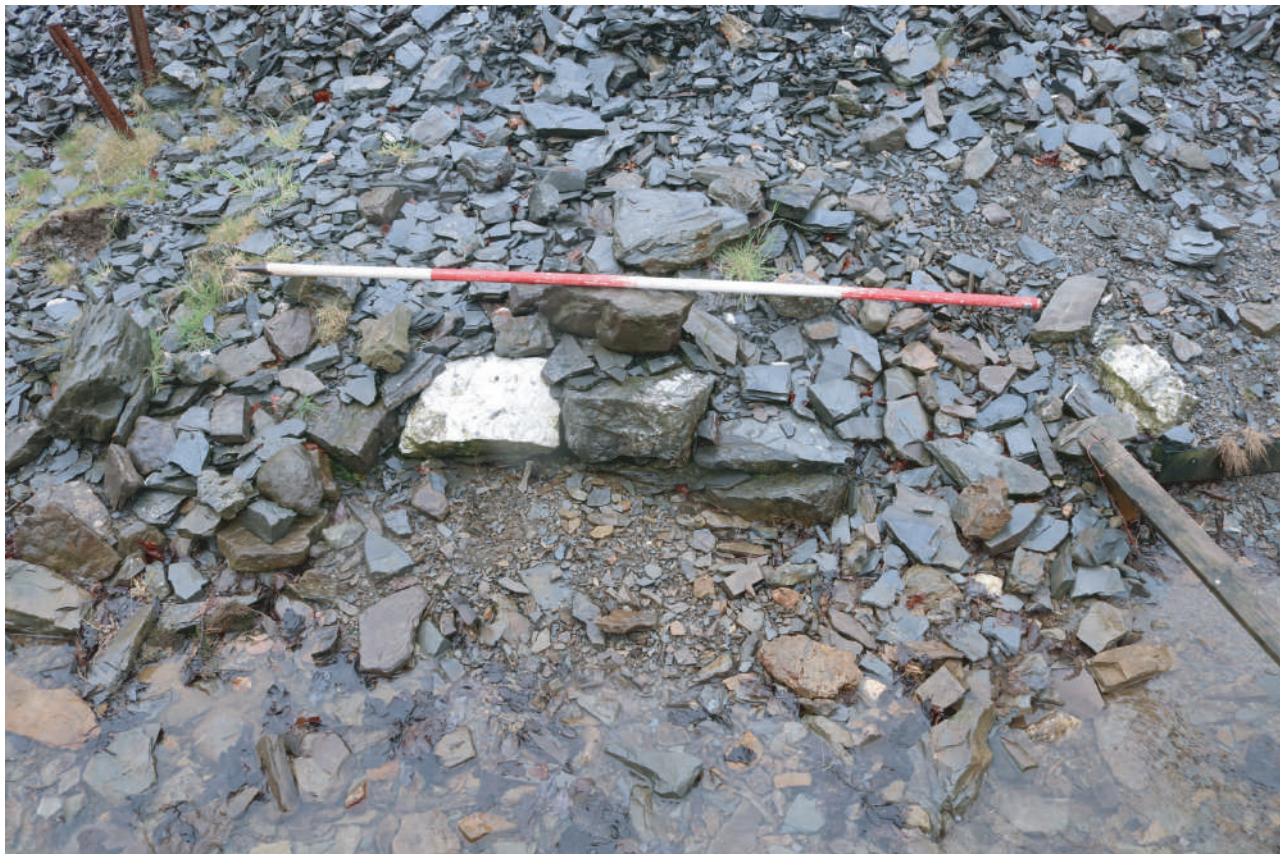
Plate 25. Apparent kerb stones at base of spoil tip alongside stream on east side in area of proposed upgraded flow gauge.

- 4.4 Prior to groundwork beginning in the area of the existing flow gauge the area was waked over and assessed. This revealed that the eastern edge of the upgraded flow gauge structure was going to disturb the base of an historic spoil tip as well and remove a series of apparent loose kerb stones that run alongside the eastern edge of the base of the tip (*see Photo 25*). The assessment also noted a series of three vertically laid former iron tramway rails protruding into the spoil tip and water level running east to west close to the kerb stones (*see Photo 26*). Further assessment of the site also noted that the stone built wall that forms the channel that takes water beneath the public road is very probably historic and associated with the Wemyss mine. However, closer inspection of this wall revealed that it had seemingly been rebuilt and remortared in areas on a number of occasions over the years. Discussions with the site manager and the representative from the Coal Authority agreed that the preservation of these historic features is important and any compromise to them in relation to the scope of works is kept to a minimum.

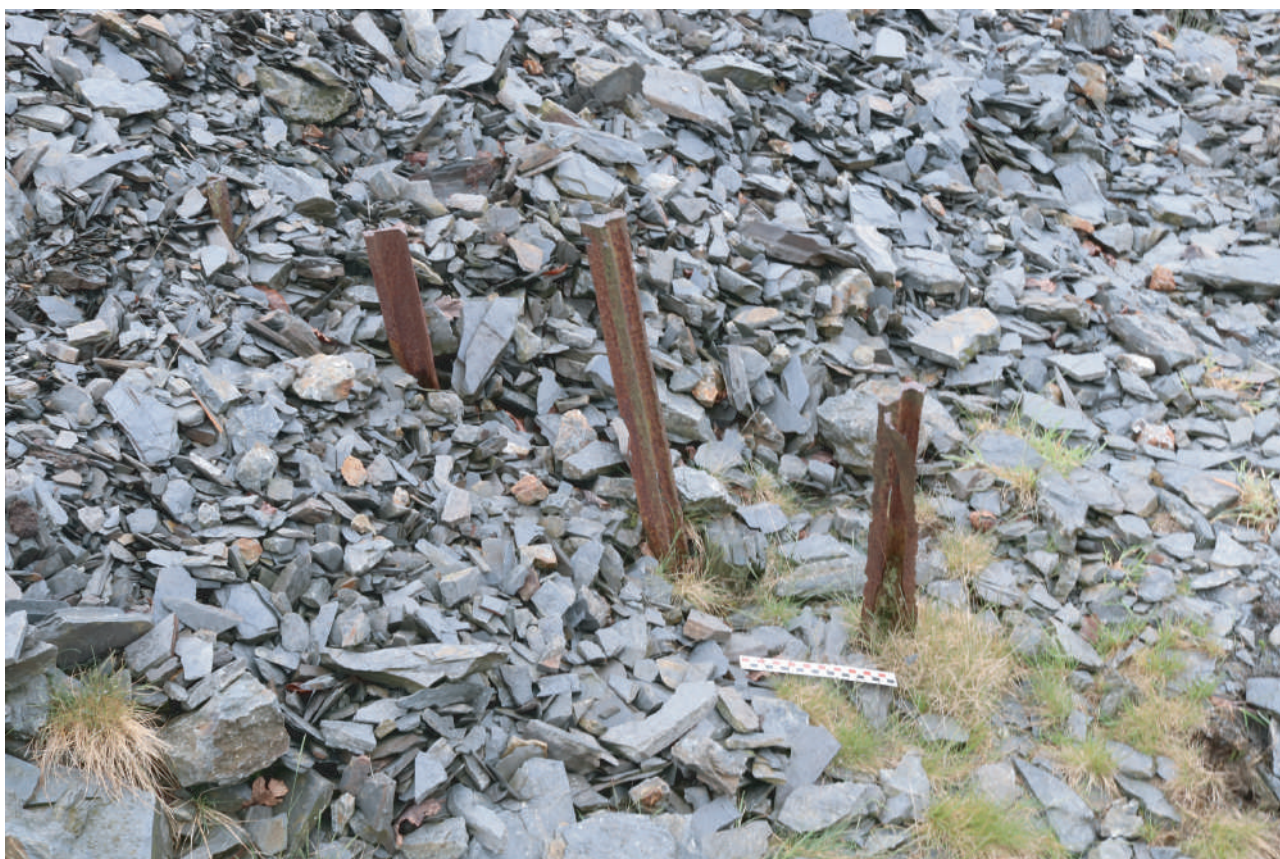
Plate 26. Remains of corroded former iron tramway rails sticking up out of ground in area of proposed new flow gauge at base of spoil tip on east side of stream. May have been used as a temporary fencing at some time across stream bed.

groes, managed to assess the area of the ground work, and in so doing recorded the position of a series of vertically laid former iron tramway rails protruding from the ground at the base to the spoil tipping on the east side of the discharge point. It also noted the position of three kerb stones along the eastern edge of the stream at the base of the spoil tip. Whether these kerb stones are historic or not is speculative, but they may well have been laid down at the time of the existing flow gauge structure. The assessment of the site also noted that the stone wall channel that dives beneath the public road is very likely an historic wall that has been dismantled and rebuilt on a number of occasions over the years and the proposed groundwork, other than the finds and features discussed, did not expose any further dateable finds and features at the site. All geology at the site consisted of a sandy gravel and grit overlying a natural sedimentary shale.
