**The Village Shop,  
No.9 Angle Village,  
Angle, Pembrokeshire,  
Pembrokeshire SA71 5AT.**

*Archaeological Watching Brief*

HRS Wales  
Report No: 267

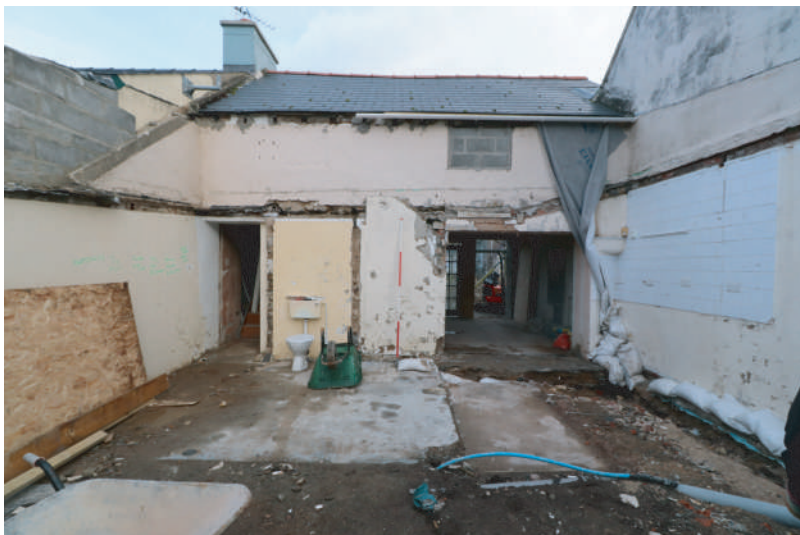
Plate 05. View of rear elevation of Village Store following demolition of former extensions. Looking north.

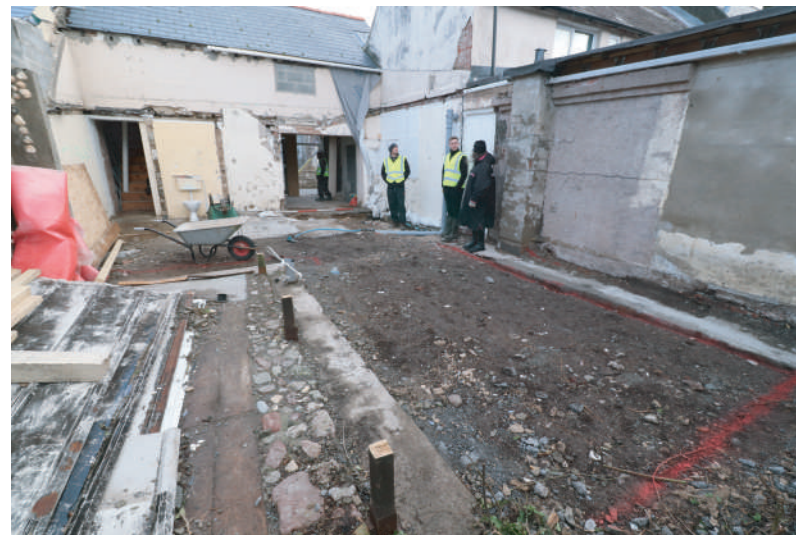
Plate 06. View of rear elevation of Village Store following demolition of former extensions and marking out of foundation trenches. Looking northward.

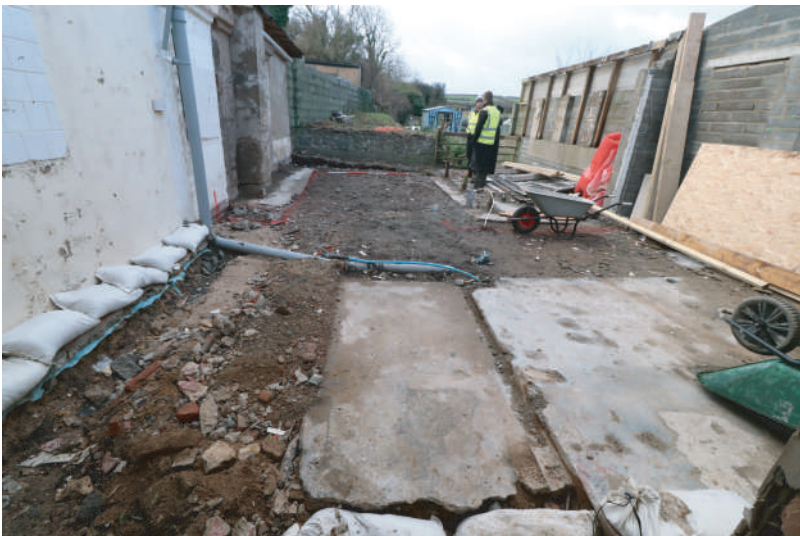
Plate 07. View of rear area of Village Store following demolition of former extensions and marking out of foundation trenches. Looking southward.

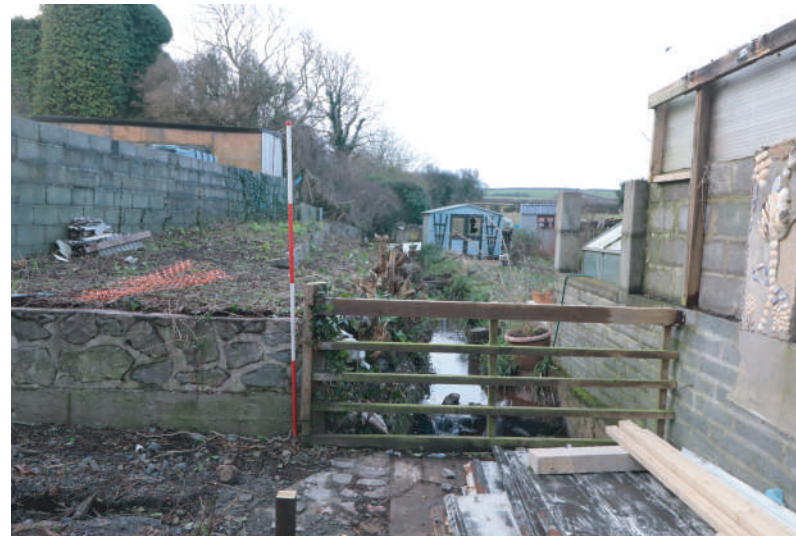
Plate 08. Garden area and culverted stream at rear of Village Store. Note former medieval fortified manor house remains at left of photo ively covered.

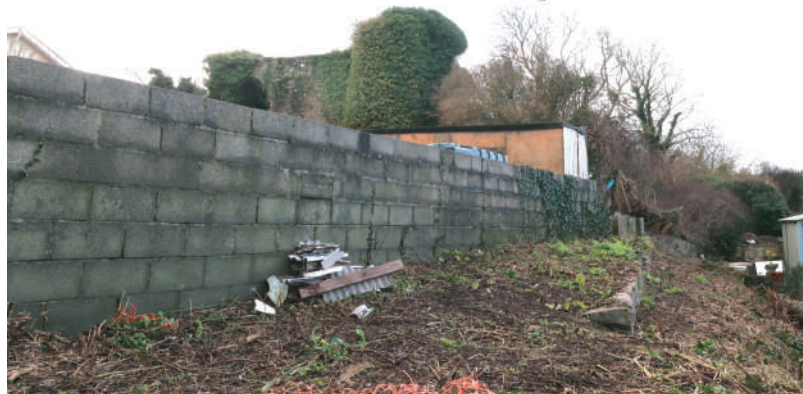
*Plate 09. View garden area to south of proposed development and remains of the medieval fortified manor house covered in ivy (PRN 3090). Looking SE.*

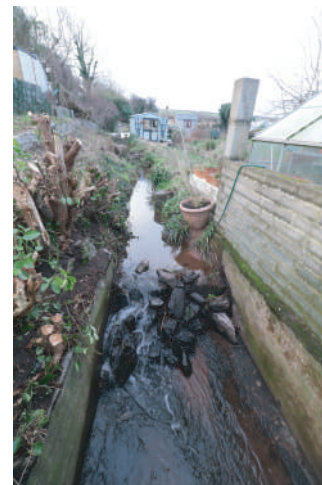
*Plate 10. View of culverted stream in garden area at rear of Village Store.*

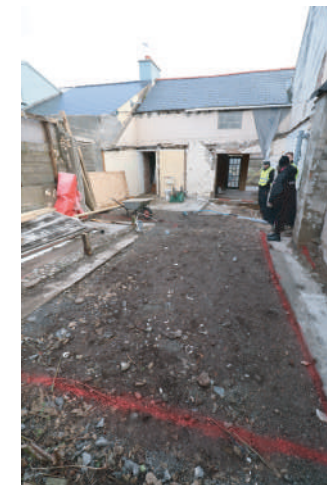
*Plate 11. View of proposed extension area at rear of Village Store. Looking northward.*

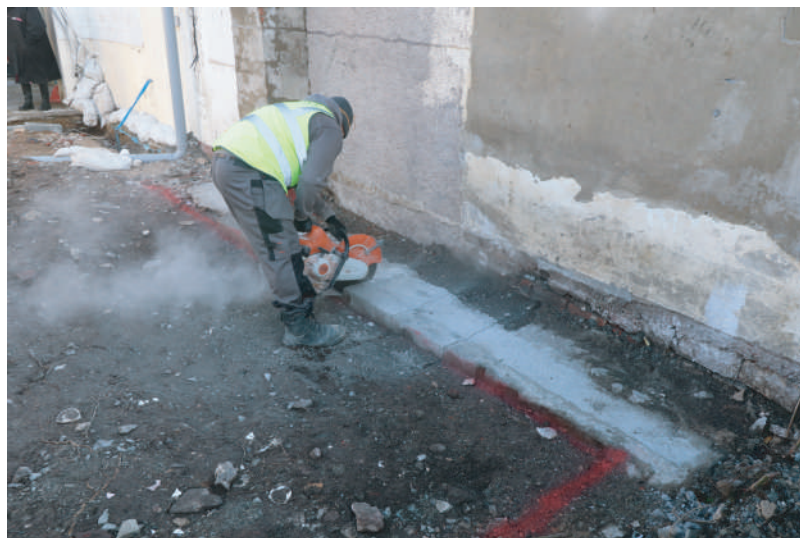
*Plate 12. Working shot during cutting of concrete on east side of proposed garden area in order to initially create foundation trench. Looking NE.*

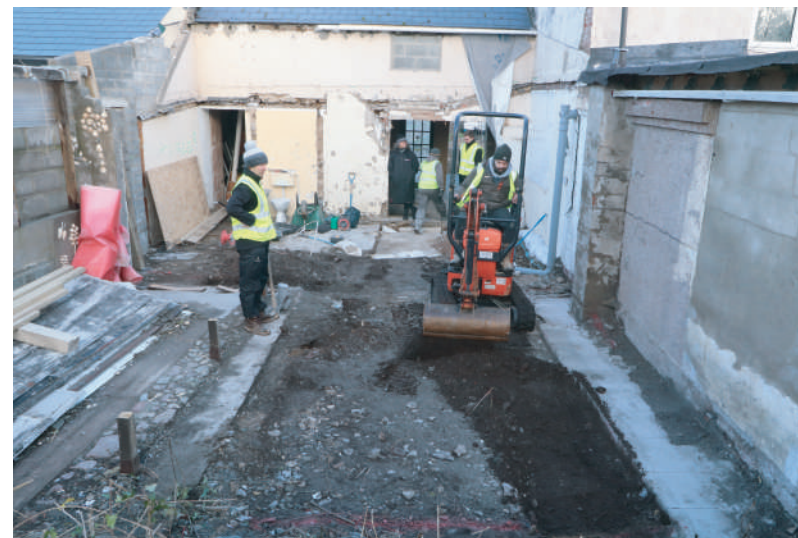
*Plate 13. Stripping back of exposed ground surface at rear of Village Store following demolition of existing extensions. Looking N.*

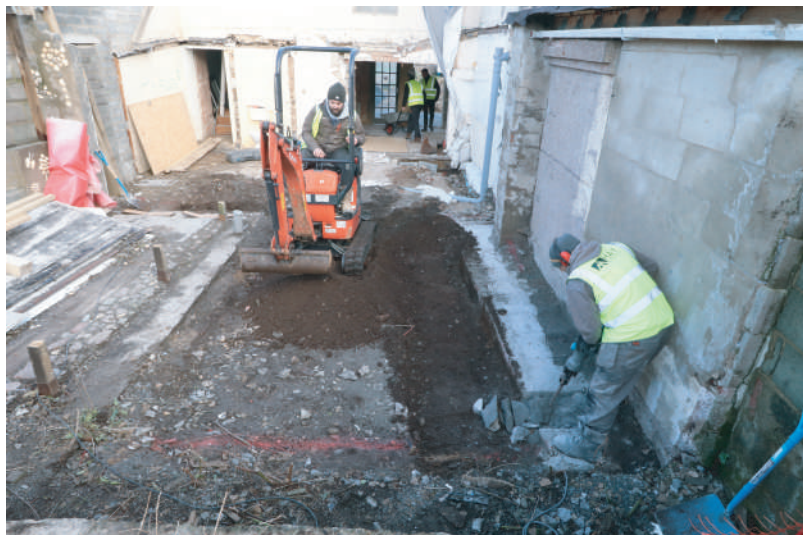
Plate 14. Stripping back of exposed ground surface at rear of Village Store following demolition of existing extensions. Looking N.

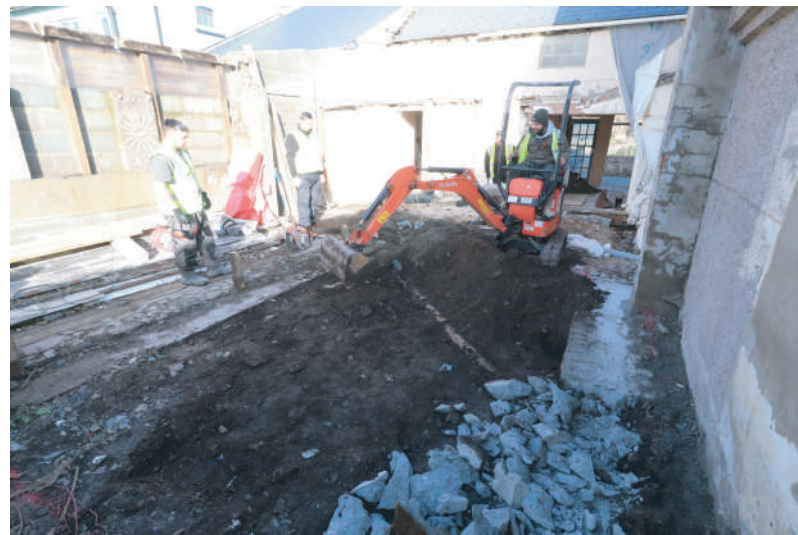
Plate 15. Stripping back of exposed ground surface at rear of Village Store following demolition of existing extensions. Looking N.

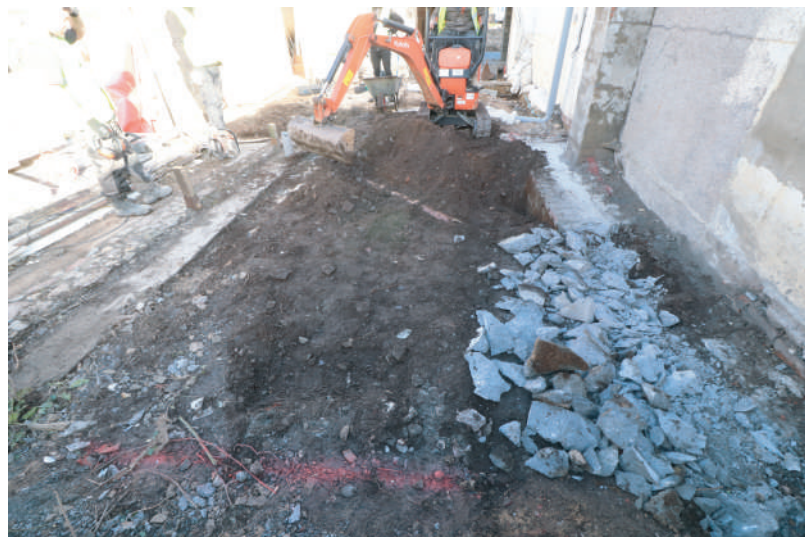
Plate 16. Stripping back of exposed ground surface at rear of Village Store following demolition of existing extensions. Looking N.

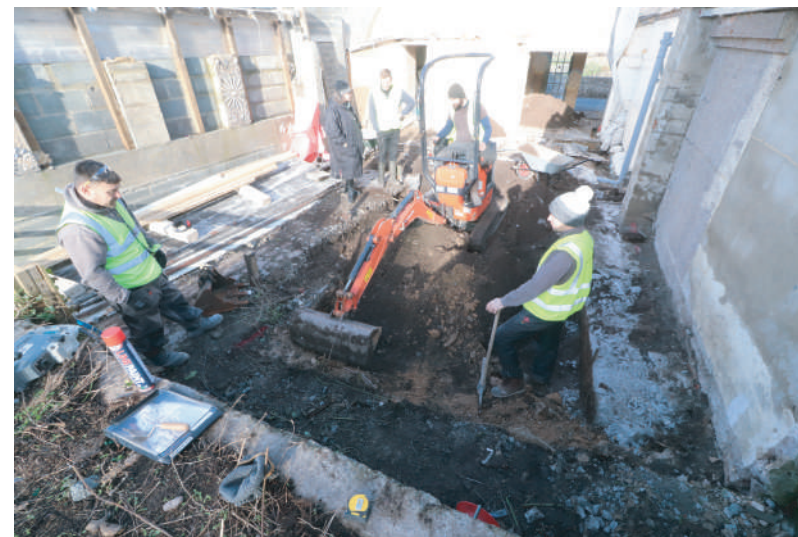
Plate 17. Stripping back of exposed ground surface at rear of Village Store following demolition of existing extensions. Looking N.

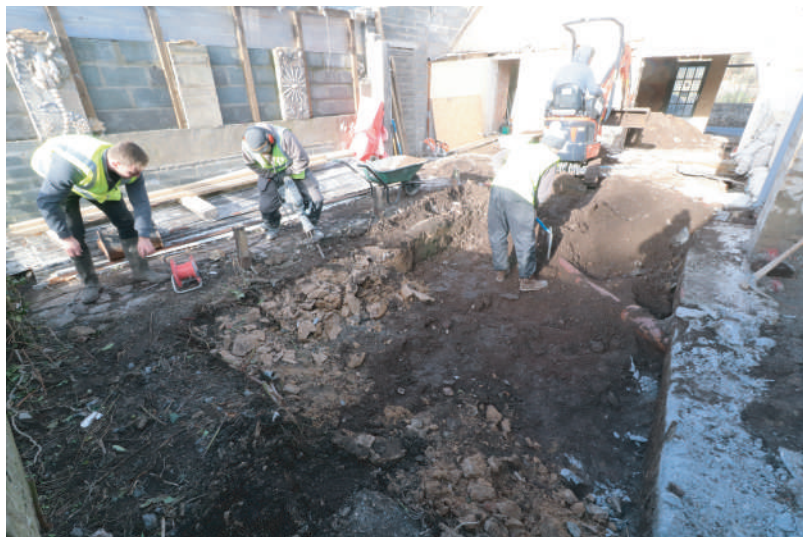
Plate 18. Working shot during stripping back of exposed ground surface at rear of Village Store following demolition of existing extensions. Looking N.

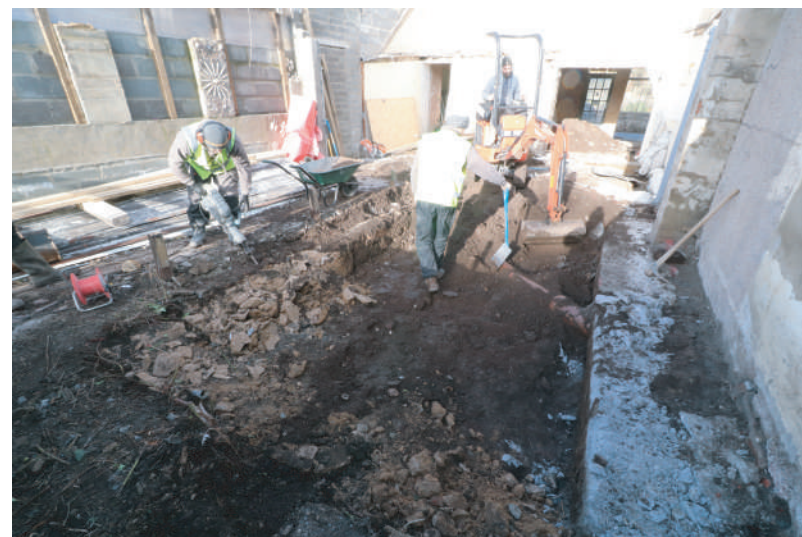
Plate 19. Working shot during stripping back of exposed ground surface at rear of Village Store following demolition of existing extensions. Looking N.

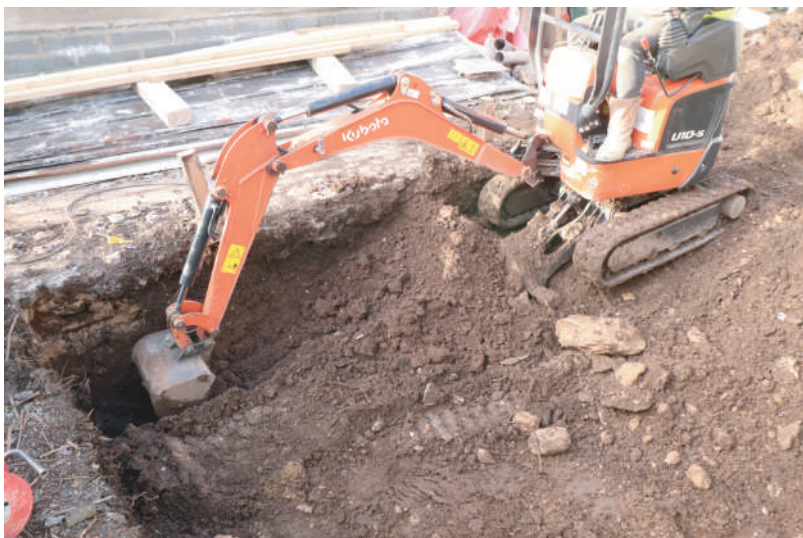
surface again as a foundation for the new extension. As such, only a 0.30m deep trench was dug N-S alongside this concrete base through the same silty sandy deposit (103). A further 0.30-40m slot was cut E-W across the southern area. Both these slots exposed no significant archaeology other than occasional 19<sup>th</sup> century pottery fragments and sea shells, including cockles, oysters and scallops. The foundation cut for the N-S wall on the west side of the area was to be dug much deeper than the earlier trenches, given that it was positioned parallel to the culverted stream. Following the removal of the remains of the former N-S wall of the existing extension and the removal of a large lump of concrete and rubble (107) that had once supported a modern sink unit, the slot was excavated to a maximum depth of only 0.80m. Once the silty sandy deposit (103) had been removed to a depth of approximately 0.30m, a band of similar sandy silty soil became exposed with a greater concentration of sea shells with it, including 19<sup>th</sup> Century pottery fragments. This deposit (104) measured only approximately 0.15m – 0.20m in depth. Directly below this was a further silty sandy deposit (105) which reached a depth of approximately 0.40m in depth. No dateable material was recovered from this deposit. At approximately 0.80m in depth a natural sandy grit (108) became exposed, this depth being at the same depth as the culverted stream to the west.

Plate 20. Working shot during cutting of foundation trench alongside culverted stream. Looking NW.

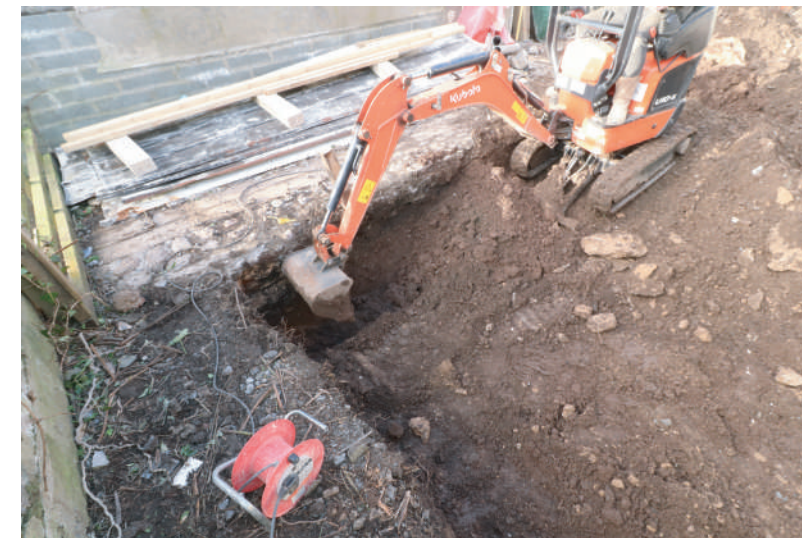
Plate 21. Working shot during cutting of foundation trench alongside culverted stream. Looking NW.

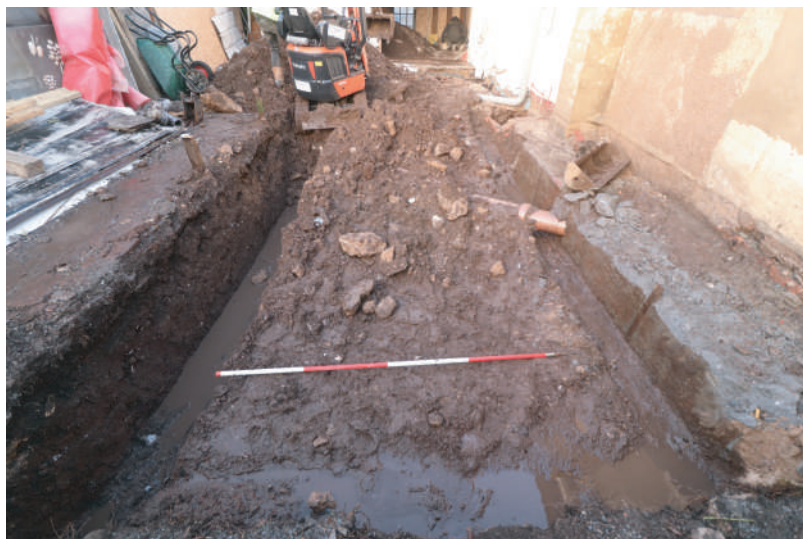
Plate 22. Completed ground work at rear of Village Store following demolition of existing extensions. Looking N.

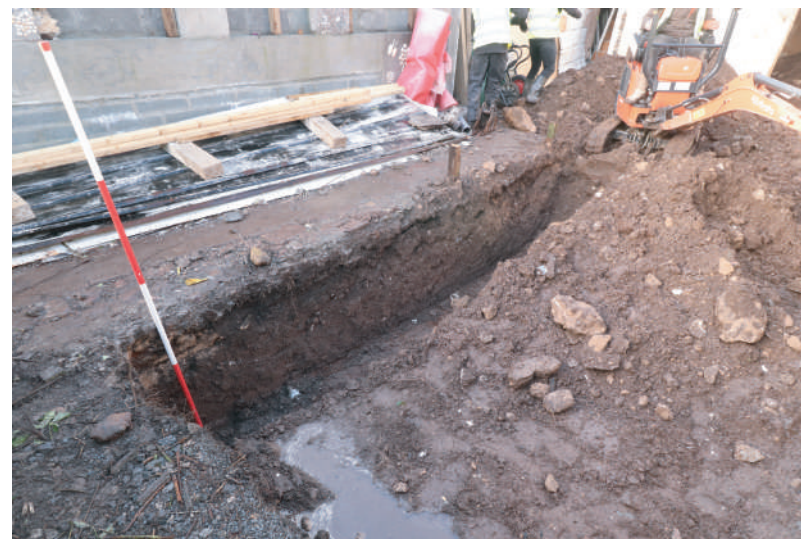
Plate 23. Completed ground work at rear of Village Store following demolition of existing extensions. East facing section. Looking NW.

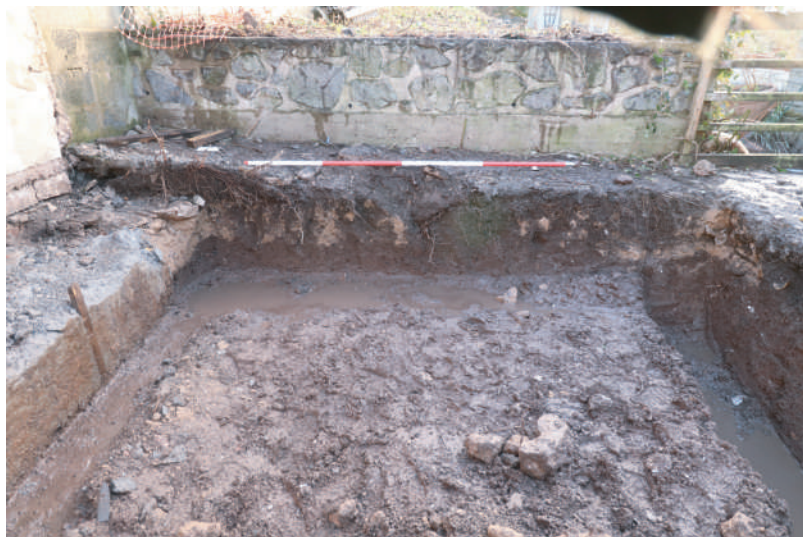
Plate 24. Completed ground work at rear of Village Store following demolition of existing extensions. North facing section. Looking S.

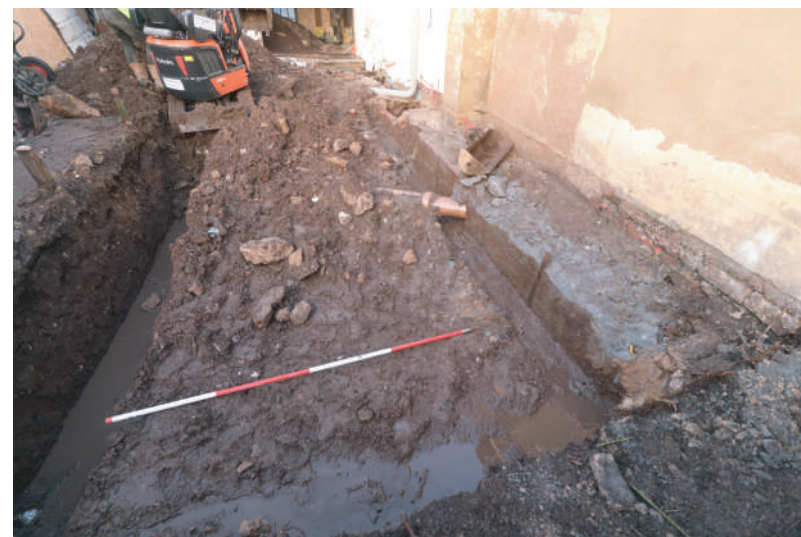
Plate 25. Completed ground work at rear of Village Store following demolition of existing extensions. Looking N.

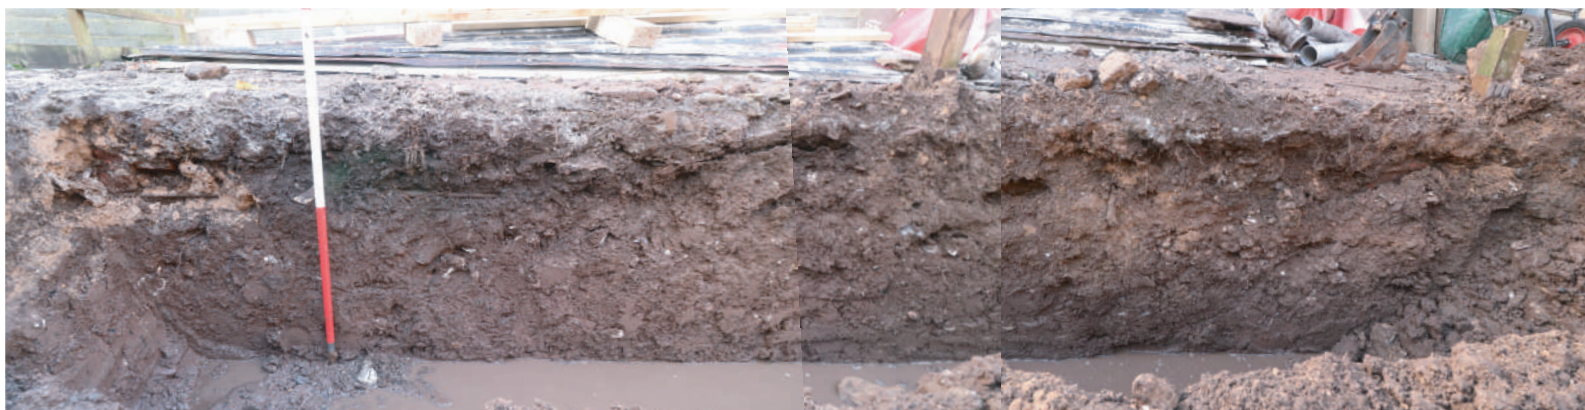
5.4 Following demolition of the existing extension at the southern end of the area and clearance of the resulting rubble and tiled floor, a dark silty sandy deposit (103) with occasional 19<sup>th</sup> Century pottery fragments became exposed. Pottery included fragments of blue on white ware, white ware, Windsor ware and stone ware. At the far east end of the area was a concrete raft that had once supported a N-S wall of the former extension, but was also serving as a base foundation for an extension at No.8 next door. Initially, groundwork entailed the cutting of this concrete in order to put in a N-S foundation cut. However, following an attempt at removal of this cut section of concrete, it was discovered that this concrete surface was approximately 0.50m in thickness. As such it was decided to excavate a narrower slot, approximately 0.30m in width alongside this concrete and use part of the concrete

*Plate 25. East facing section A- B. Looking W.*
