# **Proposed new dwellings on land adj. to Dolau Hirion, Rhydyfelin, Aberystwyth, Ceredigion**

## **Archaeological Evaluation**

HRSWales  
Report No: 175

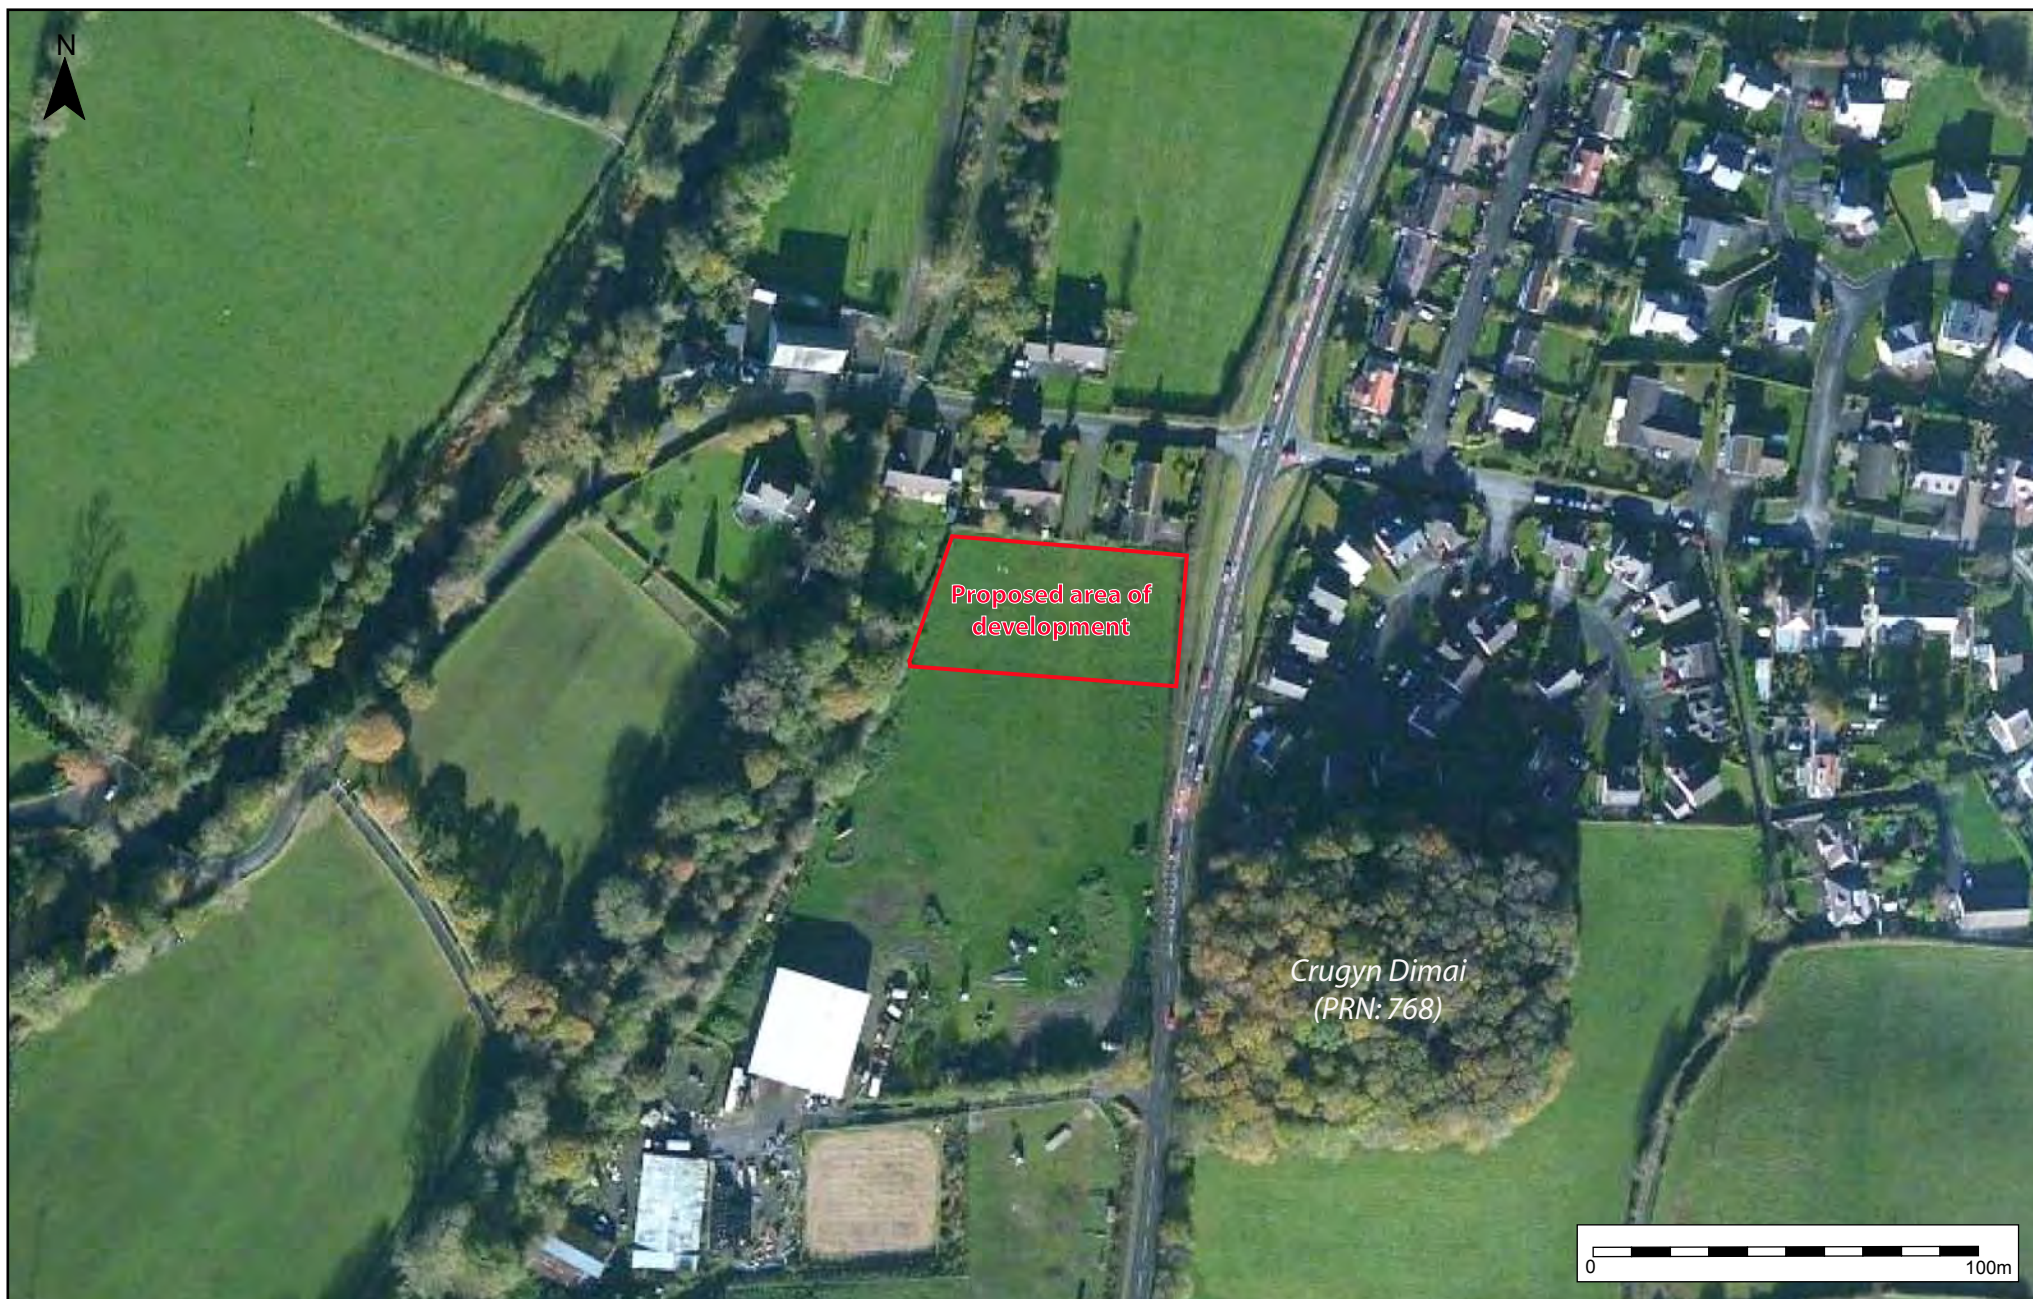
**Figure 3.** OS Aerial Photo (2013)

- 4.8 Aerial photos investigated as part of the cartographic work only looked at a 2013 Ordnance Survey vertical aerial photograph. No features were readily evident in the field on this recent OS edition map.

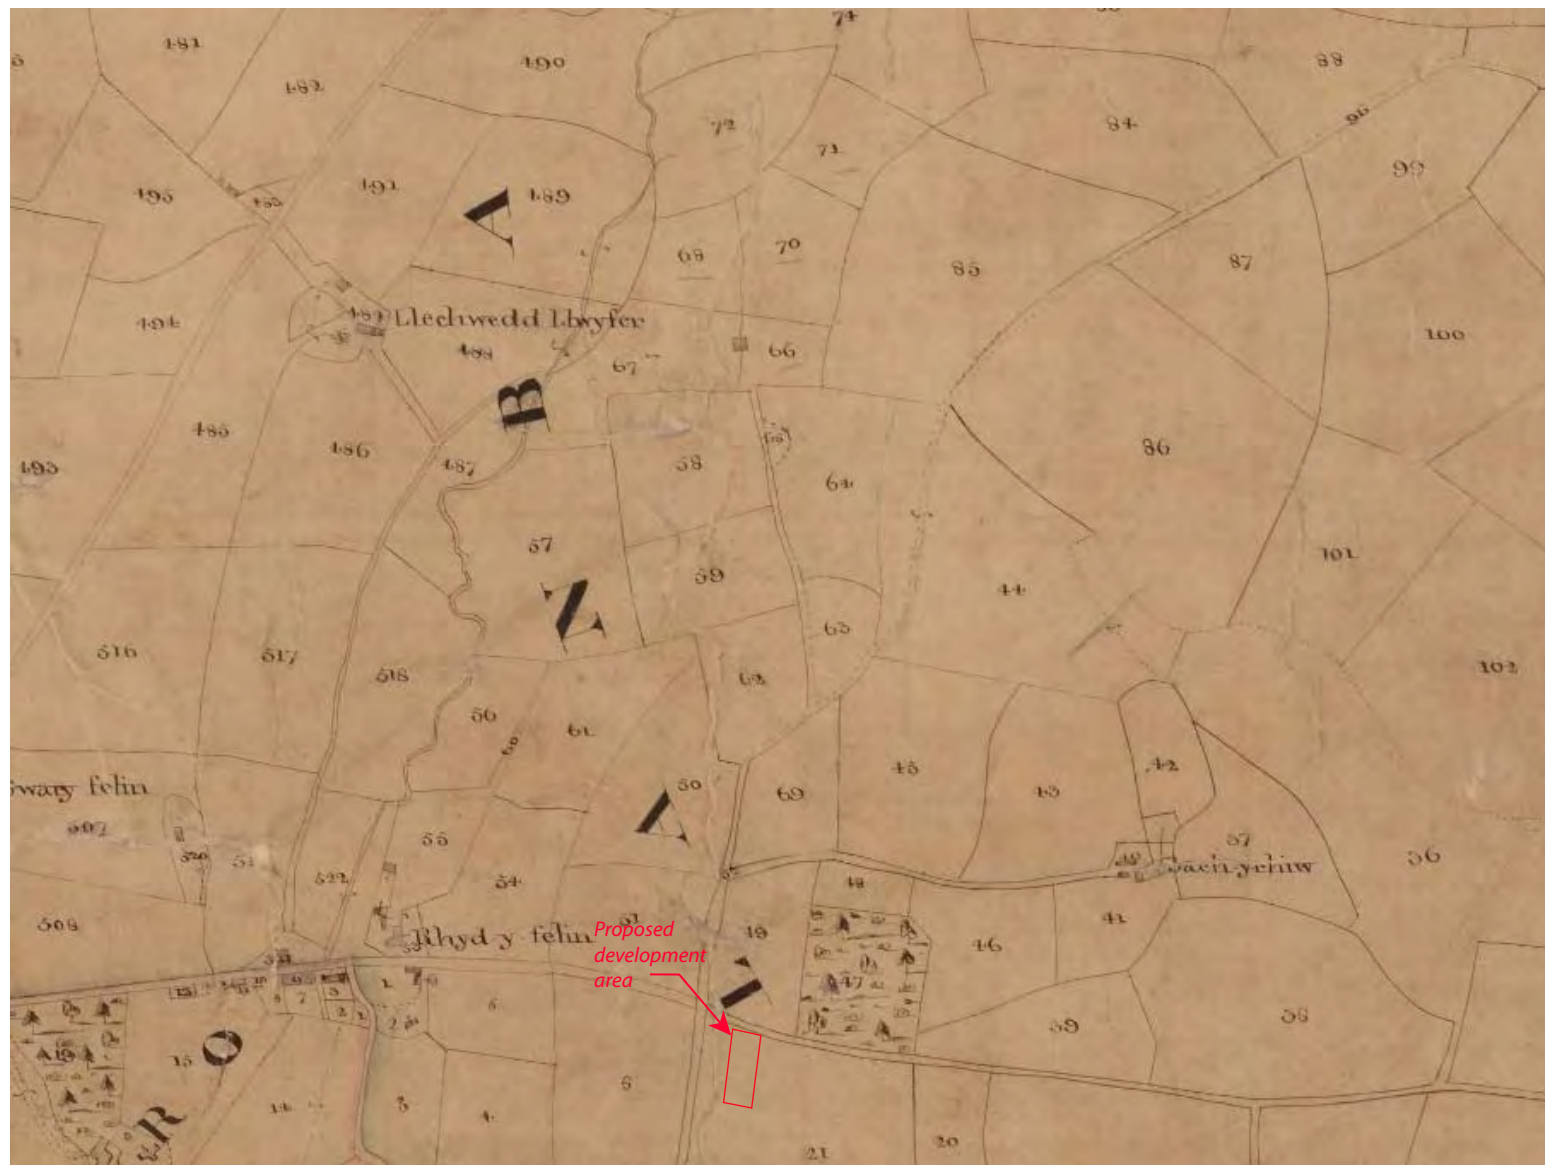
**Figure 6.**

- 4.3 The tithe map for the Llanbadarn Fawr parish shows the proposed development area as being much the same as that shown in the earlier OS Surveyors drawing of 1821. No buildings or structures within approximately 80 meters.

Tithe Map (Llanbadarn Fawr Parish - 1840)

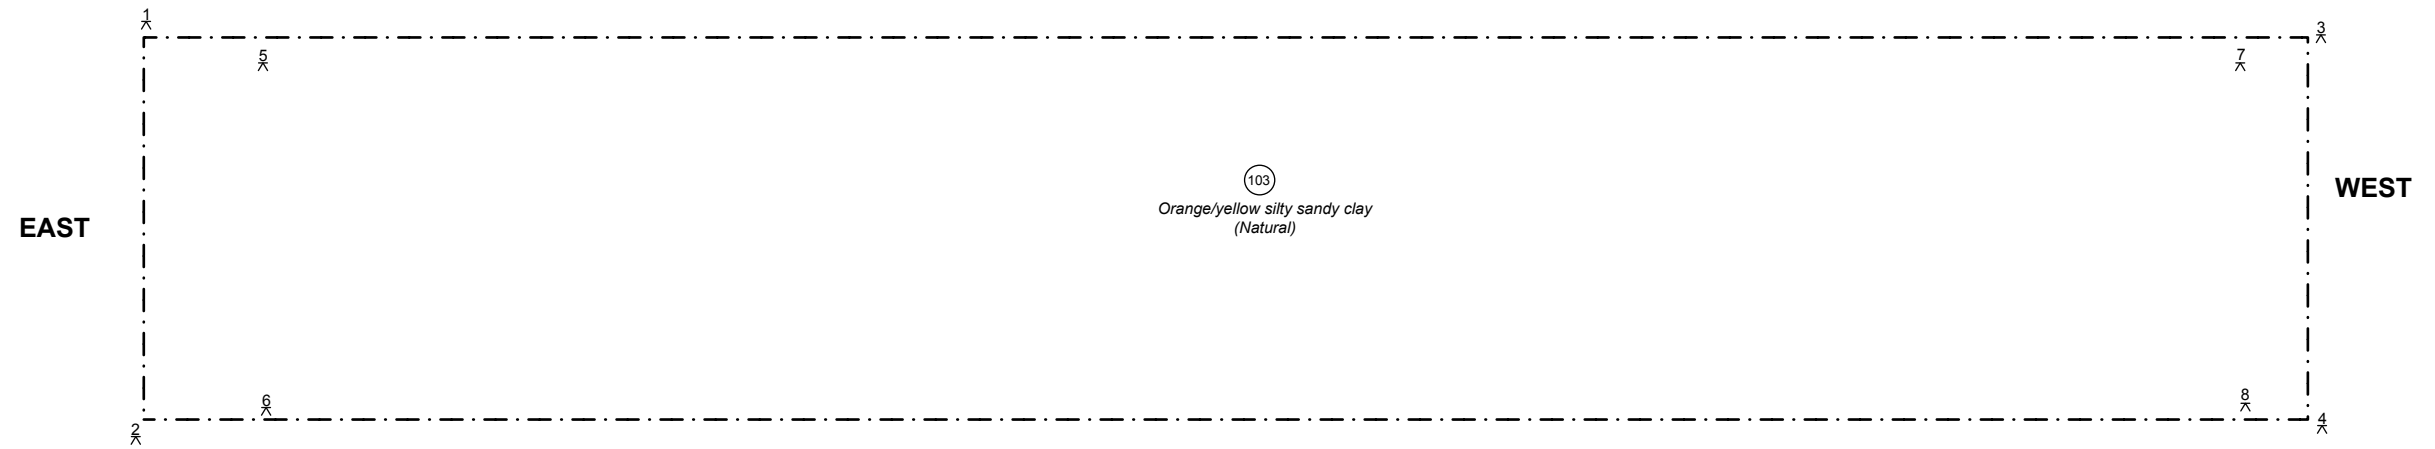
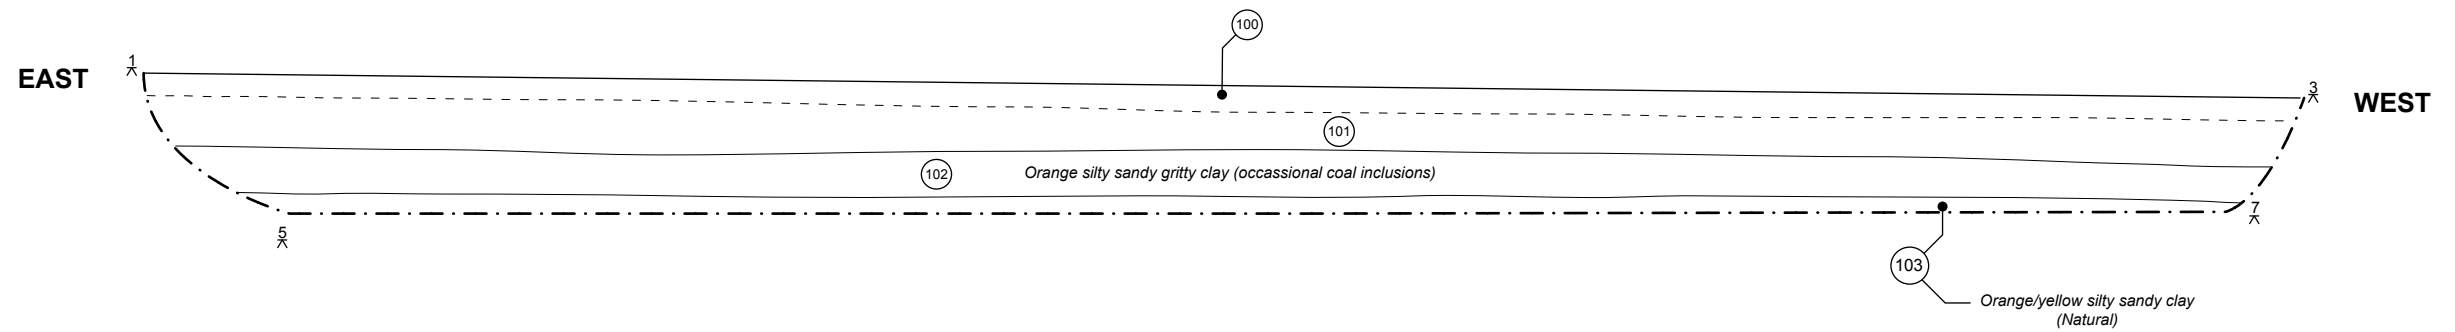
<b>Project Title:</b> Rhydyfelin, Aberystwyth, Ceredigion		<b>Figure 11.</b> Trench 1 - Ground Plan and North Facing Section

5.3 This first trench measured 10m in length x 1.8m in width and was positioned running east to west.

5.4 With the turf removed a mid brown clay/loam soil became exposed (100) which measured approximately 0.15m in depth. This deposit contained occasional fragments of early 19<sup>th</sup> century pottery, which included fragments of hand-painted floral blue on white ware, white ware and blue and black banded glazed beige ware.

5.5 Indistinctly below this top soil was a sub soil of mid brown silty sandy clay (101) which averaged a depth of approximately 0.20m. No dateable finds were recovered from this deposit in this trench.

5.6 Directly below this deposit was an orange silty sandy gritty clay deposit (102) with occasional flecks of coal (0.5%). No dateable finds were recovered from this deposit in this trench.

5.7 Directly below this was a natural orange/buff coloured silty sandy clay with sandstone inclusions (103).

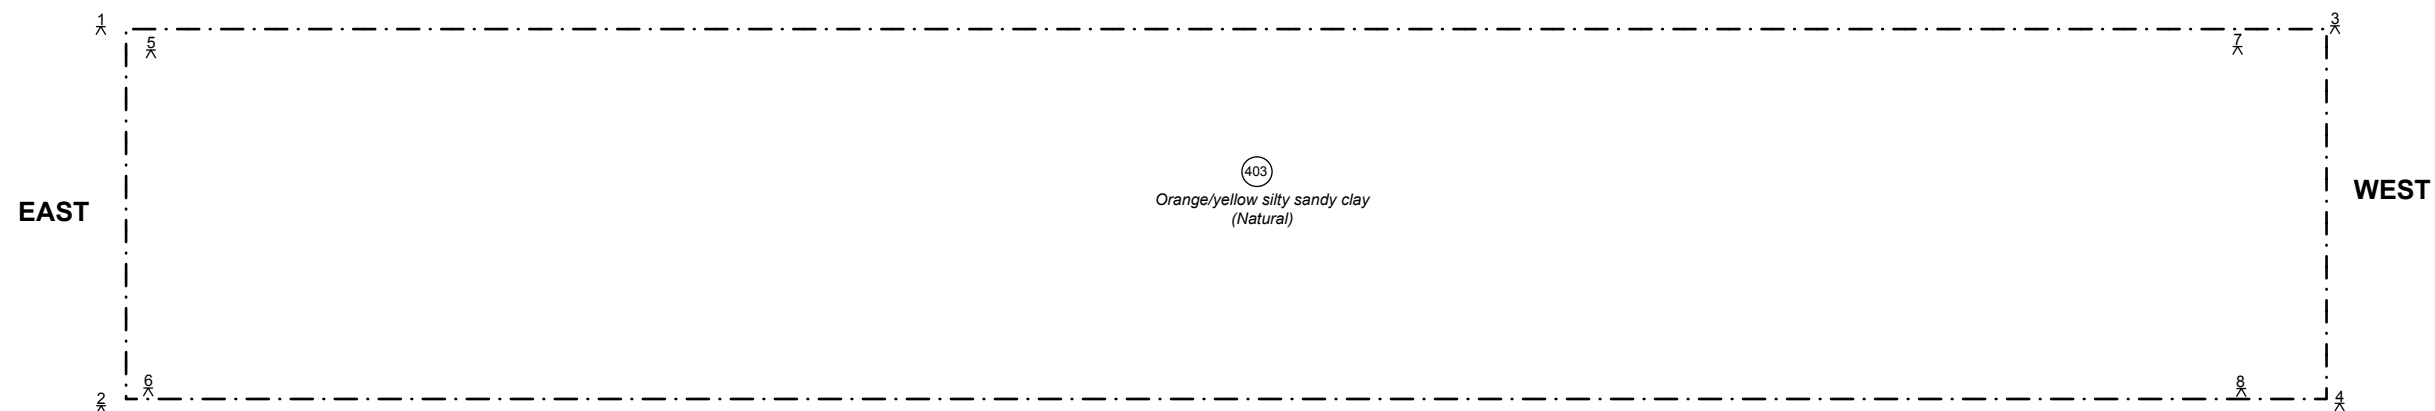
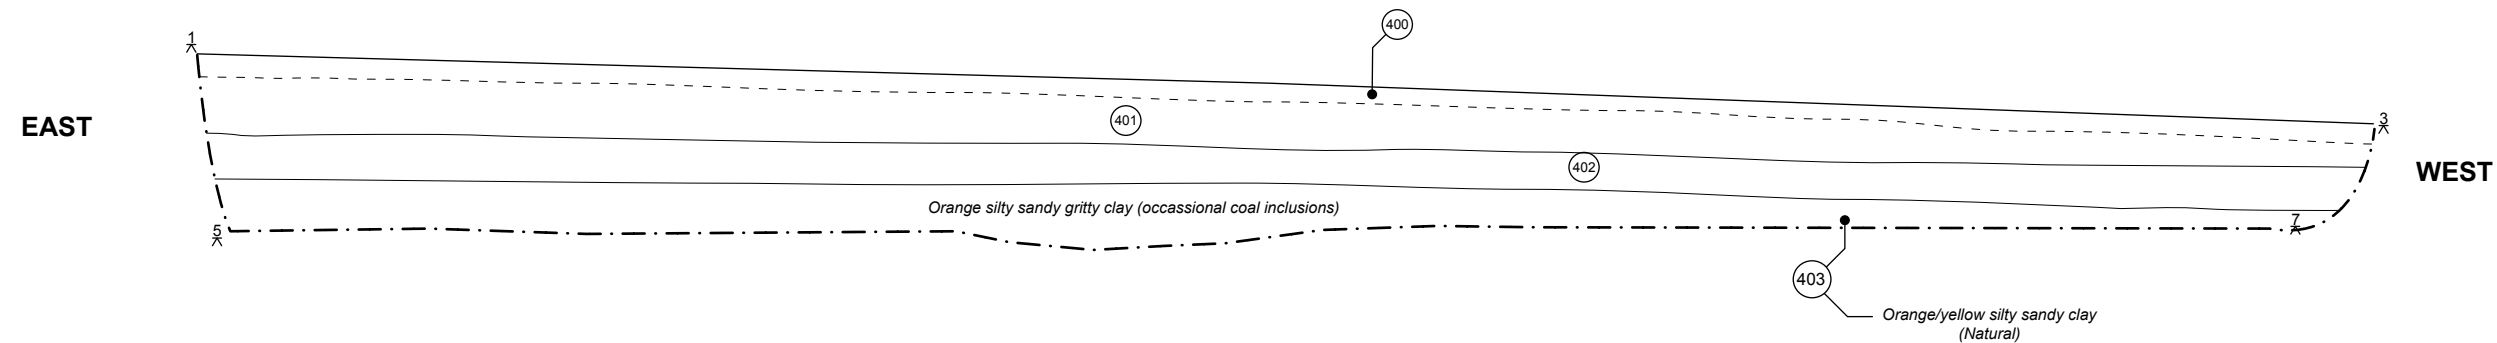
Project Title: Rhydyfelin, Aberystwyth, Ceredigion		Figure 14. Trench 4 - Ground Plan and North Facing Section	
Date: 3rd March 2016	Approx. scale (@A4):		
Drawn by: Richard Scott Jones	Drawing No.

- 5.17 With the turf removed a mid brown clay/loam soil became exposed (400) which measured approximately 0.15m in depth. This deposit contained occasional fragments of early and late 19<sup>th</sup> century pottery, which included one small fragment of hand-painted floral blue on white ware, one cream coloured fragment from a jam or pate jar, and one animal (bovine) rib bone with butchery marks.

- 5.18 As with the results from Trench 1, directly below the top soil was a sub soil (401) with an indistinct horizon of mid brown silty sandy clay, which averaged a depth of approximately 0.20m. Recovered from this deposit was a small fragment of late 18<sup>th</sup> century glazed gravel tempered ware.

- 5.19 Directly below this deposit was an orange silty sandy gritty clay deposit (402) with occasional flecks of coal (0.5%). No dateable finds were recovered from this deposit in this trench.

- 5.20 Directly below this was a natural orange/buff coloured silty sandy clay with sandstone inclusions (403).

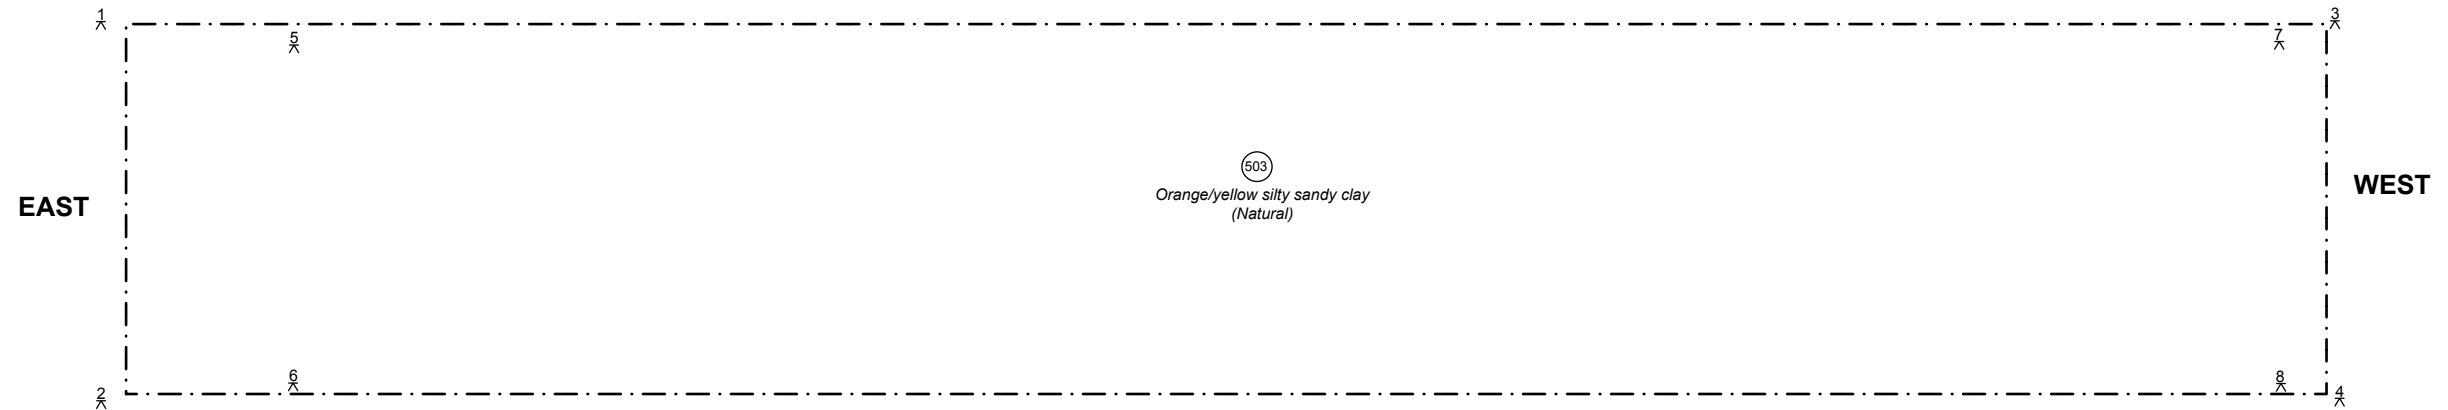
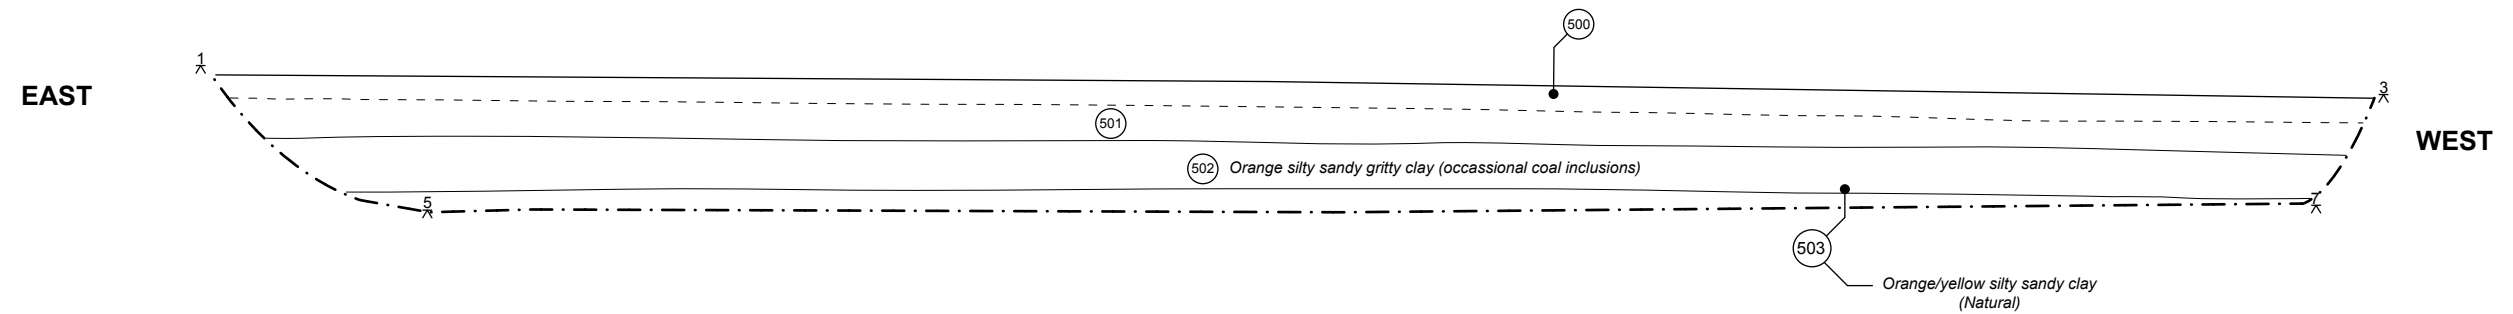
Project Title: Rhydyfelin, Aberystwyth, Ceredigion		Figure 15. Trench 5 - Ground Plan and North Facing Section	
Date: 3rd March 2016	Approx. scale (@A4):		
Drawn by: Richard Scott Jones	Drawing No.

- 5.21 With the turf removed a mid brown clay/loam soil became exposed (500) which measured approximately 0.15m in depth. This deposit contained occasional fragments of late 19<sup>th</sup> century pottery, which included one small fragment of glazed Black Ware, one small fragment of glazed white ware (china) and a fragment of unglazed terracotta clay bowl rim.
- 5.22 As with the results from Trench 1, directly below the top soil was a sub soil (501) with an indistinct horizon of mid brown silty sandy clay, which averaged a depth of approximately 0.20m.
- 5.23 Directly below this deposit was an orange silty sandy gritty clay deposit (502) with occasional flecks of coal (0.5%). No dateable finds were recovered from this deposit in this trench.
- 5.24 Directly below this was a natural orange/buff coloured silty sandy clay with sandstone inclusions (503).

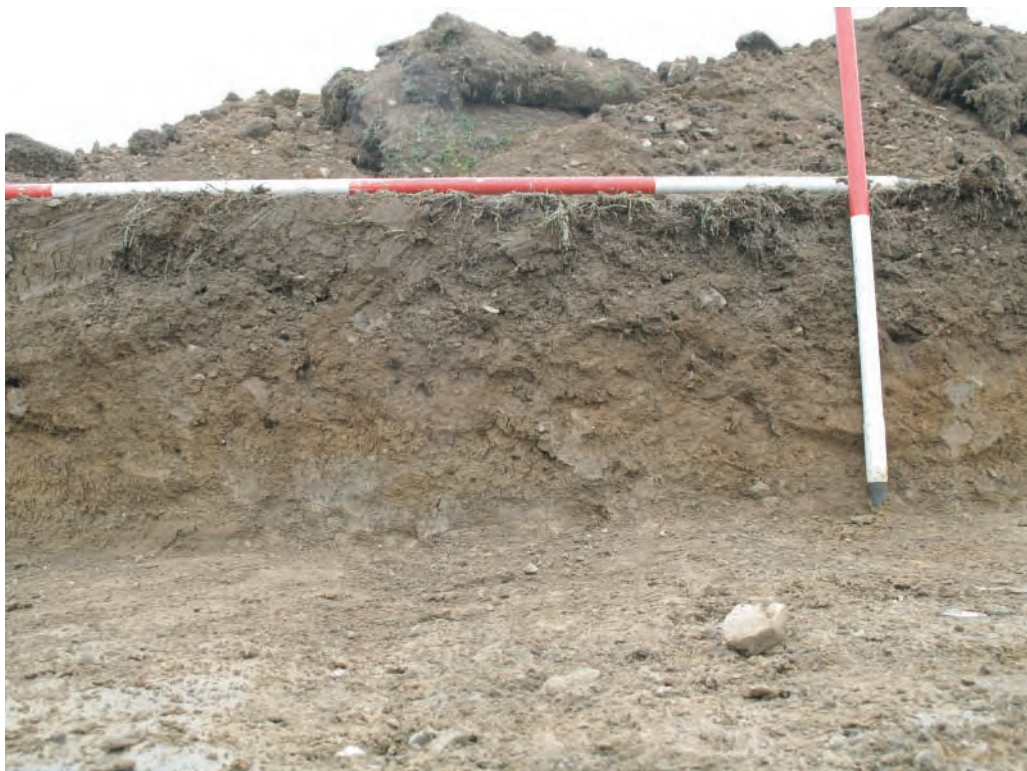
*Plate 5. Typical stratigraphy in south facing section of Trench 1.*

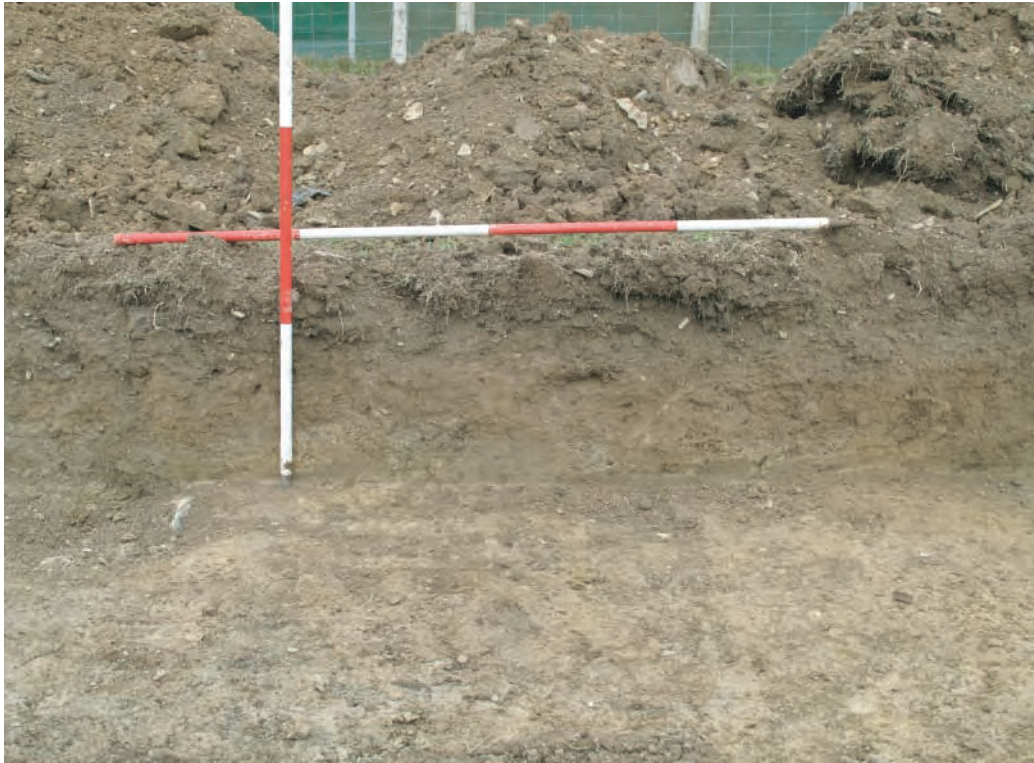
*Plate 11. Area of typical stratigraphy in south facing section of Trench 2. Looking north.*

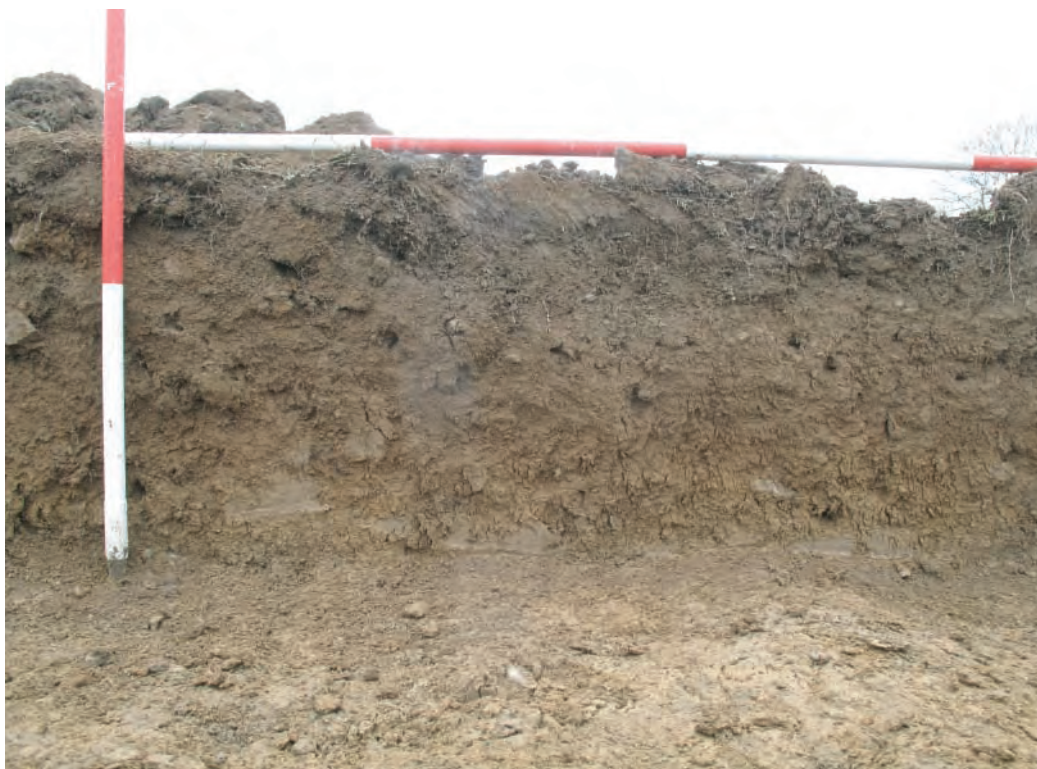
*Plate 15. Typical stratigraphy in south facing section of Trench 3. Looking north.*

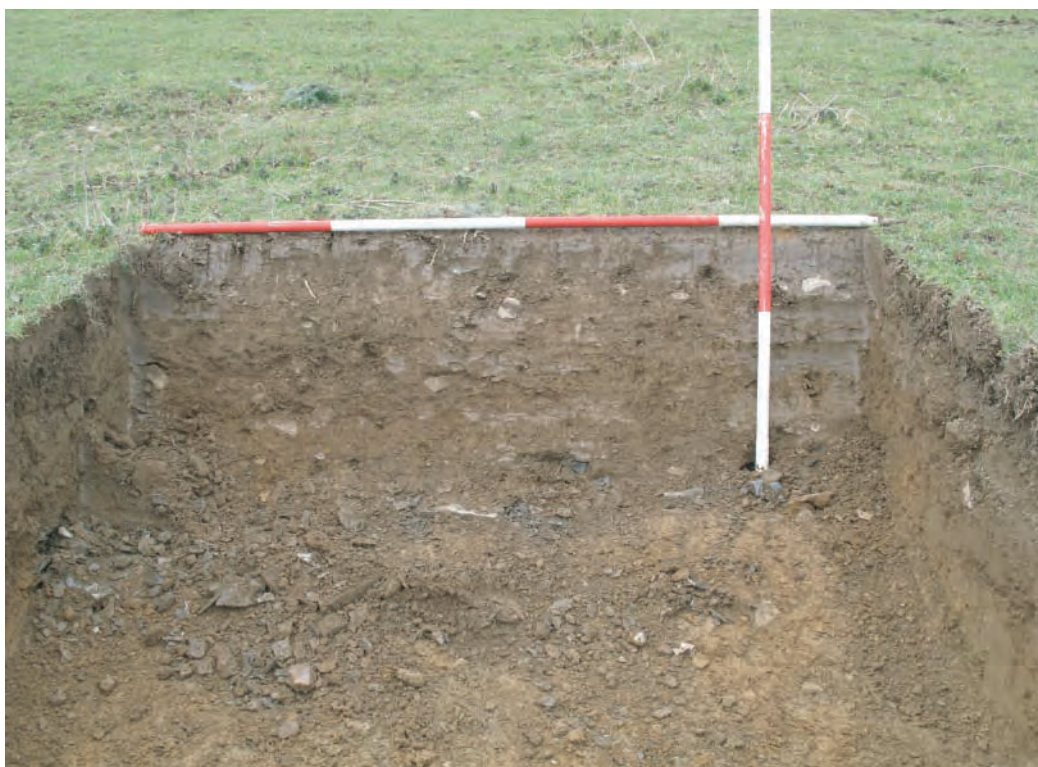
*Plate 16. East facing section of Trench 3. Looking west.*

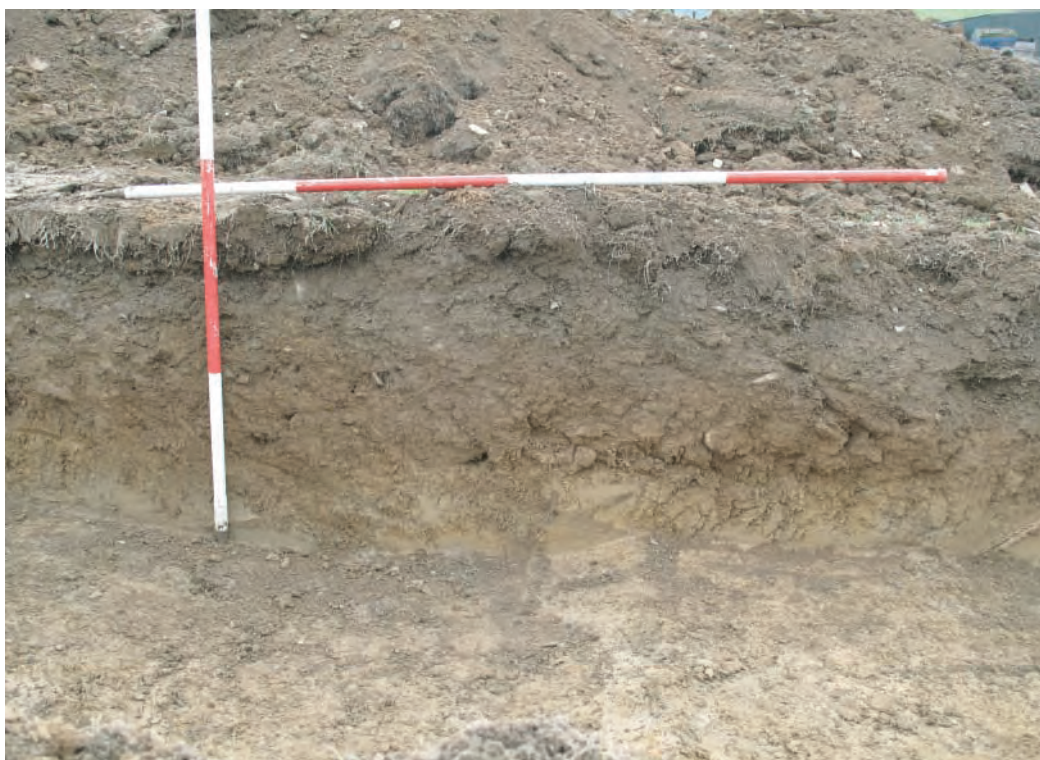
*Plate 19. Typical area of stratigraphy in north facing section of Trench 4. Looking south.*

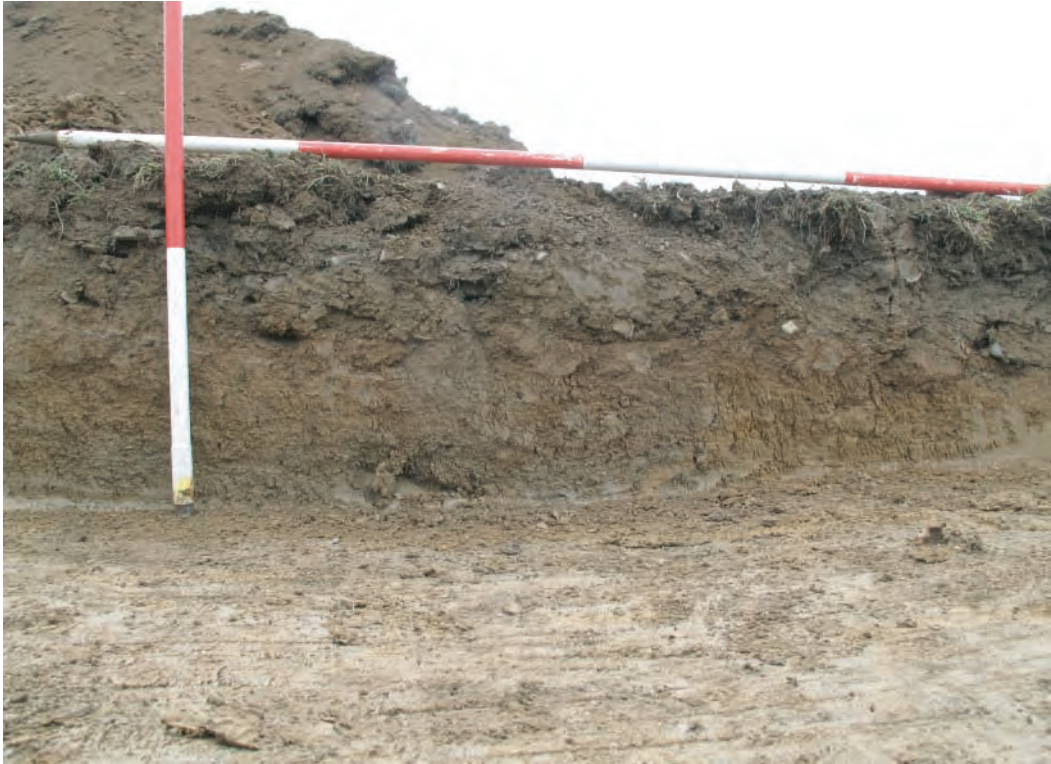
*Plate 23. Typical stratigraphy in south facing section of Trench 5. Looking northwards.*
