Proposed dwelling on land at Llandruidion, Solva, Pembrokeshire.

**Archaeological Watching Brief &
Standing Building Recording**

HRSWales
Report No: 177

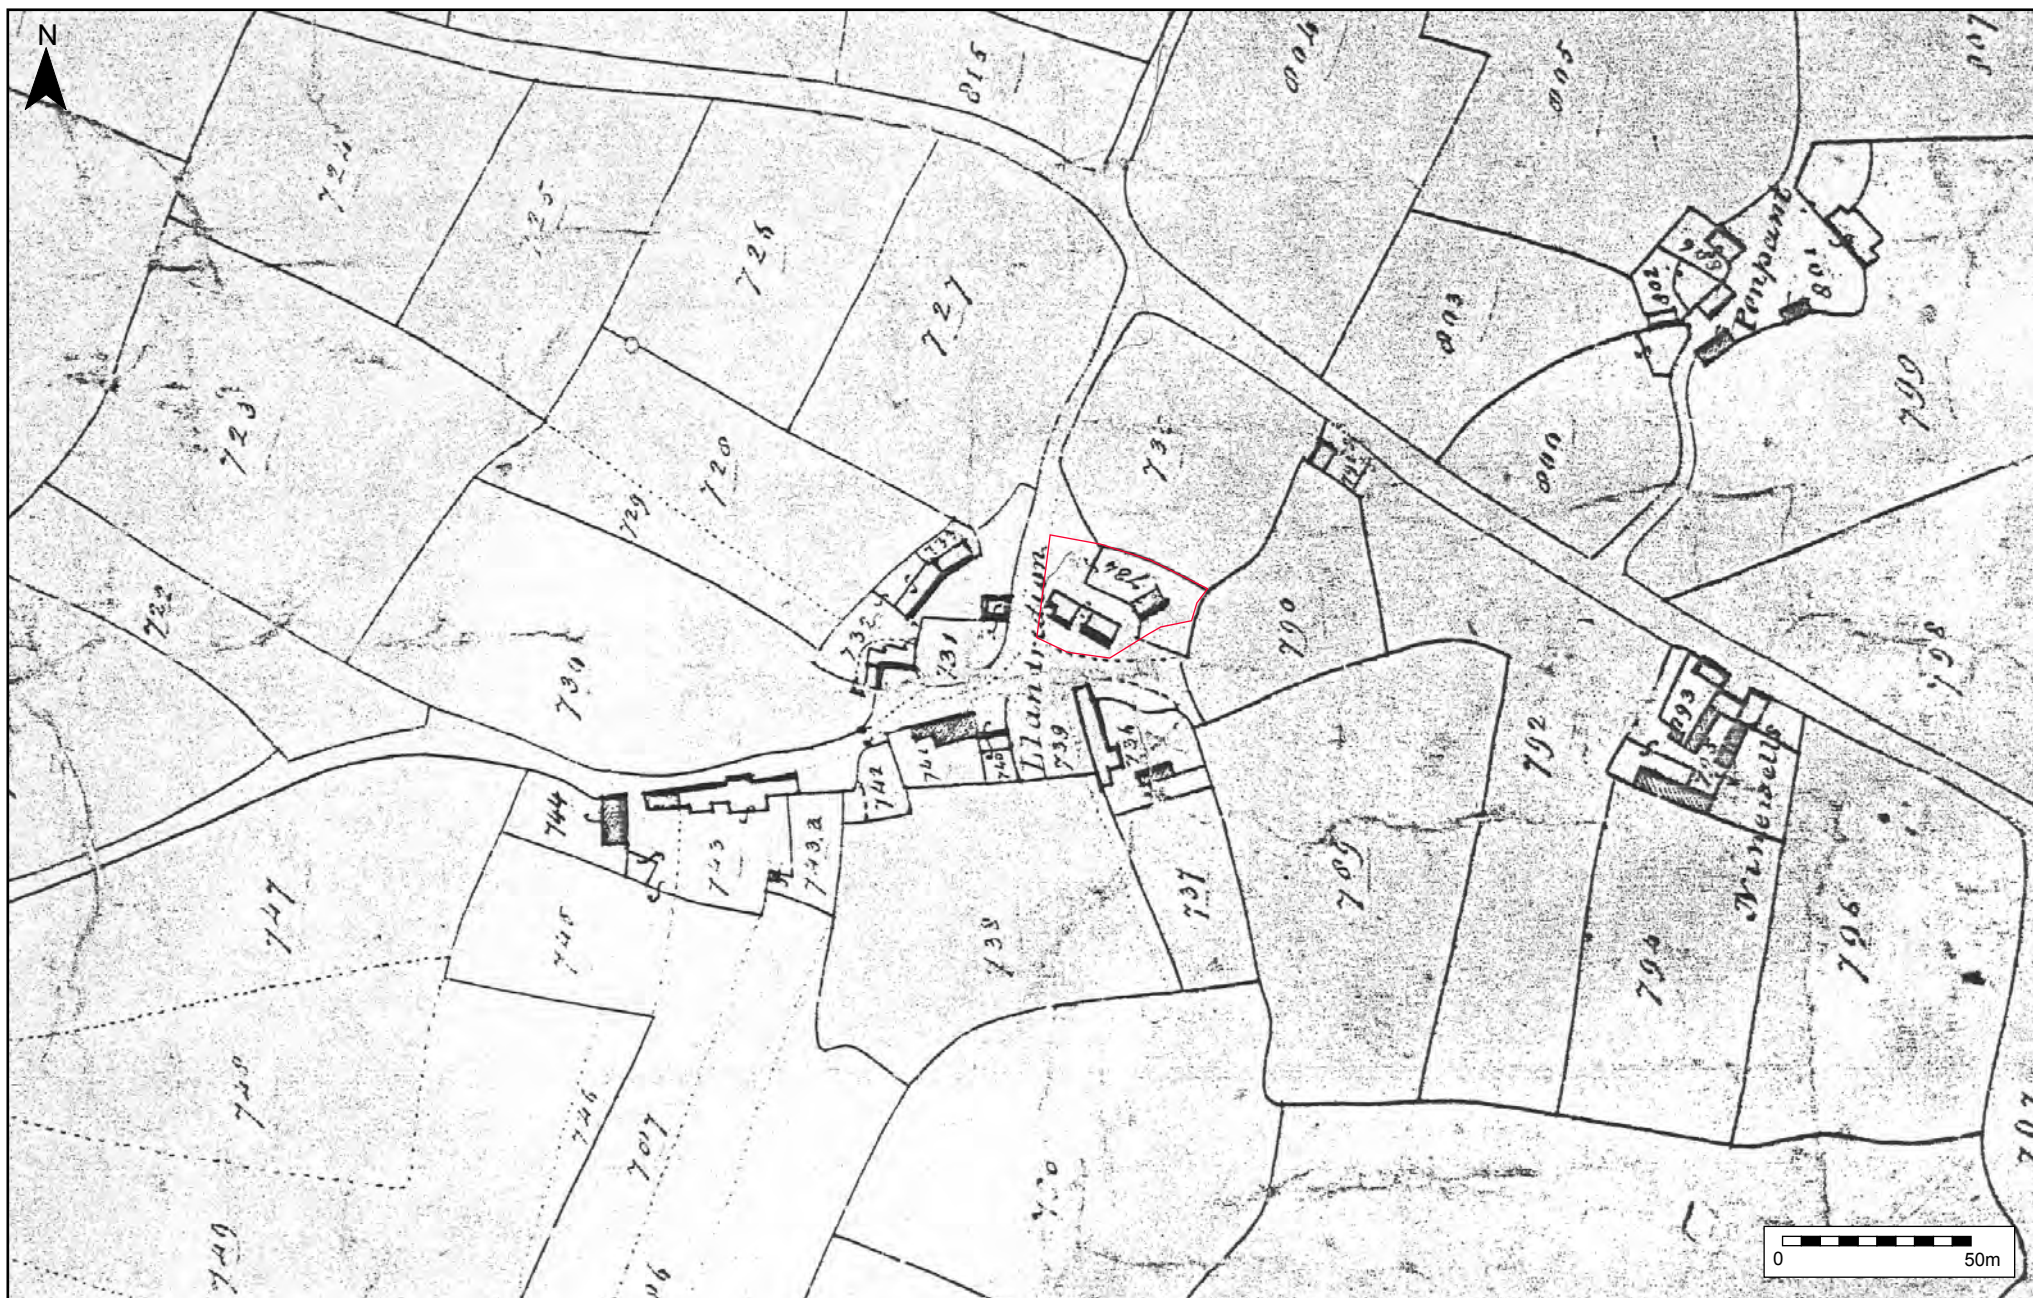
Figure 5. Portion of Tithe Map from St. David's Parish (East) dated 1842. Village marked as Llandrudion and proposed development area appears to have been shared between No's 734 and 739, John Jones MD and William Lewis respectively.

2015 evaluation trench (Trench 2) and probably represents a continuation of a former late 17th – 18th century earth and stone boundary bank, whose position is probably shown on the Tithe Map of 1842 and the early OS First Edition Map of 1887.

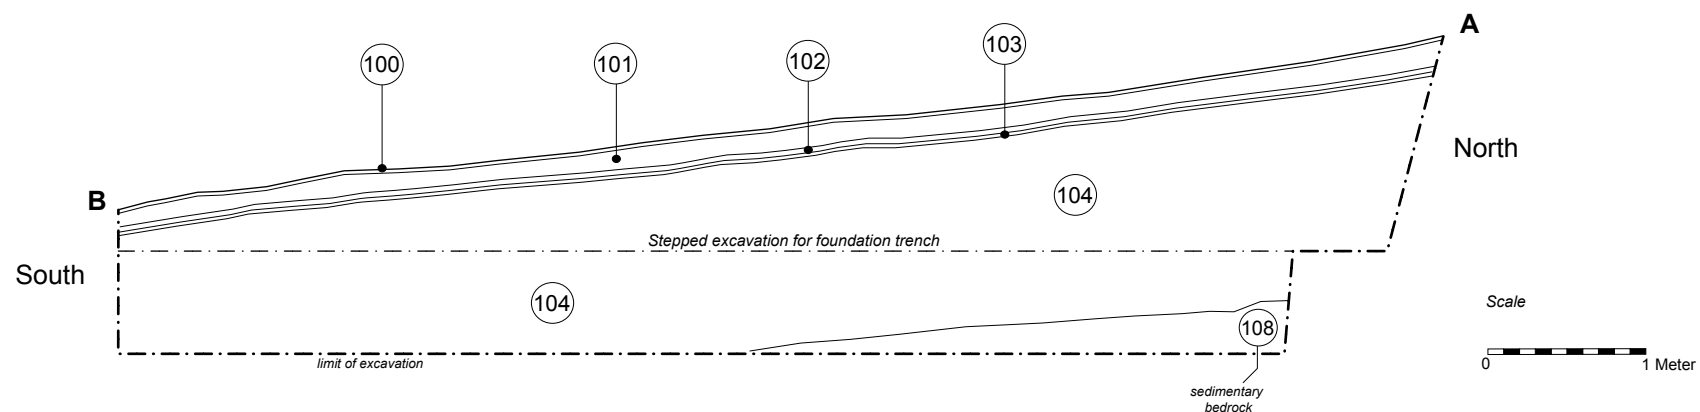
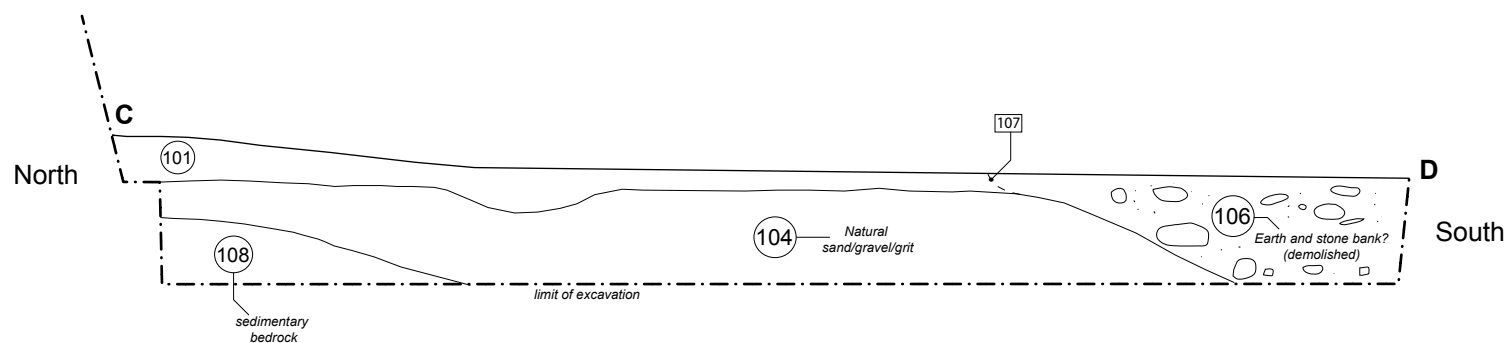
Figure 10.

East facing section (A - B) and West facing section (C - D)

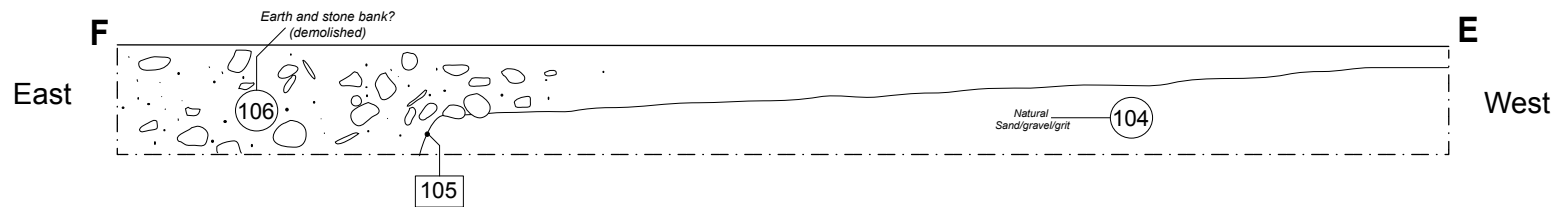
North facing section (E - F)

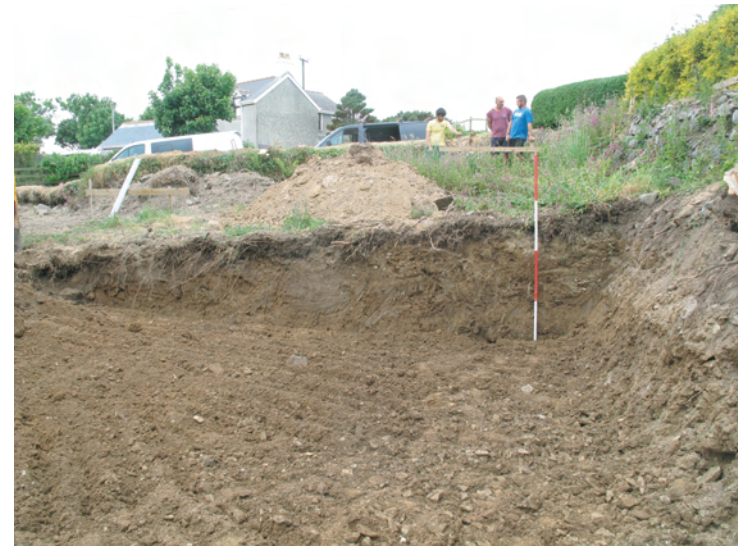
Plate 6. East facing section following ground reduction and top soil strip. Looking west.

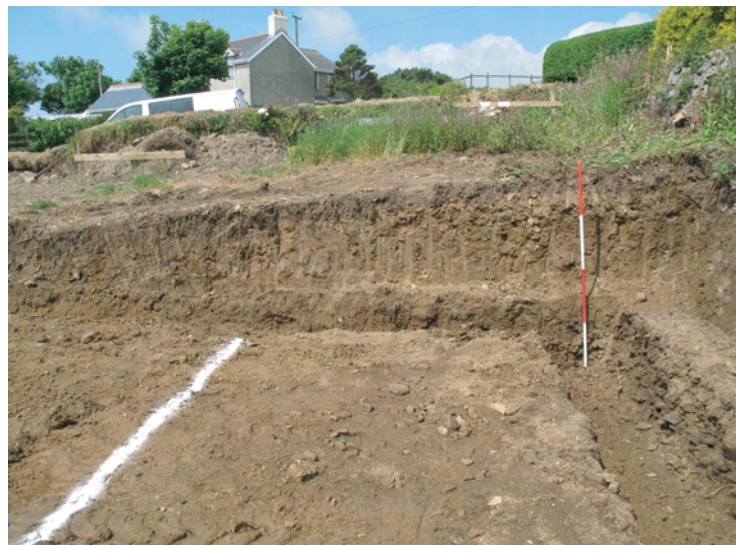
Plate 9. West facing section following groundwork. Looking west. North end.

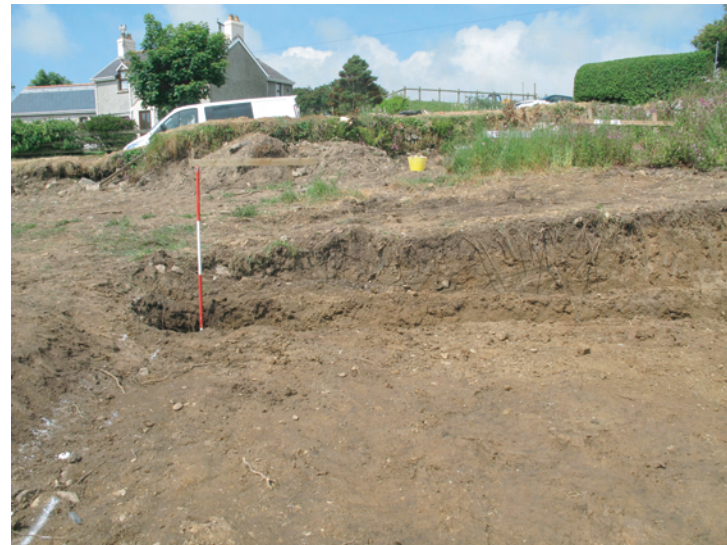
Plate 10. West facing section following groundwork. Looking west. Southern end.

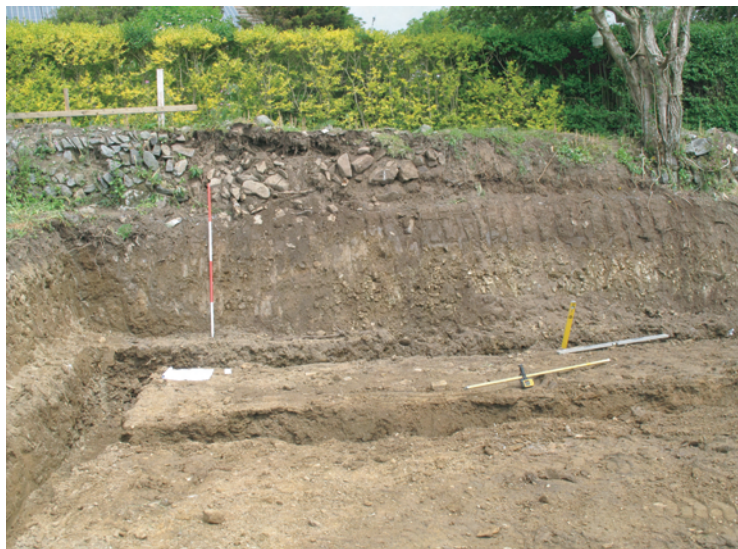
Plate 11. South facing section following groundwork. Looking north.

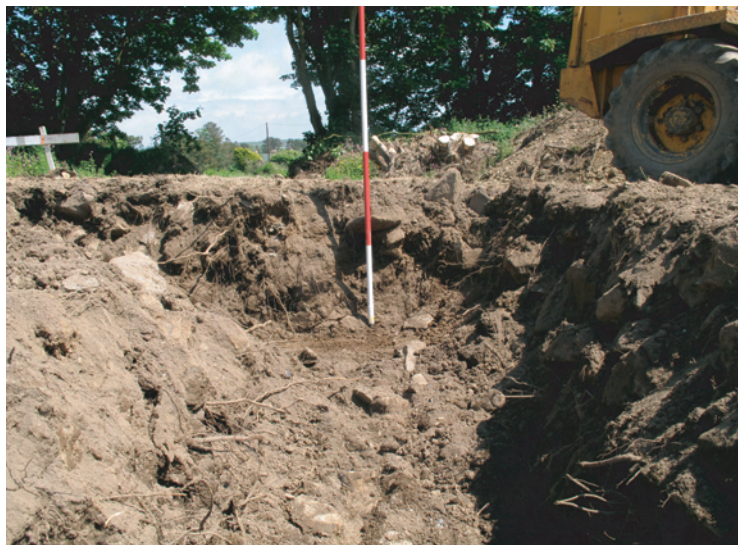
Plate 13. West facing section of southeastern corner of site following ground work. Shows deposit of earth and loose stone, indicative of demolition deposit, Looking east.

- 4.4 At the far south-eastern corner of the cleared development area, removal of the top soil and the sub soil exposed an area of stone rubble intermixed with earth (105). The position of this earth and rubble deposit coincides with the same deposit already exposed at the eastern end of the earlier

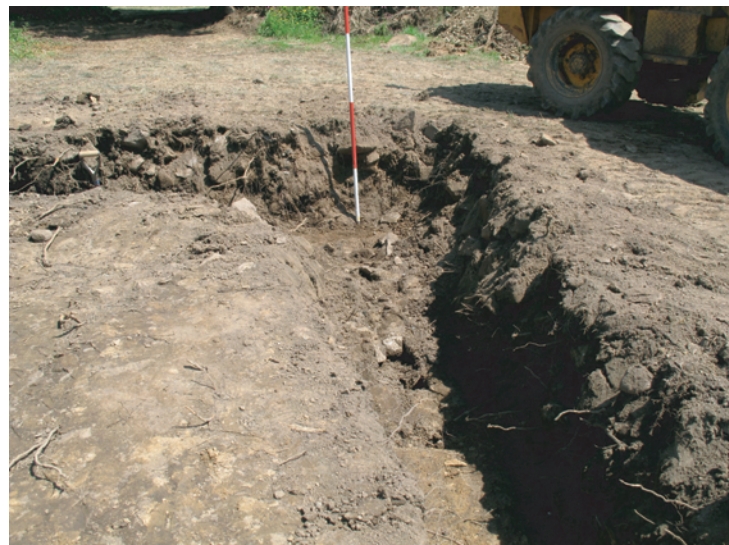
Plate 14. West facing section of southeastern corner of site following ground work. Looking east.

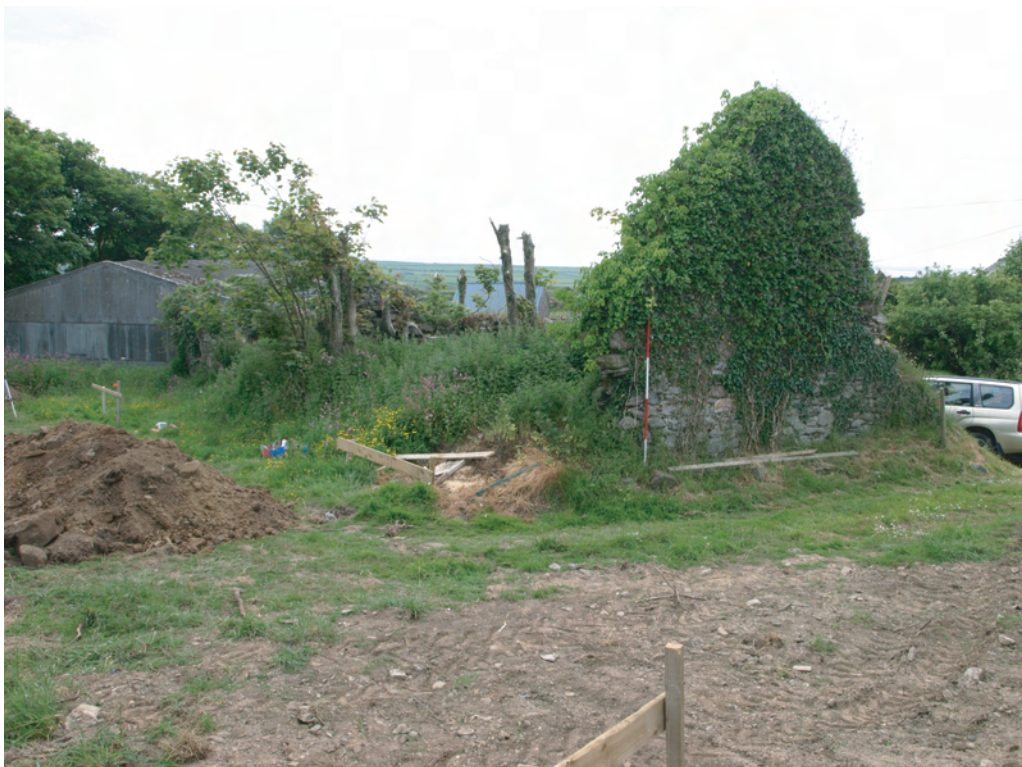
Plate 19. View of Hospitium remains prior to any clearance and consolidation work. Looking east.

within the interior. These trees have caused considerable damage to the stone walls over the years, their roots beginning to bulge and damage the walls. To further aggravate the building remains, the interior has also been used over the decades to dump garden waste and soil, which has led to the floor level being hidden beneath an estimated depth of 1 meter in garden and vegetation waste.

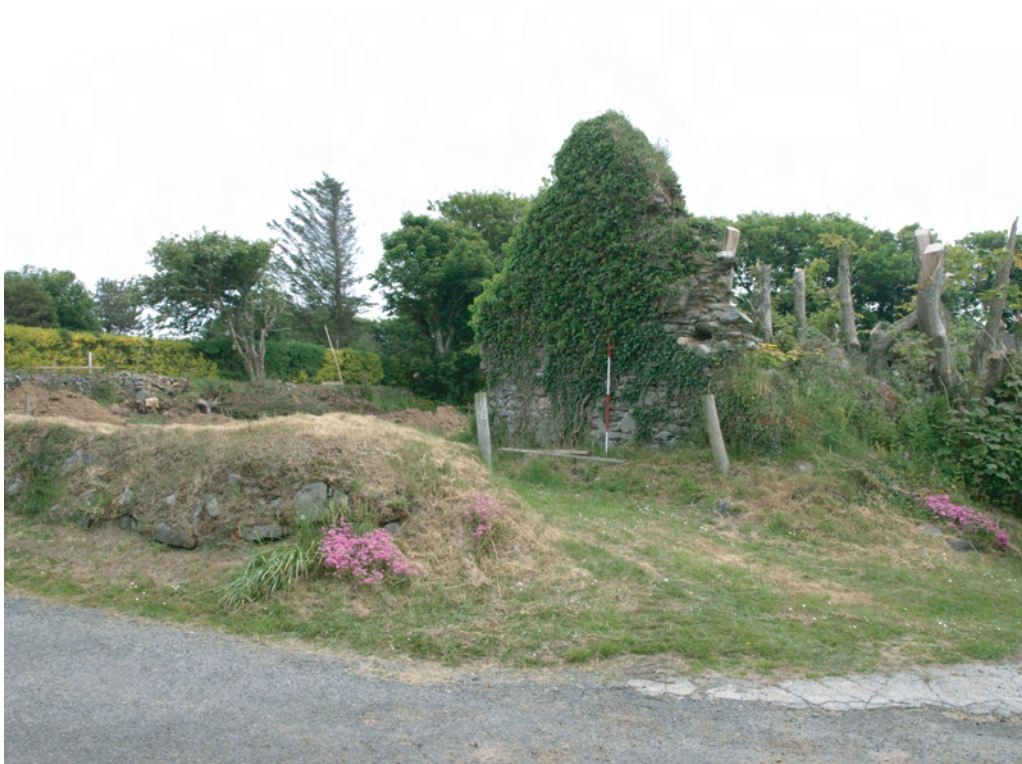
Plate 20. View of Hospitium remains prior to any clearance and consolidation work. Looking northeast.

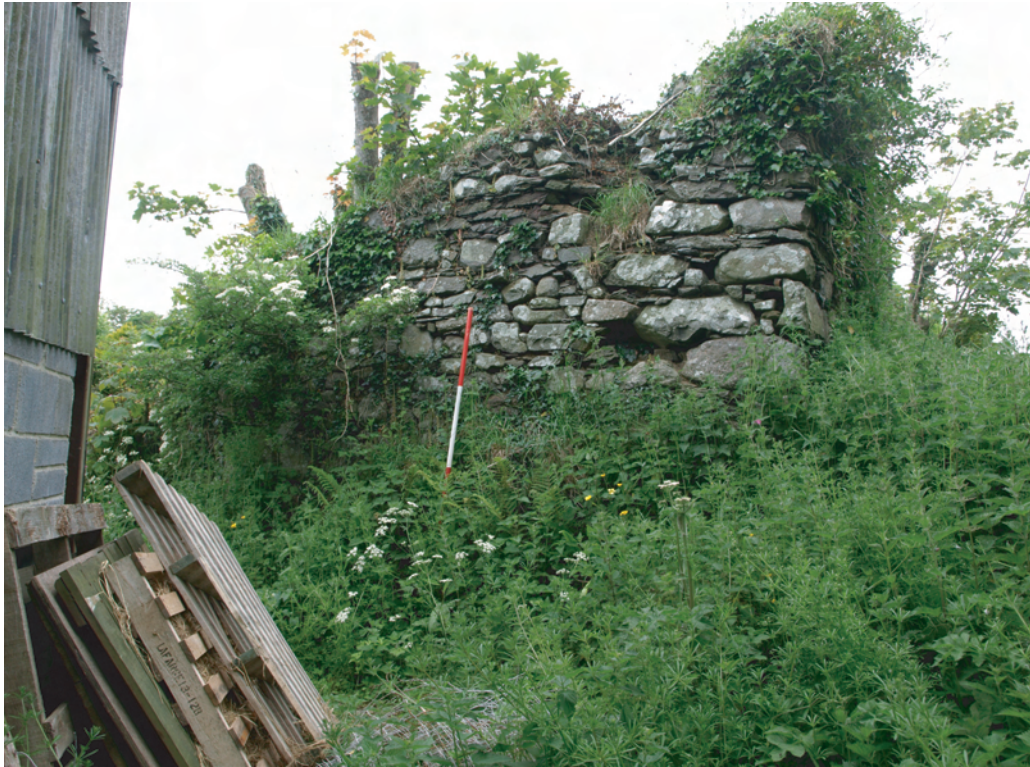
Plate 21. View of Hospitium remains prior to any clearance and consolidation work. External east facing gable end. Looking west.

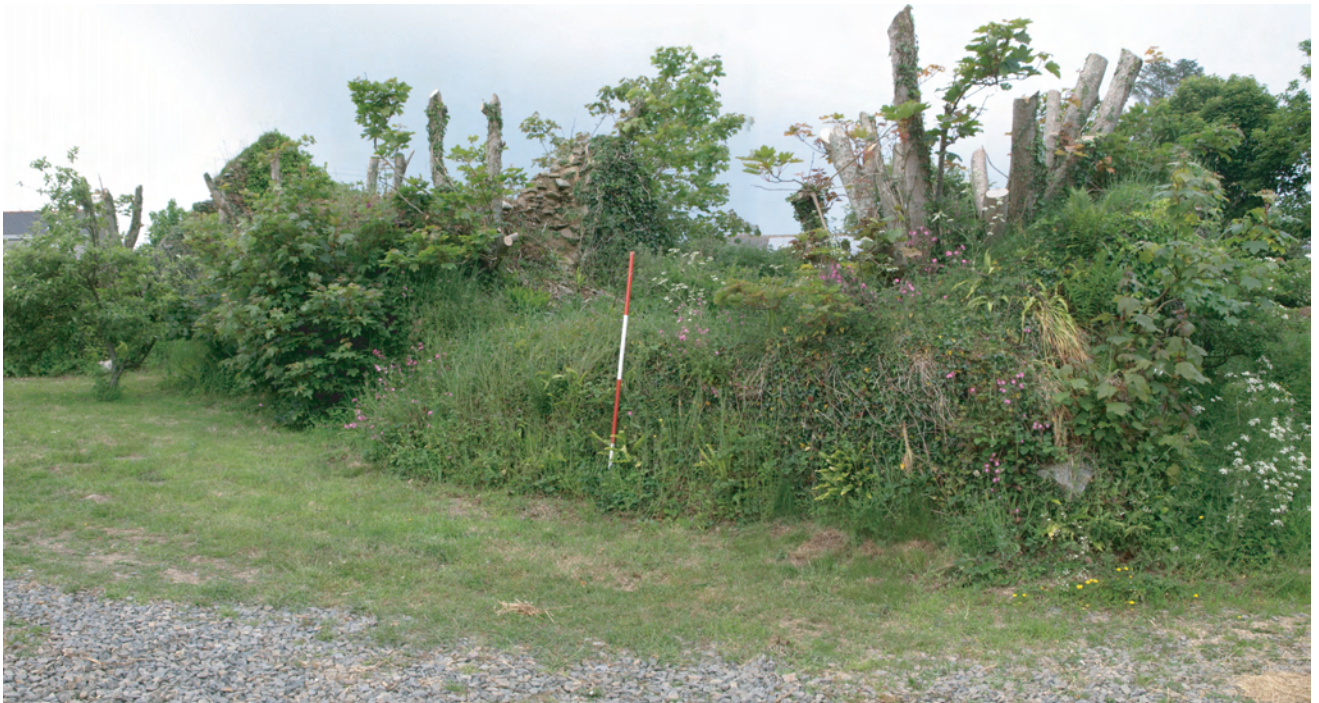
Plate 22. View of Hospitium remains prior to any clearance and consolidation work. Looking northwest.

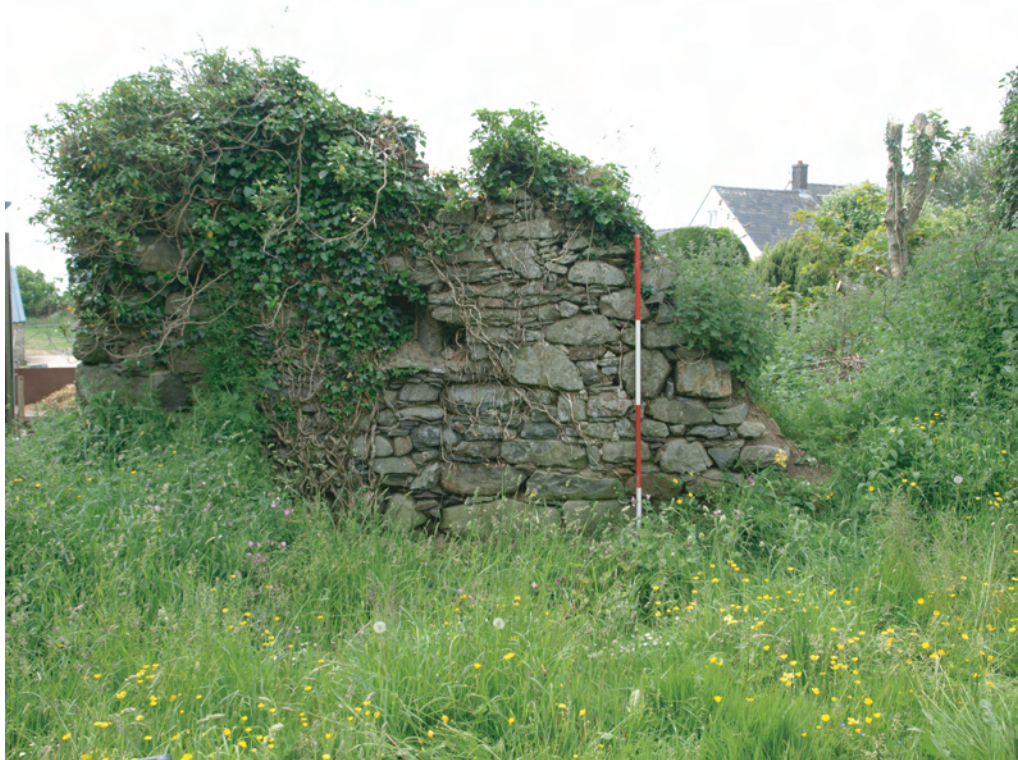
Plate 23. View of Hospitium remains prior to any clearance and consolidation work. External north facing east end. Looking south.

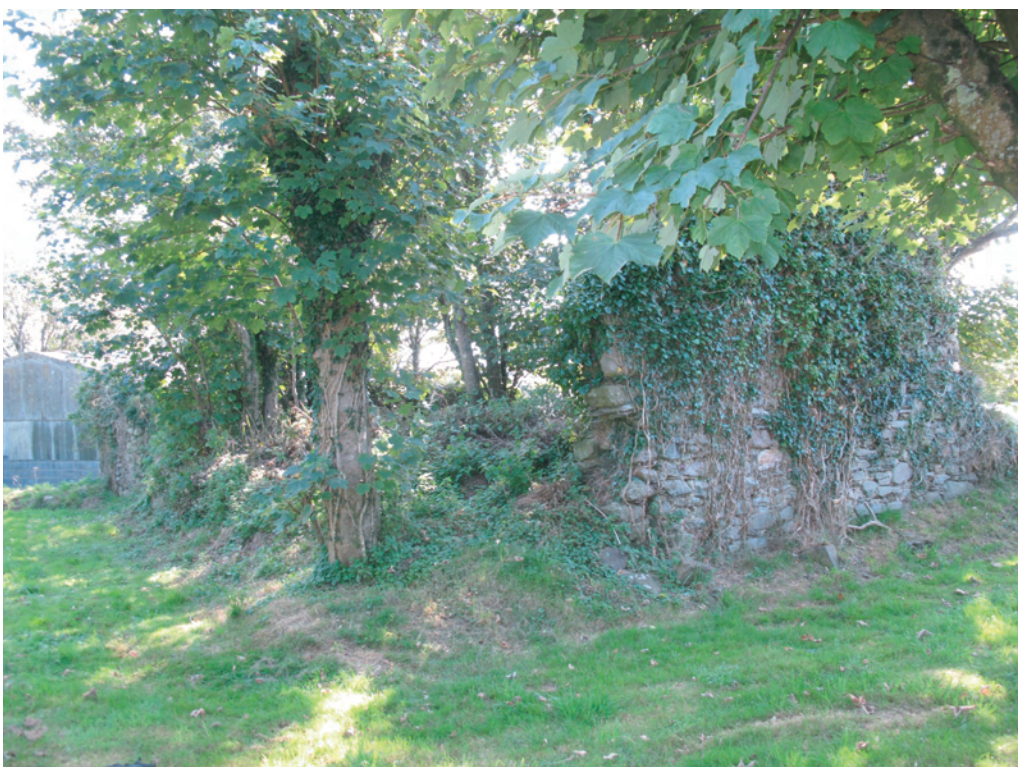
Plate 24. View of Hospitium remains prior to any clearance and consolidation work. Looking southeast.

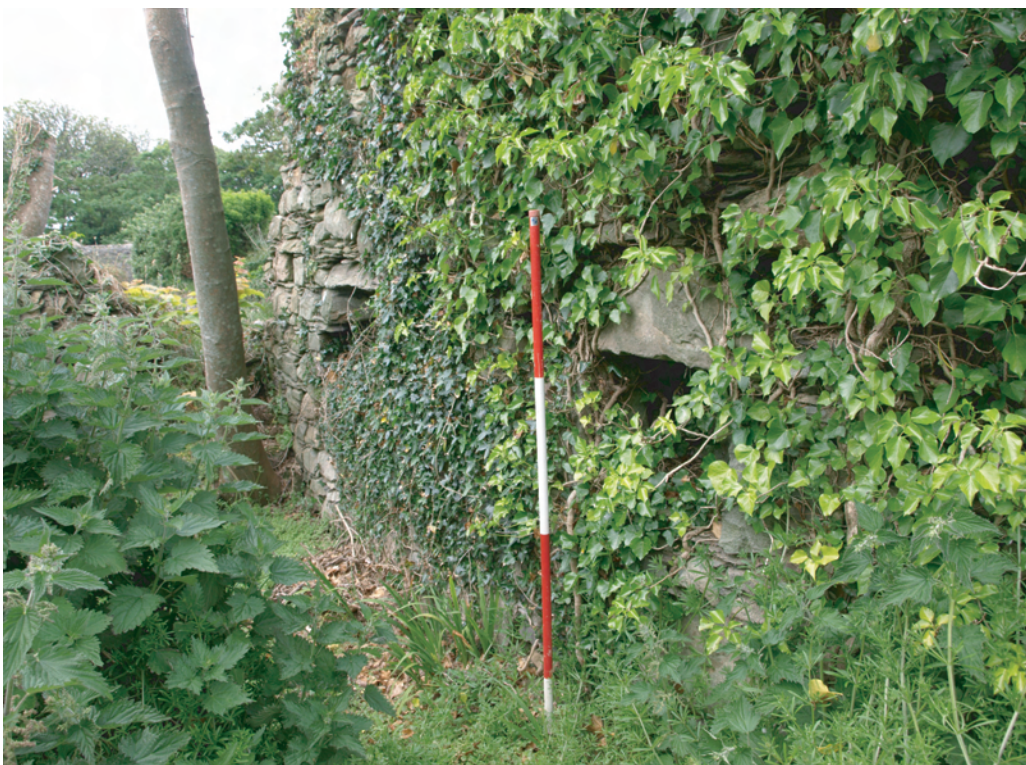
Plate 26. View of Hospitium remains prior to any clearance and consolidation work. Internal east facing gable end. Looking southwest.

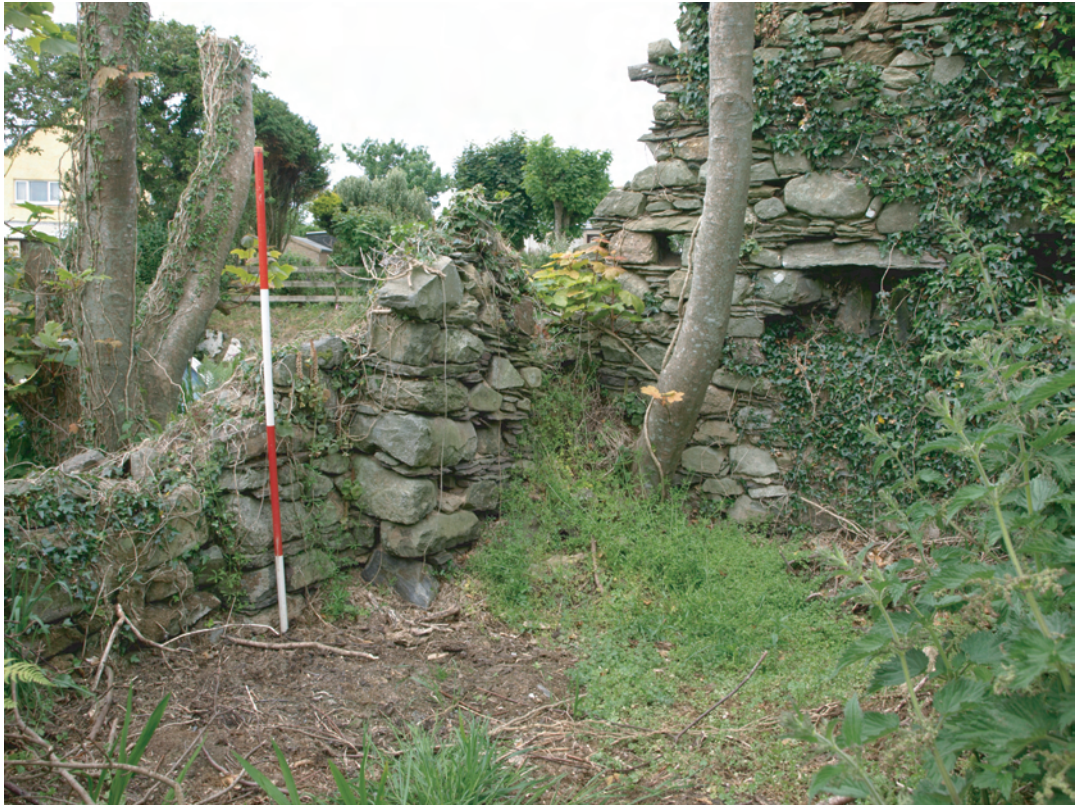
Plate 27. View of Hospitium remains prior to any clearance and consolidation work. Internal east facing gable end and part of north facing internal wall. Looking southwest.

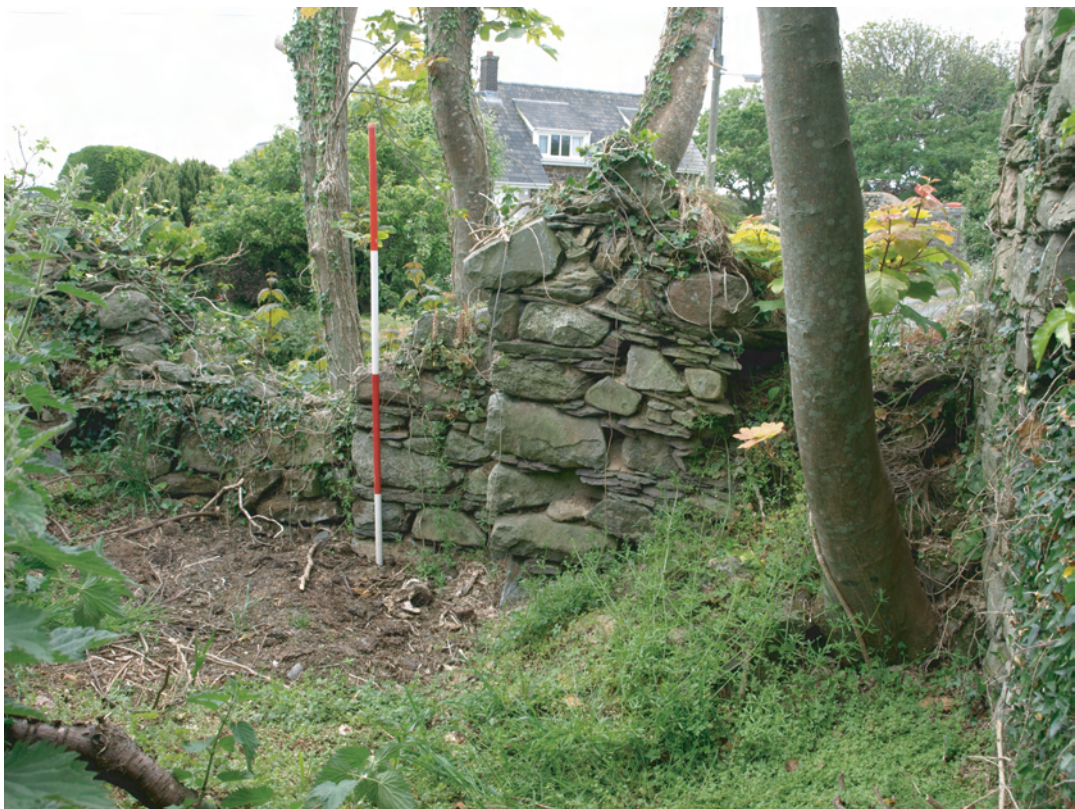
Plate 28. View of Hospitium remains prior to any clearance and consolidation work. West end of internal north facing wall. Looking south.

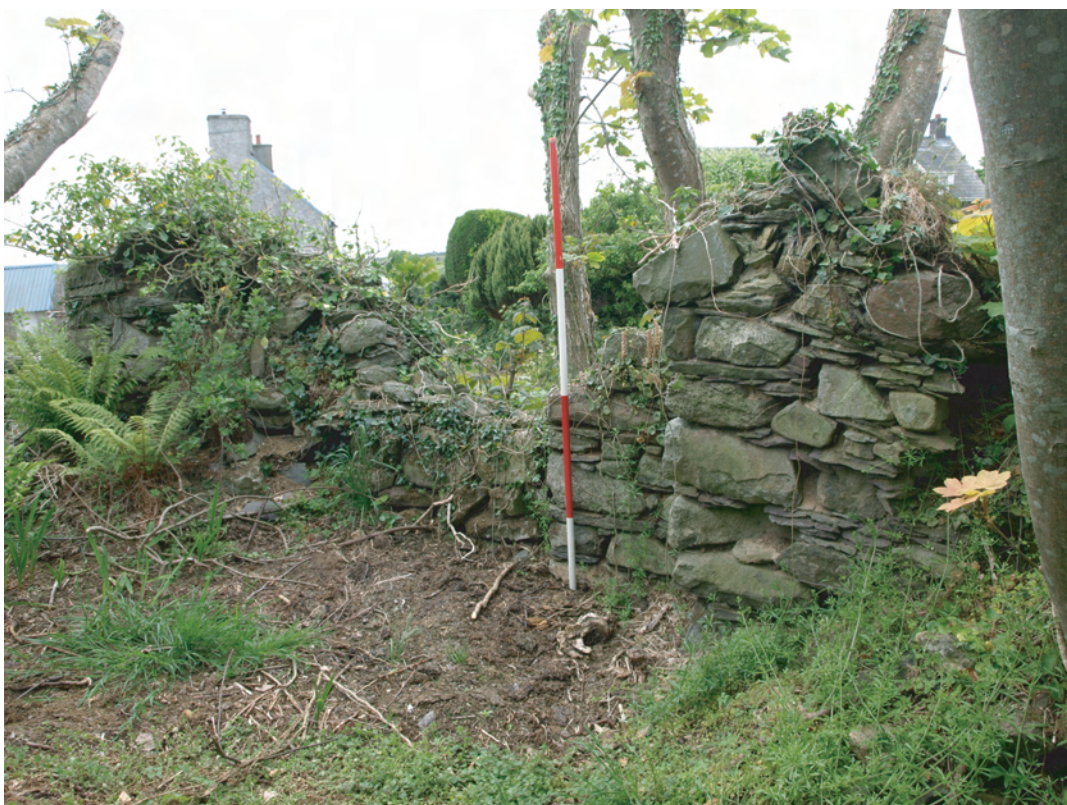
Plate 29. View of Hospitium remains prior to any clearance and consolidation work. West end of internal north facing wall. Looking south.

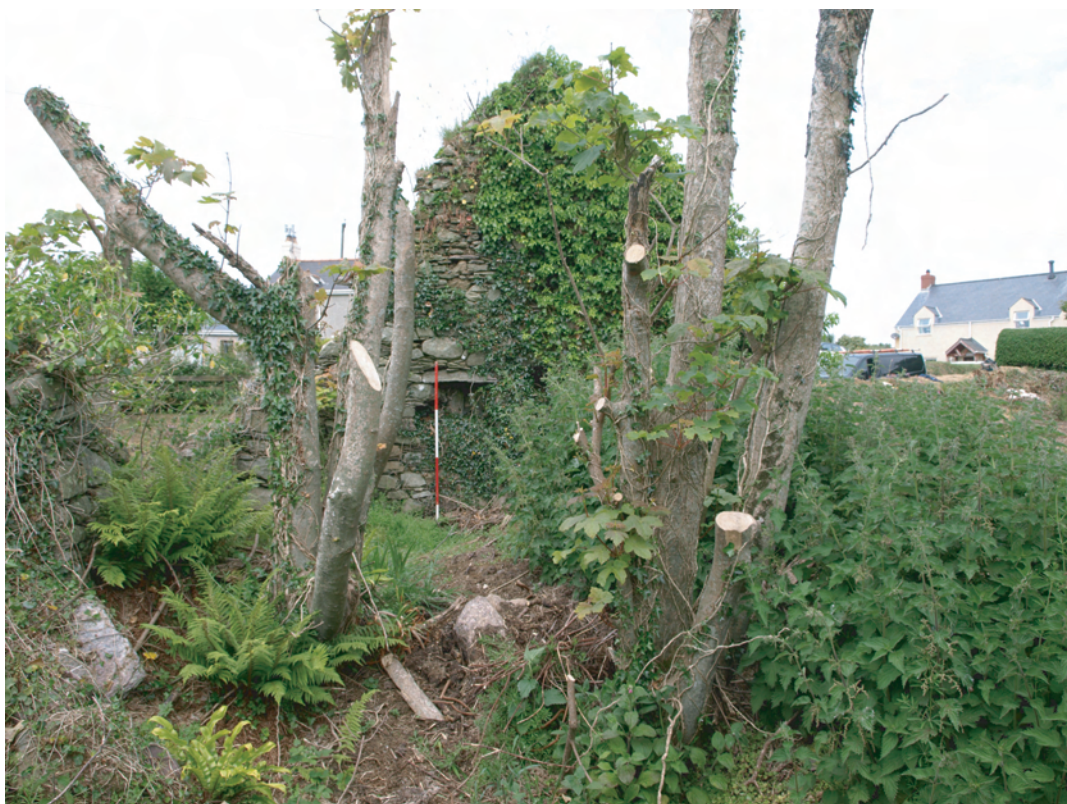
Plate 30. View of Hospitium remains prior to any clearance and consolidation work. Internal east facing gable end. Looking west.

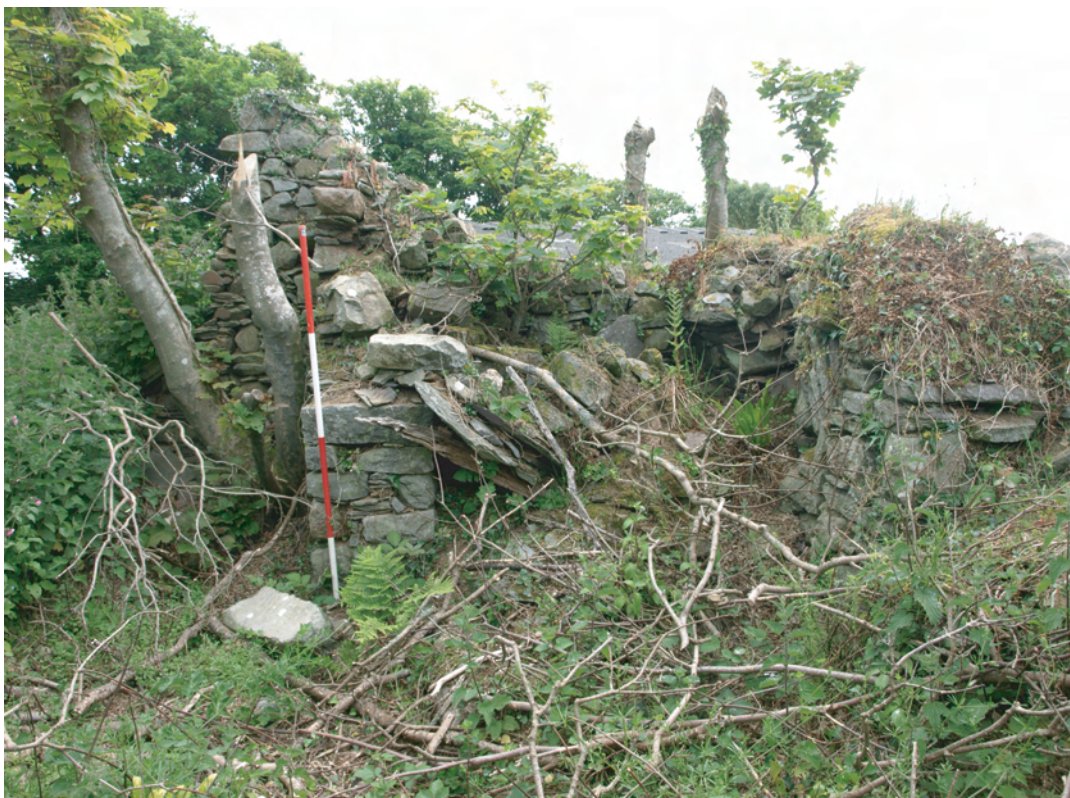
Plate 31. View of Hospitium remains prior to any clearance and consolidation work. Internal fireplace opening in central area. Looking east.

- 5.6 Internal architectural features noted, included two small niches at ground floor level head height within the western gable wall, along with the remains of three put-log holes spread evenly across the width of the wall above the niches, indicative of a former upper floor level. Within the central interior of the *hospitium*, architectural features noted include the remains of a stone built fireplace with the partial remains of its original timber lintel.

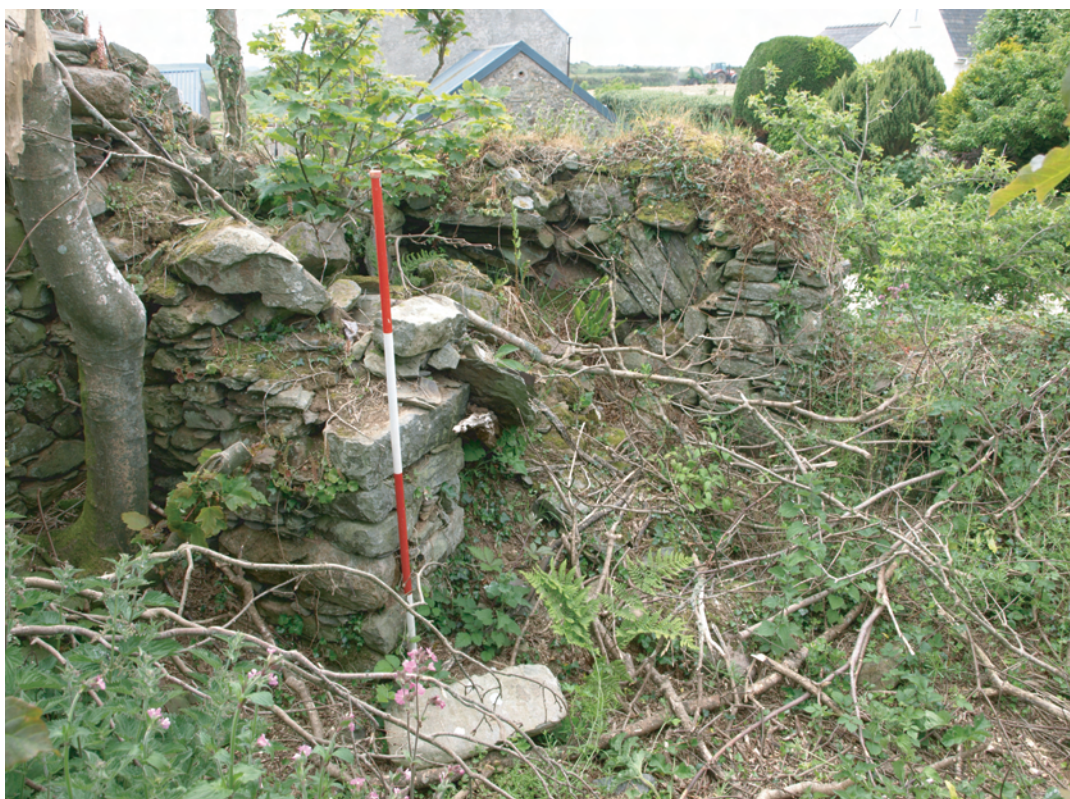
Plate 32. View of Hospitium remains prior to any clearance and consolidation work. Oblique view of remains of internal fireplace opening in central area. Looking south.

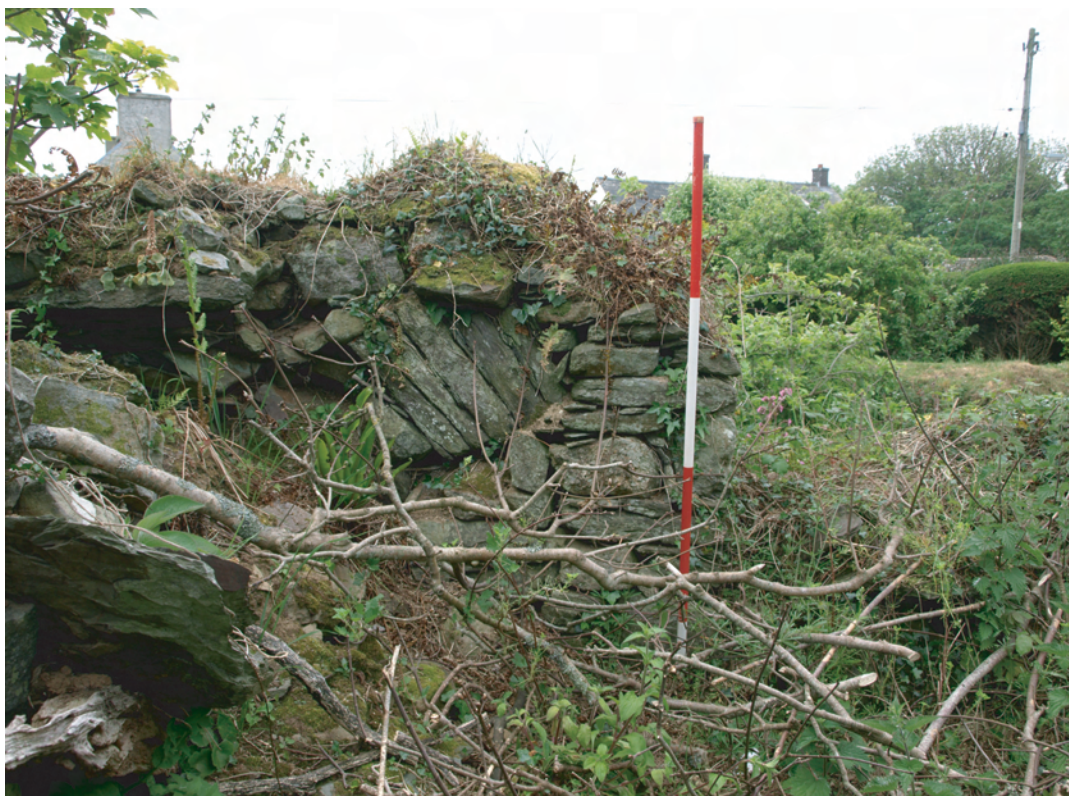
Plate 33. View of Hospitium remains prior to any clearance and consolidation work. View of remains of 'spring of arched opening' in internal masonry alongside fireplace opening in central area. South wall looking south.

- 5.7 Within the interior western unit, architectural features noted within the interior are the remains of two apparent *springs* of arches, both built into the southern wall, one alongside the western gable end and the other alongside the remains of the fireplace. These architectural features would suggest there was originally at least two arched openings in the south wall, in the western unit at least. Unfortunately detailed inspection of the eastern unit was not entirely possible due to vegetation cover. The presence of these arch springs and other internal and external features would seem to confirm the description of the *hospitium* ruins given in the Pembrokeshire Archaeological Survey of 1908 and the RCAHMW Survey in 1925, that is that the ruins included vaulted 'recesses', arches, and a possible lancet window,

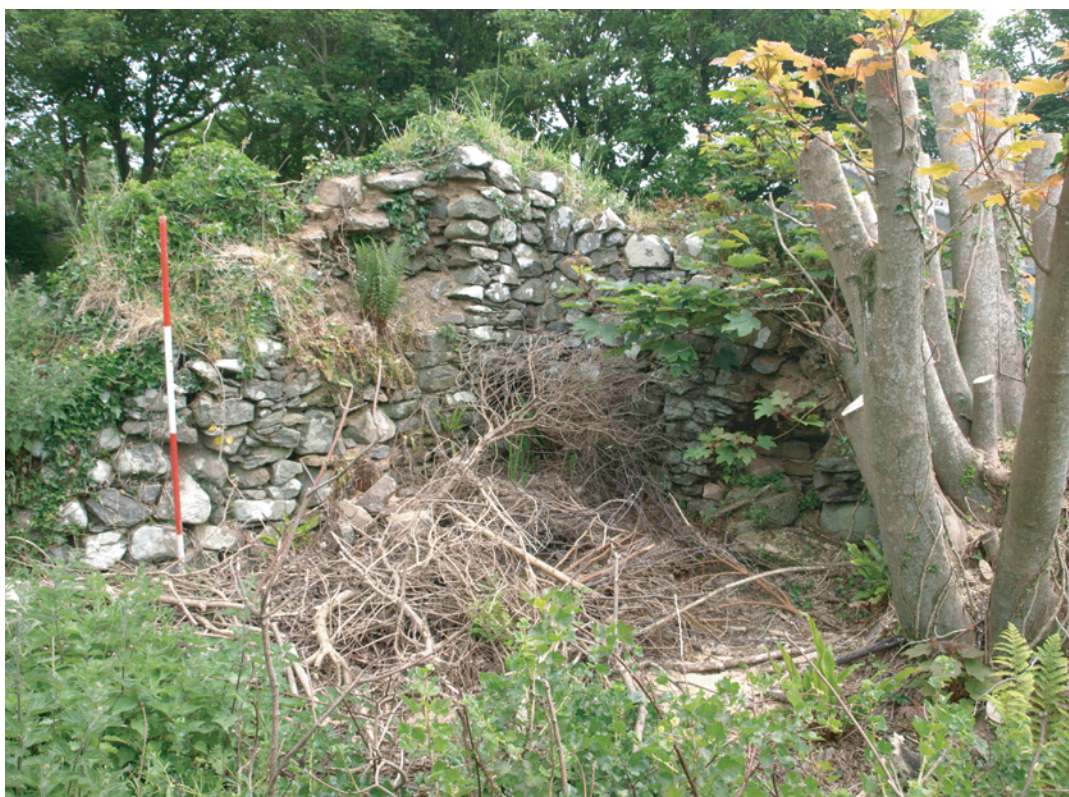
Plate 34. View of Hospitium remains prior to any clearance and consolidation work. Internal east end. Looking eastwards.

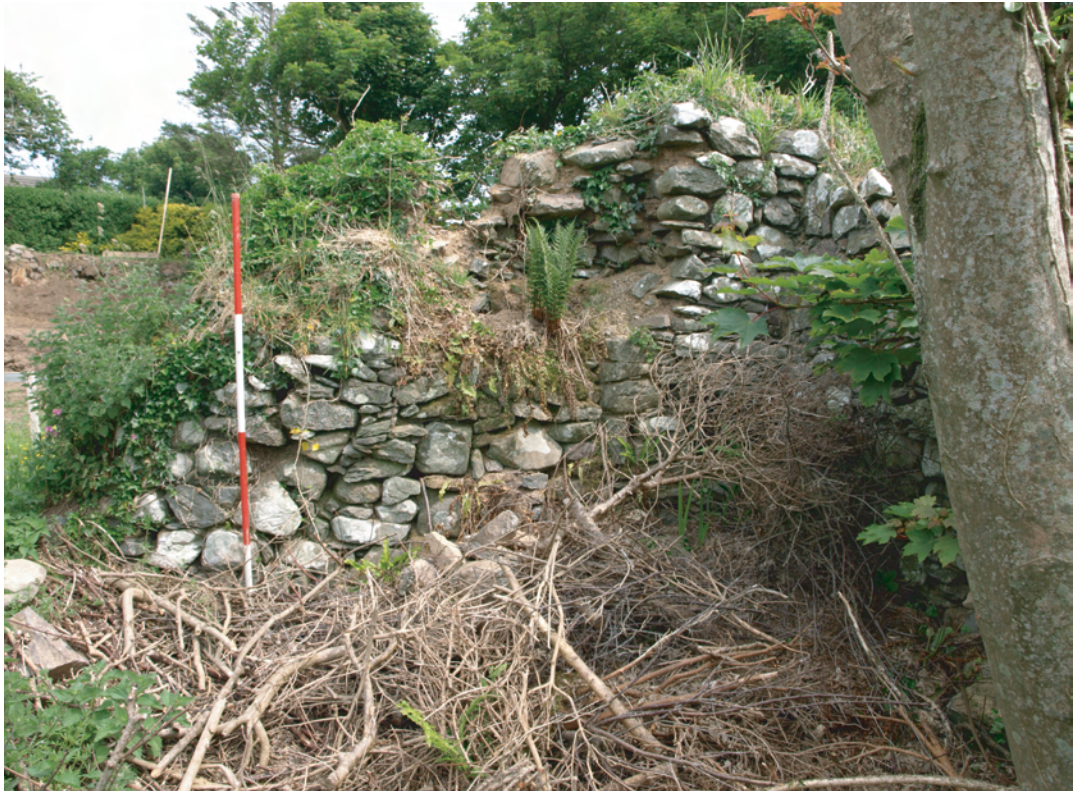
Plate 35. View of Hospitium remains prior to any clearance and consolidation work. Internal view of east end north wall. Looking north.

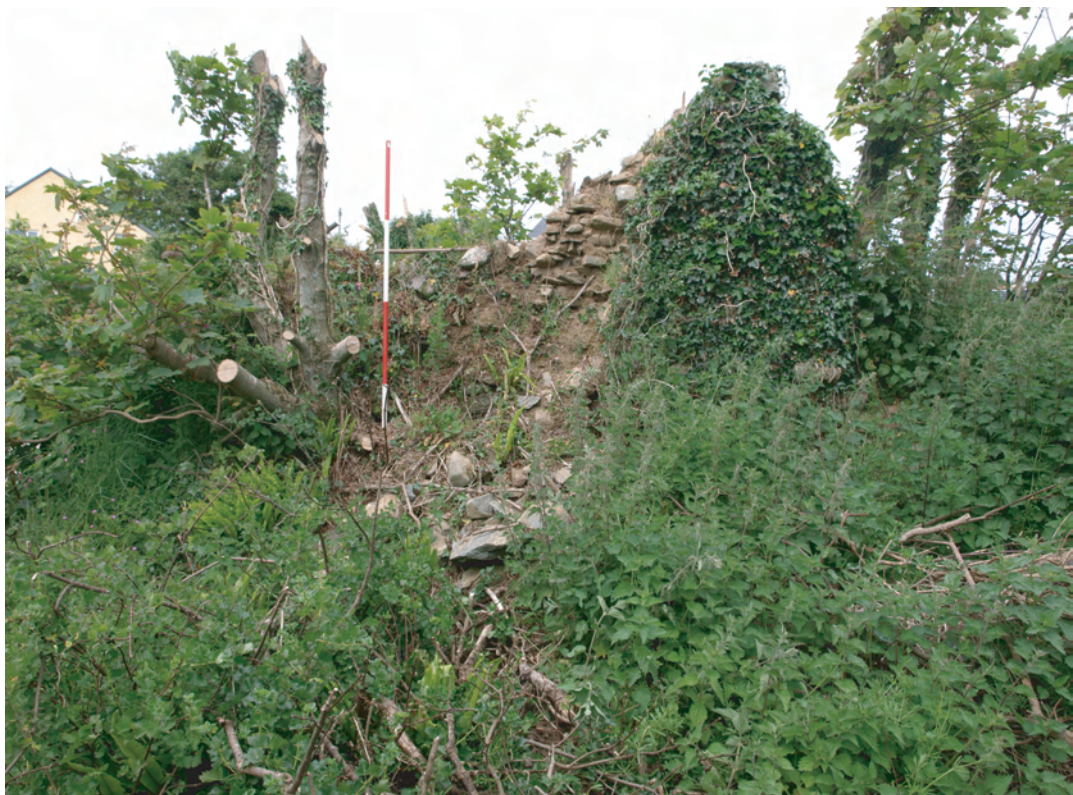
Plate 36. View of Hospitium remains prior to any clearance and consolidation work. View of internal area looking west from east end.
